SAND2004-4193  
Unlimited Release  
Printed November 2004

# **Failure Analysis for the Dual Input Quad NAND Gate CD4011 Under Dormant Storage Conditions**

N. Robert Sorensen  
Corrosion, Electrochemistry & Cleaning Department

Sandia National Laboratories  
P.O. Box 5800  
Albuquerque, NM 87185-0888

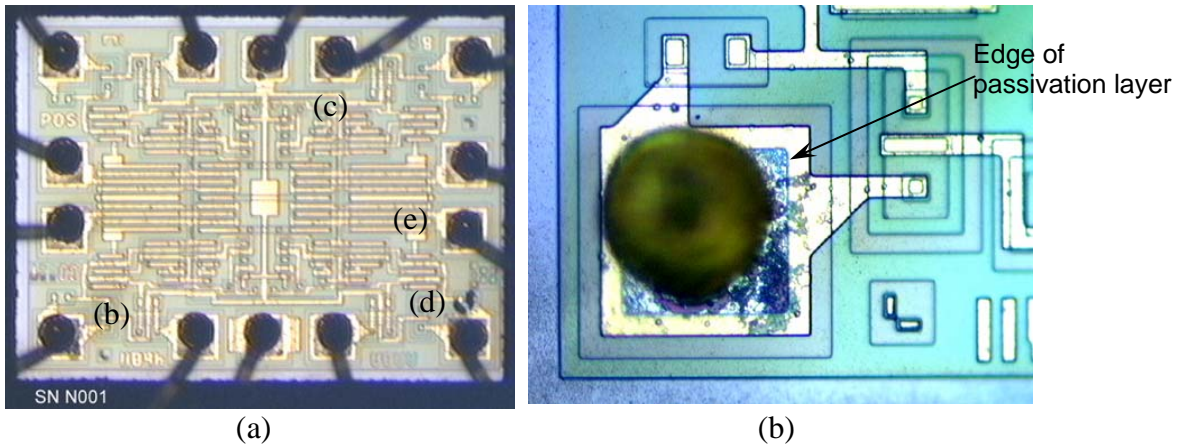
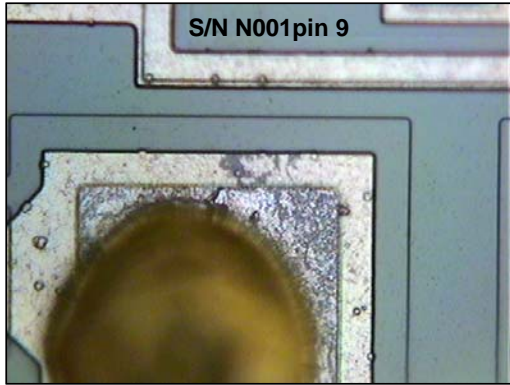
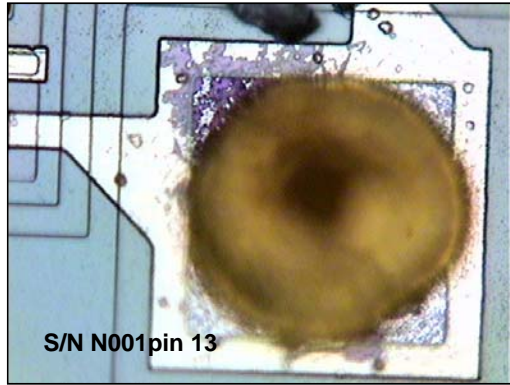
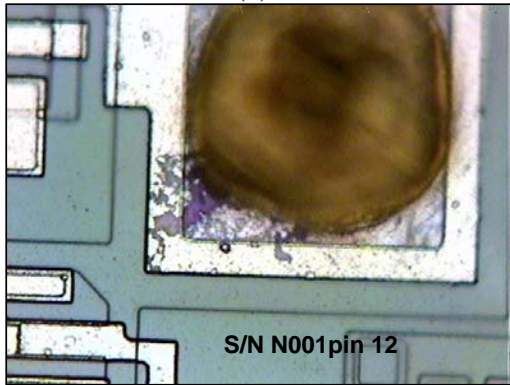
All of the parts that exhibited electrical failure were examined optically for evidence of corrosion. Figure 3 shows optical images of part S/N N001 following the decap process. Electrical testing resulted in many failures with no obvious trends being established. Corrosion was observed on many of the bondpads (1, 3, 4, 9, 12, 13 & 14). Three of the bondpads are shown (9, 12, and 13). Attack of the bondpad is visible, although the Al has not been entirely consumed. In addition, corrosion has progressed beneath the passivation layer at the edge of the bondpad. No evidence of trace corrosion was found.

Figure 3. Optical micrographs of Al bondpads for CD-4011 S/N N001. Note attack of Al and progression of attack below the passivation layer.

It is clear that corrosion of the Al bondpads was responsible for the electrical failure of several of the CD4011 parts. In general, the attack was limited to the bondpad itself. In some instances, corrosion was found beneath the passivation layer adjacent to the bondpad, but it was never observed to progress very far into the die interior. No attack of the passivated Al traces was observed. Thus, it is clear that the lack of passivation on the bondpads is a primary factor in corrosion of these devices. For bondpad corrosion to occur, both moisture and halogen (primarily chloride) contamination are required. We have experimental data showing that moisture alone will not cause corrosion of the Al bondpads (ref. 2). Based on our studies and results from industry, there is no evidence that contaminants can be transported through the plastic (ref. 3). Thus, it is likely that contaminants were present when the part was injection molded. The fact that not all of the bondpads were attacked suggests that the contamination was localized to specific locations rather than being found generally across the die surface.

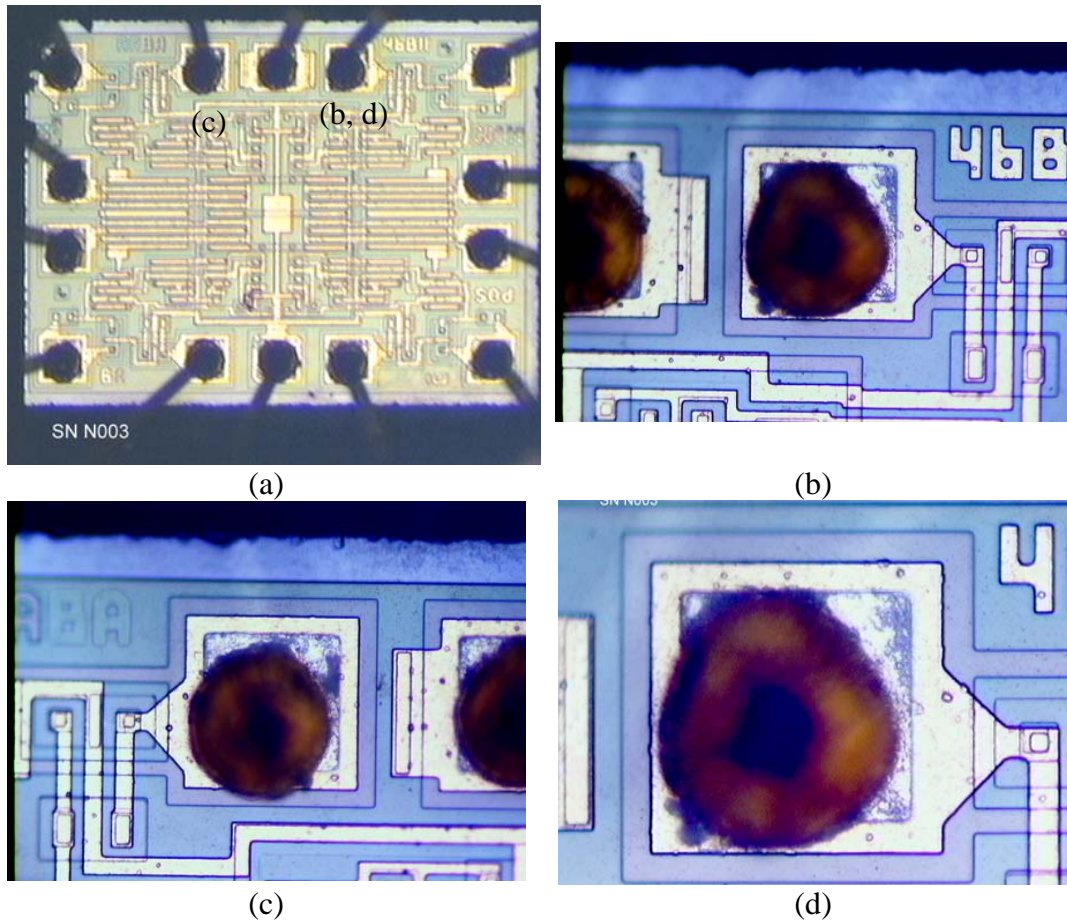
Figure 4 shows images of device N003. Electrically, numerous failures were observed, with no obvious trends. Following the de-cap process corrosion was observed on bondpads 5 and 6. In this case, the bondpads were almost completely consumed. Corrosion products are visible on the die surface. No evidence of trace corrosion was found.

Figure 4. Optical micrographs of Al bondpads for CD-4011 S/N N003. Note attack of Al and progression of attack below the passivation layer.

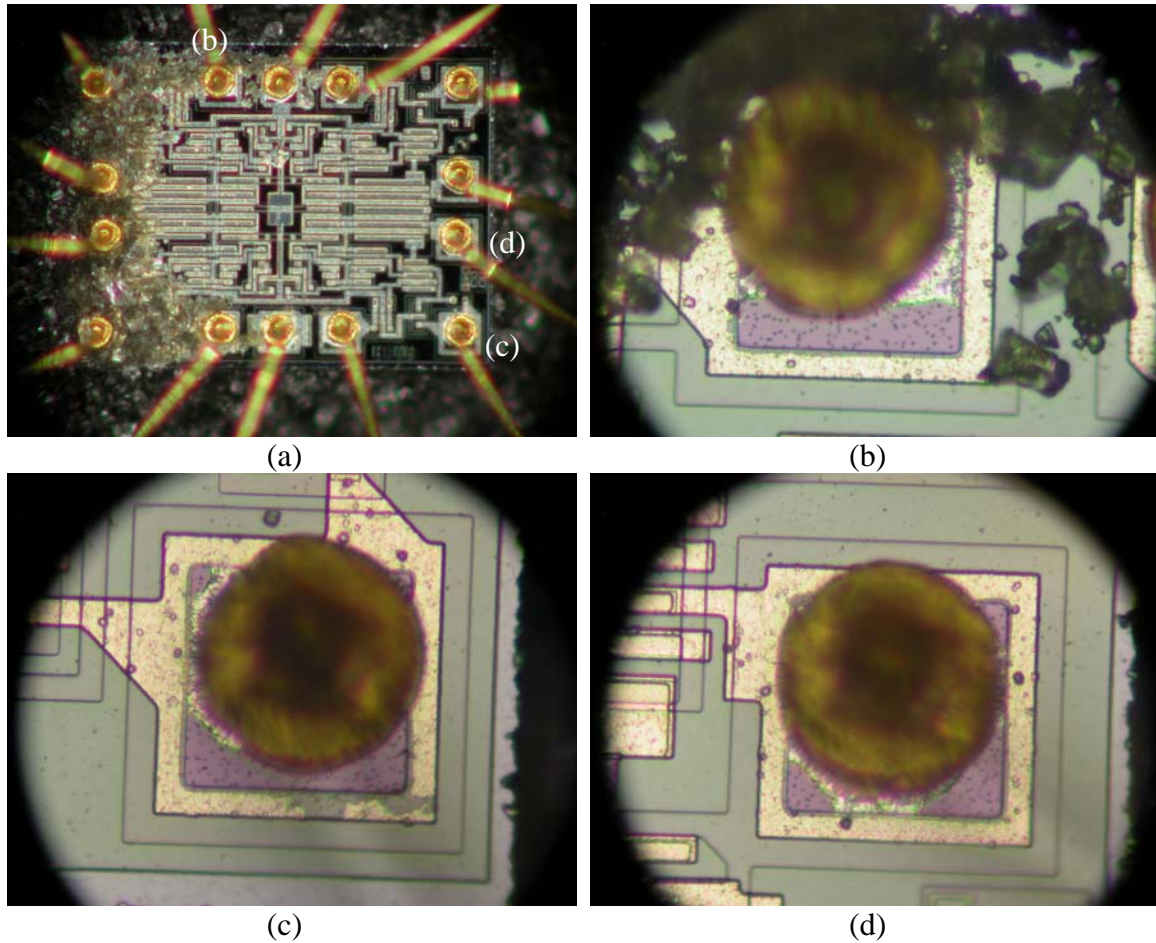
Device S/N N005 exhibited an open circuit on pin 1. Images from this device are shown in Figure 5. During the de-cap process, the epoxy was not completely removed from the die surface. Thus, several of the wirebonds were not visible for optical evaluation. Corrosion is visible on several of the bondpads. In general, it stops at the passivation layer, but some undercutting of the passivation layer is visible (c). No evidence of trace corrosion was seen.

Figure 5. Optical micrograph of CD-4011 S/N N005. Labels on the image in (a) indicate location for individual bondpads imaged in (b)-(d).

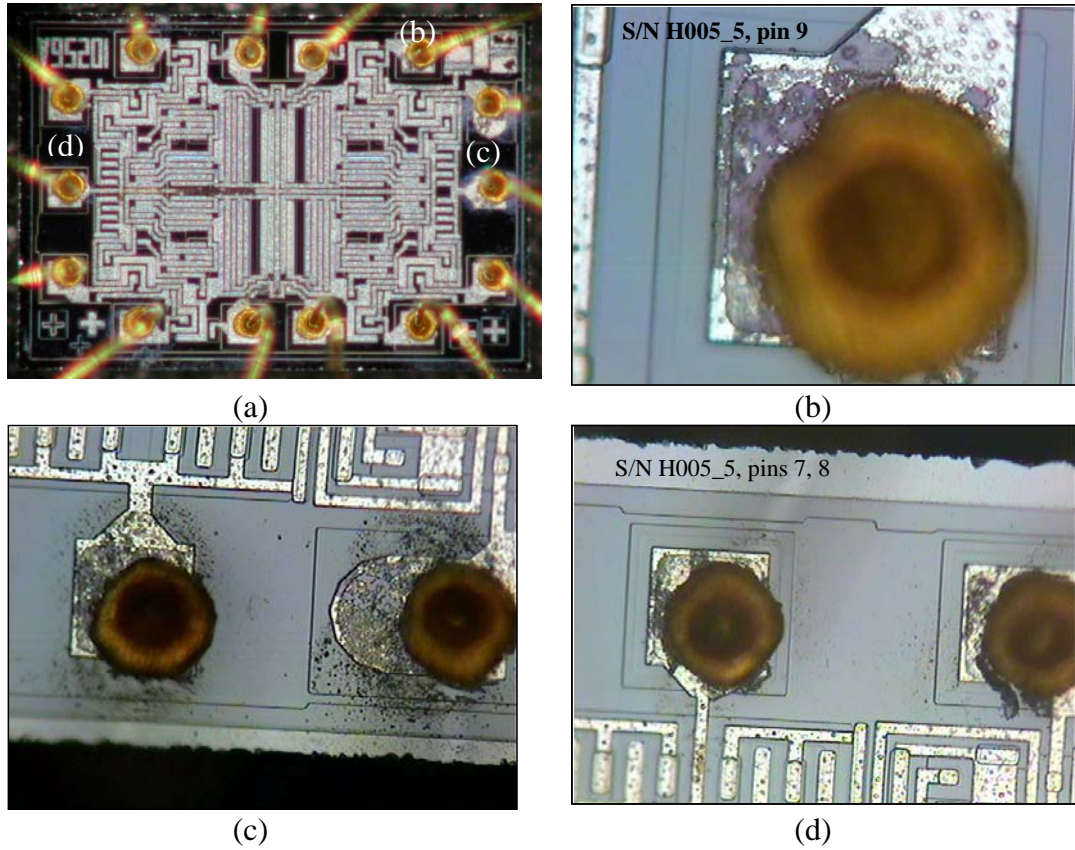
Sample S/N H005 exhibited opens at pins 8 and 9 during electrical testing. Optical microscopy (Figure 6) revealed corrosion on pins 1,2,3,7,8,9,12,13 and 14. As seen in the figure, extensive attack of the bondpad was observed. Corrosion products are visible on the die surface. Although only two of the bondpads indicated open circuit, many more were corroded which would likely lead to additional open circuits in the future. No evidence of trace corrosion was seen.

Figure 6. Optical micrographs of Al bondpads for CD-4011 S/N H005. Extensive attack of the bondpad and corrosion products on the die surface can be seen. Labels on the image in (a) indicate location for individual bondpads imaged in (b)-(d).

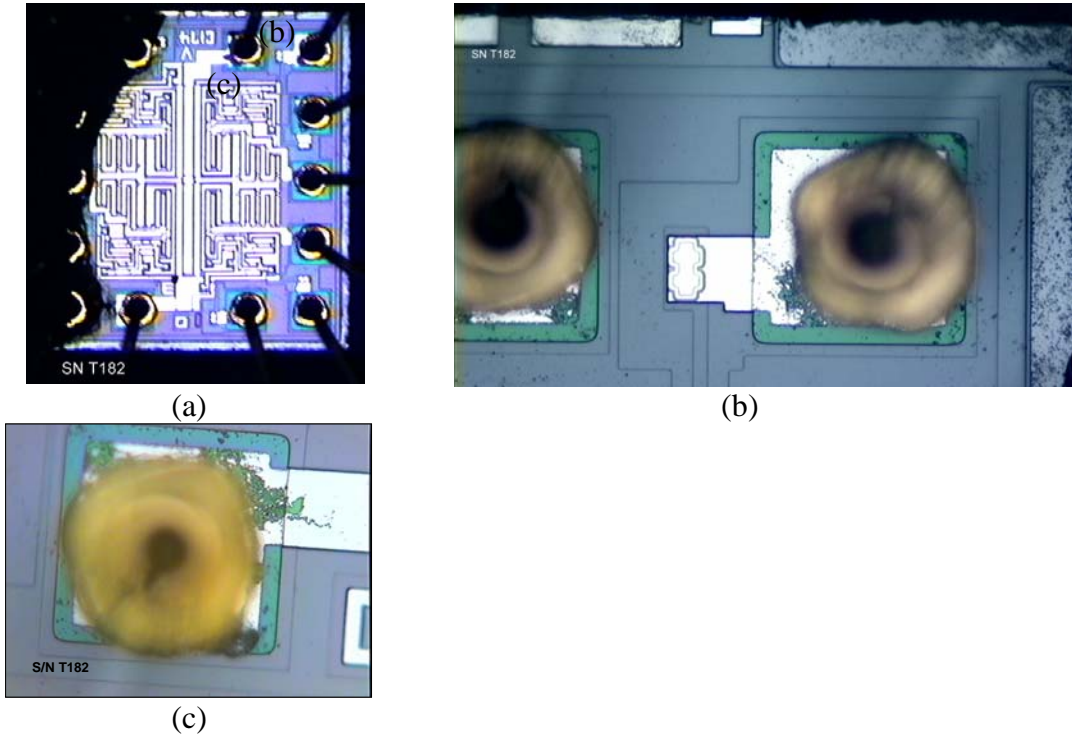
Figure 7 shows images from S/N T182. In electrical testing, several of the leads were in the wrong state. Visual analysis indicated corrosion of bondpads associated with pins 6 and 7. Those connected to pins 8 through 12 were obscured by residual epoxy, and thus, were not visible. In general, the die is very clean and shows no evidence of trace corrosion.

Figure 7. Optical micrographs of Al bondpads for CD-4011 S/N T182. Attack of the bondpad can be seen with corrosion progressing beneath the passivation layer. Pins 6 and 7 were affected. Labels on the image in (a) indicate location for individual bondpads imaged in (b)-(c).

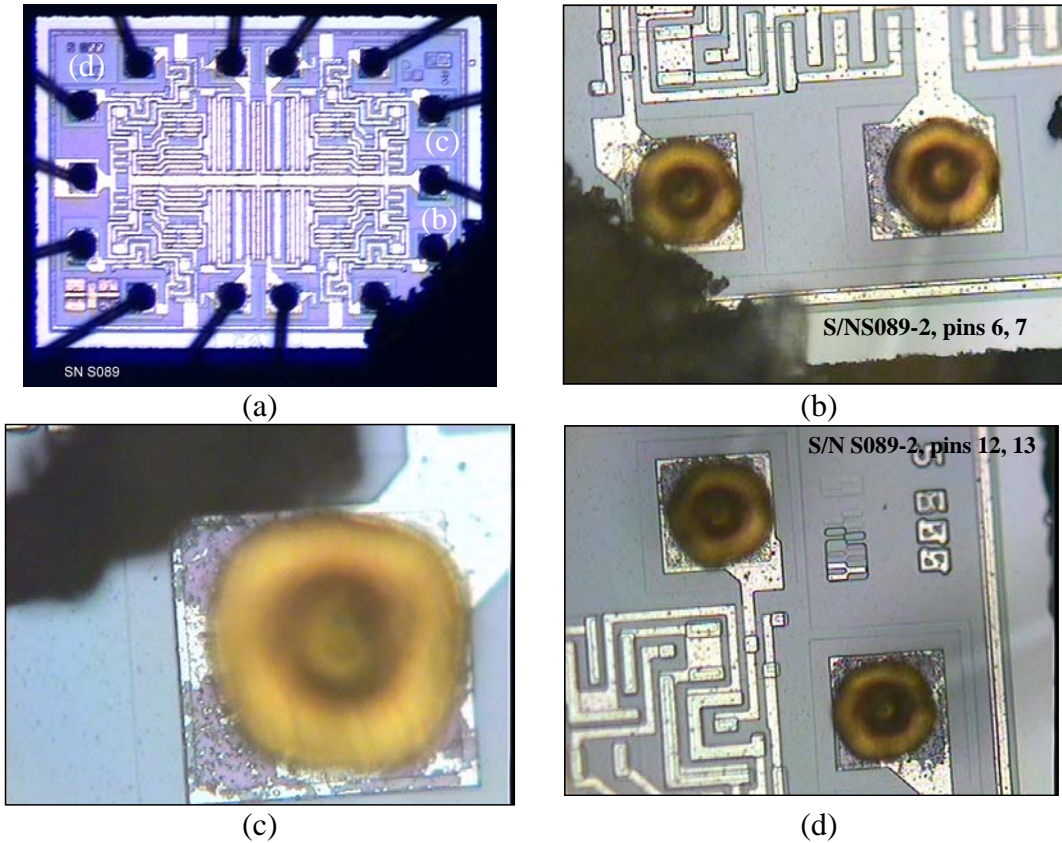
Figure 8 shows device S/N S089. Electrical testing resulted in output pin 11 in the wrong state. Corrosion was found on all pins except 11 and 14. The extent of attack ranged from slight to severe. In some instances, the bondpad was almost completely consumed. No evidence of trace corrosion was seen.

Figure 8. Optical micrographs of Al bondpads for CD-4011 S/N S089. Extensive attack of the bondpad can be seen with corrosion progressing beneath the passivation layer. Pins 6, 7, 12, and 13 were attacked. Labels on the image in (a) indicate location for individual bondpads imaged in (b)-(d).

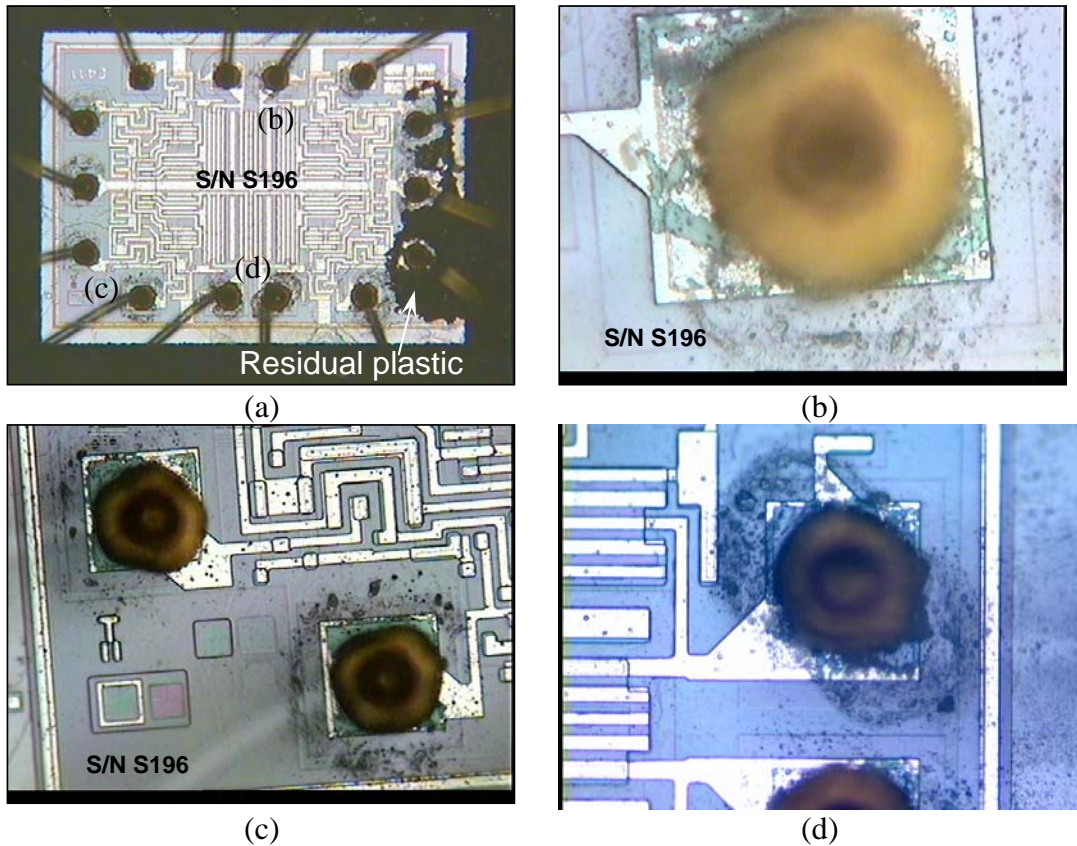
Figure 9 shows images from S/N S196. Pin 2 tested open during electrical testing. Corrosion was seen on all of the bondpads. The bondpad attack is visible, even on the low magnification image of the entire die. On some bondpads, the Al bondpad appeared to be totally consumed. In many areas, corrosion products are visible on the die surface around the bondpad.

Figure 9. Optical micrographs of Al bondpads for CD-4011 S/N S196. All bondpads exhibited some degree of attack. Labels on the image in (a) indicate location for individual bondpads imaged in (b)-(d).

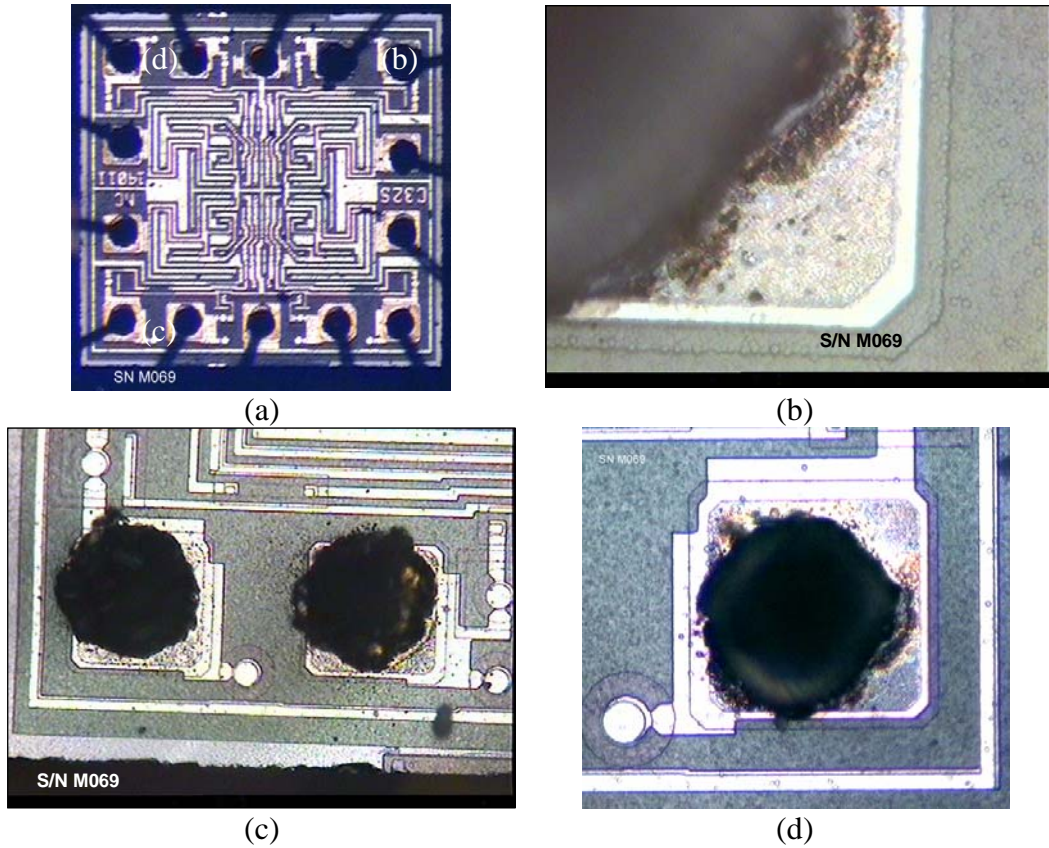
Figure 10 shows data for S/N M069. Pins 1,5, and 8 tested open. Corrosion was observed on pins 5, 6, and 9. The extent of visible corrosion was considerably lower on this device. In all cases, the majority of the Al bondpad was intact. The attack appeared to be concentrated around the edge of the gold ball. Otherwise, the die was clean, with no evidence of trace corrosion.

Figure 10. Optical micrographs of Al bondpads for CD-4011 S/N M069. Minor attack of the bondpad is visible. In addition, the rough material at the edge of the ball bond suggests formation of intermetallic compounds (ref. 1). Labels on the image in (a) indicate location for individual bondpads imaged in (b)-(d).

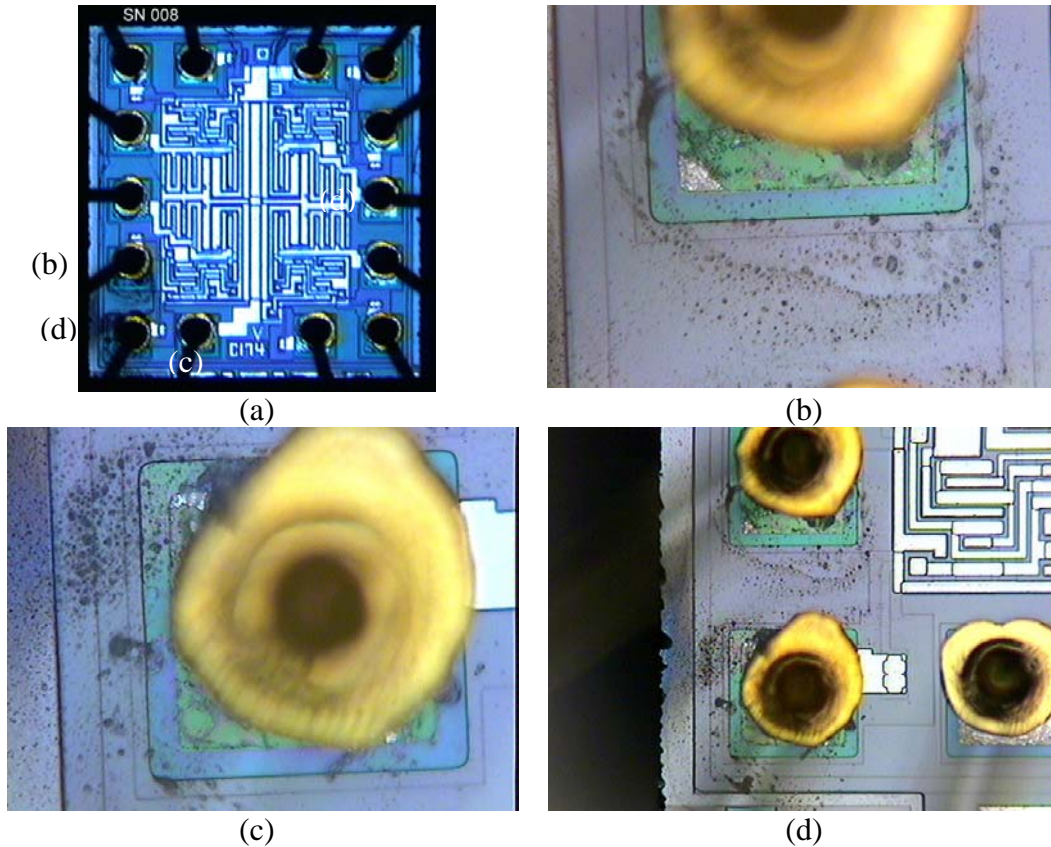
The last device examined was labeled SN 008. At this point the source of this part and the manufacturer is unknown. Based on the appearance of the die, it appears to be a Toshiba part. During testing and analysis, the identification was lost. Thus, the electrical response is unknown. This part exhibited extensive corrosion at several of the bondpads. In some instances, the entire Al bondpad had been consumed, with corrosion products visible on the die surface. Because the identification of this device is still unknown, it was not included in the failure rate data. During the next electrical testing sequence, an effort will be made to identify the source of SN 008.

Figure 11. Optical micrographs of Al bondpads for CD-4011 S/N 008. Severe attack of the bondpad is visible. In addition, corrosion products can be seen on the die surface. Labels on the image in (a) indicate location for individual bondpads imaged in (b)-(d).

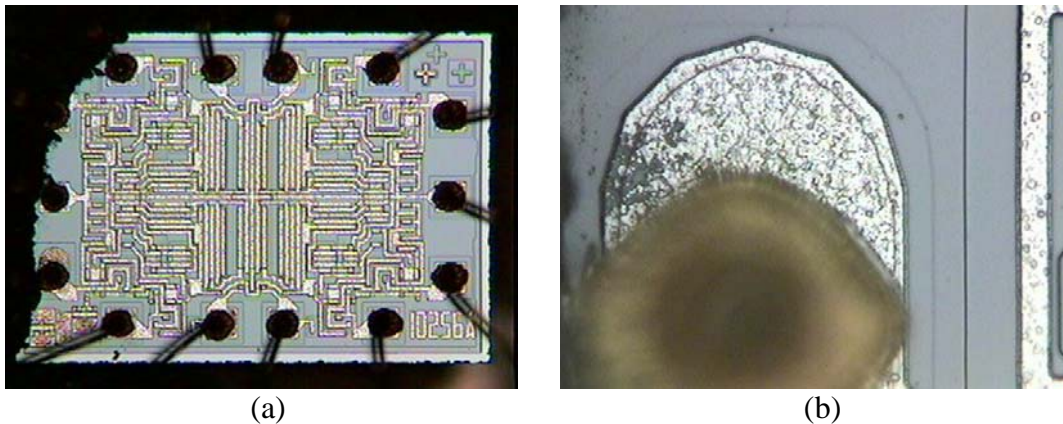
Figure 12 shows the die and bondpad for the Harris 59 device. Slight corrosion is seen on the bondpad, with no other evidence of attack.

Figure 12. Optical micrographs of Al bondpads for CD-4011 S/N H59. The die is generally healthy with a small amount of bondpad corrosion seen on pin 1.

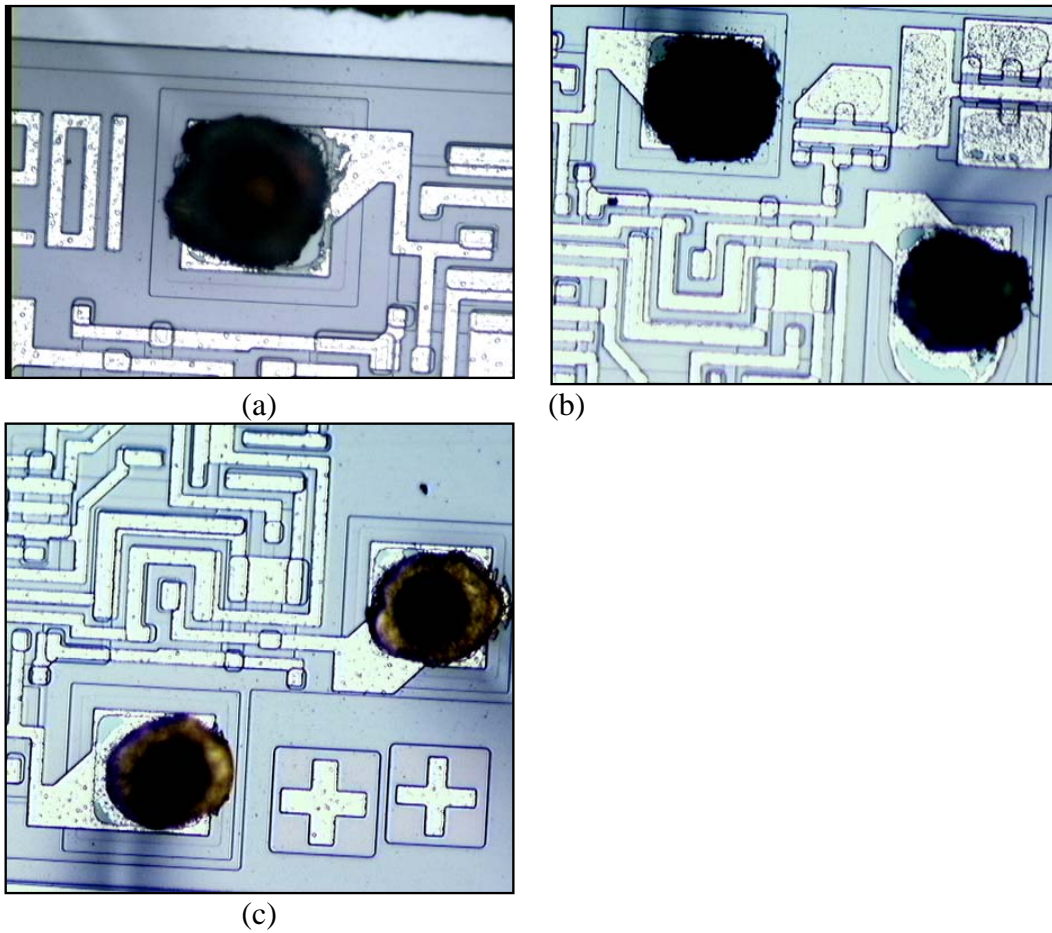
Figure 13 shows results for Harris SN 65. Attack was seen on pin 5 and 6. Although the attack was not extensive, it is possible that it was concentrated at the Au/Al interface, resulting in isolation of the Au wire and electrical open at that point.

Figure 13. Optical micrographs of Al bondpads for CD-4011 S/N H65. The die is generally healthy with a small amount of bondpad corrosion seen on several bondpads.

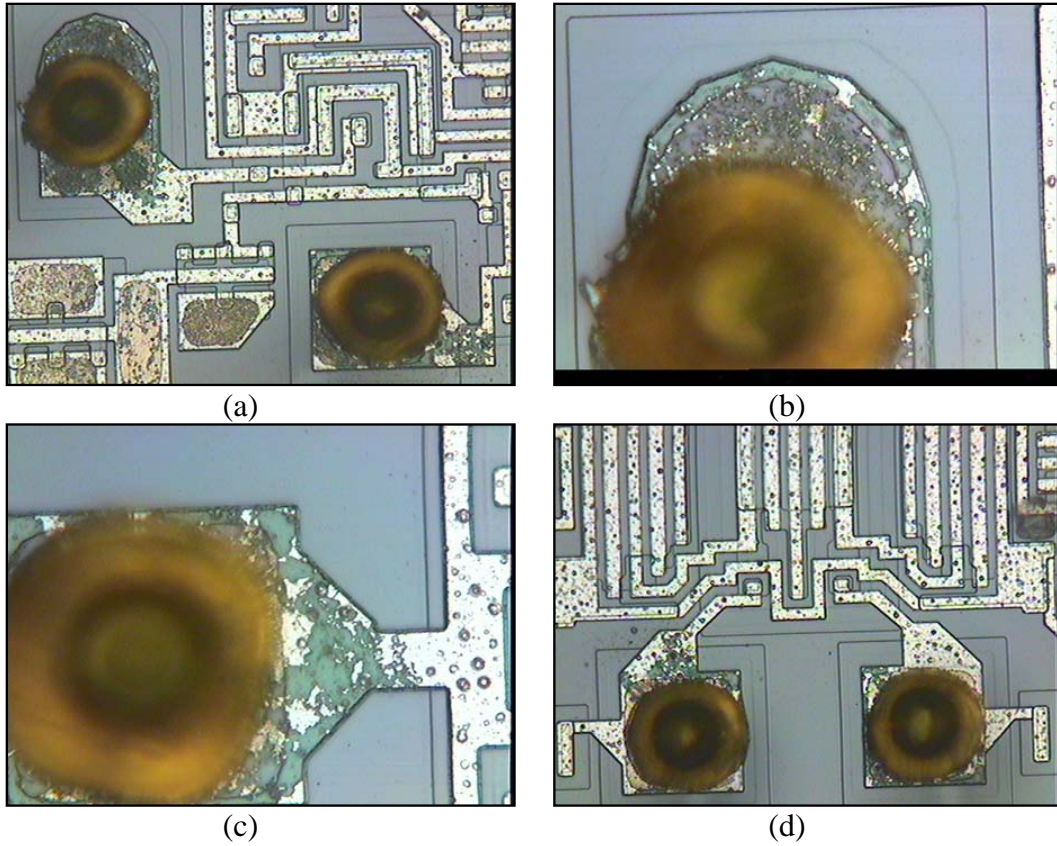
Figure 14 presents results from Harris 43. Corrosion was observed on multiple bondpads. The attack is quite severe, with substantial Al missing from several of the bondpads. In some cases (e.g. Figure 14c), corrosion has progressed from the bondpad into the trace (beneath the passivation layer) connected to the bondpad.

Figure 14 Optical micrographs of Al bondpads for CD-4011 S/N H43. Substantial corrosion can be seen on several bondpads, with some evidence of attack of the Al traces.

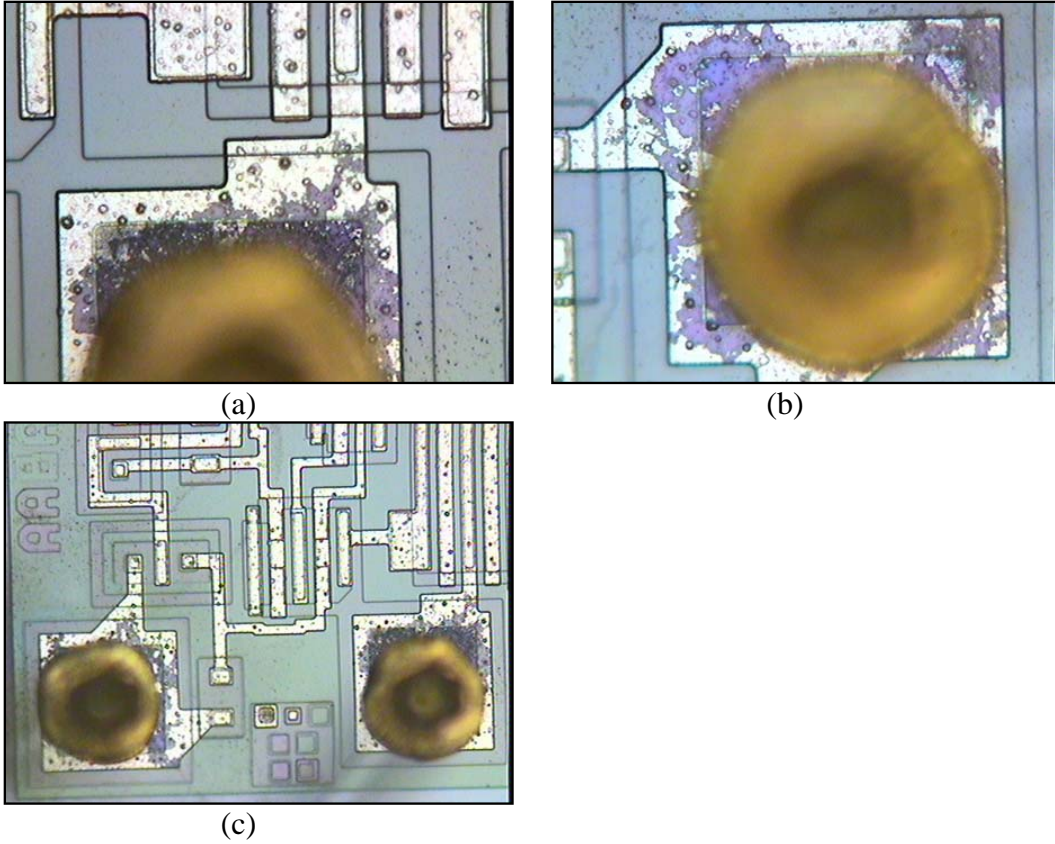
Figure 15 shows results from National 38. Corrosion was observed on multiple bondpads. In some instances, it penetrated further beneath the passivation layer and attacked the adjacent Al. The extent of attack is certainly significant enough to result in electrical failure of the part. No attack of the traces was observed.

Figure 15. Optical micrographs of Al bondpads for CD-4011 S/N N38. Substantial corrosion can be seen on several bondpads.

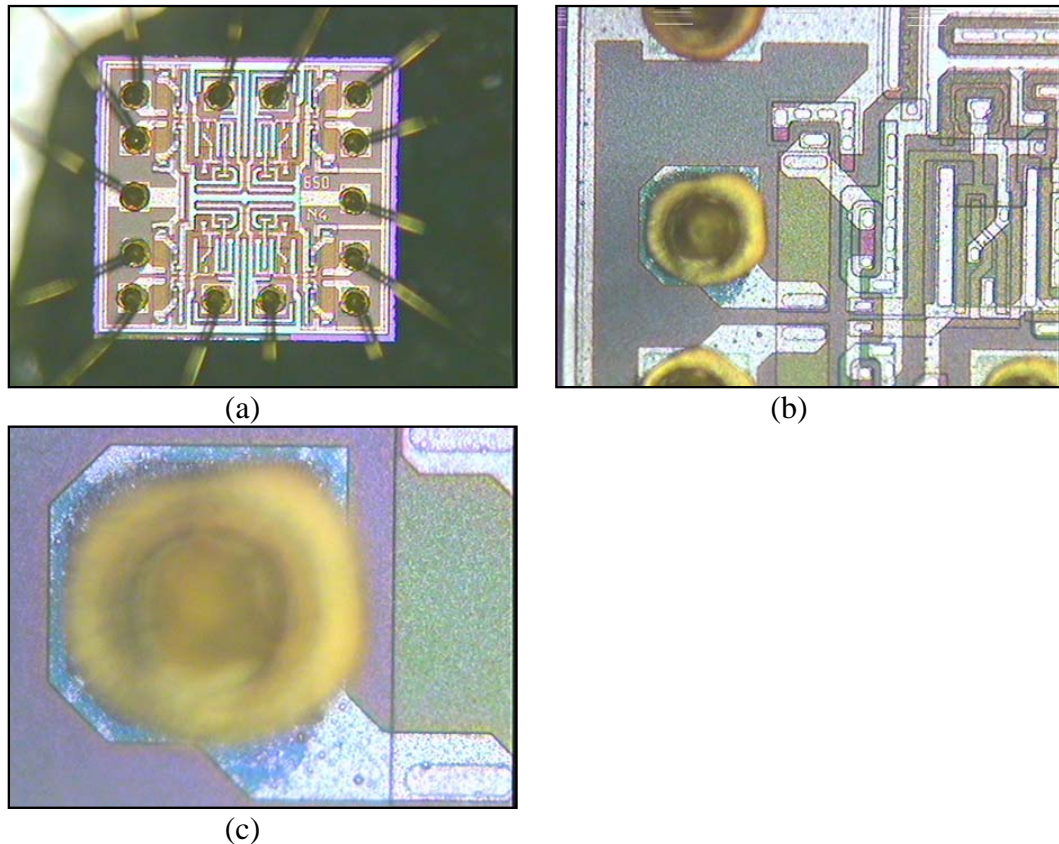
Figure 16 shows micrographs for Philips 43. Corrosion was observed on pin1. Significant attack of the bondpad can be seen. Other bondpads did not appear to be corroded. In addition, there was no evidence of trace corrosion.

Figure 16. Optical micrographs of Al bondpads for CD-4011 S/N P43. Die is generally healthy. Some attack can be seen on pin 1.
