DESTRUCTIVE EXAMINATION OF SHIPPING PACKAGE 9975-02028

Publication Date: December 2009

**Savannah River Nuclear Solutions
Savannah River Site
Aiken, SC 29808**

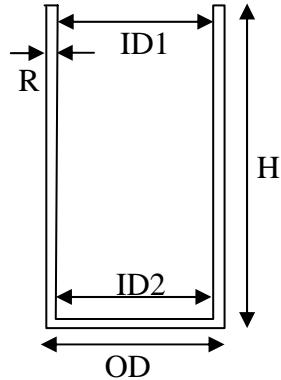
Table 3. Lead shield dimensions

Several lead shield dimensions were measured (Table 3) and all but one are consistent with drawing requirements. The height of the shield (average of 4 measurements) was 24.706 inches, while the drawing specifies a maximum height of 24.7 inches.

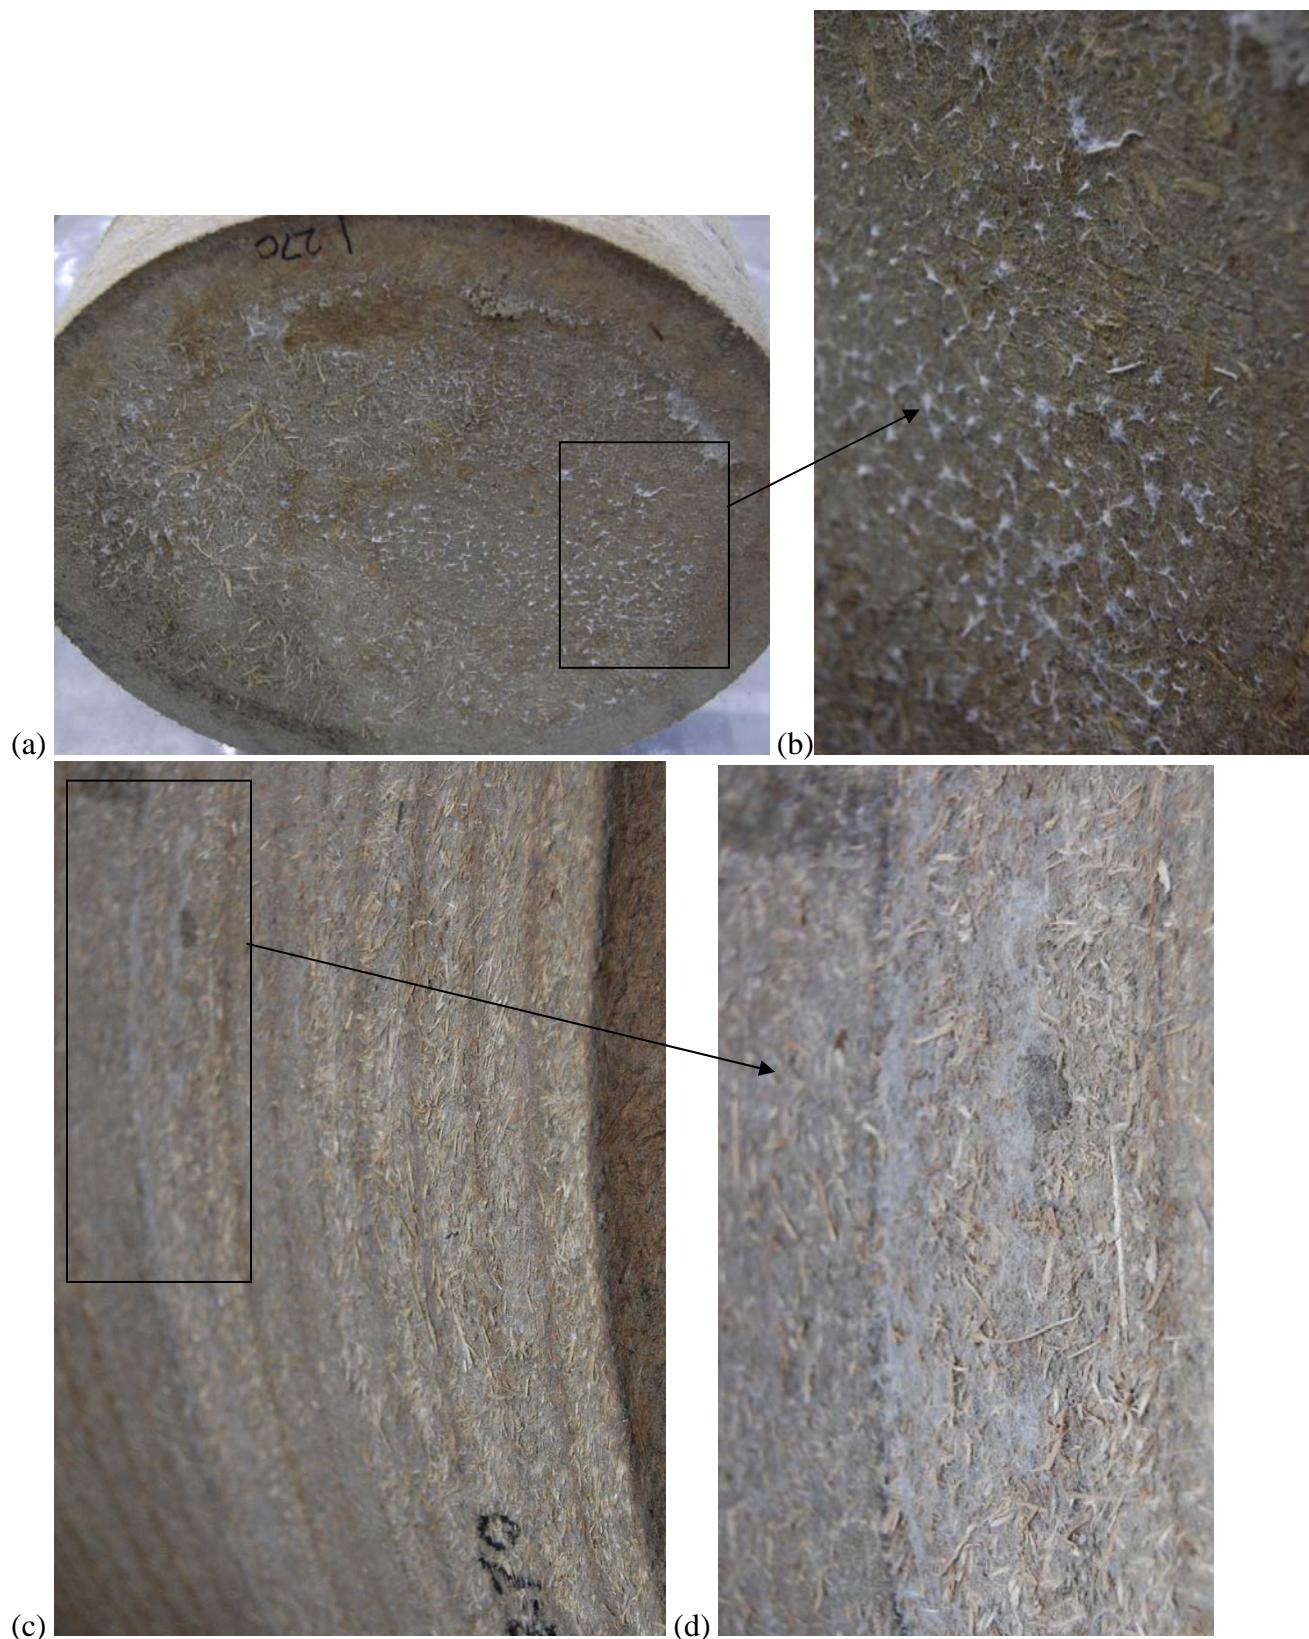
Following removal of both the top and bottom fiberboard subassemblies from the outer drum, both were inspected visually. Although no obvious odor of mold or mildew was noted when opening the package, mold was observed on the lower fiberboard subassembly (Figure 1). Patches of mold were observed across the lower subassembly bottom and in a local region of the lower subassembly OD. Some patches of mold from the bottom of the lower subassembly and fiberboard residue remained adhered to the bottom of the drum (Figure 2). Mold was also initially reported on the upper subassembly, but it was difficult to distinguish from the fiberboard structure. This mold was not apparent in subsequent examination of the upper subassembly, but a slight musty odor was present at that time. The lower fiberboard subassembly contained two local dents that were approximately 0.2 inches deep, and two longer scrape marks on the OD surface. The indentations were located at 280° and approximately 15 inches from the bottom (Figure 3).

Figure 1. Mold on the bottom (a, b) and side (c, d) of lower fiberboard subassembly.

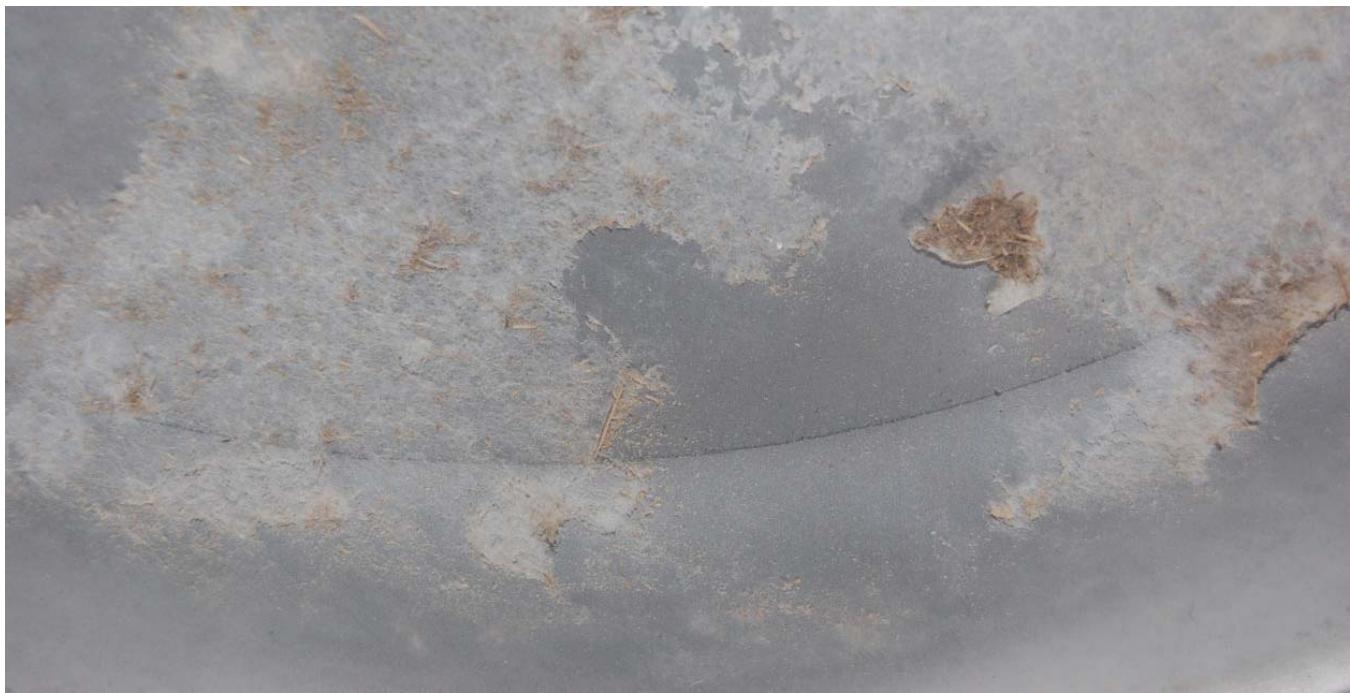
Figure 2. Mold and fiberboard residue on the inside bottom of drum.

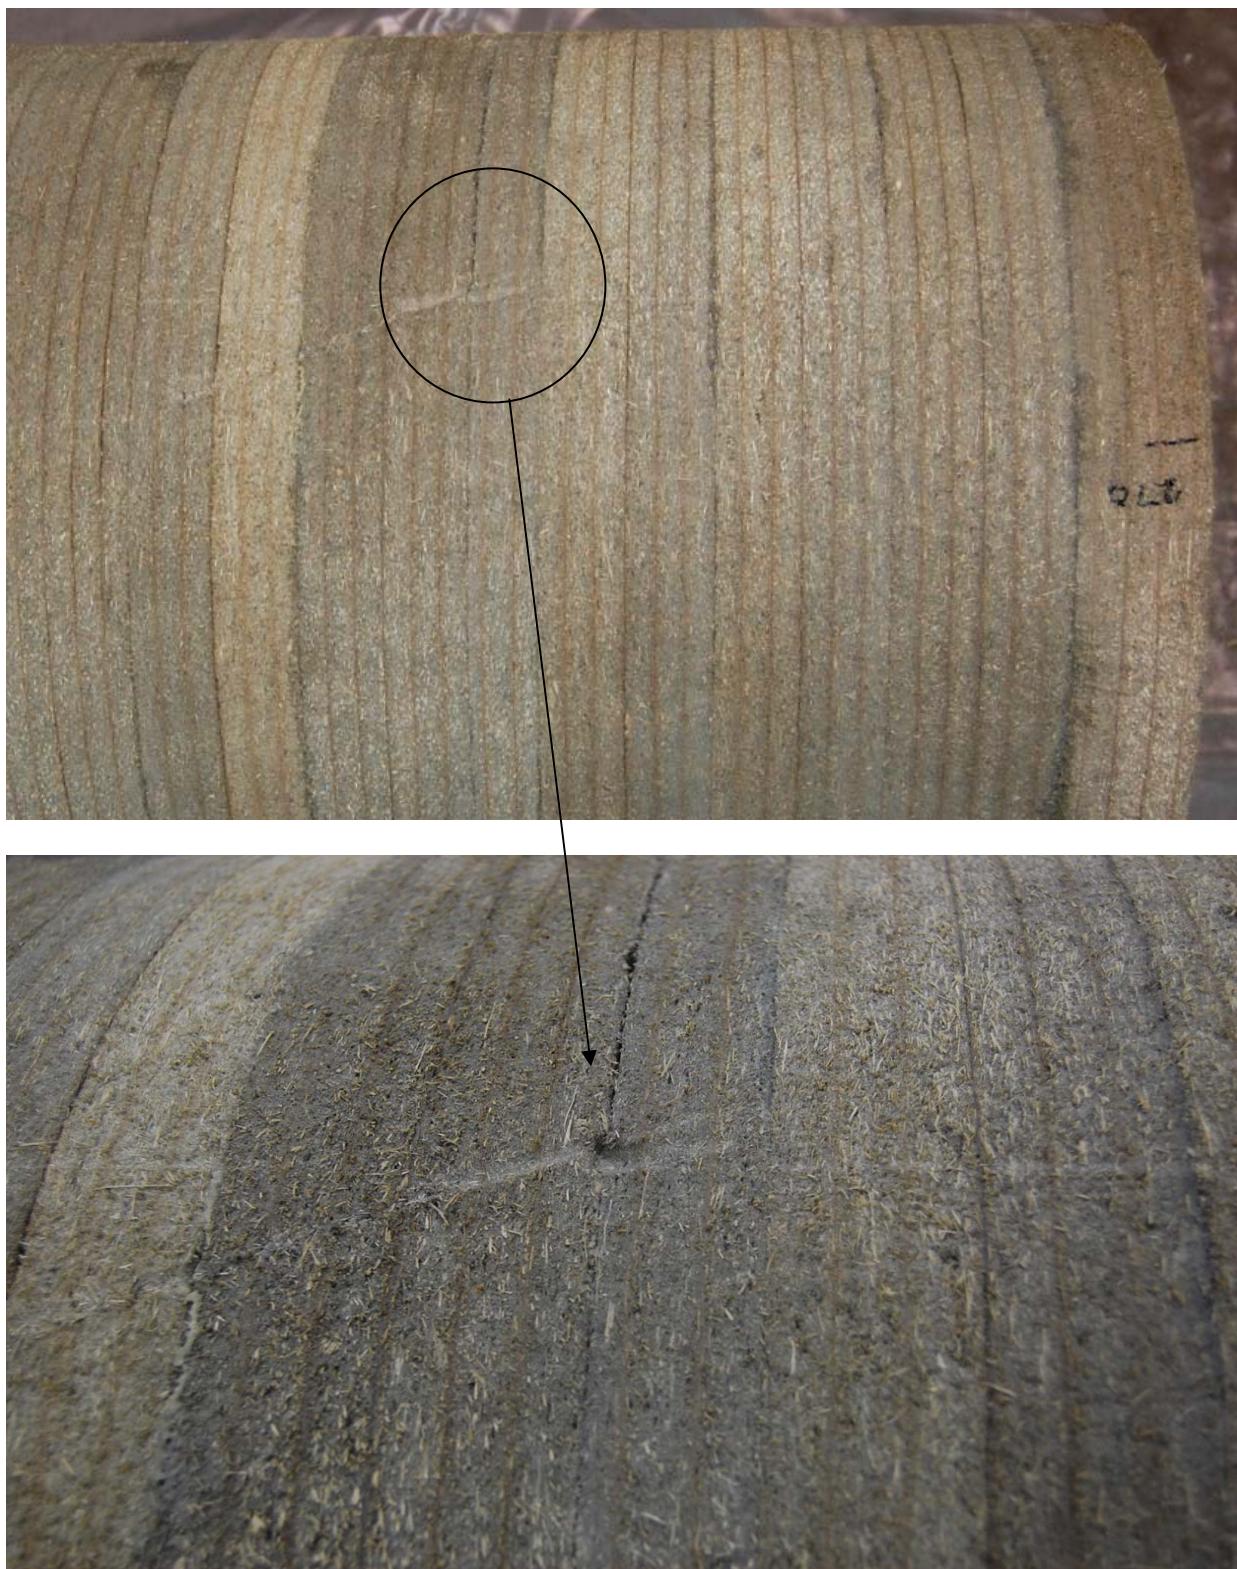
Figure 3. Scrape marks and one of two dents in the lower fiberboard OD surface, approximately 15 inches from the bottom.

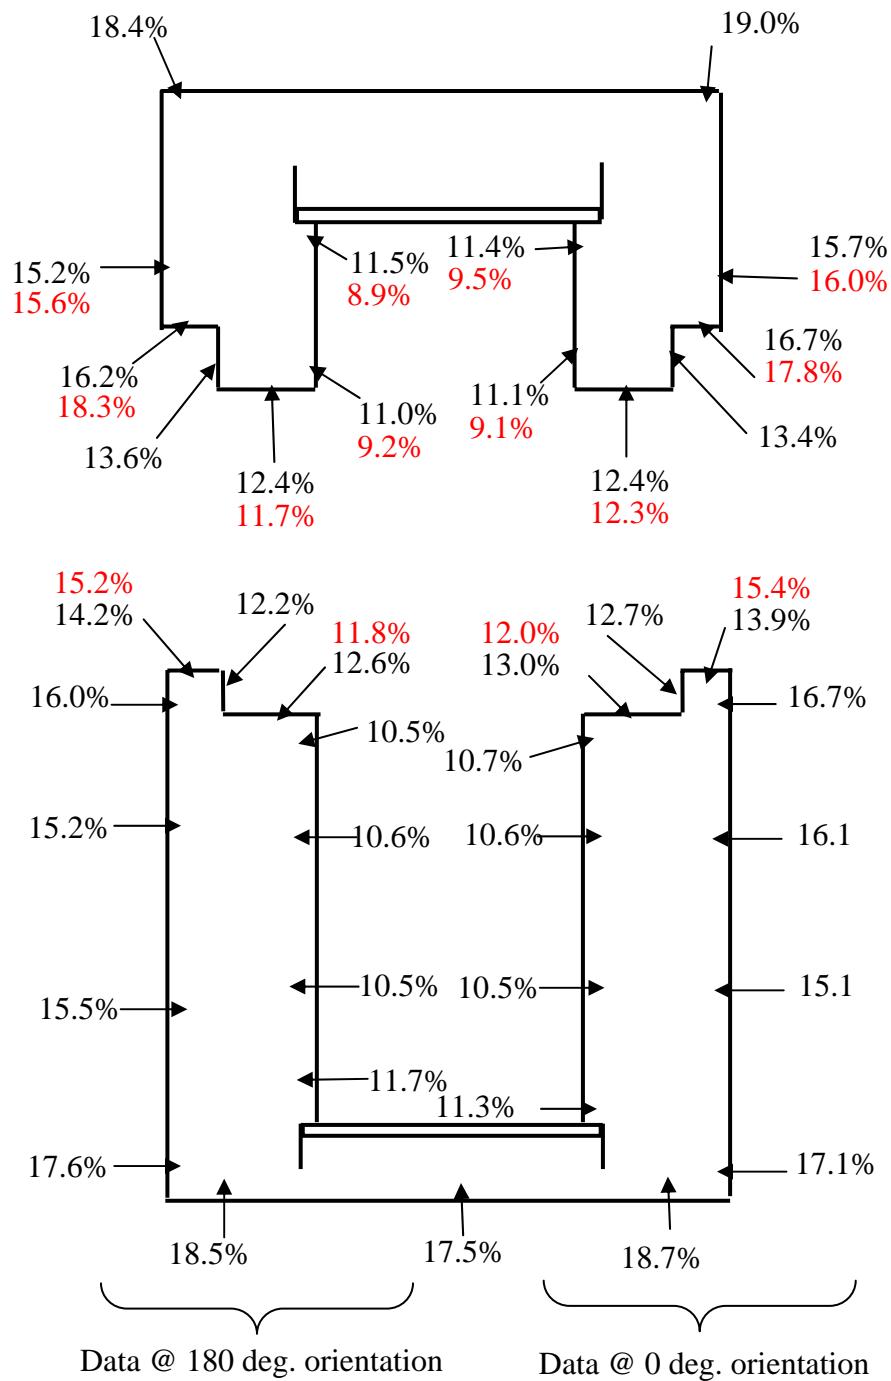
Moisture measurements were compared to those taken during previous destructive examinations [8 - 11]. The readings on 9975-02028 generally fall within the range of reading on previous packages, but the distribution is somewhat different. For the current package lower subassembly values range from 10.5 to 18.7 %WME, with the higher values around the bottom OD. The highest of these values is

greater than observed on previous DE packages. Upper subassembly moisture readings range from 11.1 to 19.0 %WME, with the higher values at the top under the air shield. The higher of these values are also greater than observed on previous DE packages. Another difference from previous DE packages is that the moisture gradient from the ID to OD is ~4-6 %WME, in contrast to the 2 – 4 %WME range typically seen before.

The fiberboard moisture measurements made during field surveillance show agreement on average with the subsequent data. However, they also show a higher moisture gradient across the fiberboard sidewall (Figure 4). The moisture gradient that developed as a result of the internal heat source had decreased slightly during the ~6 weeks between unloading and destructive examination.

Figure 4. Fiberboard moisture content data. The **values in red** were measured during field surveillance. All values are % wood moisture equivalent.

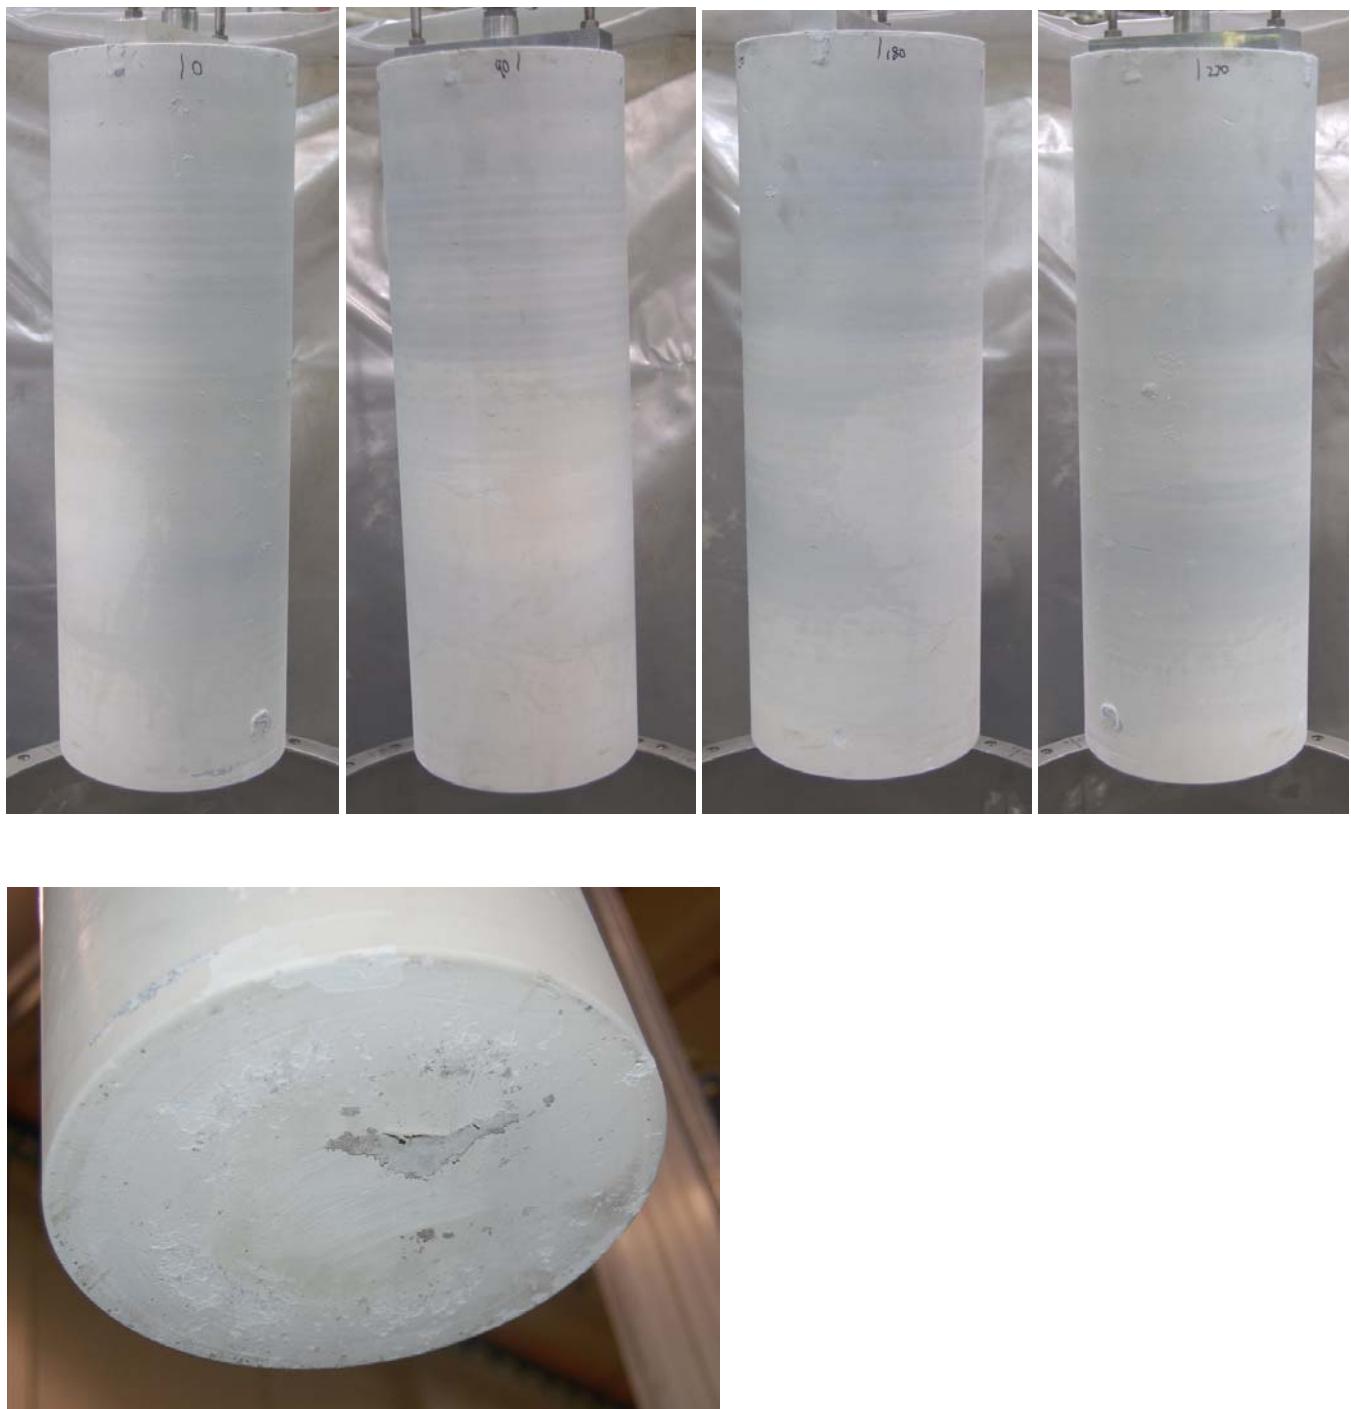
The entire surface of the lead shield was visually examined. It was found to be free from significant deformation and physical damage, but the outside surface (in contact with the fiberboard) was covered with a white corrosion product (Figure 10). From prior examination of the shield from package 9975-02234, the corrosion product was identified as basic lead carbonate (hydrocerussite), Pb₃(CO₃)₂(OH)₂. No further characterizations of the corrosion product were performed.

Figure 10. Lead shield with corrosion product.

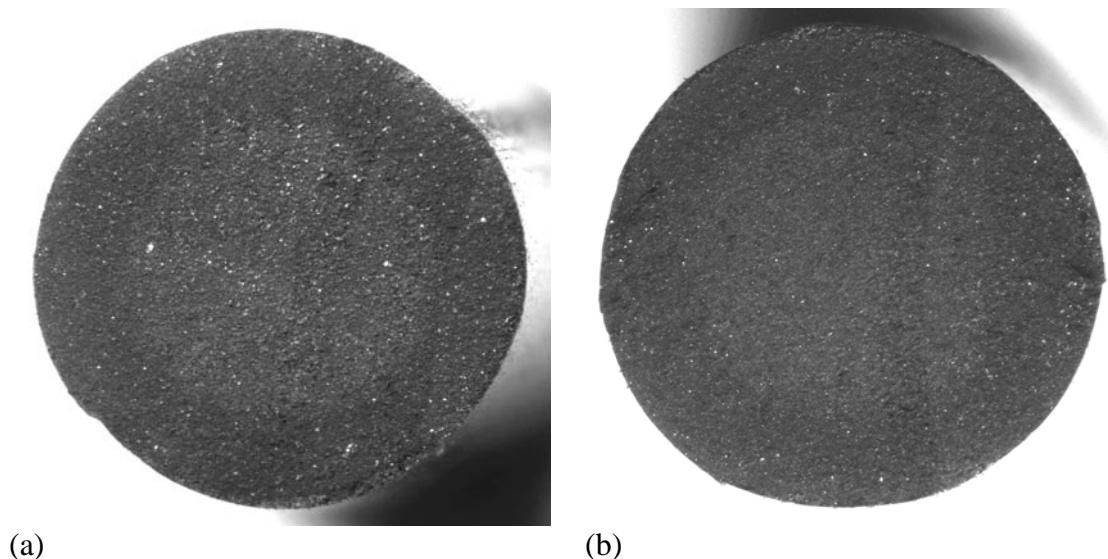
As with previous destructive examinations, visual (Figure 12) and SEM (Figure 13) examination of the cross sections identified a distribution of very small particles throughout each O-ring. Each O-ring also had a transition between the inner and outer regions of the cross section, with the center region being slightly coarser in appearance. X-ray analysis on the SEM identified no significant variation in element distribution across this transition. Aside from carbon and fluorine (which are the primary constituents of Viton[®]) the SEM identified aluminum, silicon, oxygen, zinc, sulfur and calcium. These elements are present in small amounts, and are generally associated with the particles. Though the actual compound is proprietary, zinc, calcium and oxygen are consistent with Viton[®]-type fluoroelastomer compounds, which typically contain MgO, CaO, Ca(OH)₂, ZnO or lead compounds as acid acceptors and heat stabilizers [13]. Aluminum, silicon and sulfur are generally not added to peroxide-cured fluoroelastomer recipes (although there are other sulfur-cured varieties), but may be present as a trace contaminant.

Figure 12. Visual cross section of the (a) PCV outer and (b) SCV outer O-rings.

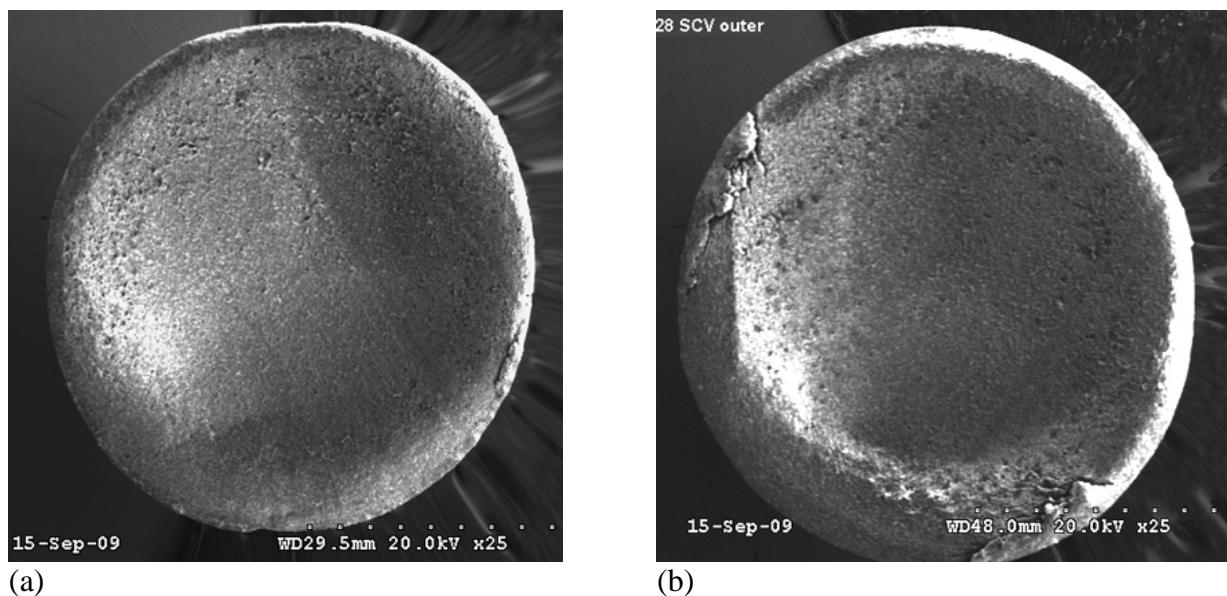
Figure 13. SEM cross section of the (a) PCV outer and (b) SCV outer O-rings.

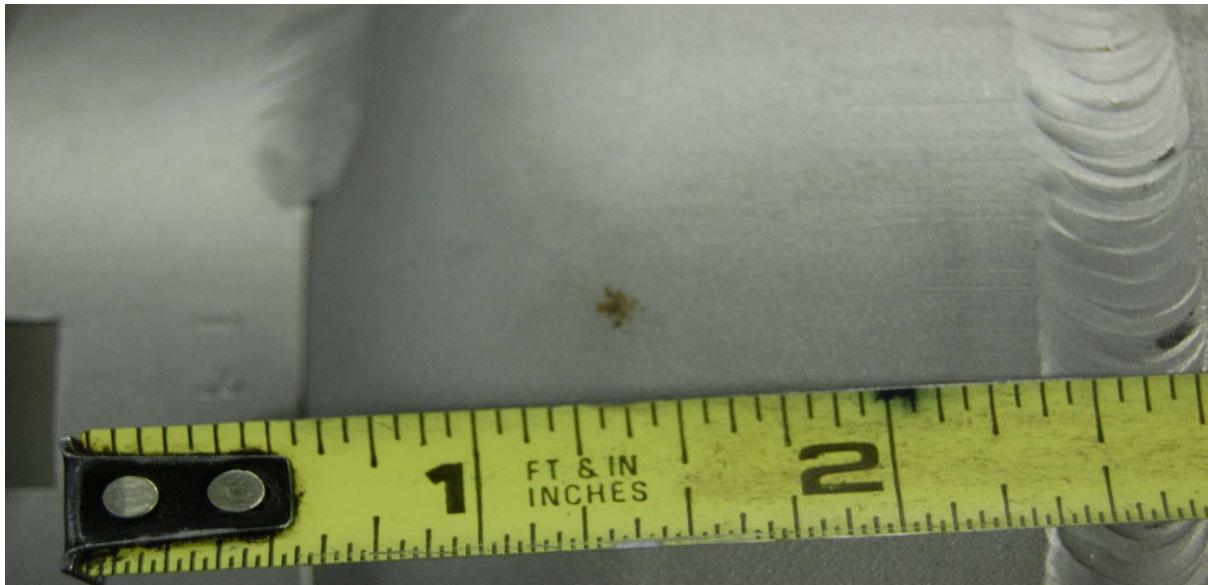
A general visual examination was performed on all metallic components. Aside from the corrosion of the lead shield (discussed above) no significant damage or degradation was observed, although a small spot (~1/8 inch diameter) on the PCV exterior surface had the appearance of a stain or superficial rust (Figure 15). Several components were observed to have fabrication markings. Various markings were stamped or engraved on the containment vessels and lids (Figure 16). These markings appear to be identification numbers used during manufacture, prior to association of the parts with a final package number.

Figure 15. Small stain or superficial rust spot near bottom of PCV exterior.
