RFP-2647
February 14, 1978

INTERACTION OF XENON LIGHT WITH THE
SURFACE OF 304 STAINLESS STEEL

Research and Development
GENERAL METALLURGY GROUP

Rockwell International

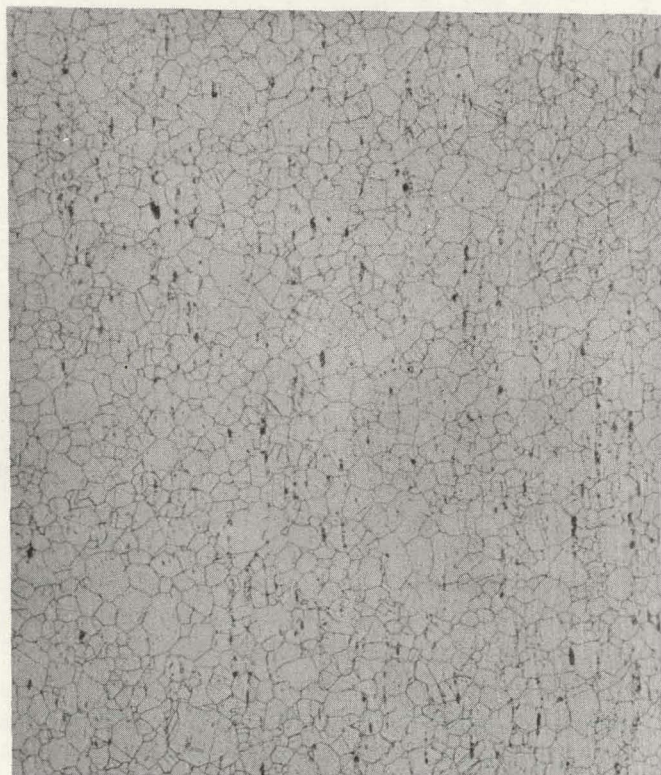
The Type 304 steel sheet used in this study was typical of commercial purity, fully annealed sheet. The sheet contained numerous inclusions, as shown in Figure 1, aligned in stringers parallel to the rolling direction. The majority of the inclusions varied from approximately 5 to 25 microns in width, and up to about 50 microns maximum length. The grain structure near the surface of the as-received sheet is slightly duplexed, with a grain size ranging from ASTM 6 to 9.

FIGURE 1. Microstructure of As-Received Type 304 Stainless Steel. Magnification 100X.

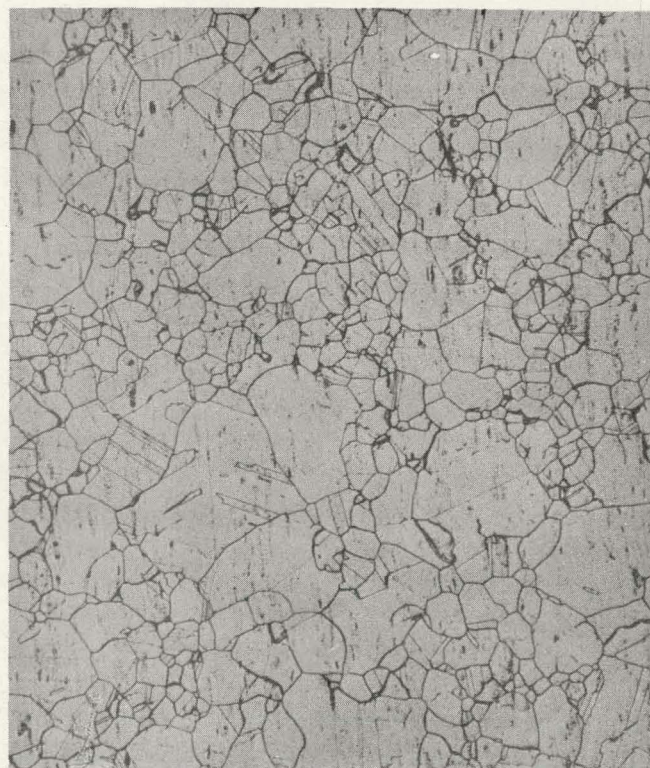
All of the samples were initially solution-treated at 1050°C for one hour. Some samples were subsequently heat treated at lower temperatures to either sensitize or stabilize the alloy. All three heat treated conditions resulted in fairly equivalent grain structures, heavily duplexed with a grain size ranging from ASTM 1 to 7, as typified in the stabilized sample shown in Figure 2.

FIGURE 2. Microstructure of Sample Solution Treated at 1050 °C, then Stabilized at 850 °C. Magnification 100X.

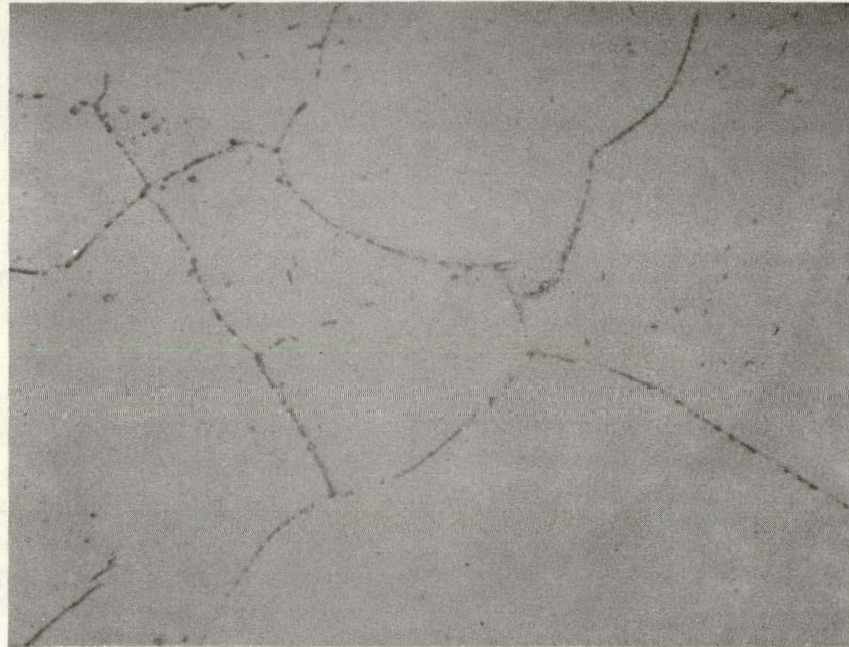
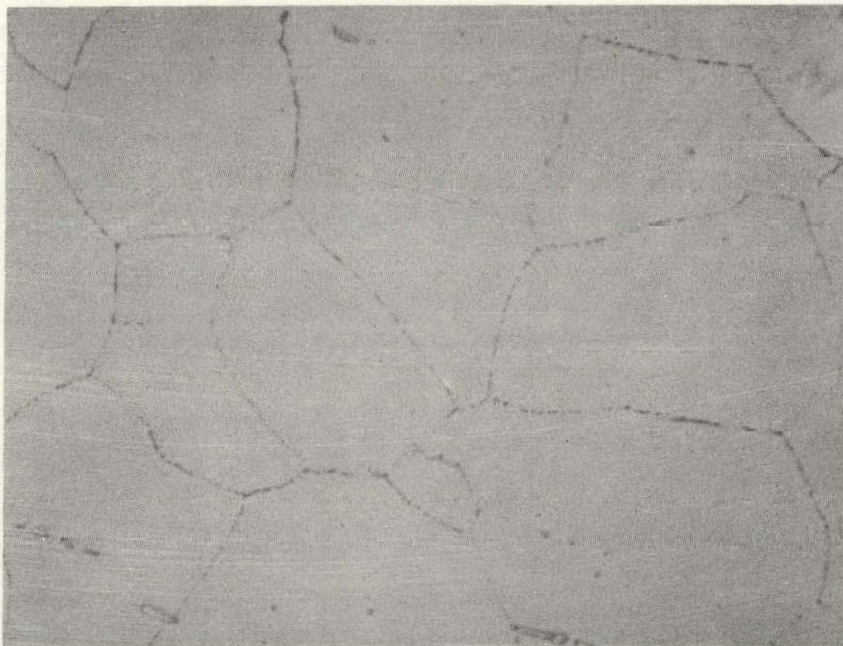
FIGURE 3. Grain Boundary Carbide Precipitation in the (a) Stabilized and (b) Sensitized Samples. Magnification 1200X.

At high magnifications, microstructural differences between samples solution-treated, and either sensitized or stabilized, were readily apparent. The grain boundaries of the solution-treated material are relatively free of carbide precipitation, whereas both the sensitized and stabilized samples exhibit heavy carbide precipitation in the boundaries, as shown in Figure 3. The carbide particles in the stabilized sample are somewhat coarser; however, the carbides in both cases are <3 microns in diameter, much smaller than the inclusions in stringers.

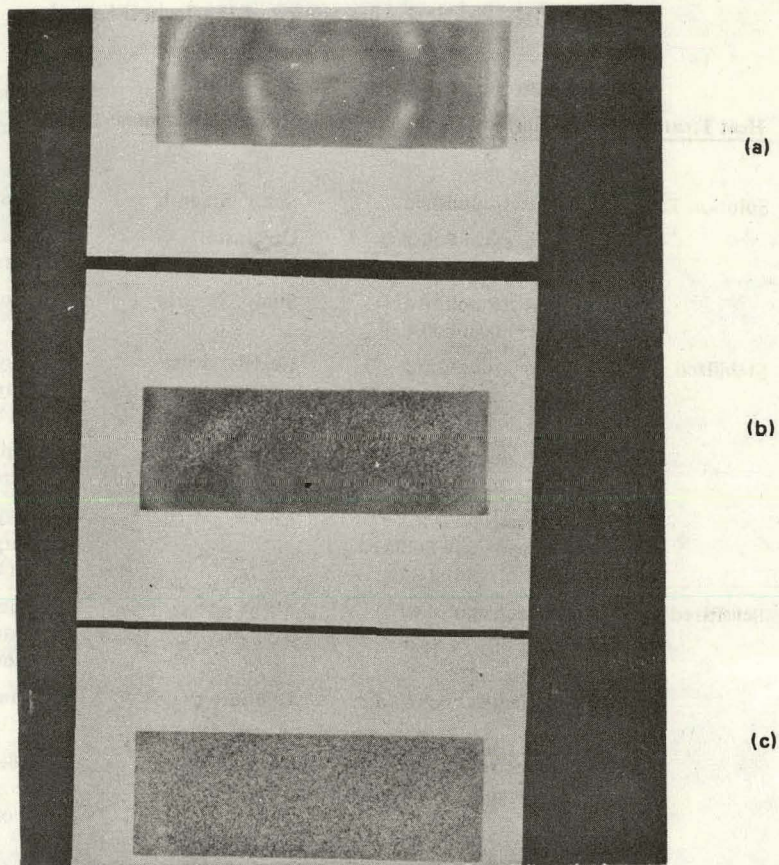
In the case of the solution-treated sample, where most of the grain boundary carbides are dissolved, electropolishing produced a very shiny, smooth surface finish. However, in both the stabilized and sensitized conditions, electropolishing produced a very irregular surface finish with preferential attack at the grain boundaries. The surface in both cases was pitted, quite different from the shiny surface of the solution-treated/electropolished samples shown in Figure 4. Carbide particles within the boundaries are more cathodic than the surrounding matrix, and thus, become exposed as the electropolishing process continues. Figure 5 compares the surface condition of samples given different heat treatments, electropolished, but not flashed.

FIGURE 4. Surface Appearance of (a) Solution Treated, (b) Sensitized, and (c) Stabilized Samples after Electro-polishing. Magnification 1.3X. Rings on (a) Due to Reflection of Camera Lense on Shiny Surface, White Speckled Pattern on (b) and (c) Due to Surface-Pitting.

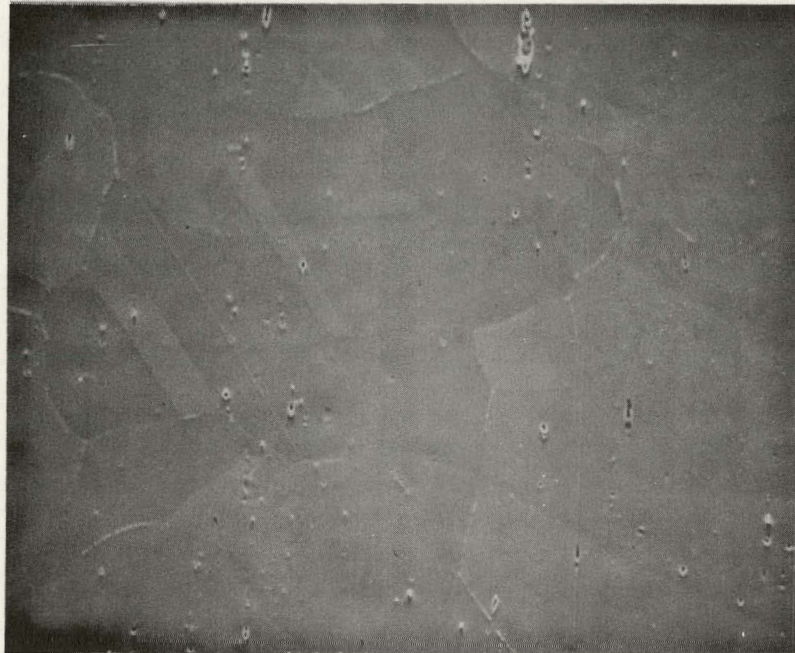
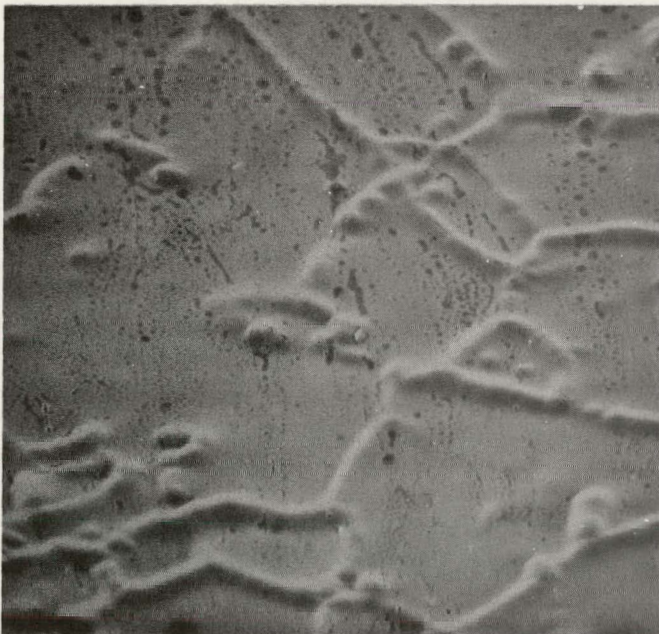
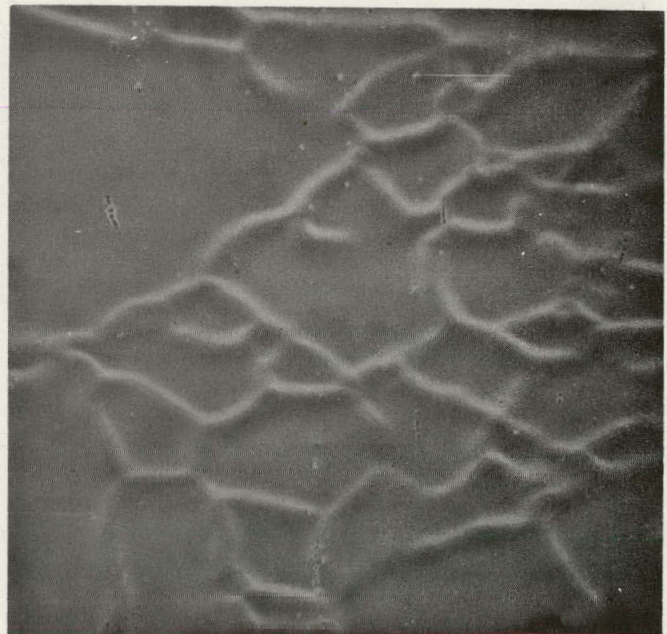
FIGURE 5. Comparison of Surface Condition of (a) Solution-Treated, (b) Stabilized, and (c) Sensitized Samples after Electropolishing. Magnification 500X.

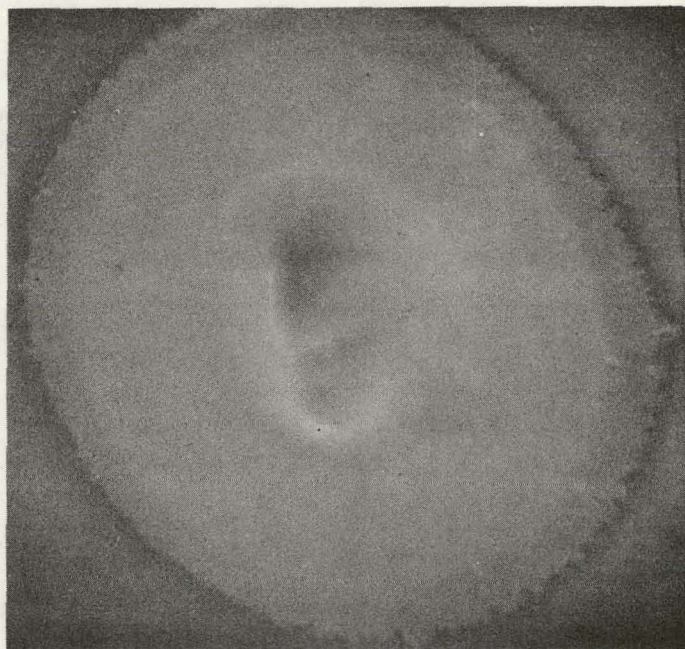
FIGURE 6. Damage Site Containing Only Iron. Sample VH-3. Magnification 525X.

The size of the damage sites are also consistent with the inclusion size observed in the as-received stock. Several different types of damage sites were observed. Figures 6 and 7 are sites which were found to contain only Fe. Figure 8 shows one that contained only Ni. Several sites contained Fe and Cr, as shown in Figures 9 and 10. The concentric rings in Figure 11 were

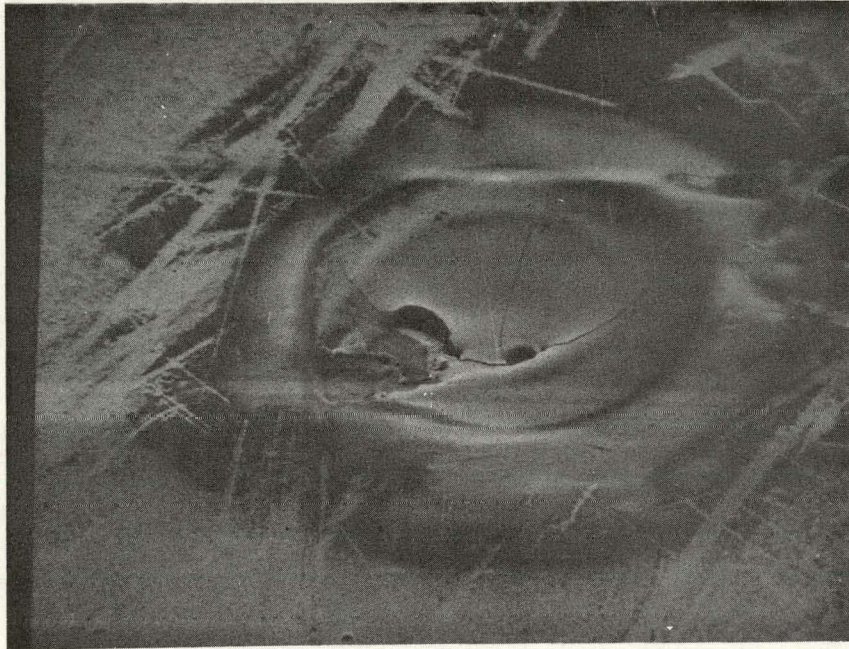
FIGURE 7. Damage Site Containing Only Iron. Sample VK-6. Magnification 85X.

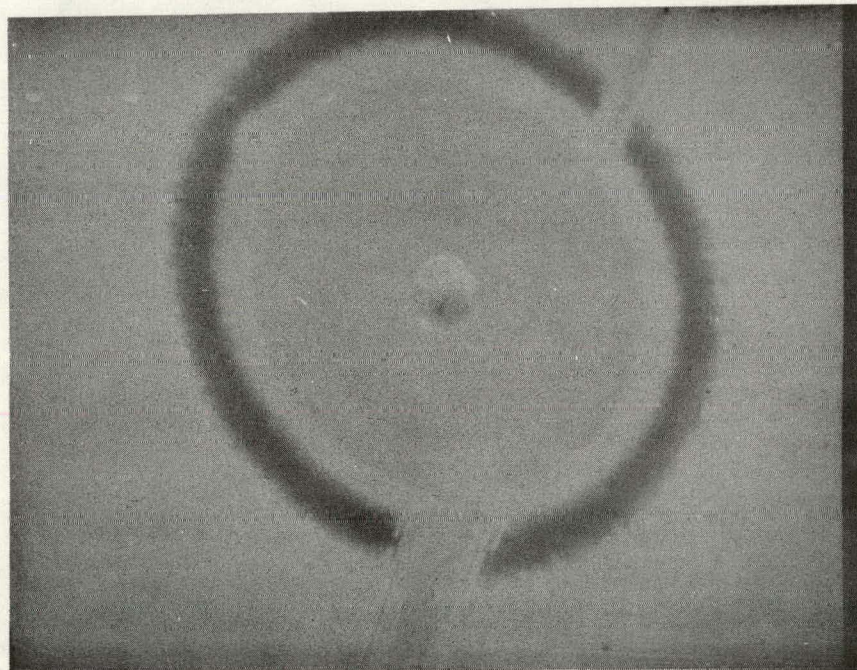
FIGURE 8. Damage Site Containing Only Nickel. Sample VH-2. Magnification 300X.

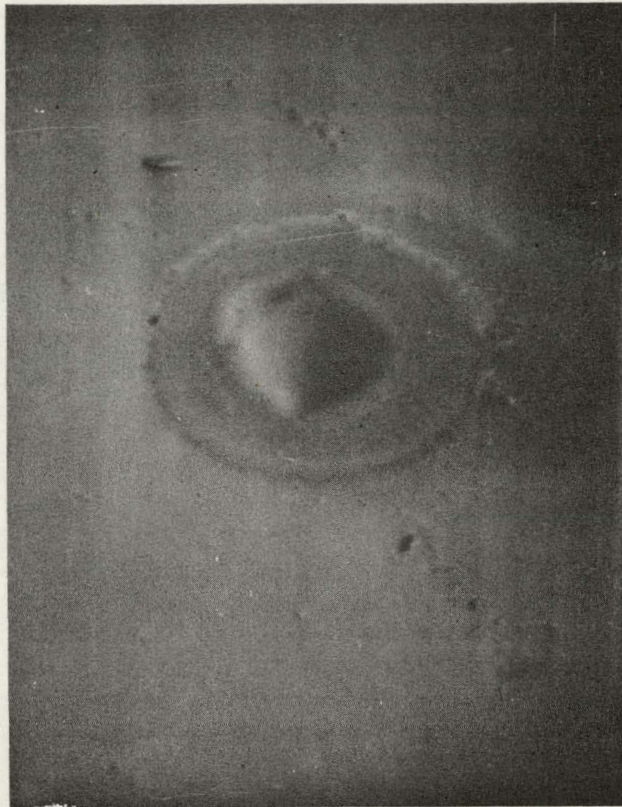
FIGURE 9. Damage Site Containing Iron and Chromium. Sample VH-7. Magnification 750X.

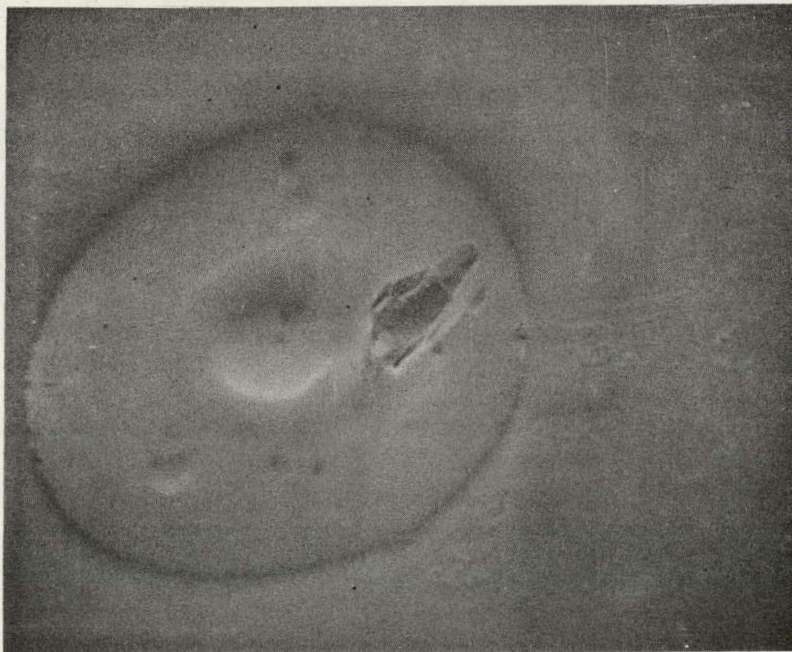
FIGURE 10. Damage Site Containing Iron and Chromium. Sample VH-7. Magnification 400X.

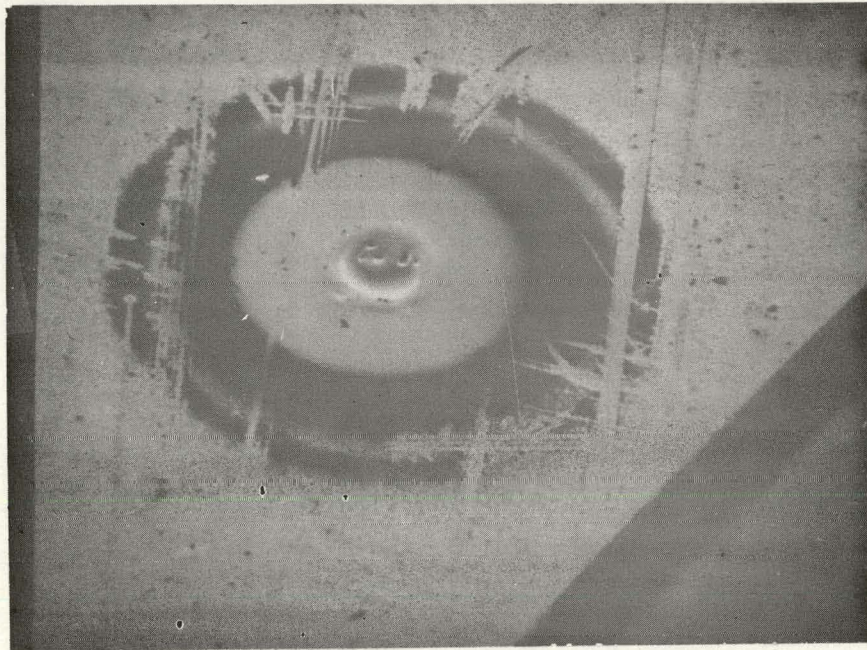
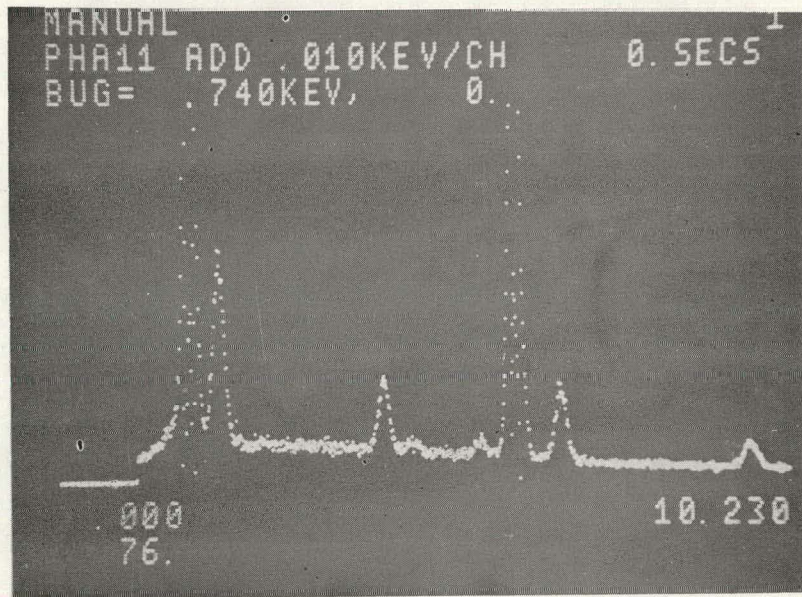
FIGURE 11. Damage Site (a) Containing Iron, Titanium, Manganese in Center, Iron + Nickel in Light Gray Region Around Center, Iron with Trace of Nickel in Black Ring. X-ray Spectrum (b) of Center, Silicon and Gold Due to Quartz Capsule and Sample Coating. Sample, VK-6. Magnification 85X.

found to contain (Fe, Ni) and (Fe, Ti, Mn). Manganese is an alloying element in the steel and its presence is not surprising. Titanium is used as a

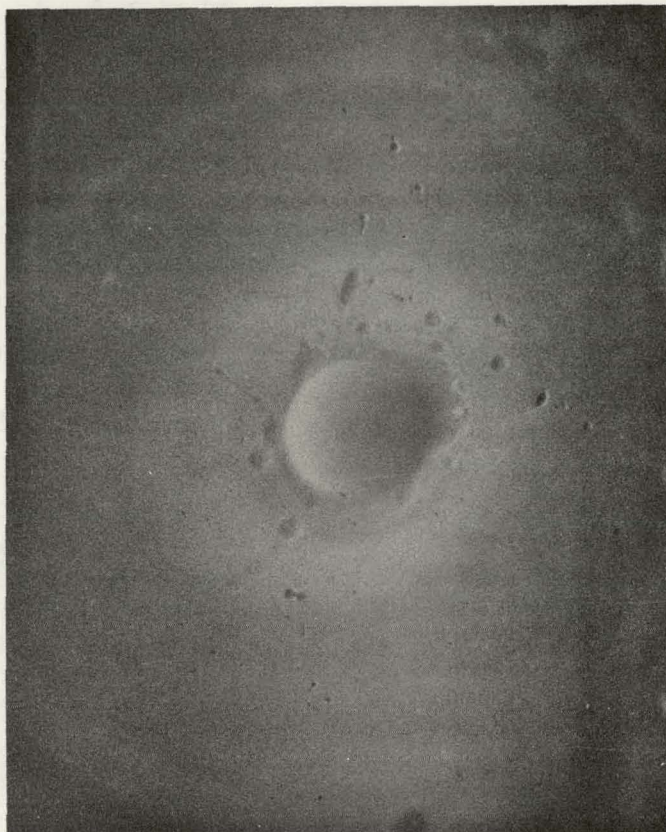
deoxidant in steelmaking, and its presence in the form of an oxide is possible. The association of Cu and Zn with Fe, shown in Figure 12, is more unusual.

FIGURE 12. Damage Site Containing Iron, Copper, and Zinc. Sample VH-6. Magnification 190X.

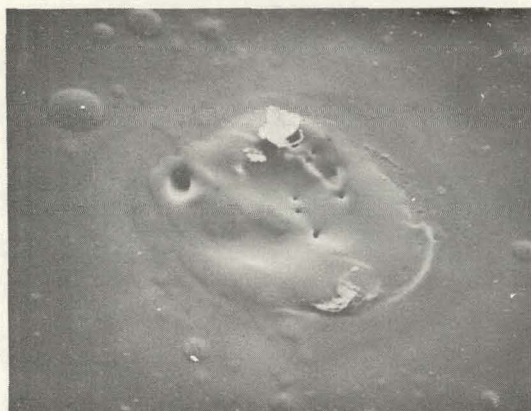
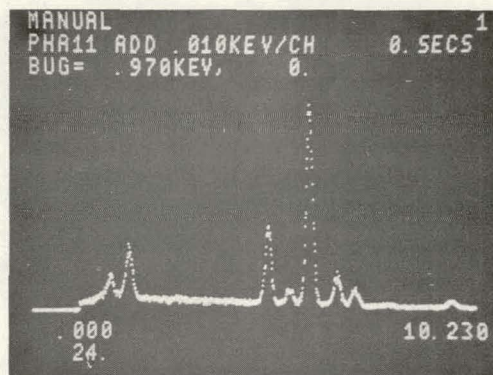
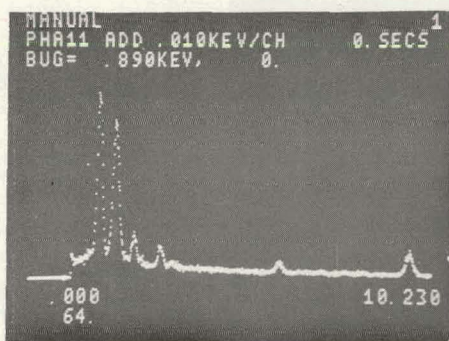
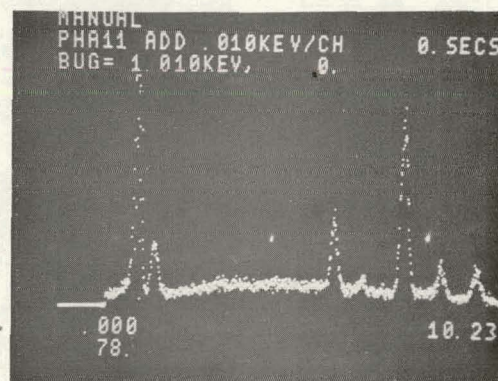
A variety of particles was found in the damage site shown in Figure 13 together with the respective x-ray spectrum. The large, white particle contains (Fe, K, Cl). The other two darker particles are stainless steel, which appear to be machine chips or burrs that were removed from the metal. The black spots are primarily Cu, and the major area of the damage site is Fe.

FIGURE 13. Multiple-Phase Damage Site (a) Containing Large White Particle Iron, Potassium, Chlorine, Two Smaller Particles Iron, Chromium, Nickel, and Black Spots Copper, (b) X-ray Spectrum of Large White Particle. Silicon and Gold Peaks are Due to Quartz Capsule and Gold Coating on Sample. Sample VK-6. Magnification 300X. (c) X-ray Spectrum of Iron, Chromium, Nickel, Stainless Steel Pattern, and (d) X-ray Spectrum of Copper and Iron Background. Sample VK-6. Magnification 300X.

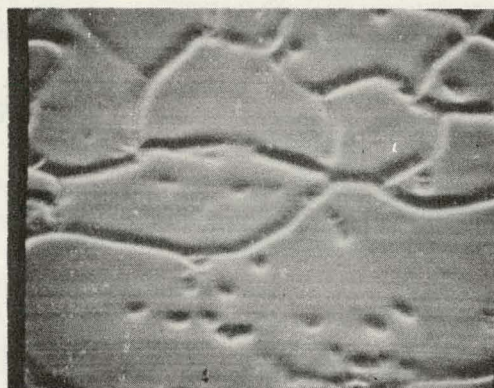
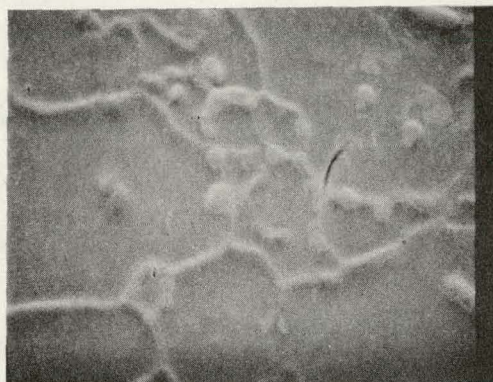
Two general features were observed which showed a change in surface condition as a result of flashing. First, the appearance of coarse inclusions resulting from the stabilization treatment changed, as shown in Figure 14. The inclusions, both in the matrix and grain boundaries, in the preflashed sample are rounded and well-defined at the bottom of each pit, whereas in the flashed sample, the region around each inclusion appears to be flattened, indicating that some type of reaction has occurred. This could be due to localized melting within the inclusion region.

FIGURE 14. Comparison of Matrix and Grain Boundary Inclusions in a Stabilized, Electropolished and Chemical Polished Sample (a) Before, and (b) After Flashing. Sample VH-5. Magnification 300X.

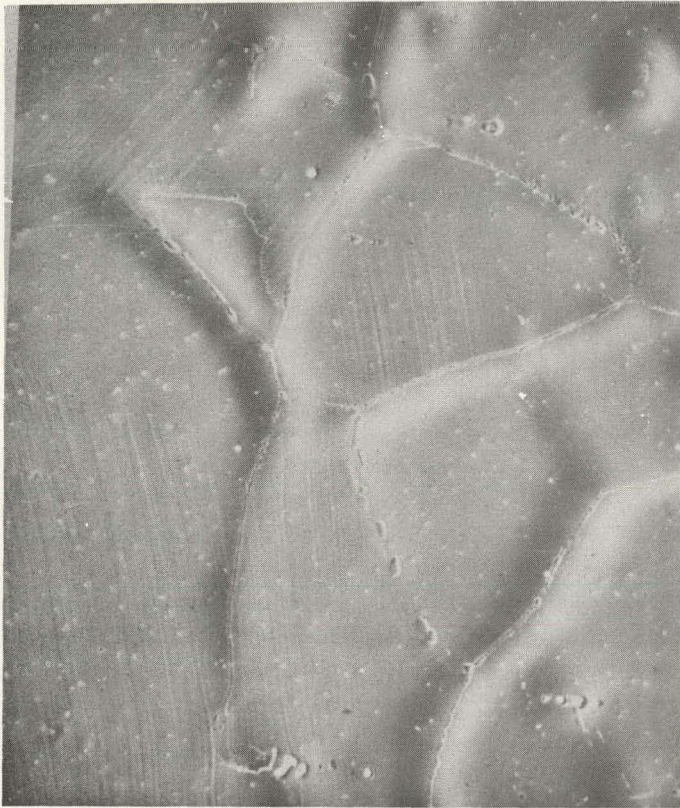
samples were flashed. Figures 15, 16, and 17 illustrate this phenomenon. The striations are well-defined within each grain and follow definite crystallographic orientations. As shown in Figure 18, the striations change direction at a grain boundary, showing the mismatch in crystallographic orientation between adjacent grains. Change-in-direction is also apparent at twin boundaries, as shown in Figure 19.

FIGURE 15. Surface Striations on Flashed Sample. Sample VH-10. Magnification 500X.

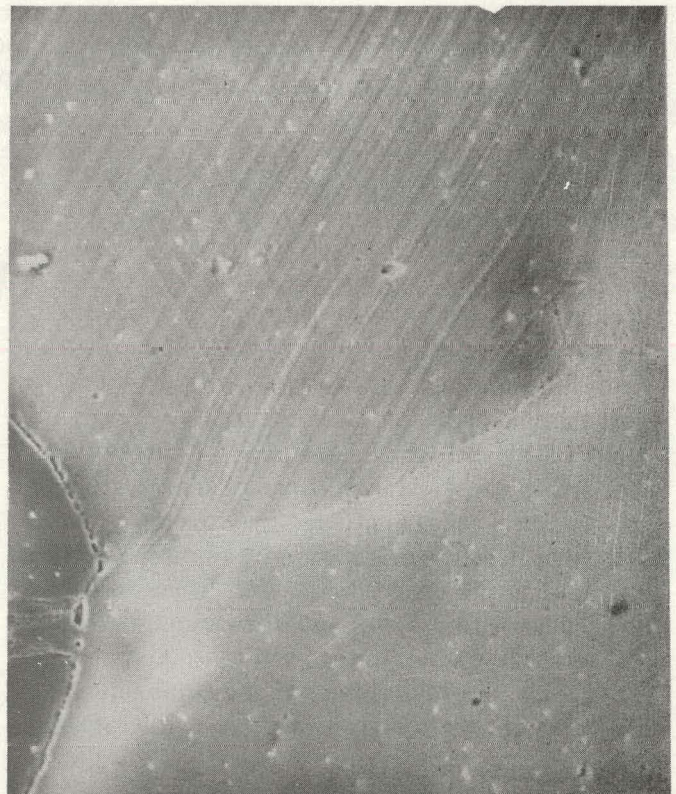
FIGURE 16. Surface Striations and Grain Boundary Precipitates. Sample VH-10. Magnification 2000X.

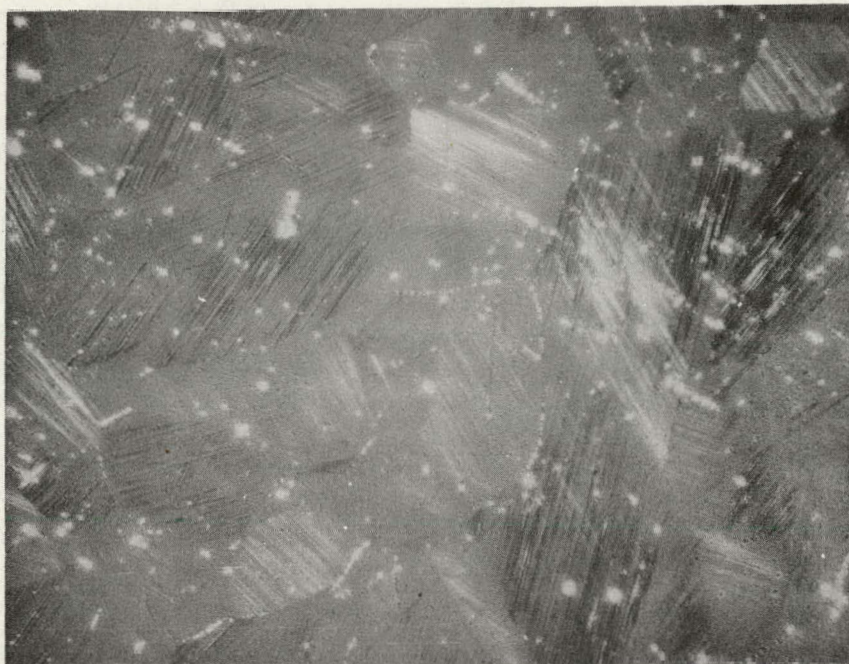
FIGURE 17. Different Orientations of Striations Within Each Grain. Sample VK-1. Polarized Light. Magnification 400X.

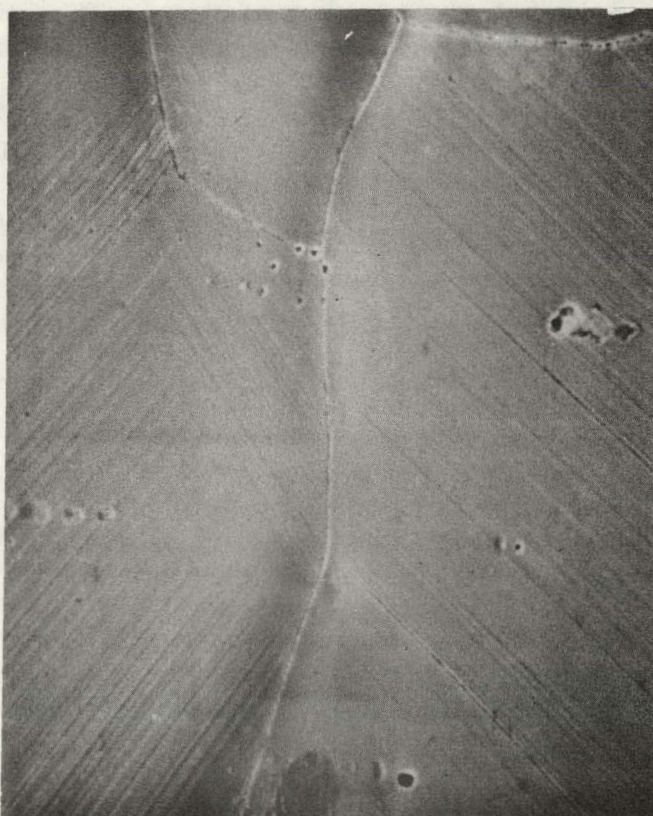
FIGURE 18. Orientation Mismatch of Striations at a Grain Boundary. Sample VH-4. Magnification 2000X.

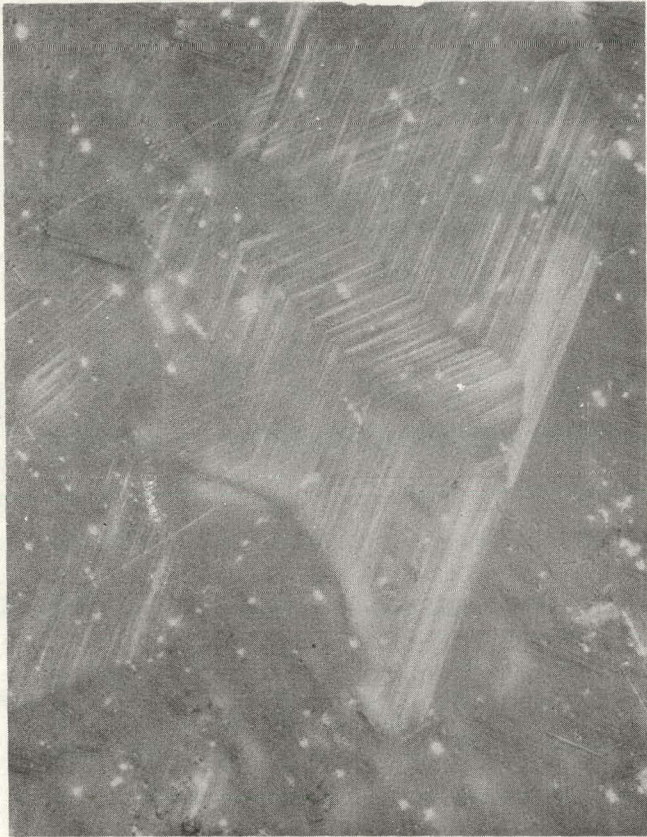
FIGURE 19. Change in Crystallographic Orientation of Striations at a Twin Boundary. Sample VH-2. Polarized Light. Magnification 400X.
