FRACTOGRAPHY OF HYDROGEN-EMBRITTLED STAINLESS STEEL*

G. R. Caskey, Jr.

Savannah River Laboratory
E. I. du Pont de Nemours and Company
Aiken, South Carolina 29801

Paper for Presentation at the
106th AIME Annual Meeting
Atlanta, Georgia
March 6-10, 1977

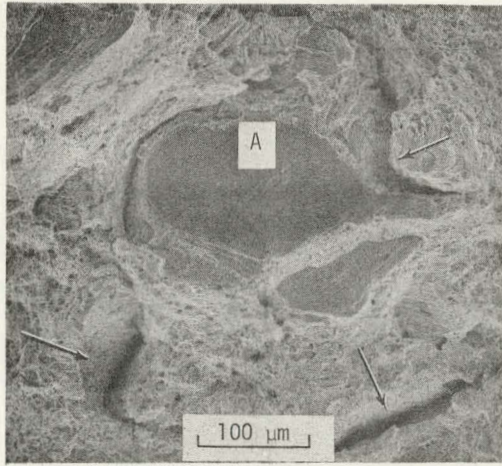
The dominant feature on the fracture surfaces of the two embrittled specimens is the presence of facets (Figure 1). These highly reflective, flat areas were not confined to any particular part of the surface but were distributed uniformly (Figure 2) and are more numerous on the specimen fractured at 198 K than on the one broken at 273 K. In addition, steps and diagonal traces are observed on the facets (Figure 3). The steps are usually shallow, irregular in outline, and do not extend beyond the particular facet where they are located. Inclusions that intersect facets lack the characteristic dimple associated with them in regions of ductile rupture.

Facet A and Secondary Cracks (arrow)

FIGURE 1. Fracture Surfaces of Type 304L Stainless Steel

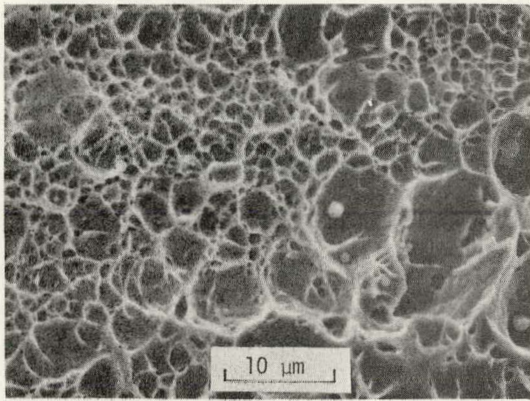
Dimple

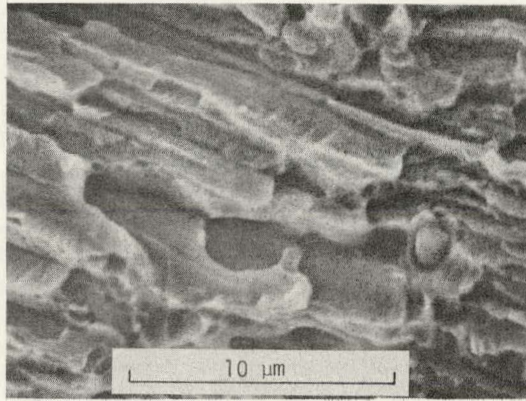
Striation

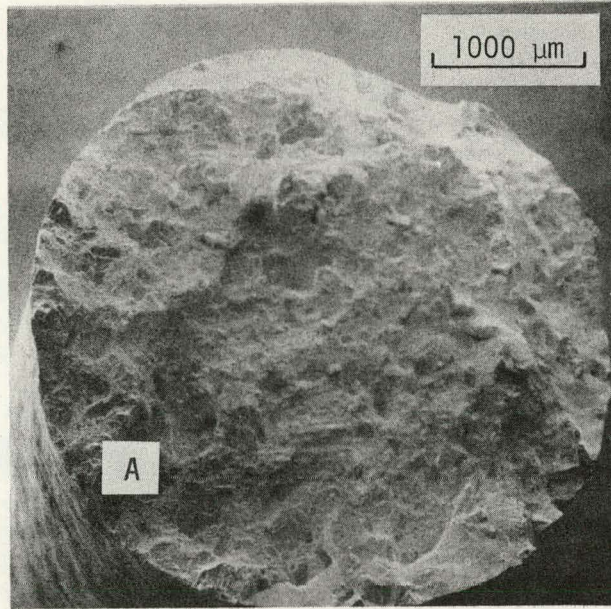
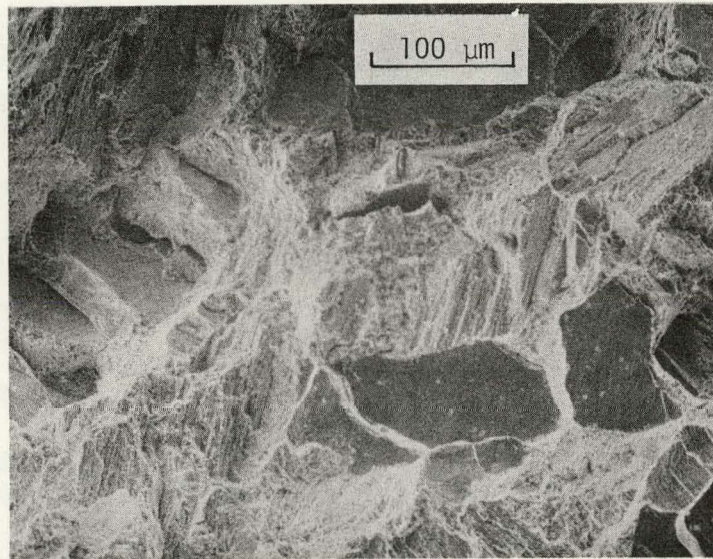
Facet Distribution Over Fracture Face

Detail at A

FIGURE 2. Facets on Deuterium-Saturated Specimen Tested at 198 K

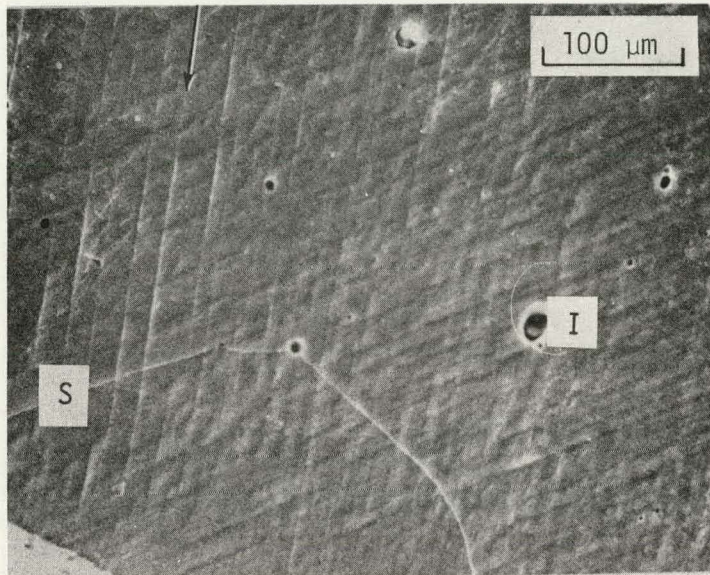
FIGURE 3. Facet Showing Step (S), Inclusion (I), and Trace (arrow) on Specimen Tested at 198 K

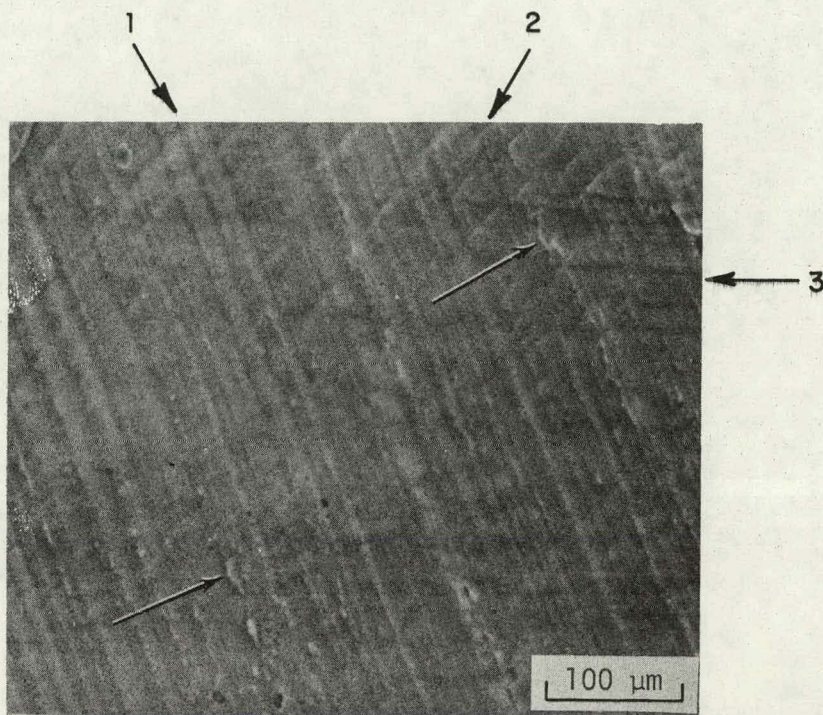
traces will be more predominant than the others (Figure 4). Angles between pairs of traces are consistent with the hypothesis that all of the traces, as well as the plane of the facet, are $\{111\}$ planes in the parent austenite. The traces, therefore, could arise from twins in the austenite, α' -martensite, or ϵ -martensite because the habit planes for all three of these microstructural features are $\{111\}$ planes in the austenite. Facet shape, steps, and trace angles suggest that the facets have formed along twins in the austenite, which are always present in annealed Type 304L austenitic stainless steel. The traces then would arise from intersection of a facet face with strain-induced transformation to ϵ - and α' -martensite. The alternative explanation, that the facets are grain faces, appears less likely given the regularity of the traces that are always observed on the facets and the apparent constancy of the angles between traces.

FIGURE 4. Facet Showing Three Sets of Traces
[Note irregularities (arrow) along
edge of dominant set.]

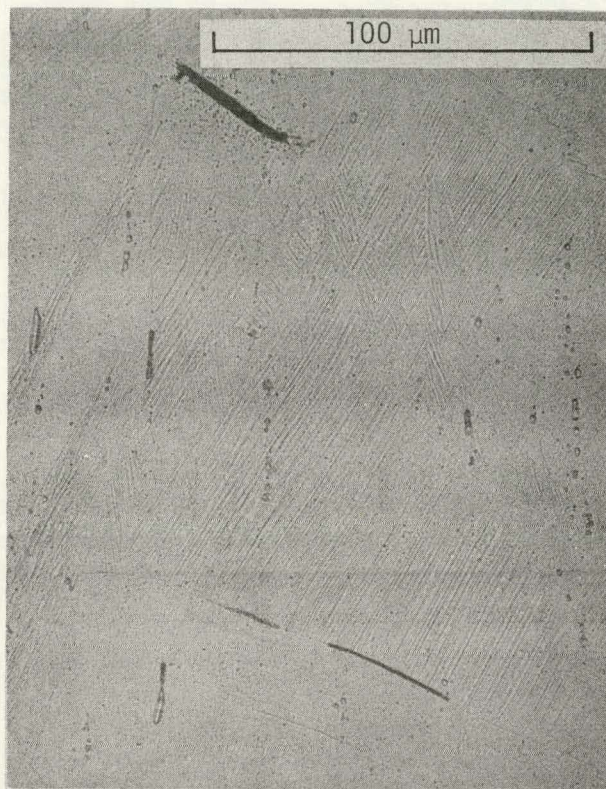
Additional support for identification of the facets as annealing twin boundaries is obtained from inspection of longitudinal sections through the broken specimens. Many cracks are observed in the embrittled specimens, diminishing in frequency as the distance from the fracture face is increased. These cracks are often along twin boundaries (Figure 5), in which case, the cracks are straight and relatively flat.

FIGURE 5. Longitudinal Section Showing Cracks Along Twin Boundaries at Test Temperature of 198 K

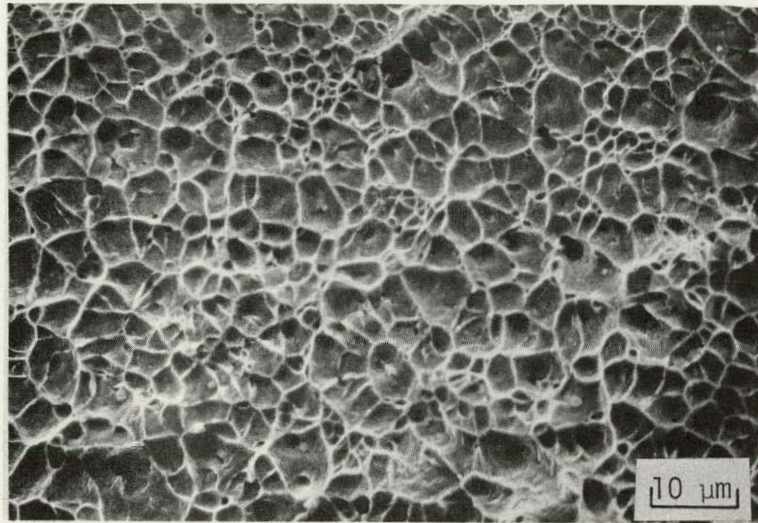
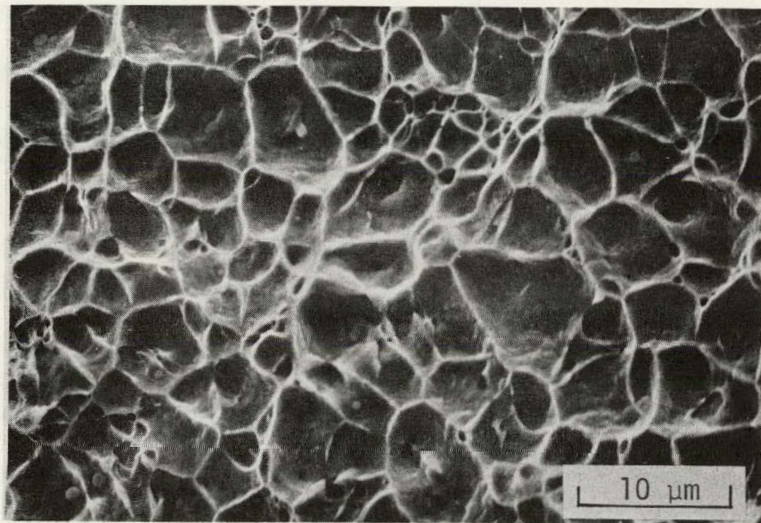
Dimpled rupture is the only fracture mode in common among all of the specimens. In the deuterium-free specimens, the ridges between the dimples appear more pronounced in the central region than in the shear lips (Figure 6). In both areas, dimple sizes have a distinct bimodal distribution. The same characteristics were observed in the specimens that had been saturated with deuterium (Figure 7). In this case, however, dimple sizes appear somewhat smaller than in the deuterium-free specimens.

FIGURE 6. Dimpled Rupture of Deuterium-Free Specimen Tested at 273 K

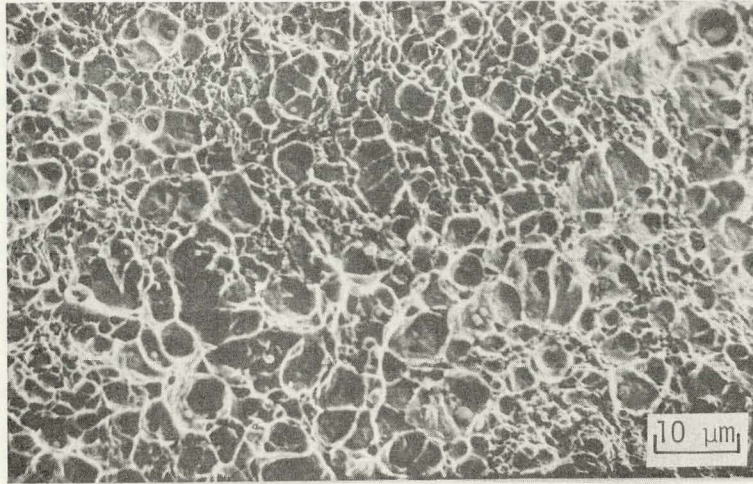
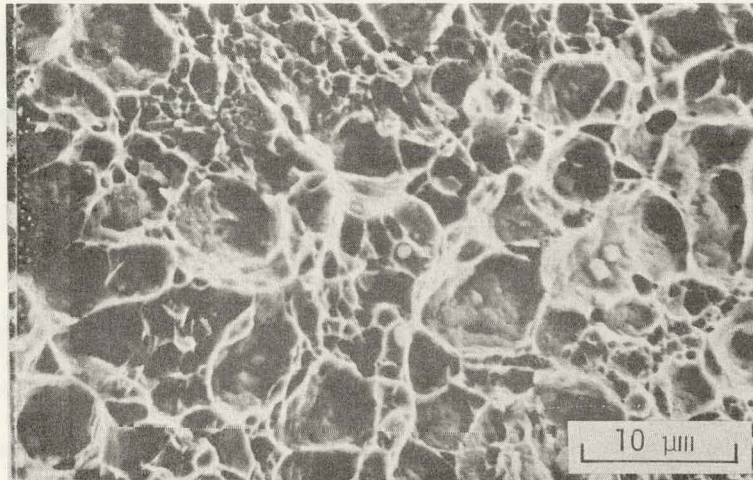
FIGURE 7. Dimpled Rupture of Deuterium-Saturated Specimen Tested at 273 K

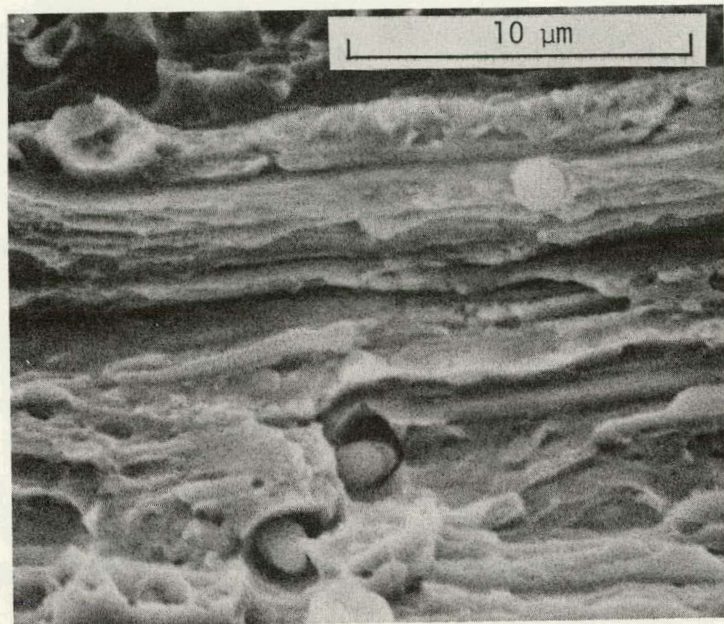
Both specimens that were embrittled by the deuterium had areas (Figure 8) designated as striations. They appear over more or less flat areas intermixed among facets and small areas of dimpled rupture (Figure 3). In each area, the dominant dimension of the striations is uniformly oriented. Their appearance is somewhat more distinct at 198 than at 273 K.

FIGURE 8. Striations Near Center of Deuterium-Saturated Specimen Tested at 273 K

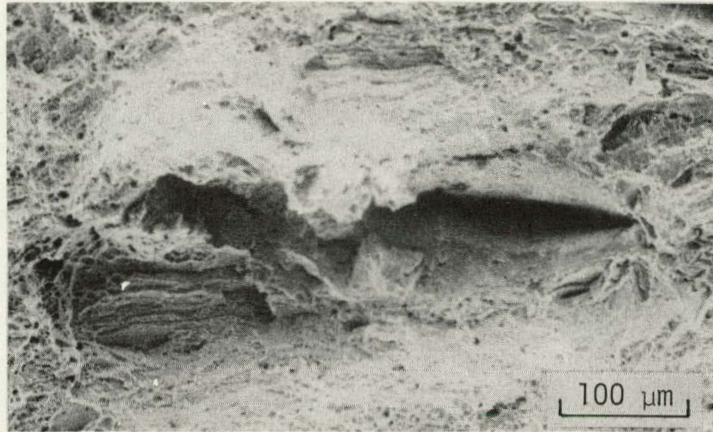
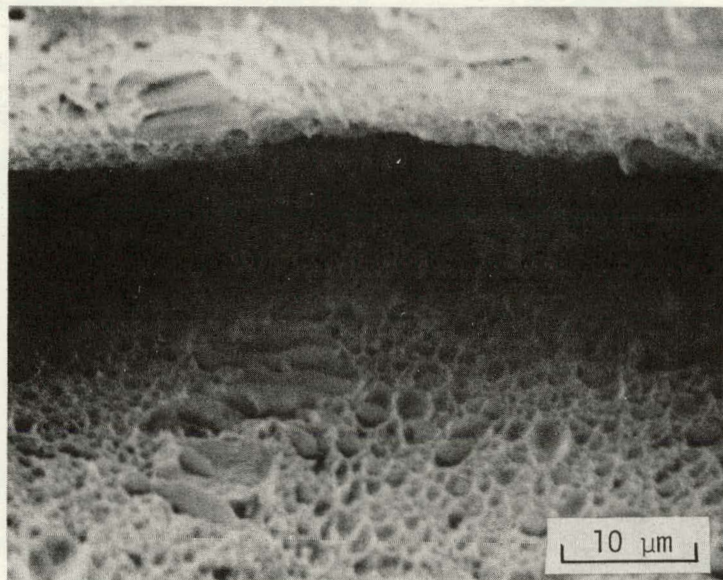
Small cracks roughly parallel to the tensile axis were observed on the deuterium-saturated specimens tested at 198 and 273 K. The faces of these cracks are relatively smooth, but fine dimples can be seen in some cases (Figure 9).

FIGURE 9. Secondary Crack With Dimpled Surface
of Deuterium-Saturated Specimen
Tested at 273 K

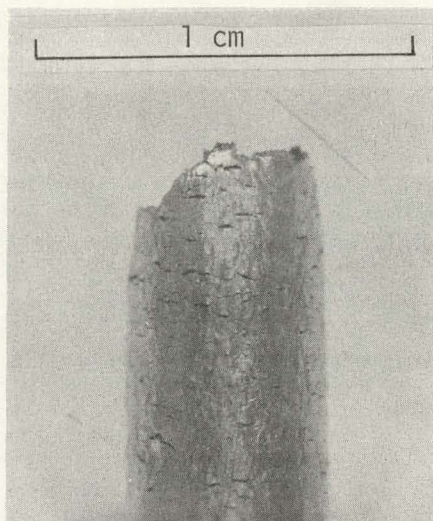
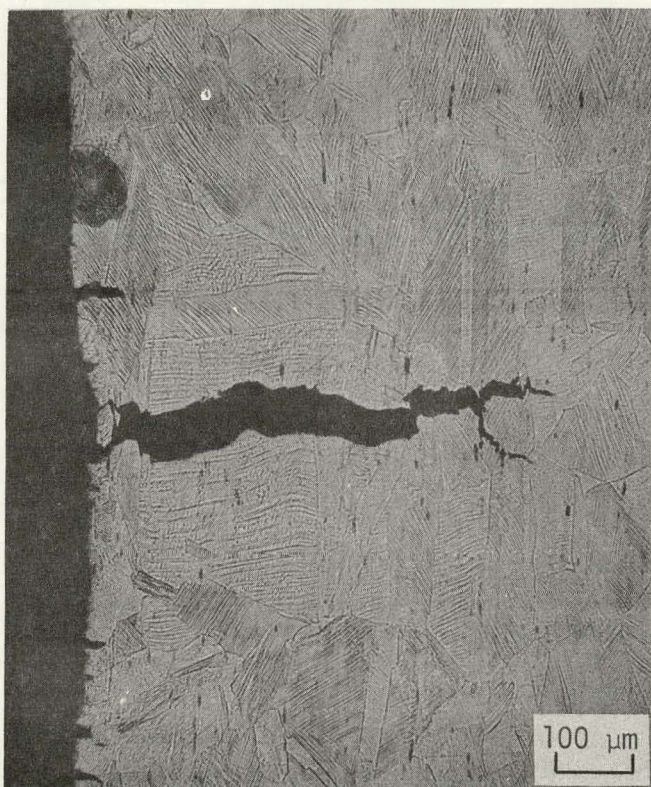
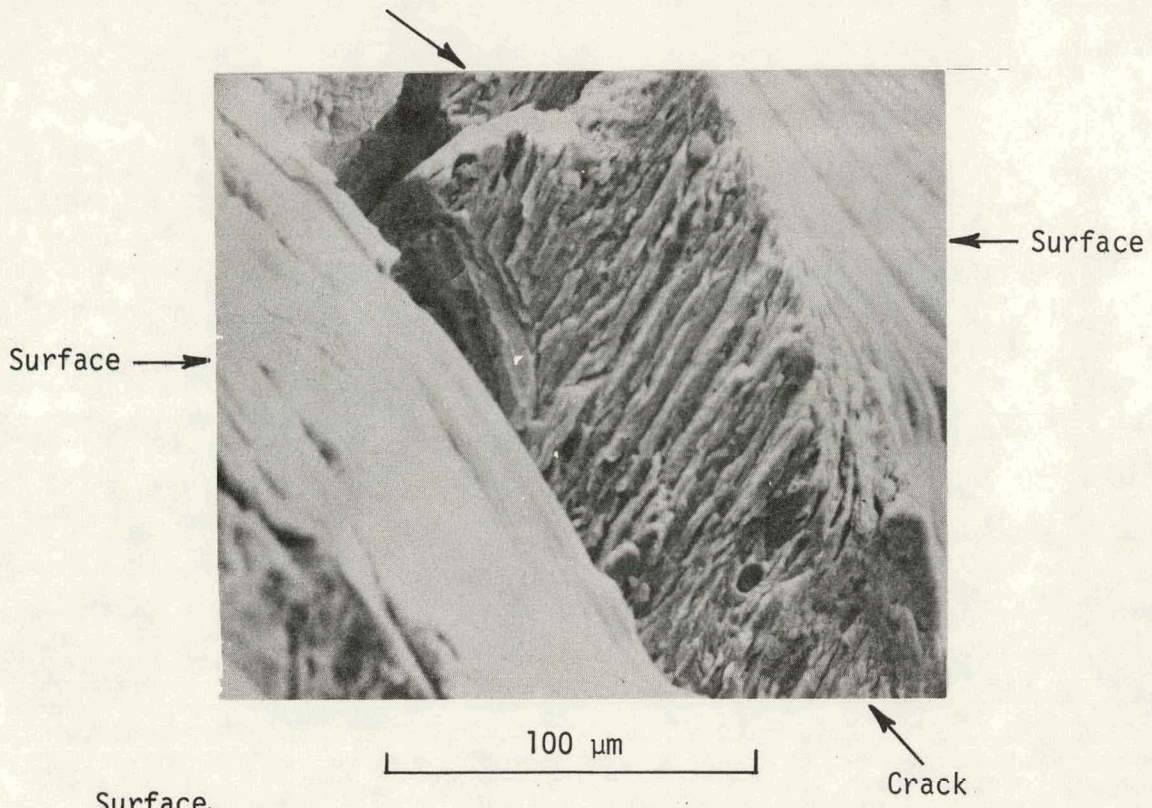
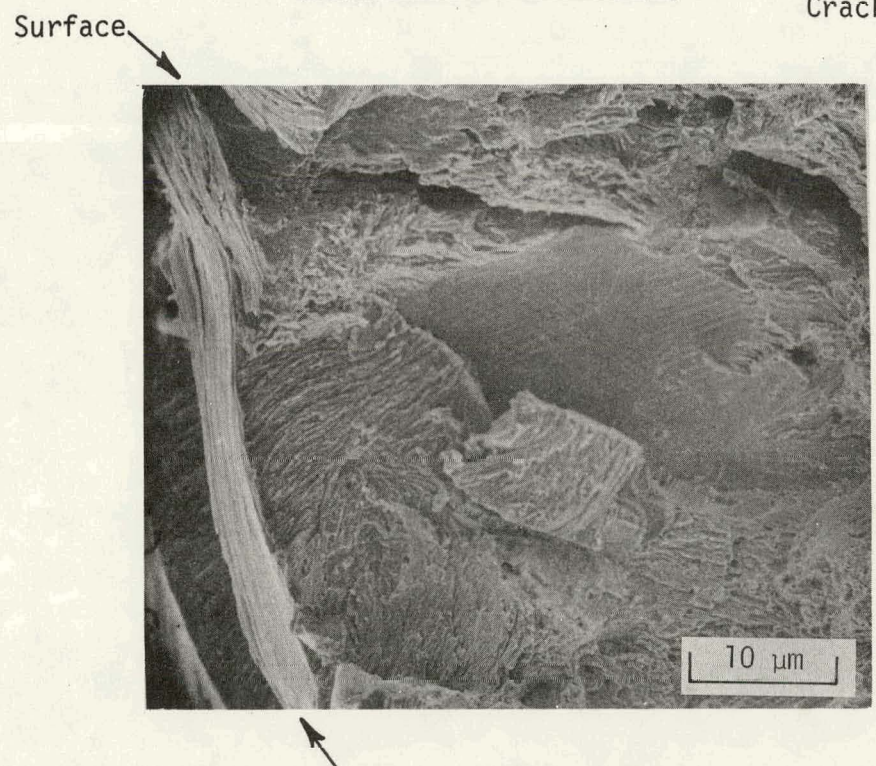
Surface cracks on the deuterium-saturated specimen tested at 273 K (Figure 10) are identical in appearance to those formed on specimens of Type 304L stainless steel pulled to failure in a high-pressure hydrogen atmosphere. The cracks extend to a maximum depth of about 0.01 cm in the deuterium-saturated specimen. Although ductility loss was greater at 198 than at 273 K, only a few surface cracks were on surfaces of specimens tested at the lower temperature. The faces of some surface cracks were examined in detail. Striations were common, but occasionally facets were observed with them (Figure 4).

FIGURE 10. Surface Cracks of Deuterium-Saturated Specimen Tested at 273 K
