**Los Alamos**  
NATIONAL LABORATORY

# Fracture Characterization of the Bandelier Tuff in OU-1098 (TA-2 and TA-41)

Kenneth H. Wohletz

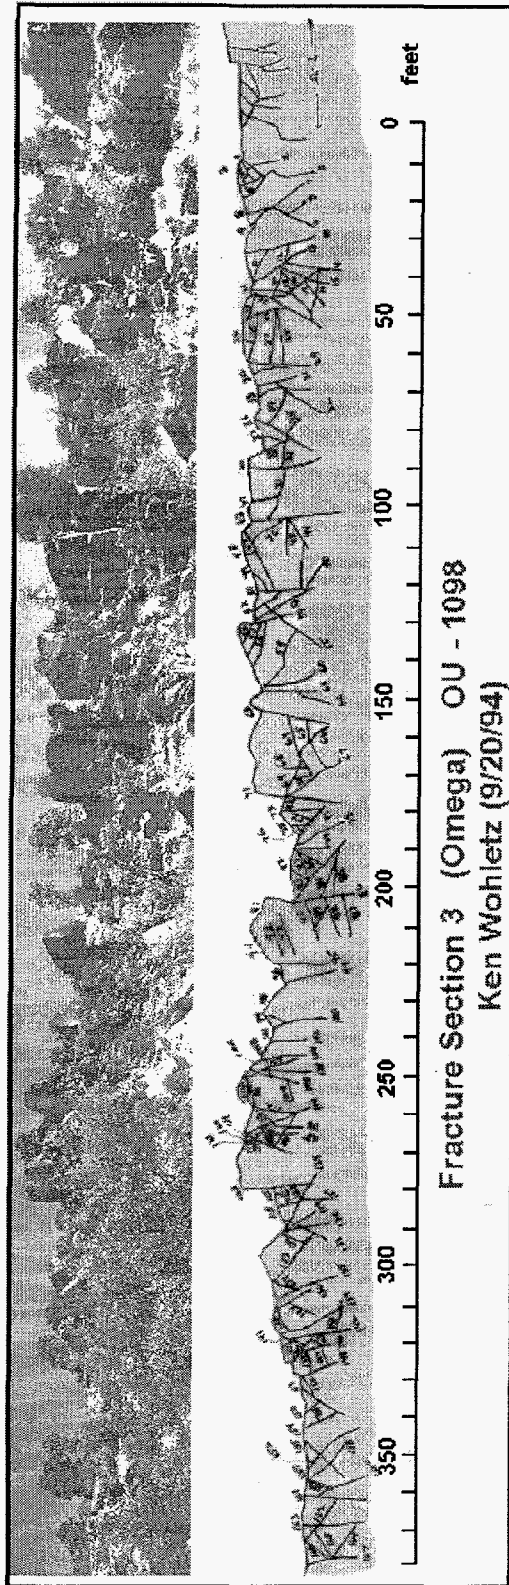
Figure 3. An example fracture photomosaic map (map 3) adjacent to Omega Site (TA-2-1). Each documented fracture has a number for its identification in the fracture data base.

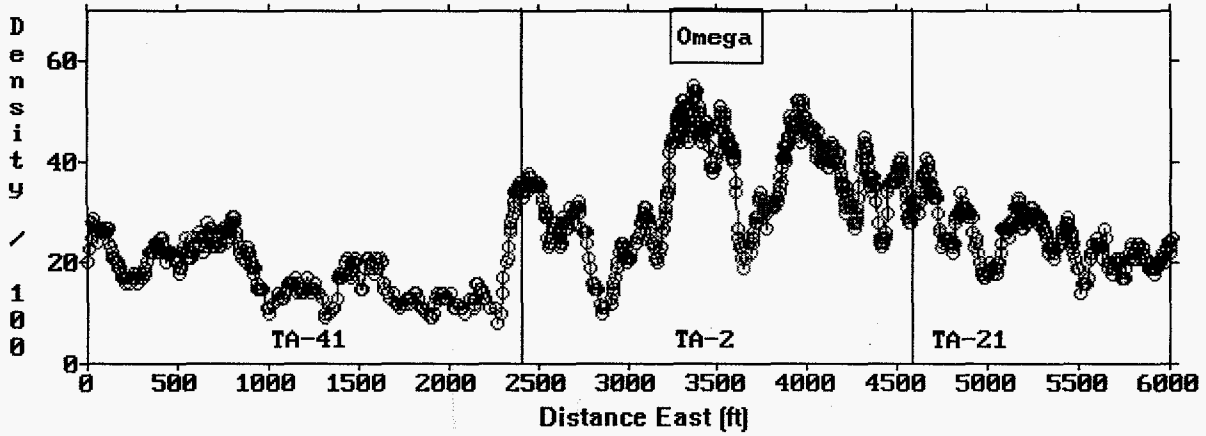
**Fracture Density Along Los Alamos Canyon  
(OU - 1098)**

**Fracture Density.** Linear fracture density is portrayed in Figure 4 as the number of fractures within a 100-foot interval centered on each fracture for the section starting west of building TA-41-4 and extending 6013 feet down Los Alamos Canyon. From Table 1, fracture density increases from a western background value of 22 fractures per 100-foot interval to over 40 within the GMFZ and then declining to about 30 east of GMFZ. The densities of NW and NE fractures are virtually the same. From previous studies, background fracture densities in the Bandelier Tuff are about 20 fractures per 100-foot interval (Vaniman and Wohletz, 1990; Wohletz, 1995). The value of 30 fractures per 100-foot interval east of the GMFZ likely shows the influence of another fault zone existing near Material Disposal Area V (MDA-V) in TA-21 (~7000 feet east; Wohletz, 1995). Figure 4 shows the prominent rise in fracture density within TA-2 near Omega Site, reaching maximum values between 50 and 60 fractures per 100-foot interval. At 2500 feet another peak in fracture density is apparent. Figure 5 is an enlargement of Figure 4 over the area adjacent to Omega Site building TA-2-1, which likely constitutes a western branch of the Guaje Mountain Fault; the eastern branch exists about 400 feet east of TA-2-1.

Figure 4. Fracture density shows the number of fractures per 100-foot interval centered on each fracture along the traverse of approximately 6000 feet. Note the increase in density from about 3200 to 4200 feet (adjacent to Omega Site), which is the signature of the Guaje Mountain Fault Zone.

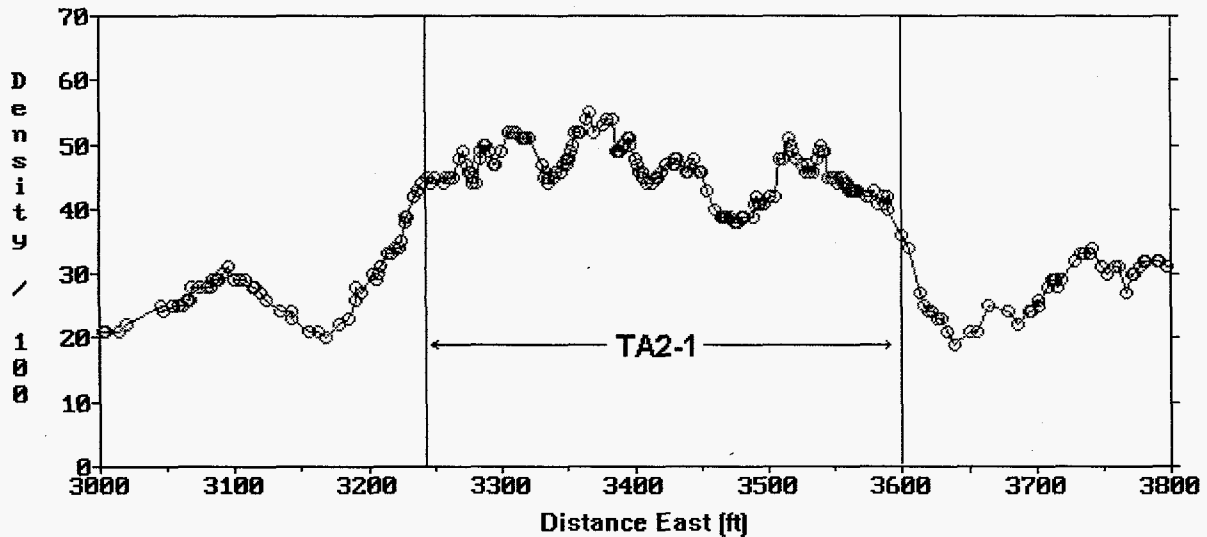
**Fracture Density Adjacent to TA2-1  
(Omega West)**

Figure 5. Detail of fracture density from 3000 to 3800 feet along the fracture traverse in the region of building TA-2-1 (Omega West reactor).

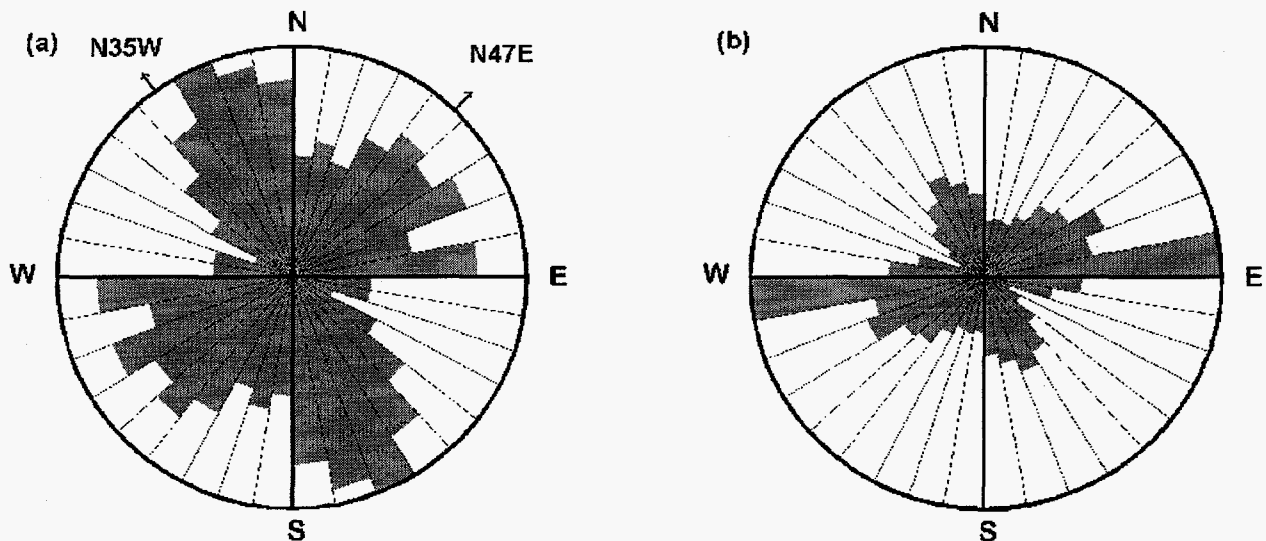
**Fracture Strike.** Plotted in a rose diagram (Fig. 6a), fracture strikes show two groupings with mean strikes at N35W and N47E, supporting the conjugate joint-set assumption for distribution of the fractures. As mentioned above, measurement of fractures along a nearly E-W line precludes unbiased representation of fractures nearly parallel to that trend. A compensation algorithm can be defined based on the assumption that the observed fracture abundance is inversely proportional to the cosine of the angle between the fractures and the perpendicular to the line of observation. This algorithm is modified to take into account that the fracture traverse is not a straight line and represents about 20 degrees of variability (canyon wall reentrants allow measurement of some of the fractures striking parallel to the canyon); hence, the maximum compensation will not be infinity but about a factor of 3 [ $1/(\cos 70^\circ)$ ]. Figure 6b is a rose diagram depicting this compensation, which defines a hypothetical but dominant E-W grouping (note that rose diagram depicts E-W trend in bin adjacent to E-W line). The angle between mean strikes is  $82^\circ$  (NW and NE sets) and between  $43^\circ$  (EW and NE sets) and  $55^\circ$  (EW and NW sets).

Figure 6. (a) Rose diagram showing the frequency of measured fracture strikes with conjugate set mean values at N35W and N47E. (b) Compensated rose diagram showing hypothetical frequencies of fractures nearly paralleling the fracture traverse.

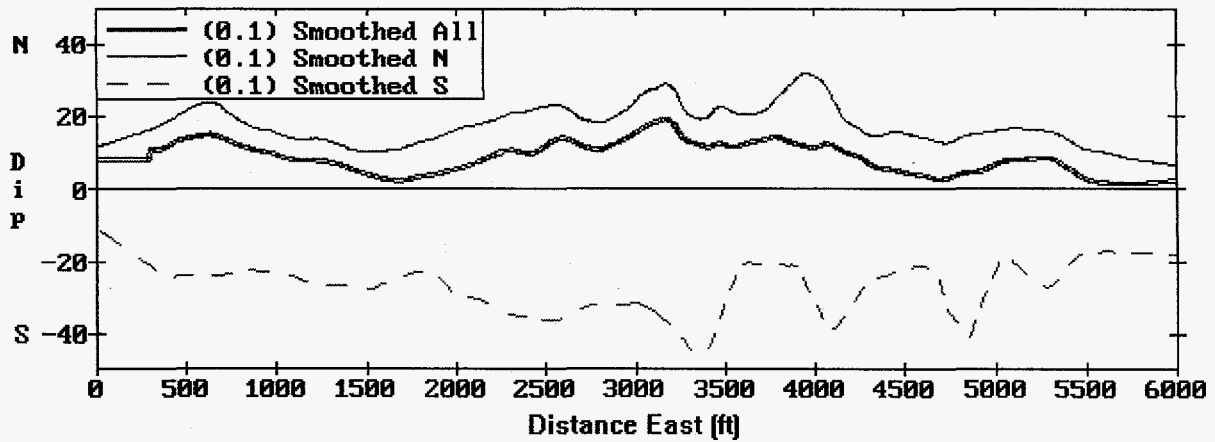
**Fracture Dip Along Los Alamos Canyon  
(OU - 1098)**

Figure 8. LOWESS (0.1) smoothed curves of fracture dips relative to vertical (0) where southerly dips are shown as negative values. Because there are more north dipping fractures than south dipping ones, the smoothed average of all data shows northerly dipping tendencies.

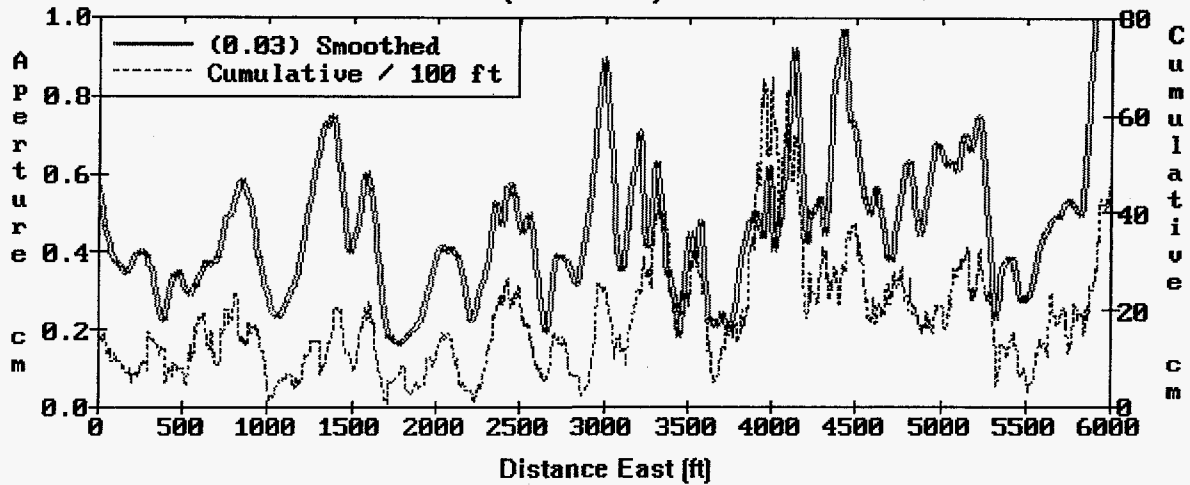
### Fracture Aperture Along Los Alamos Canyon (OU - 1098)

Figure 9. LOWESS (0.03; 45 point) smoothed curve of fracture apertures and the curve for cumulative fracture aperture per 100-foot interval centered on each fracture. The cumulative curve shows peak values in the region of the GMFZ.

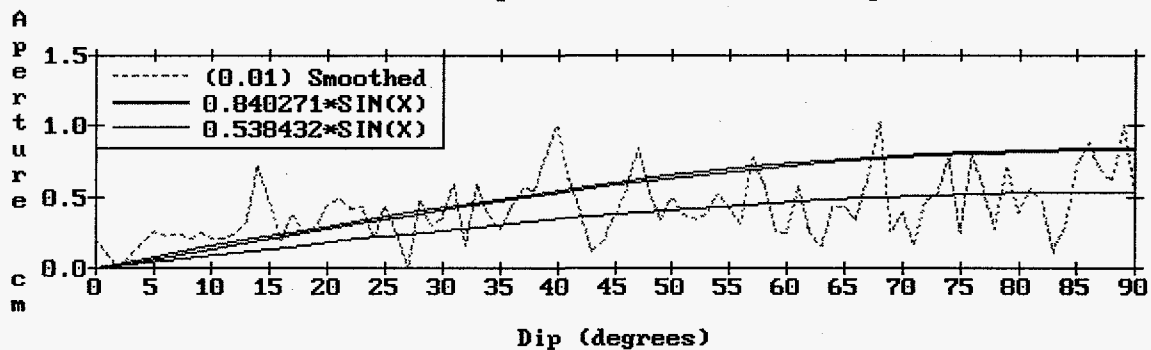
### Fracture Aperture as Function of Dip

Figure 10. LOWESS (0.01) smoothed curve (dotted) of fracture apertures as a function of dip. Sine curves are shown for a best fit of all aperture data (double) and best fit of smooth data (single). This plot shows that there is a general observed increase in fracture aperture with increasing fracture dip, such that horizontal fractures generally show little or no aperture while vertical ones generally show apertures of about 0.8 cm.

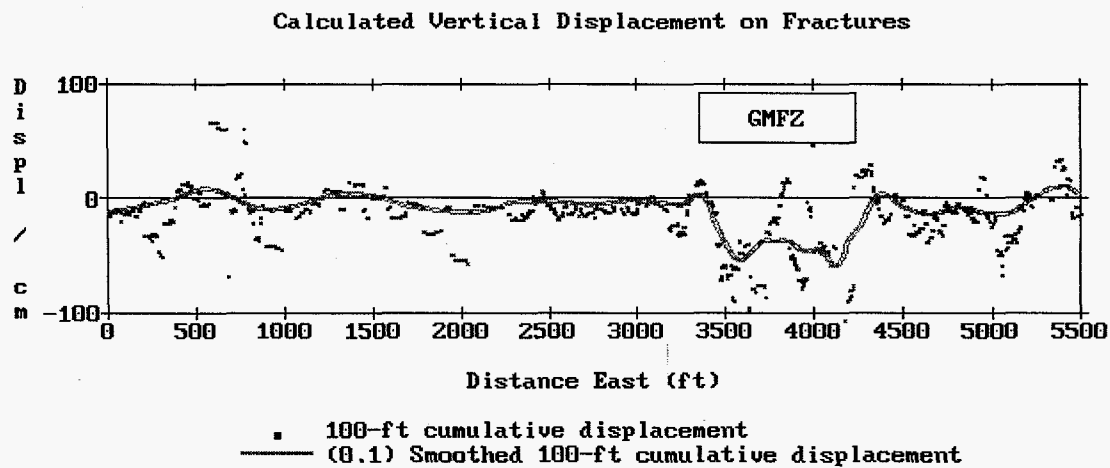
Figure 12. Fracture aperture per 100-foot interval (interval centered on each fracture) and LOWESS (0.1) smoothed curve of these data calculated as shown in Figure 11. Note the negative (down to the west) signature over the GMFZ between 3200 and 4200 feet.

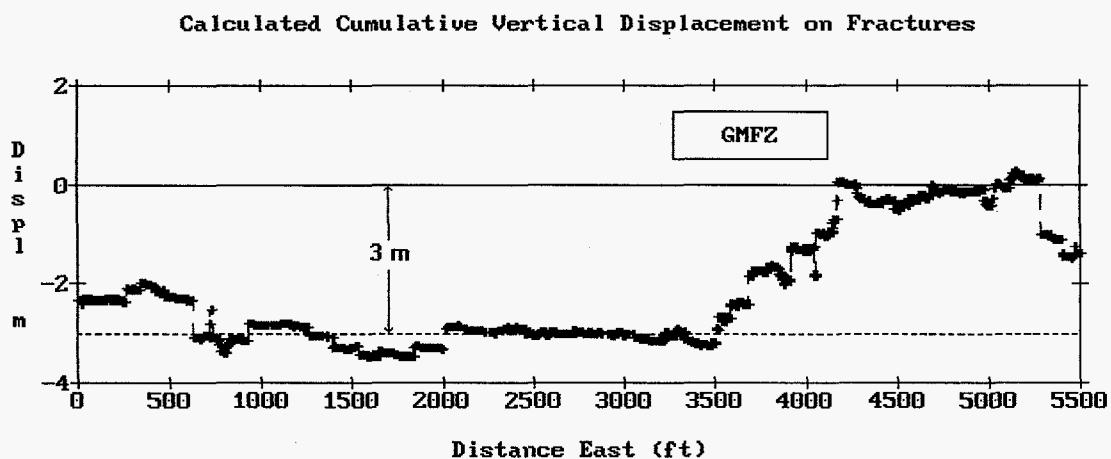
If in fact tectonic displacement has been accommodated by the 409 documented fractures over the GMFZ (3200 to 4200 feet) by incremental, vertical displacement on each fracture, then with summation of these displacements one can test the model of Gardner and House (1987) that shows downdrop on the west side of this fault zone. Because most fractures do not show measurable evidence of incremental displacement, an alternative method is proposed here, a method based on the assumption that fracture apertures have developed by vertical displacement along initially closed cooling joints. Figure 11 illustrates this method, showing how a vertical displacement along a fracture produces a fracture aperture where the apparent downdrop equals the aperture divided by the cosine of the dip. This method also requires the assumption that vertical fractures produce no aperture, which is incorrect considering observed data (Fig. 10); however, if vertical fractures were included in this method, then an infinite vertical displacement would arise, which is obviously incorrect. Furthermore, cooling contraction of the tuff may have produced fracture apertures, but I note that many localities in the Bandelier Tuff show cooling joints having no aperture. Keeping in mind the above assumptions, an application of this method (Figs. 12 and 13) does show an apparent cumulative downdrop of approximately 3 m (10 ft) to west has been accommodated by fractures in this zone. In support of this calculation, Vaniman and Wohletz (1990) calculated ~2 m of vertical displacement on the GMFZ where it crosses East Jemez Road to the south of Los Alamos Canyon. In addition this former study noted an inflection of the Los Alamos Canyon stream gradient of about 20 feet over the GMFZ, which is a common geomorphic feature of fault displacement.

Figure 13. Cumulative fracture vertical displacement calculated as shown in Figure 11. Note the apparent westward downdrop over the GMFZ. Approximately 4m of apparent displacement occurs between 3500 and 4200 feet, where cumulative offset is taken from an arbitrary zero level east of the GMFZ.
