KAPL-2203

CORROSION OF ZIRCALOY IN CREVICES UNDER NUCLEATE BOILING CONDITIONS

W. Kermit Anderson, M. J. McGoff

April 13, 1962

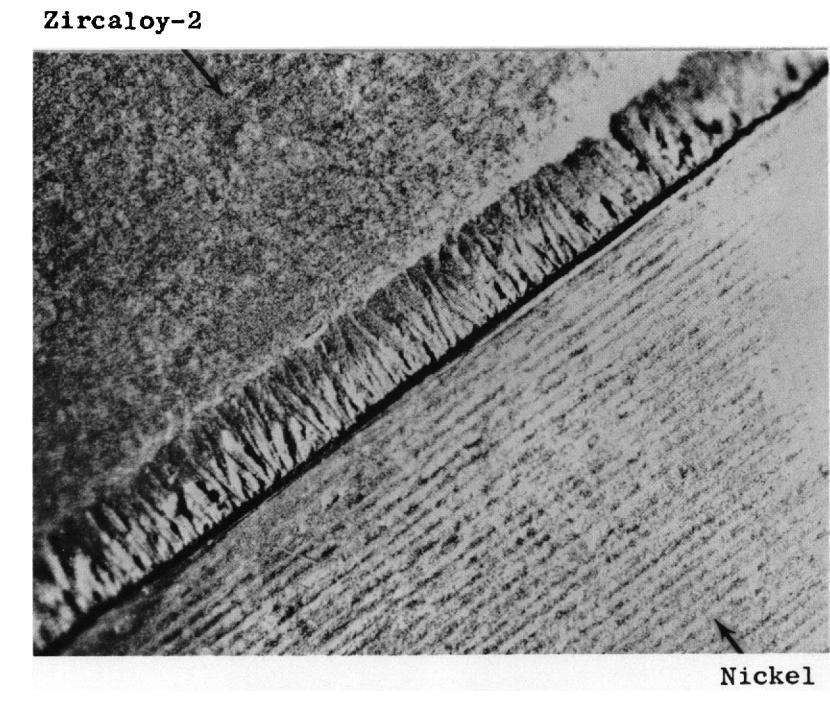
Lithiated, Hydrogenated Water, - pH-10

FIGURE 10. Corrosion of Nickel - Zircaloy-2 Diffusion Bond.

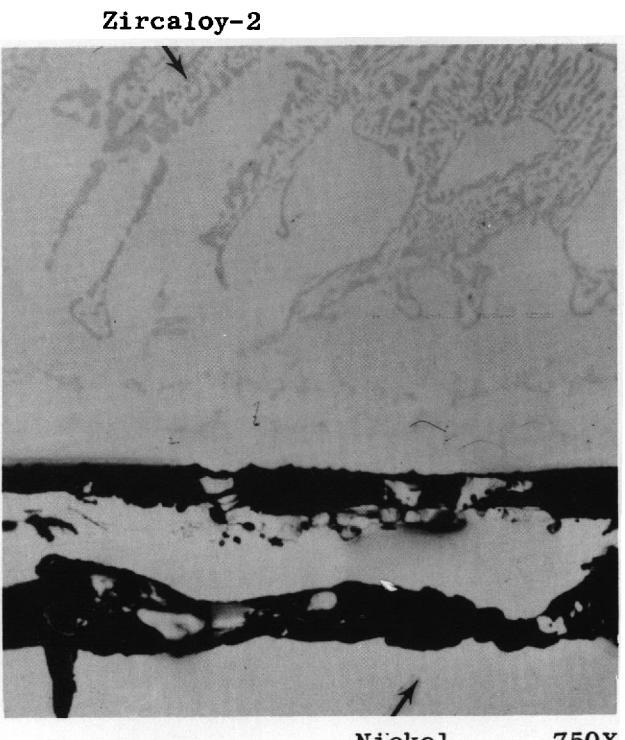
FIGURE 11. Corrosion of Nickel - Zircaloy-2 Diffusion Bond in Ammoniated, Hydrogenated Water - pH 10. KS-45130 Unclassified

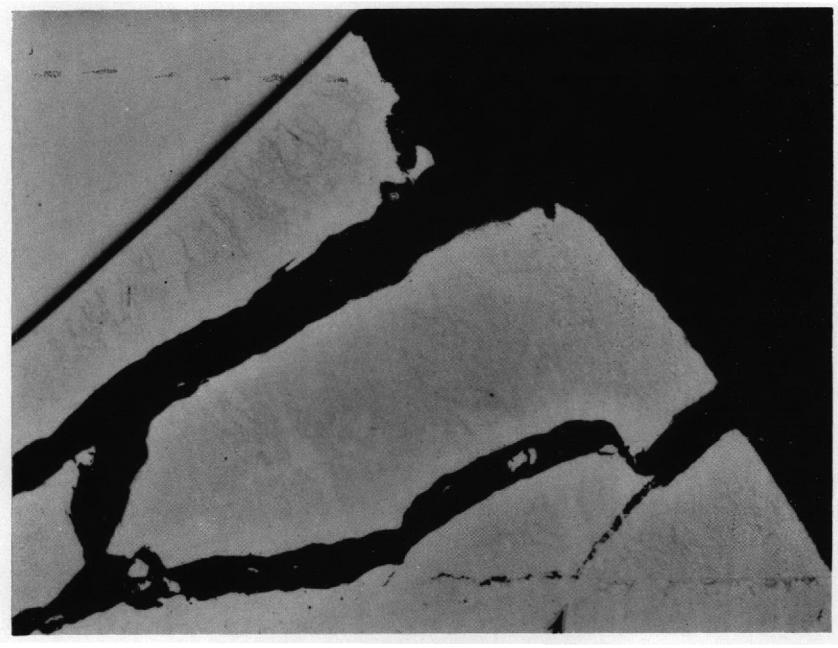
FIGURE 12. Corrosion of Nickel - Zircaloy-2 Diffusion Bond in Lithiated, Hydrogenated Water - pH 10. Unclassified KS-45131

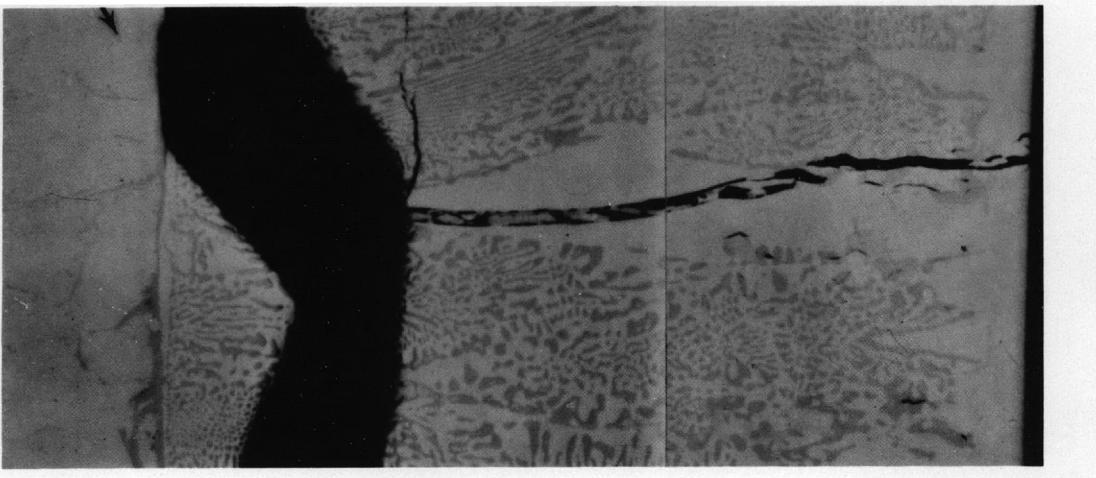
FIGURE 13. Corrosion of Nickel - Zircaloy-2 Diffusion Bond in Lithiated, Hydrogenated Water - pH 10. Unclassified KS-45132

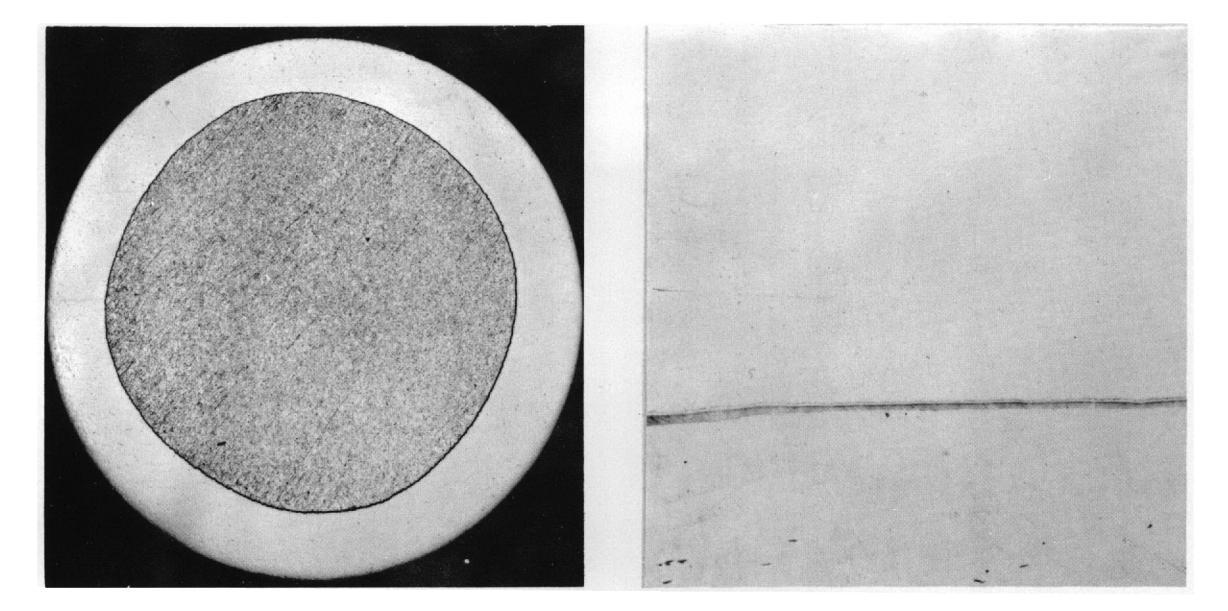
A. Cross Section (Macro) 3X FIGURE 15. Transverse Section of Copper-Zircaloy Clad Bus after 1000-hr Loop Exposure at 585F.

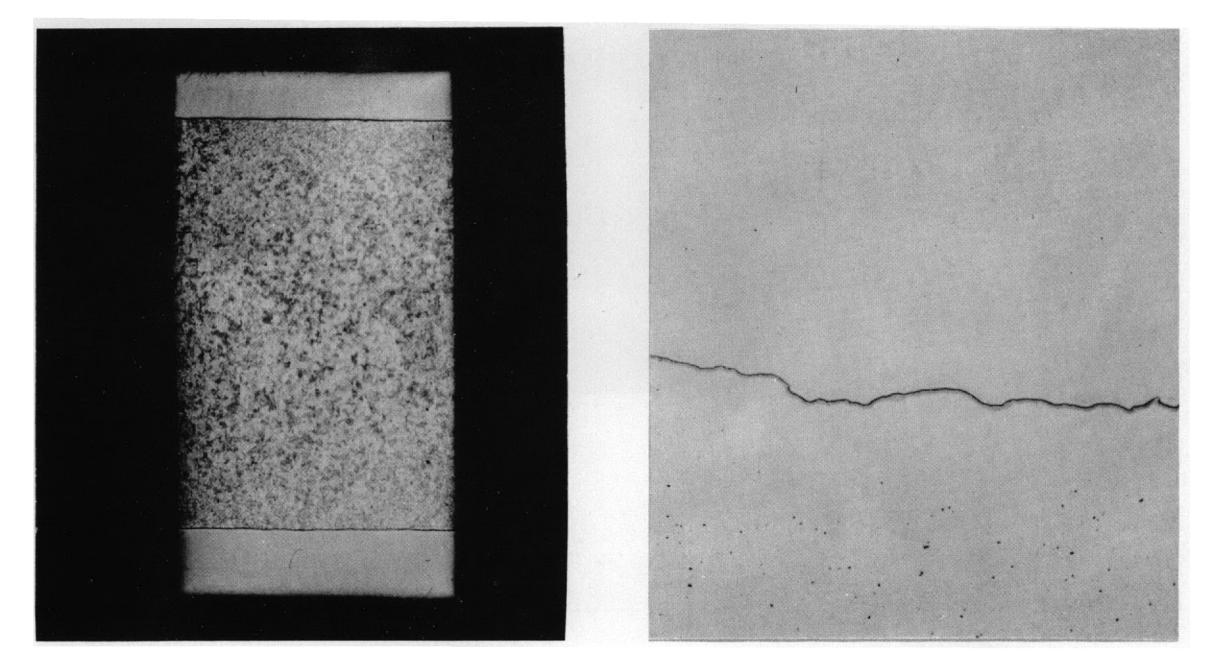
A. Longitudinal Section, 3X FIGURE 16. Longitudinal Section Taken from Same Region in Bus Bar as in Figure 11.

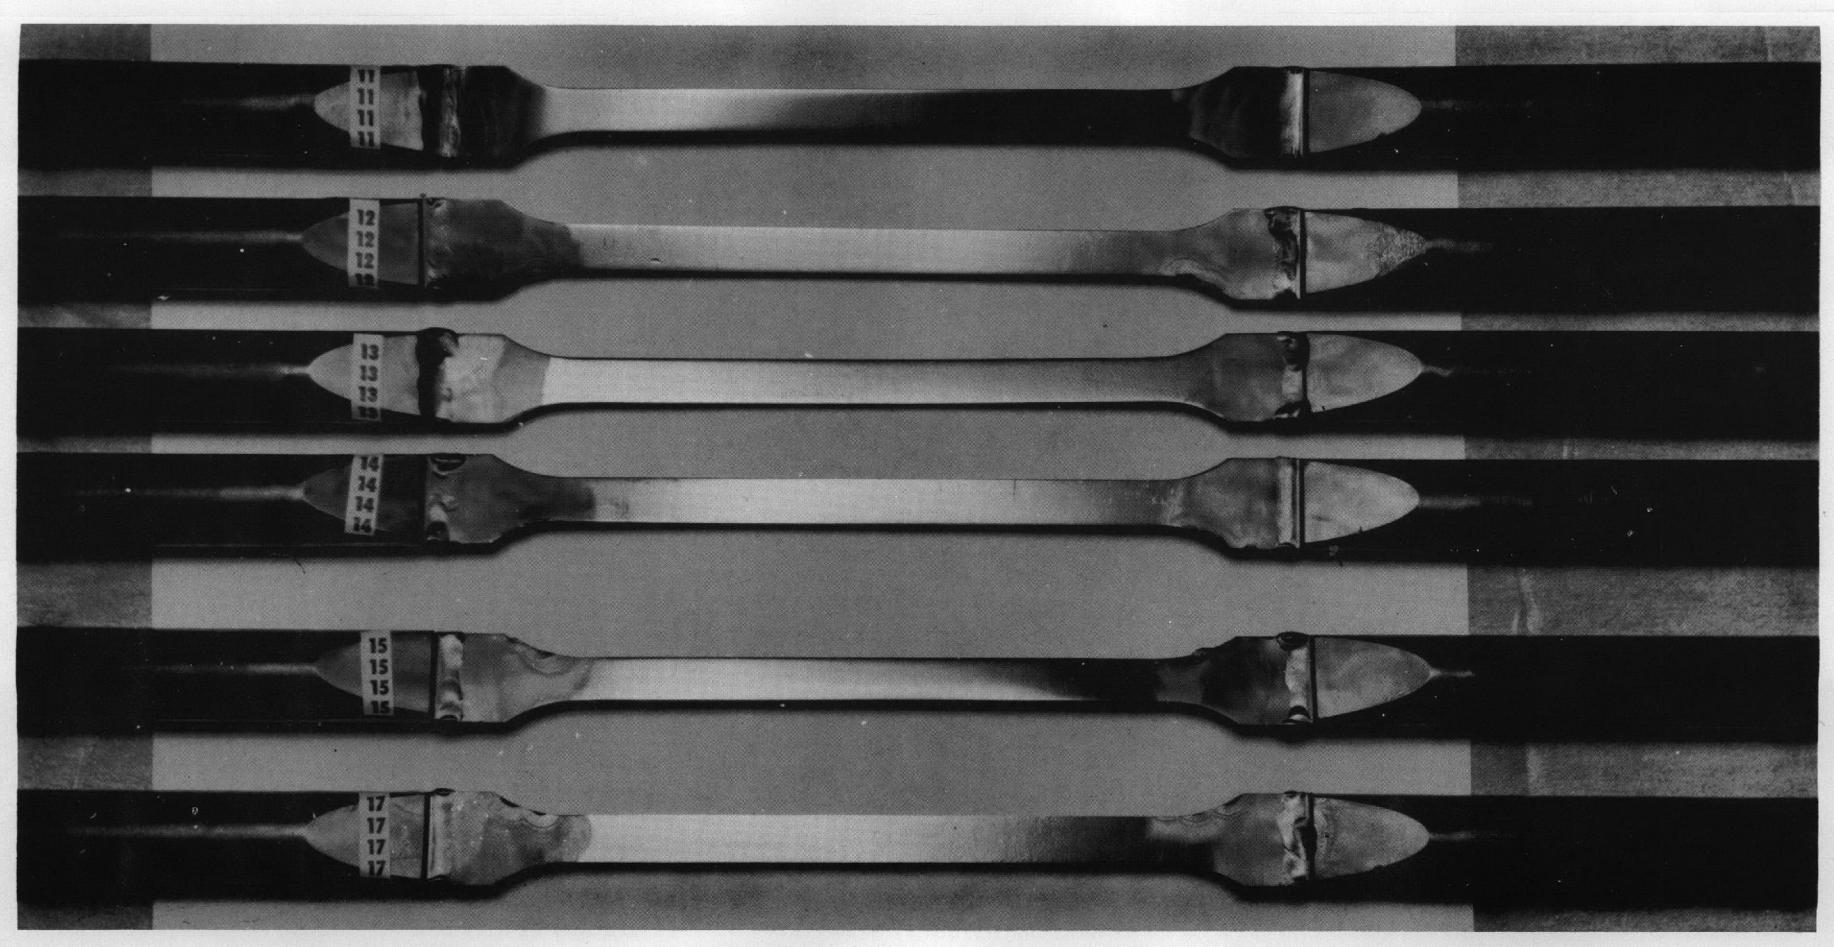
FIGURE 18. Specimens 11 through 15, and 17 after Corrosion Test. KS-45245 Unclassified

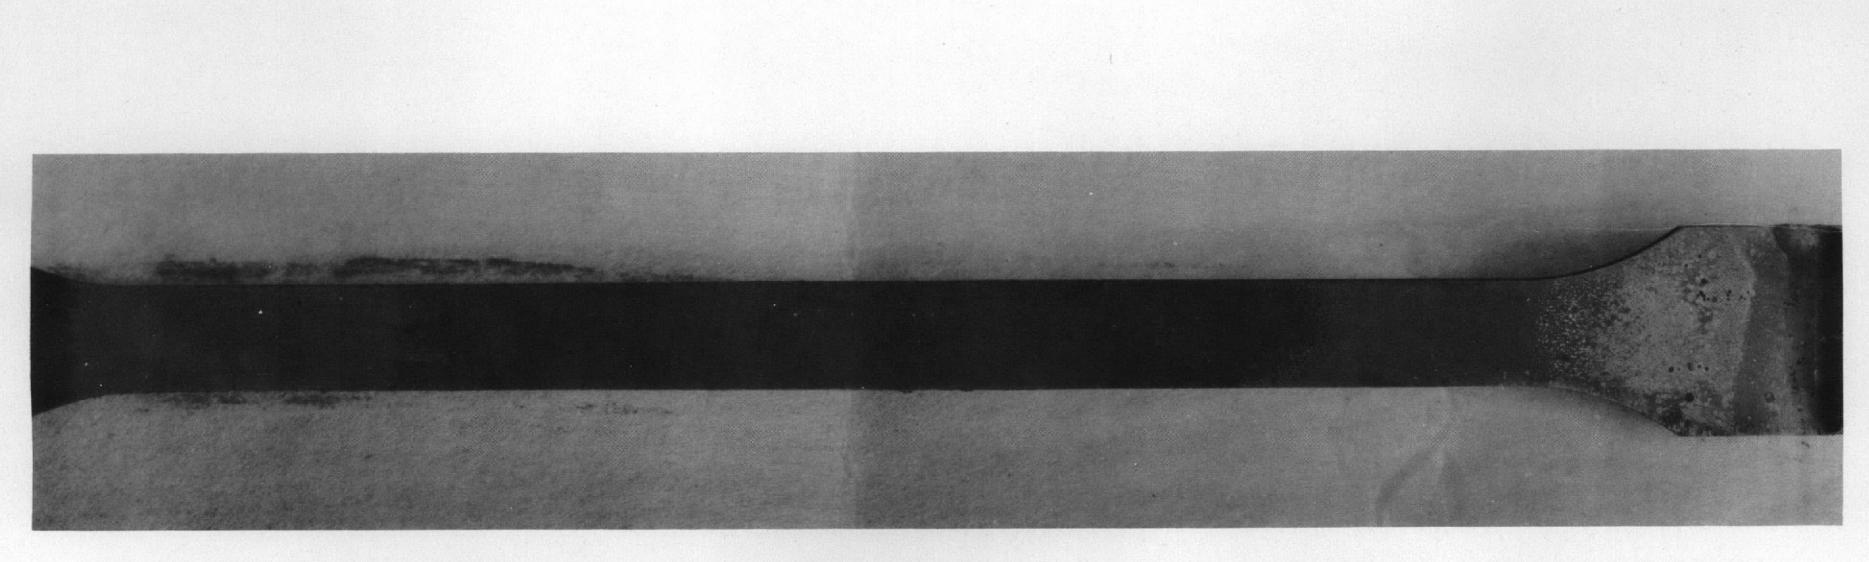
FIGURE 20. Enlarged View of Opposite Face of Specimen 3 to that Shown in Figure 19. (2X reduced 95%.) KS-30640 Unclassified

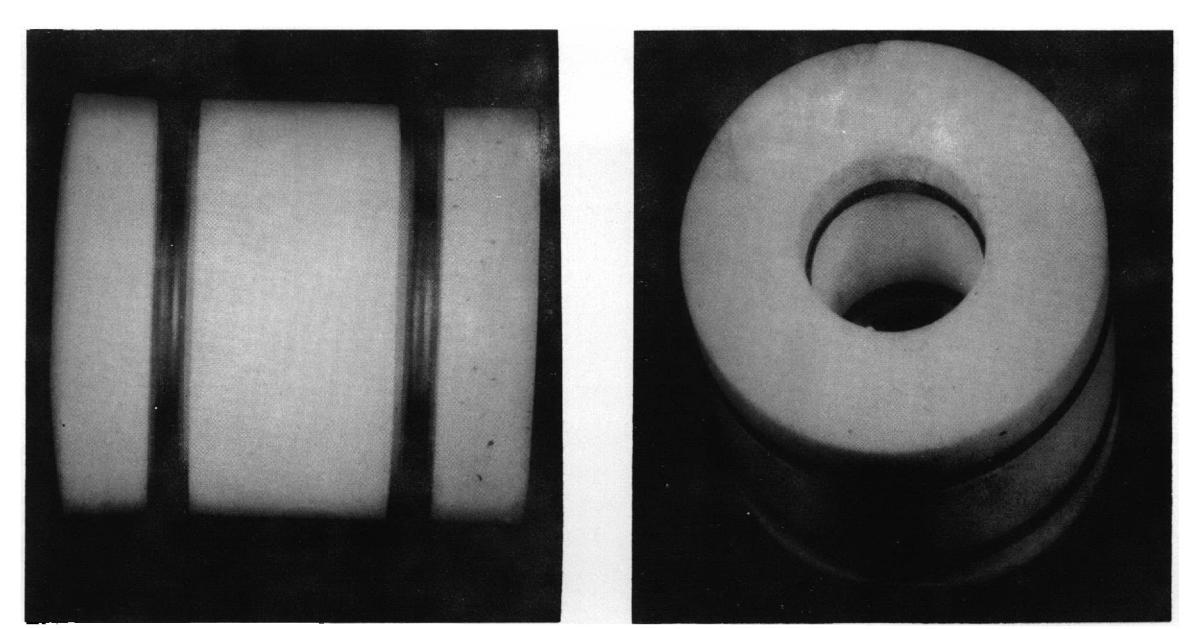
A. Side View Showing Outside of Teflon Part with External Rubber O-Rings Visible B. Photograph from Top (Hottest Portion) of Seal Showing Parts of Two Inside Rubber O-Rings.

FIGURE 25. Photograph of Rubber O-Ring Used in Ammonia Test in Test Chamber 2.

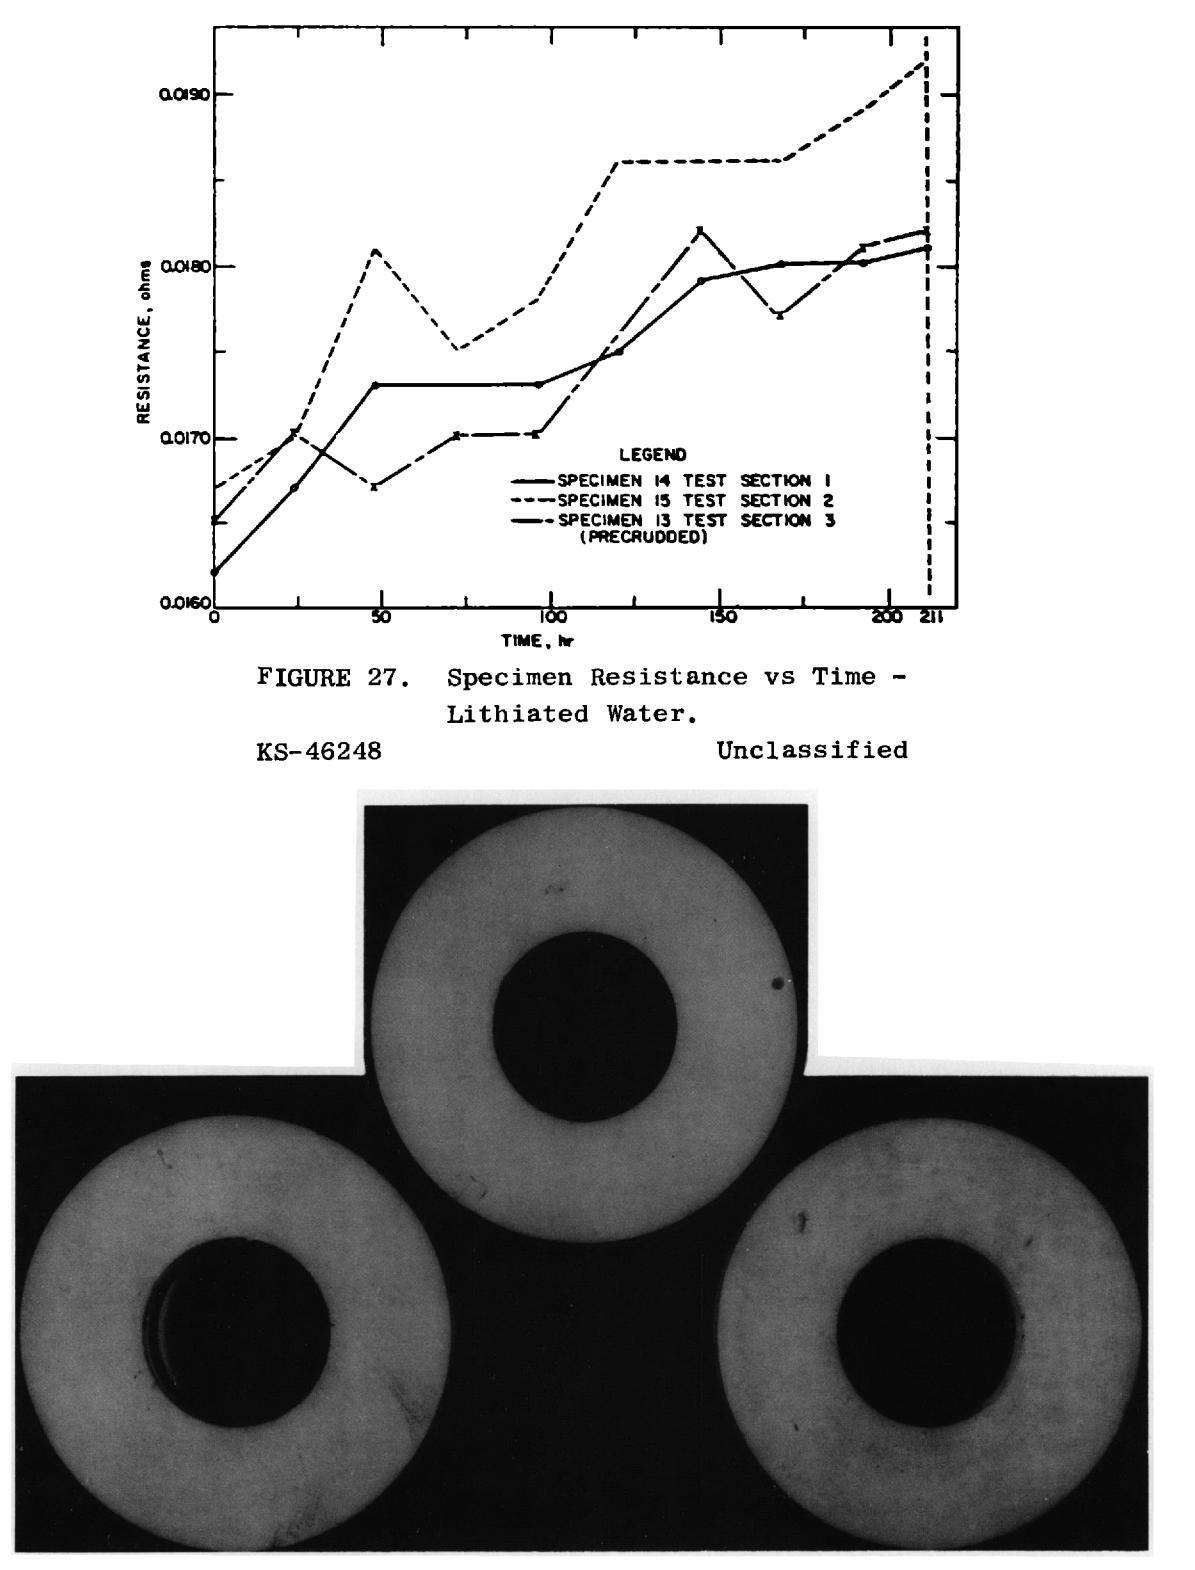
FIGURE 28. Photographs of Top (Hottest Parts) of All Three Teflon Seal Members Used in Test Chambers for Lithiated Water Run. KS-46249 Unclassified

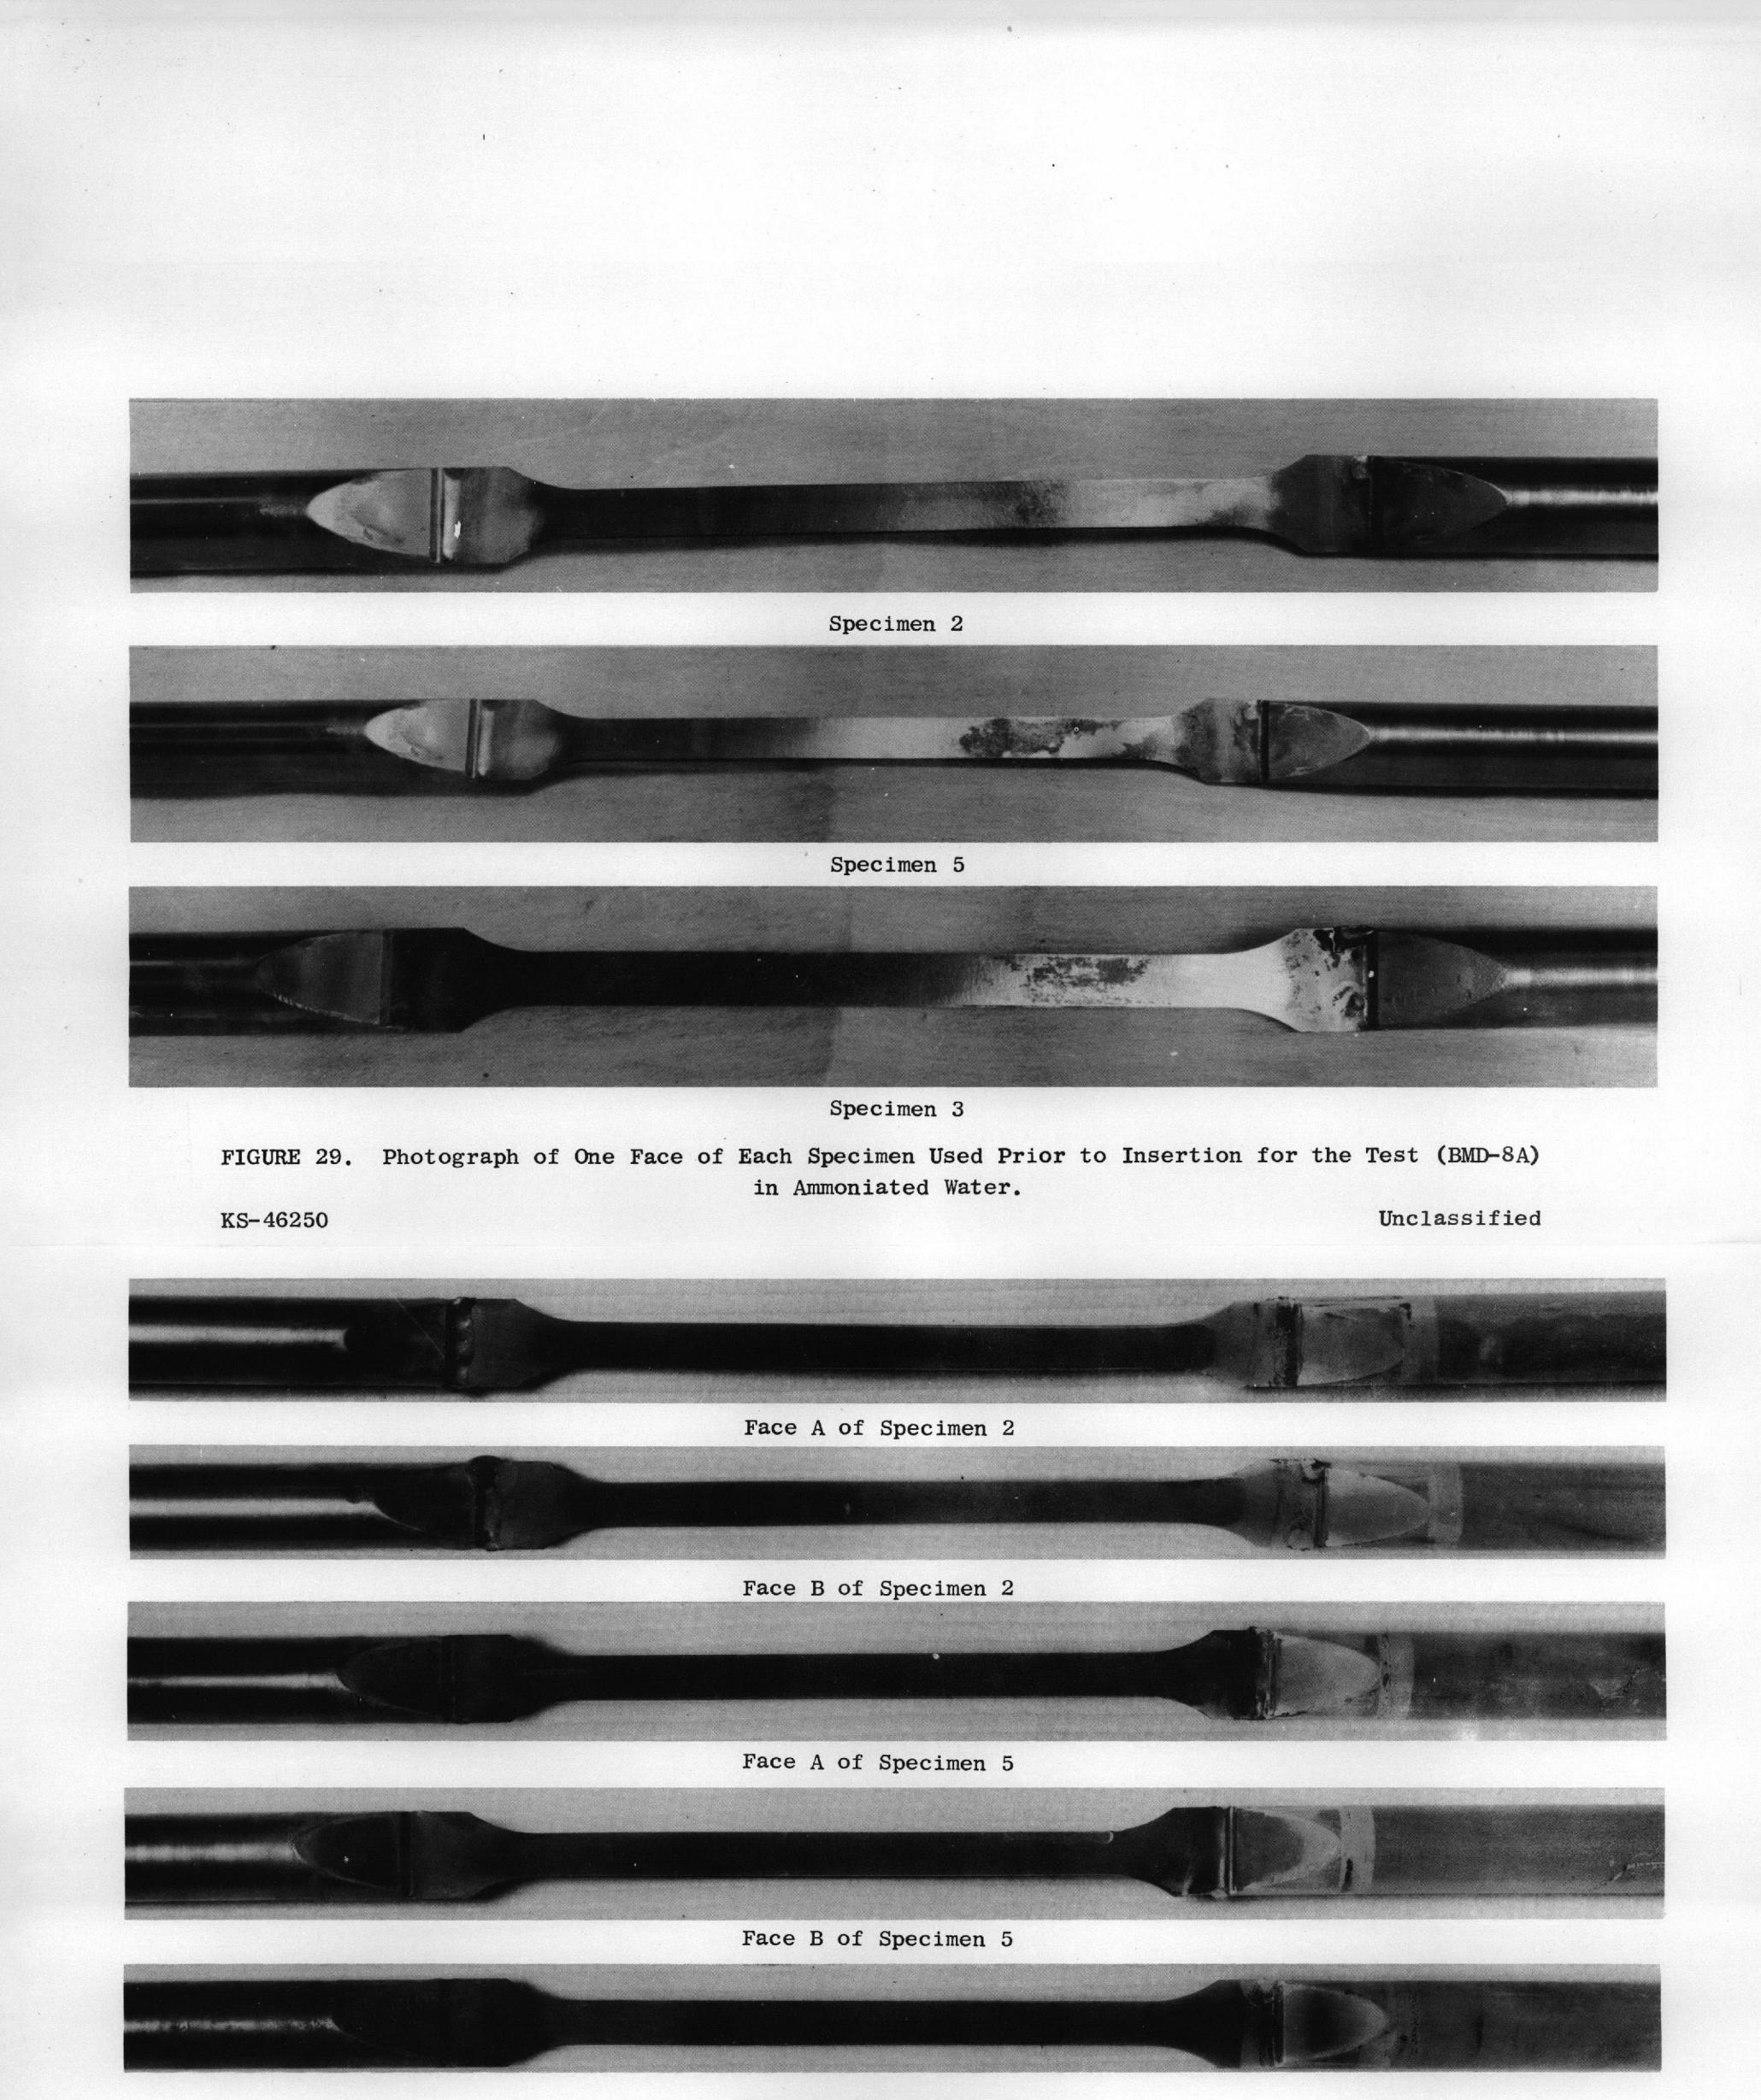
FIGURE 30. Composite Photographs Showing Both Faces of Specimens 2, 5, and 3 after Loop Exposure for 1000 hr in pH 10.5 Ammoniated Water. The lower, inlet end of these specimens is oriented toward the right in the picture. This end, nearest the Teflon seals, was exposed to liquid-phase water. Notice the thin deposits of nonadherent zirconium oxide on these lower ends of all three specimens. KS-46251

Figure 33 shows inner faces of specimens 2, 5, and 3. The white oxide visible in these photographs is largely hydrated alumina (boehmite) of the chemical composition $Al_2O_2(OH)_2$. It has been established that this aluminum oxide deposit probably came from the parts of a charging pump that had been used to pump water into the loop. Spectrographic analyses and X-ray diffraction data have been used to establish the composition of all three of these oxide deposits on specimens 2, 5, and 3.

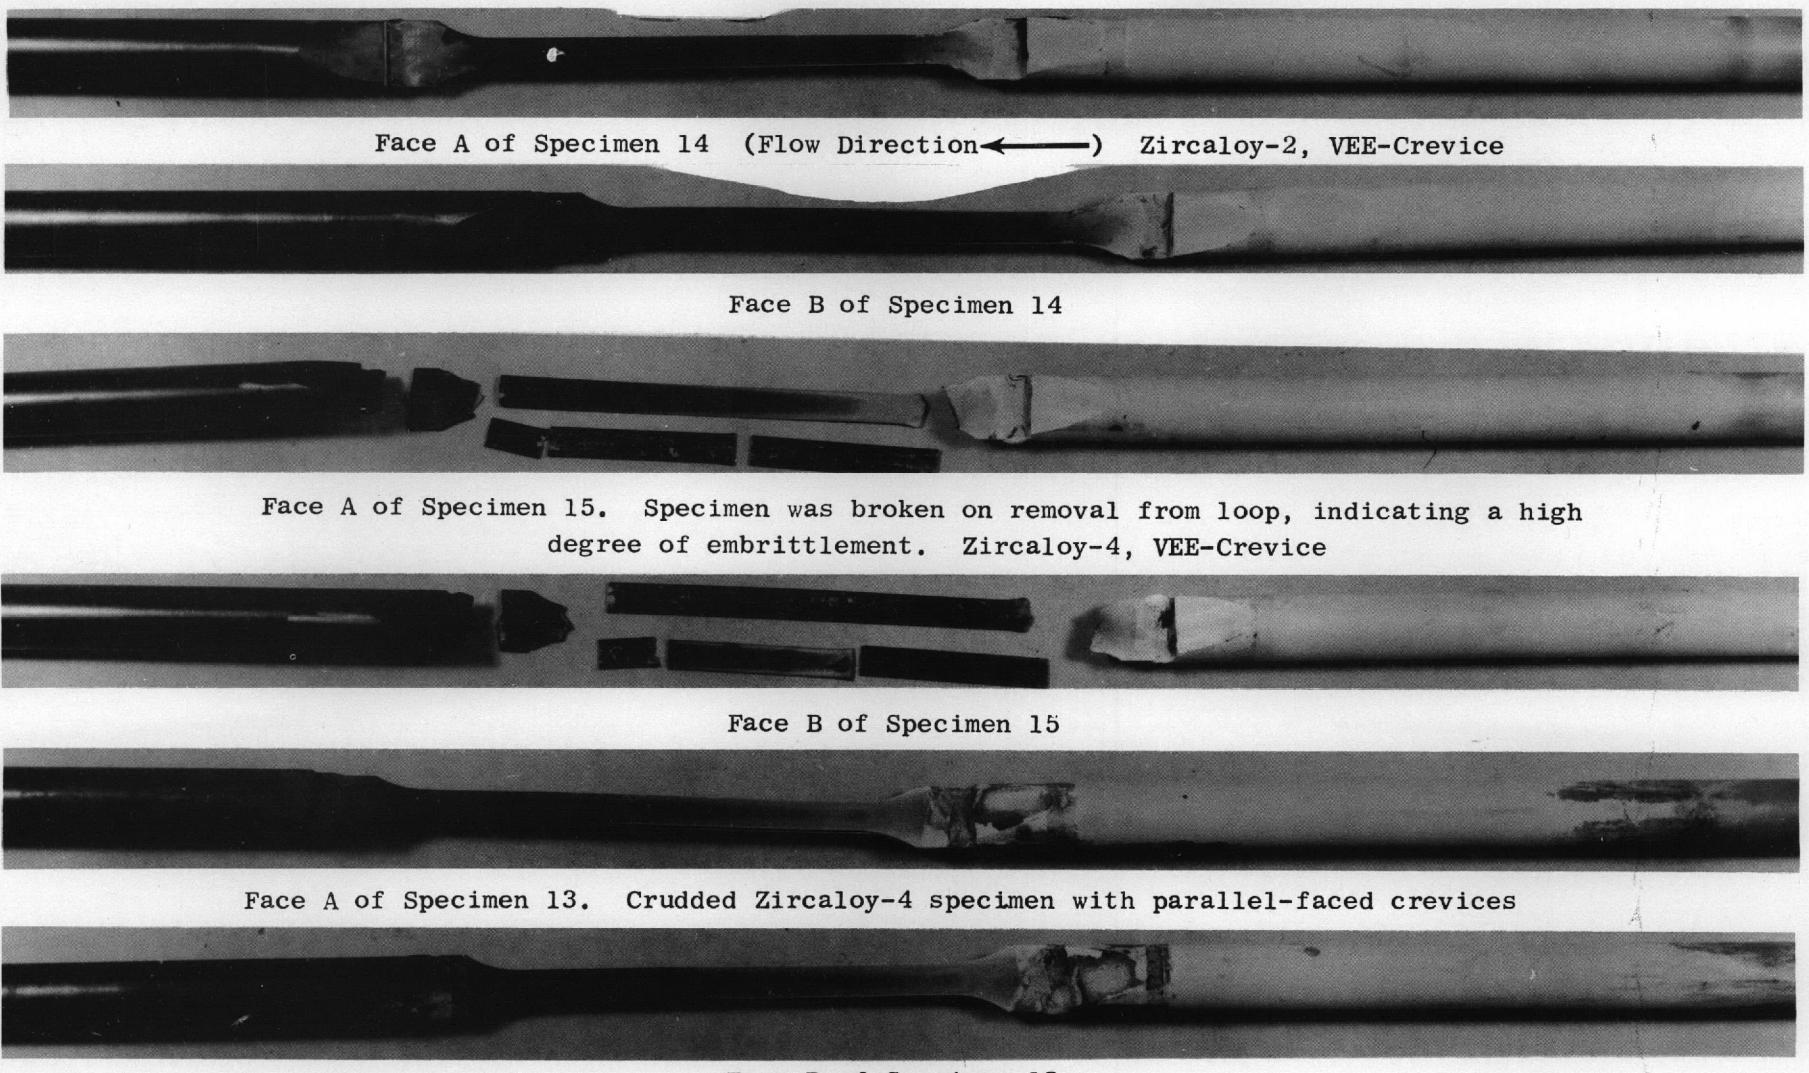
FIGURE 32. Specimens 14, 15, and 13 after Loop Exposure for 200 hr in pH 10.5 Lithiated Water. Extreme embrittlement due to hydrogen pickup under accelerated corrosion conditions was indicated by the breaking of the Zircaloy-4 VEE-crevice specimen during removal from the loop. Notice the increased amount of nonadherent white oxide compared with that of Figure 29 on the upstream ends of these specimens. Unclassified KS-46253

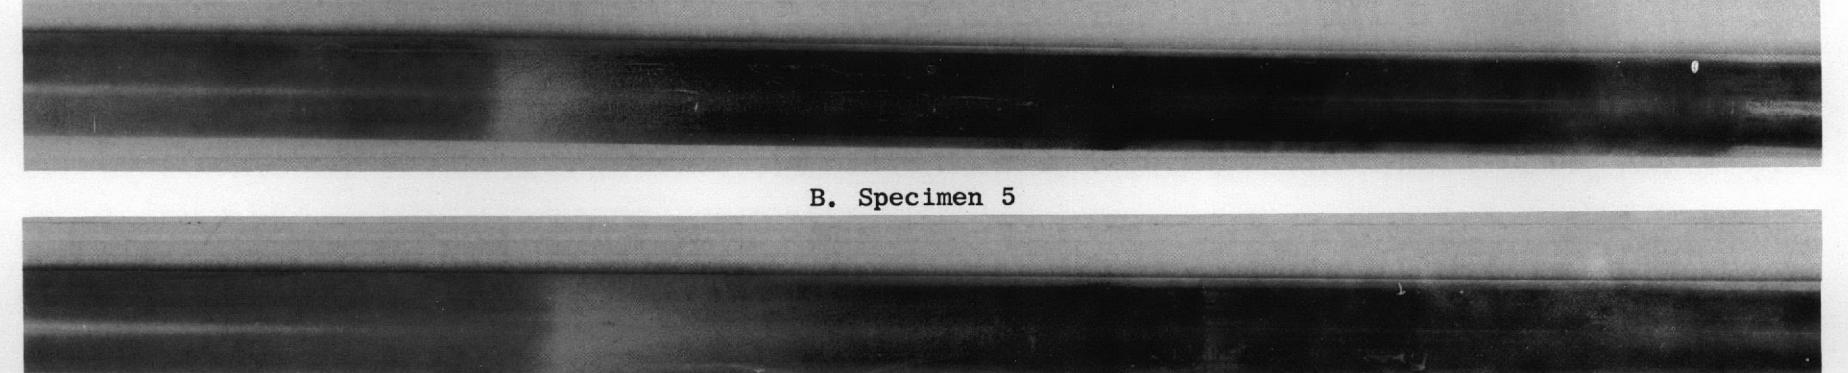
FIGURE 36. Nonadherent White Zirconium Oxide Product Formed in Ammoniated Water Test on Upstream Bus Bars. KS-45673 Unclassified

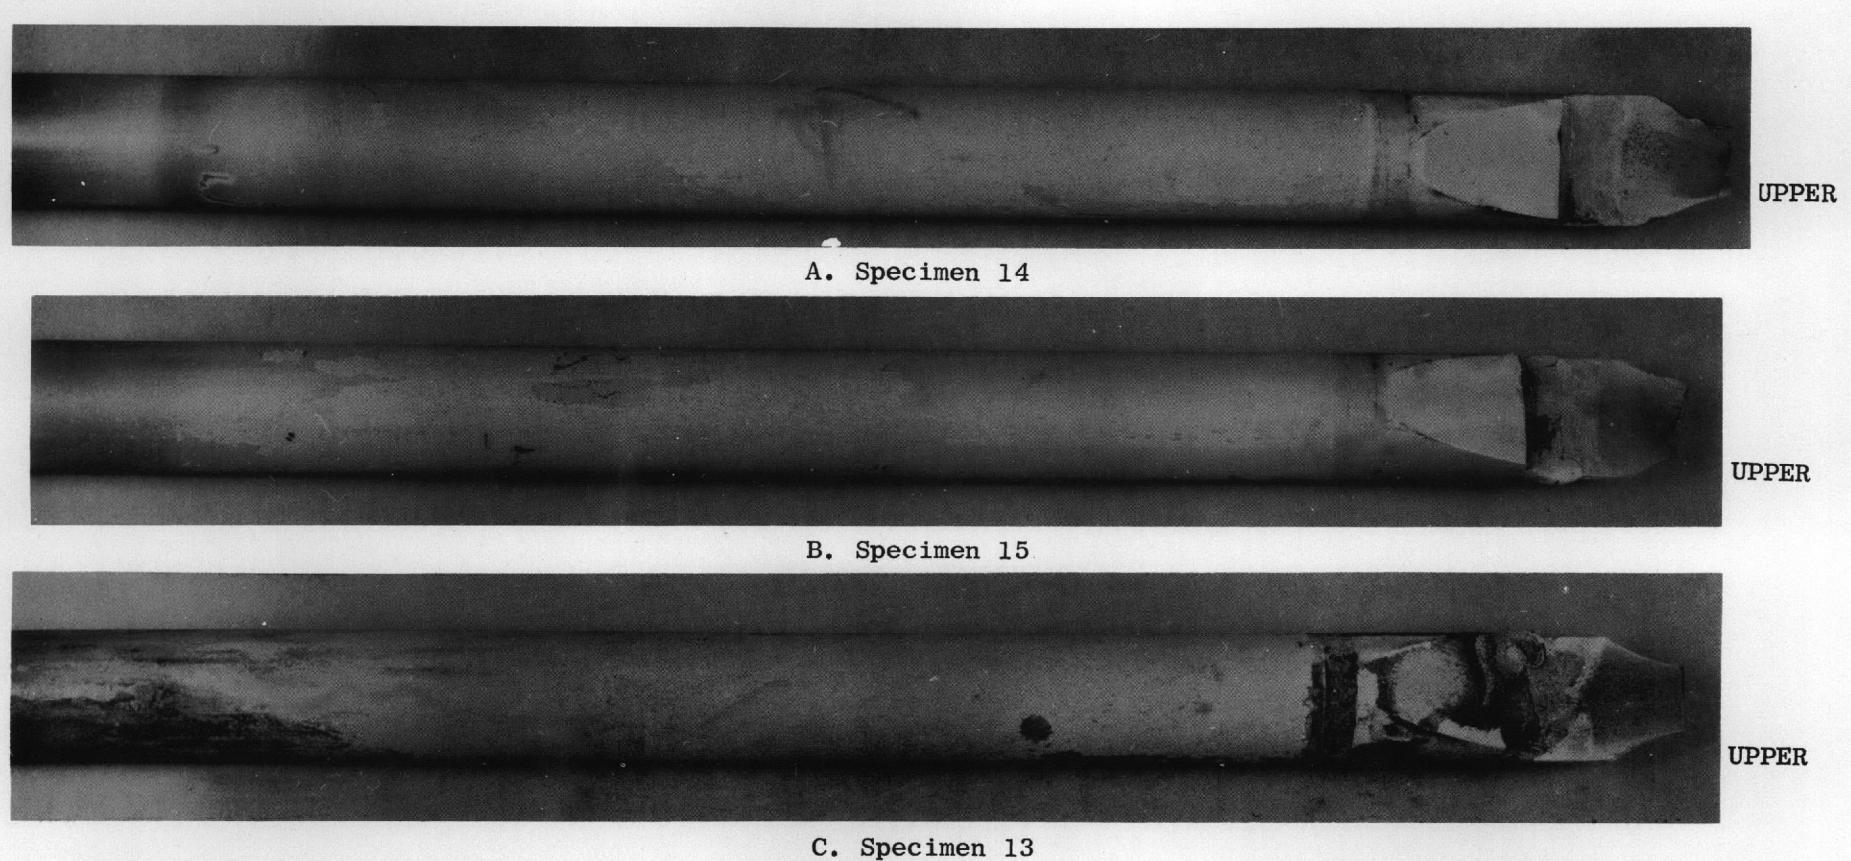
FIGURE 37. Views of Upstream Bus Bars from Test in Lithiated Water Showing Extensive White Oxide on Surfaces. KS-46257

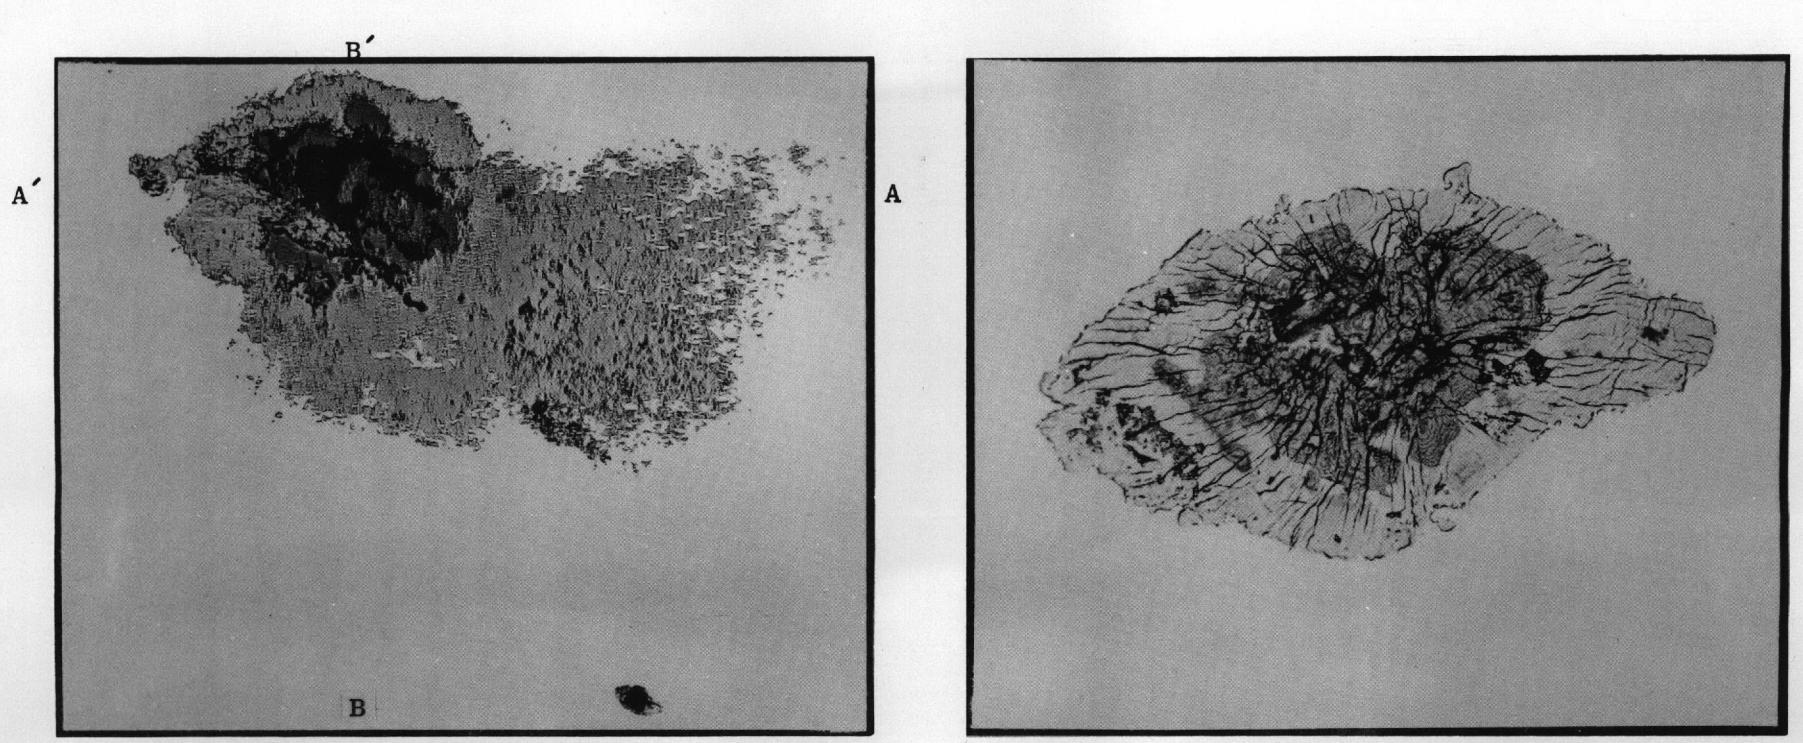
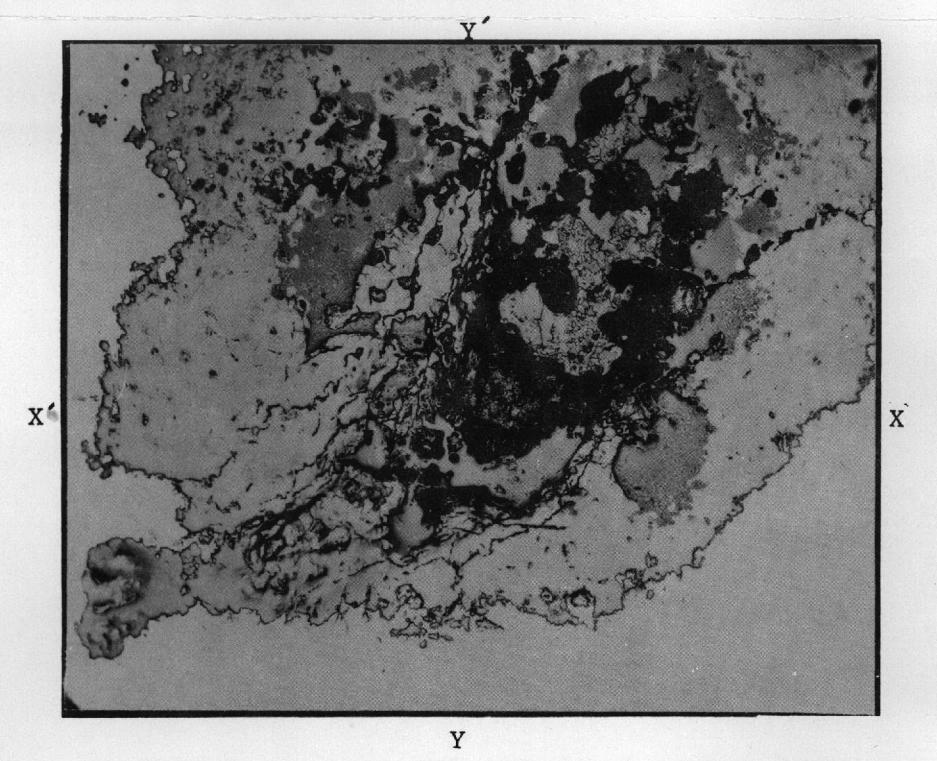
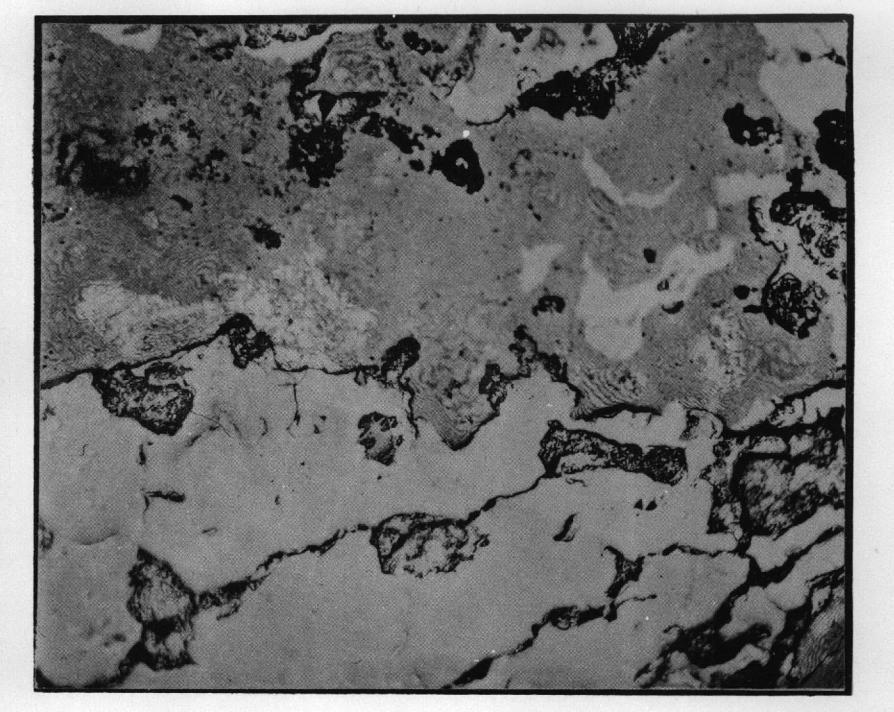
C. Pitted region at 50X located at intersection D. Intersection of lines XX' and YY' on C, 250X of lines AA' and BB' on A. FIGURE 43. Magnified Views of Pits in Specimen 3, the Zircaloy-4 Crudded Test Specimen. KS-46262 Unclassified

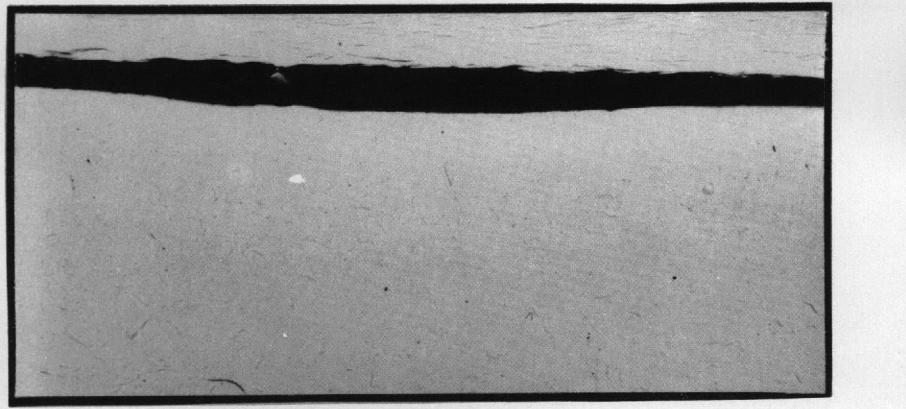
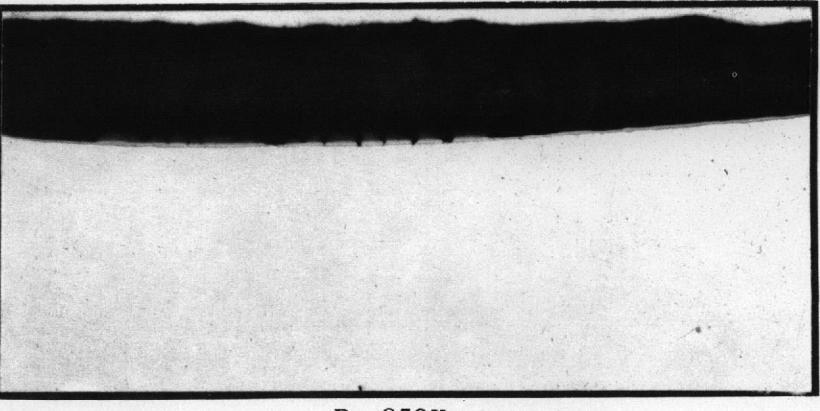
FIGURE 44. Views of Pitting Perpendicular to Figure 42. KS-46263 Unclassified

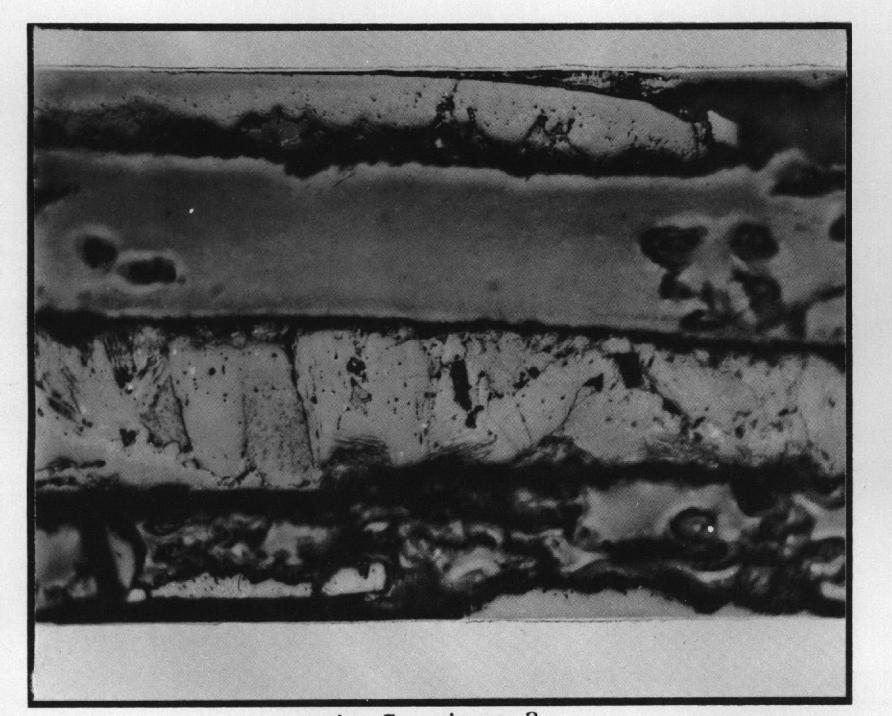
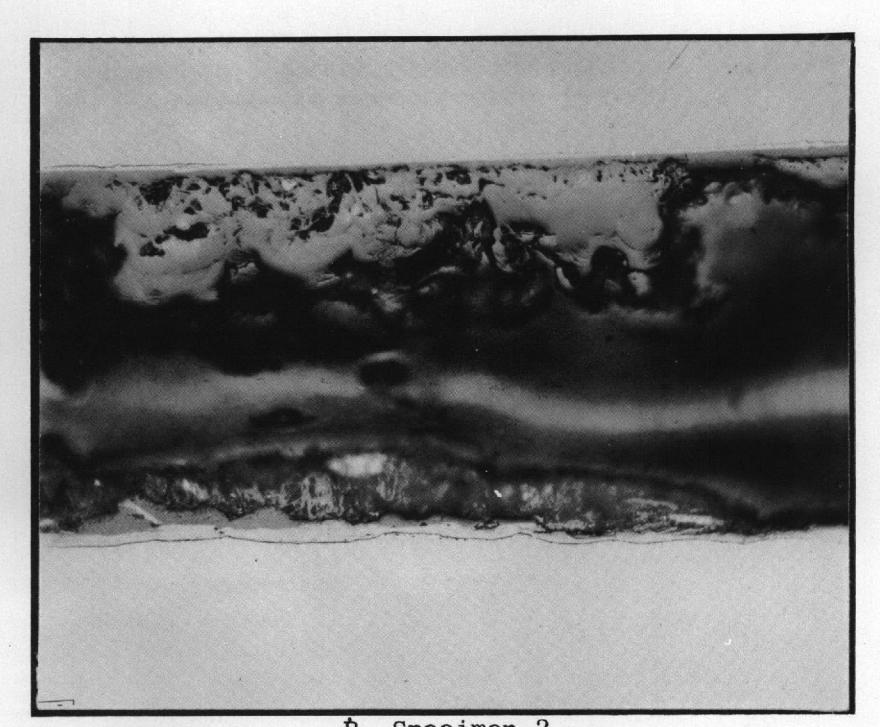
A. Specimen 3B. Specimen 2FIGURE 45.Views of Transverse Sections of Specimens 3 and 2 at 250X.KS-46264Unclassified
