KAPL-2203

CORROSION OF ZIRCALOY IN CREVICES UNDER NUCLEATE BOILING CONDITIONS

W. Kermit Anderson, M. J. McGoff

April 13, 1962

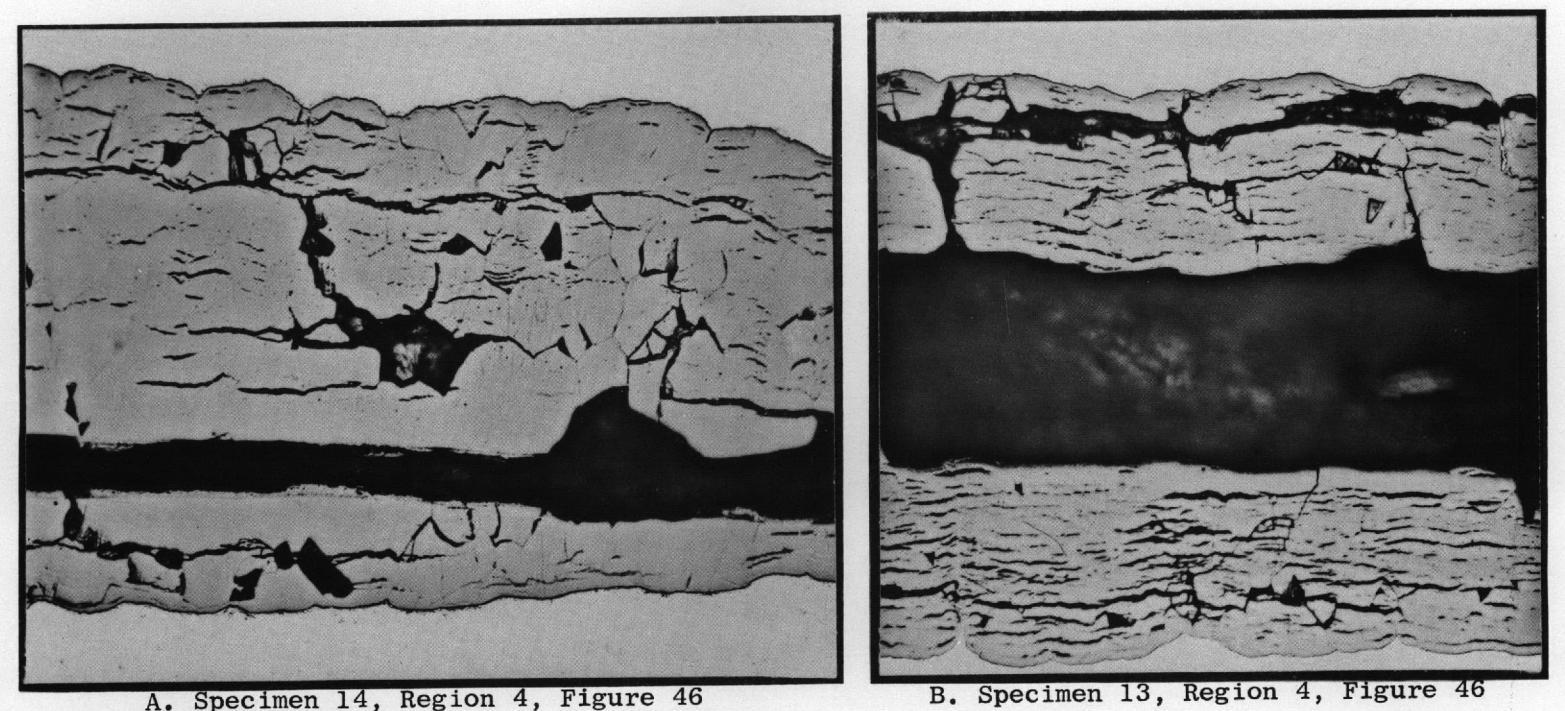
A. Specimen 14, Region 4, Figure 46 FIGURE 49. Transverse Views of Specimens 14 and 13 at 250X. Unclassified KS-46268

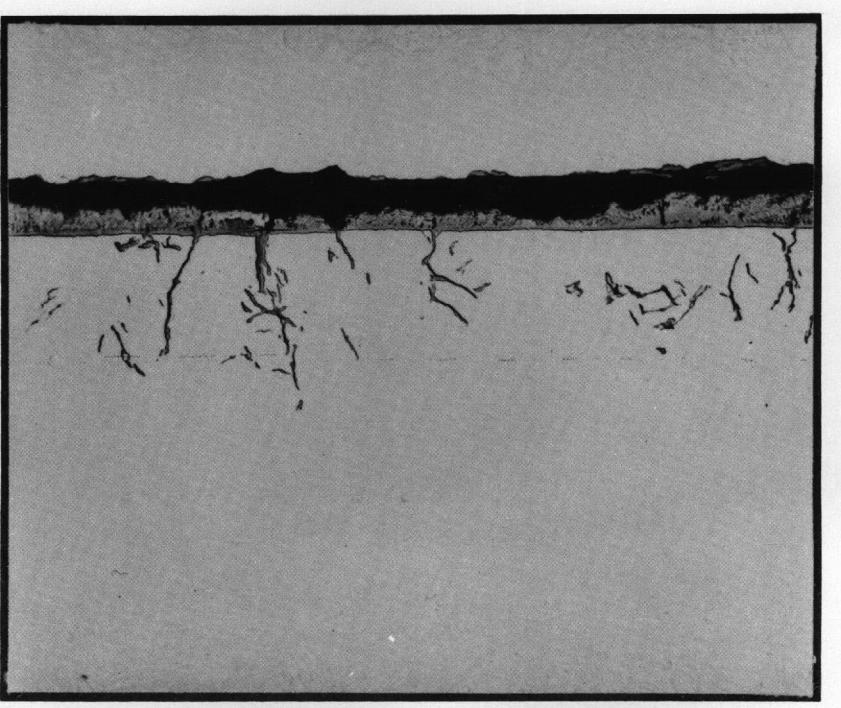
FIGURE 50. View Showing Cracks Along Outside Surface of a Part of Specimen 14 Exposed to Steam. KS-46269 Unclassified

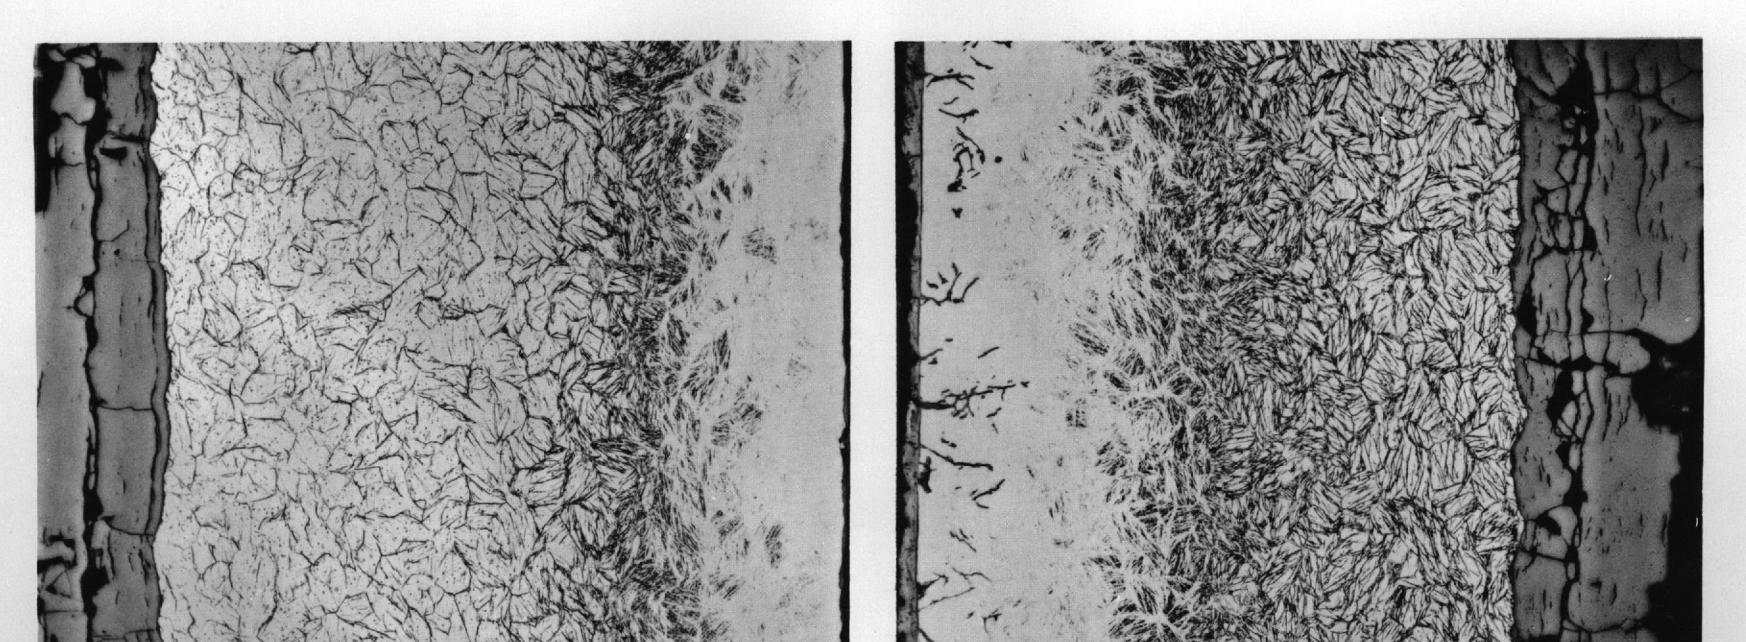
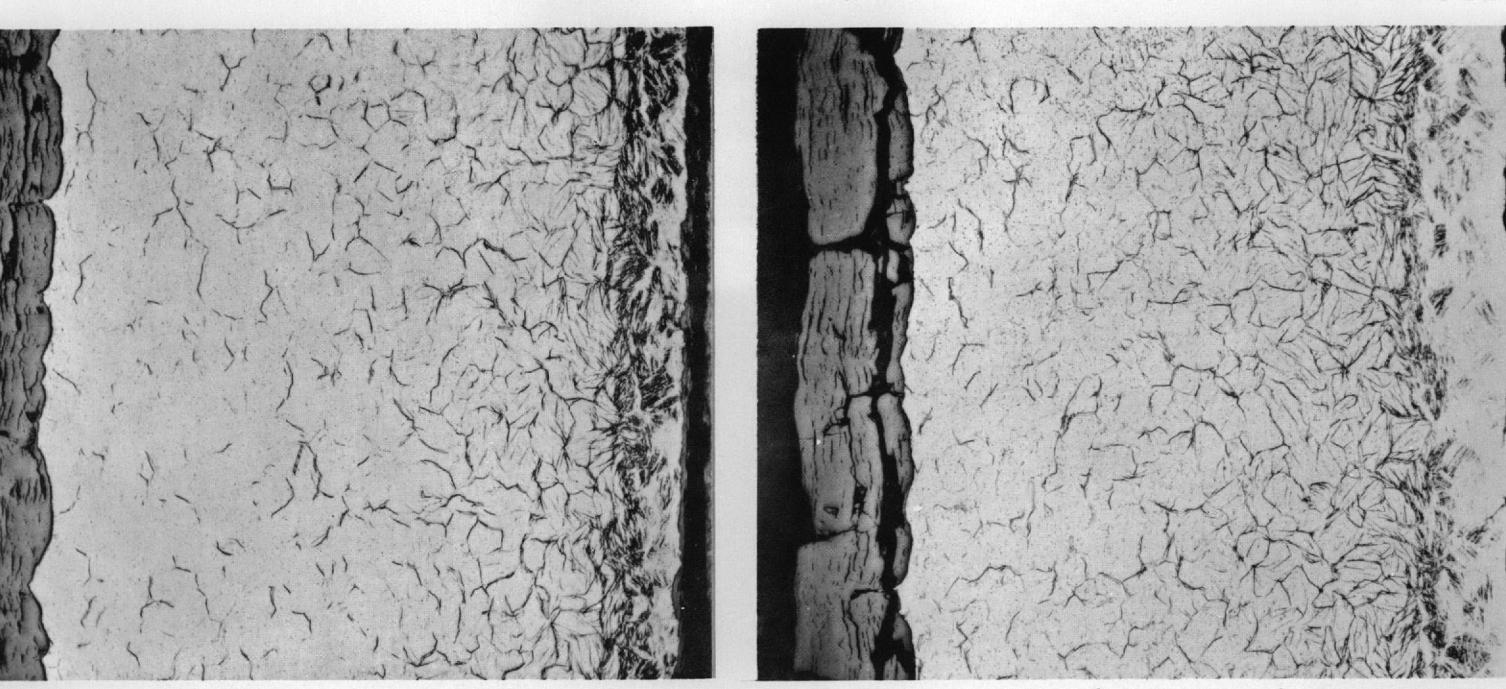
D. Upper portion (steam phase) Specimen 13 C. Lower portion (water phase) Specimen 13 FIGURE 53. Views of Transverse Sections of Specimens 13 and 14. Specimen 14 was the Zircaloy-2 VEEcrevice specimen; specimen 13 was the precrudded parallel-faced specimen. Both views show high hydride concentrations, but such concentration is unaccountably lower in the precrudded, more open design represented in views C and D. Unclassified KS-46272

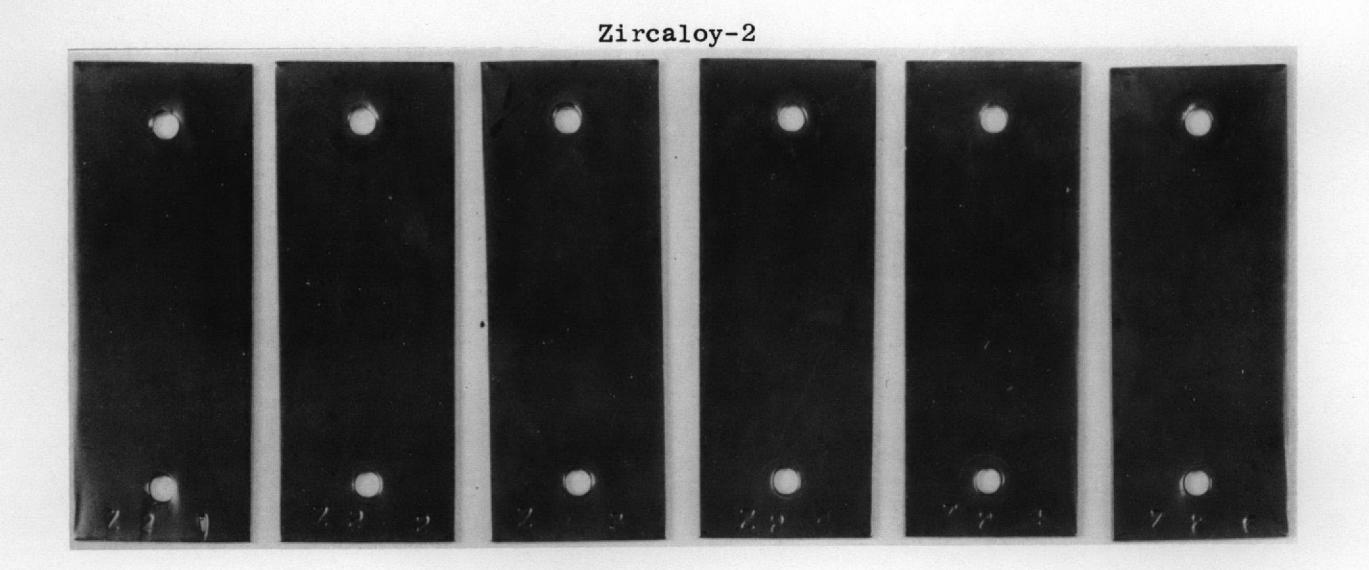
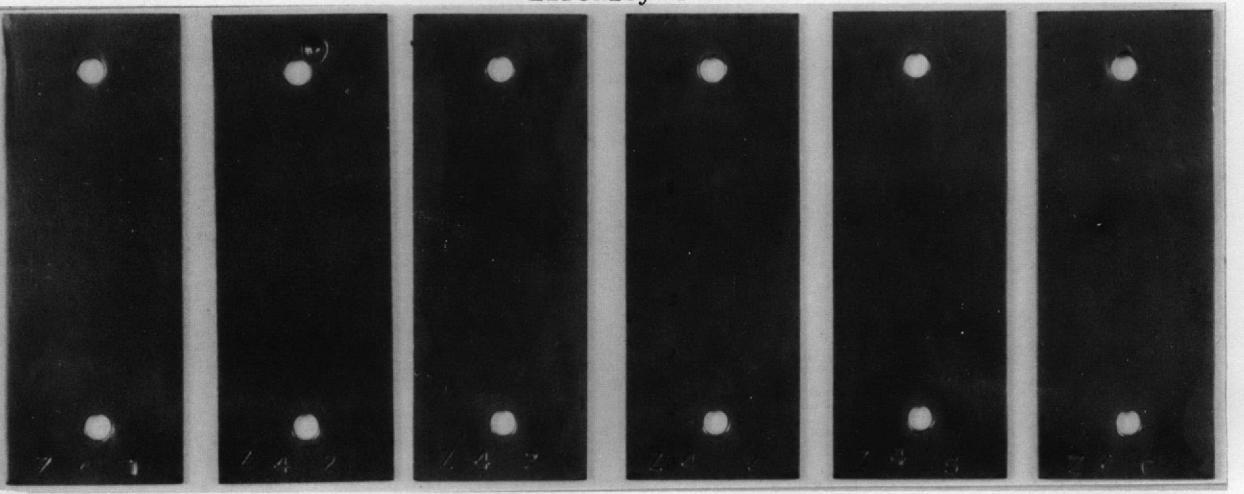
FIGURE 54. Oxide Appearances of Coupons Tested in First MSA Loop Test in Ammoniated Water for 1000 hr. KS-46143 Unclassified

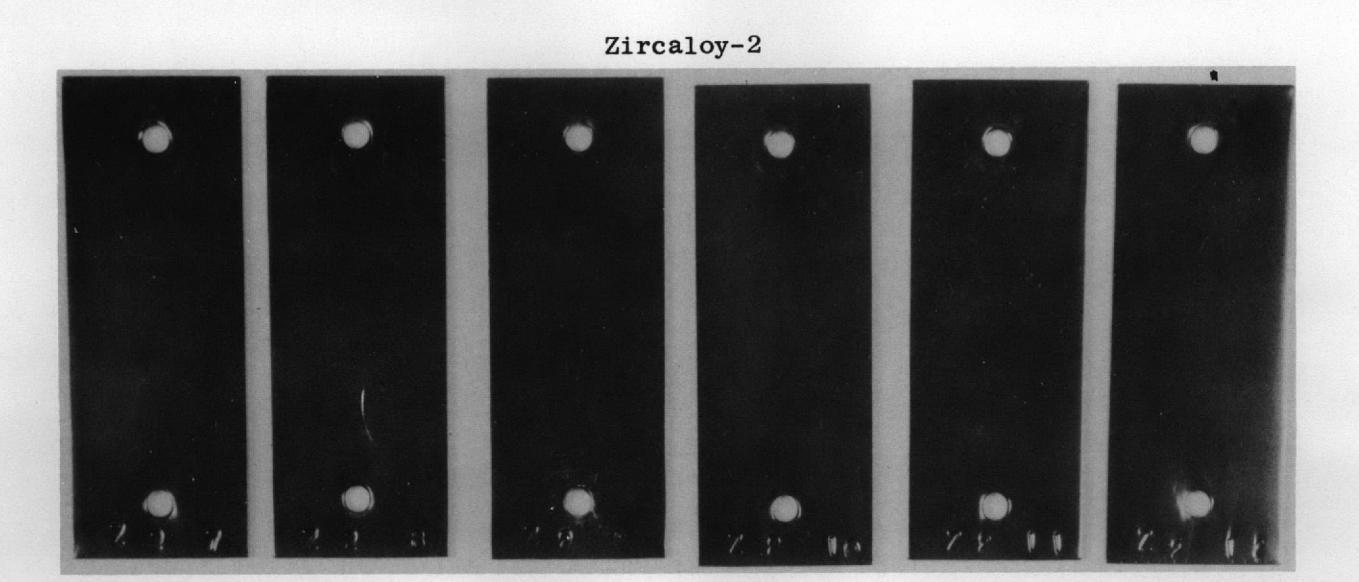
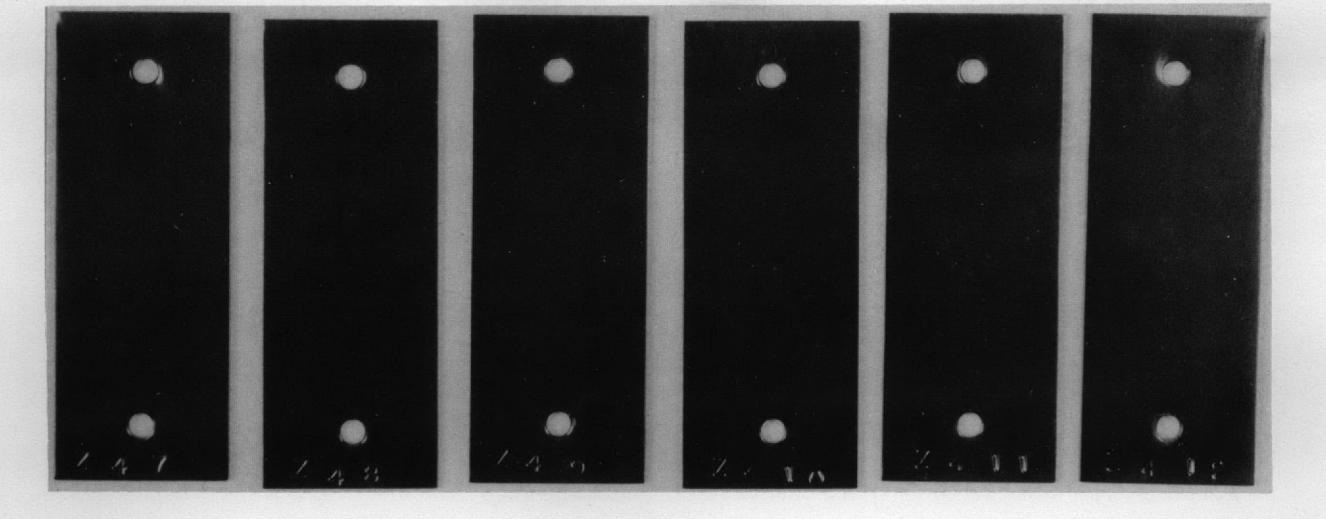
FIGURE 55. Oxide Appearances of Coupons Tested in Second MSA Loop Test in Lithiated Water for 200 hr.
