SANDIA REPORT

SAND2008-5736

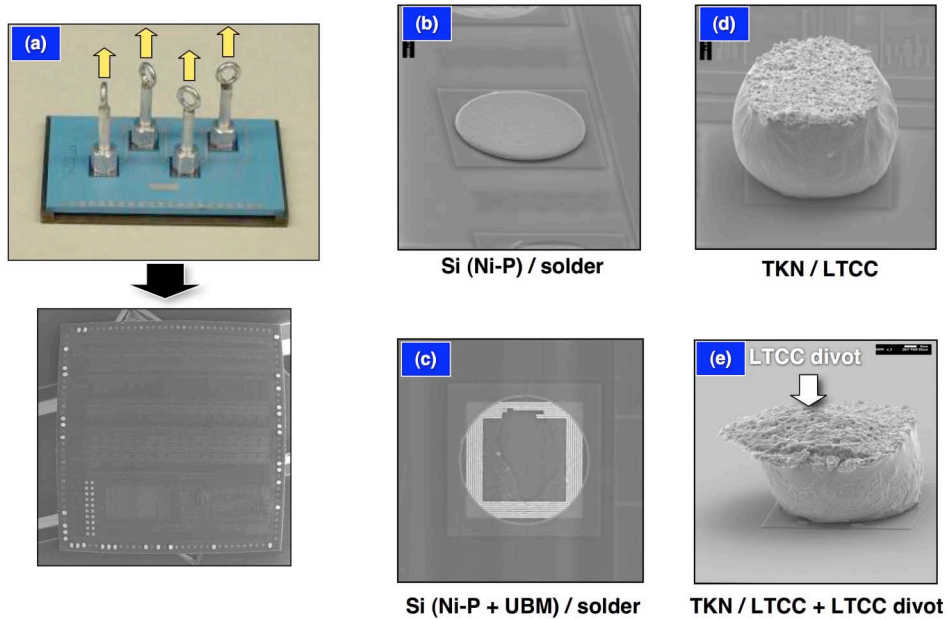
As-fabricated: [Mean – 95%CI] > 6.75 lbs
 Minimum load of any one die > 4.5 lbs
 [TKN/LTCC + divot] < 25% of *all* joints.

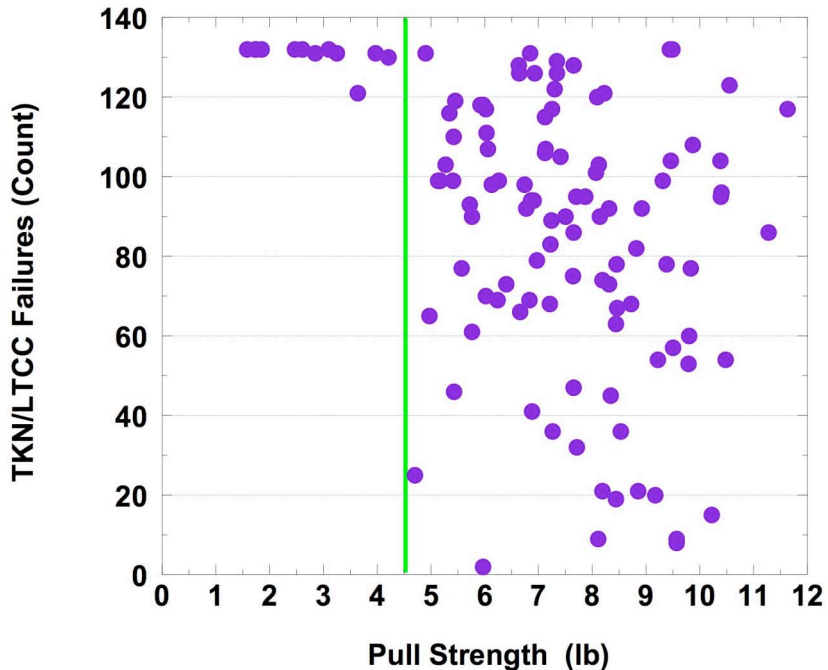
mode. Incidentally, the data in Fig. 2 illustrate the basis for 4.5 lb as the lower limit of the acceptance criteria.

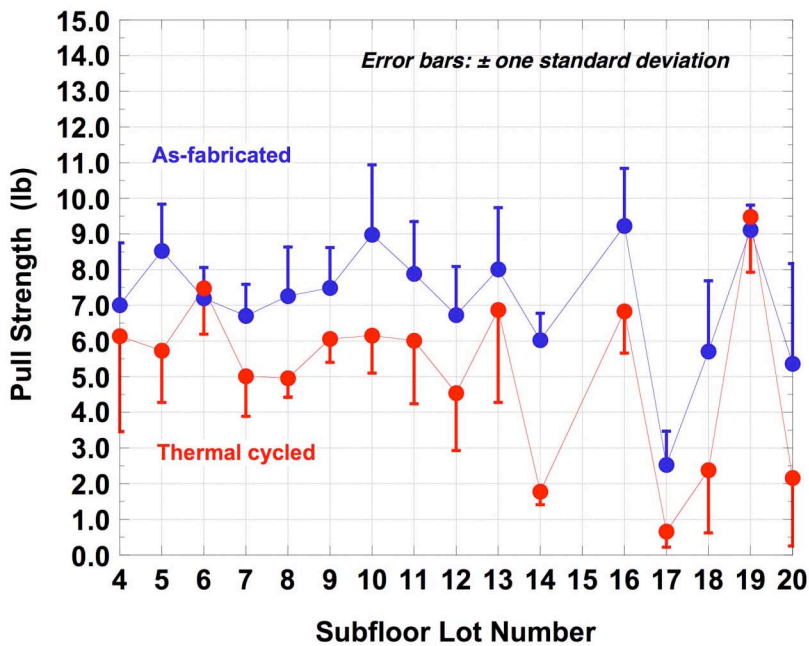
Fig. 3 Graph of as-fabricated (blue) and post-thermal cycle (red) die pull strengths as a function of sub-floor lot # 4 – 20 per the associated process monitor.

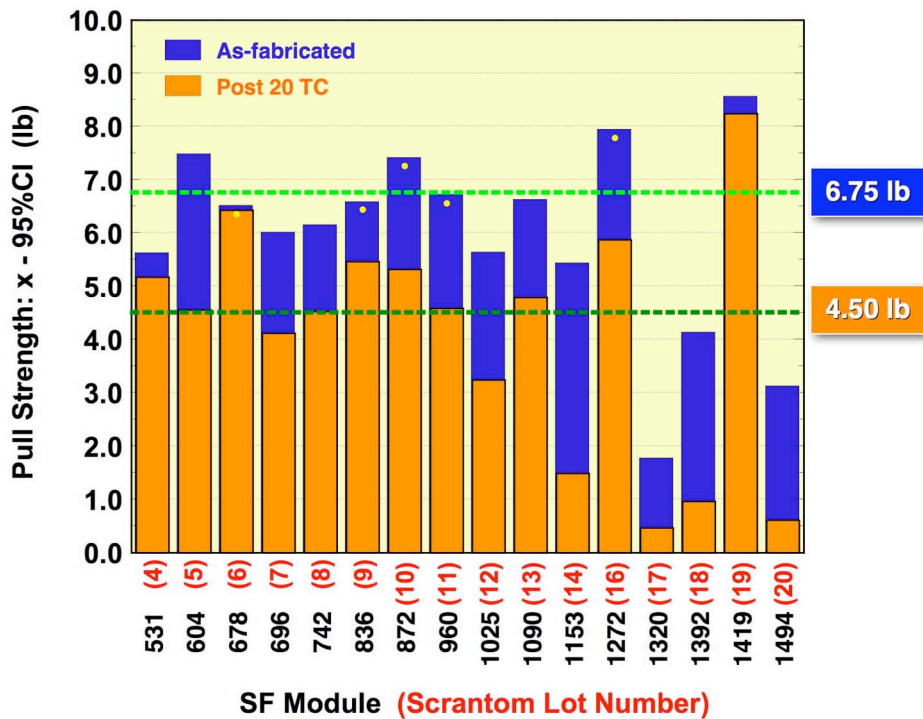
Fig. 4 Bar graph showing the [Mean – 95%CI] acceptance parameter as a function of sub-floor lot number 4 to 20 of the process monitors. Both the as-fabricated and post thermal cycle data were included in the plot, along with the acceptance criteria, 6.75 lb and 4.5 lb, respectively.

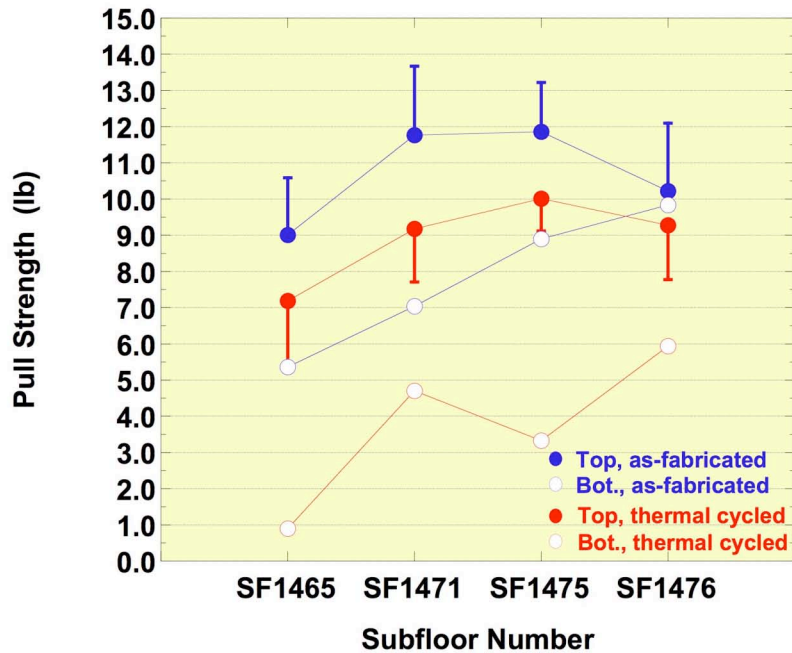
Fig. 5 Plot of pull strength (load) versus four sub-modules built from sub-floors of lot #20. The pull strengths data were separated into top side and bottom side values. The data included the as-fabricated condition as well as after thermal cycling. The error bars were one standard deviation.

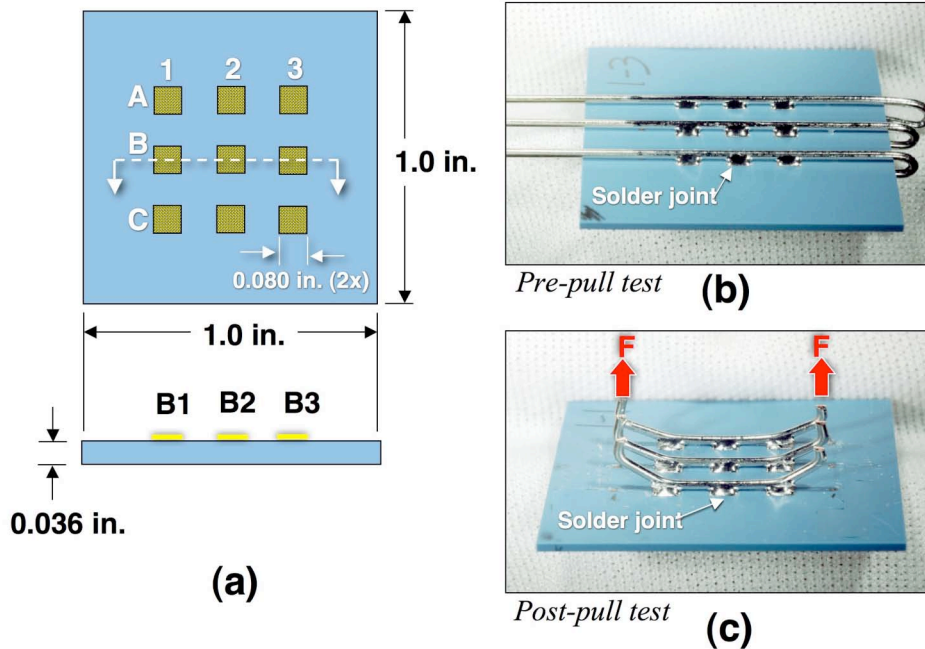
Fig. 6 (a) Schematic diagram of the DuPont™ pull test sample in Reference [1]. (b) Stereo photograph of the test sample with the wires (“shepherd’s hooks”) soldered to the pads. (c) Stereo photograph showing the test sample after the pull test, which was performed on sites having column designators “1” and “3” per (a) [1].

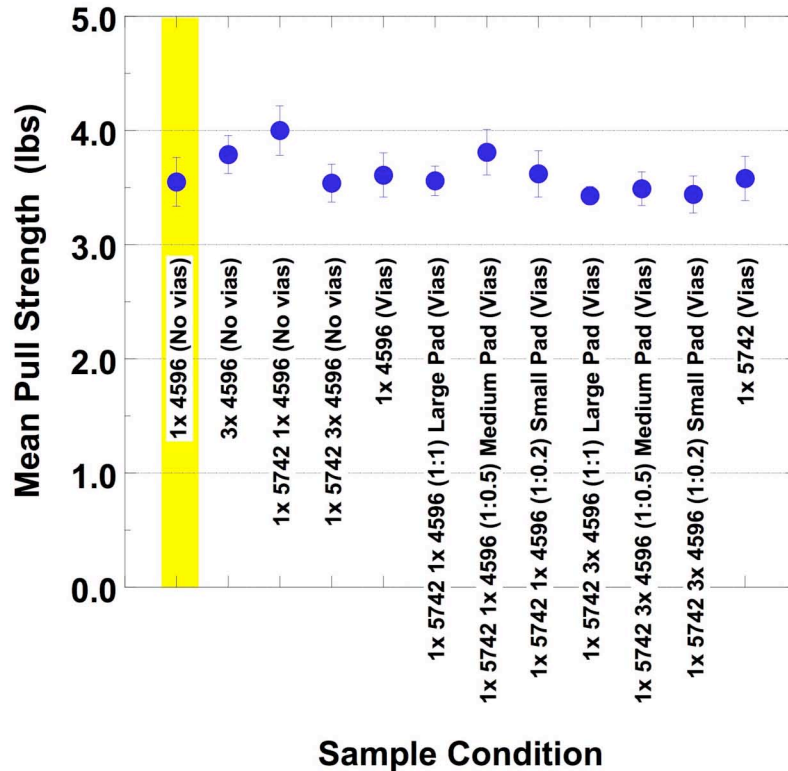
Fig. 7 Pull strength as a function of thick film configuration from the testing in Reference 1. The test configuration that was pertinent to the BDYE application has been highlighted in yellow. The error bars are based upon a 95% confidence interval for the mean.

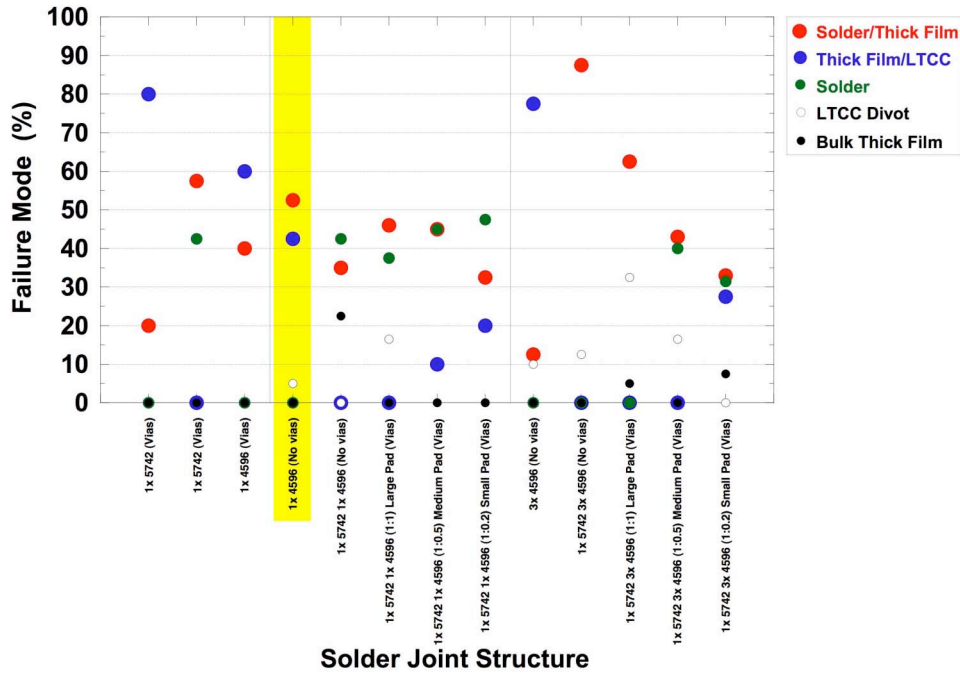
Fig. 8 Failure mode analysis of DuPont™ pull tests in Reference 1 based upon the scanning electron micrographs of the cross sections of four test sites.

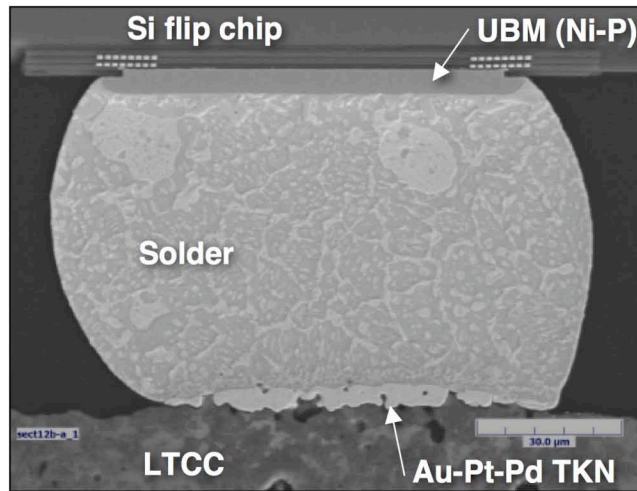
Fig. 9 Flip chip solder bump on die U12, SF1168 showing the microstructure of the interconnection.

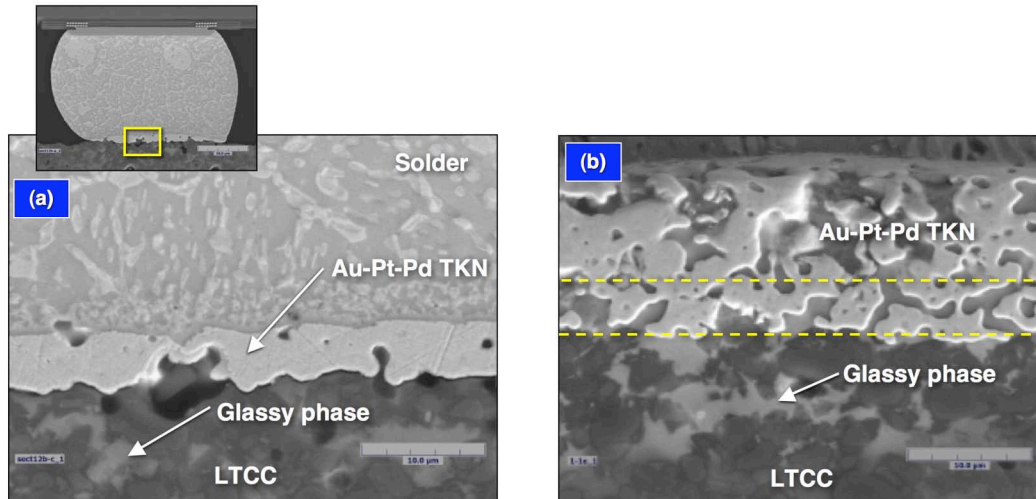
Fig. 10 SEM photographs showing the single print, thick film structures from (a) the BDYE die flip chip and (b) the DuPont™ pull test specimen (Reference 1).

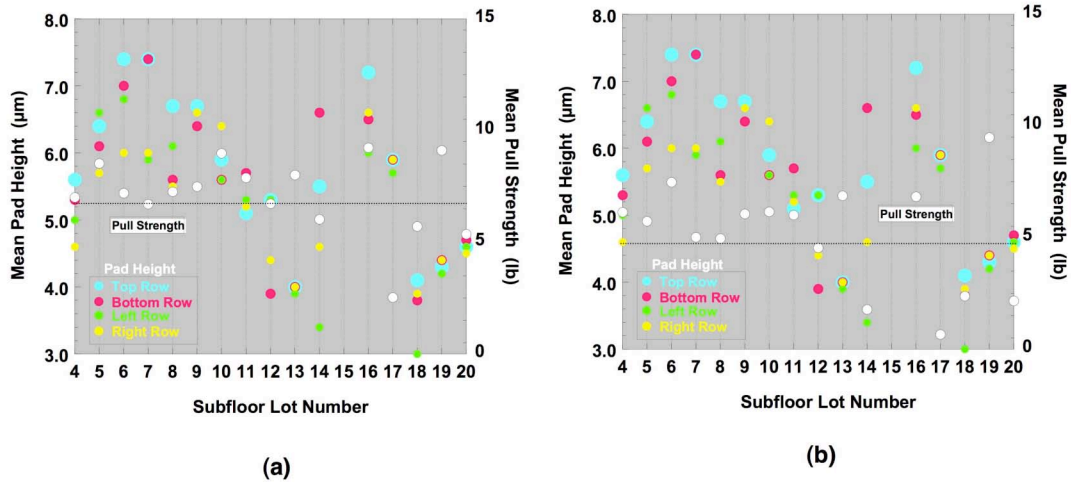
Fig. 12 Plots of mean pad heights (blue, top row; red, bottom row; green, left row; and yellow, right row) and pull strength (white) as a function of sub-floor lot: (a) as-fabricated condition and (b) post-20 thermal cycles (-55°C/125°C). The dotted lines represented the acceptance criteria limits for the individual die pull strengths.

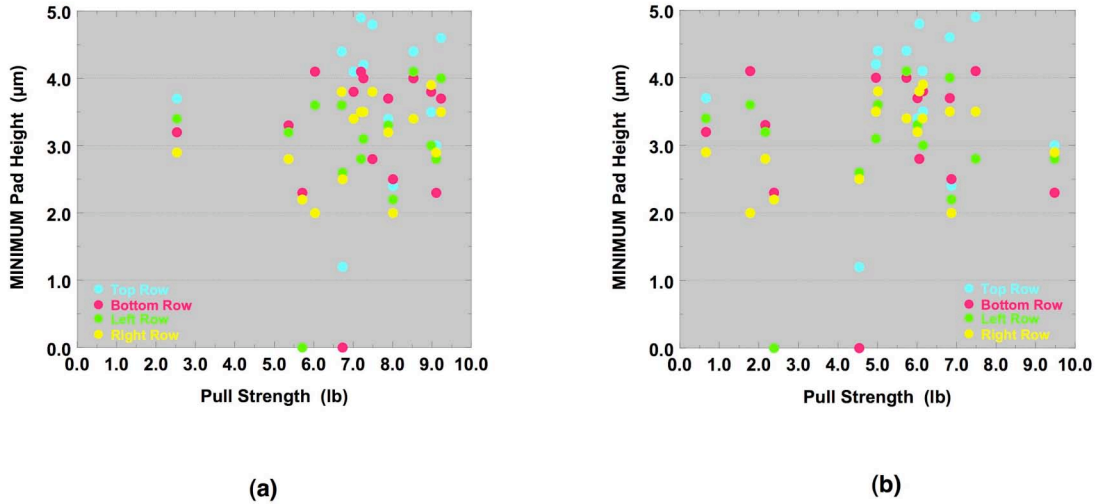
Fig. 13 Plots of minimum pad heights (blue, top row; red, bottom row; green, left row; and yellow, right row) and pull strength (white) as a function of sub-floor lot: (a) as-fabricated condition and (b) post-20 thermal cycles (-55°C/125°C).

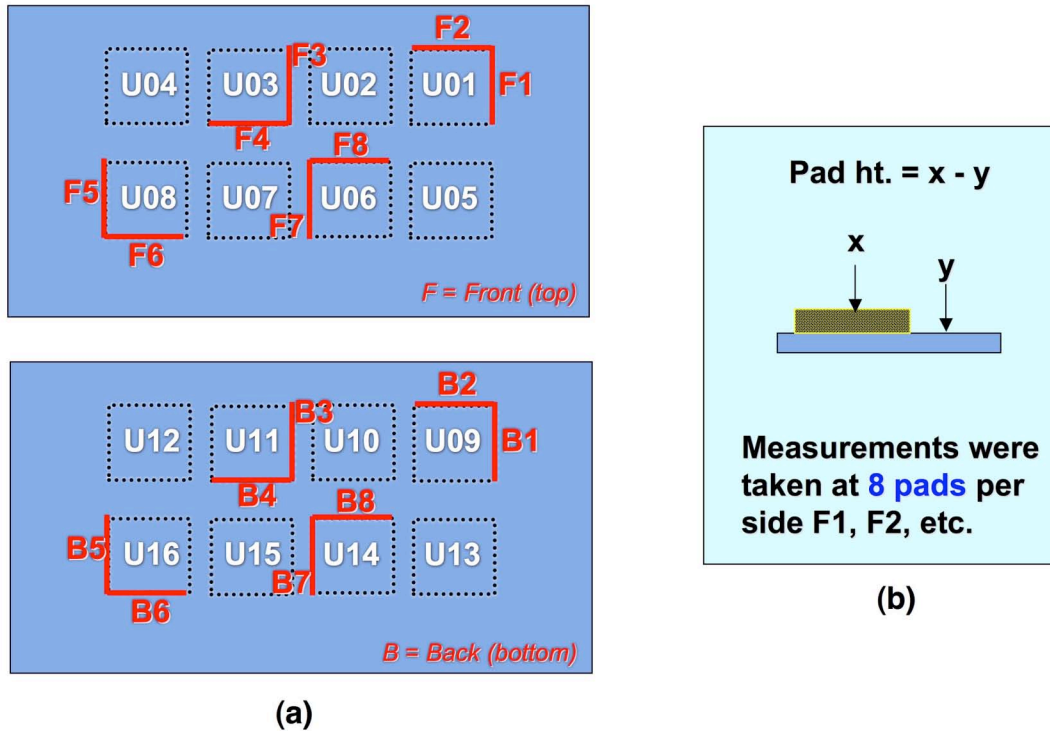
Fig. 14 (a) Schematic diagram showing the location of the pad height measurements made on the lot #21 sub-floors prior to die flip chip assembly. The selected locations were of dice to be tested in the as-fabricated condition. The remaining sites used the same pattern, but had the assembled dice pull tested after thermal cycling. (b) The method used to calculate the height of the pads on each row.

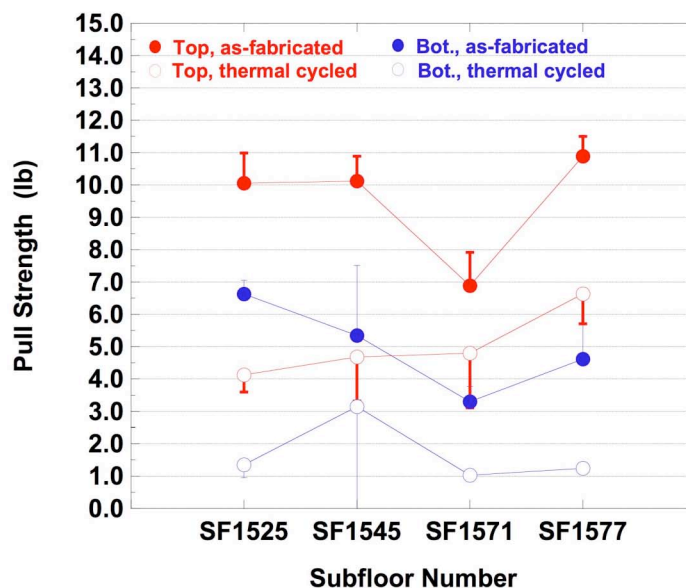
Fig. 16 Plot of the mean strengths of the four sub-modules built from lot #21 sub-floors. The data were identified as top side (closed symbols) and bottom side (open symbols) as well as as-fabricated (blue-colored symbols) and thermal cycled (red-colored symbols).

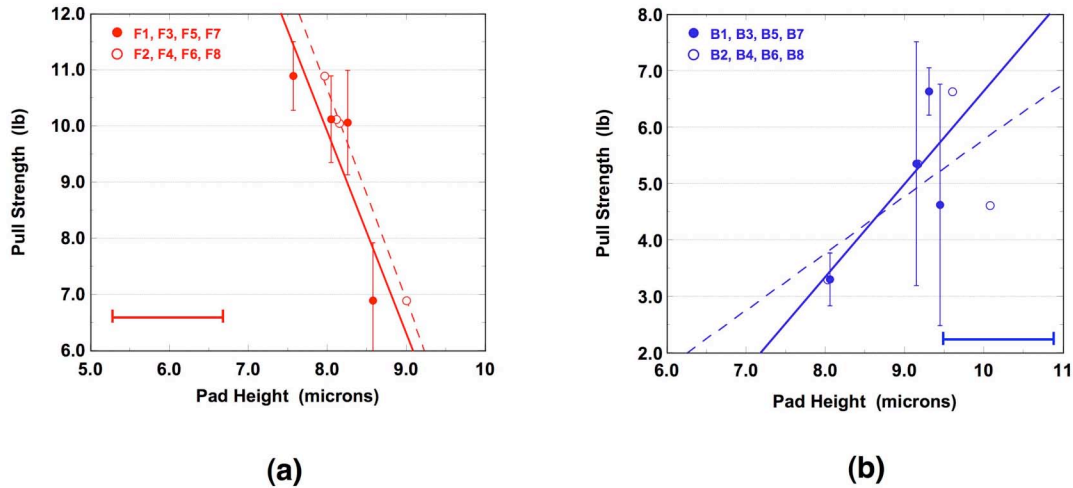
Fig. 17 Plots of pull strength versus pad height as determined from the four sub-modules representing lot #21. These data were for the *as-fabricated* condition: (a) top side and (b) bottom side. Solid lines were the linear regression to the solid symbols; dashed line pertained to the open symbols. The error bars were \pm one standard deviation.

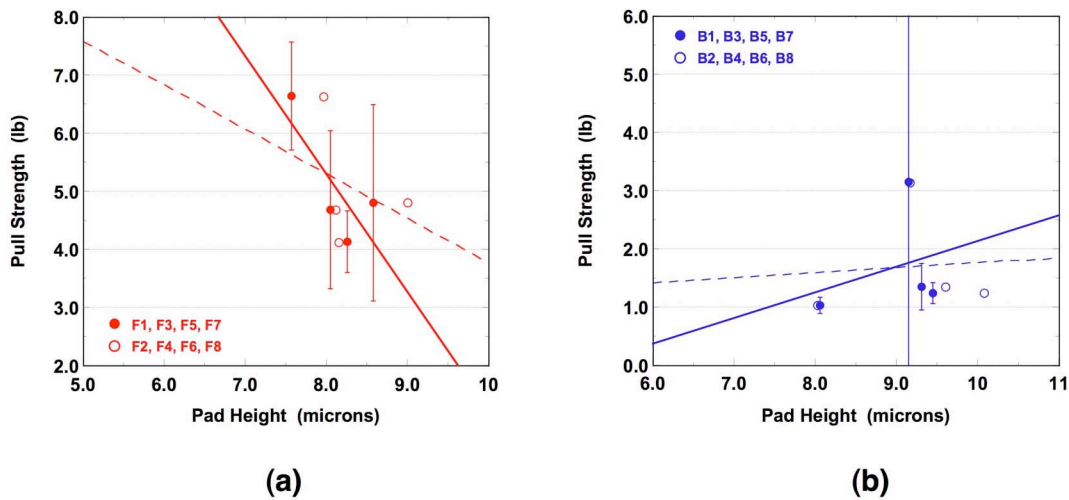
Fig. 18 Plots of pull strength versus pad height as determined from the four sub-modules representing lot #21. These data were for the *thermal cycled* condition: (a) top side and (b) bottom side. Solid lines were the linear regression to the solid symbols; dashed line pertained to the open symbols. The error bars were \pm one standard deviation.

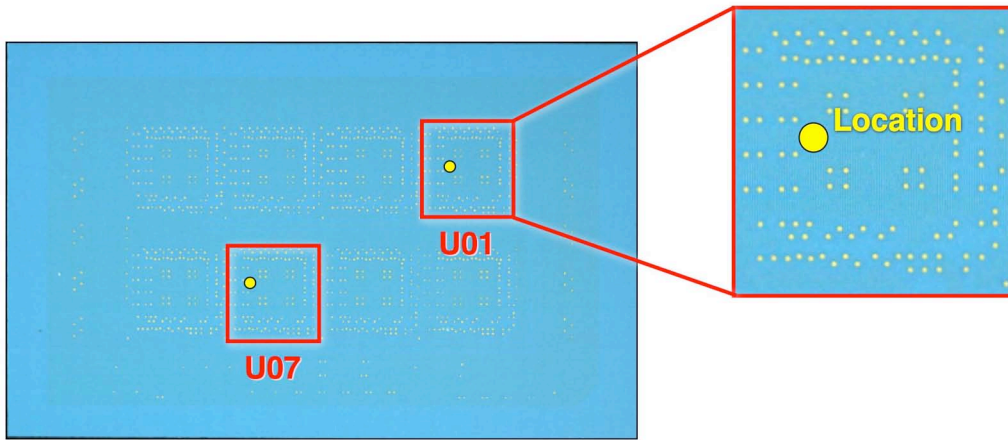
The sites are shown in Fig. 19 where the surface analyses were performed on the baseline sub-floor (case 1 above). Two sites were selected on each side. The locations, which were identified by the corresponding die site, were: top side (Fig. 19a), U01 and U07 and bottom side (Fig. 19b), U09 and U15. Only the vias are apparent on the surfaces. The precise locations of the sites were chosen so that they were near to the flip chip bond pads would have been present on a fully-processed assembly.

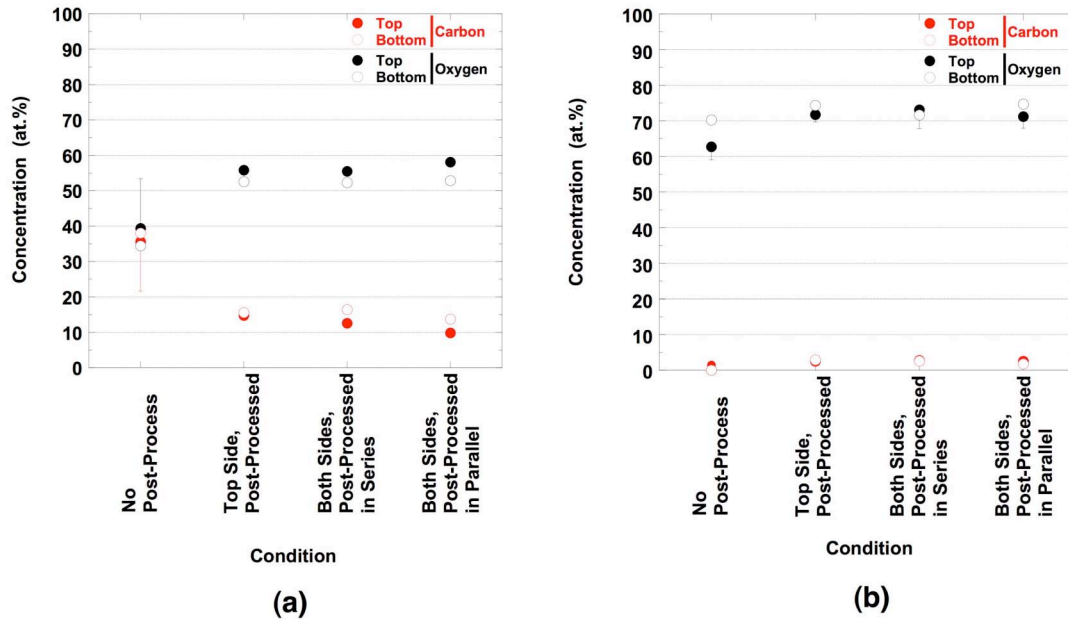
Fig. 21 Plots of carbon (C) and oxygen (O) atomic concentrations as a function of the thick film (post-process) firing steps determined by Auger electron spectroscopy: (a) surface analysis and (b) at a near-surface depth where C < 3 at.%. The “half” error bars indicated one standard deviation.

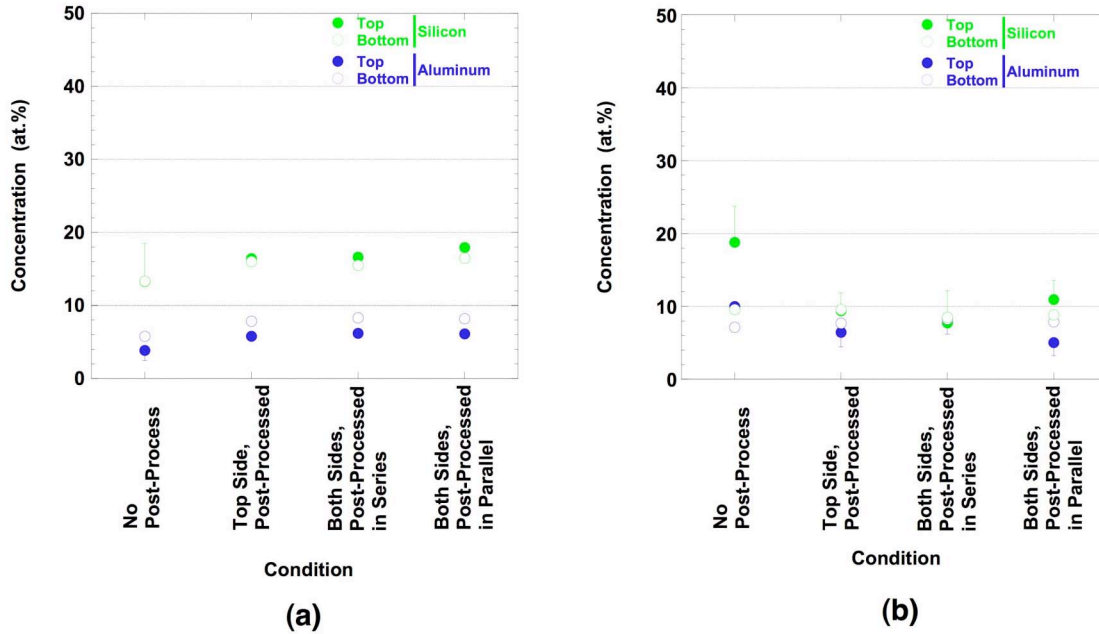
Fig. 22 Plots of silicon (Si) and aluminum (Al) atomic concentrations as a function of the thick film (post-process) firing steps determined by Auger spectroscopy: (a) surface analysis and (b) at a sub-surface depth where $C < 3$ at.%. The “half” error bars indicated one standard deviation.

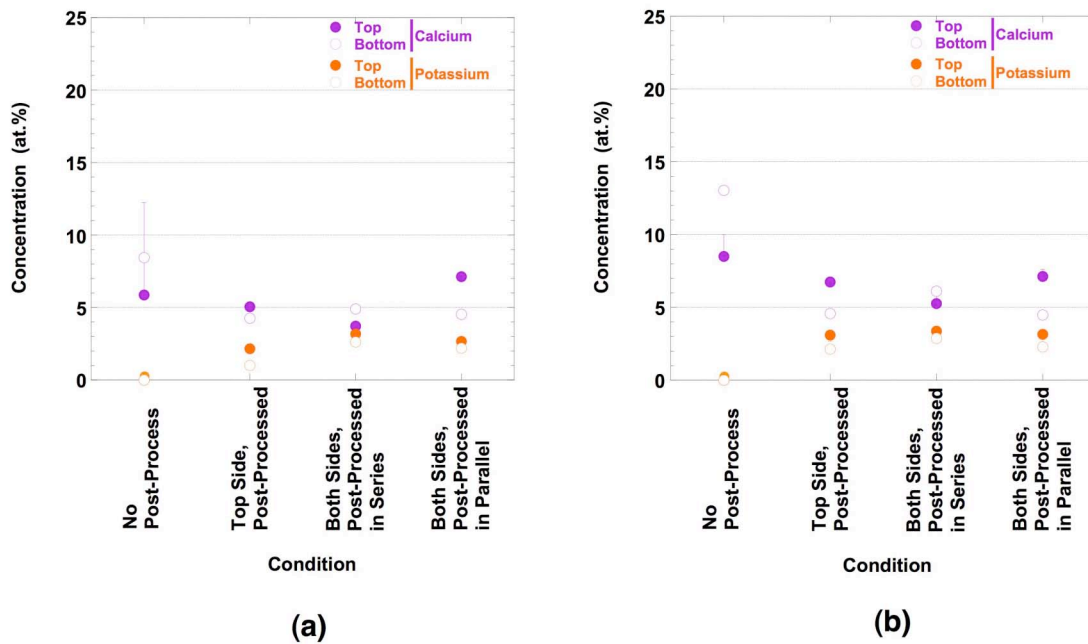
Fig. 23 Plots of calcium (Ca) and potassium (K) atomic concentrations as a function of the thick film (post-process) firing steps determined by Auger spectroscopy: (a) surface analysis and (b) at a sub-surface depth where C < 3 at.%. The “half” error bars indicated one standard deviation.

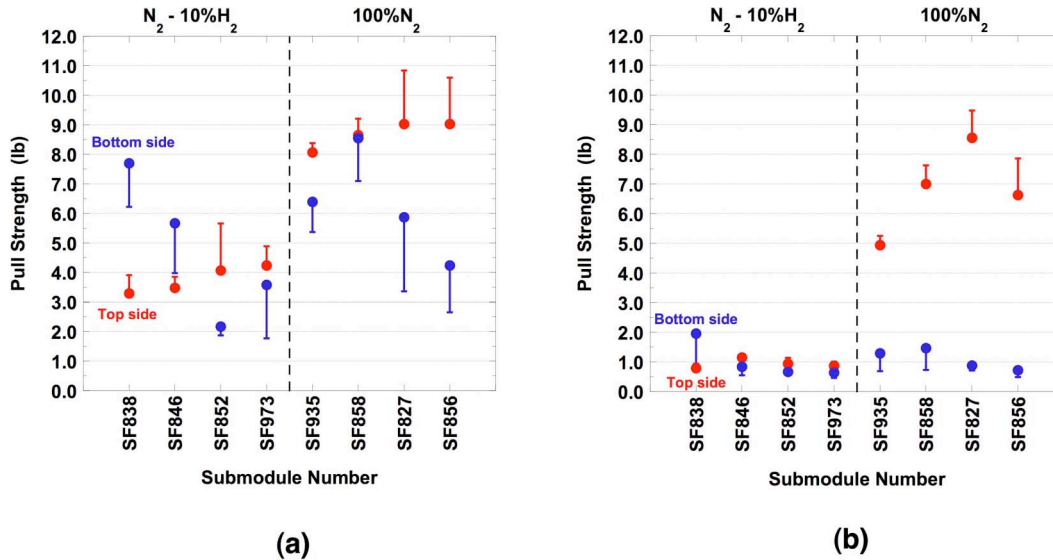
Fig. 25 Plots of pull strength as a function of sub-module pedigree: (a) as-fabricated and (b) post-20 thermal cycles ($-55^{\circ}C/125^{\circ}C$). All sub-modules were initially exposed to the N_2 edge pin soldering cycle. Then, four of the eight were exposed to the $N_2-10\%H_2$ environment and the other four were exposed to a second N_2 environment. The red symbols are the top side data; the blue symbols were the bottom side data. The “single side” error bar is one standard deviation.

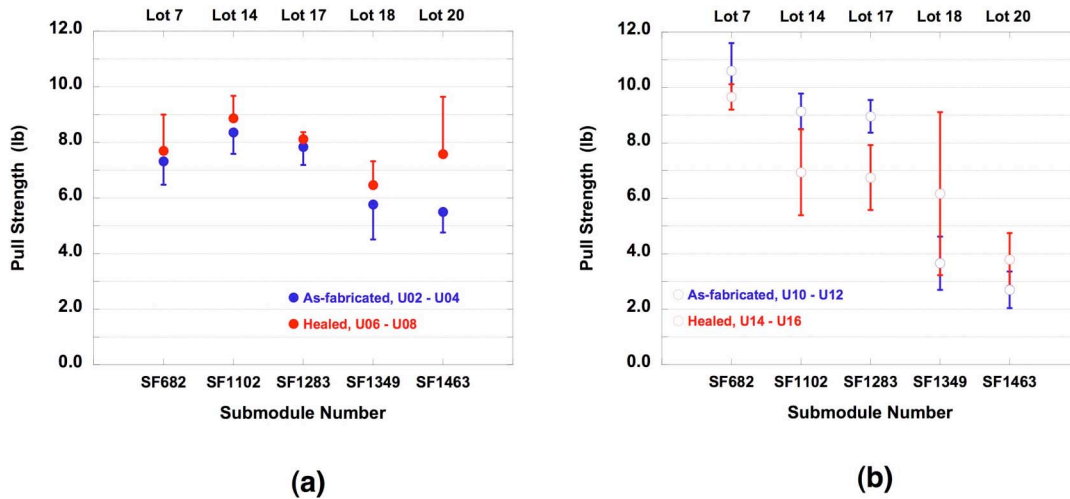
Fig. 26 Pull strengths as a function of sub-module (lot) units in the as-fabricated and healed conditions: (a) top side dice and (b) bottom side dice. These sub-modules were suspected of being exposed to the N_2 -10% H_2 furnace environment: The half-error bar is one standard deviation.

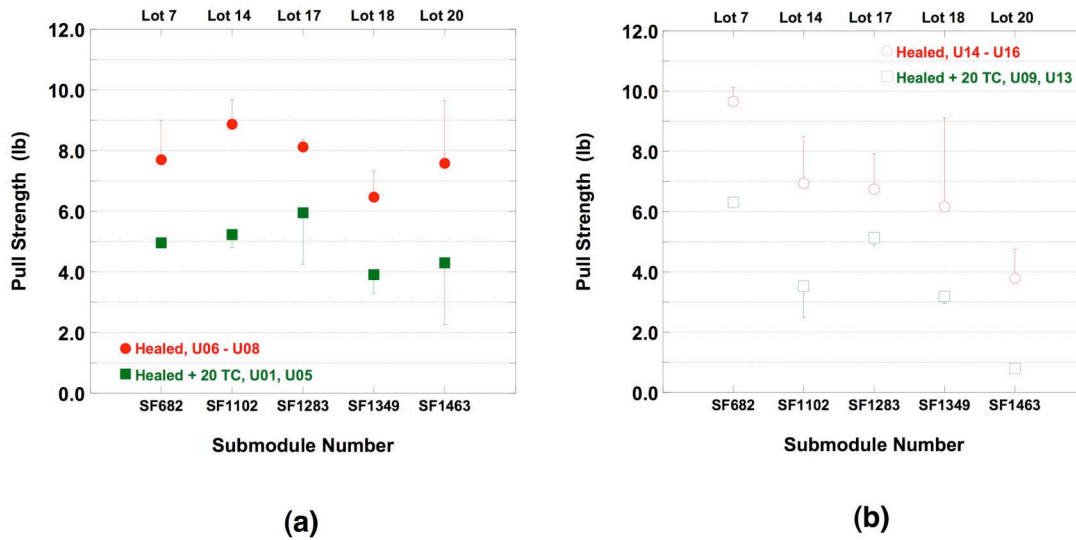
Fig. 27 Pull strengths as a function of sub-module (lot) units in the healed (as-fabricated) and healed-plus-thermal cycled (20 cycles, $-55^{\circ}\text{C}/125^{\circ}\text{C}$) conditions: (a) top side dice and (b) bottom side dice. These sub-modules were suspected of being exposed to the N_2 -10% H_2 furnace environment: The half-error bar is one standard deviation.

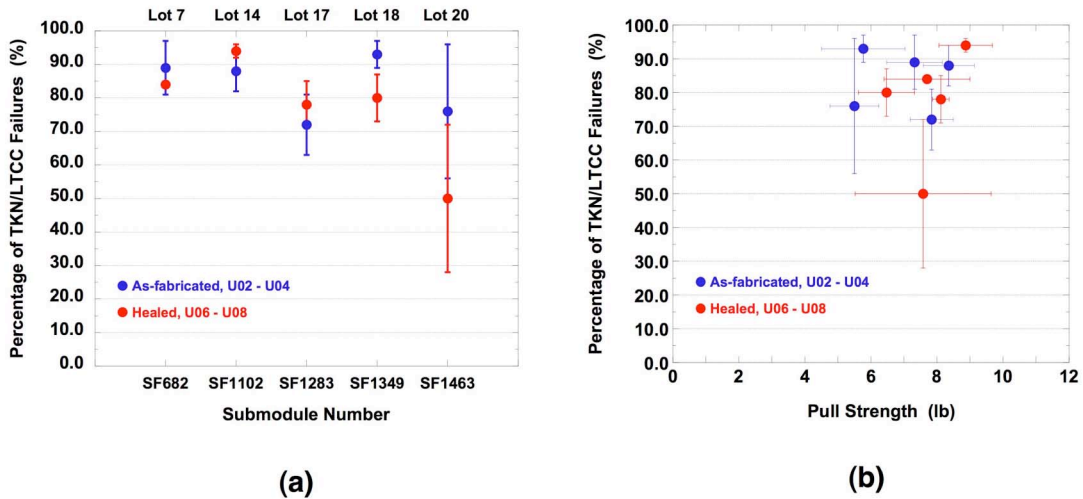
Fig. 28 (a) Plot of TKN/LTCC failure mode percentage as a function of sub-module pedigree for the pull strengths representing the as-fabricated dice and those dice subjected to the healing treatment (250°C, 260 hours) located on the *top side* of each sub-module. (b) Graph of TKN/LTCC failure mode percentage as a function of pull strength showing the lack of correlation between the two metrics. The symbol colors designate the source of the respective data groups. The error bars are \pm one standard deviation.

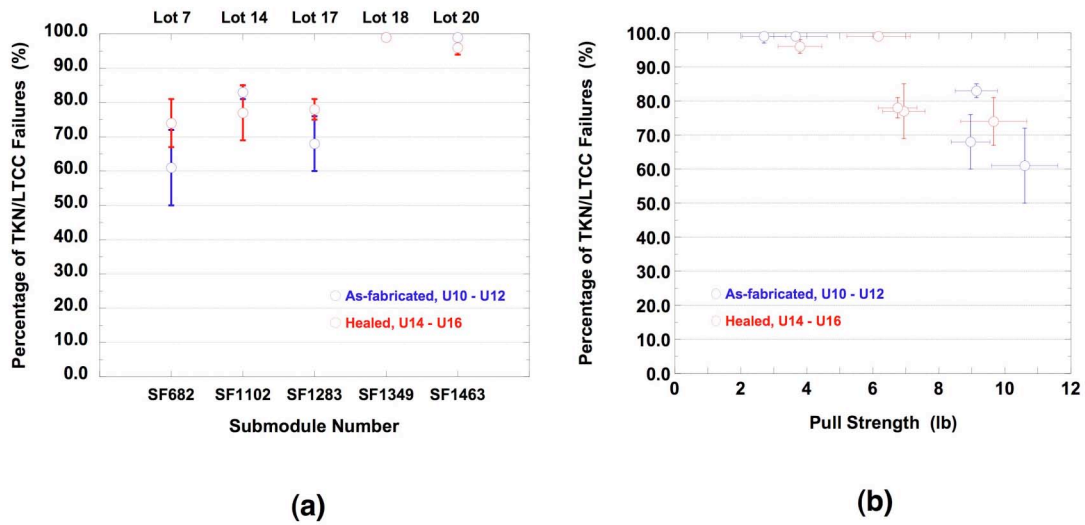
Fig. 29 (a) Plot of TKN/LTCC failure mode percentage as a function of sub-module pedigree for the pull strengths representing the as-fabricated and post-healing treatment (250°C, 260 hours) conditions for the *bottom side* of the sub-modules. (b) Graph of TKN/LTCC failure mode percentage as a function of pull strength. The symbol colors designate the source of the respective data groups. The error bars are \pm one standard deviation.

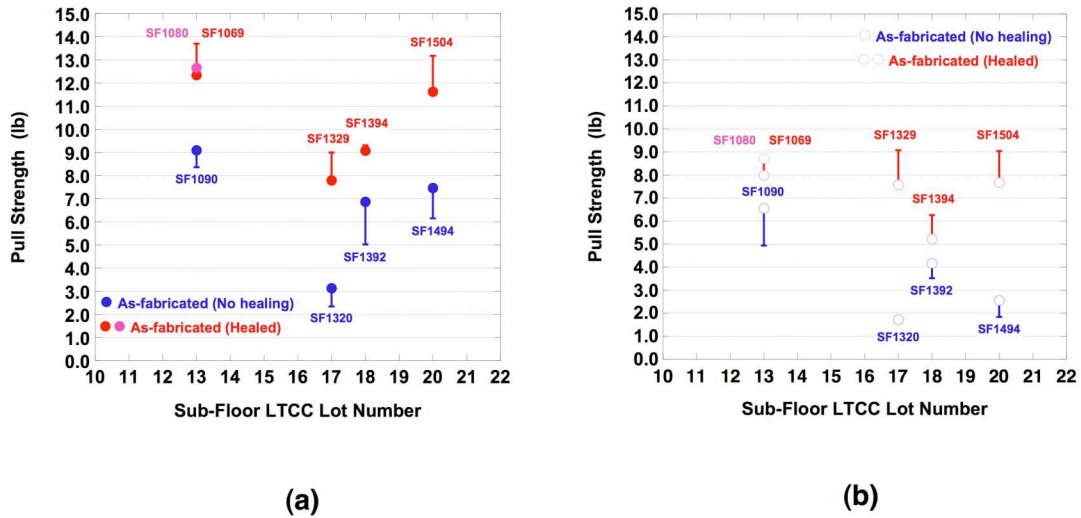
Fig. 30 Pull strength as a function of sub-floor LTCC lot numbers for (a) top side and (b) bottom side dice. The sub-modules were in the as fabricated condition. The red symbols (“Rev 1”) were data from sub-modules that were exposed to the healing treatment (250°C, 260 hours, air). The blue symbols (“Rev 0”) were the strength values of sub-modules from the same respective lots, which were not subjected to the healing treatment. All sub-modules were suspected of having been exposed to the N₂-10%H₂ atmosphere. The one-half error bars were equal to one standard deviation.

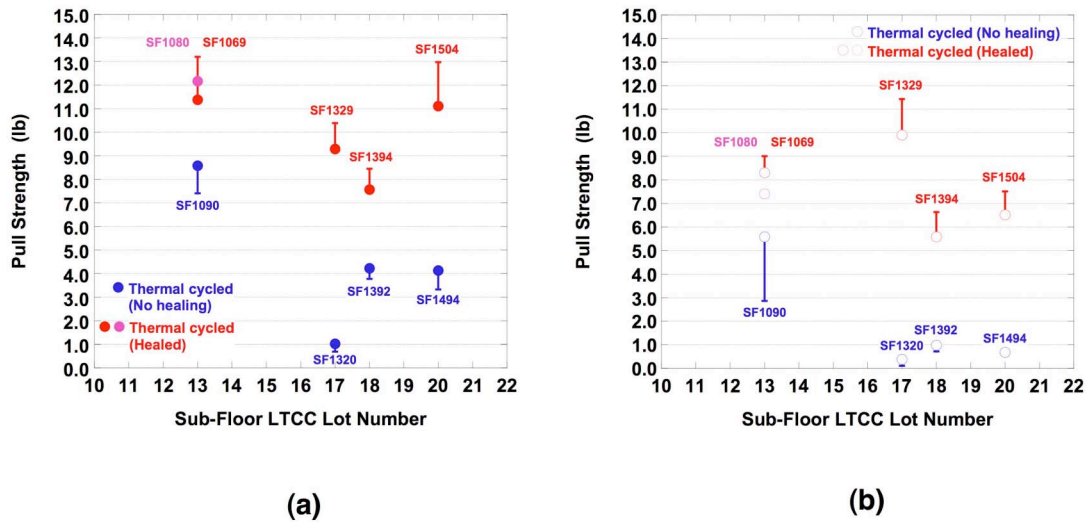
Fig. 31 Pull strength as a function of sub-floor LTCC lot numbers for (a) top side and (b) bottom side dice. The sub-modules were exposed to 20 thermal cycles (-55°C/125°C) prior to testing. The red symbols (“Rev 1”) were data from sub-modules that were exposed to the healing treatment (250°C, 260 hours, air). The blue symbols (“Rev 0”) were the strength values of sub-modules that were not subjected to the healing treatment. The one-half error bars were one standard deviation.

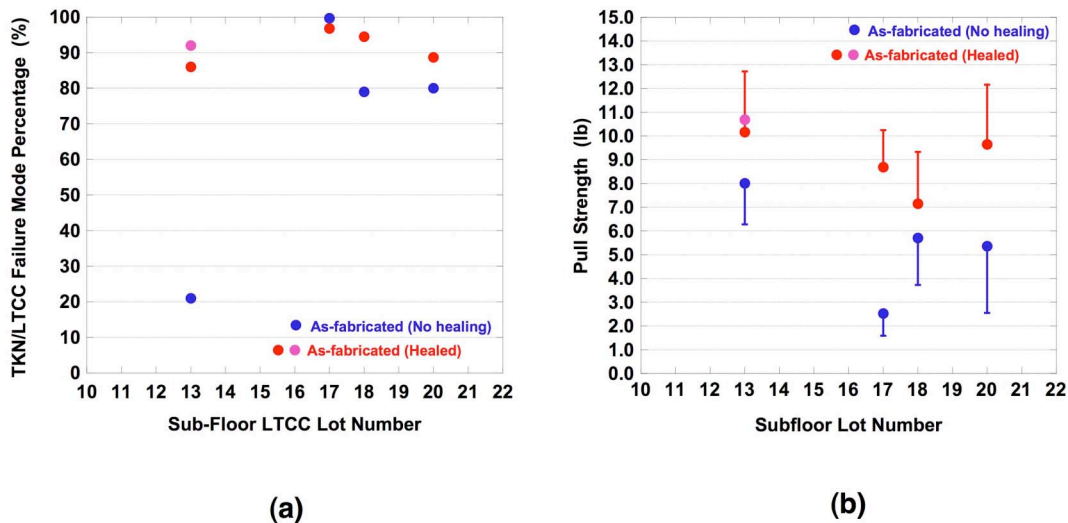
Fig. 32 (a) TKN/LTCC failure mode percentage and (b) pull strength as a function of sub-floor LTCC lot numbers. The respective data were averaged between the top side and bottom side dices of the sub-modules. The sub-modules were in the *as-fabricated condition*. The red symbols (“Rev 1”) were data from sub-modules that were exposed to the healing treatment (250°C, 260 hours, air). The blue symbols (“Rev 0”) were the strength values of sub-modules that were not subjected to the healing treatment. The one-half error bars were one standard deviation.

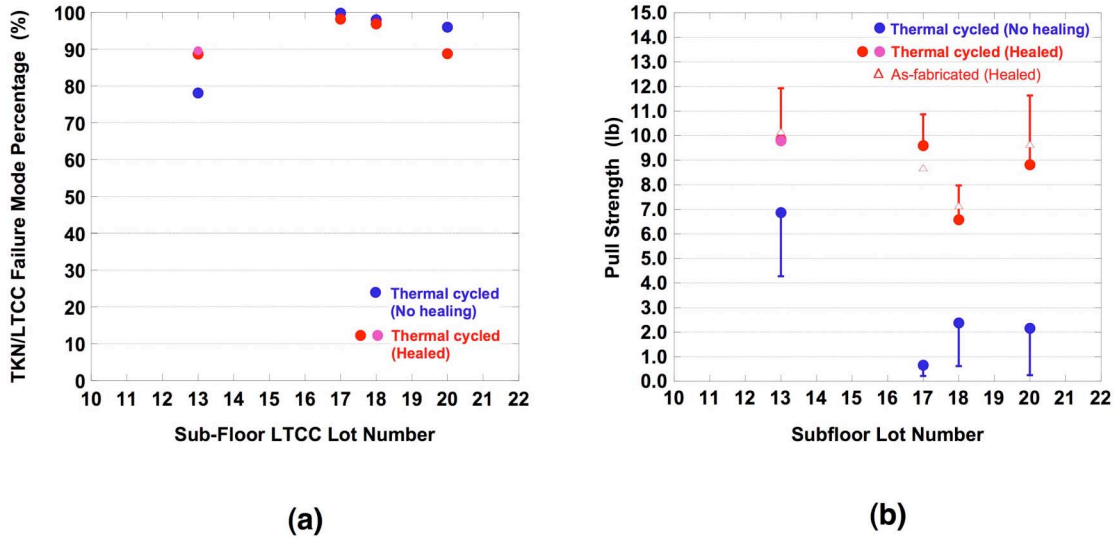
Fig. 33 (a) TKN/LTCC failure mode percentage and (b) pull strength as a function of sub-floor LTCC lot numbers. The respective data were averaged between the top side and bottom side dices. The sub-modules were in the *thermal cycled condition*. The red symbols (“Rev 1”) were data from sub-modules that were exposed to the healing treatment (250°C, 260 hours, air). The open triangles were the as-fabricated pull strength values. The blue symbols (“Rev 0”) were the strength values of sub-modules that were not subjected to the healing treatment. The one-half error bars were one standard deviation.

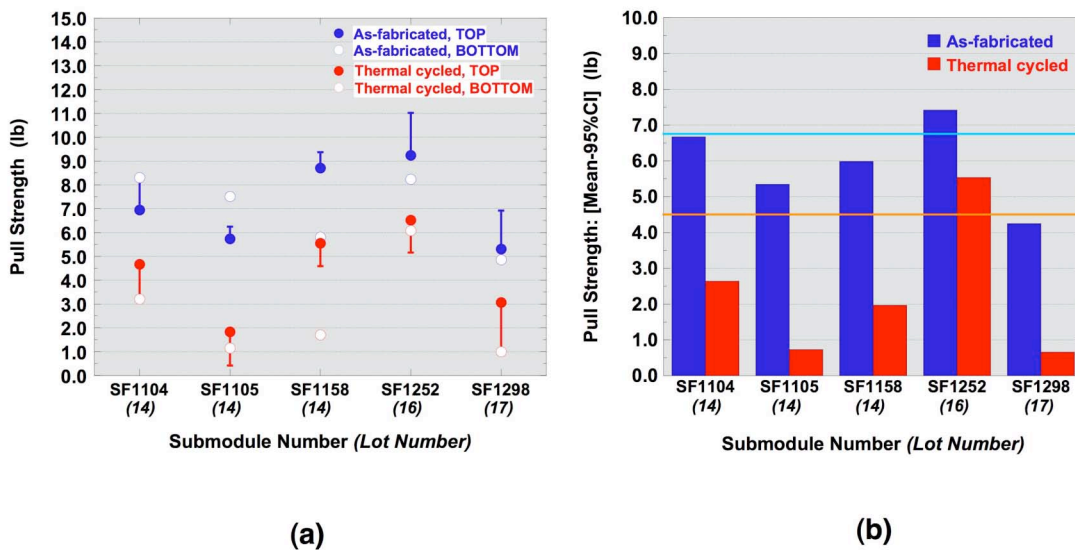
Fig. 34 (a) Pull strength as a function of sub-module number (lot number in italics). All of the sub-floors were exposed to the healing treatment (250°C, 260 hours, in air) prior to assembly into the sub-modules. The error bars were one standard deviation. (b) Pull strength lower acceptance limit (mean – 95% confidence interval) as a function of sub-module number. The strength data are the average of top side and bottom side. The turquoise and orange lines note the acceptance limit for the as-fabricated and post-thermal cycled cases.

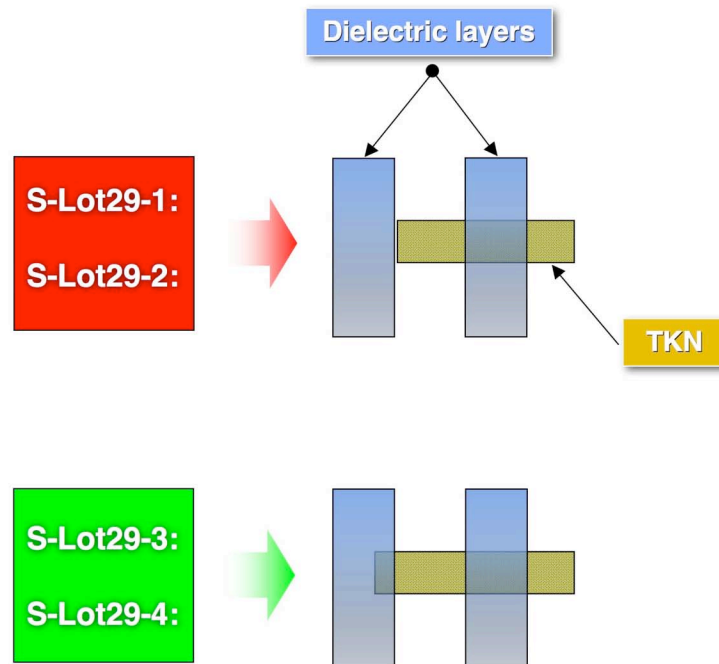
Fig. 35 Illustration of the location of the Au-Pt-Pd thick film flip chip pad relative to the dielectric layers in the initial sub-floor manufacturing step with lot #29 material. The illustration shows the configuration of the two sub-floors, S-Lot29-1 and -2, which were made with the higher viscosity, thick film paste while the sub-floors, S-Lot29-3 and -4, were made with for the TKN paste having the correct viscosity.

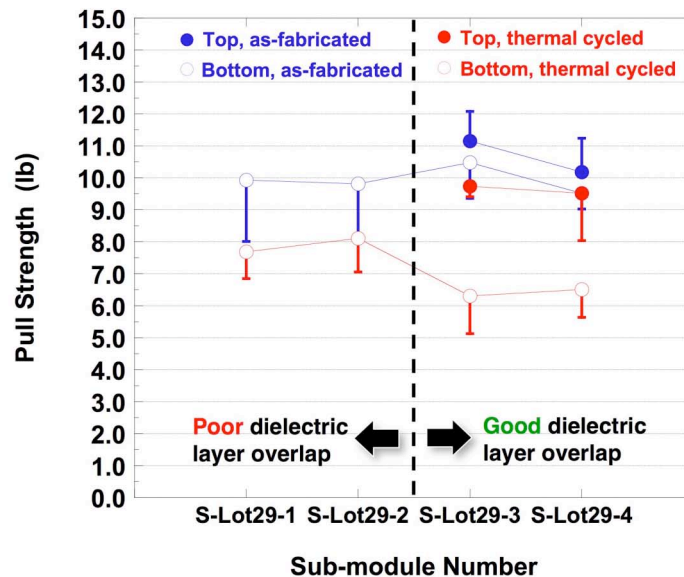
Fig. 36 Pull strength as a function of sub-floor number of the four sub-module units assembled with lot #29 LTCC material designated S-Lot29-X (X = 1, 2, 3, and 4). The half-error bars are one standard deviation.

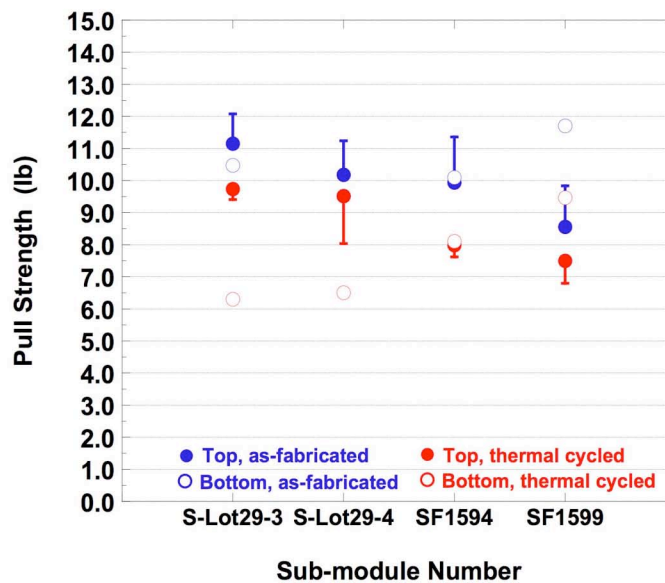
Fig. 37 Pull strength as a function of sub-module number of the four sub-module units assembled with lot #29 LTCC material: SF-Lot29-3, S-Lot29-4, SF1594, and SF1599. The data were separated into top side and bottom side strengths for the as-fabricated or thermal cycled conditions. The half-error bars are one standard deviation.

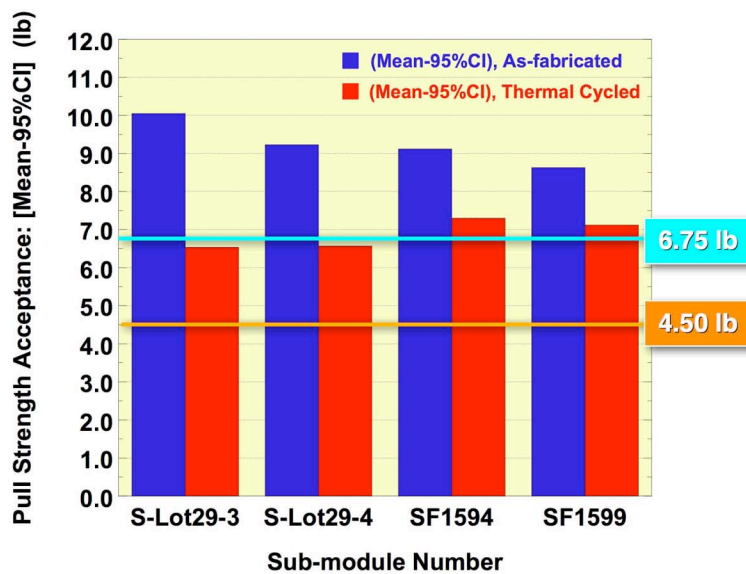
Fig. 38 Pull strength acceptance metrics, [Mean-95%CI] as a function of sub-floor number SF-Lot29-3, S-Lot29-4, SF1594, and SF1599 assembled from lot #29 LTCC material. The metric acceptance criteria are a minimum of 6.75 lb, as-fabricated (turquoise line) and 4.5 lb, post-thermal cycled (orange line).

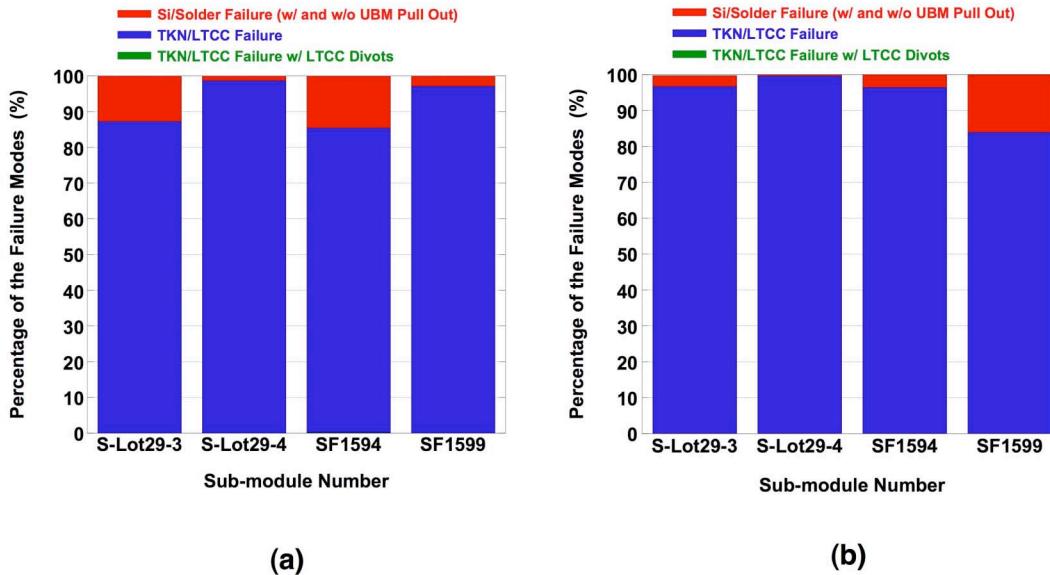
Fig. 39 Failure mode analysis of sub-modules SF-Lot29-3, S-Lot29-4, SF1594, and SF1594 assembled from lot #29 LTCC material. The pull tests were made on units in the as-fabricated condition. The plots represent (a) the top side and (b) the bottom side.
