SANDIA REPORT

SAND2008-5736

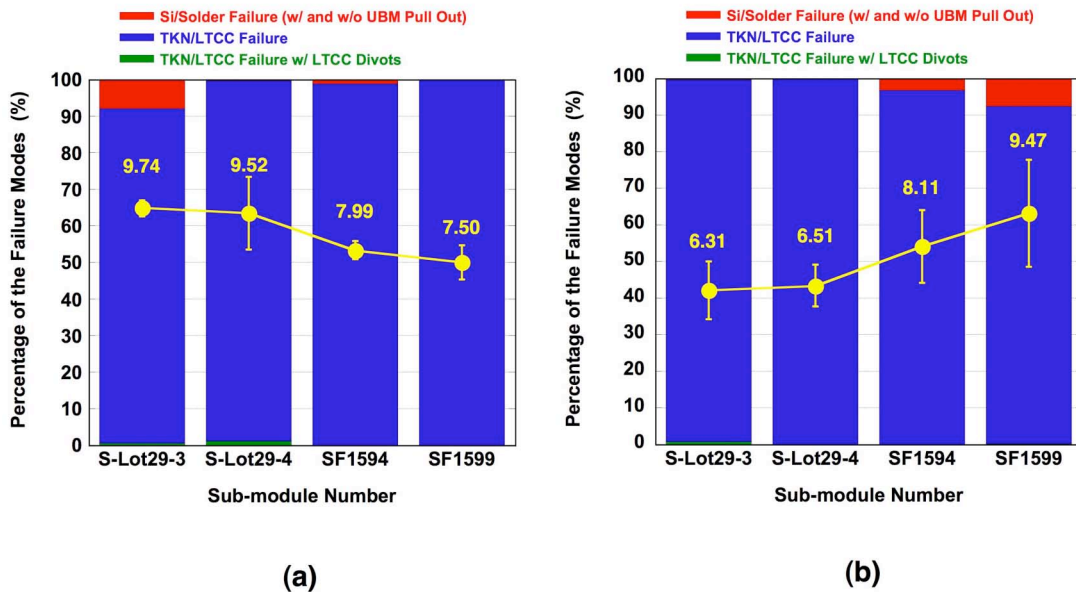
Fig. 40 Failure mode analysis of sub-modules SF-Lot29-3, S-Lot29-4, SF1594, and SF1599 assembled from lot #29 LTCC material. The pull tests were made on units after exposure to the thermal cycling environment. The plots represent (a) the top side and (b) the bottom side. In addition, the pull strength data were overlaid on the bar graphs; the error bars are \pm one standard deviation.

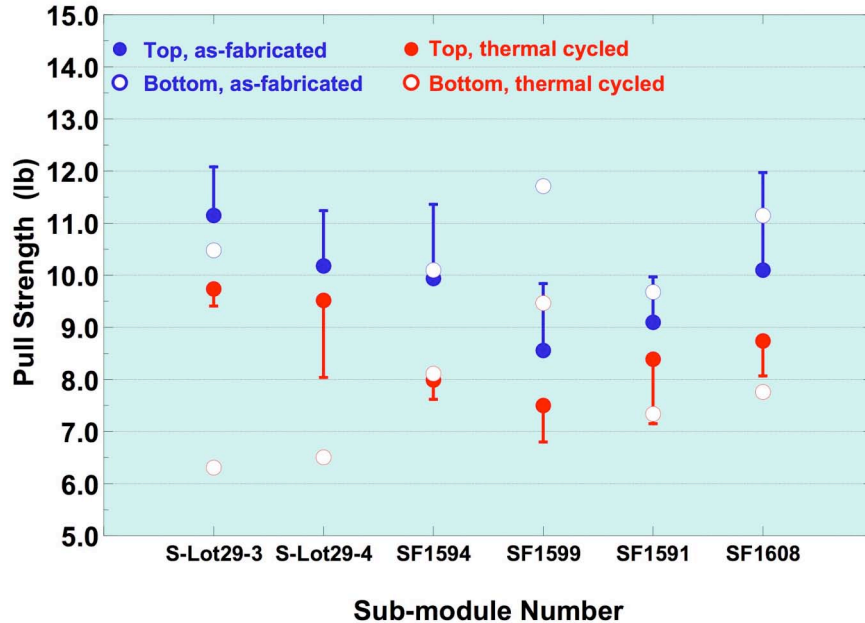
Fig. 41 Pull strengths of SF-Lot29-3, S-Lot29-4, SF1594, SF1599, and Flight 11 process monitors SF1591 and SF1608 assembled from lot #29 LTCC material. Top side and bottom side data were indicated by closed and open symbols, respectively. The as-fabricated condition symbols are in blue; the thermal cycled data are in red. The half-error bars are one standard deviation.

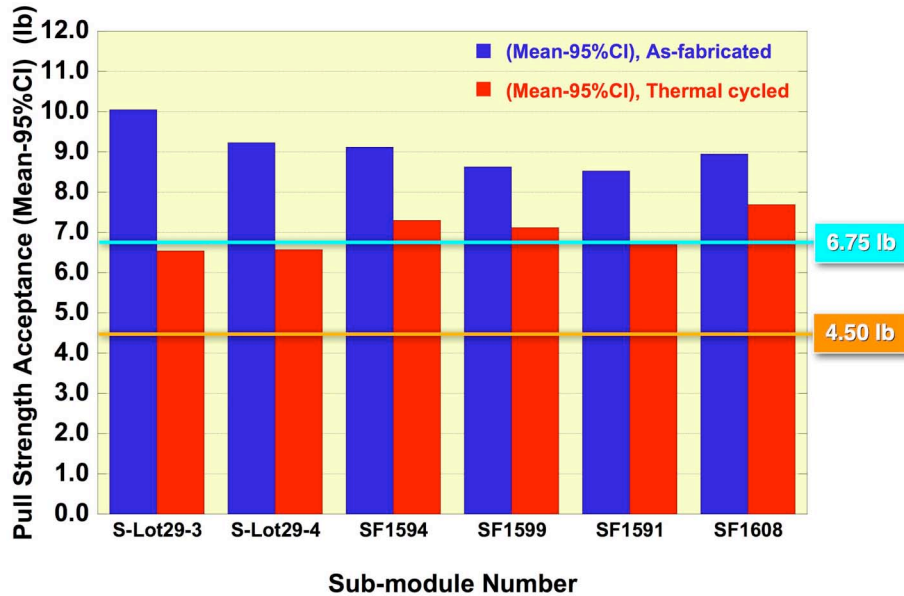
Fig. 42 Acceptance parameter, [Mean-95%CI] as a function of the sub-modules: SF-Lot29-3, S-Lot29-4, SF1594, SF1594, and Flight 11 process monitors SF1591 and SF1608 assembled from lot #29 LTCC material. The flags, 6.75 lb and 4.5lb, are the acceptance limits for the as-fabricated and post-thermal cycled pull strengths, respectively.

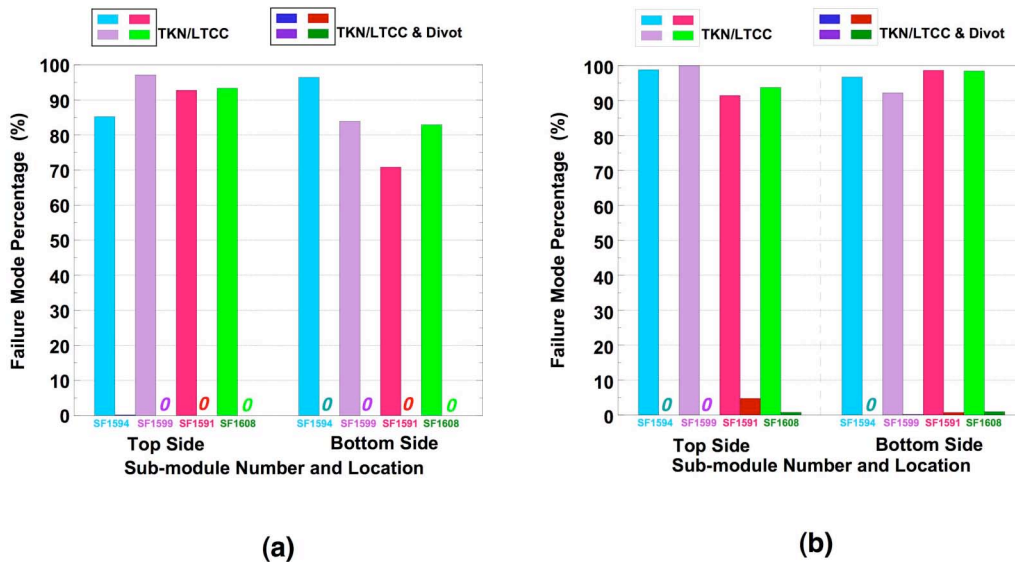
Fig. 43 Failure mode analysis of sub-modules SF1594, SF1594, and Flight 11 process monitors SF1591 and SF1608 assembled from lot #29 LTCC material: (a) as-fabricated and (b) post-thermal cycle. Per the legends, the lighter shades of colors are the TKN/LTCC failure mode and darker shades are the TKN/LTCC+divots mode. Top side (left) and bottom side (right) data were separated within each plot.

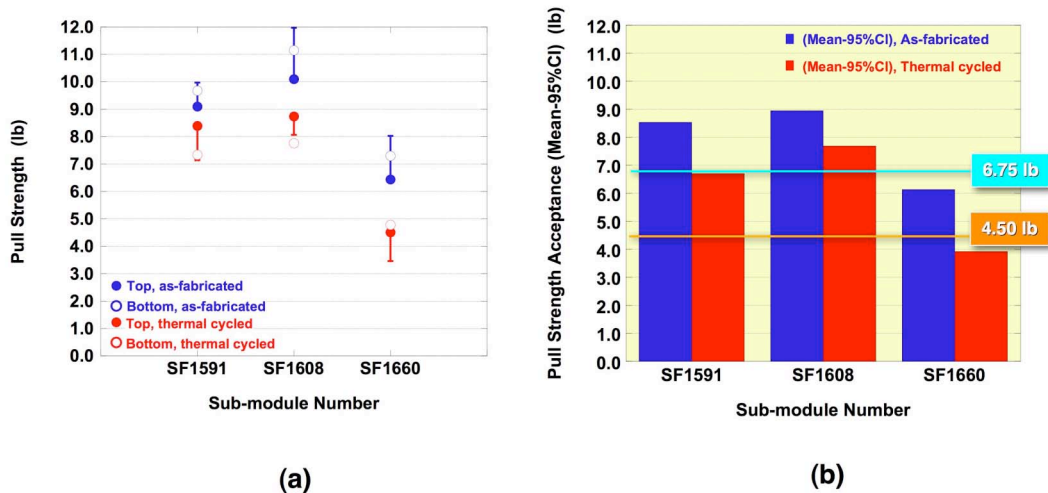
Fig. 44 (a) Pull strength as a function of sub-module designation for the Flight 12 process monitor, SF1660 (sub-floor lot #30). The pull strength data from the Flight 11 process monitors, SF1591 and SF1608 were also included. The as-fabricated and thermal cycle conditions were represented by the blue and red symbols, respectively; top side data were designated by the solid symbols while open symbols indicated the bottom side data. The error bars are one standard deviation. (b) Pull strength acceptance data as a function of the process monitor sub-module. The minimum strength criteria (which are averages of the top side and bottom side results) are 6.75 lb and 4.5 lb for the as-fabricated and post-thermal cycled conditions, respectively.

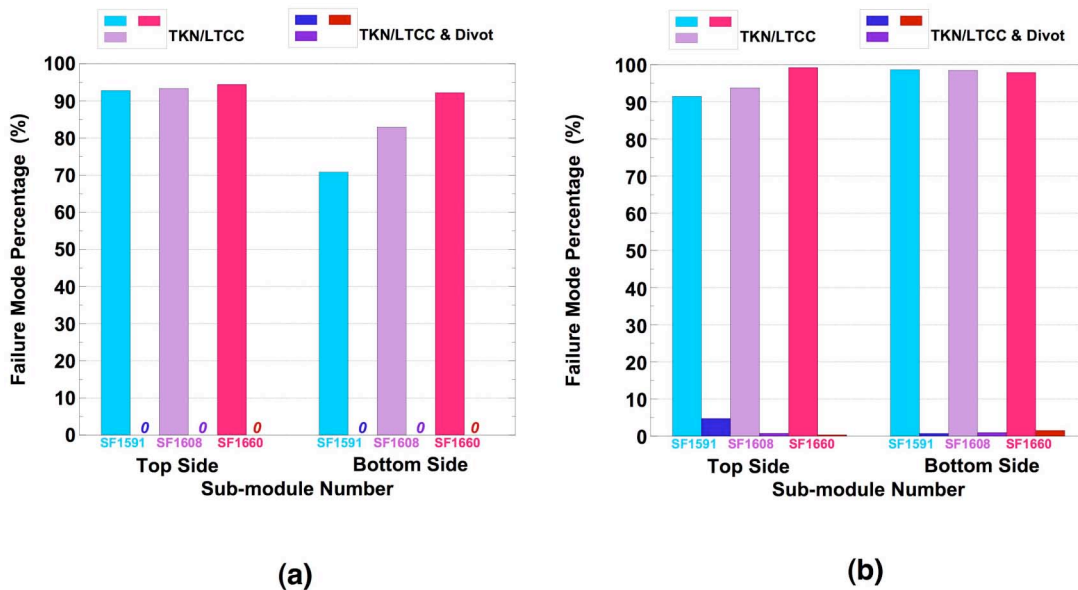
Fig. 45 Failure mode analysis of sub-modules SF1591 and SF1608 (both Flight 11) as well as SF1660 (Flight 12) assembled from lot #30 LTCC material: (a) as-fabricated and (b) post-thermal cycle conditions. Per the legends, the lighter shade of colors are the TKN/LTCC failure mode and darker shades are the TKN/LTCC+divots mode. Top side and bottom side data were distinguished in each plot.

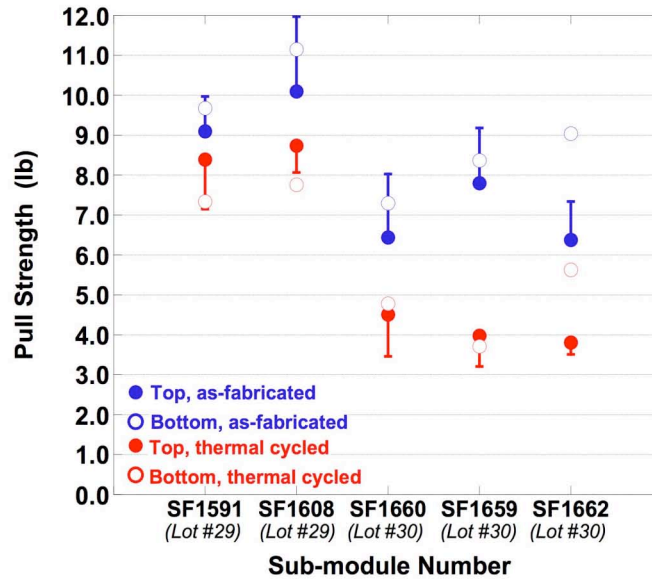
Nevertheless, an increased degree of scrutiny was given to sub-module performance by having two process monitors assembled for the Flight 13 build. The two sub-modules were designated SF1659 and SF1662. These units originated from sub-floors built of lot #30 LTCC material. Shown in Fig. 46a are the pull strength data. Again, the top side and bottom side pull strengths were separated. The LTCC lot numbers were included on the x-axis. Low pull strengths were observed for these latest sub-modules. As observed with the previous three sub-modules, the as-fabricated, bottom side pull strengths of SF1659 and SF1662 were greater than those of the top side, particularly for SF1662 where the difference was very significant. This trend was diminished after thermal cycling because of the substantial strength loss that occurred for both the top sides and bottom sides.

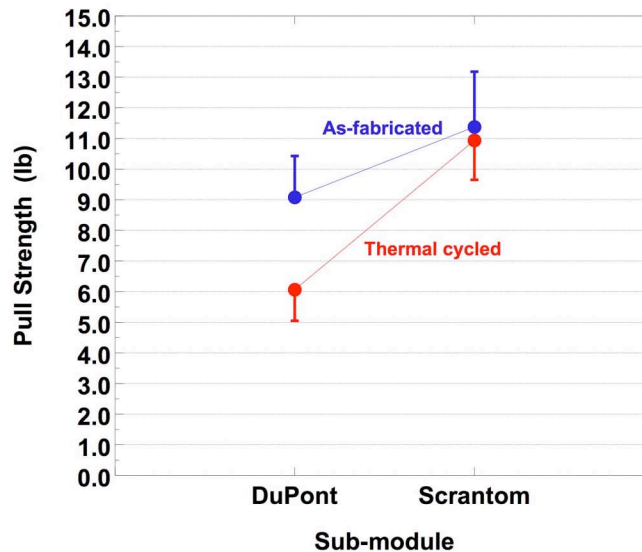
Fig. 48 Pull strength as a function of sub-module pedigree per the thick film (post-process) firing location: DuPont™ and Scrantom. Both the as-fabricated and post-thermal cycle (20 cycles, -55°C/125°C) data are combined on the same plot. The pull tests were performed only on dice on the bottom side. The error bars are one standard deviation.

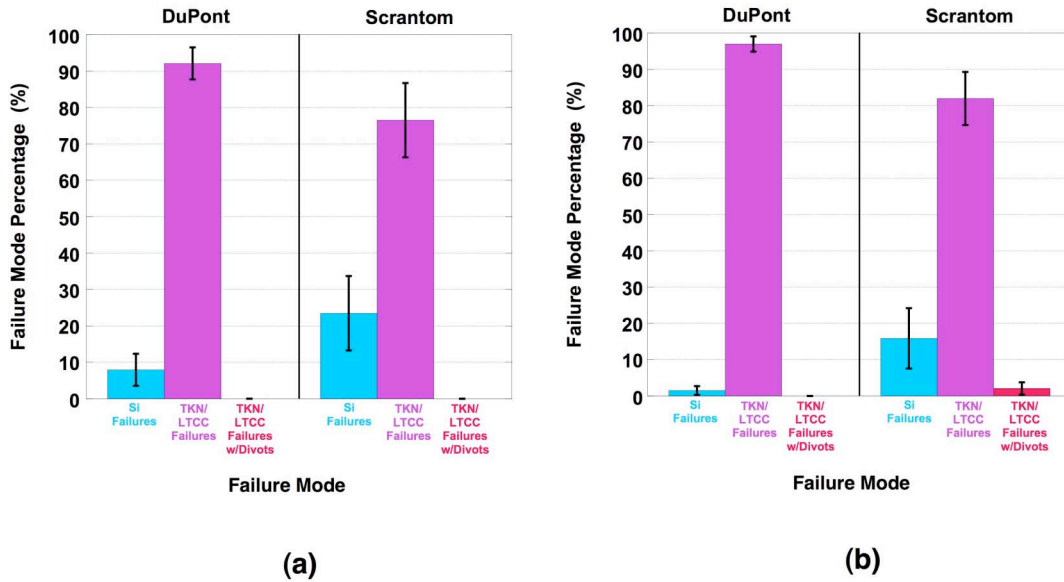
Fig. 49 Graphs showing the failure mode percentages for the DuPont™ and Scrantom post-processed sub-modules. The error bars are ±one standard deviation.

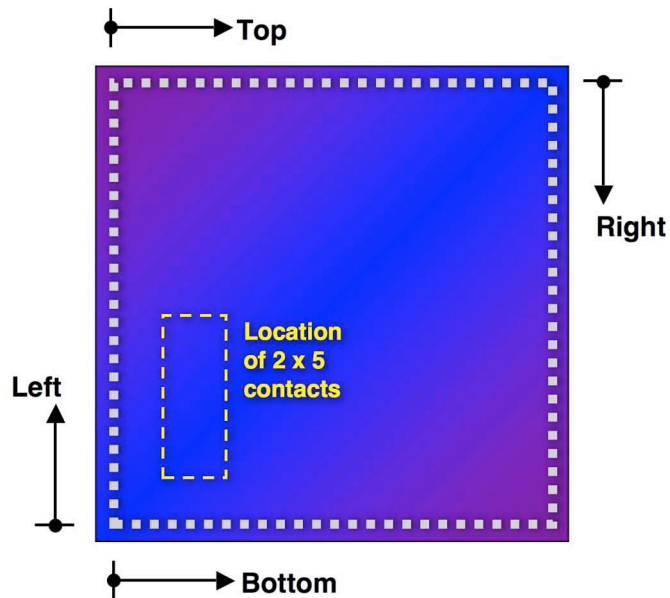
Fig. 50 Schematic diagram showing the legend used to identify the location of solder bumps examined by SEM or destructively, by metallographic cross sections.

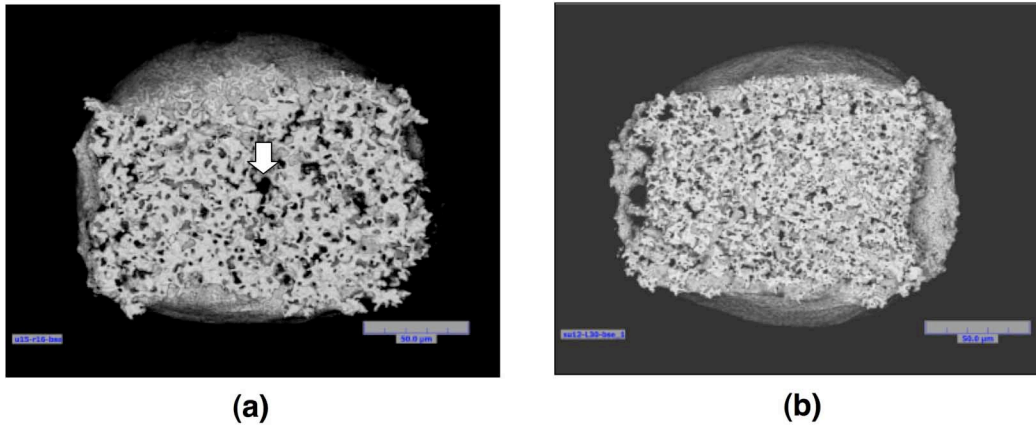
Fig. 51 Scanning electron microscopy (SEM), backscattered electron (BSE) images of the TKN/LTCC fracture surfaces of solder joints referencing the as-fabricated condition: (a) DuPont™ test vehicle, die U15, joint L16 and (b) Scrantom test vehicle, die U12, joint L30. The white arrow in (a) exemplifies a void.

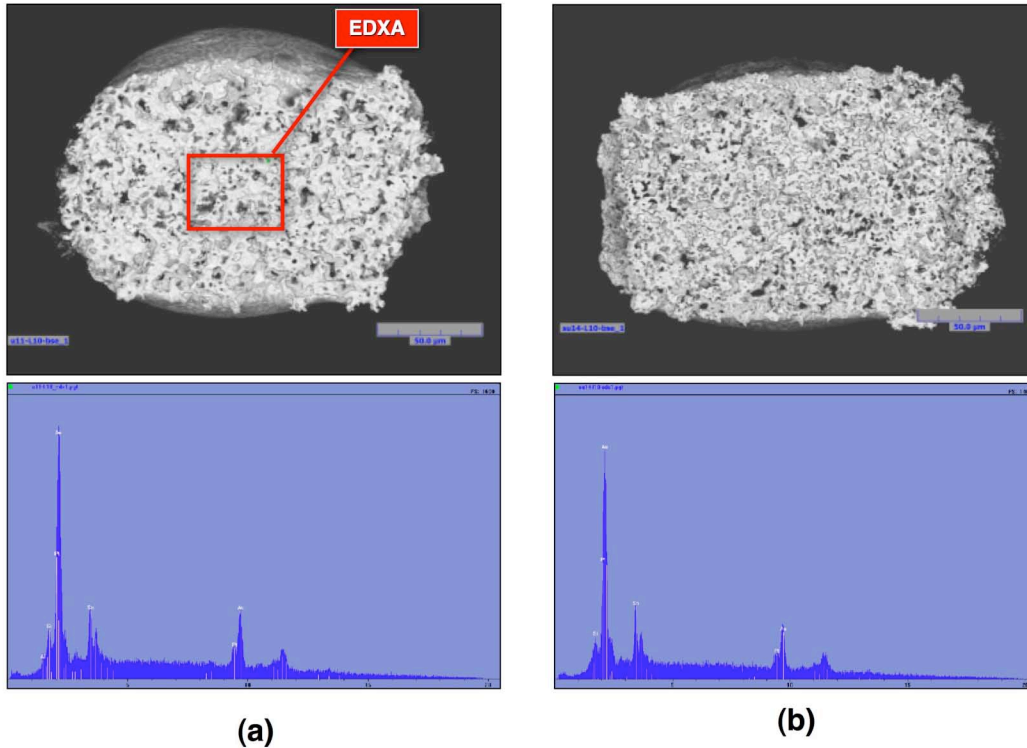
Fig. 52 Scanning electron microscopy (SEM), backscattered electron (BSE) images of the TKN/LTCC fracture surfaces of solder joints of dice pull tested after thermal cycling: (a) DuPont test vehicle, die U11, joint left 10 and (b) Scrantom test vehicle, die U14, joint left 10. The area that was scanned for the energy dispersive x-ray analysis (EDXA) spectra beneath them is represented by the red rectangle.

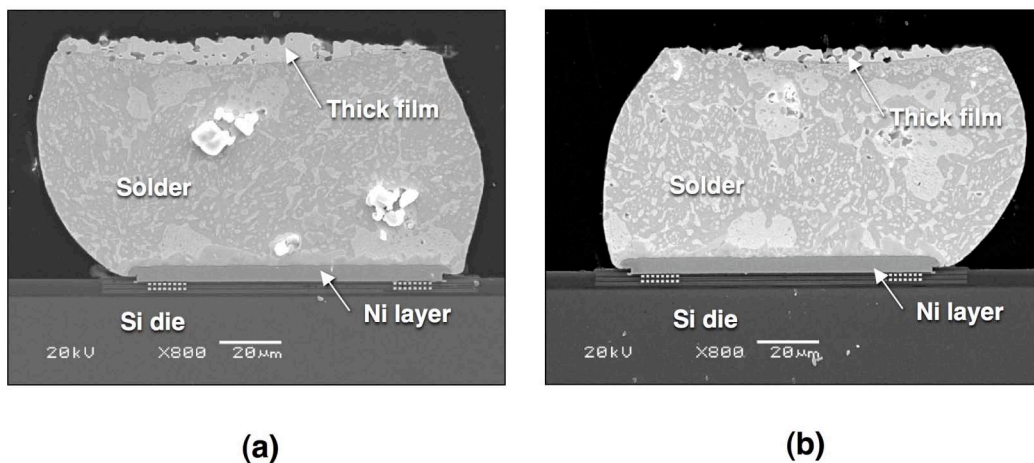
Fig. 53 SEM (SE) images of the cross sections of two solder joints from the U15 die of the DuPont™ test vehicle. The U15 die was pulled in the as-fabricated condition. The solder joints were: (a) R4 and (b) L25.

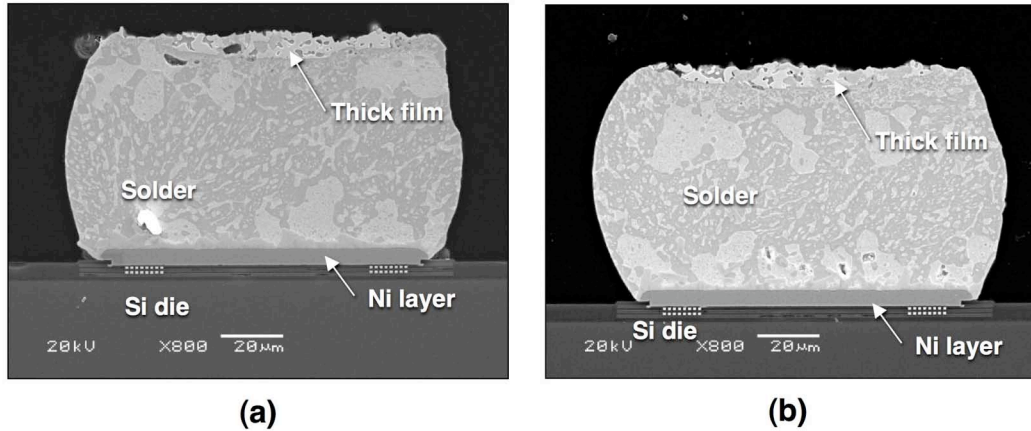
Fig. 54 SEM (SE) images of the cross sections of two solder joints from the U12 die of the Scrantom test vehicle. The U12 die was pulled in the as-fabricated condition. The solder joints were: (a) L5 and (b) R21.

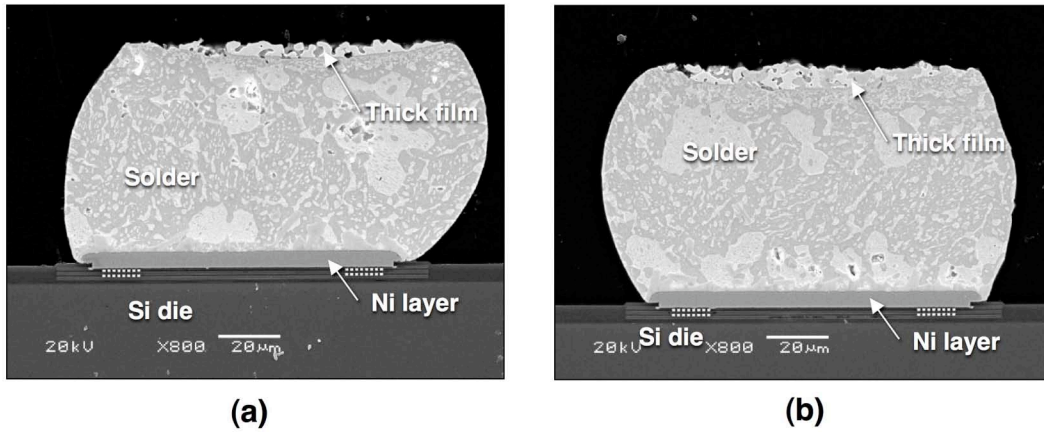
Fig. 55 Low magnification, SEM (SE) images of the cross sections of two solder joints pull tested in the as-fabricated condition (TKN/LTCC failure mode) comparing the two test vehicles: (a) DuPont™, U15, joint R4 and (b) Scrantom, U12, joint R21.

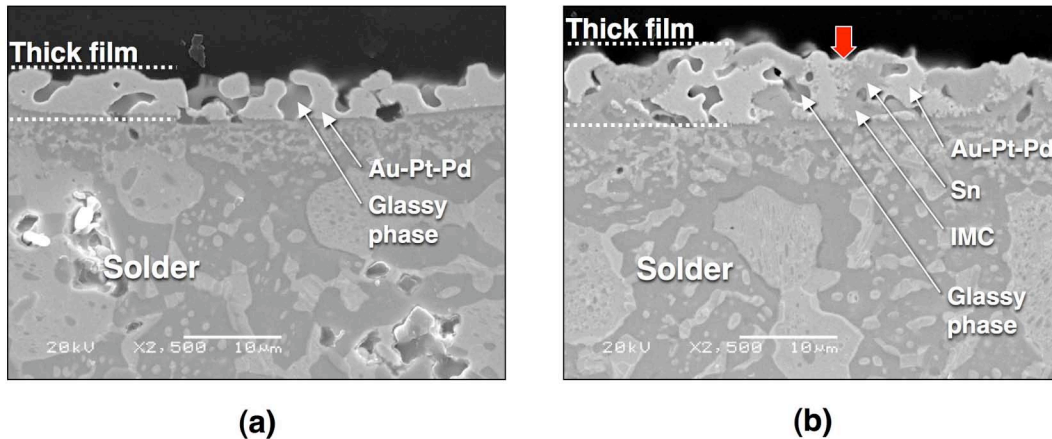
Fig. 56 High magnification, SEM (SE) images of the cross sections of two solder joints pull tested in the as-fabricated condition (TKN/LTCC failure mode) comparing the two test vehicles: (a) DuPont™, U15, joint R4 and (b) Scrantom, U12, joint R21. The morphology of the partially dissolved Scrantom TKN is identified by the red arrow.

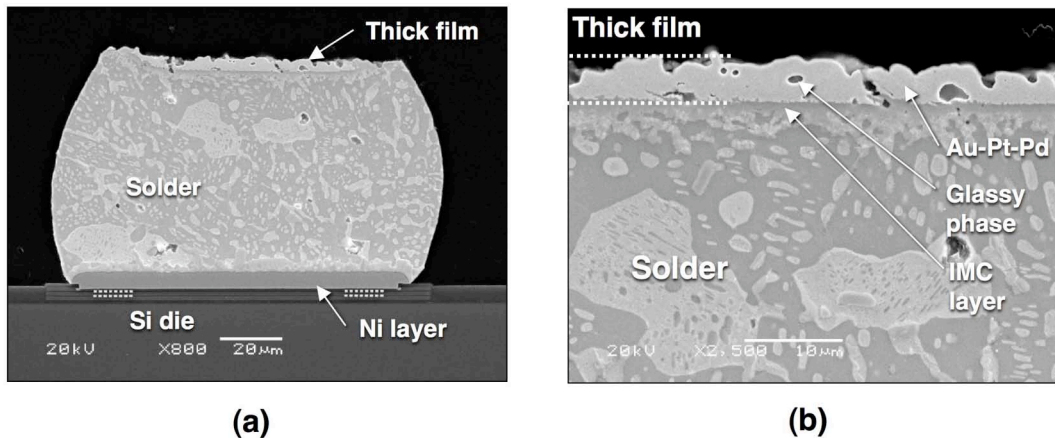
Fig. 57 SEM (SE) images of the cross sections of the T33 from the U11 die of the DuPont™ test vehicle that was pull tested after thermal cycling: (a) low magnification and (b) high magnification.

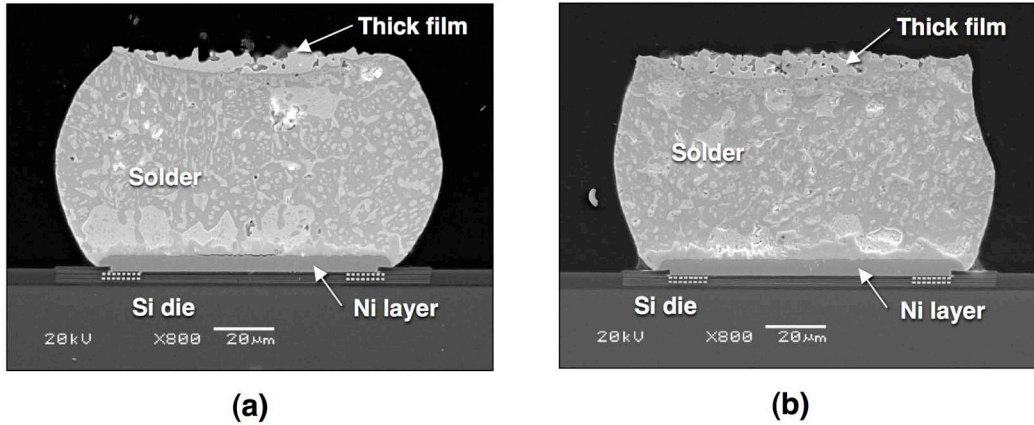
Fig. 58 Low magnification, SEM (SE) images of the cross sections of two solder joints pull tested in the post-thermal cycled condition (TKN/LTCC failure mode) comparing the two test vehicles: (a) DuPont™, U11, joint T6 and (b) Scrantom, U14, joint T2.

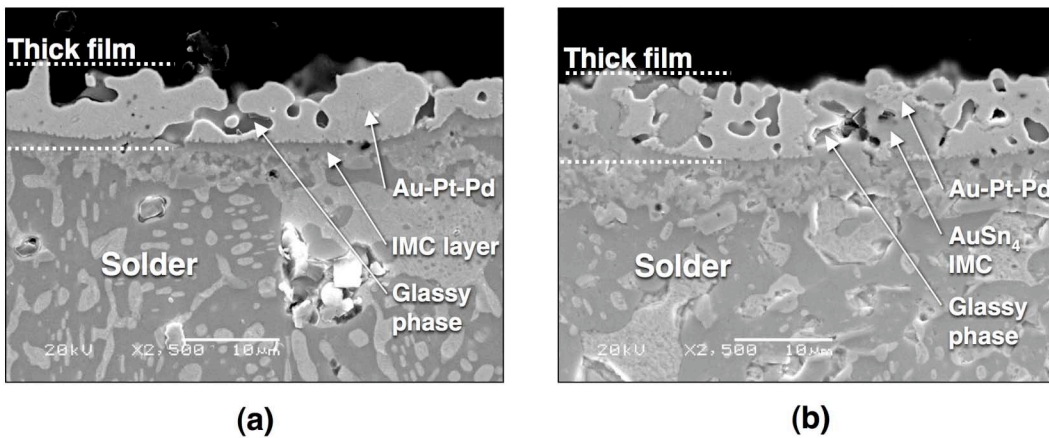
Fig. 59 High magnification, SEM (SE) images of the cross sections of two solder joints pull tested in the post-thermal cycled condition (TKN/LTCC failure mode) comparing the two test vehicles: (a) DuPont™, U11, joint T6 and (b) Scrantom, U14, joint T2.

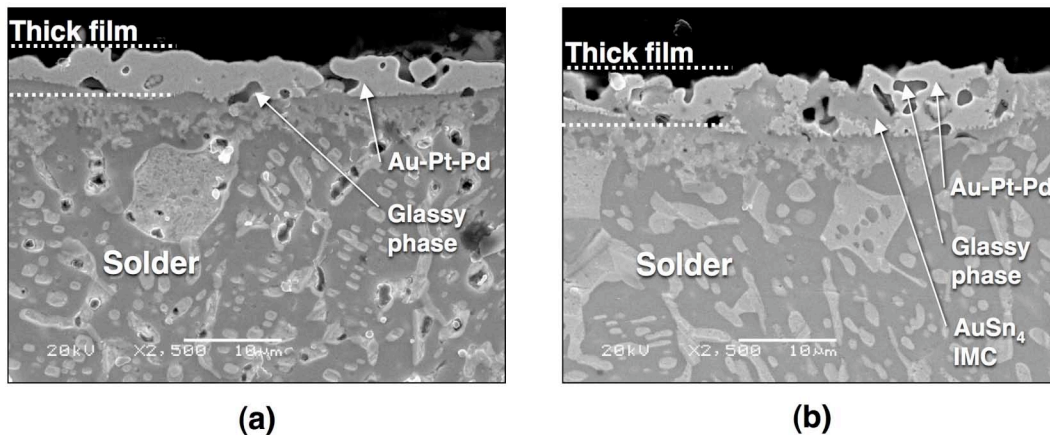
Fig. 60 High magnification, SEM (SE) images of the cross sections of two solder joints pull tested in the post-thermal cycled condition (TKN/LTCC failure mode) comparing the two test vehicles: (a) DuPont™, U11, B5 and (b) Scrantom, U14, joint B24.

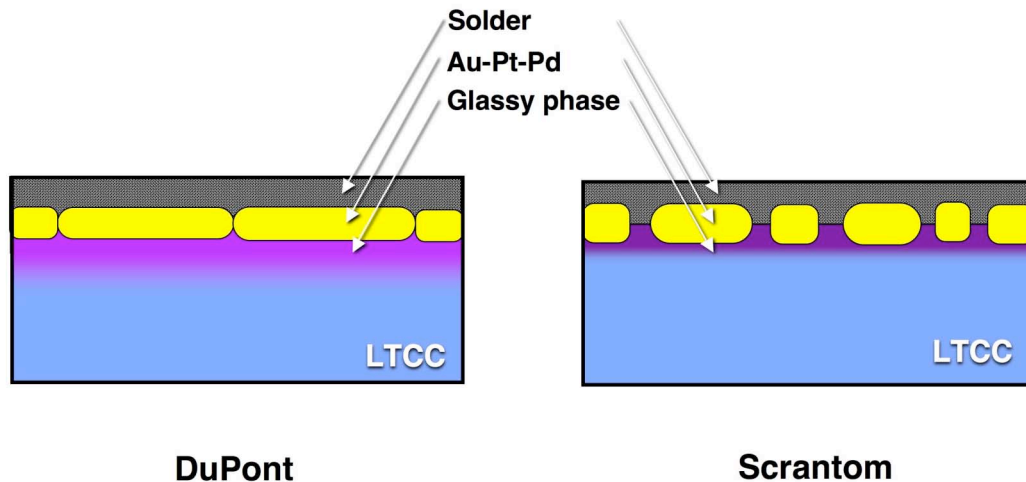
Fig. 61 Schematic diagrams showing the interface structures of the DuPont™ and Scrantom flip chip solder joints. The greater extent of sintering in the DuPont™ case resulted in a more contiguous Au-Pt-Pd thick film layer.

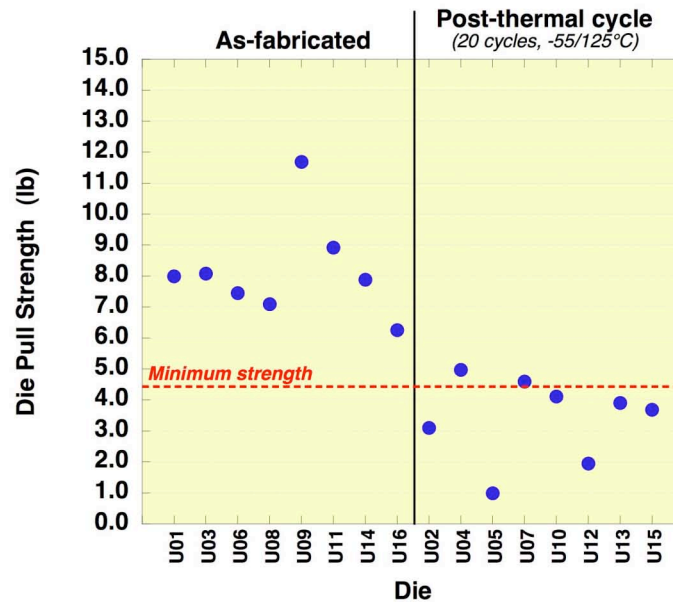
Fig. 62 Graph of pull strength as a function of die site for the sub-module SF512. The data were divided into segments representing the as-fabricated and post-thermal cycled conditions. The minimum individual die pull strength limit is shown. Sites U01 – U08 are on the top side of the sub-module while sites U09 – U16 are on the bottom side.

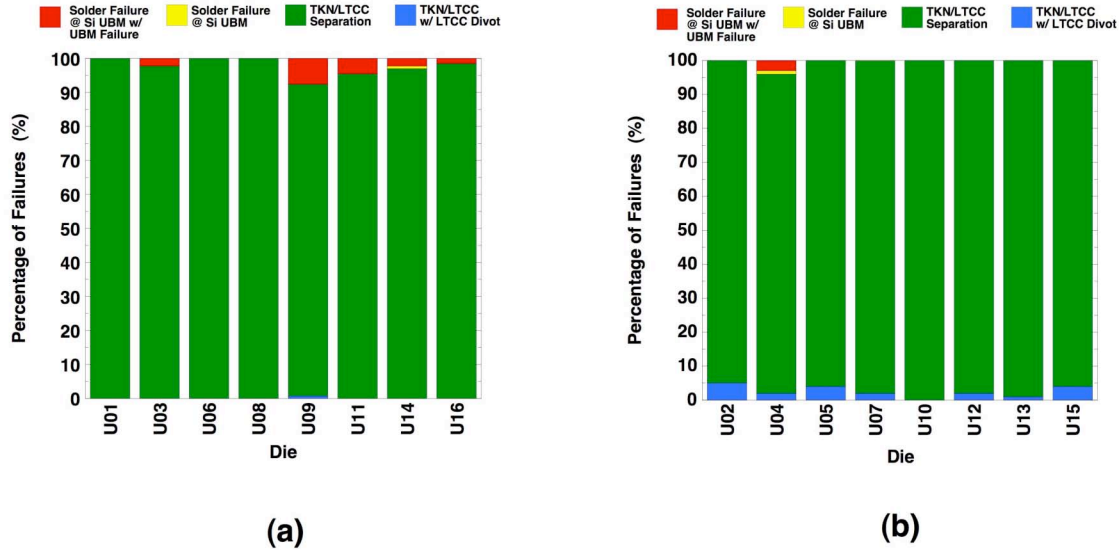
Fig. 63 Graphs of the failure mode results from sub-module SF512 for: (a) as-fabricated condition and (b) post thermal cycled condition. Each of the four failure modes is designated by color on the bar graphs.

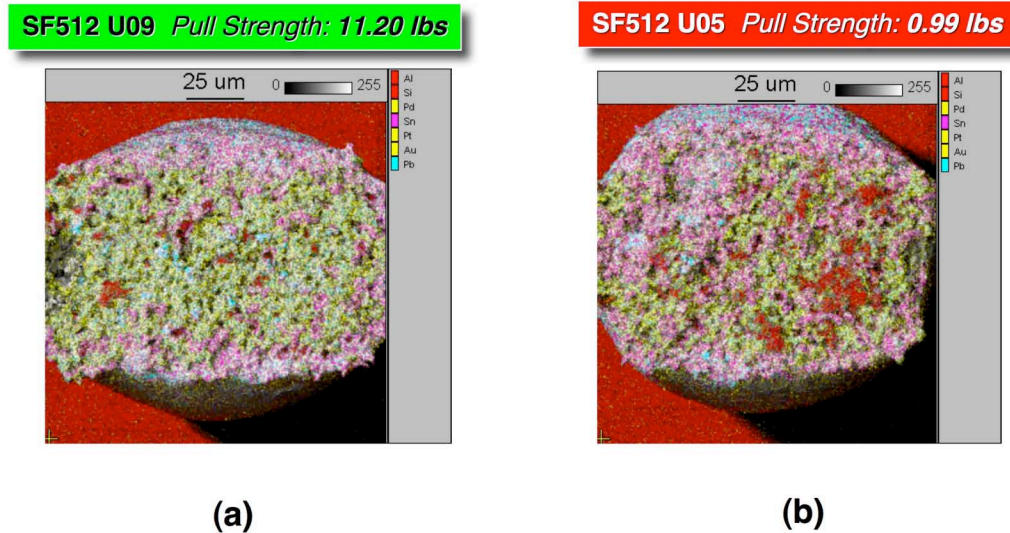
Fig. 64 SEM/EDXA elemental maps of selected flip chip solder joints from die on the sub-module SF512 having the TKN/LTCC failure mode after pull testing: (a) U09, joint L15, as-fabricated condition, high strength of 11.2 lb and (b) U05, joint R15, post-thermal cycled condition, having a low strength of 0.99lb. The elements of Au, Pt, and Pd were combined into a single color, yellow, to represent the thick film metal. The elements Si and Al were combined as red, representing the LTCC material. Pink is the Sn element and blue is Pb, the latter corresponding primarily to the TKN glassy phase.

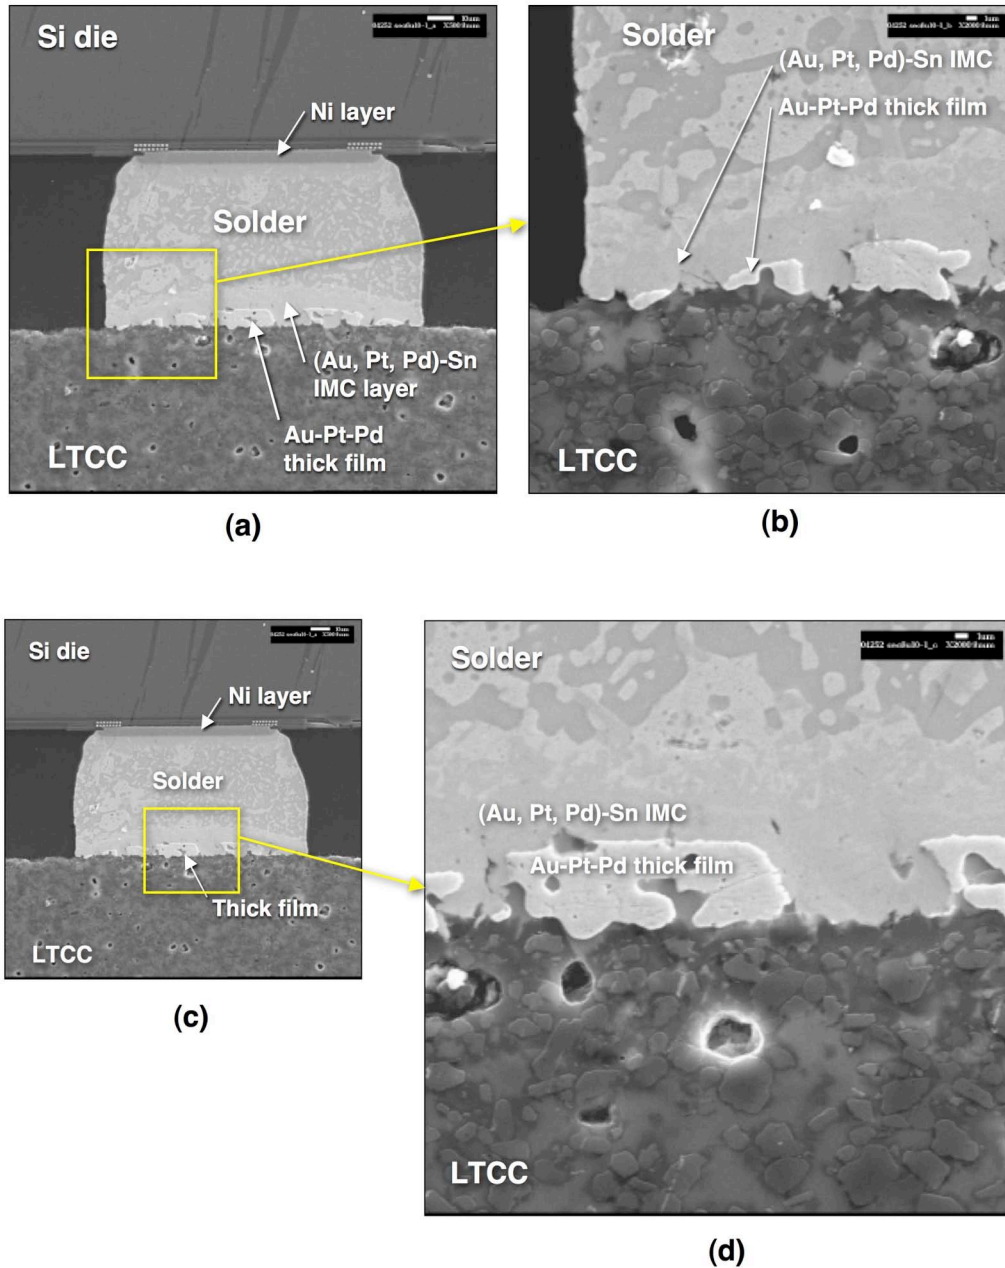
Fig. 66 (a – d) SEM micrographs showing the microstructure of a representative solder joint, in this case, taken from the die U10 (post-thermal cycle; no underfill) from SF523. Both high magnification images (b, d) confirmed good integrity of the (Au, Pt, Pd)Sn₄ IMC/LTCC and TKN/LTCC interfaces.

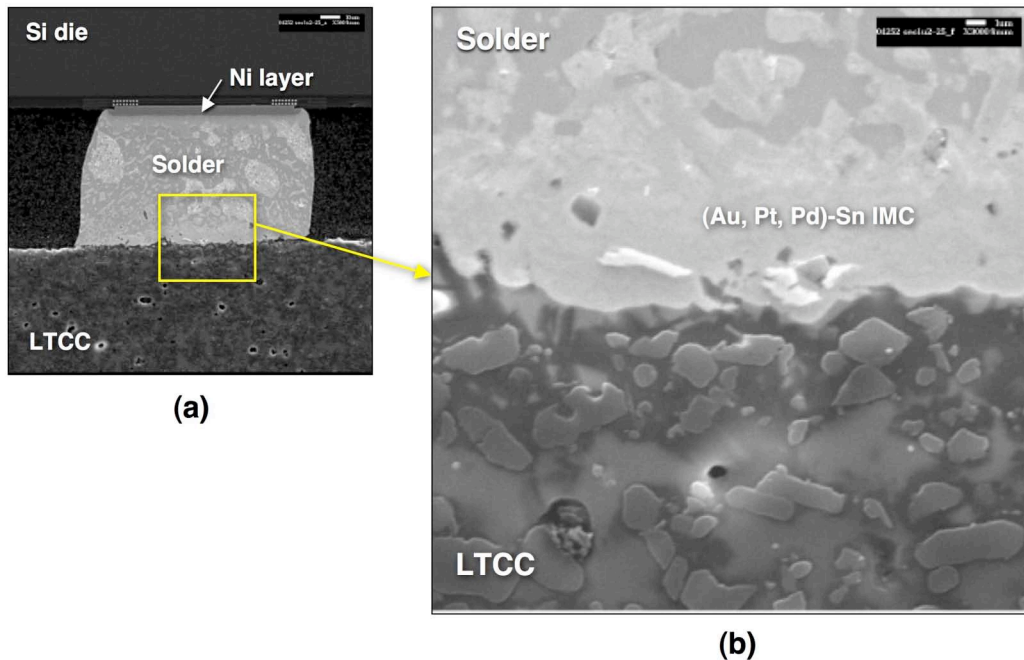
Fig. 67 SEM micrographs showing the microstructure of a representative solder joint of the die U02 (post-thermal cycle with underfill from sub-module SF541). There were no indications of cracking along the interface between the $(\text{Au, Pt, Pd})\text{Sn}_4$ IMC and LTCC substrate.

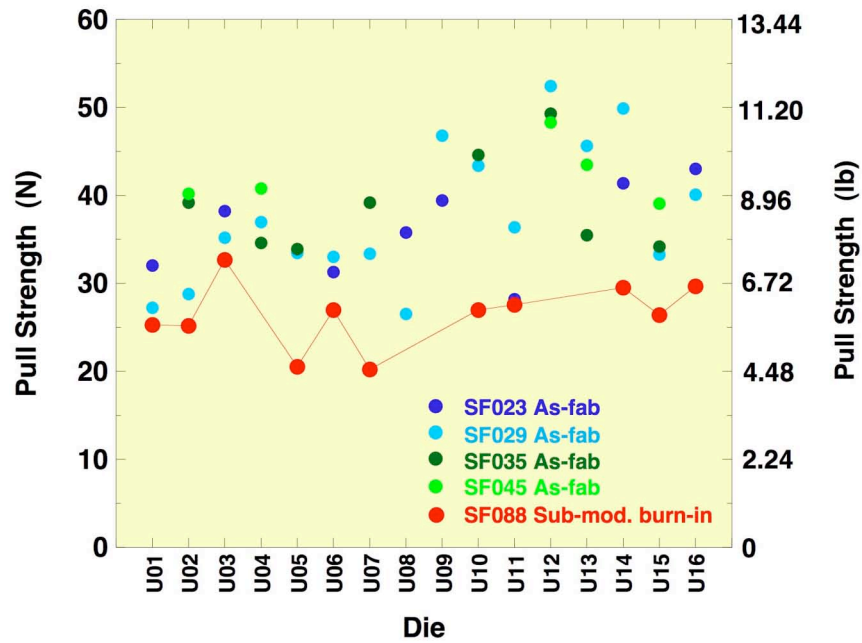
Fig. 68 Pull strength of dice on SF088 that was subjected to an air burn-in at 125°C for 282 hours. Comparable data were included from four other sub-modules, SF023, SF029, SF035, and SF045, that were not subjected to a burn-in treatment.

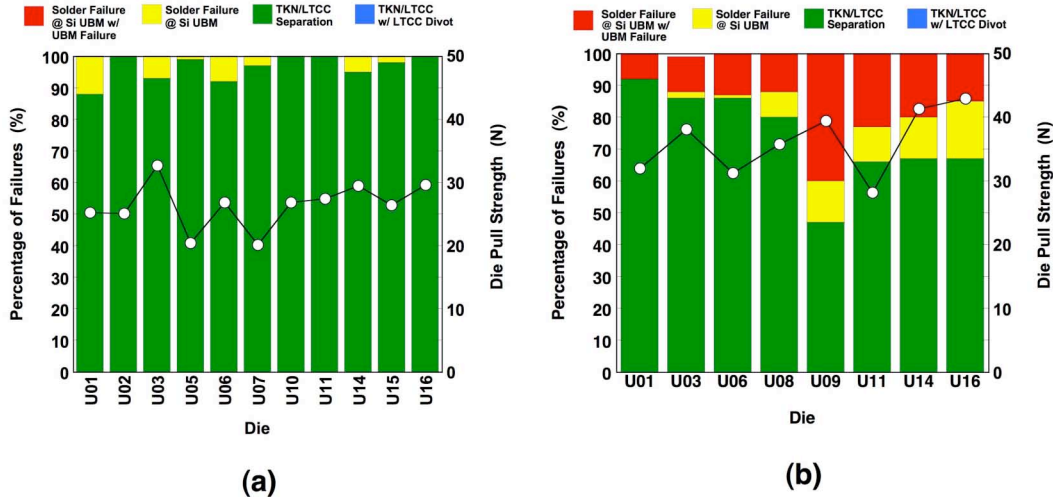
Fig. 69 Failure modes associated with the pull-tested dice on sub-modules (a) SF088 that was subjected to an air burn-in at 125°C for 282 hours and (b) SF023 that was not exposed to the burn-in treatment. All tests were performed in the as-received condition. The pull strength values were placed over the failure mode bar charts for comparison. (The pull strengths were in the units of Newtons (N); the conversion is 0.224 lb/N.)

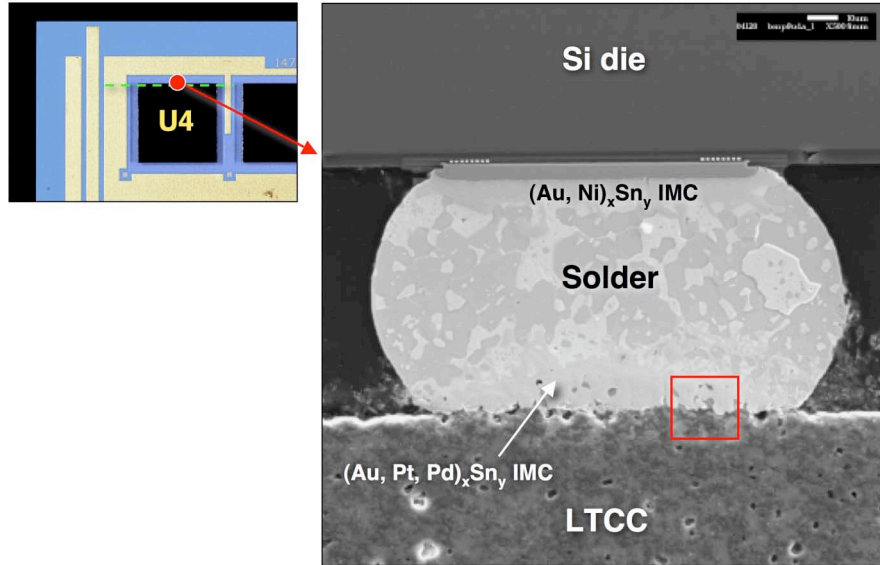
Fig. 70 Stereo photograph identifying the location of the center-wise solder bump on U04 of the sub-module, SF088, that underwent the burn-in treatment of 125°C, 282 hours. The SEM photograph shows the solder joint in cross section and the location (red box) of the region examined at higher magnification.

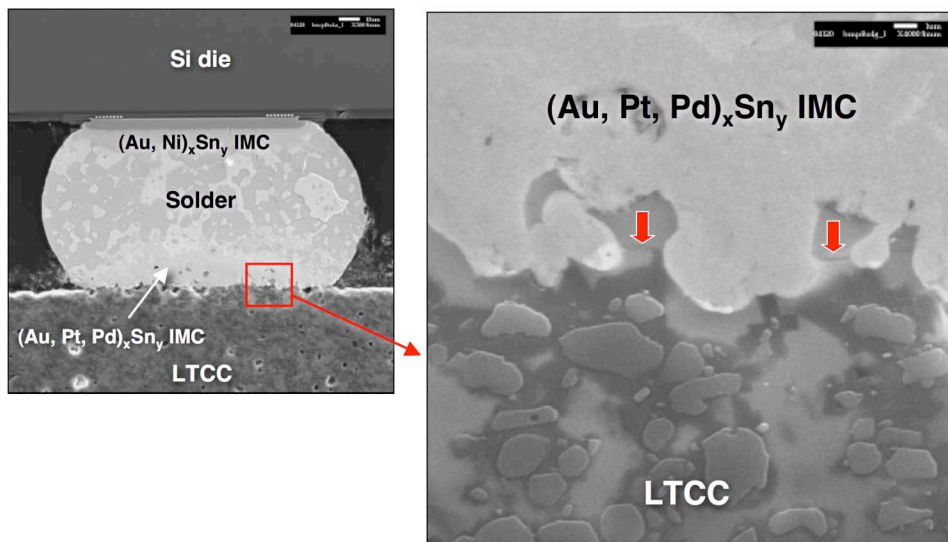
Fig. 71 Low magnification SEM photograph of the U04 solder joint near the center of the row, and high magnification image of the $(\text{Au, Pt, Pd})_x\text{Sn}_y/\text{LTCC}$ interface. The red arrows identify small cracks in the glassy phase that belonged to the thick film layer.

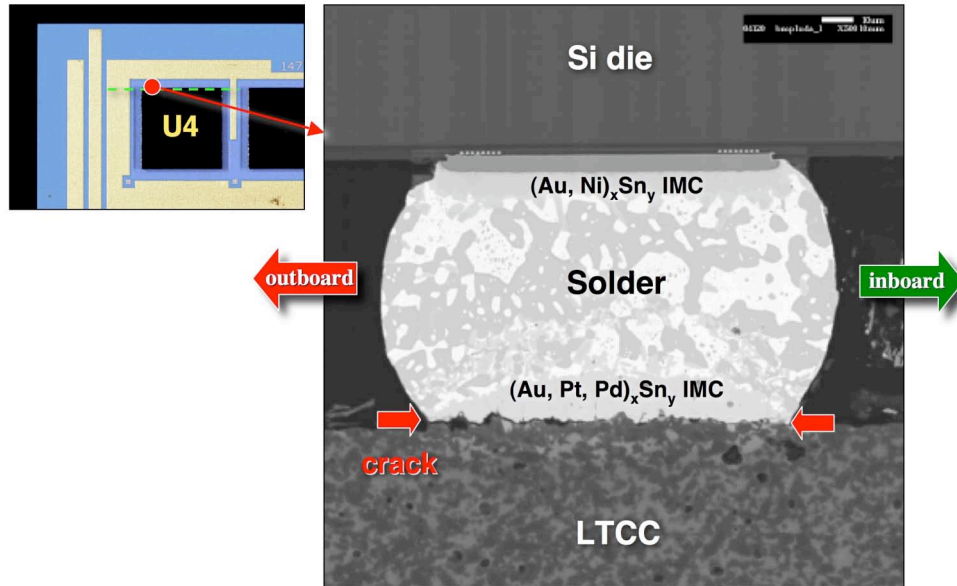
Fig. 72 Stereo photograph identifying the location of the edge solder bump at the edge of the row on U04 of SF088 that underwent the burn-in treatment of 125°C, 282 hours and the SEM photograph of the solder joint in cross section.

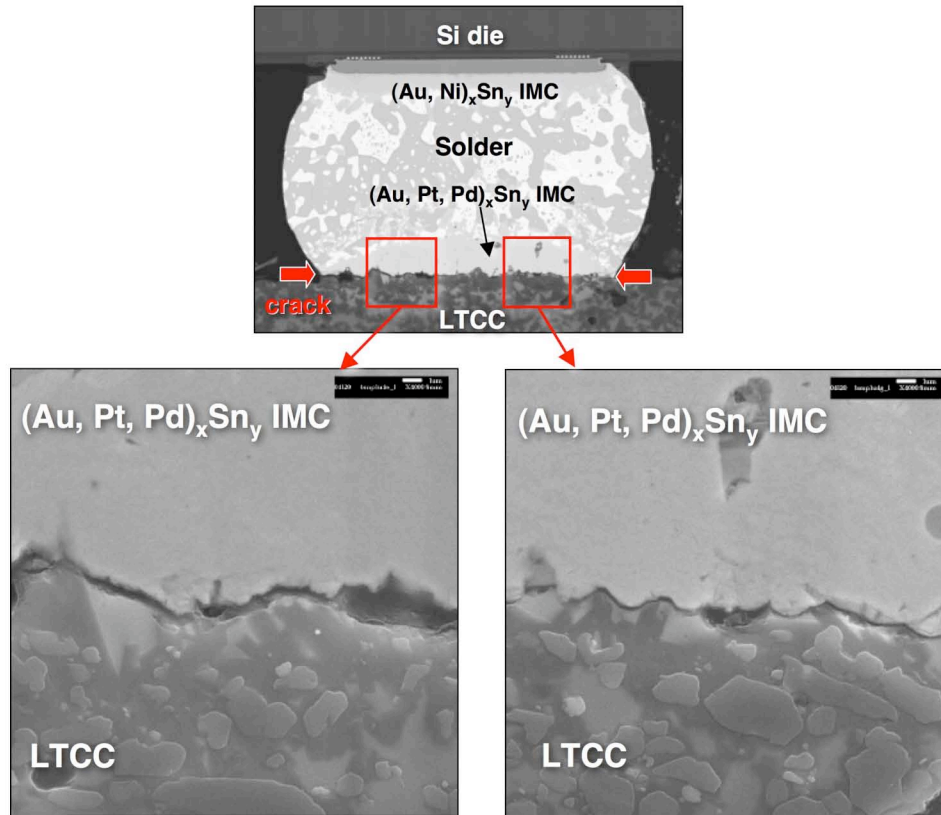
Fig. 73 Low magnification SEM photograph of the U04 solder joint near the edge of the row, and high magnification images showing cracks along the $(\text{Au, Pt, Pd})_x\text{Sn}_y$ /LTCC interface.

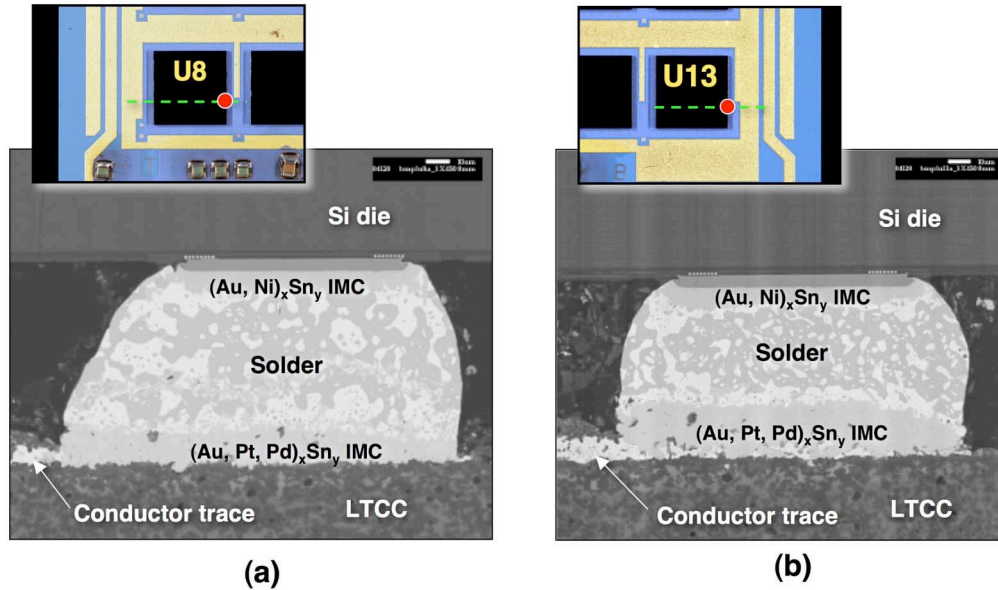
Fig. 74 Low magnification stereo photographs and SEM images of the cross-die sections of solder joints on the U08 and U13 die from sub-module SF088. These sections provide a view of the junction between the pad and the conductor trace.

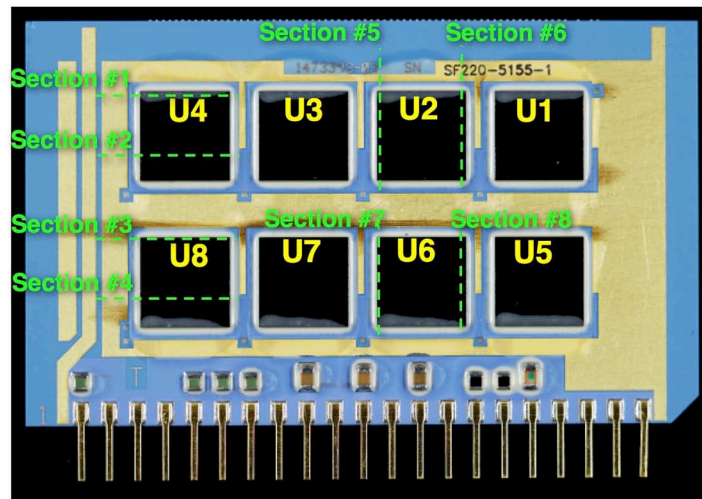
Fig. 75 Stereo photograph showing the locations of the cross sections made to the dice on sub-module SF220 that was not exposed to the burn-in treatment. The same locations were evaluated for sub-module SF264, which was exposed to the burn-in conditions of 125°C, 240 hours.

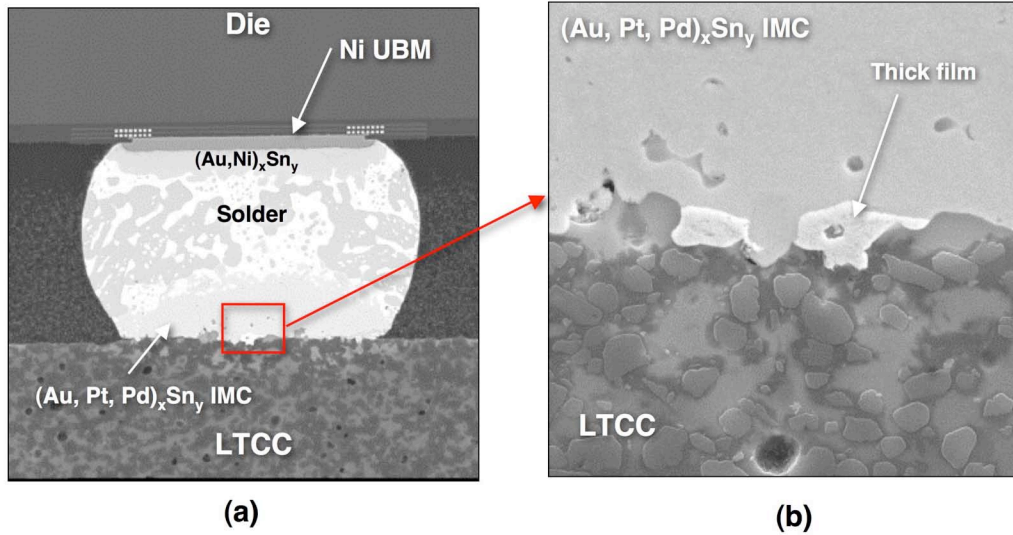
Fig. 76 SEM photographs of the solder joint on U02 (top side) of the sub-module SF264 that was exposed to the burn-in conditions of 125°C, 240 hours: (a) low magnification view of the joint and (b) high magnification image of the interface between the $(\text{Au, Pt, Pd})_x\text{Sn}_y$ IMC and the LTCC substrate.

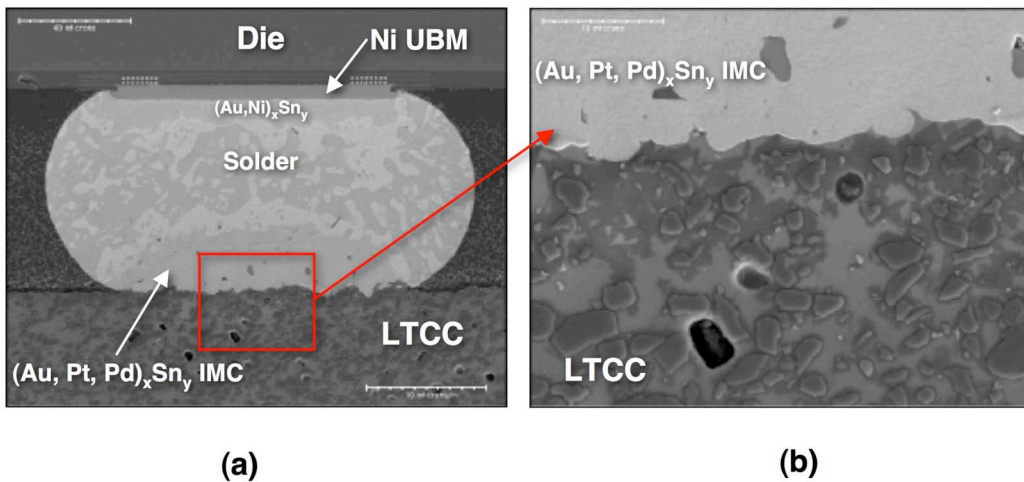
Fig. 77 SEM photographs of the solder joint on U13 (bottom side) of the sub-module SF264 that was exposed to the burn-in conditions of 125°C, 240 hours: (a) low magnification view of the joint and (b) high magnification image of the interface between the $(\text{Au, Pt, Pd})_x\text{Sn}_y$ IMC and the LTCC substrate.
