SANDIA REPORT

SAND2008-5736

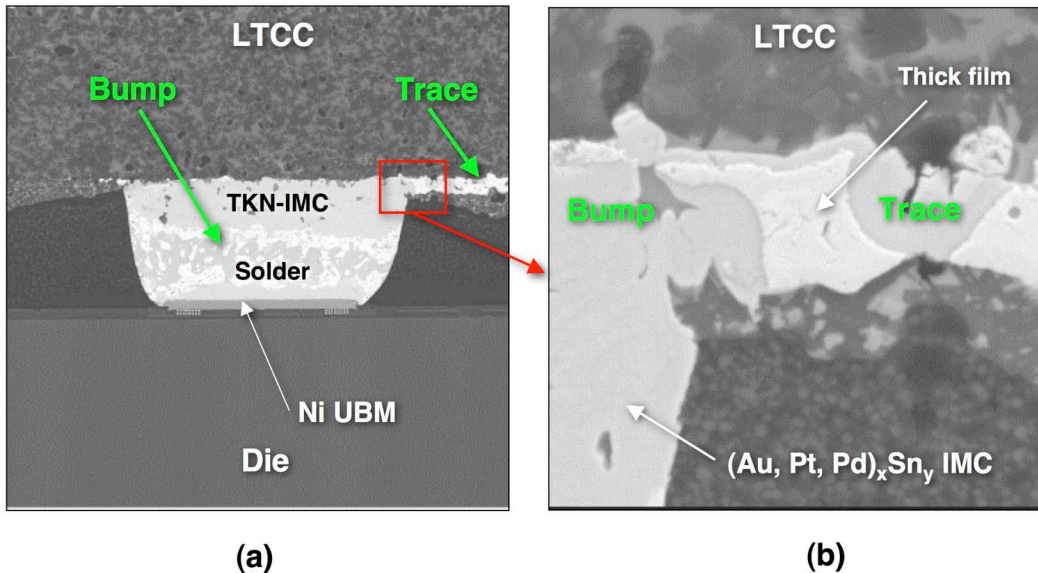
Fig. 78 SEM photographs of a solder joint on U13 (bottom side) of the sub-module SF264 that was exposed to the burn-in conditions of 125°C, 240 hours: (a) low magnification view of the joint and (b) high magnification image of the junction between the pad and the trace showing good integrity there.

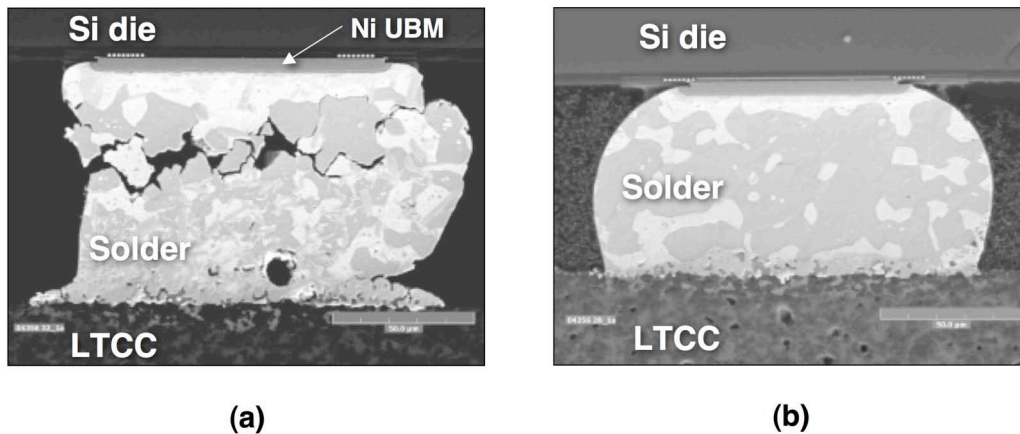
Fig. 79 SEM photographs of solder joints from the test vehicle FCMSIP005 exposed to 2800 thermal cycles (0°C/100°C, 15 min hold times): (a) die without underfill and (b) die with underfill.

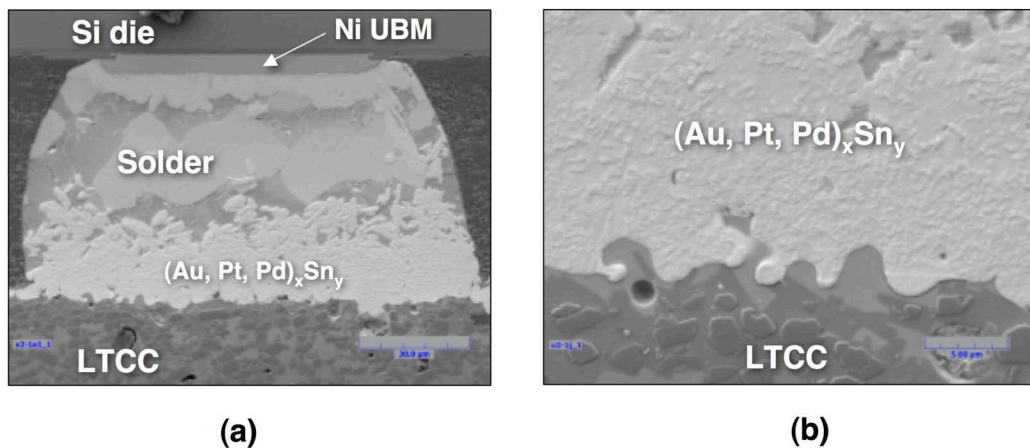
Fig. 80 (a) Low magnification and (b) high magnification SEM photographs of a representative solder joint from the test vehicle SCA075 exposed to 10800 thermal cycles ($0^{\circ}\text{C}/100^{\circ}\text{C}$, 15 min hold times). The die were underfilled after assembly.

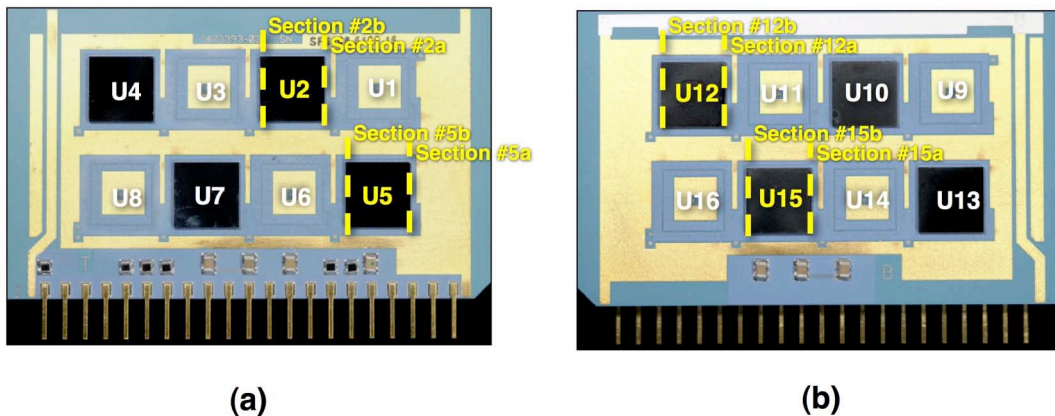
Fig. 81 Photographs of sub-module SF1168 showing (a) the top side and (b) the bottom side after dice were pull tested in the as-fabricated condition. The remaining were used for metallographic cross sections, the positions of which, were denoted by the labels and dashed lines.

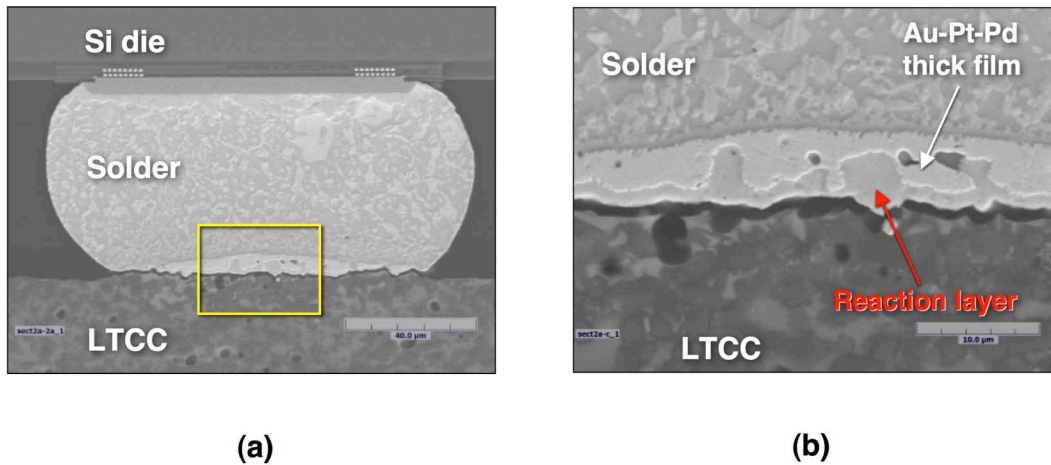
Fig. 82 (a, b) Low and high magnification, SEM photographs showing a solder joint on U02 (top side, section #2) of sub-module SF1168.

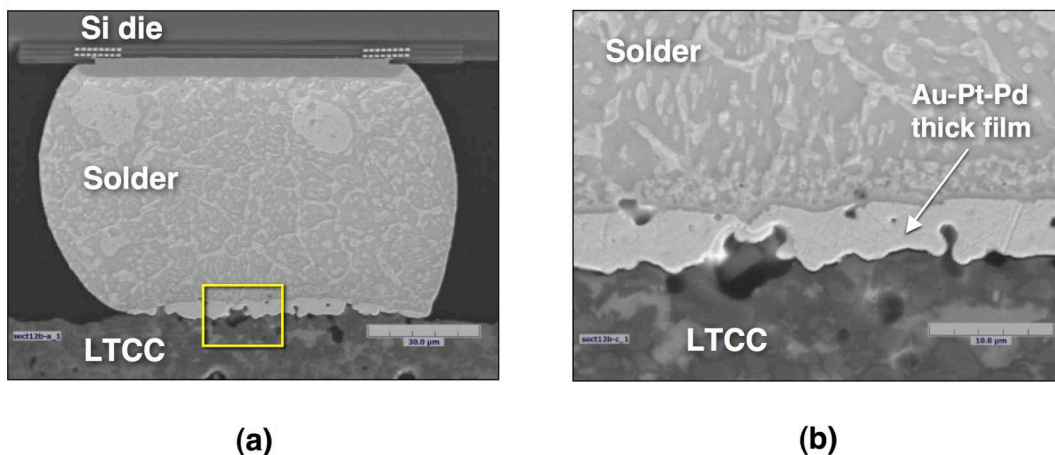
Fig. 83 (a, b) Low and high magnification, SEM photographs showing a solder joint on U12 (bottom side, section #12) of sub-module SF1168, which did not exhibit the reaction layer between the TKN and LTCC nor crack development there.

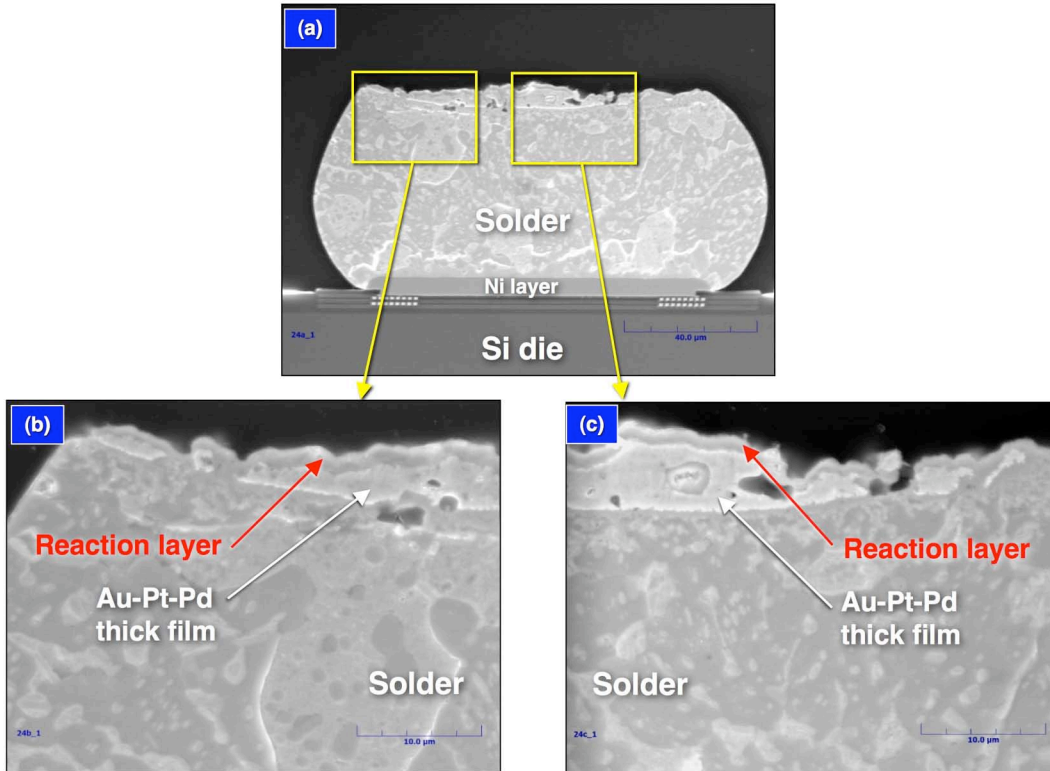
Fig. 84 (a) Low and high magnification, SEM photograph of solder joint #24, die U11 that was pull tested from bottom side of sub-module SF1168. The pull strength of the die was 0.98 lb. (b, c) High magnification images of the TKN/LTCC failure mode, showing the reaction layer that would have be located between the thick film and LTCC substrate.

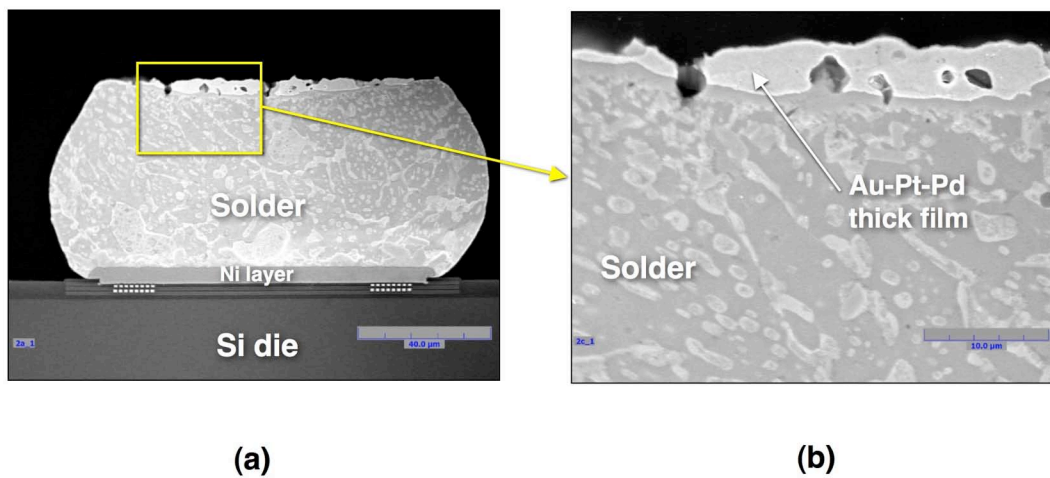
Fig. 85 (a, b) Low and high magnification, SEM photograph of solder joint #2, die U01 that was pull tested from the top side of sub-module SF1155. The pull strength was 7.26 lb.

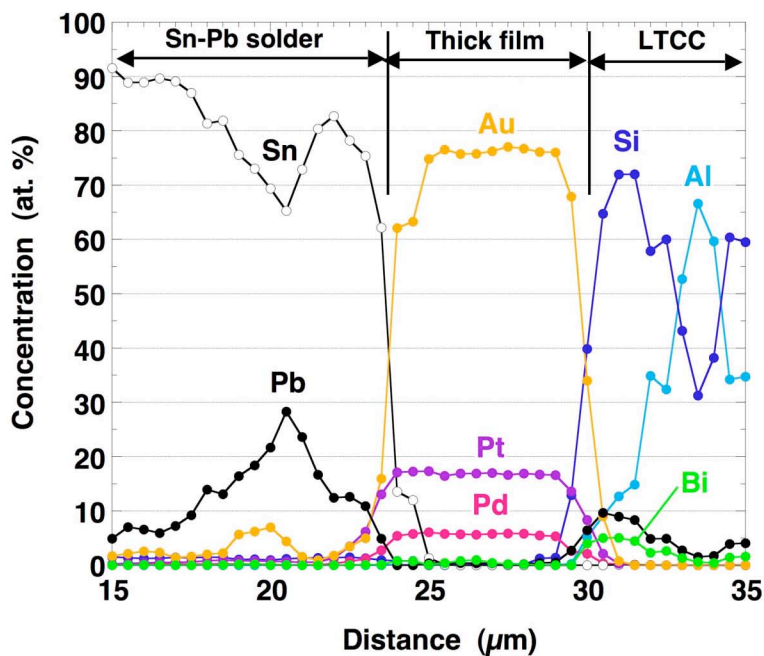
Fig. 86 EPMA trace across the solder joint from the sub-module SF1168 die, which did *not* show the TKN/LTCC interface reaction layer (U02, joint #7, trace 4). This trace served as a baseline case.

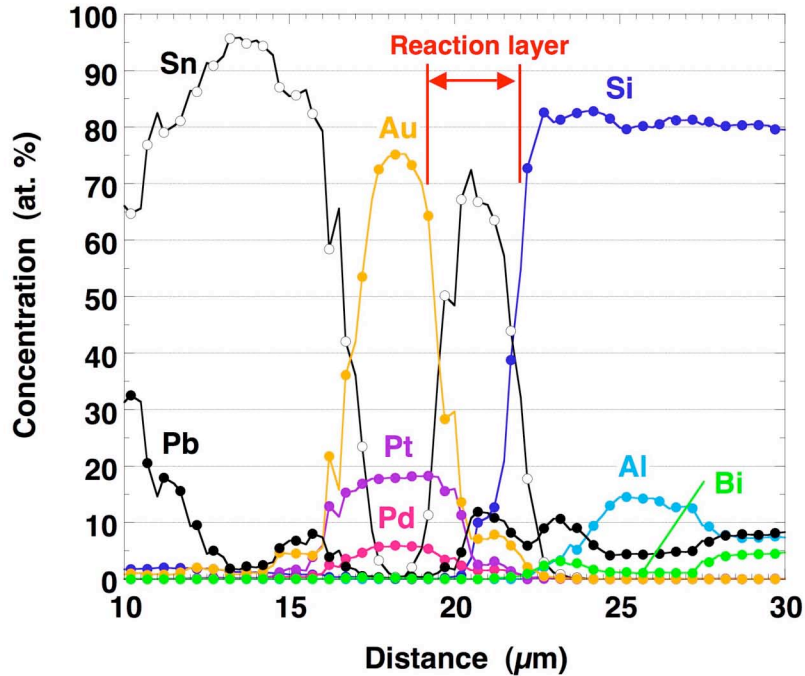
Fig. 88 EPMA trace across the solder joint from the submodule SF1168 die, which did show the reaction layer at the TKN/LTCC interface (U02, joint #3, trace #2). In the case, the reaction layer had a far greater concentration of Sn in that layer.

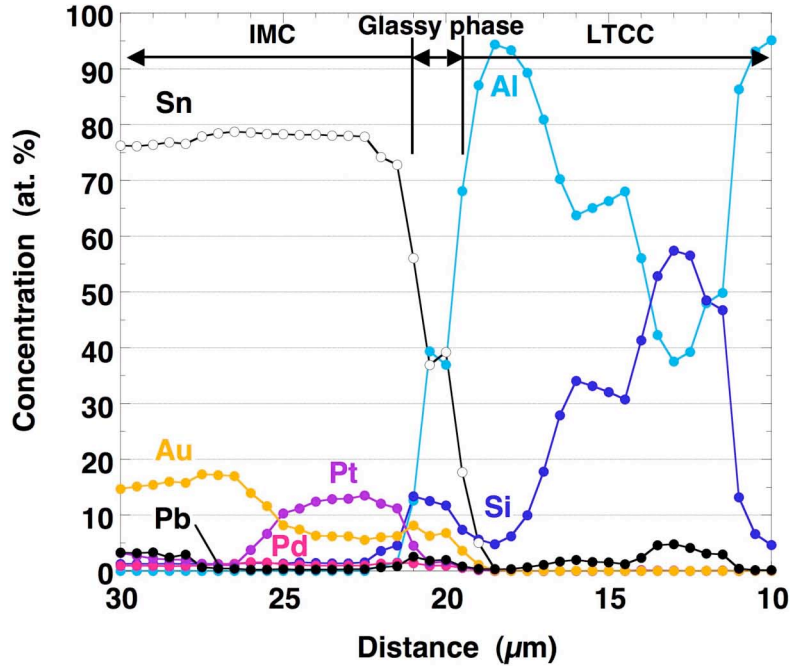
Fig. 89 EPMA trace across the solder joint of a die from the sub-module SCA076 (joint C; Trace 3), which was exposed to 7200 thermal cycles (0°C/100°C). The glassy phase is indicated by the small Si peak.

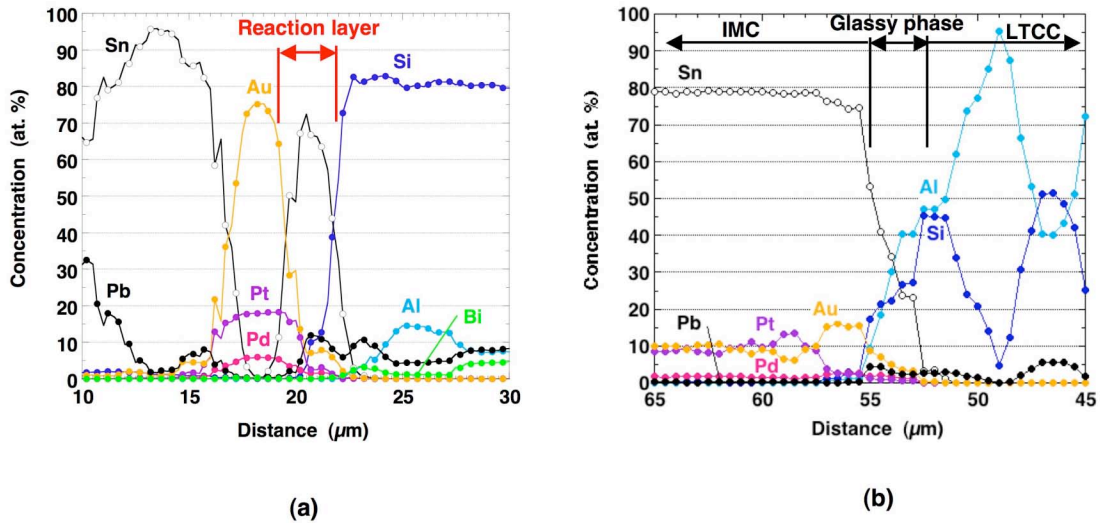
Fig. 90 (a) EPMA trace across the TKN/LTCC interface of a solder joint of a die from the sub-module SF1168 (joint 3; Trace 3) that exhibited the reaction layer. (b) EPMA trace across the IMC/LTCC interface of a solder joint (Die U04, joint 3; Trace 2) of SCA075 was exposed to 10800 thermal cycles ($0^{\circ}\text{C}/100^{\circ}\text{C}$). The TKN was fully consumed by solid-state IMC growth.

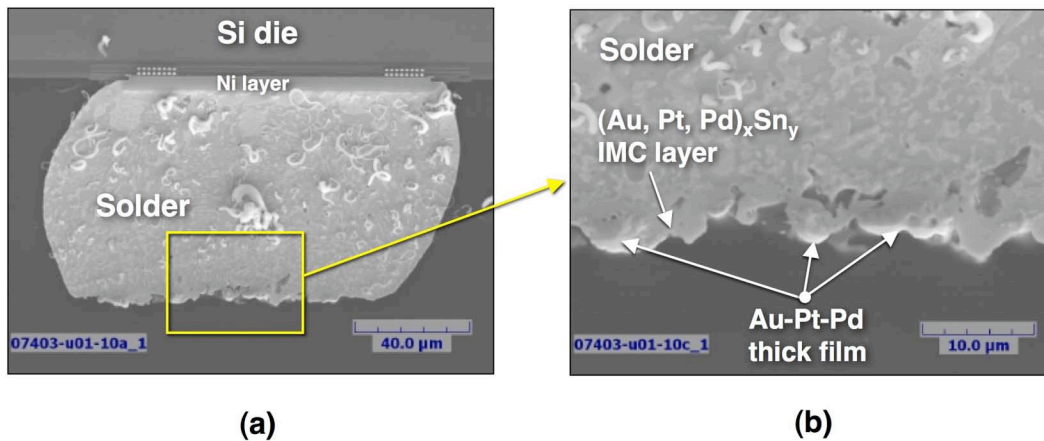
Fig. 91 (a) Low magnification SEM photograph of a solder joint from the U01 pull-tested die of SF1855 (lot #33). The die was located on the top side and represented the as-fabricated condition. (b) High magnification SEM photograph of the solder joint side of, what would have been, the TKN/LTCC interface.

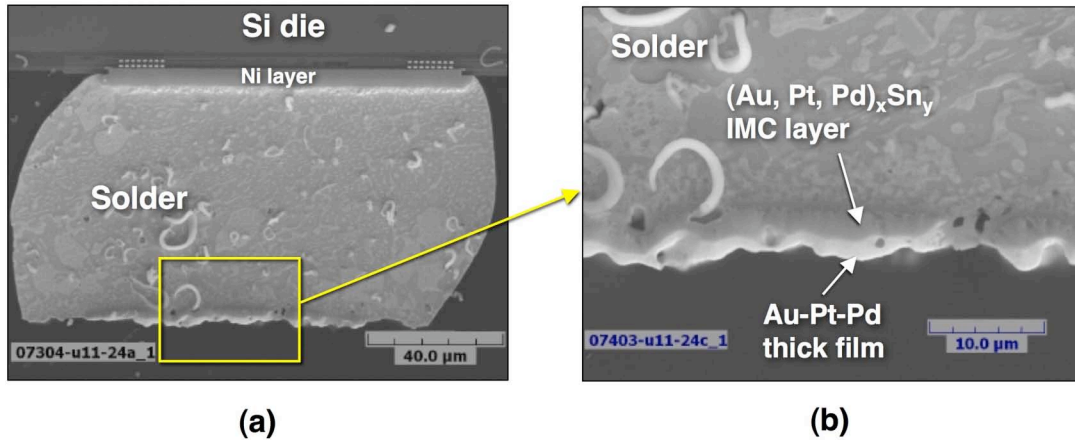
Fig. 92 (a) Low magnification SEM photograph of a solder joint from the U11 pull-tested die of SF1855. The die was located on the bottom side and represented the as-fabricated condition. (b) High magnification SEM photograph of the solder joint side of, what would have been, the TKN/LTCC interface.

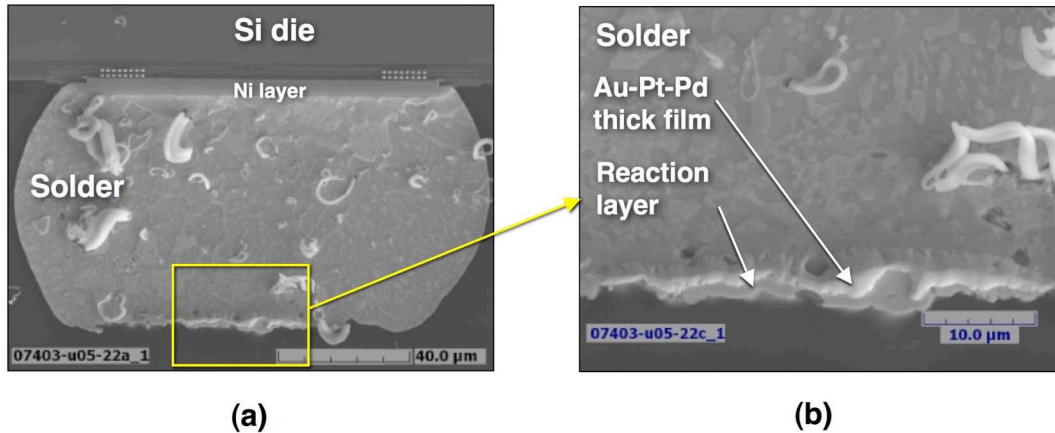
Fig. 93 (a) Low magnification SEM photograph of the solder joint number 11 from the pull-tested die U05 of SF1855. The die was located on the top side and was tested after thermal cycling (20 cycles; -55°C/125°C) condition. The failure mode was TKN/LTCC separation. (b) High magnification image showing that a significant reaction layer that had developed at the TKN/LTCC interface. (c, d) Low and high magnification SEM photographs of the solder joint number 16 (U05) that shows very limited formation of the reaction layer. The failure mode remained that of TKN/LTCC interface separation.

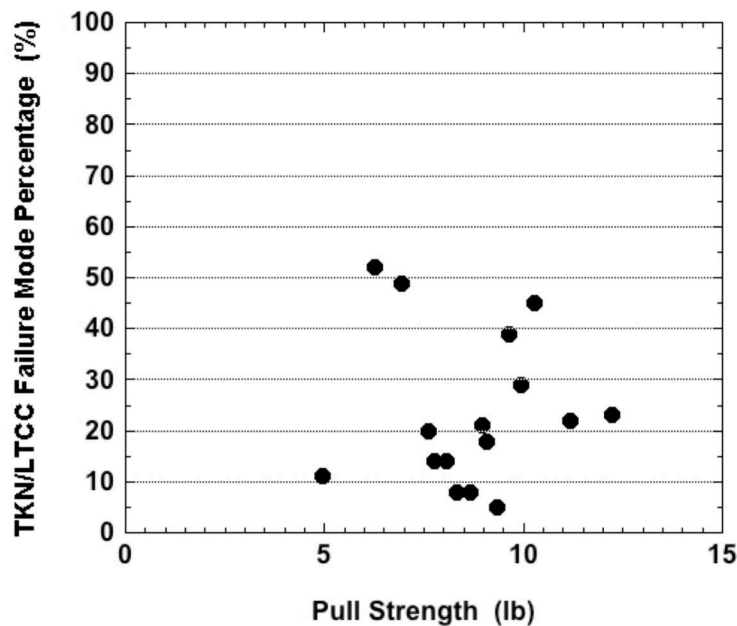
Fig. 94 TKN/LTCC failure mode percentage as a function of pull strength for the sub-modules SN006 and SN008. The data included only the as-fabricated condition.

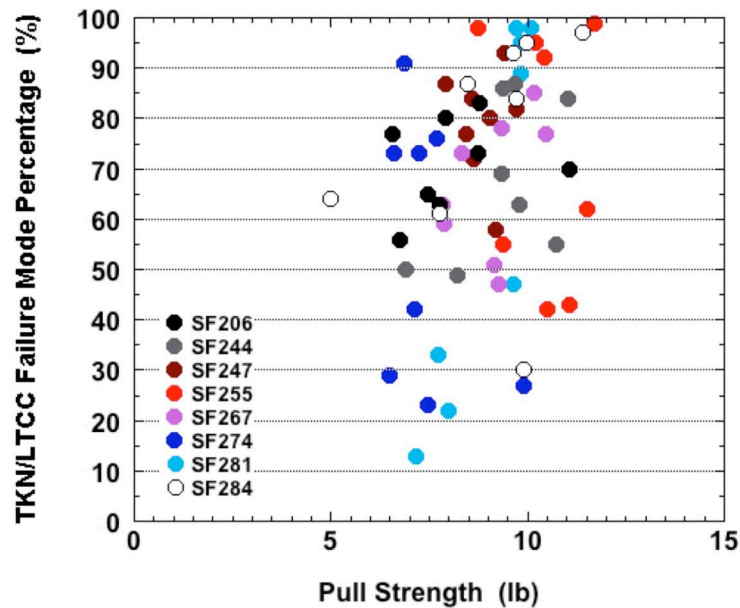
Fig. 95 TKN/LTCC failure mode percentage as a function of pull strength for the sub-modules SF206, SF244, SF247, SF255, SF267, SF274, SF281, and SF284. The data represent the as-fabricated condition.

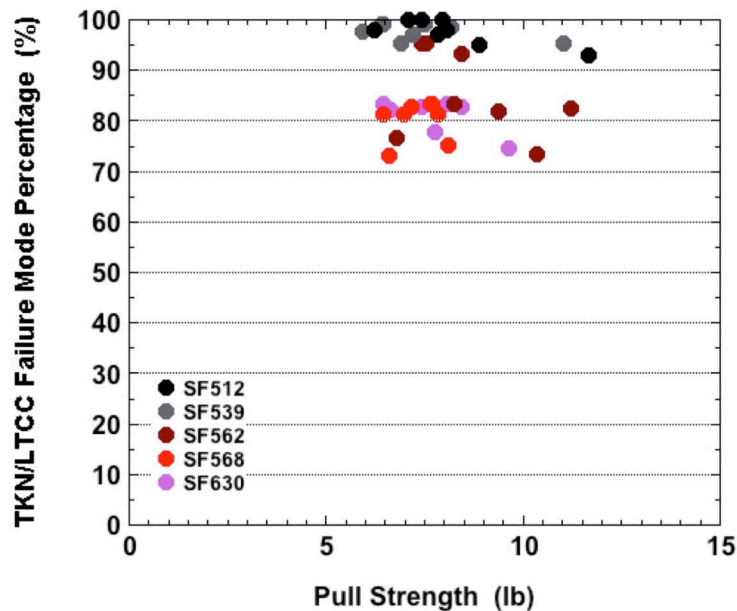
Fig. 96 TKN/LTCC failure mode percentage as a function of pull strength for the sub-modules SF512, SF539, SF562, SF568, and SF630 representing the as-fabricated condition.

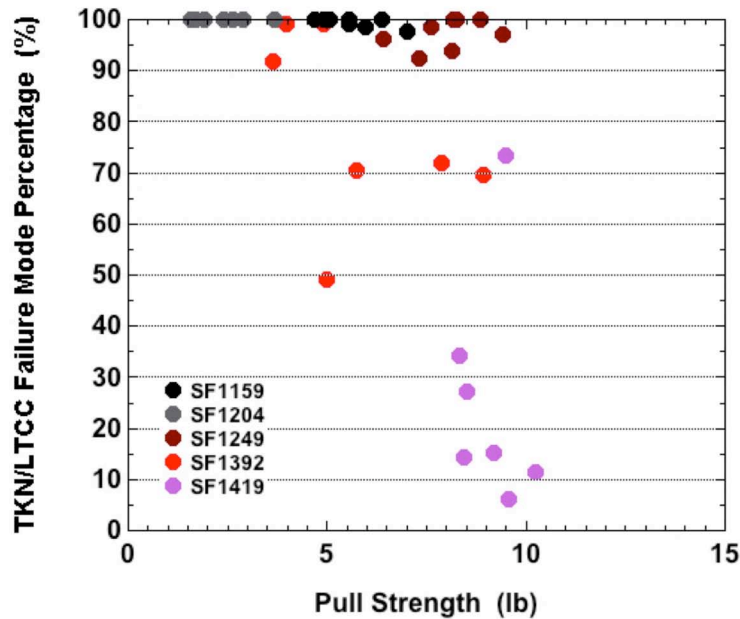
Fig. 97 TKN/LTCC failure mode percentage as a function of pull strength for the sub-modules SF1159, SF1204, SF1249, SF1392, and SF1419 representing the as-fabricated condition.

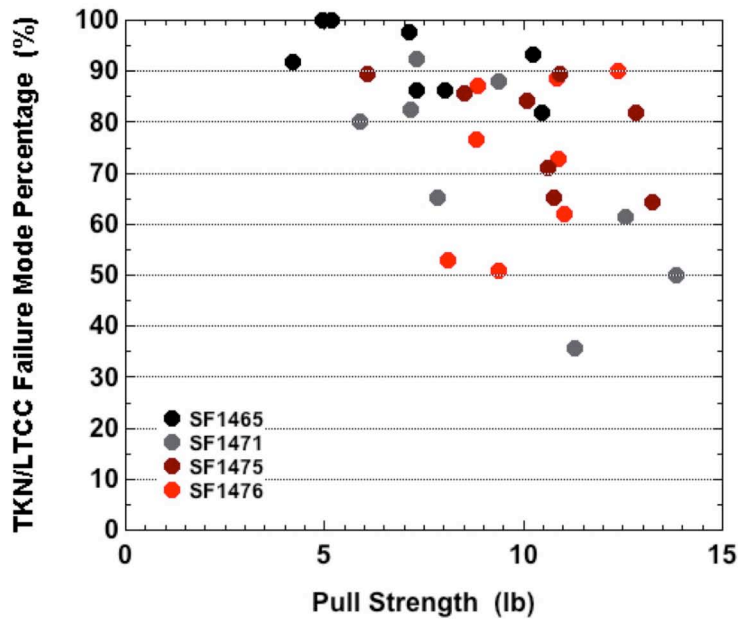
Fig. 98 TKN/LTCC failure mode percentage as a function of pull strength for the sub-modules SF1465, SF1471, SF1475, and SF1476 representing the as-fabricated condition.

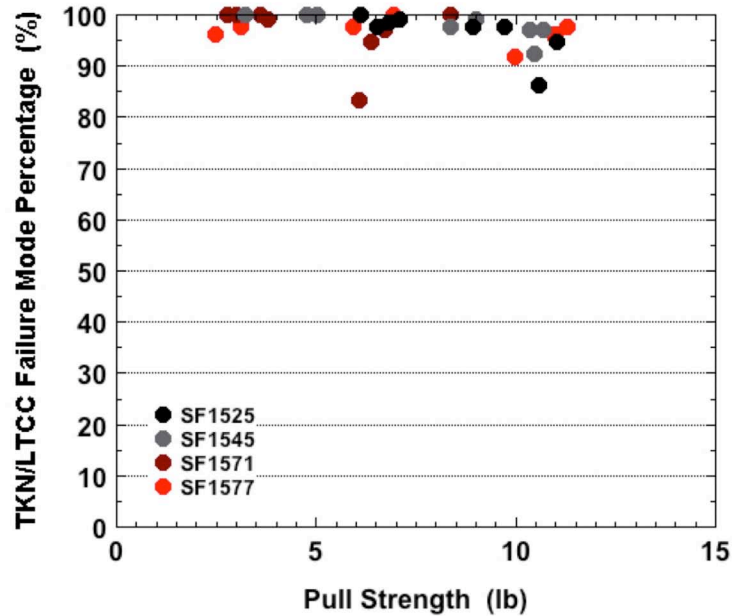
Fig. 99 TKN/LTCC failure mode percentage as a function of pull strength for the sub-modules SF1525, SF1545, SF1571, and SF1577 representing the as-fabricated condition.

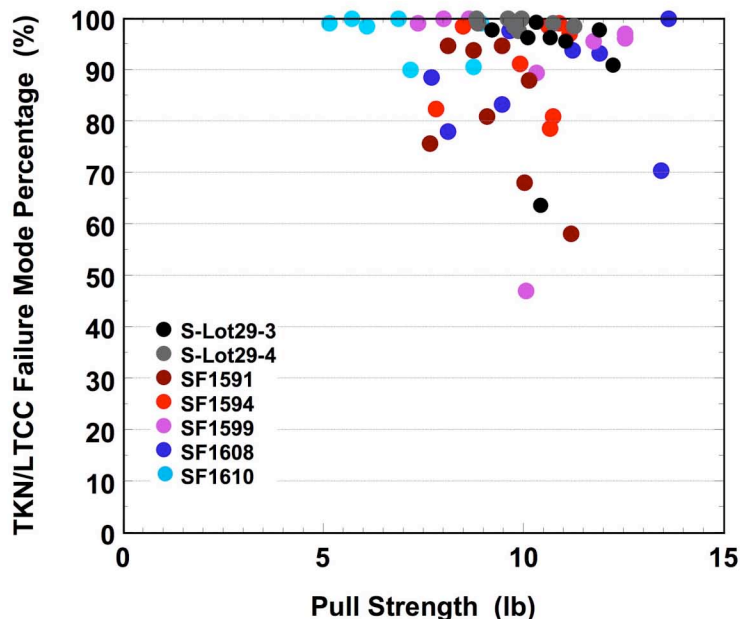
Fig. 100 TKN/LTCC failure mode percentage as a function of pull strength for the sub-modules S-Lot29-X (X=3 and 4) representing a build of sub-floors that were the precursor to lot #29 and SF1591, SF1594, SF1599, SF1608, and SF1610. All data pertain to the as-fabricated condition.

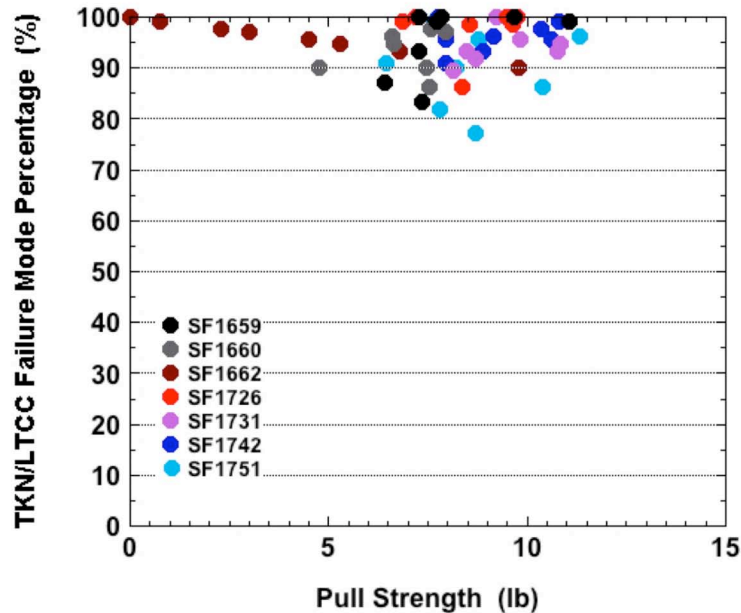
Fig. 101 TKN/LTCC failure mode percentage as a function of pull strength for the sub-modules from lots #30 (SF1659, SF1660, and SF1662) and #31 (SF1726, SF1731, SF1742, and SF1751). All data pertain to the as-fabricated condition.

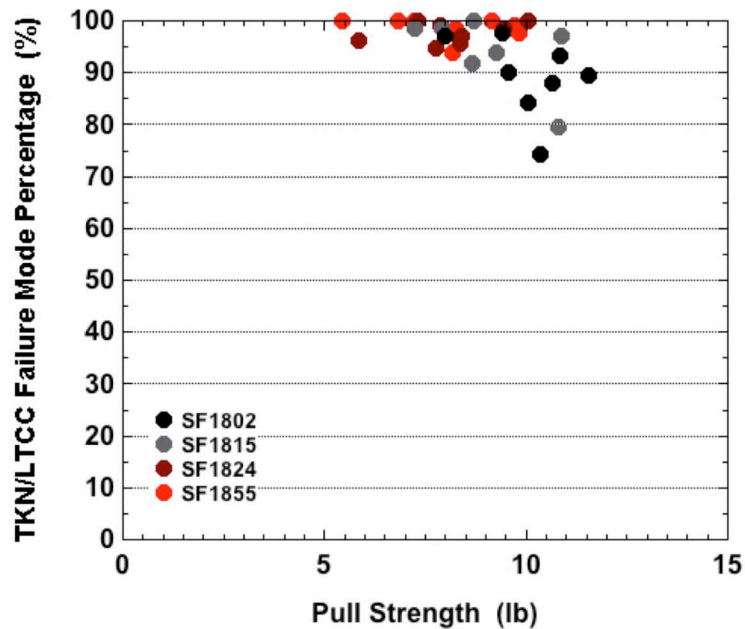
Fig. 102 TKN/LTCC failure mode percentage as a function of pull strength for the sub-modules from lots #32 (SF1802 and SF1815) and #33 (SF1824 and SF1855). All data pertain to the as-fabricated condition.
