RADIATION EFFECTS ON EPOXY/CARBON-FIBER COMPOSITE

E.N. Hoffman, T.E. Skidmore

Savannah River National Laboratory: SRS Road 1, Aiken, SC, 29808, Elizabeth.Hoffman@srnl.doe.gov

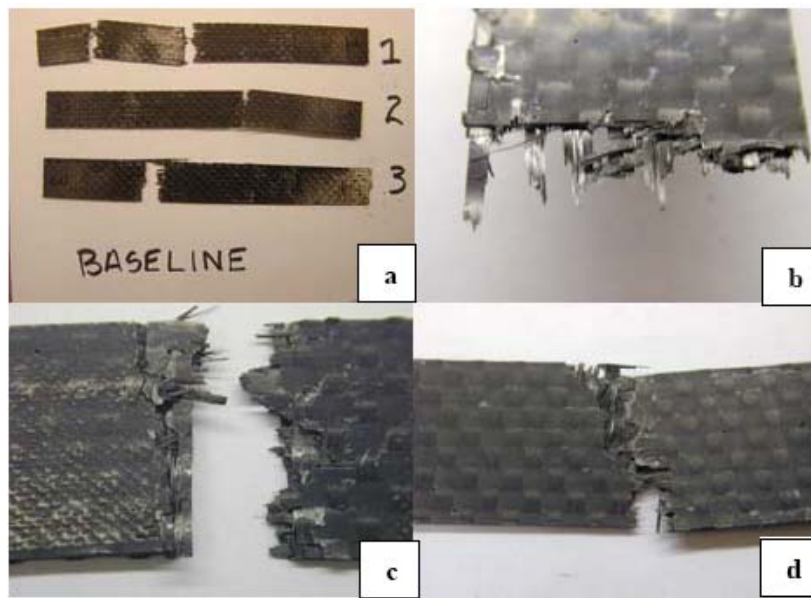
Figure 2

Photographs of the fracture surfaces of the tensile bars are shown in Figures 2-5. The tensile bars before exposure to radiation were shades of gray in color with some lighter patches most likely due to the presence of excess cured resin as shown in Fig. 2a. The baseline tensile samples fractured approximately perpendicular to the length of the tensile bar. Further visual examination revealed visible protruding fibers as shown in Figs. 2b, c and d. Minimal evidence of delamination between the resin and carbon fibers is visible.

Figure 2. Baseline fracture tensile test bars (a), fractured surface with protruding carbon fibers (b) and (c), minimal evidence of delamination are visible adjacent to the fracture region (d).

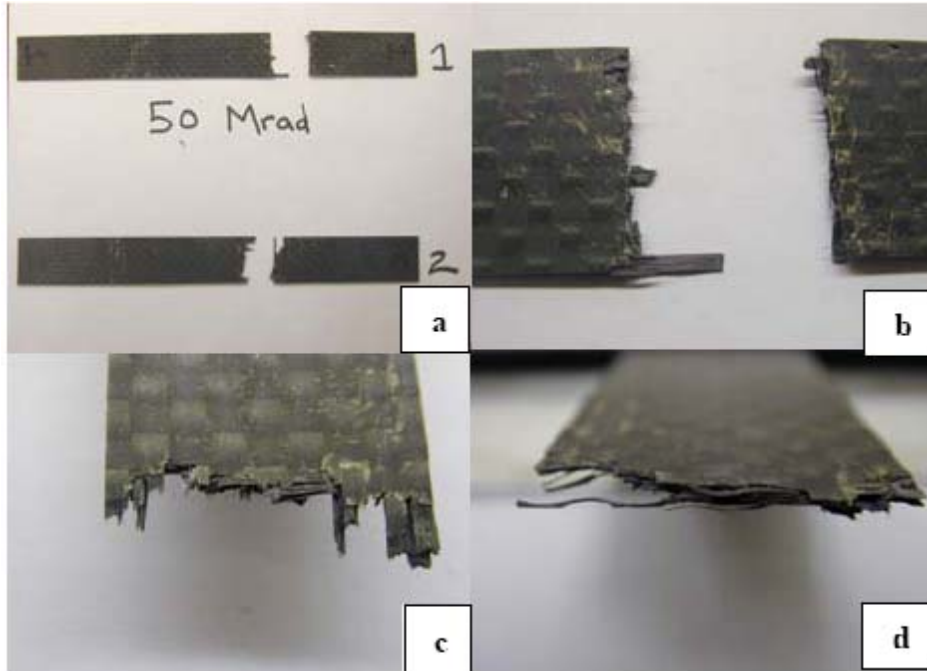
The resin underwent a color change from clear/transparent to light yellow after exposure to a gamma radiation dose of 5.0 MGy, typical of polymers exposed to gamma irradiation, Fig. 3. [12] The fractures were nominally perpendicular to the tensile stress (length of the bar). Visual examination revealed that damage due to fracture was primarily limited to the fracture area. **Similar to Fig. 2, protruding fibers were found at the minimal delamination or other damage exists was found outside the fracture area.**

Figure 3 Fractured tensile test bars after 5.0×10^5 Gy (a), fractured surface with protruding carbon fibers with slight evidence of delamination on the surface of adjacent area to the fractures surface (b), minimal evidence of delamination (c). The resin has developed a slight yellow color visible in delamination areas (d).

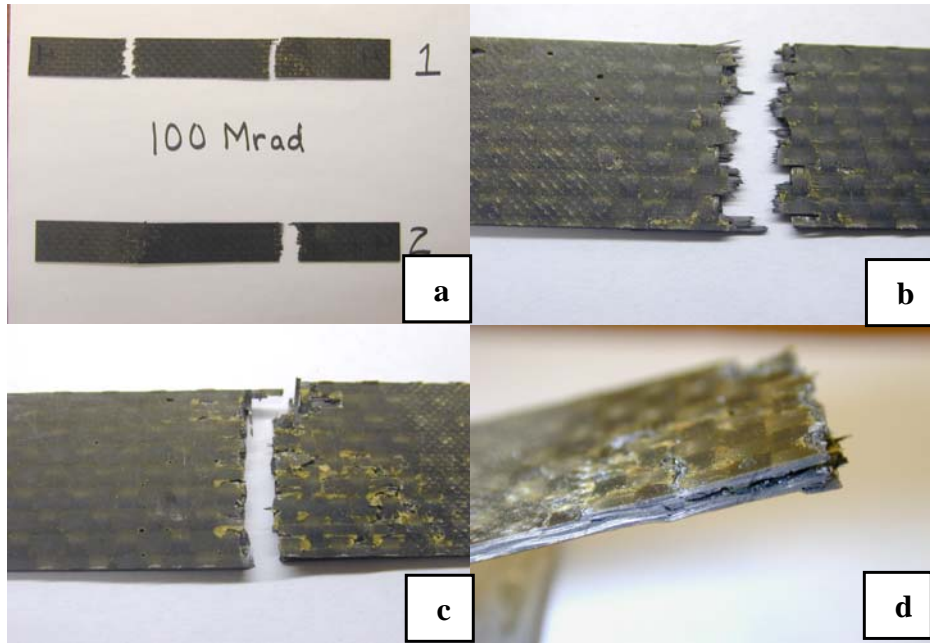
The resin showed an increased color change with a visibly darkened yellow color, after exposure to total 1.0 MGy gamma dose as shown in Figure 4. The tensile bars fractured with visible damage primarily contained within the fracture area as shown in Figure 4a. Similar to the baseline and 5.0 MGy samples, protruding fibers are visible at the fracture site shown in Figs. 4 b and c. Visible delamination exists at the fracture site, with minimal damage extending beyond the fracture area as shown in Figure 4d.

Figure 4 Fractured tensile test bars exposed to 1.0×10^6 Gy (a), fractured surface with minimal protruding carbon fibers (b), increased surface delamination adjacent to the fracture area with a darker yellow color (c), increased delamination along the length of the bar (d).

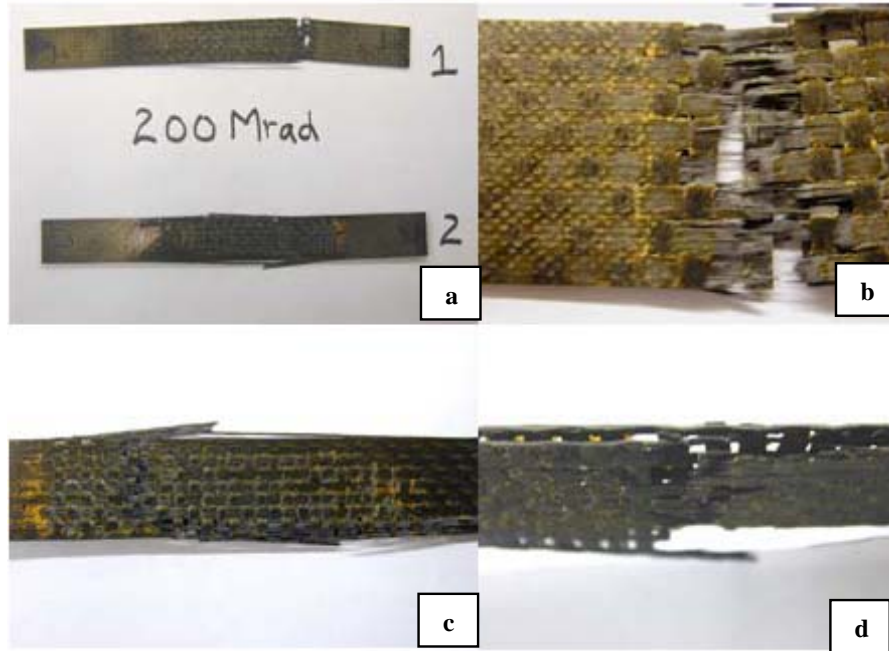
At the higher dose of 2.0 MGy, the resin underwent a significant color change with a visible dark yellow color as shown in Figure 5. Damage extends along the length of the tensile bar and is not confined to the fracture site, Figure 5a. In addition to color changes, pockets of resin are missing at the interface between carbon fiber woven points, Figure 5b. This damage extends several centimeters from the fracture site down the length of the tensile sample. Noticeable volume of resin is also absent from the interior of the tensile bars, Figure 5d.

Figure 5 Fractured tensile test bars exposed to 2.0×10^6 Gy (a), fractured surface with protruding carbon fibers and a visible deep yellow color (b), void formation is visible at the adjacent to the fracture surface (c), significant delamination throughout the core of the bar (d).

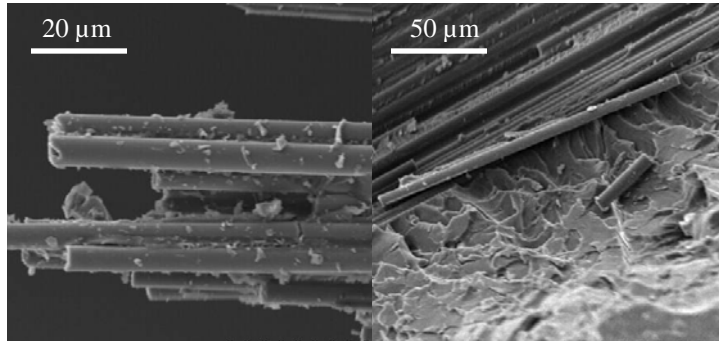
Scanning electron micrographs of the fracture surfaces of the tensile bars are shown in Figures 6-10. The virgin composite exhibited significant amounts of interfacial failure. Fiber pullout found in the baseline samples contained minimal polymer debris, Figure 6, suggesting failure at the interface of the fibers and the epoxy. The epoxy matrix exhibited a dimpled fracture surface suggestive of ductile fracture.

Figure 6 Baseline tensile bar with carbon fibers with small amount of resin debris (left), fractured resin surface at failure site. Fractured surface contains evidence of fracture with a significant degree of ductility (right).

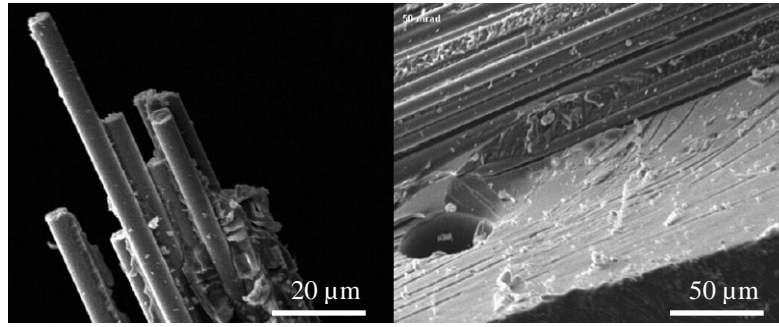
Figure 7

After 0.5 MGy of gamma radiation, minimal debris on fibers suggest interfacial failure as the primary failure mechanism, however, the fracture mode of the epoxy has undergone a transformation to a more brittle fracture, evidenced by the facets on the fracture surfaces as shown in Figure 7.

Figure 7. Tensile bar subjected to 5.0×10^5 Gy gamma radiation with carbon fibers with small amount of resin debris (left), fractured resin surface at failure site. Fractured surface suggests a fracture with a smaller degree of ductility compared to baseline samples shown in Figure 5 (right).

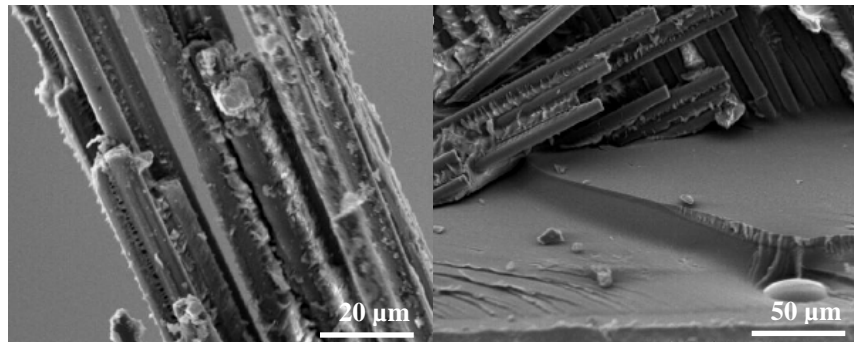
Figure 8

At radiation doses of 1.0 MGy, Figure 8, significant amounts of polymer debris are present on the carbon fibers, with limited evidence of interfacial failure. The primary failure mechanism is through the epoxy rather than along the interface of the carbon fibers and epoxy. The fracture surface of the epoxy is increasingly brittle in nature.

Figure 8. Tensile bar subjected to 1.0×10^6 Gy gamma radiation with carbon fibers coated with substantial amount of resin (left). The fracture surface of the resin is mostly brittle in nature (right).

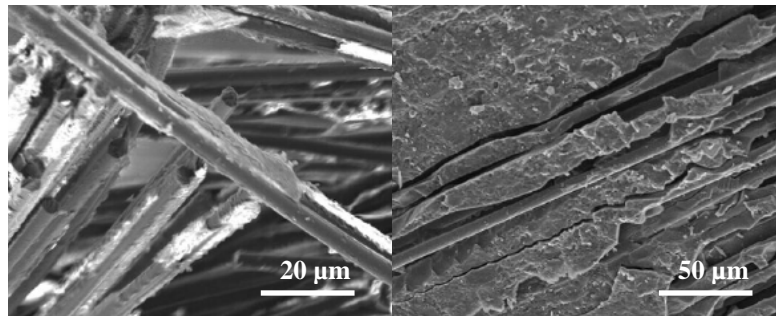
Figure 9

At radiation doses of 2.0 MGy, the integrity of the composite is substantially diminished. Significant epoxy debris remains on carbon fibers and numerous cracks run through the epoxy core, Figure 9.

Figure 9. Tensile bar subjected to 2.0×10^6 Gy gamma radiation with carbon fibers coated with substantial amount of resin (left). Numerous fractures are present within the resin parallel to the length of the fibers (right).

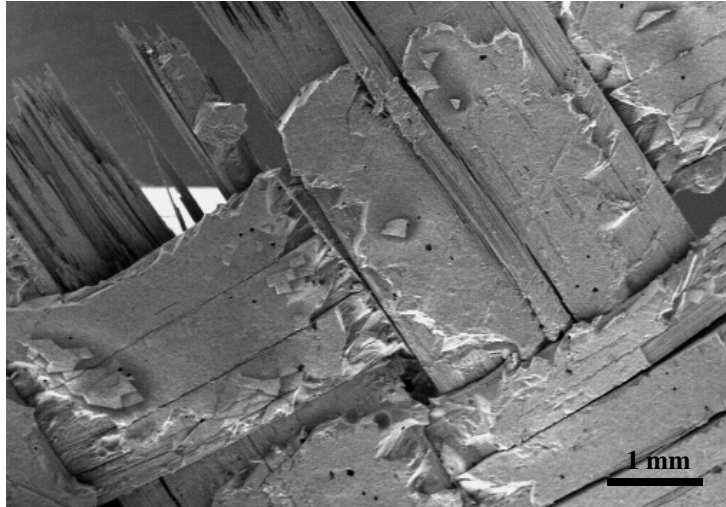
As further evidence of increased degradation after a 2.0 MGy gamma irradiation, several bulges covered in cracks have formed on the irradiated sample. These are possibly due to the release of gases from the epoxy upon radiation decomposition or a post-cure phenomenon. Off-gassing of polymers during radiation exposure is expected. Additional images of radiation damage are shown in Figure 10, depicting the macroscopic disconnect between sections of epoxy on the carbon fiber weave. Macrocracks form at the interface of carbon fiber bundles as well as along the length of the carbon fiber bundles. The crack formation suggests the epoxy has lost significant reinforcing properties.

Figure 10 Epoxy surface on tensile bar subjected to 2.0×10^6 Gy gamma radiation
