SANDIA REPORT

SAND2010-5229
Unclassified Unlimited Release
Printed August 2010

2009 Antarctica X-Band MiniSAR Crevasse Detection Radar: Final Report

This document includes discussion of the hardware development, system capabilities, and results from data collections in Antarctica during the fall of 2009.

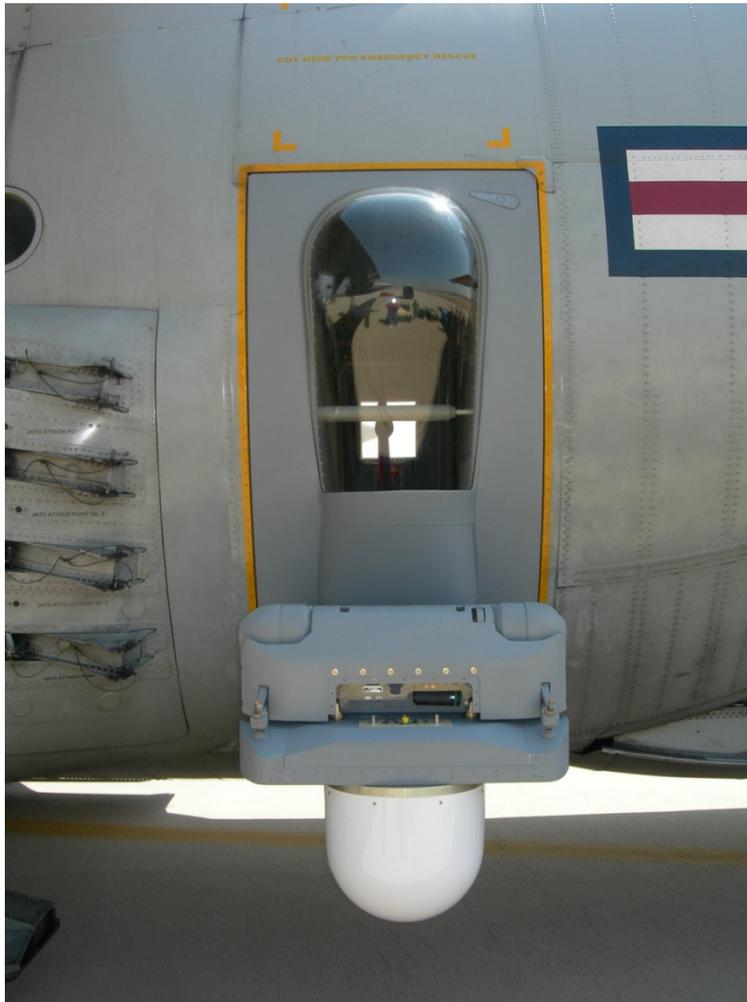
The antenna and radome assembly for this phase of the Crevasse Detection Radar (CDR) project were mounted on a sabir arm which in turn attaches to the door near the aft of the LC130. The arm was developed by Airdyne Corporation, and a picture of the arm and antenna assembly are shown in the following figure. The arm is lowered for imaging, and raised for landing.

Figure 1: Arm with mounted CDR antenna/radome assembly on side of LC130

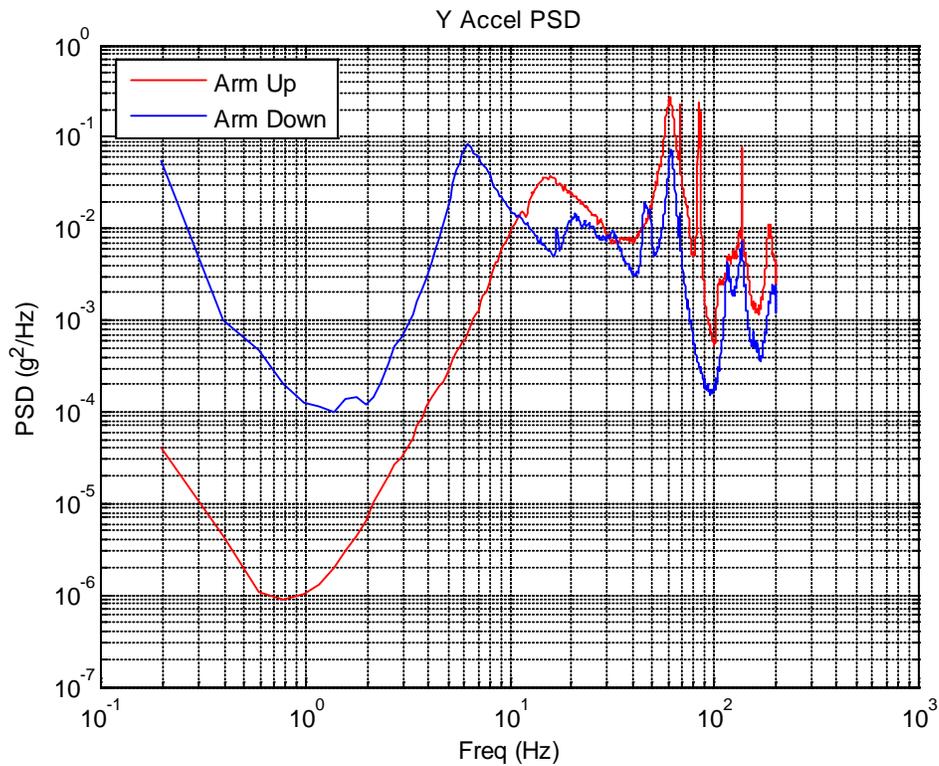
A power spectral density plot of the y-acceleration (horizontal, towards/away from plane) from accelerometer measurements is shown in the figure below. The plots were taken from data recorded during the 08Nov2009 flights in Antarctica. The plots show with arm deployed (down) and with it up. The peak vibration appears to be around 6 Hz, with the arm deployed.

Figure 2: Y-acceleration PSD plot showing arm vibration

The arm does introduce unwanted vibration into the radar assembly; however, testing showed that the motion measurement system was able to provide the information necessary to remove the vibration during processing. The CDR impulse responses for corner reflectors did not show any ill-effects. The vibration was visible from the door window and from an internally mounted camera. The vibration seemed to increase in amplitude with increasing aircraft speed.

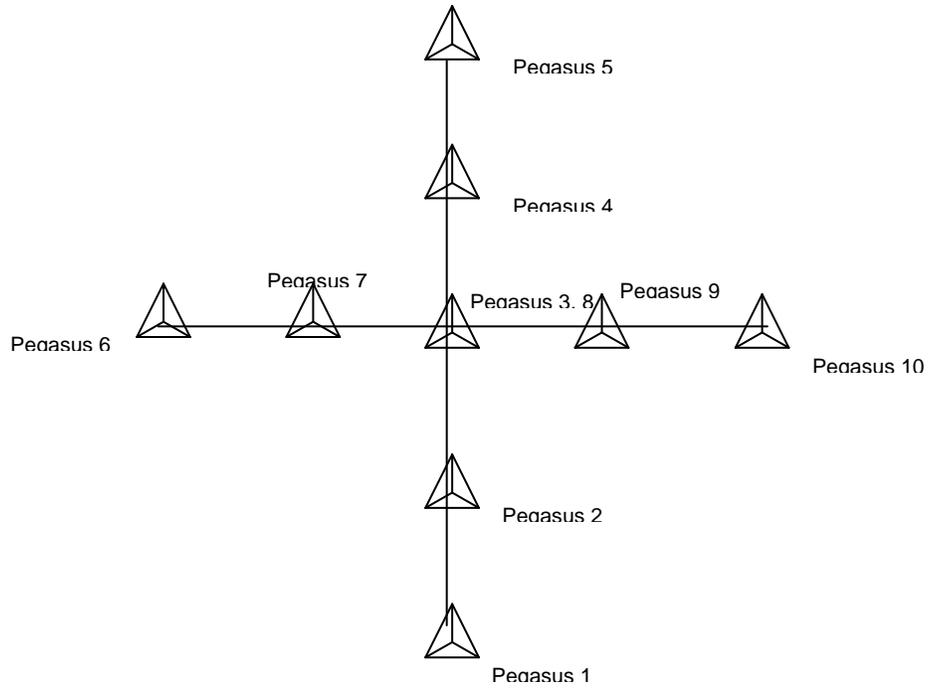
Figure 1: Approximate Layout of Pegasus Wreck Site Imaged October 30, 2009

The October 30, 2009, Pegasus flight is somewhat of a repeat from [1]. The main purpose was to make sure that the radar was working properly after shipping, and installation. A radar reflector array was set out as shown in Figure 1. Figure 2 shows a photograph of the area. Figure 3 shows a radar image of the area. Drifting snow and ice dampened the response of some of the reflectors. Figure 4 shows that snow accumulated in the reflectors during a storm that hit between the time the reflectors were put out and the time that the radar was flown. Not all reflectors were as full of snow as shown in this figure.

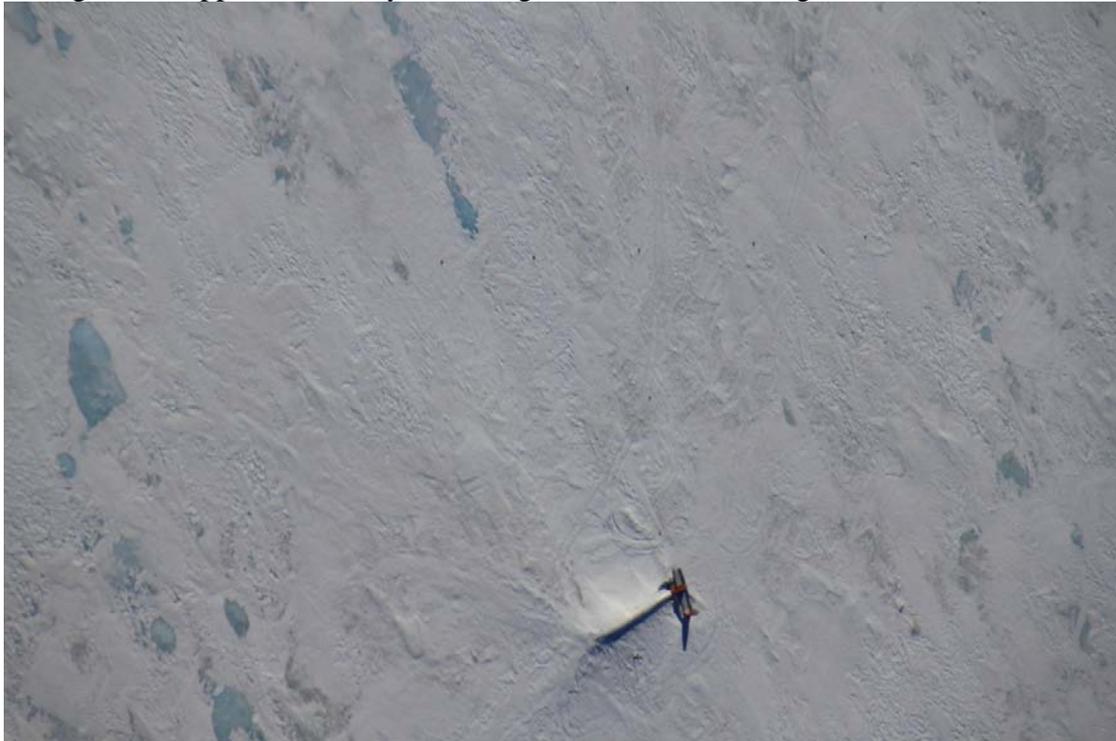
Figure 2a: Aerial photo of Pegasus wreck site with radar reflectors visible (courtesy Ross Neyedly)

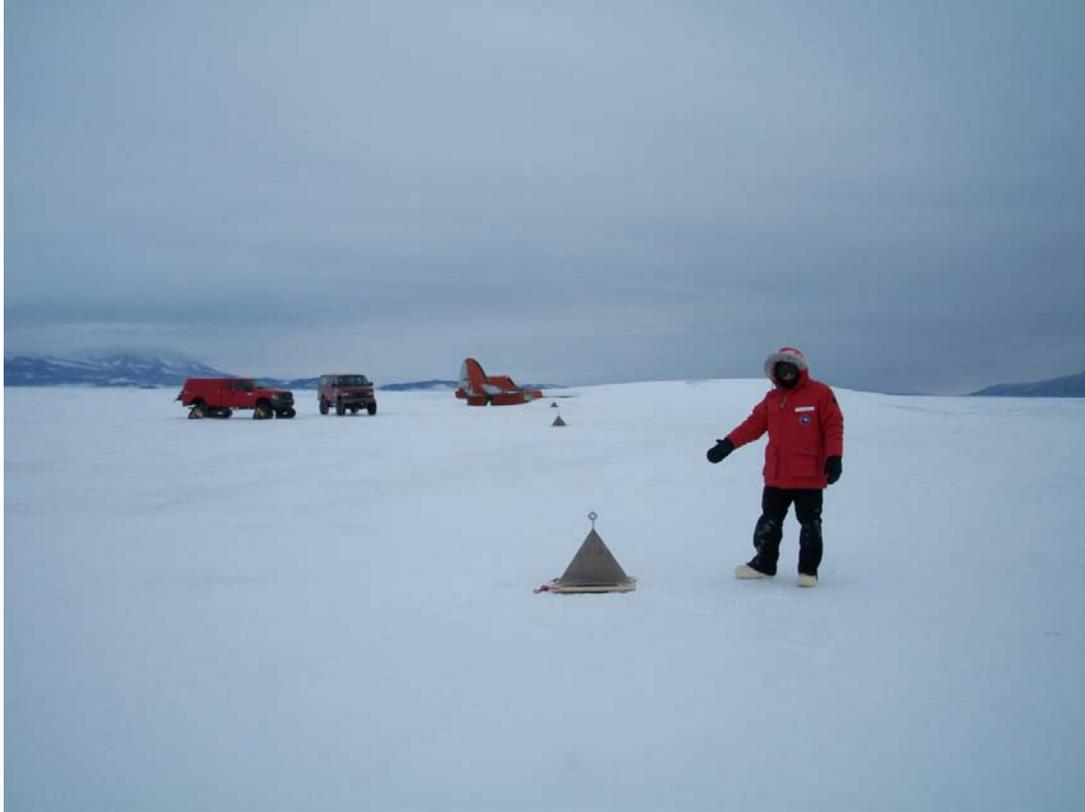
Figure2b: Portion of the radar array being setup

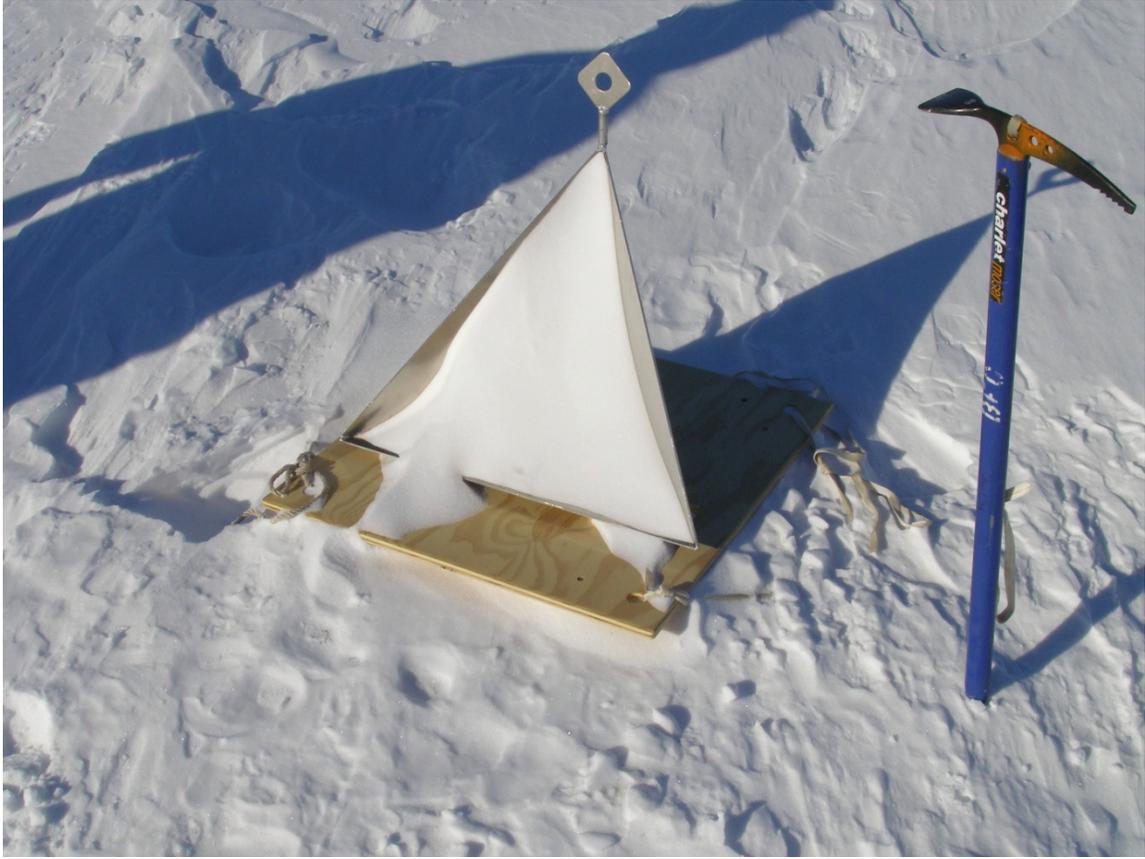
Figure 4: Photograph of radar reflector at Pegasus drifted full of snow

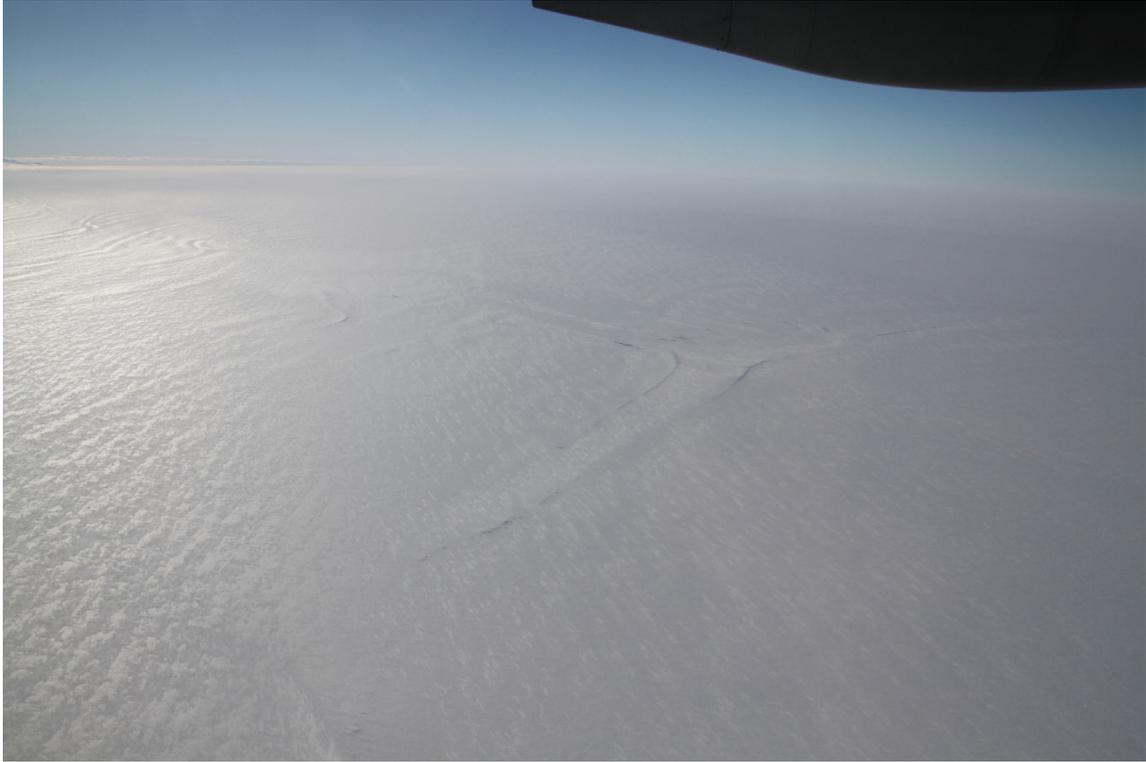
Figure 6: Photograph taken of the Shear Zone Tres Hermanas site (courtesy of Ross Neyedly)

A photograph of the area from taken from the LC-130 is shown in Figure 6.

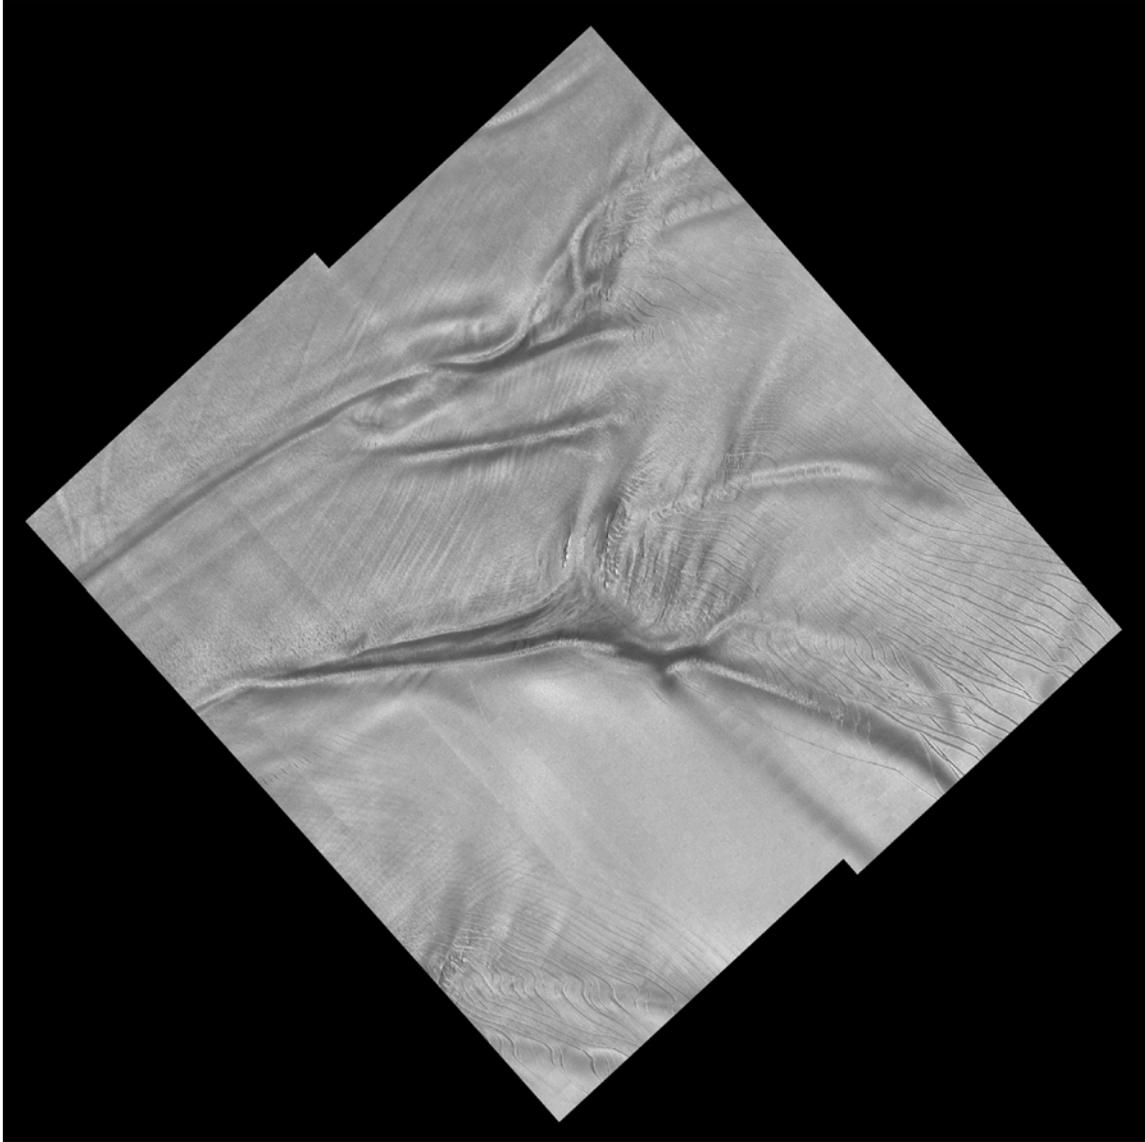
Figure 7: SNL SAR Mosaic of 1 foot resolution SAR imagery of the Shear Zone at the Tres Hermanas site on October 31, 2009.

On October 31, 2009, the 5 nmi by 5 nmi Tres Hermanas area was remapped as a repeat of the mapping performed in [1]. This was to validate that we were still observing the crevasses that we had observed in 2006. Note that the Tres Hermanas site is in the Shear Zone. This area has glacial ice moving up to 3 ft. per day. The area moved significantly in the 3 years between imaging, although we attempted to map the same coordinates as in 2006. The 3 crevasses we nicknamed the “tres hermanas” were still visible in 2009.

Figure 7 shows the mosaic of the Tres Hermanas site mapped during the 2009 collect.

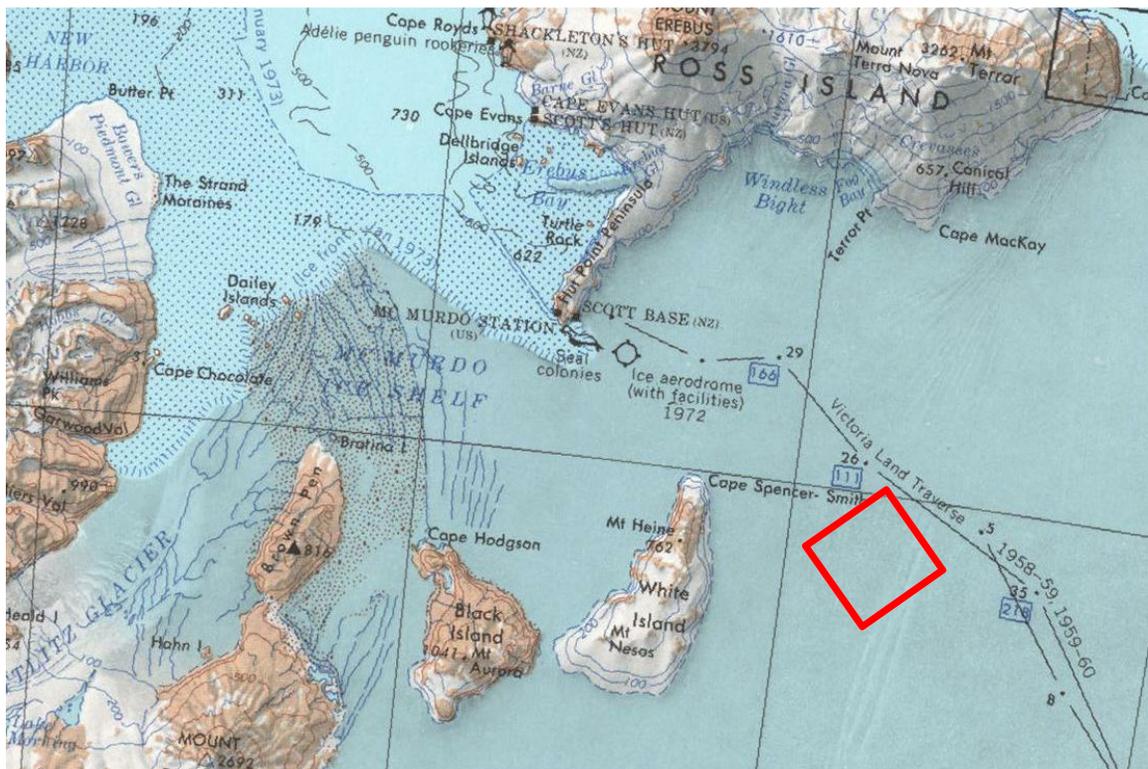
Figure 8: Approximate Location of 5 nmi by 5 nmi Area Imaged during South Pole Traverse Collect on Dec. 6, 2006 and again on November 3, 2009.

On November 3 2009, the 5 nmi by 5 nmi Shear-Zone along the South Pole Traverse area was remapped as a repeat of the mapping performed in [1]. Figure 8, is repeated from [1], and shows the approximate area that was mapped again in 2009. When we got down to Antarctica, we found that the South Pole Traverse route had been re-instituted. Crevasses on the South Pole Traverse site had been well mapped by Raytheon Polar Services. Walter Hallman and Mark Armstrong worked with Raytheon Polar Services to identify small crevasses (12” to 18” wide) to see if we could detect these with the radar. They also worked with the mountaineer staff to place radar reflectors near and inside of

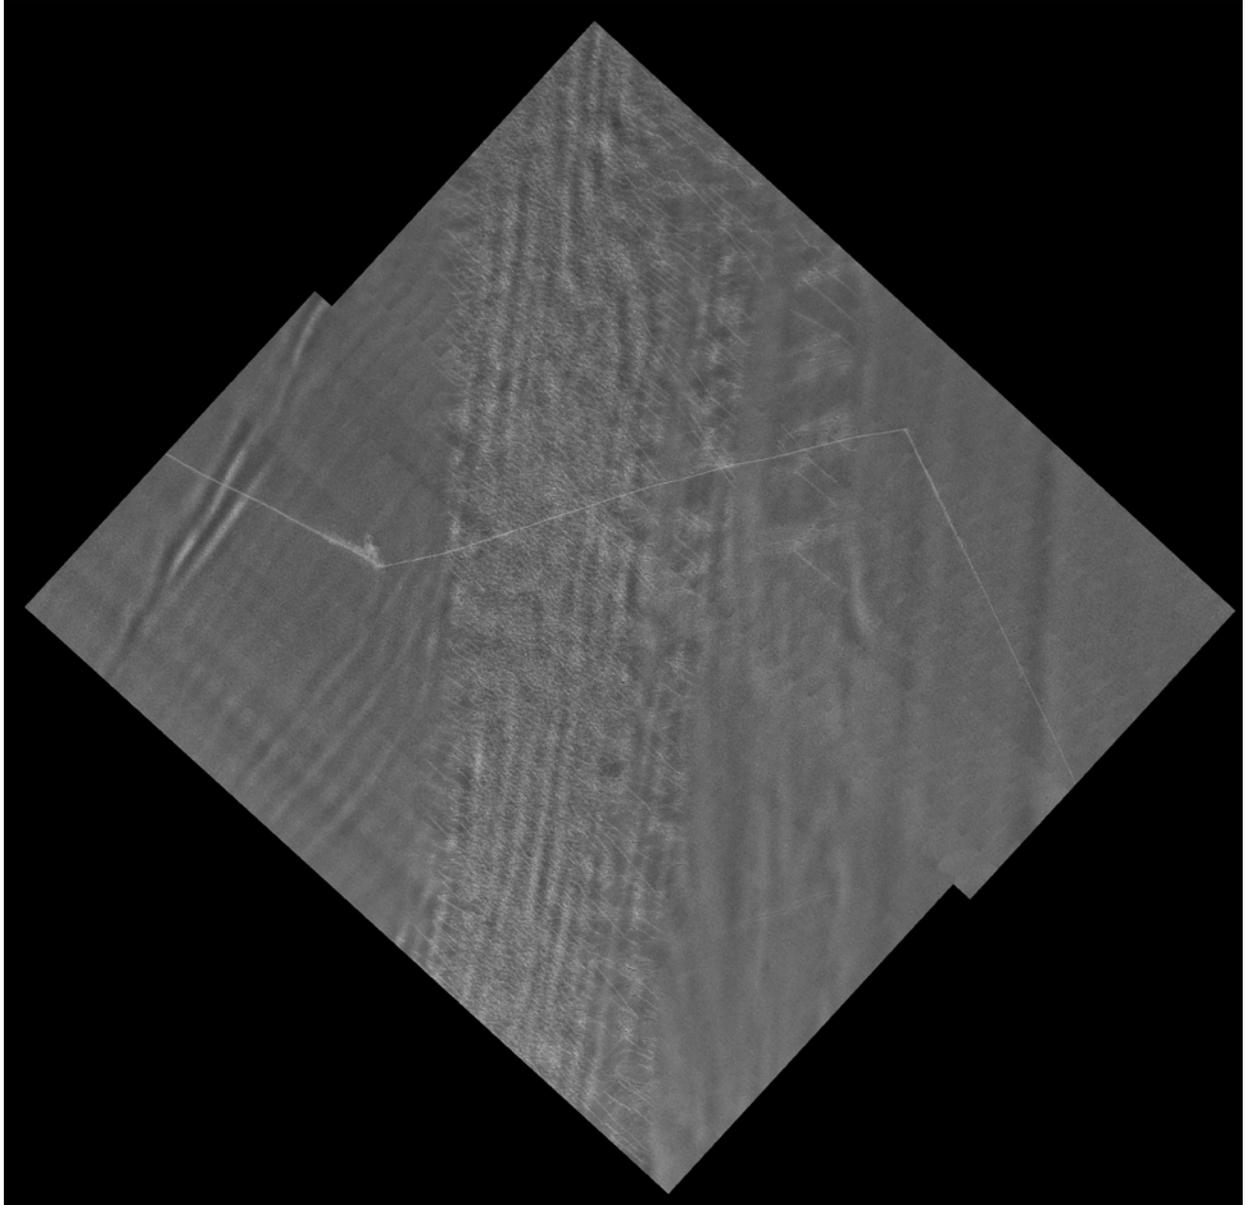
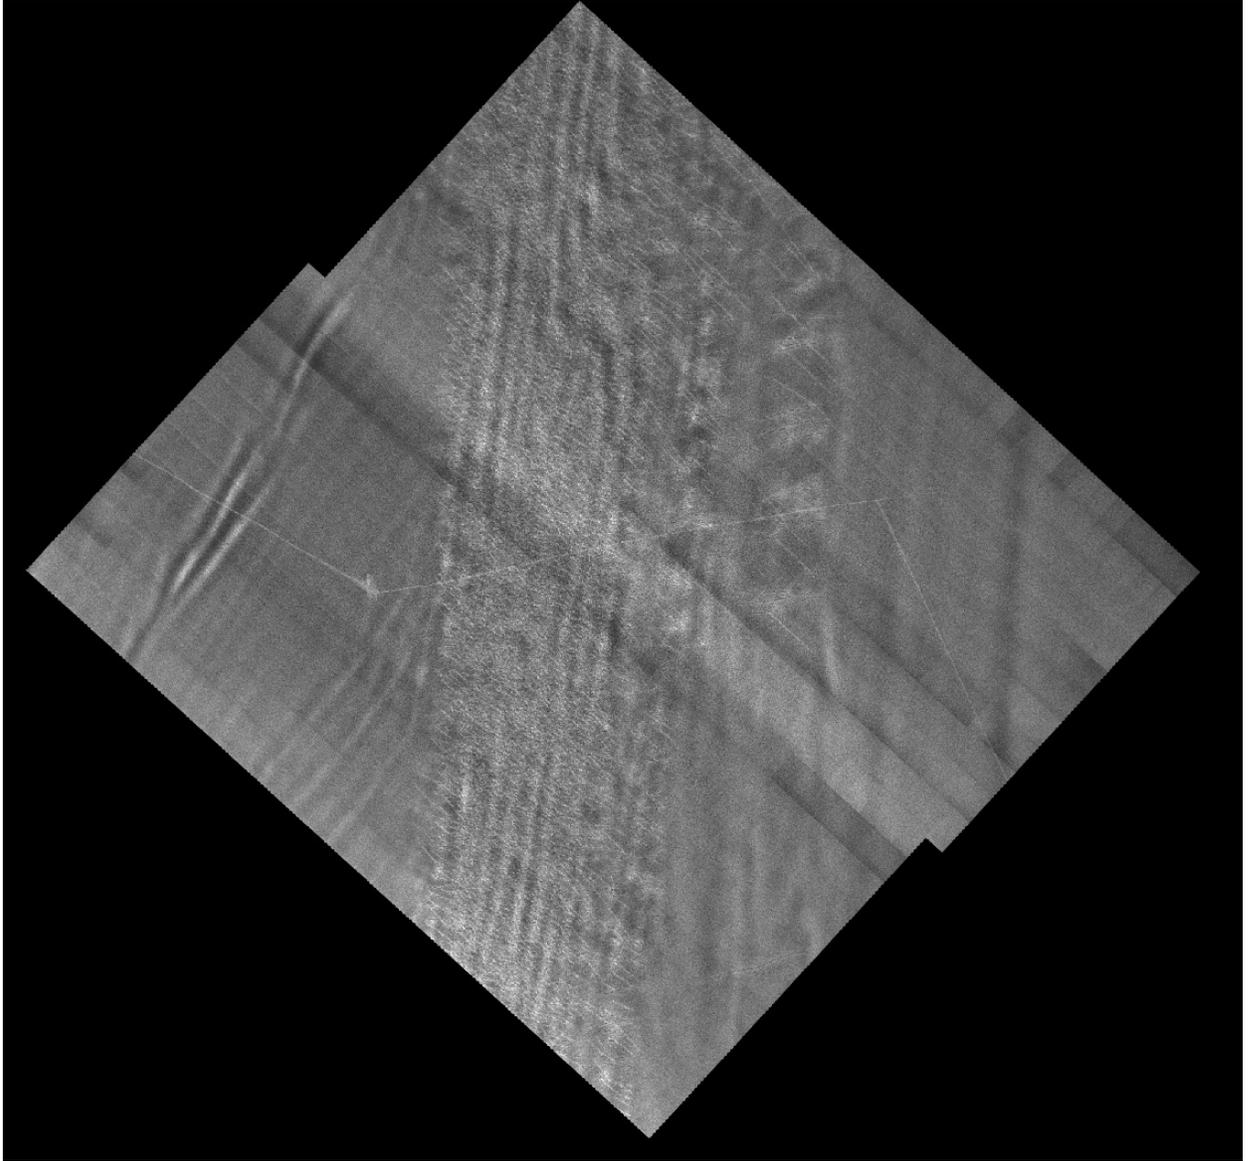
Figure 9: Mosaic of the SNL SAR 1 foot resolution imagery from the Tres Hermanas site in the Shear Zone imaged on October 30, 2009

Figure 10: Mosaic of the SNL SAR imagery from the Tres Hermanas site in the Shear Zone imaged in December 6, 2006.

Figures 9 and 10 show the mosaics of the Shear Zone South Pole Traverse site from 2009 and 2006, respectively. As with the Tres Hermanas site, the glacial ice moving up to 3 ft. per day. Most of the features are the same between the images, but have moved due to the aforementioned motion of the glacial ice. The most obvious example of the motion is the South Pole Traverse road, which is the bright, piece-wise linear feature which cuts across the crevasses and spans the middle portion of the mosaic. It is obvious that this feature has moved north (up) in the images from 2006 to 2009. The right side of the road has moved faster than the left side, causing an increased cant in the image, as well.

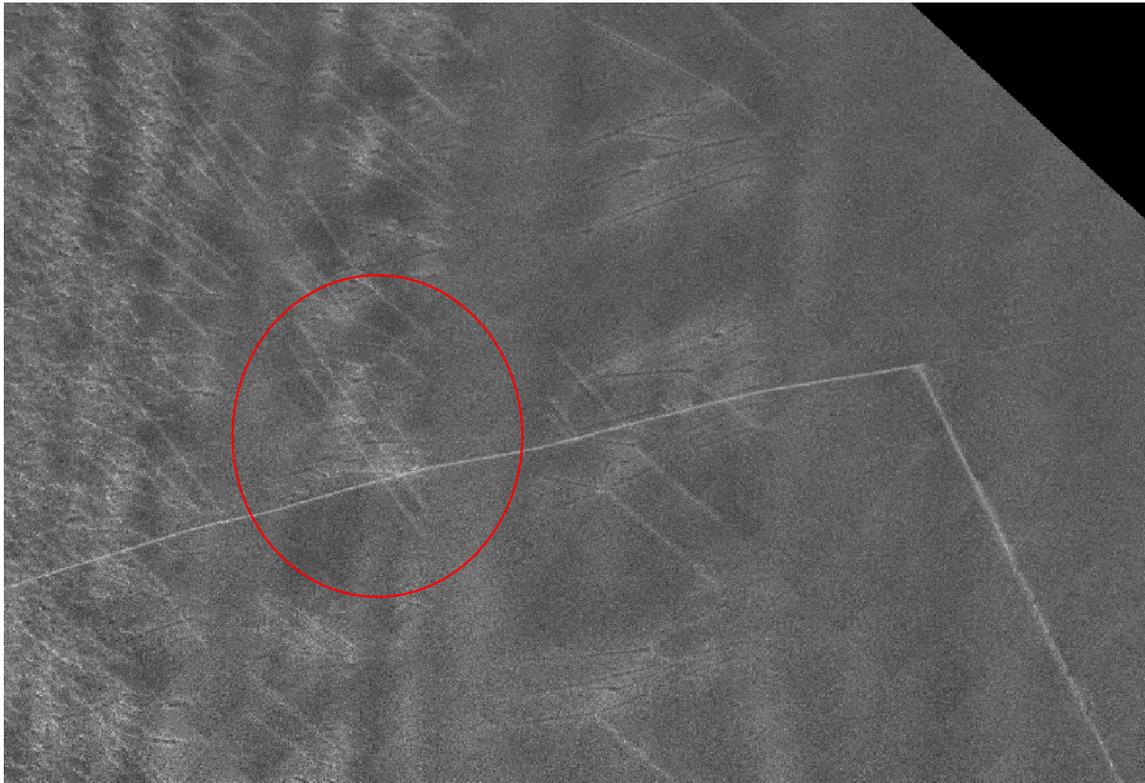
Figure 11: SAR images of 12" to 18" crevasses of interest (in red circle at about 11 o'clock) in South Pole Traverse Shear Zone, November 3, 2009.

The small crevasses of interest are shown in Figure 11. They appear as straight, very bright lines, as opposed to alternating bright and dark crooked lines that we observed in Tres Hermanas crevasses [1]. Figure 12 shows that these crevasses appear to be newly developed since 2006.

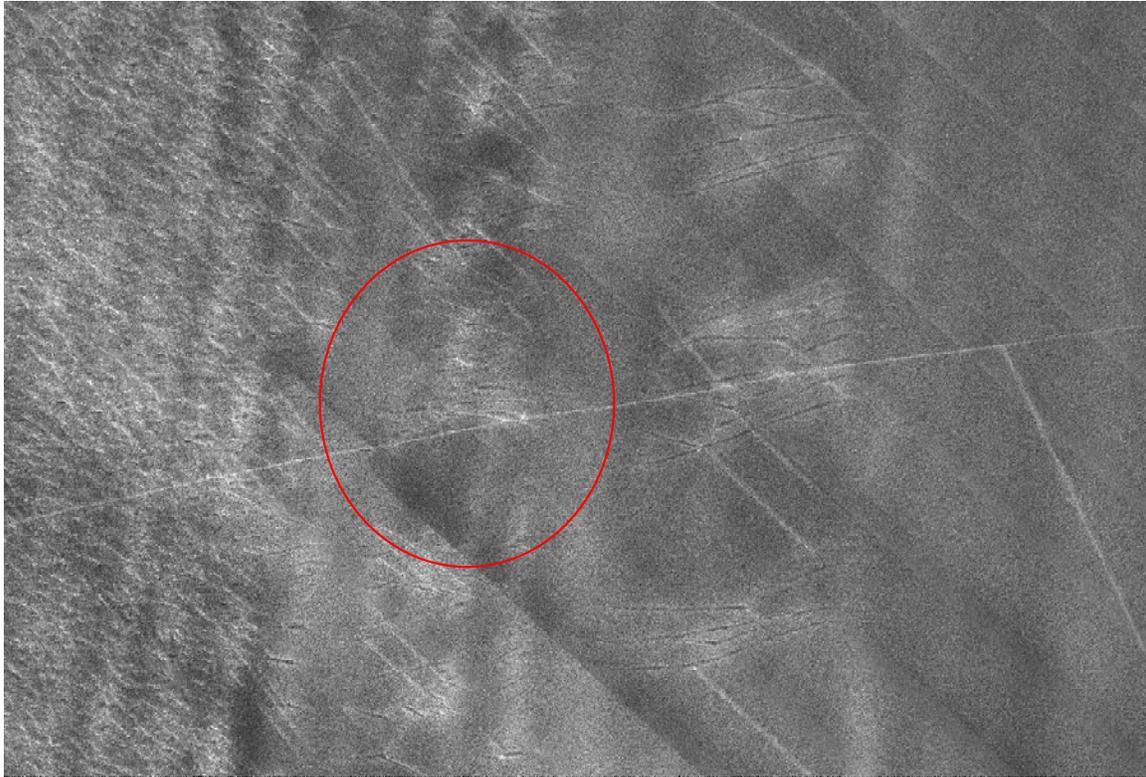
Figure 12: SAR images from 2006 of same site as Figure 11, showing the small crevasses were not present then

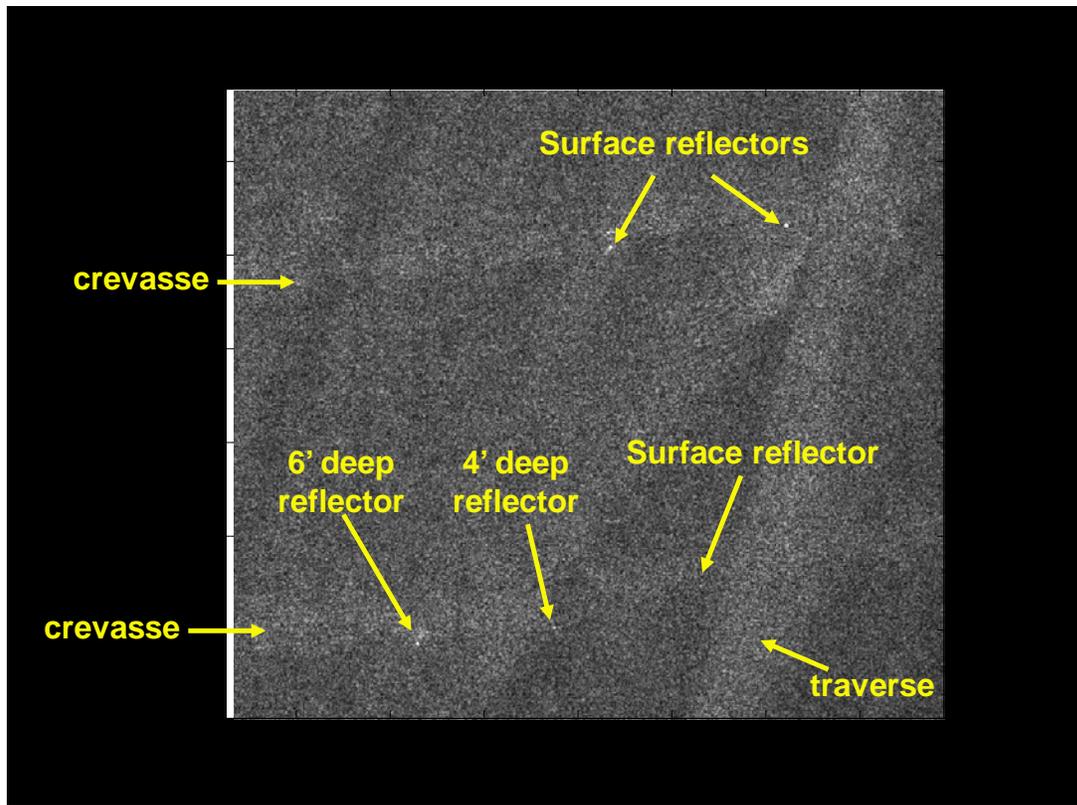
Figure 13: 8'' resolution image of the crevasses which show the buried reflectors along the South Pole Traverse in the Shear Zone

Figure 13 shows an 8" resolution spotlight mode image taken around the 12" to 18" crevasses in the shear zone. In this image, the buried reflectors are evident as well.

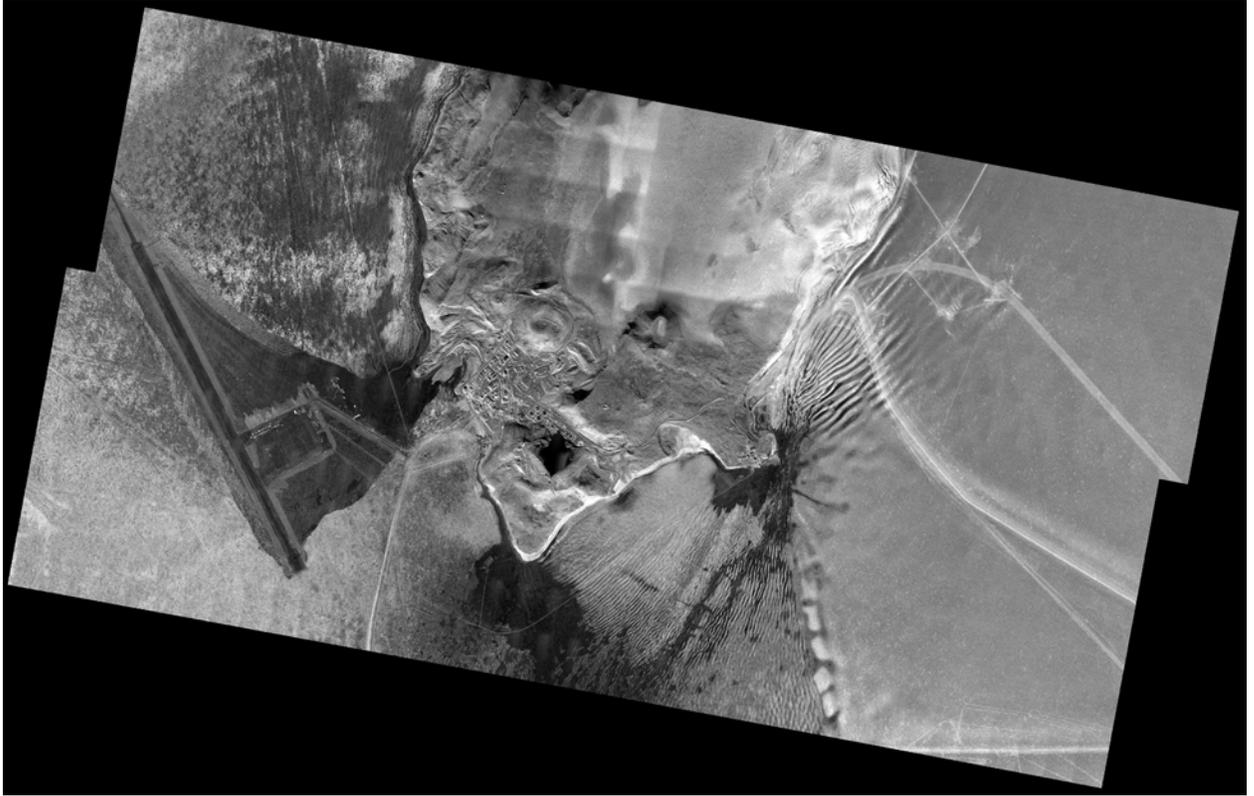
Figure 14: Mosaic of the 1 foot SAR imagery of McMurdo station including the ice runway (to the left) and the pressure ridge (to the right) from the November 6, 2009 EMI test of the CDR

On November 6 2009, the Sandia crevasse detection radar imaged McMurdo station as part of EMI testing to see if there would be any interference of sensitive RF equipment by our radar. This was a repeat of the test flown on December 5, 2006. In both 2006 and 2009, the flight tests were coordinate with the managers of key Antarctica RF systems. In both 2006 and 2009, the managers reported no issues with the CDR radar while it was operational.

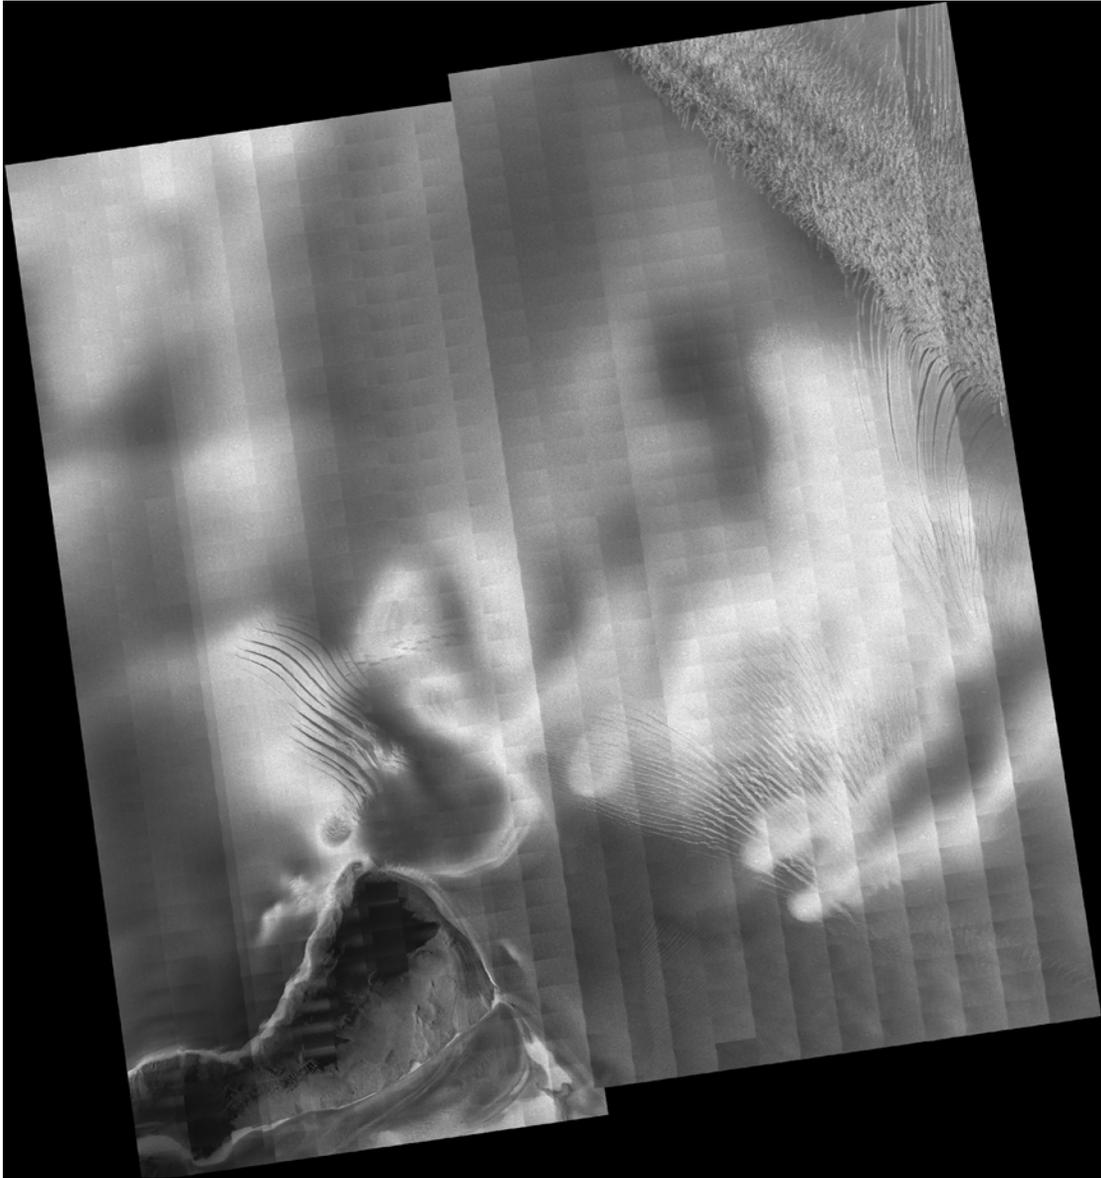
Figure 16: Mosaic of the Grosvenor CDR 1 foot resolution data over a 5 nmi by 5 nmi area

Figure 16 shows the Grosvenor 5 nmi by 5 nmi mosaic of the 1 foot resolution CDR data. A region of severe crevassing is obvious in the upper right corner of the image. In addition, smaller crevasses are evident when the image is zoomed in. The patchiness in the mosaic is due to pointing issues that were more prevalent on this day than on other flights. Figures 17 and 18 show close-ups of crevasses in the Grosvenor data.

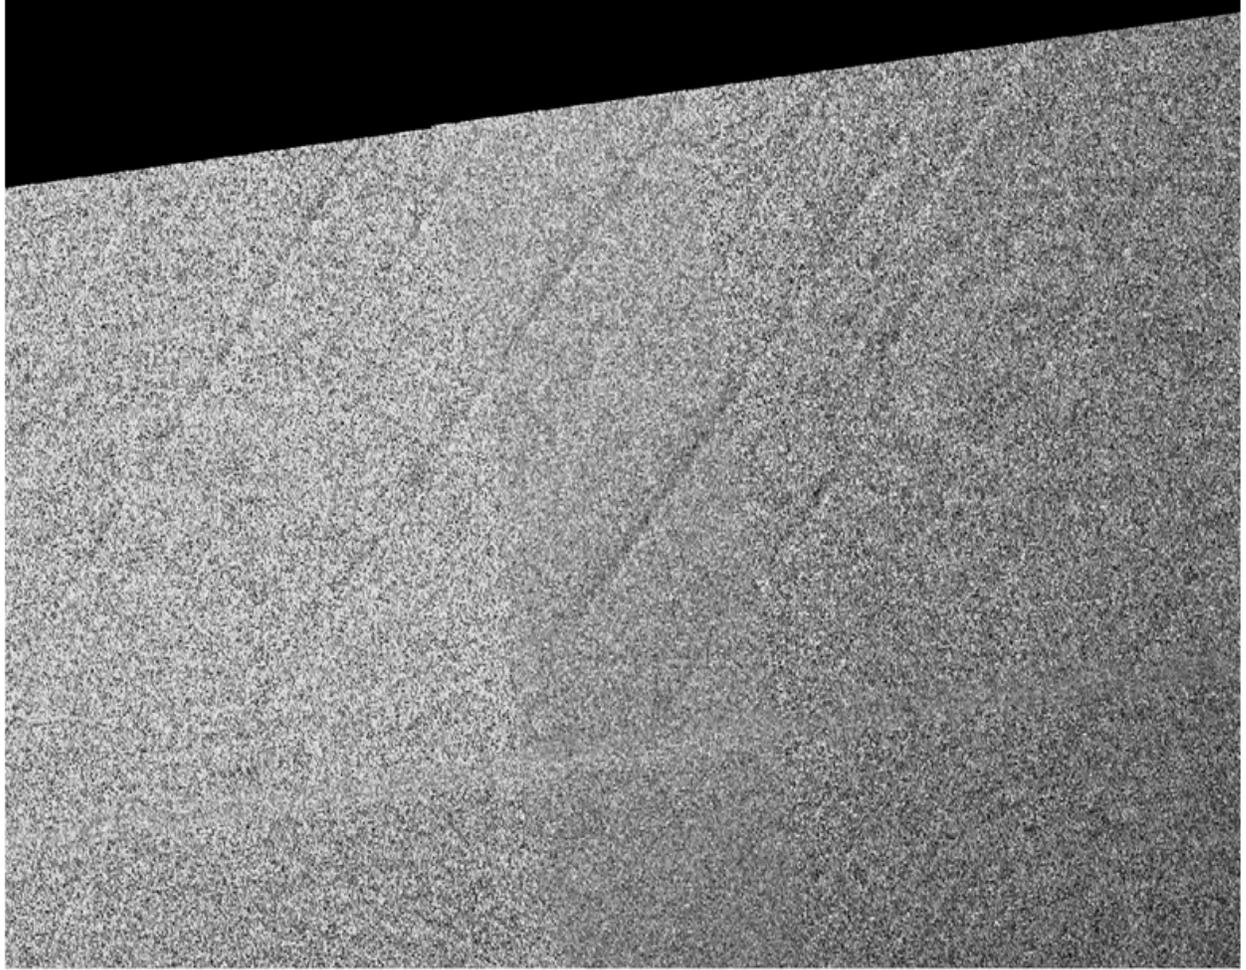
Figure 17: Close-up of crevasses from the upper middle of Figure 16

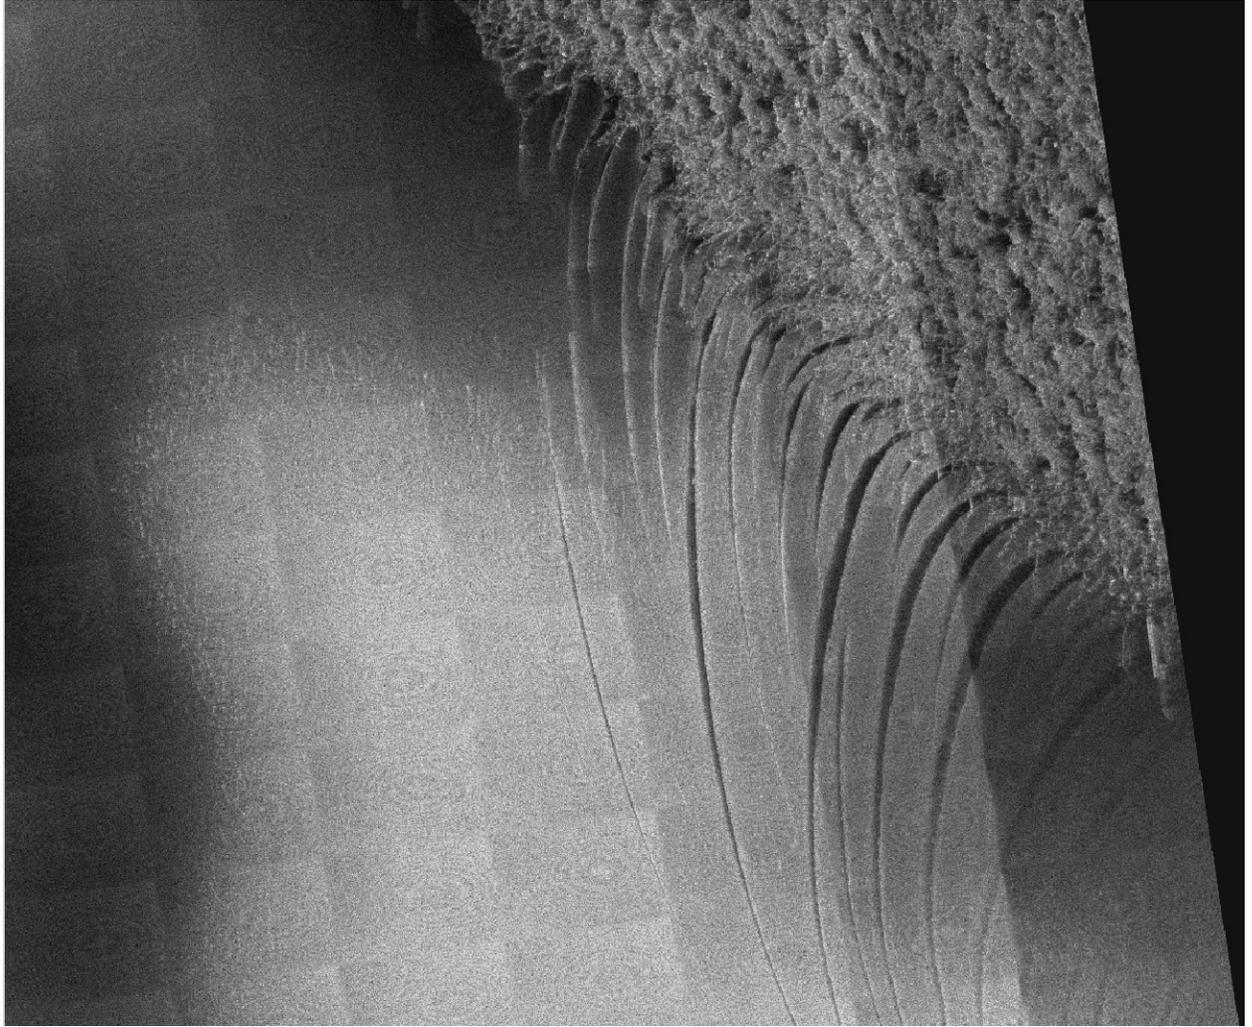
Figure 18: Close-up of more crevasses from the middle right part of Figure 16

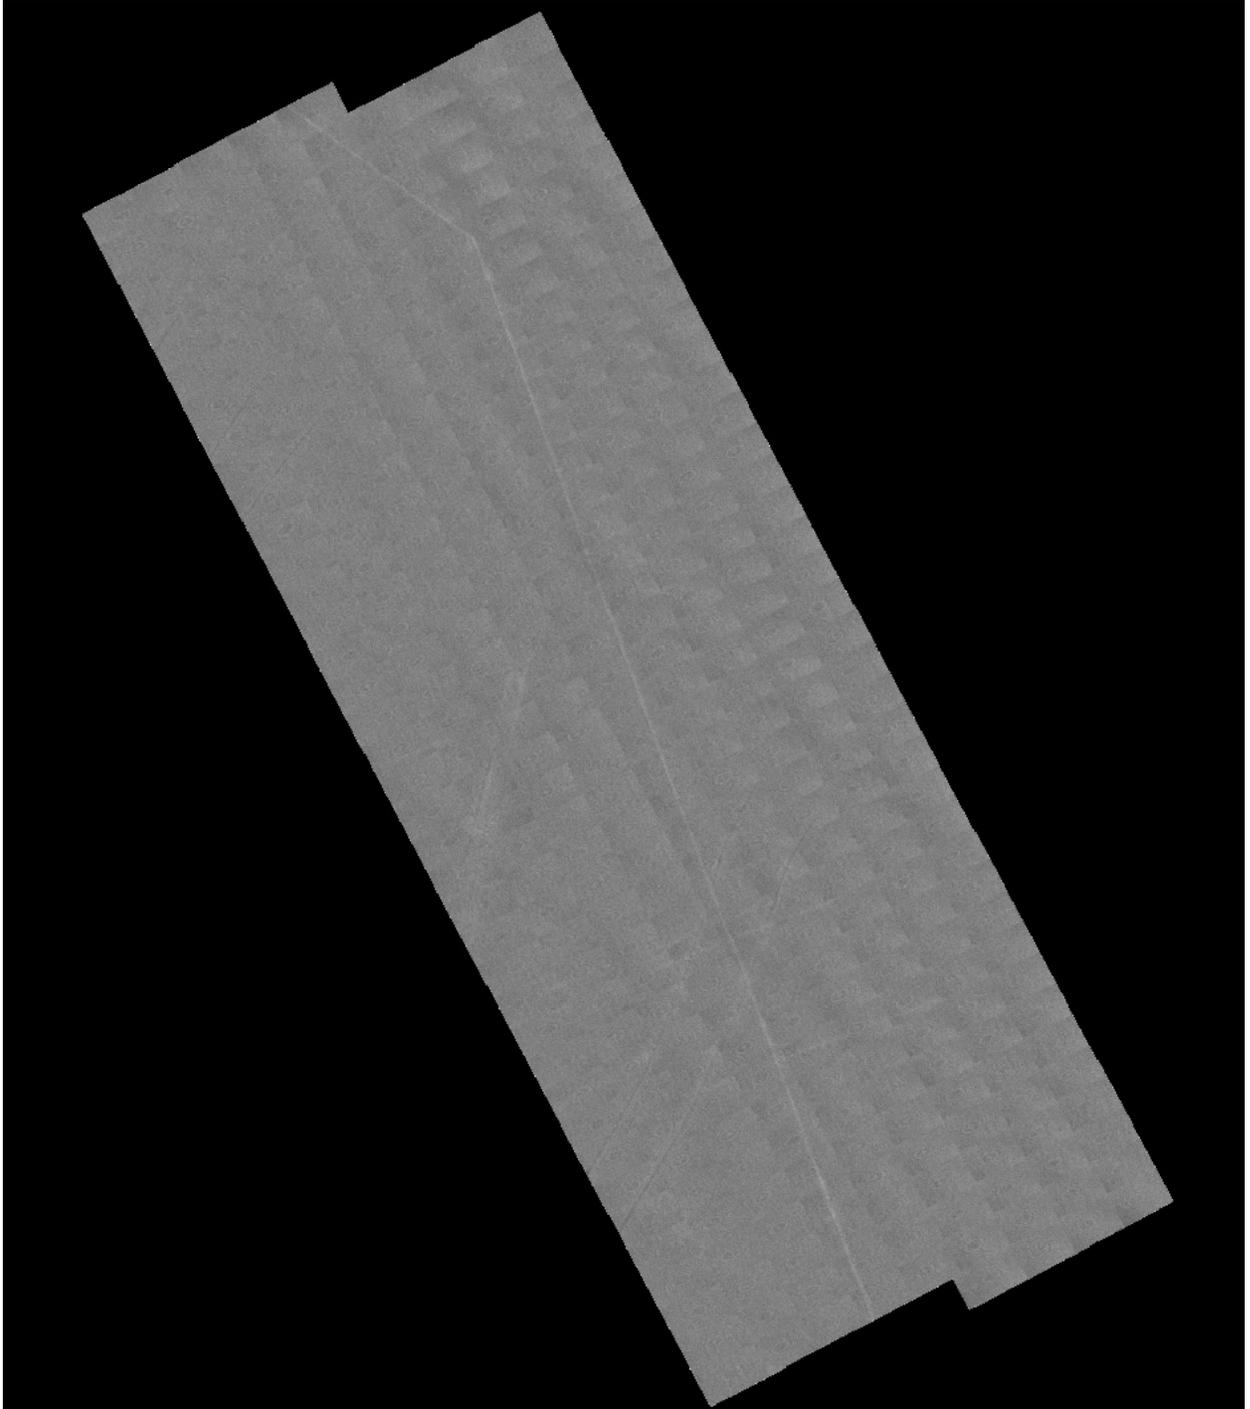
Figure 19: Mosaic of the Leverett CDR 1 foot resolution data over a 2 nmi by 5 nmi area along the South Pole Traverse

Figure 19 shows an approximately 2 nmi by 5 nmi mosaic of CDR 1 foot resolution imagery of the South Pole Traverse at Leverett. The traverse road is evident in the image even though it had rarely been used, and not for a year. The crevassing is much more subtle in this imagery. Figure 20 shows that there are a couple of crevasses that cross at about a 45° angle to the traverse road and a couple more that appear to nearly perpendicular to the road. One of these latter two crevasses seems to cross the road and the other comes right up to the road, but does not cross. In addition, several crevasses off to the side of the road are visible in Figure 19.
