SANDIA REPORT

SAND2010-5229
Unclassified Unlimited Release
Printed August 2010

2009 Antarctica X-Band MiniSAR Crevasse Detection Radar: Final Report

This document includes discussion of the hardware development, system capabilities, and results from data collections in Antarctica during the fall of 2009.

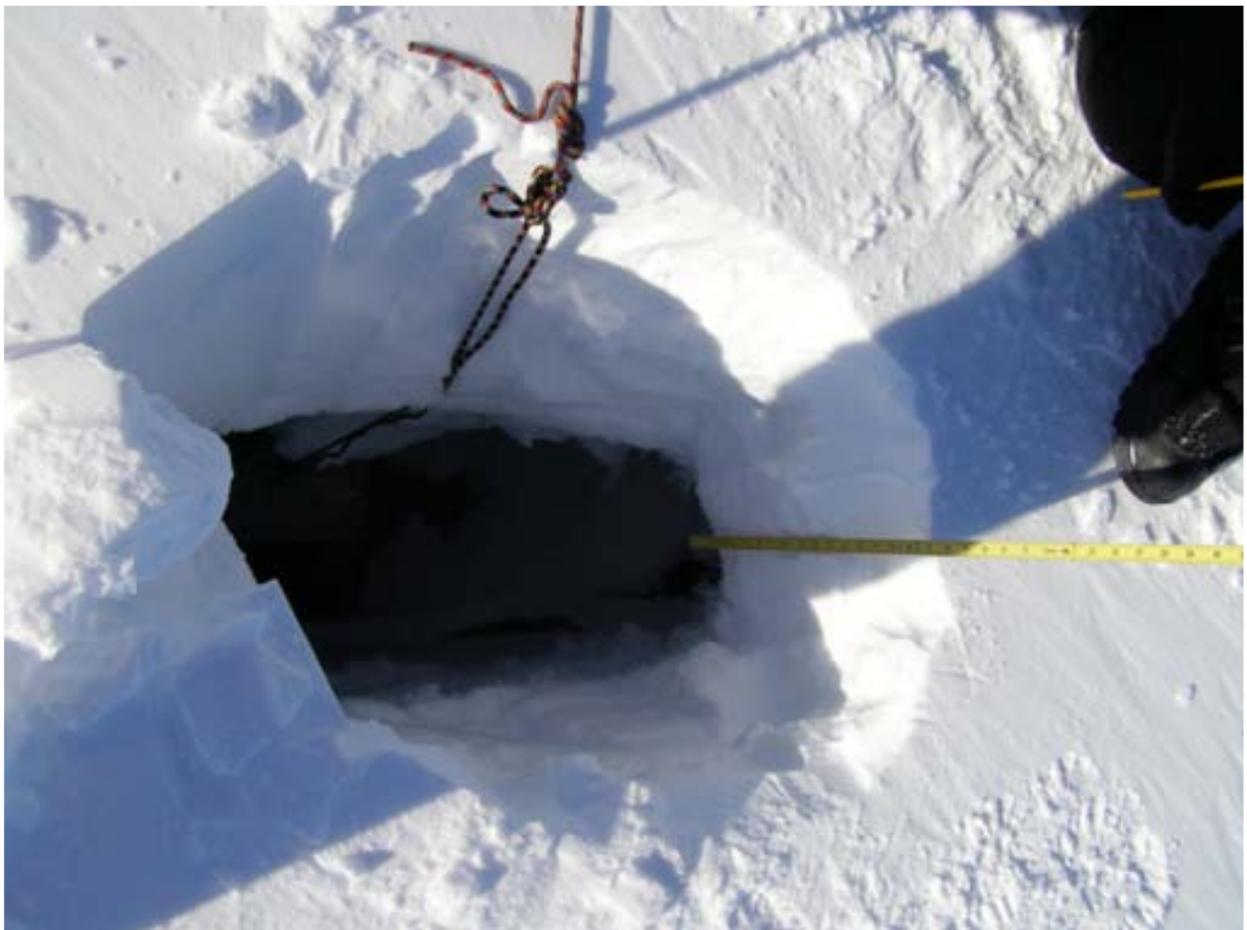
Rough recollections by Mark Armstrong were that the 12" to 18" wide crevasses were at least 30 to 40 foot deep with approximately 18 to 20" snow bridges covering them. The following photograph shows the opened up snow bridge.

Figure A1: Snow bridge over small crevasse.

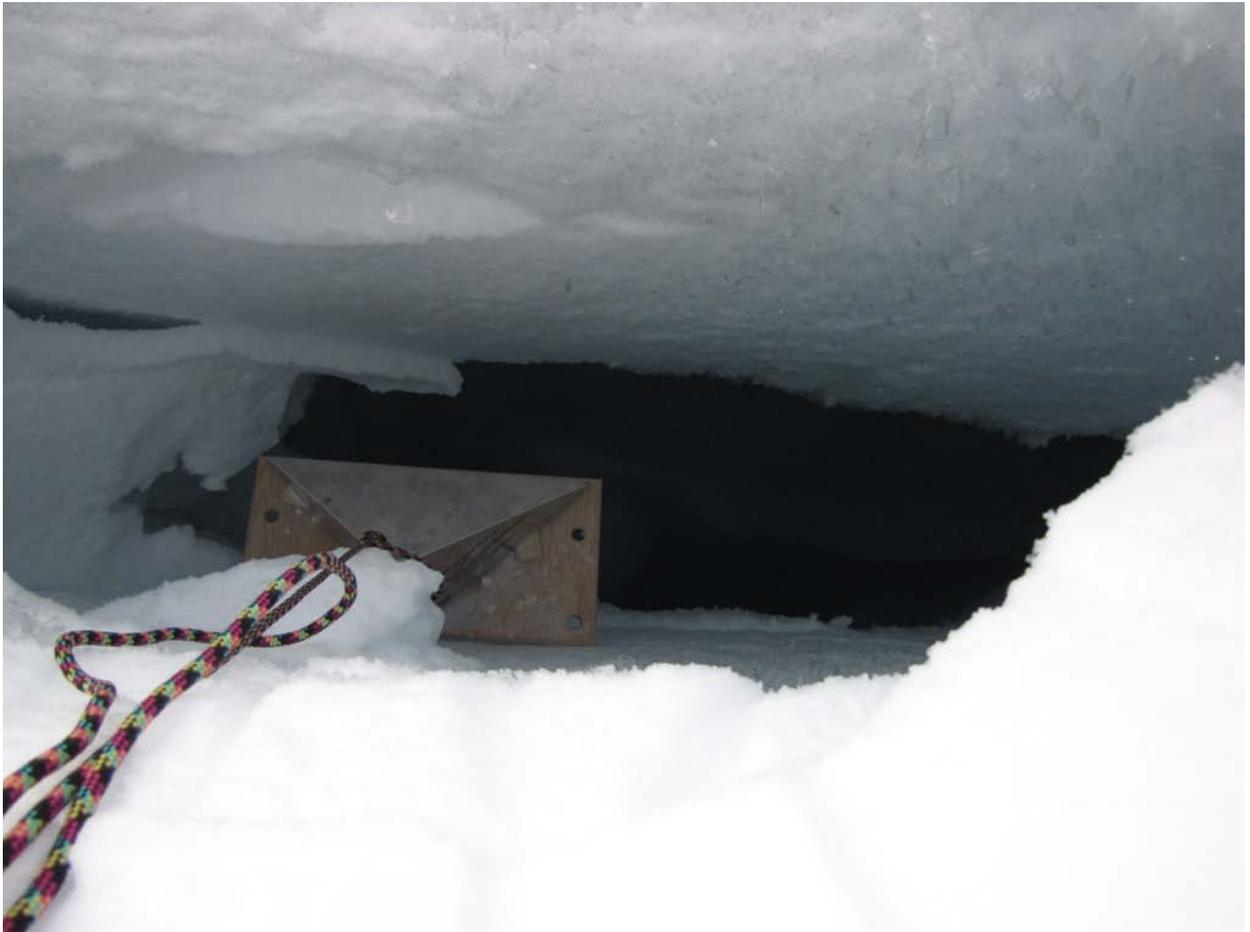
The photograph shown below shows the radar reflector placed inside the crevasse.

Figure A2: Radar reflector placed inside the crevasse.
