DOE/NV--1396

Corrective Action Decision Document for Corrective Action Unit 562: Waste Systems Nevada Test Site, Nevada

August 2010

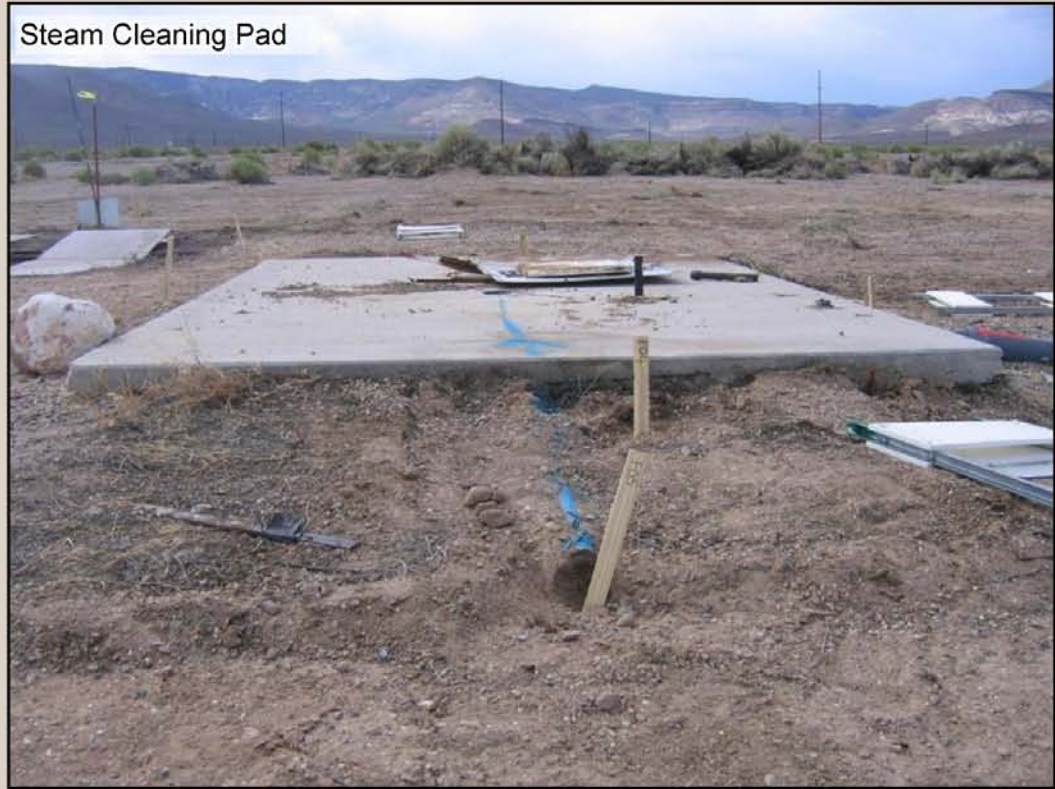
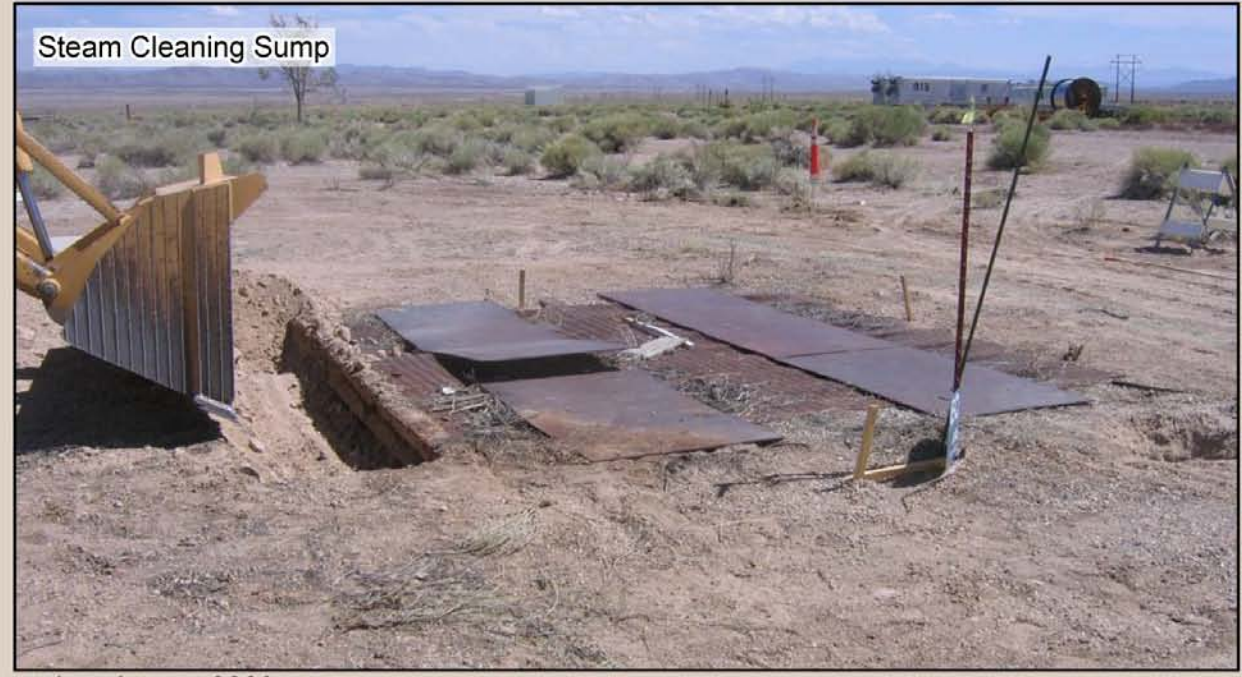
Figure A.8-1
 Sample Locations at CAS 02-60-03, Steam Cleaning Drain

Steam Cleaning Sump – Visual inspection of the steam cleaning sump revealed that it consists of a shallow earthen pit with a fabricated steel grate cover designed to allow for vehicles to drive over it and waste water to drain to the subsurface soil. No liners or associated drain pipes were identified in the sump. The base of the sump consisted of a thin layer of silty sand underlain by leach rock. The

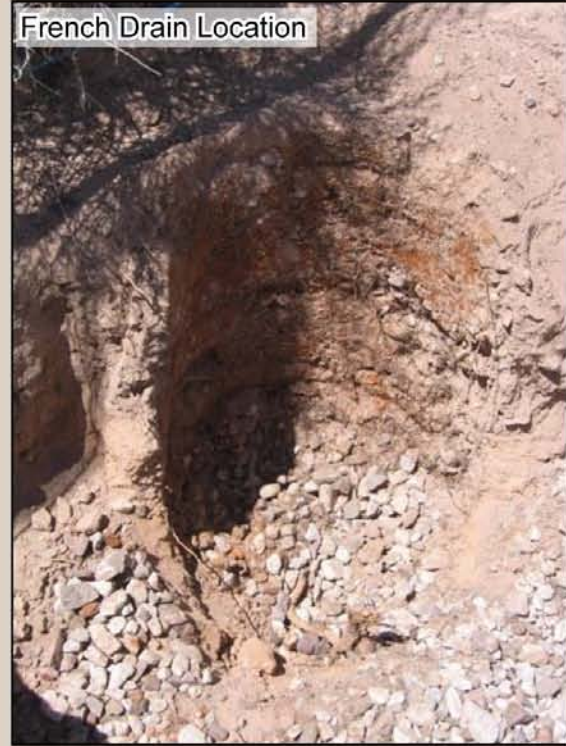
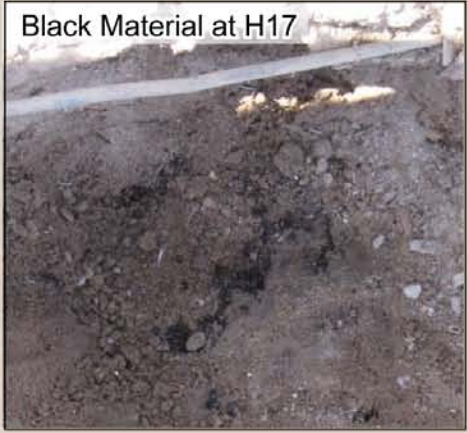
Figure A.10-1
 Sample Locations at CAS 02-60-05, French Drain

Inspection of the french drain revealed that it consisted of a bottomless 55-gal drum that was rusted and corroded. The top 6.0 in. of the drum contained accumulated soil that was likely windblown or backfill material. The rest of the drum was filled with leach rock with very little soil and was set in a bed of leach rock that extended to 5.5 ft bgs to the native soil interface. It was noted during surface sampling (with the exception of the surface sample collected at the french drain) that there was a layer of black material present throughout the area sampled. The thickness of the layer varied from barely visible to 1 in.; the depth of the layer was from less than 1 in. to 7.0 in. bgs. In places, the material

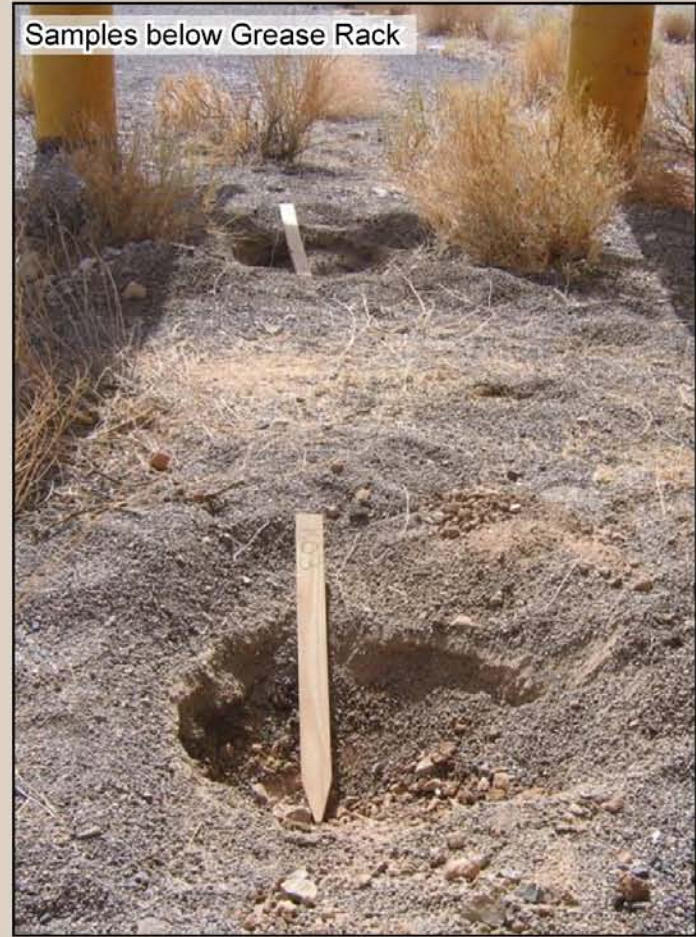
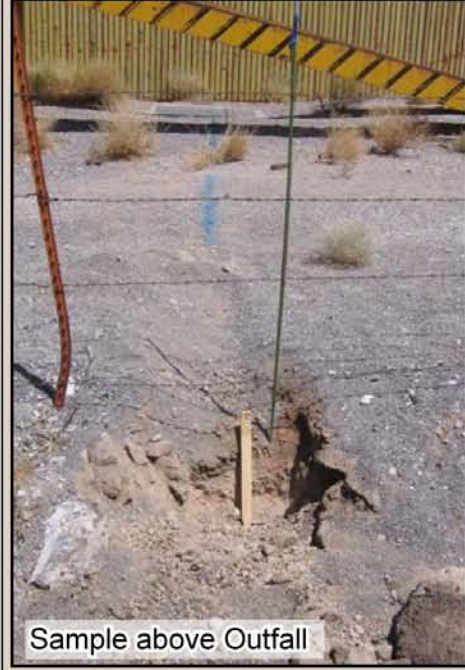
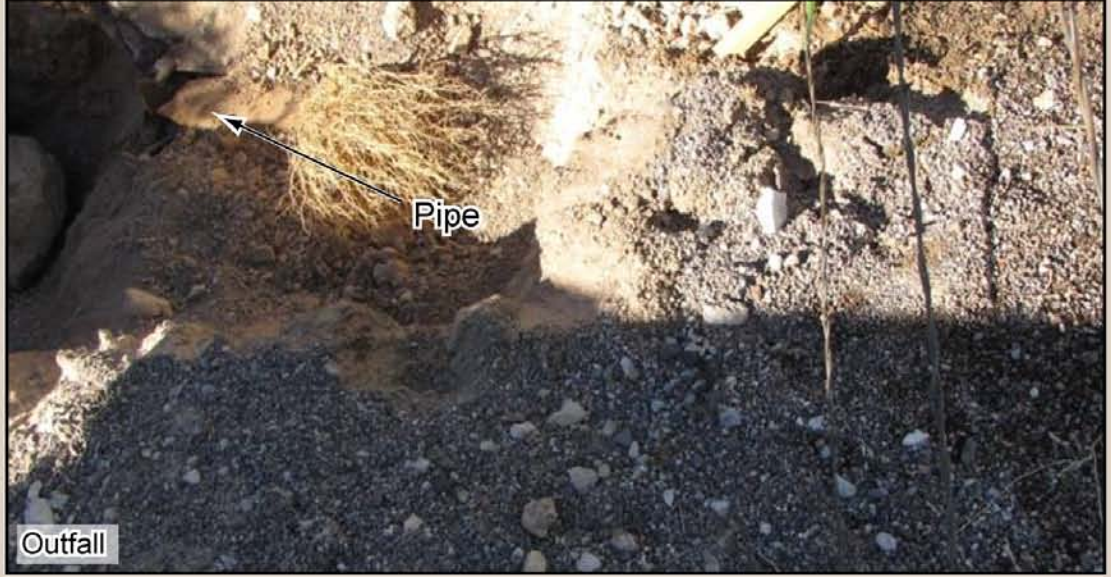
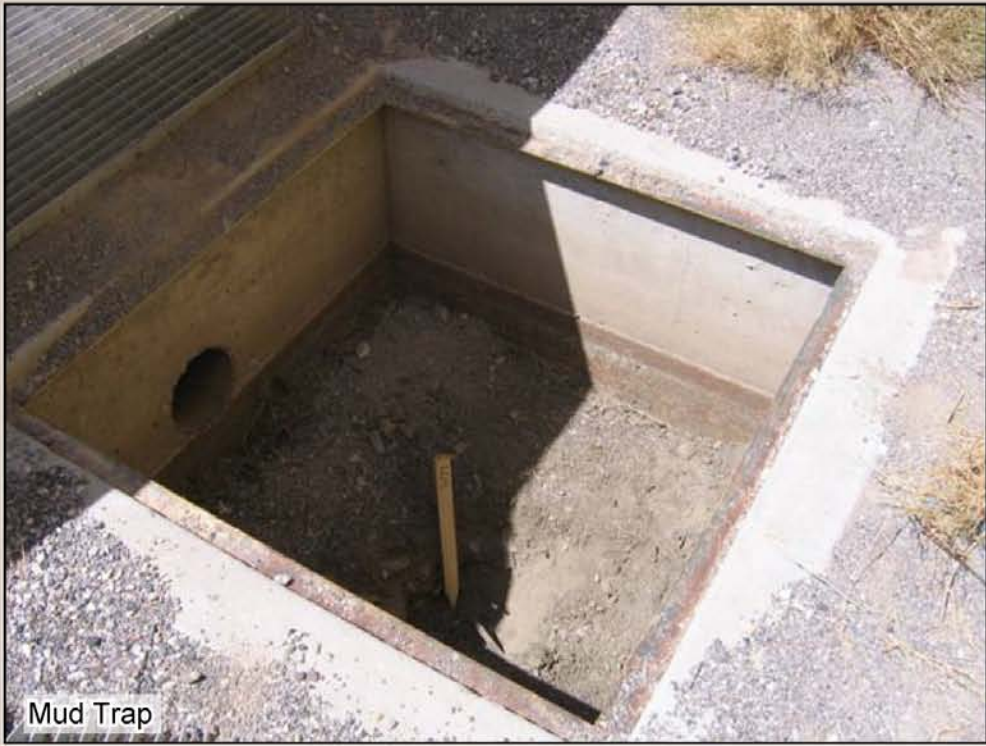
Figure A.13-1
Sample Locations at CAS 23-60-01, Mud Trap Drain and Outfall

Mud Trap Drain – The concrete trench in the floor of the wash shed that drains to the mud trap was visually inspected to select a biased sample location. The trench had a concrete bottom and an outlet pipe at the midpoint of its length that drained to the mud trap located outside the south wall of the wash shed. The PSM in the drain consisted of fine dirt with well-sorted gravels that were covered with abundant windblown trash and vegetation debris. No staining was identified; therefore, sample location K01 was selected at the center of the trench adjacent to the outlet pipe. The mud trap drain was visually inspected to select a biased sample location. The mud trap consists of a concrete vault measuring 4.0 by 4.0 by 3.5 ft with a metal grate cover. The contents included approximately 1.5 ft of sediment with some miscellaneous debris.

Grease Rack – The soil below the grease rack was visually inspected to select biased sample locations. No surface staining was observed.

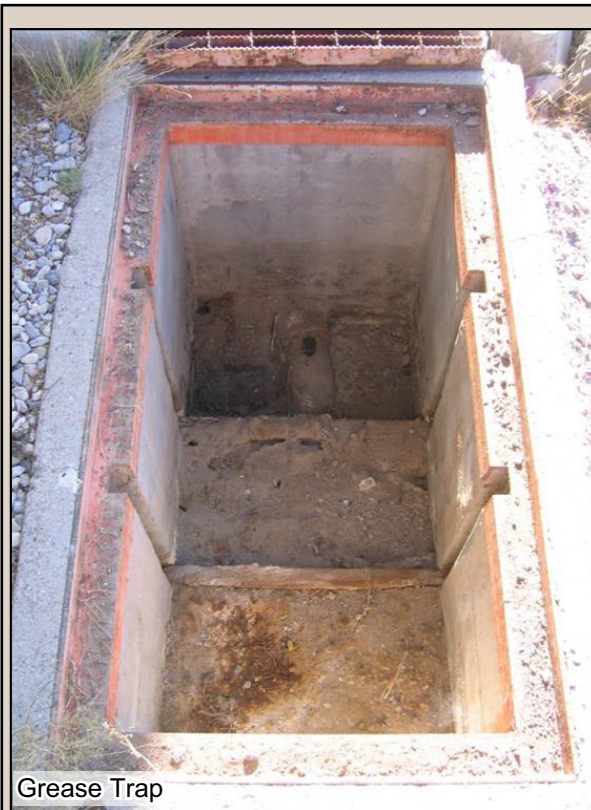
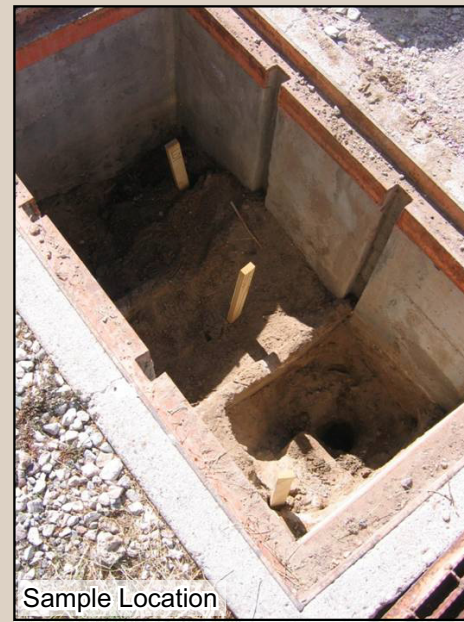
Figure A.14-1
Sample Locations at CAS 23-99-06, Grease Trap

Samples 562L001 and FD 562L002 were collected at the bottom of the lower weir (location L01) at a depth of 3.5 to 4.0 ft bgs and consisted of dark brown sandy sediment with small pieces of paper and

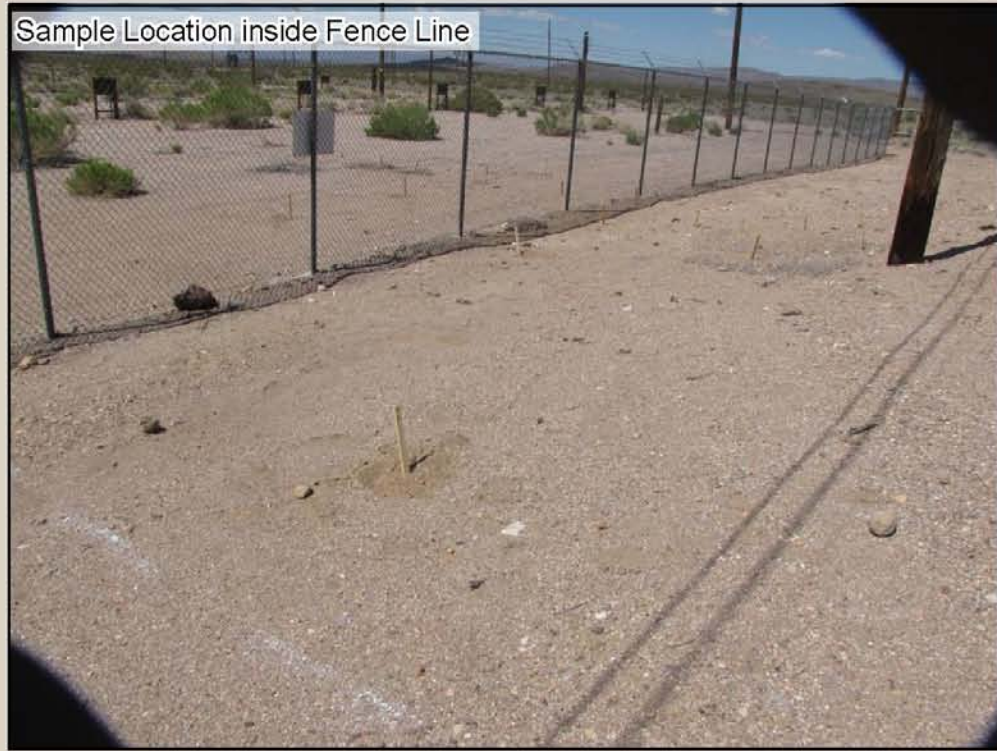
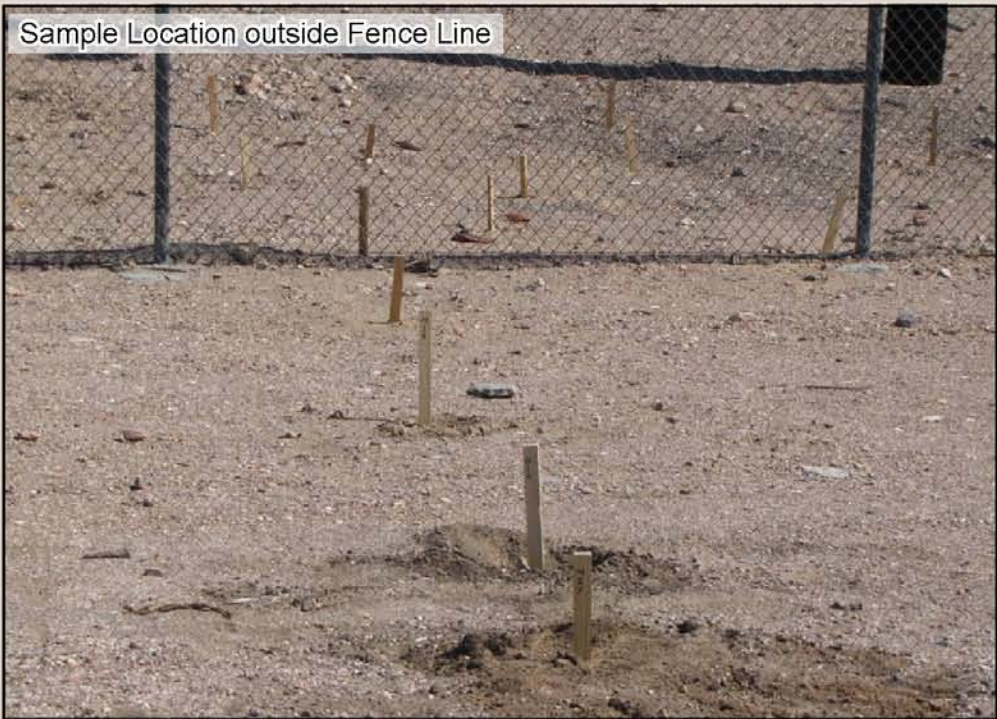
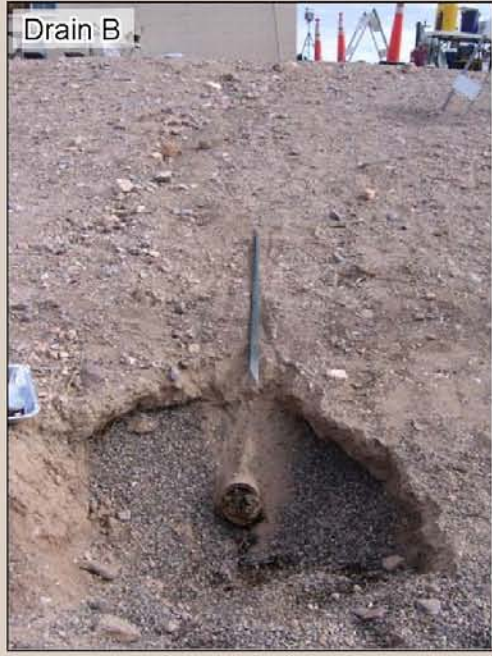
Figure A.15-1
Sample Locations at CAS 25-60-04, Building 3123 Outfalls

Drain A – The outfall was previously removed during a renovation of a sewer line in the area. There were requirements for remaining 5.0 ft away from the reconfigured active sewer line so the area sampled (location M01) was 5.0 ft from the original opening of the outfall. The sampling interval was accessed by hand digging 5.0 ft west of the active sewer line and then moving 2.0 ft east toward the former location of the original outfall opening of Drain A. A second sample, location M02, was marked 100.00 ft south of the original outfall opening. The sampling interval was accessed by hand digging 5.0 ft south of this location because of the active sewer line. No biasing factors, such as staining, debris, and odor, were identified in the subsurface.

Drain B – The Drain B outfall was uncovered at 1.0 ft bgs by hand digging 47.0 ft south of Building 3123. The drain consists of a 4.0-in. vitrified clay pipe with sludge contents and is underlain
