NOTES OF MONTHLY DEVELOPMENT TEST PROGRAM REVIEW MEETING
HELD WITH SNPO AT WANL ON MARCH 28, 1968
(Title Unclassified)

Westinghouse Electric Corporation
Astronuclear Laboratory
P. O. Box 10864
Pittsburgh, Pennsylvania 15236

NOTES OF MONTHLY DEVELOPMENT TEST PROGRAM REVIEW MEETING
HELD WITH SNPO AT WANL ON MARCH 28, 1968
(U)

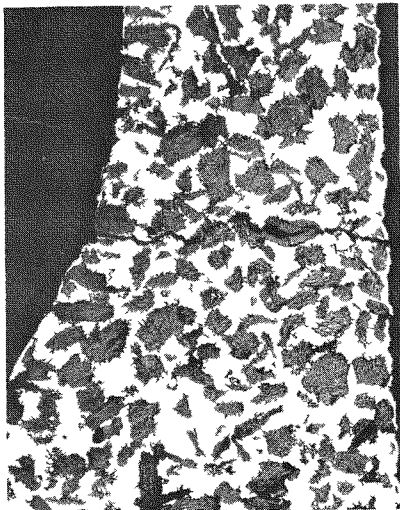
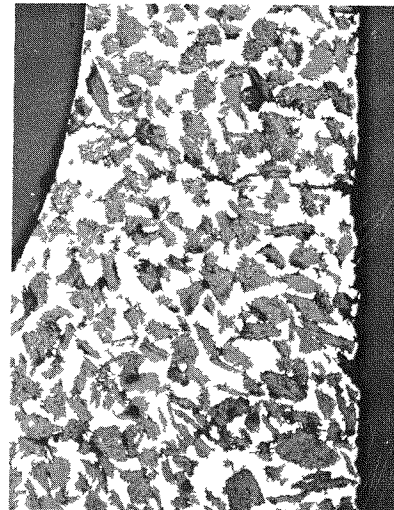
(100X) Normal to Flow Direction

Normal to Flow Direction (100X)

Axially With Flow (75X)

(75X) Axially With Flow

FIGURE 7
PHOTOMICROGRAPHS OF TIP CRACK
EML-C.1

(U) Detailed metallography from a study of a crack found in a carbide tip from the second Thermal Cycle Test has shown that the crack penetrates through to the nearest flow channel. This is shown in Figures 6 and 7. On the same tip, another crack of the same magnitude was confirmed in a questionable area. Both cracks appeared to terminate at the braze joint of the ATJ transition section, except on the external surface where the crack continued into the ATJ. Investigation of these cracks is continuing.

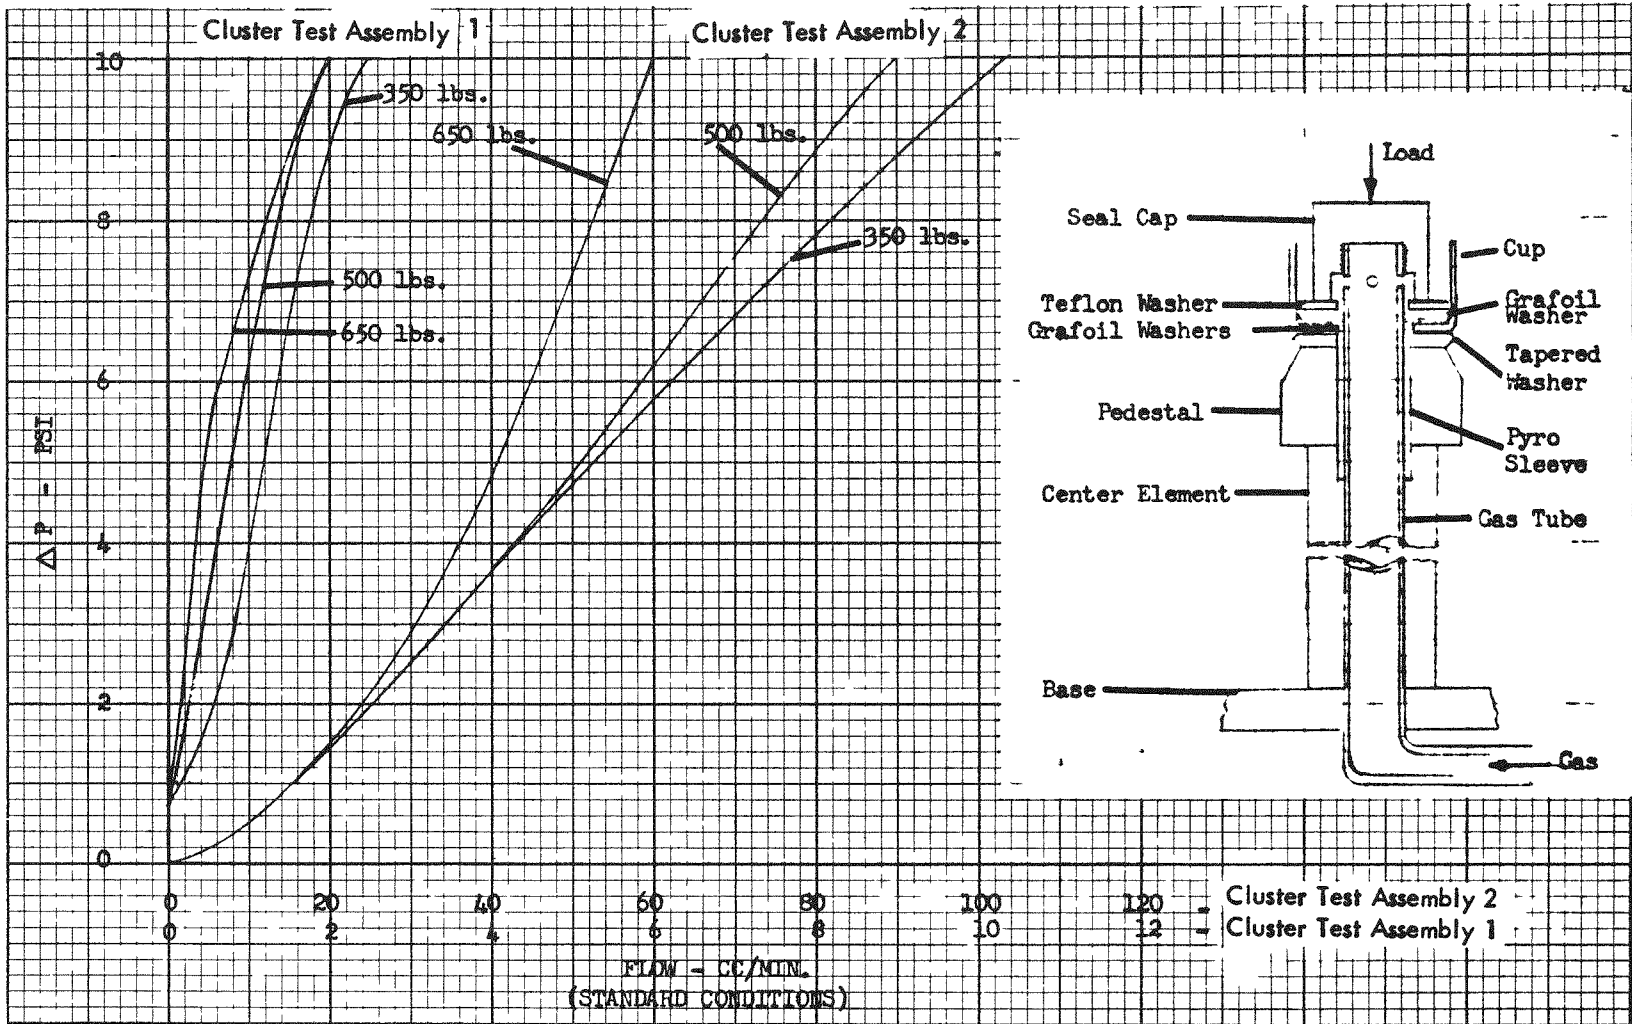
FIGURE 9
 LEAKAGE BETWEEN INSULATING CUP AND WASHER
 EML-C.1

(U) Leakage rates were measured on the pyrofoil seals at axial loads up to 650 lbs and pressures up to 10 psig. The results for the two cluster test assemblies varied widely because the center element of the second cluster had a non-concentric center hole and a skewed end that increased the leakage by a factor of approximately 5. Leakage data has been plotted on Figure 9 for the three load conditions. Note that despite the discrepancies found on the center element of the second test cluster, the leakage rate is still very low.

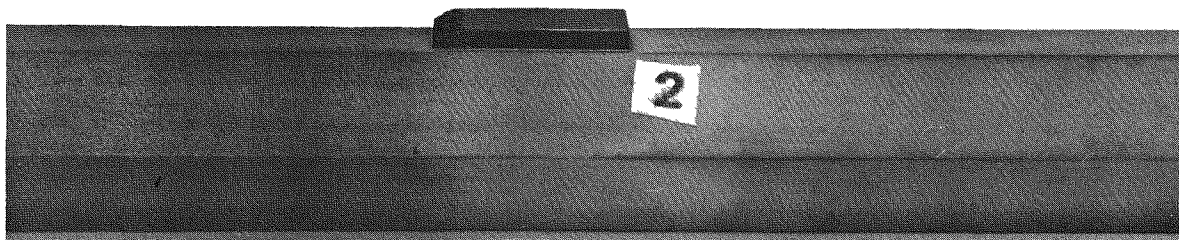
FIGURE 23c
TYPICAL FAILURE - CRYOGENIC CONDITIONS - AFTER NRX-A6

Figure 23 shows the similarity of all the failures produced in the laboratory. In each case an examination of the test specimen indicated that no damage had occurred in the braze or the element.
