OAK RIDGE NATIONAL LABORATORY

CF-57-4-55

DATE: April 30, 1957

SUBJECT: Quarterly Report of the Solution Corrosion Group for the Period Ending April 30, 1957.

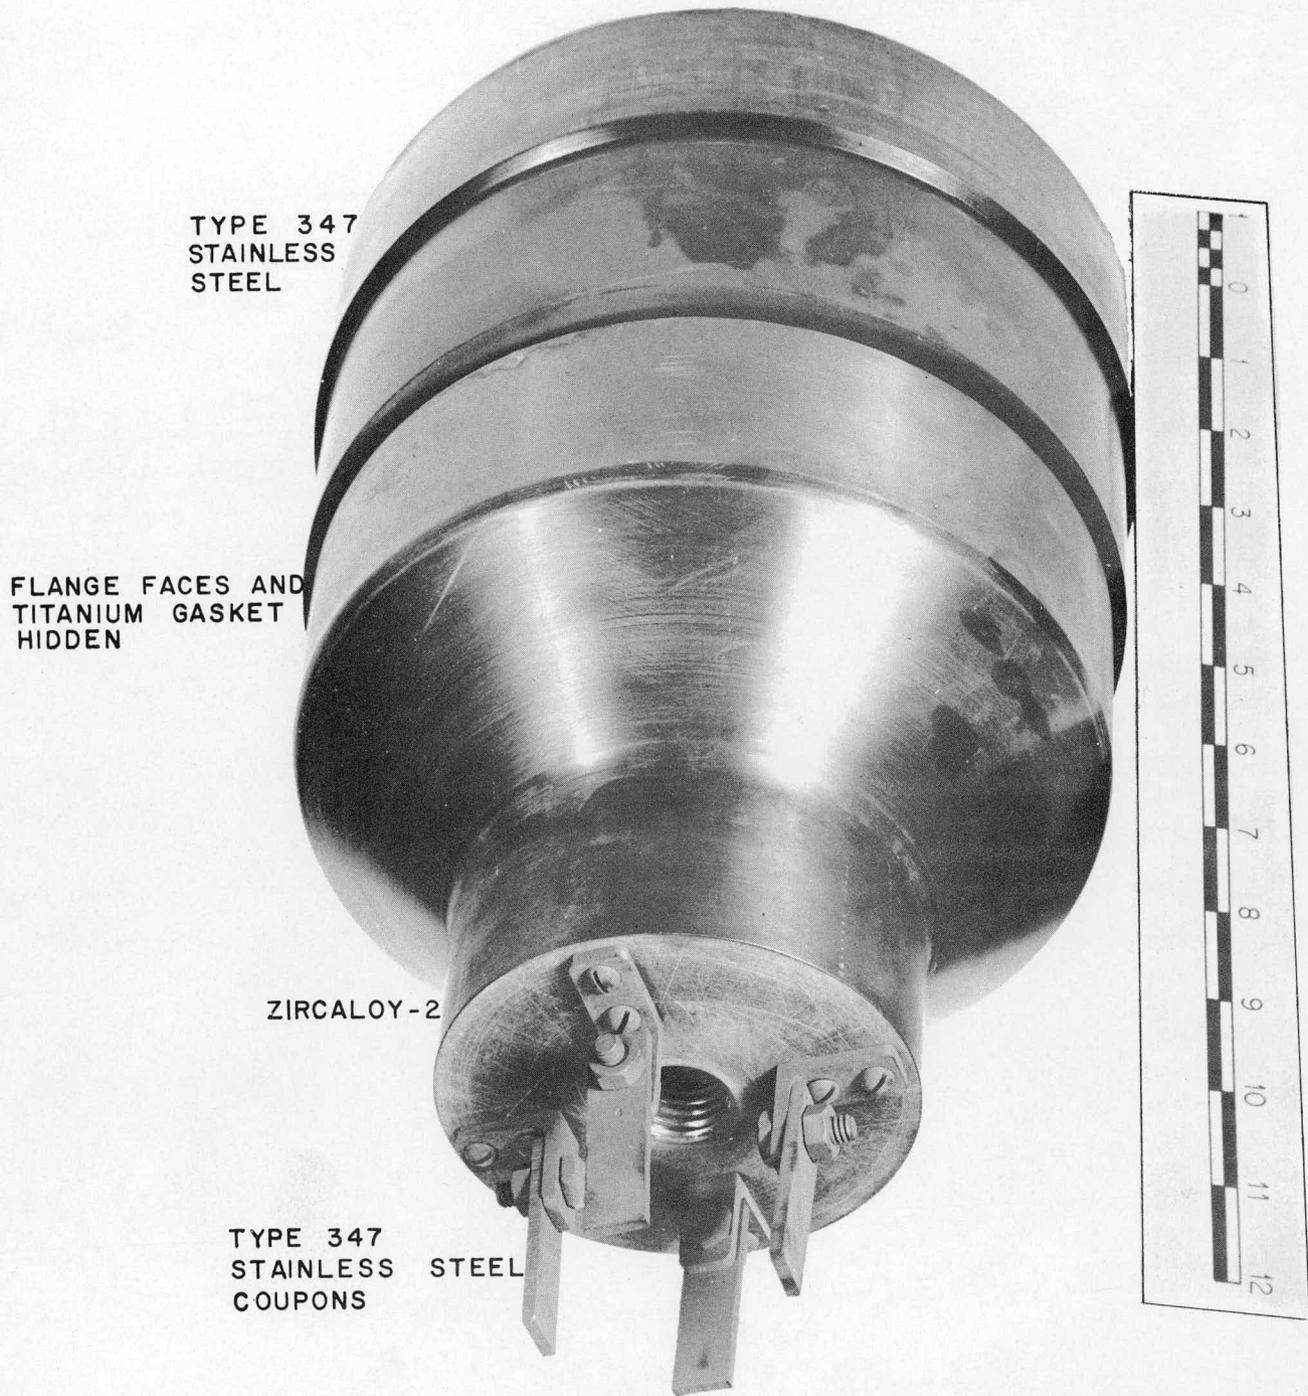
Fig. 1 Transition Joint Removed from Bellows Test Unit
after 2920 hr Exposure to Water at 100 - 300°C

For the first time since the test unit was constructed, the weld holding the transition joint in place was cut and the transition joint removed as a unit for examination. The joint itself was not disassembled and is shown in Fig. 1. The surfaces shown in the figure had been exposed to oxygen-containing distilled water at 100 to 300°C for 2900 hr and to approximately 0.02 *m* UO₂SO₄ for about 50 hr. The stainless steel surfaces were covered with a rough black film; the Zircaloy-2 surface was covered with a much smoother, more adherent black film, and the titanium surfaces showed bluish-green interference colors. The four type 347 stainless steel coupons had gained a slight amount of weight (undefilmed).

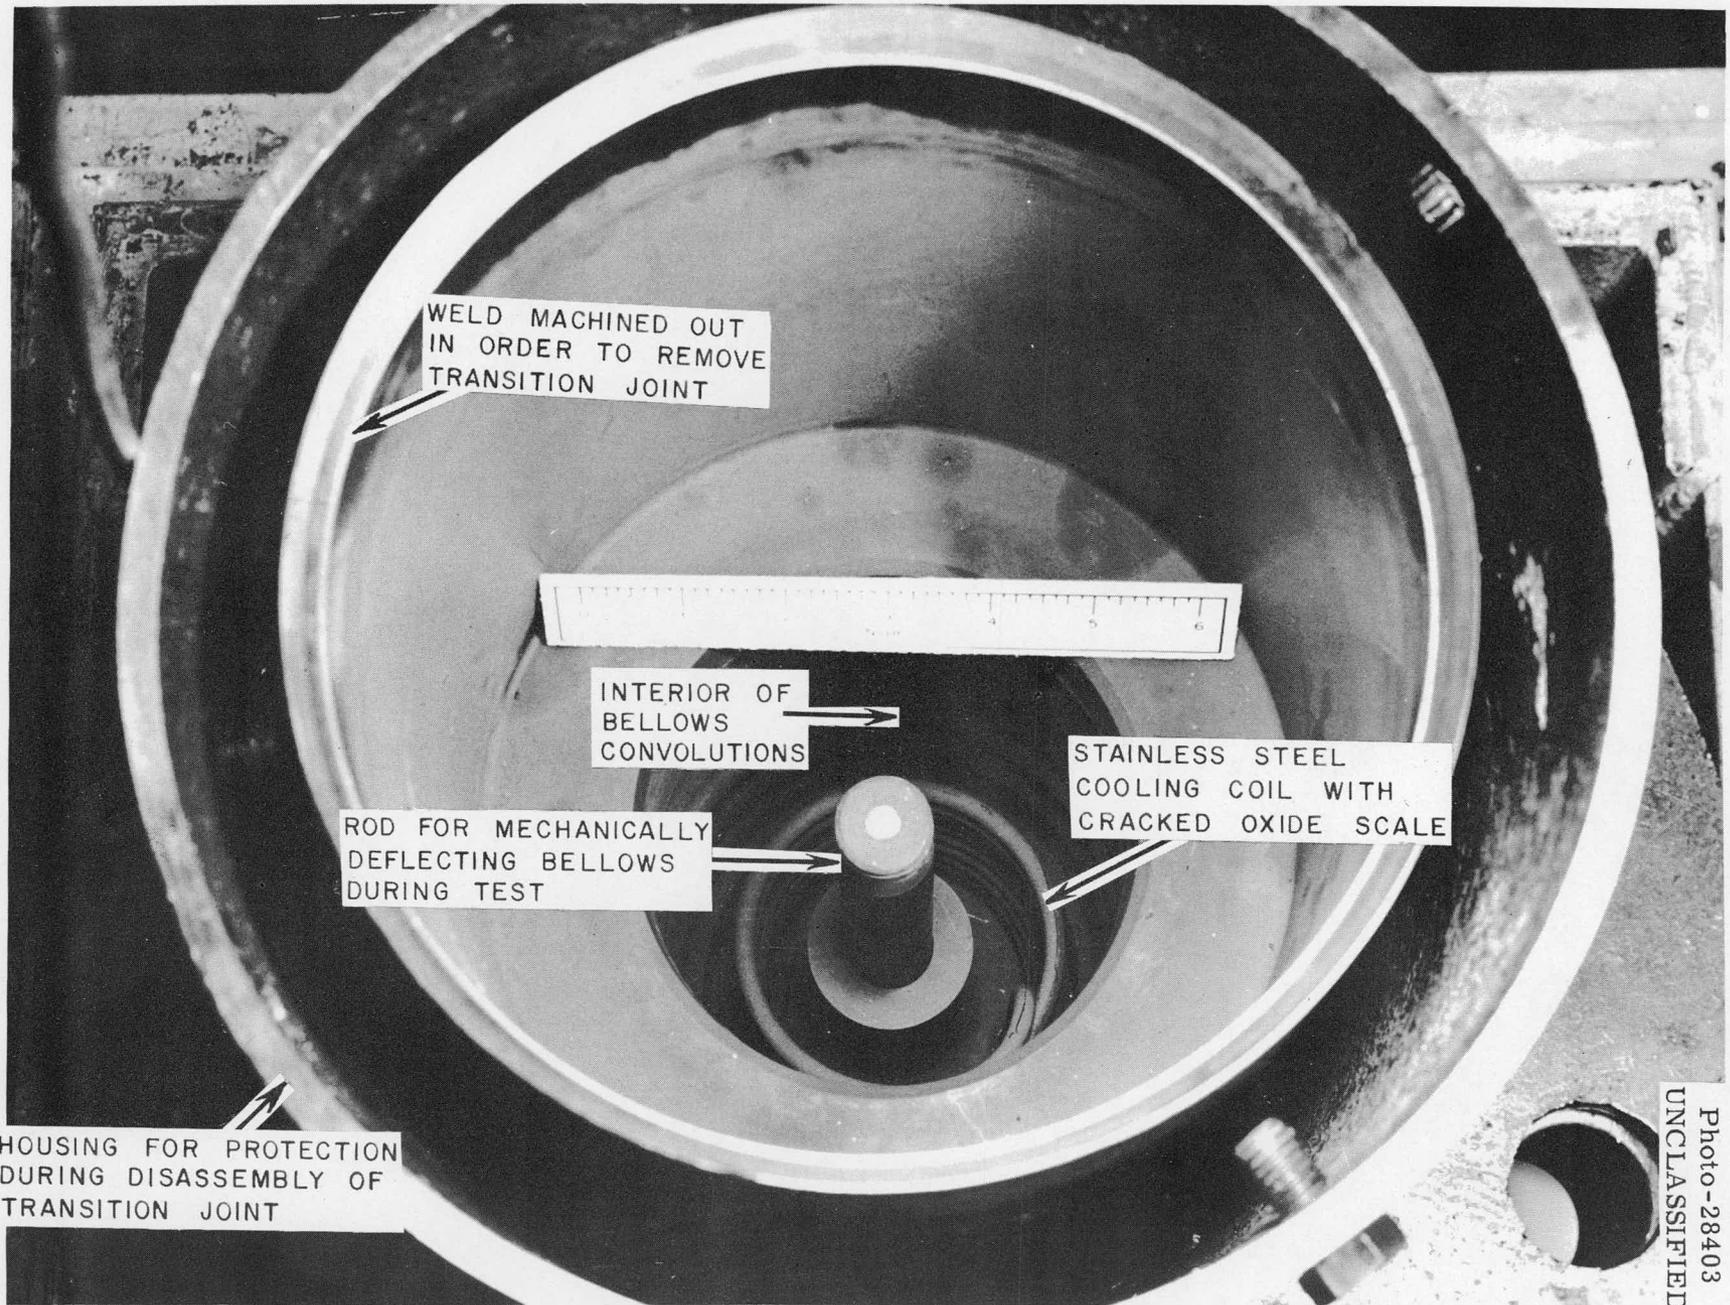
Fig. 2 Interior of Bellows after 2920 hr Exposure to Water at 100-300°C

The removal of the transition joint allowed the interior of the bellows to be inspected. Figure 2 is a photograph of the interior of the bellows after removal of the transition joint. No pits or cracks were found, although a deposit of a red oxide, identified as Fe₂O₃ by x-ray diffraction, on top of a heavy dark scale prevented detailed examination of the metal surface.

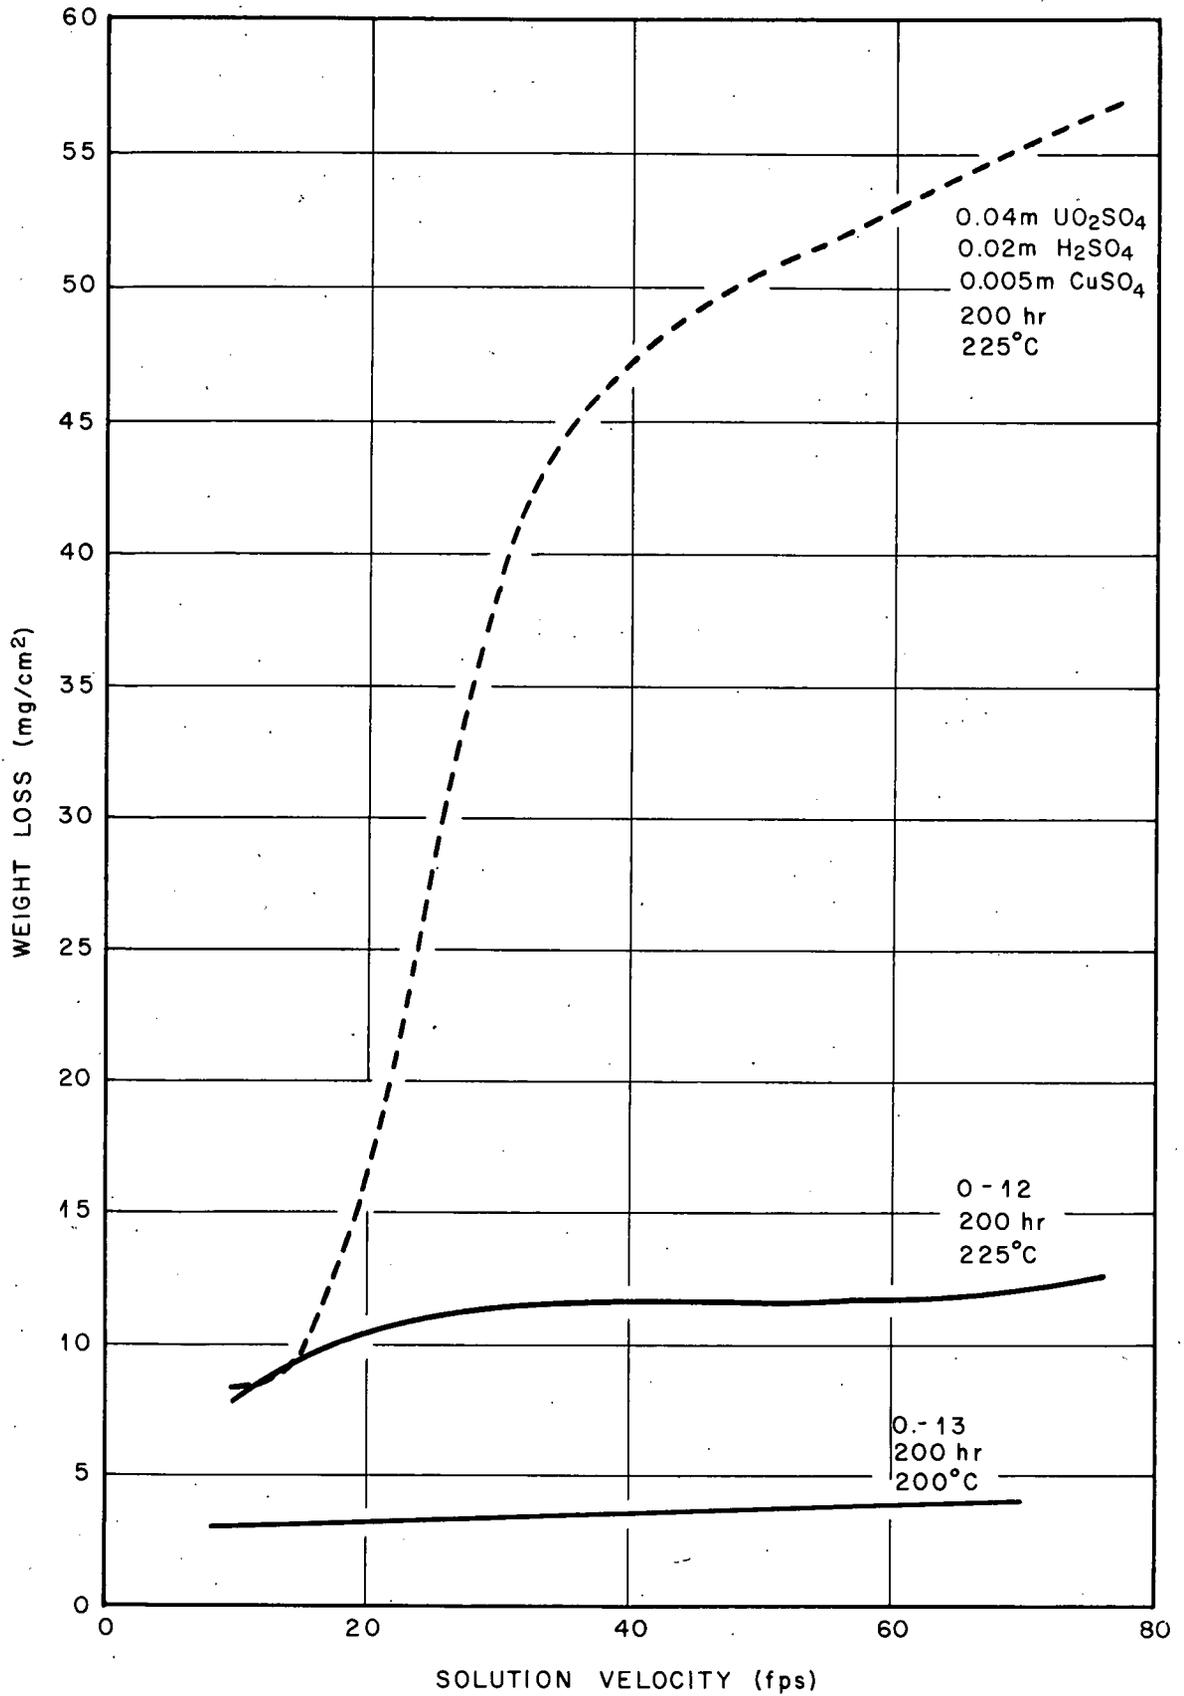
Fig. 3 Weight Losses of Type 347SS Coupons in 0.04m UO₂SO₄ + 0.04m BeSO₄ + 0.005m CuSO₄

The corrosion results for type 347 stainless steel obtained with the 0.04 m UO₂SO₄ - 0.04 m BeSO₄ - 0.005 m CuSO₄ solution at 200 and 225°C are shown in Fig. 3 and are compared with a similar run with the HRT fuel solution at 225°C. In the beryllium-containing solutions, the weight losses of the specimens were nearly independent of velocity at 200 and 225°C. At 225°C, the weight losses of the specimens were about the same as in the HRT solution up to 15 fps and very much lower at higher flow rates. The stainless steel specimens in the beryllium-containing solution at 200 and 225°C were not filmed over at any flow rate in contrast to those exposed in the HRT solution which were filmed over up to about 15 fps. Longer runs will be necessary to show whether corrosion continues at a constant rate. The solution appeared to be completely stable at 200 and 225°C.

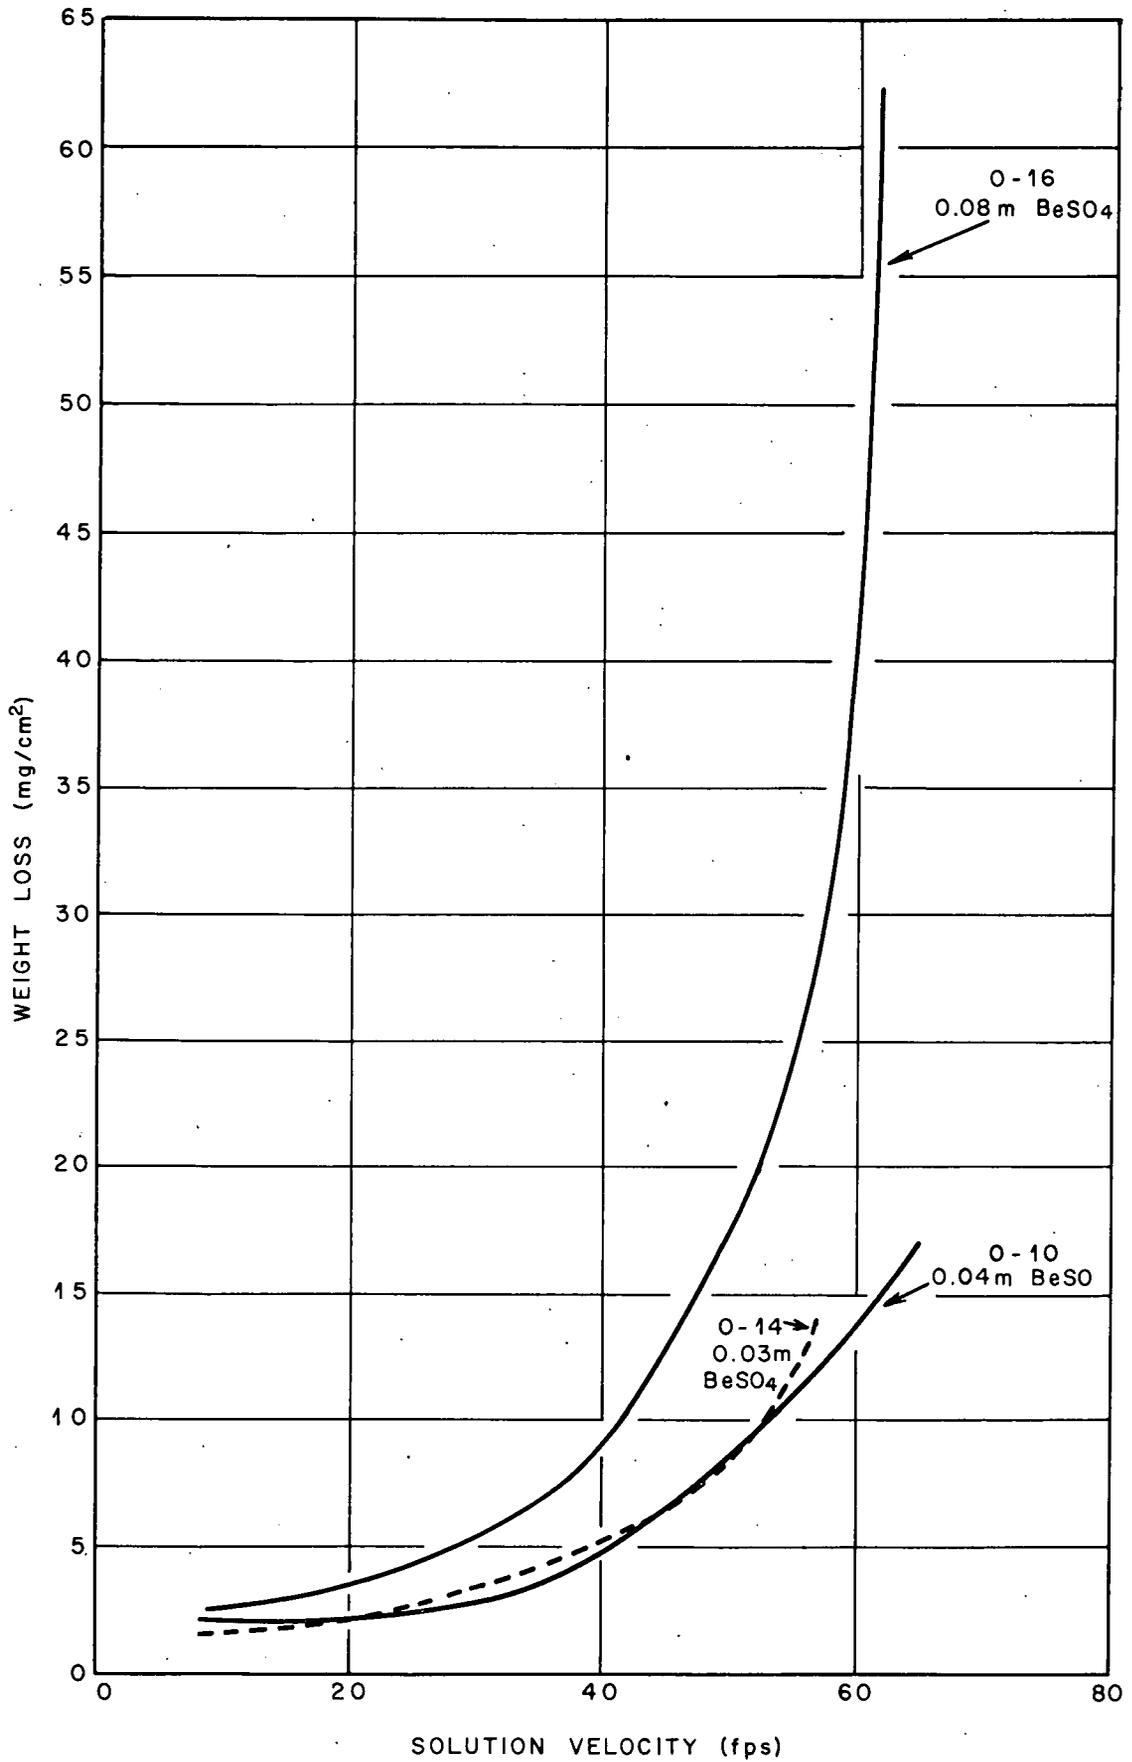
Fig. 4 Weight Losses of Type 347SS Coupons in 0.04 m UO₂SO₄ + 0.005 m CuSO₄ + BeSO₄ at 300°C (200 hr)

The corrosion of type 347 stainless steel in the above two solutions is shown in Fig. 4, as well as the data obtained under the same conditions with the solution containing 0.04 m BeSO_4 . It can be seen that the critical velocities were the same with the solutions containing 0.03 and 0.04 m BeSO_4 and that a slightly lower critical velocity was observed in the presence of the 0.08 m BeSO_4 .

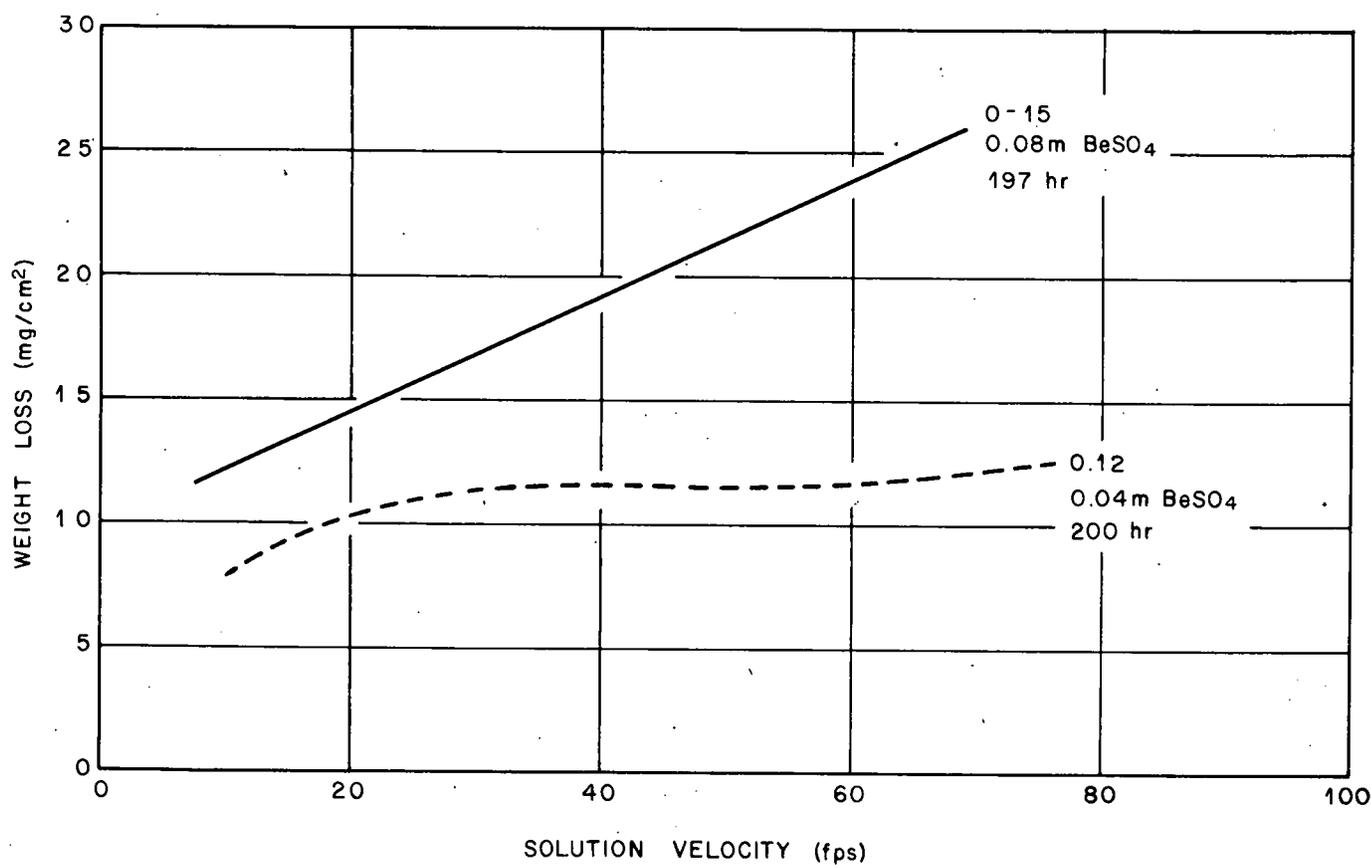
Fig. 5 Weight Losses of Type 347 SS Coupons in 0.04m UO₂SO₄ + 0.005m CuSO₄ + BeSO₄ at 225°C

Figure 5 compares the corrosion of stainless steel at 225°C in the $0.04\text{ m UO}_2\text{SO}_4 - 0.08\text{ m BeSO}_4 - 0.005\text{ m CuSO}_4$ solution with a similar solution containing 0.04 m BeSO_4 . It can be seen that the solution with the greater concentration of beryllium sulfate was the more corrosive. Both solutions were completely stable during the runs.

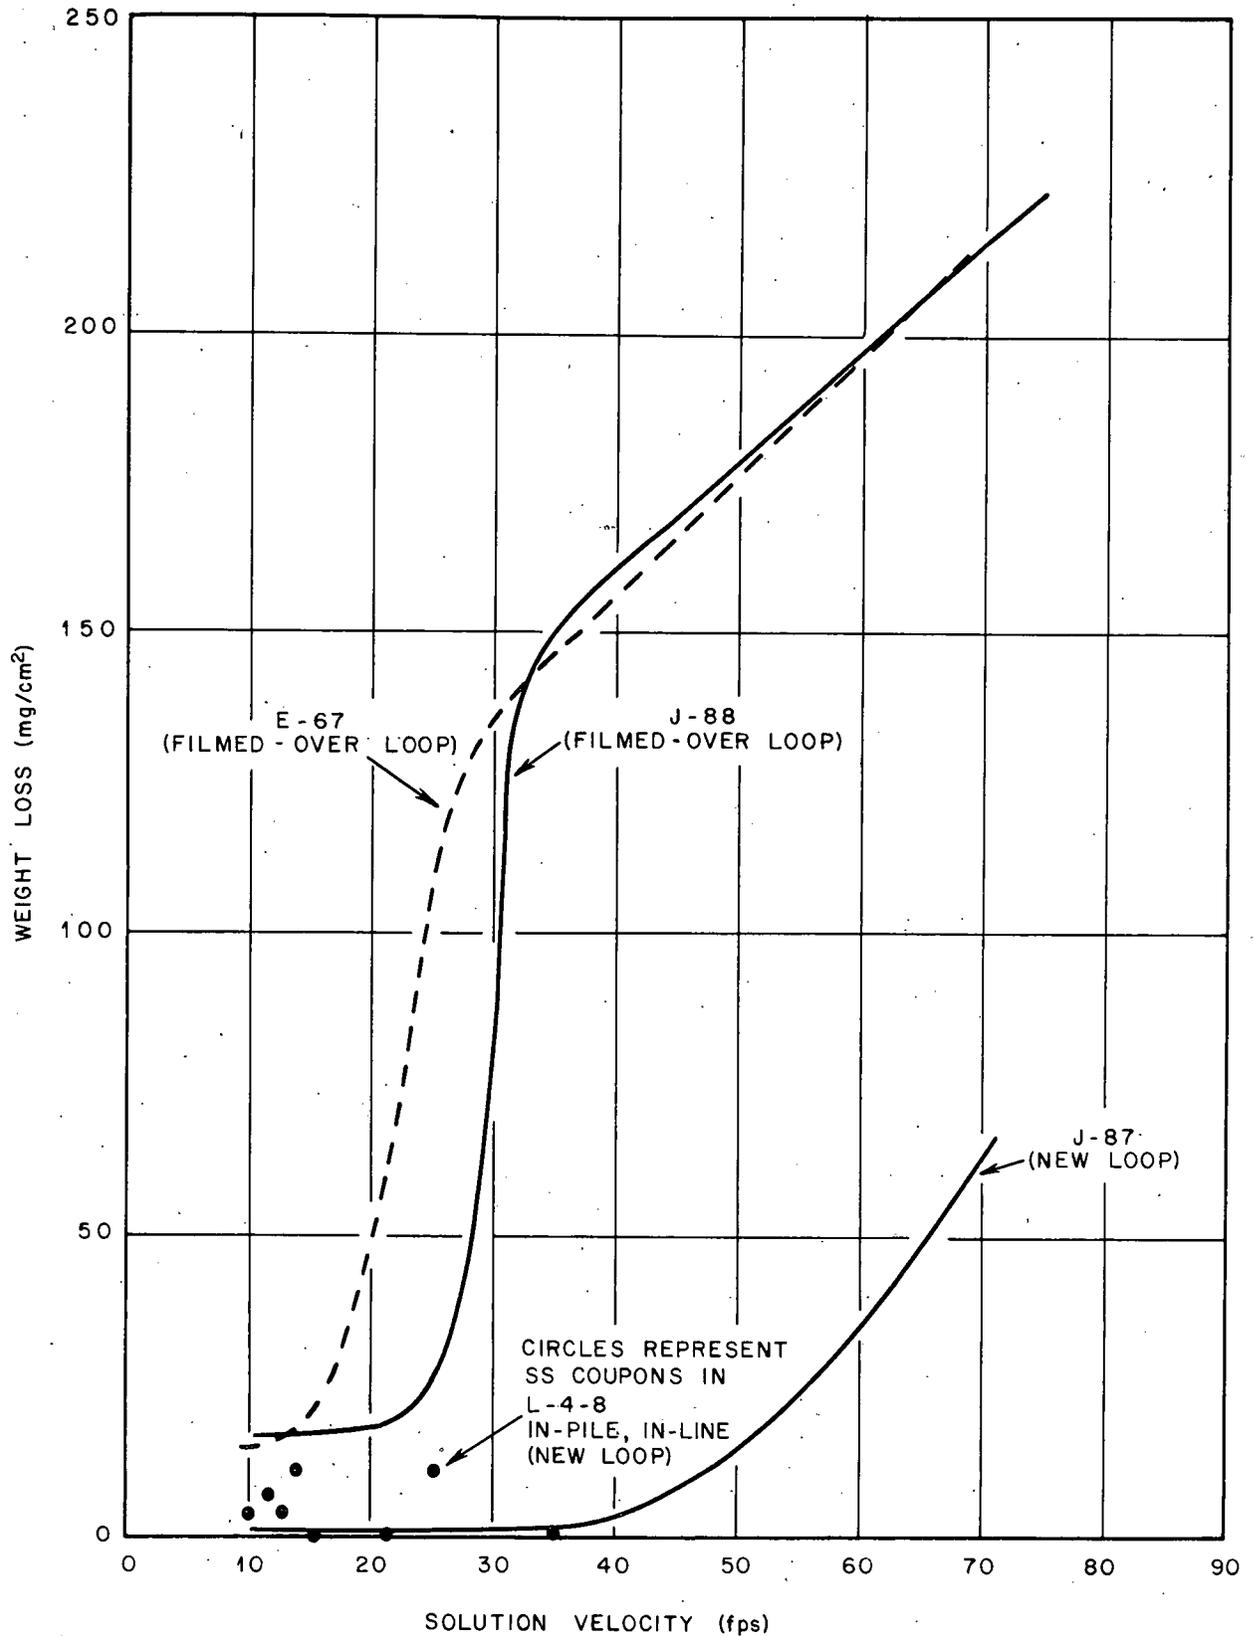
Fig. 6 Effect of Loop History on Corrosion of Type 347 Stainless Steel Coupons in 0.17m UO₂SO₄ + 0.04m H₂SO₄ + 0.03m CuSO₄ at 250°C

The conditions of the two series of runs J-87 and J-88, and of a comparison in-pile run, L-4-8¹¹, are given in Table V. The weight losses of type 347 stainless steel coupons are plotted versus solution velocity in Fig. 6.

The results showed that stainless steel specimens exposed in a new loop (J-87) had markedly lower weight losses and a higher critical velocity than specimens exposed in a filmed-over loop (J-88); also, good agreement was obtained between specimens exposed in a new loop (J-87) and "in-pile" "in-line" specimens (L-4-8)¹¹. The results from run J-88 agreed very closely with those from run E-67¹², a previous run made under similar conditions, except the critical velocity was slightly higher in run J-88. The higher critical velocity may have been due to the slightly higher steam overpressure in run J-88 (about 350 psi) than in run E-67 (about 250 psi)¹³.

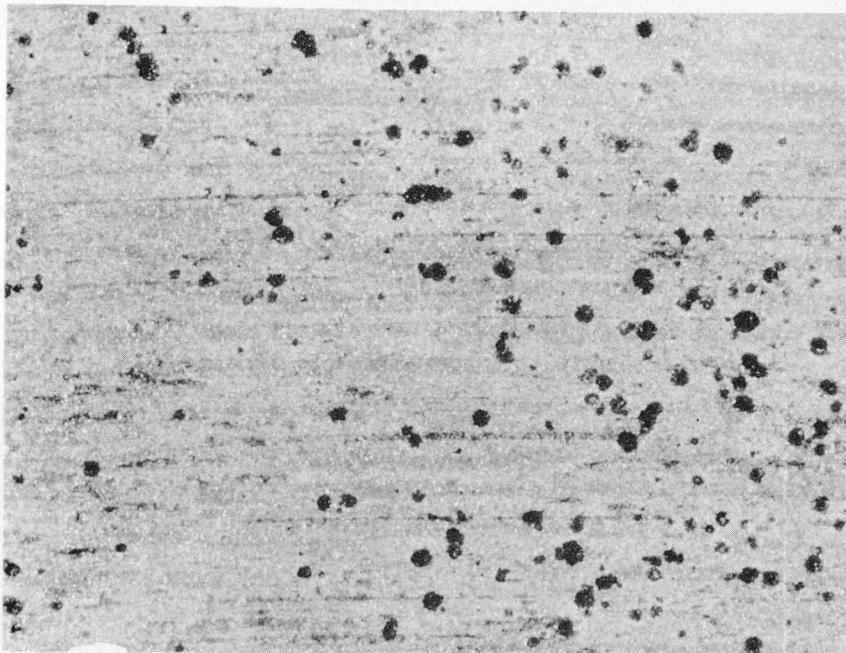
Figure 7

Photomicrograph of Pitted Surface of Type 347 Stainless Steel Stressed Specimen Exposed at 250°C to 0.17 *m* UO₂SO₄ Containing 50 ppm Chloride.

The run was continued as H-104d, with no oxygen until precipitation occurred and the pH of the solution dropped from 2.5 to 1.7. Examination of the specimens after H-104d showed no cracks; however, all specimens showed extensive, general pitting. The pits were shallow, roughly 1 mil deep, which suggests that the pitting attack occurred only during H-104d when oxygen exhaustion occurred. Fig. 7 is a photomicrograph of the surface of one of the stressed specimens exposed to spray in H-104, showing the dark pits. Fig. 8 is a photomicrograph of several of the pits showing the absence of cracking.

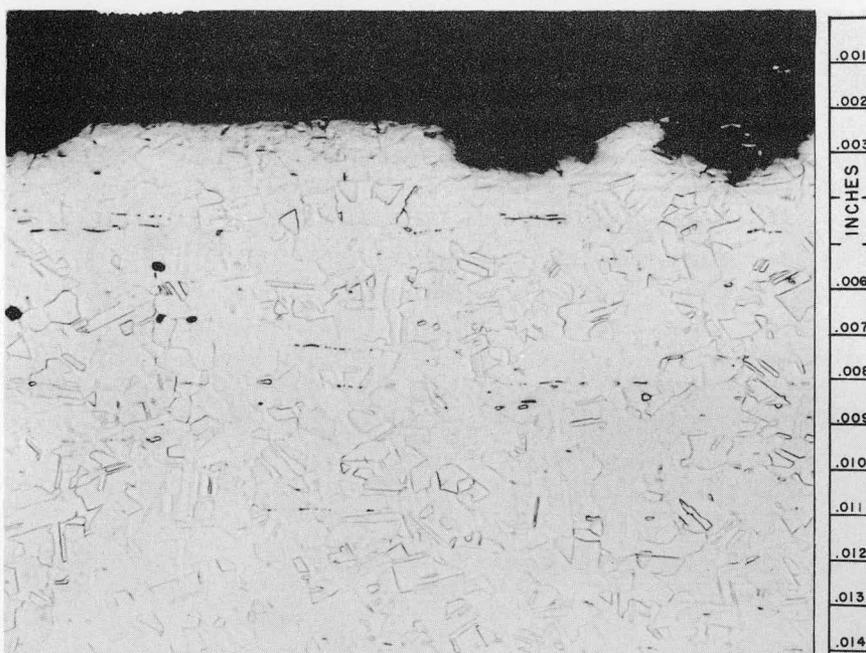
Figure 8

Photomicrograph of Pits Shown in Figure 7.

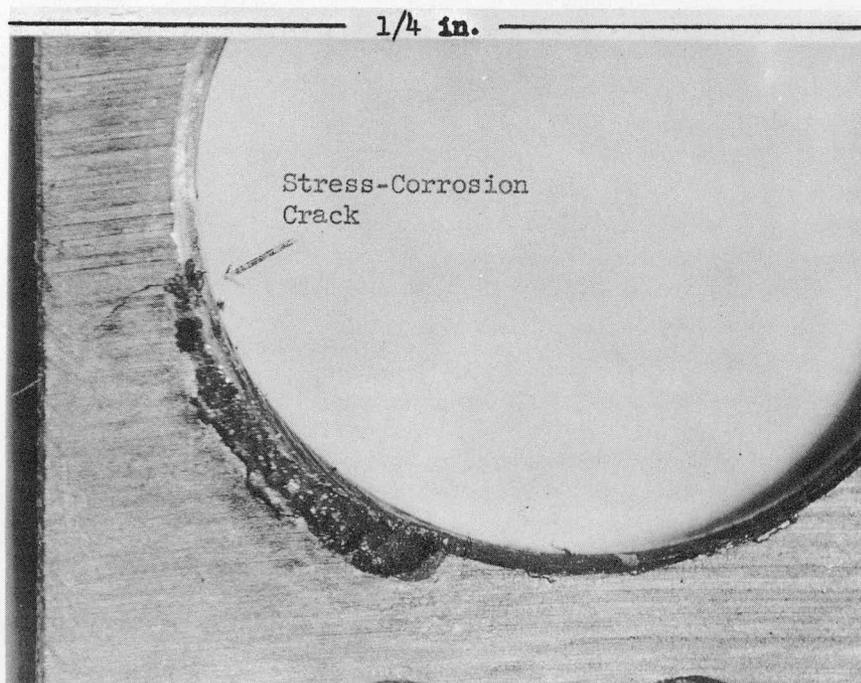
Figure 9

Stress-Corrosion Crack on a Type 347 Stainless Steel Stressed Specimen Underneath a Bolt Head After 211 hr in 0.17 *m* UO₂SO₄ Containing 50 ppm Chloride and 1000-3000 ppm Oxygen at 200°C

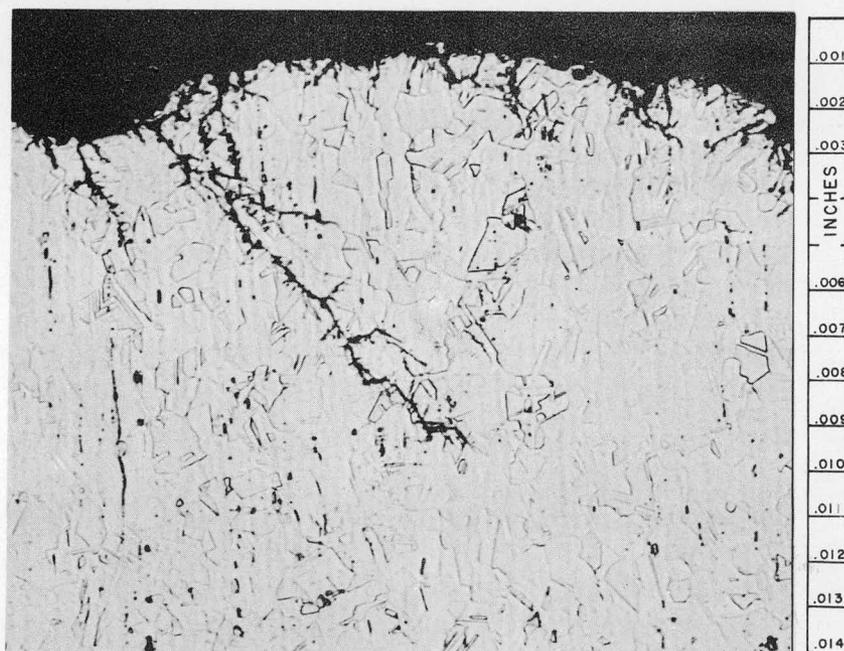
Figure 10

Photomicrograph of Stress-Corrosion Crack Shown in Figure 9
Magnification 250X

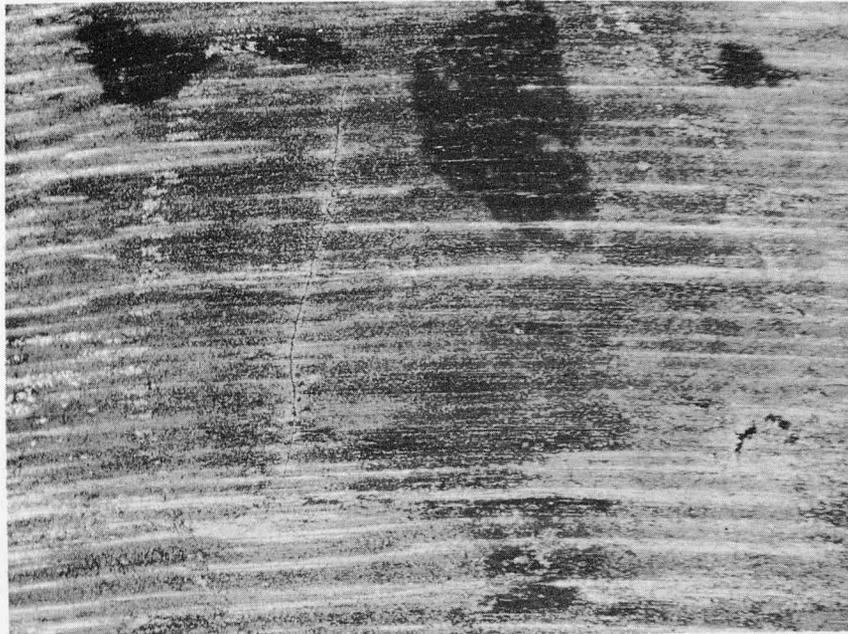
Figure 11

Stress-Corrosion Crack on a Type 347 Stainless Steel Stressed Specimen After 200 hr in 0.17 m UO_2SO_4 Containing 50 ppm Chloride in the Absence of Oxygen at 200°C. 16 X

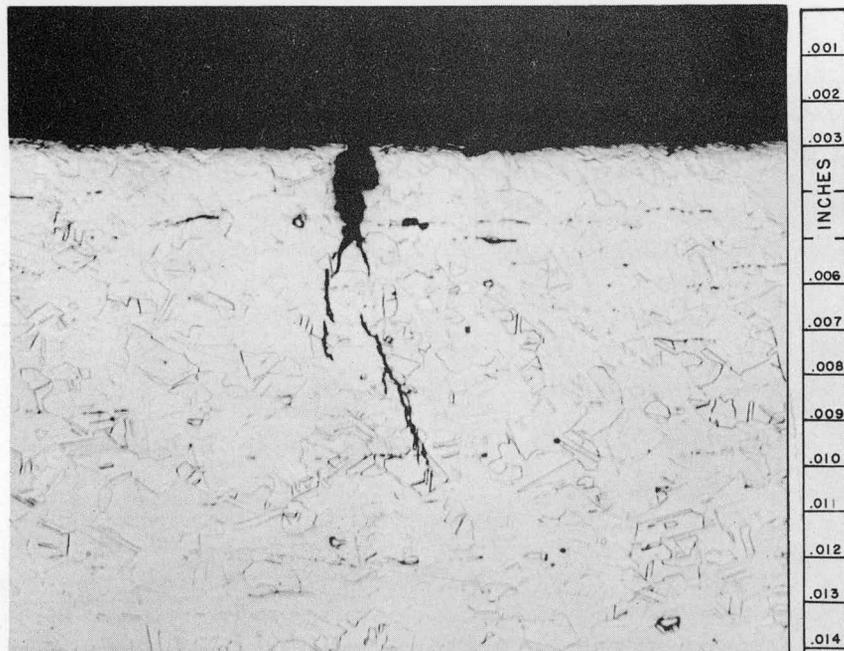
Figure 12

Photomicrograph of Stress-Corrosion Crack Shown in Figure 11. Magnification 250 X
