Argonne National Laboratory

**HYDROGEN EMBRITTLEMENT
IN IRRADIATED STEELS**

A. D. Rossin

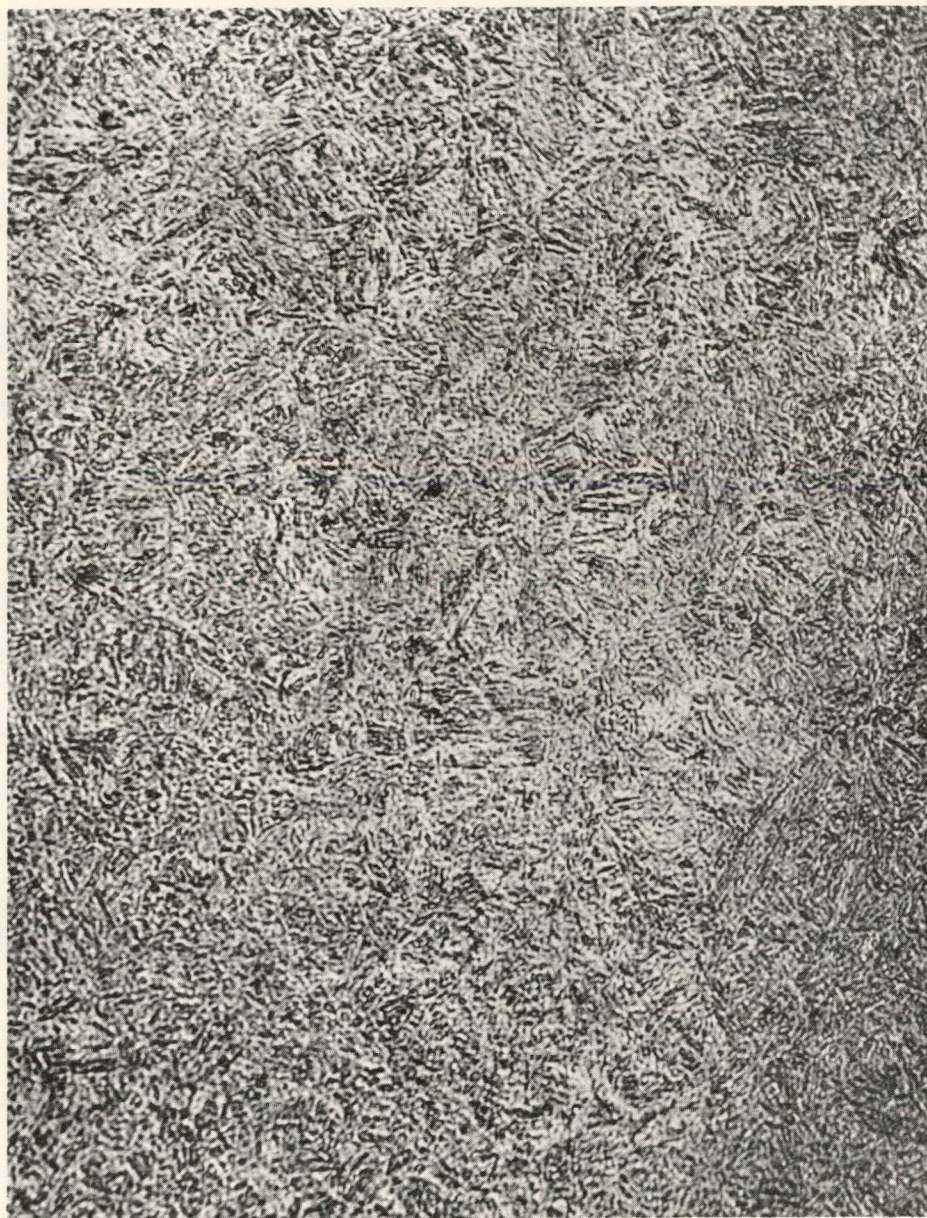
Fig. 16. Tempered Martensite Microstructure of 4340 (Etch 2% Nital, 1000X)

The heat-treated 4340 has a tempered martensite microstructure. Micrographs were taken with and without hydrogen, unirradiated and irradiated. Figure 16 is typical. No differences in microstructure could be detected among these four conditions.

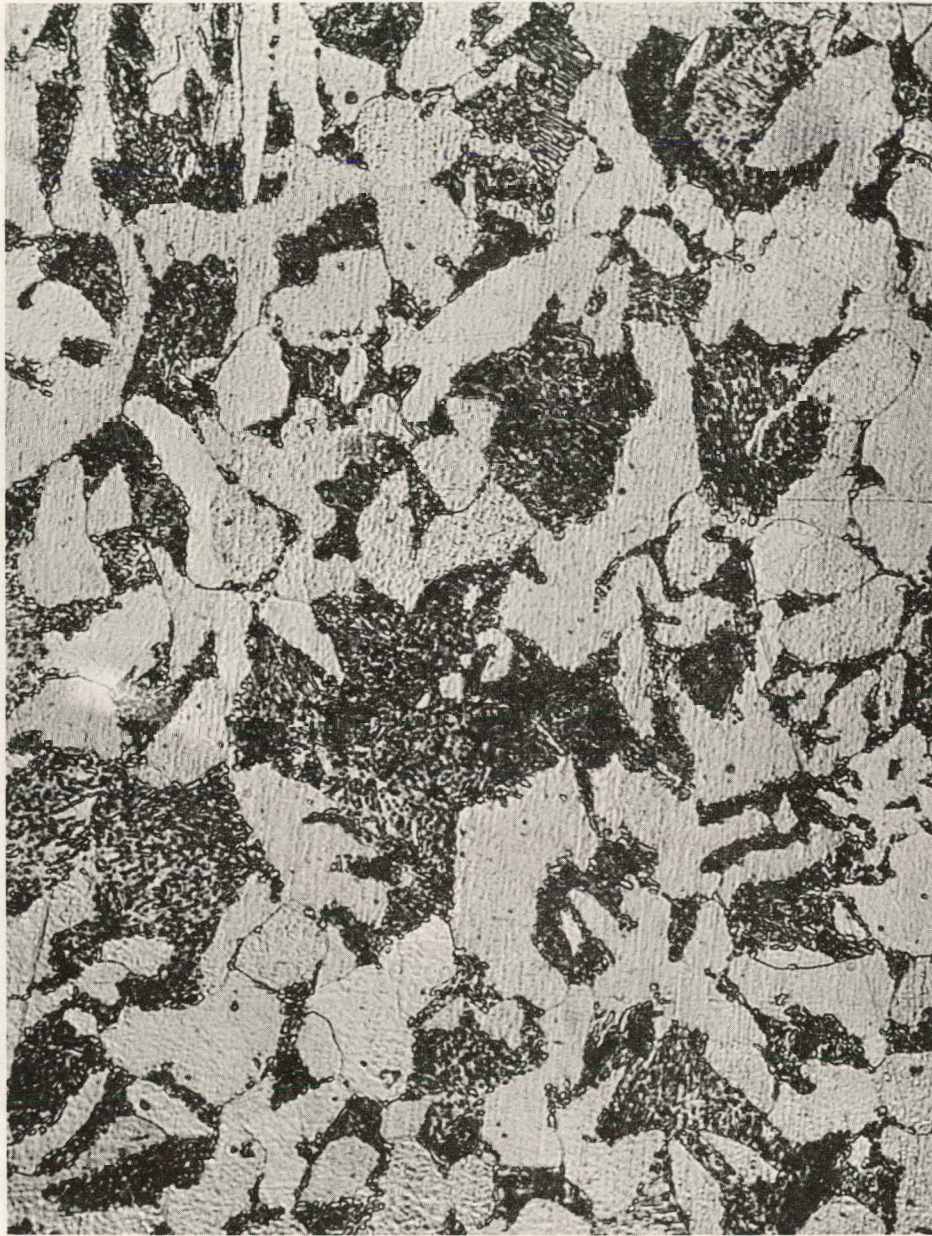
Fig. 24. Photomicrograph of 212-B Typical Ferrite and Pearlite Microstructure (Etch 2% Nital, 1000X)

Photomicrographs were taken of samples from each condition. At a magnification of 1000, no differences were visible among any of the pictures. Figure 24 is a typical micrograph of the ferrite-pearlite structure of this steel.
