WANL-TME-1416  
April, 1966

Westinghouse Astronuclear Laboratory

NOTES OF MONTHLY DEVELOPMENT TEST PROGRAM REVIEW MEETING  
HELD WITH SNPO AT WANL ON MARCH 30, 1966  
(Title Unclassified)

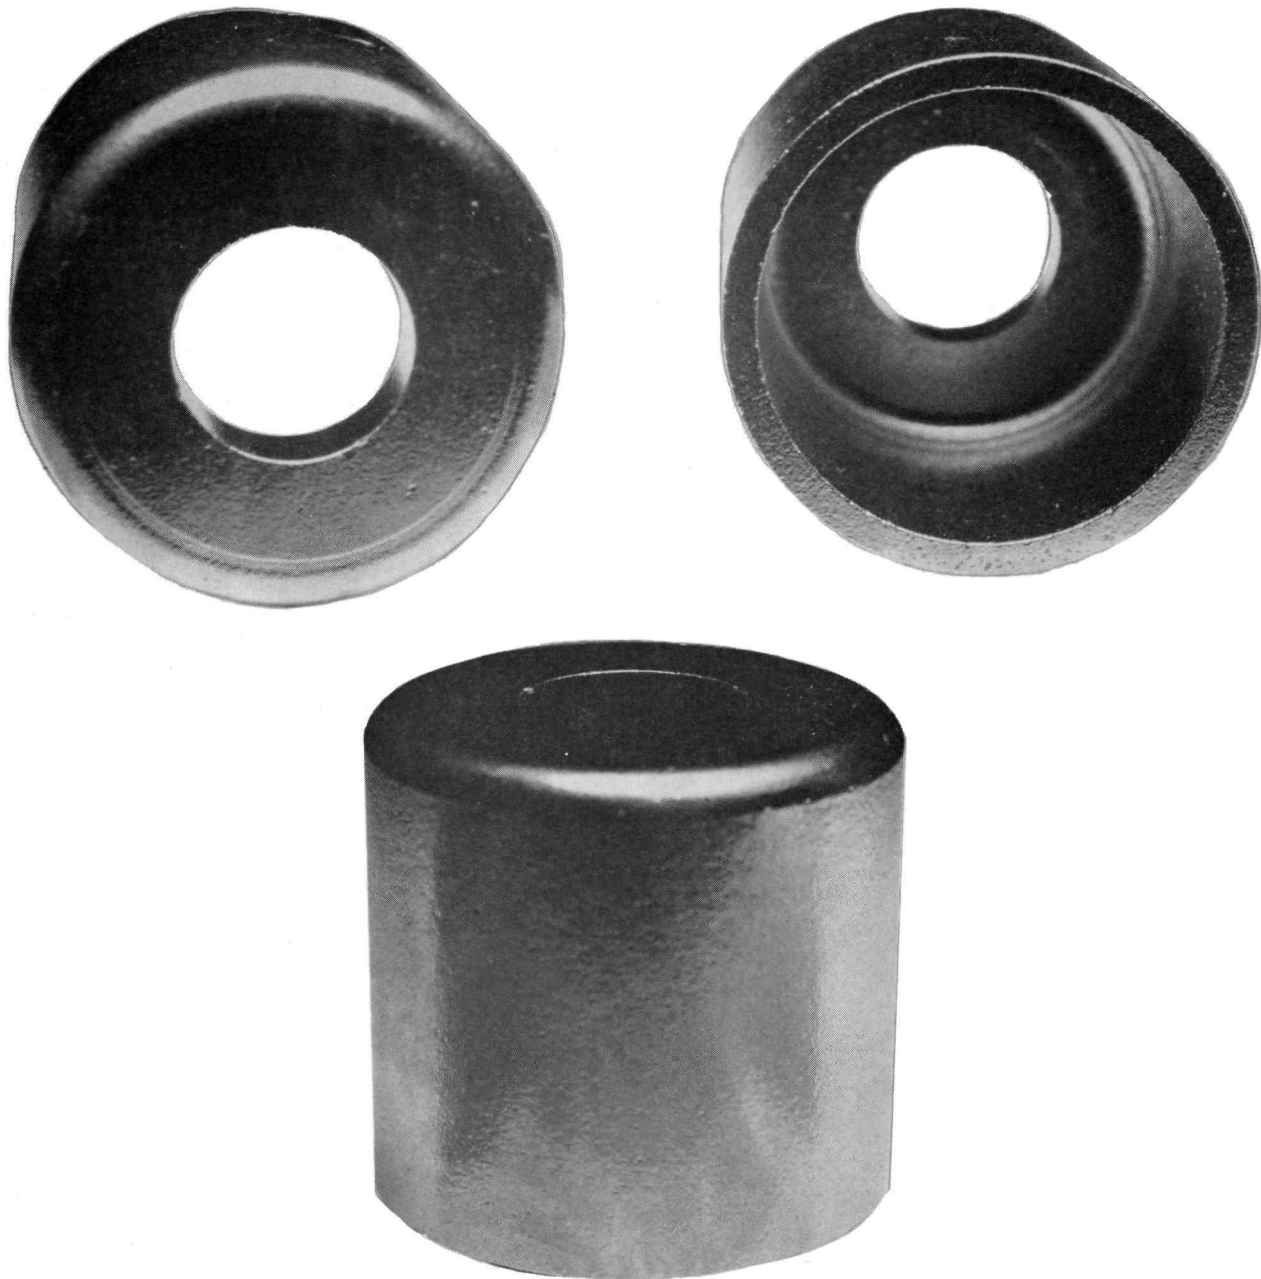
FIGURE 1  
PROTECTION CUP USED IN SINGLE ELEMENT TEST

A sixty minute test, designed to evaluate a pyro cup of the A-6 design, was made with a skirtless block. The test was made in three 20 minute cycles. A fourth cycle was attempted but had to be terminated because of a broken chuck. After the first 20 minute run, many hair line cracks were observed on the cup. These cracks appeared to become more pronounced after each cycle but at the end of the test the cup still looked good (Figure 1). Additional testing is planned.

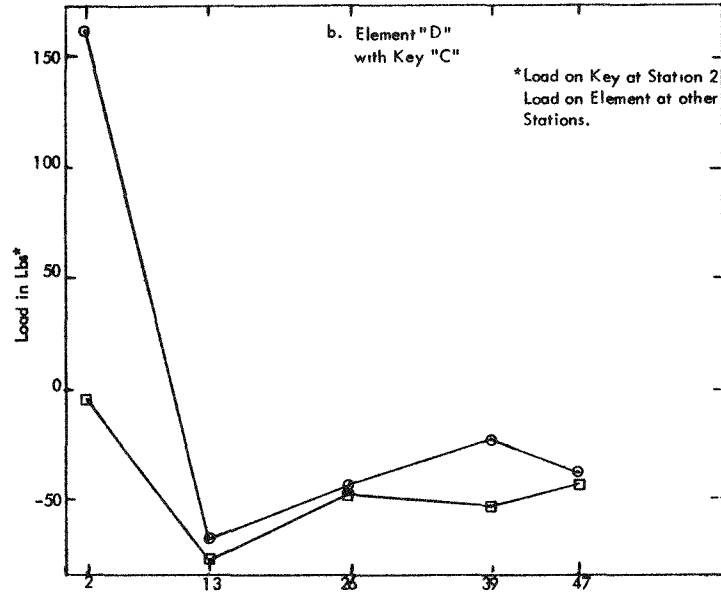
FIGURE 18

DISTRIBUTION OF AXIAL LOAD ALONG KEYED ELEMENTS
