EXAMINATION OF 304 STAINLESS STEEL CLADDING  
FROM COLD-SWAGED AND ROLLED FUEL RODS

By  
W. V. Cummings  
D. R. Lewis  
R. E. Blood

July 1962

Vallecitos Atomic Laboratory  
General Electric Company  
San Jose, California

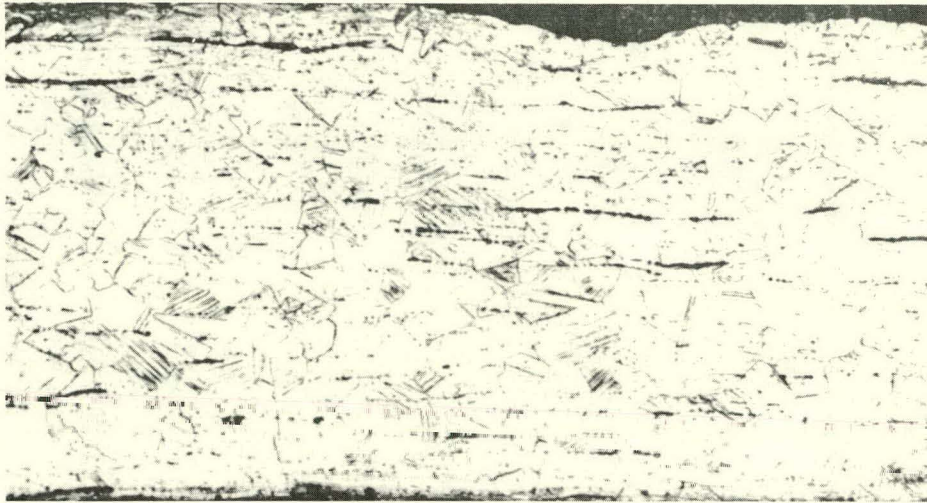
150 X

**FIGURE 4 COLD SWAGED, PROTOTYPE, LONGITUDINAL SECTION**

The microstructure of this tube was typical of cold worked 304 stainless steel. The grains were highly distorted and often elongated in the direction of working. Slip lines were visible in all of the samples. In addition to the usual slip lines, "flow lines" or lines of deformation could be seen throughout the tube wall in the direction of swaging. These lines formed a wavy pattern which appeared to flow the full length of each specimen but showed a slight misalignment at the grain boundaries.
