EROSION FLOW TESTING OF PURPOSELY  
DEFECTED STAINLESS STEEL CLAD  
COMPACTED  $UO_2$  POWDER FUEL

By  
J. W. Lingafelter  
E. A. Lees  
R. J. Seely

February 1962

Atomic Power Equipment Department  
General Electric Company  
San Jose, California

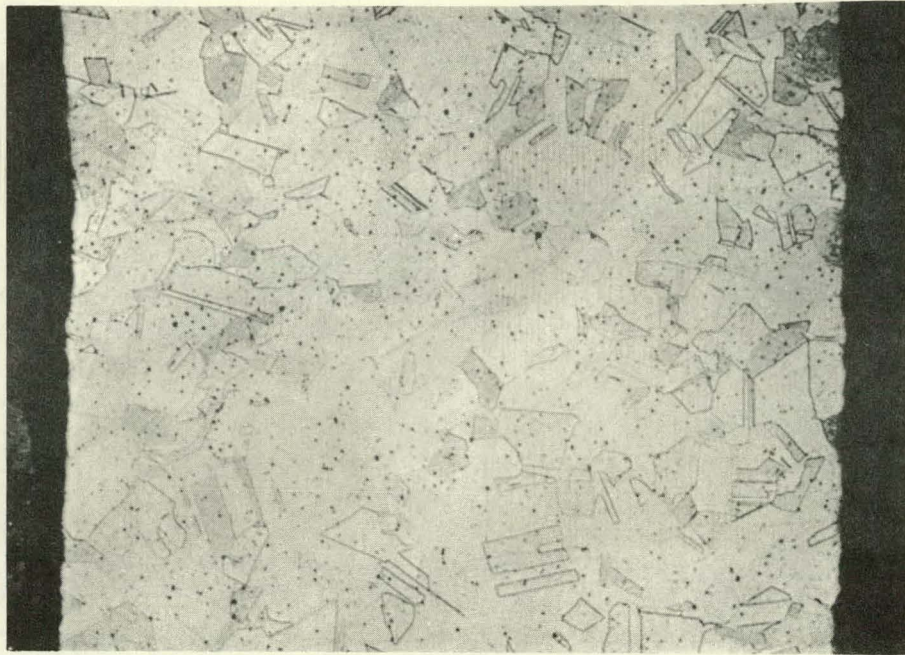
FIGURE 11 PHOTOMICROGRAPHS (150X) OF CLAD AND UO<sub>2</sub> FROM COLD SWAGE-ANNEALED SAMPLE

CLADDING

UO<sub>2</sub> AT BASE OF SLIT

The cladding of the four specimens tested 6000 hours was examined for evidences of corrosion attack after exposure to flowing 536 F water. The clad conditions represented by the four specimens were: cold swaged and cold rolled (~ 1/2 hard condition), hot swaged (~1/8 hard condition), and fully annealed. Typical clad surfaces are shown in Figures 11-14. None of the clad surfaces showed evidences of corrosion attack or unusual film formation. Of particular interest is Figure 13, showing a fold in the clad produced during hot swaging. Note that no corrosion attack is evident within the crevice.

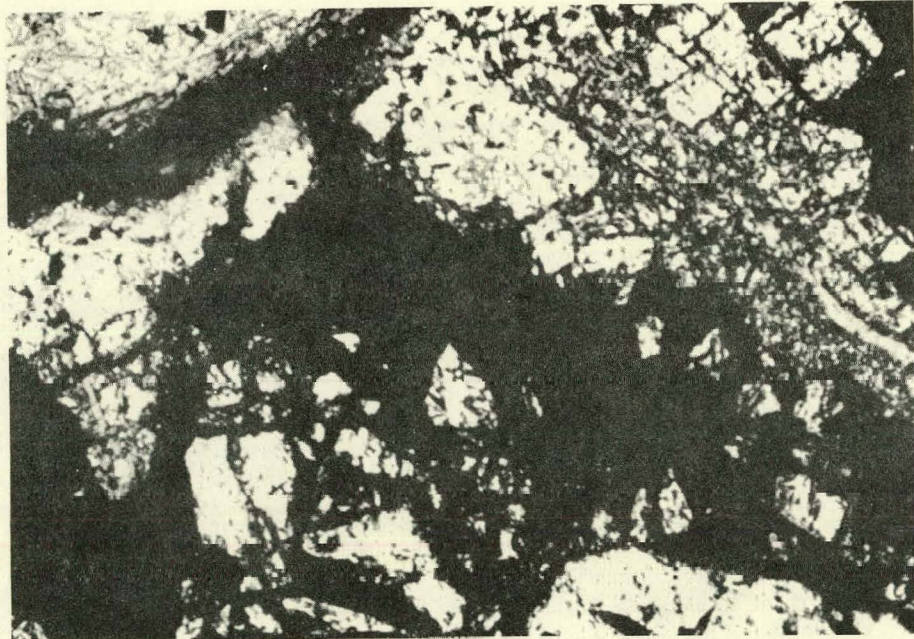
FIGURE 12 (150X) PHOTOMICROGRAPHS, OF CLAD AND UO<sub>2</sub> FROM COLD SWAGED SAMPLE NO. 3

CLADDING

UO<sub>2</sub> AT BASE OF SLIT

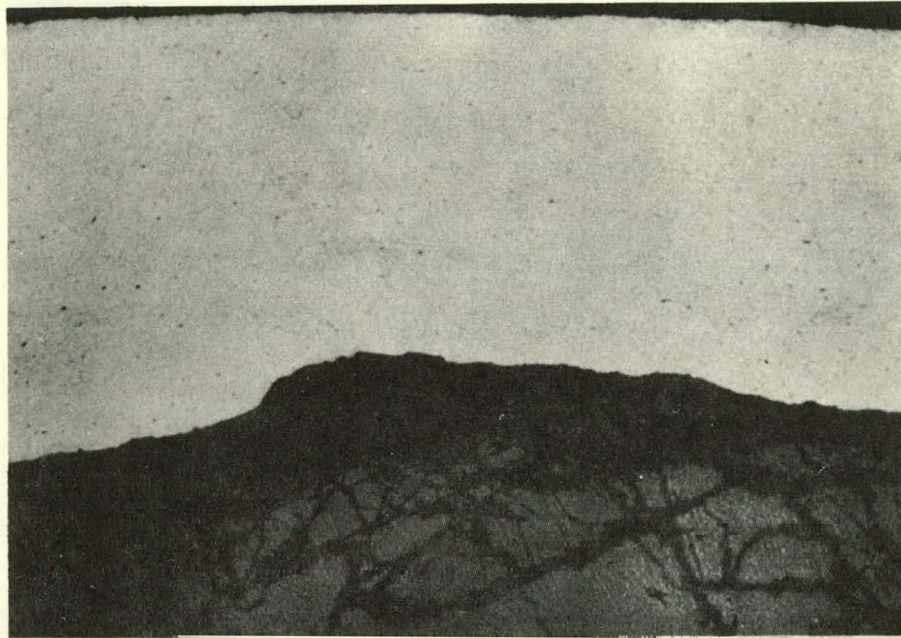
CLADDING (TOP)

UO<sub>2</sub> AT BASE OF SLIT
