INTERIM REPORT ON HTLTR MOCKUP - RUN NUMBER 2

Equipment Development Unit
Reactor and Material Technology Department

Herein are presented results from Run Number 2 of the large mockup designed and built by Equipment Development for research and development in support of the High Temperature Lattice Test Reactor. Results from Run Number 1 have been presented in BNCC-87.

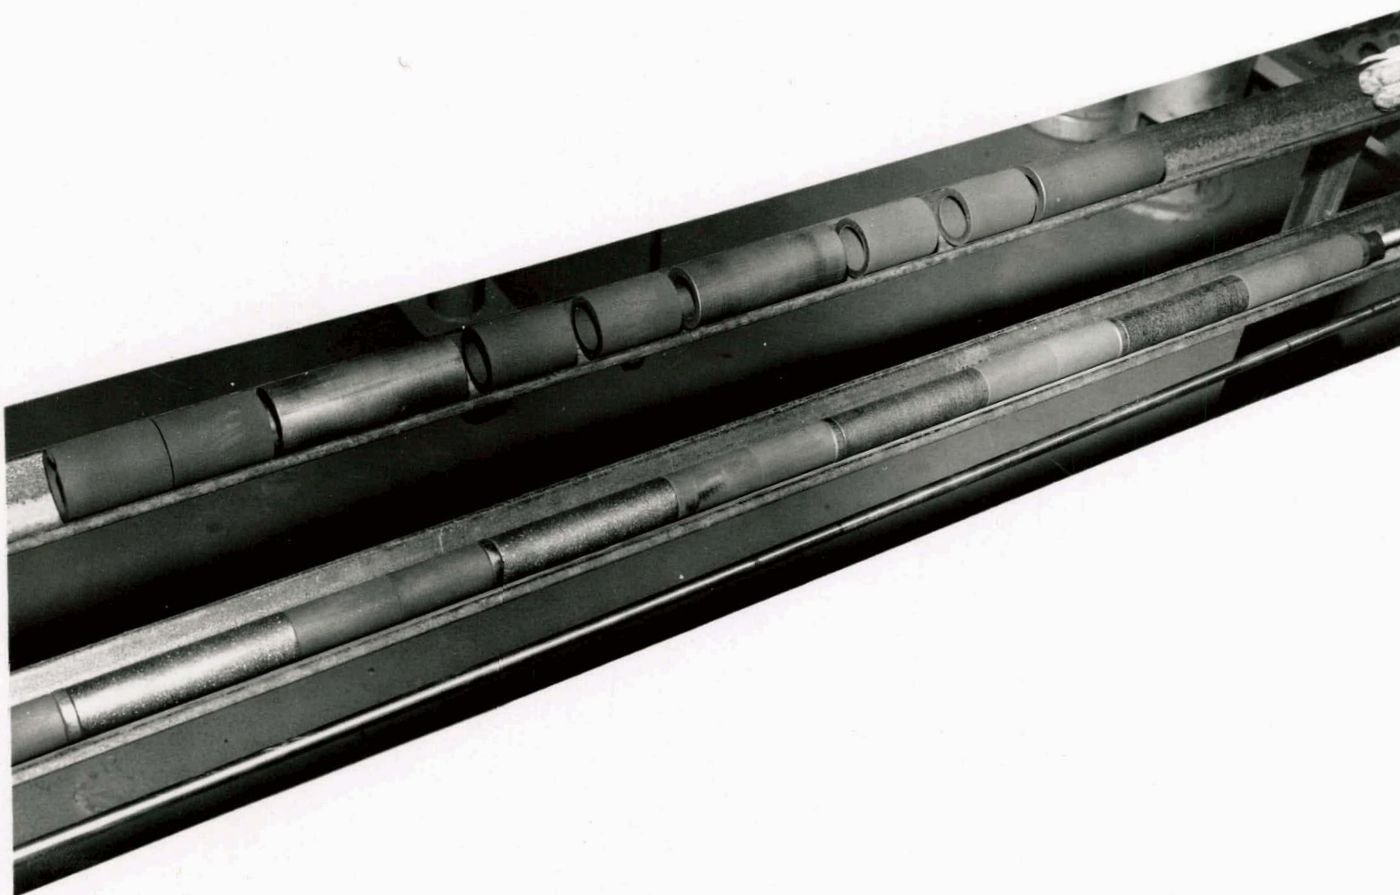
FIGURE 1
Control Rod Elements

A graphite core temperature of approximately 700°C was maintained for a period of 115 hours at which time the mockup was cooled for inspection of the control rod, safety blade, and heater elements. Visual examination of the above-mentioned items revealed little or no graphite corrosion as can be seen in Figures 1, 2, 3, and 4. These conclusions were substantiated by weighing small graphite samples which remained in the mockup during the entire operating period. The interior of the mockup is shown in Figure 17.
