**HIGH-TEMPERATURE TURBINE TECHNOLOGY PROGRAM HOT-GAS  
PATH DEVELOPMENT TEST**

**Part II (Testing)**

**Topical Report**

**General Electric Company  
Schenectady, New York**

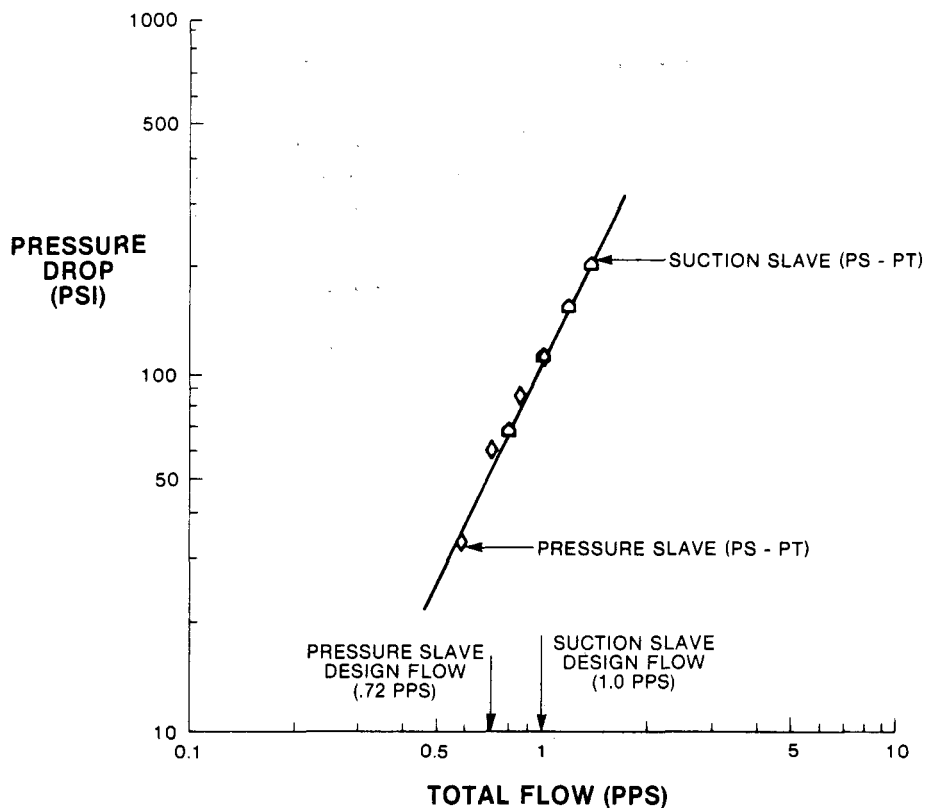
**Figure 2-14. Slave segment coolant flow vs pressure drop**

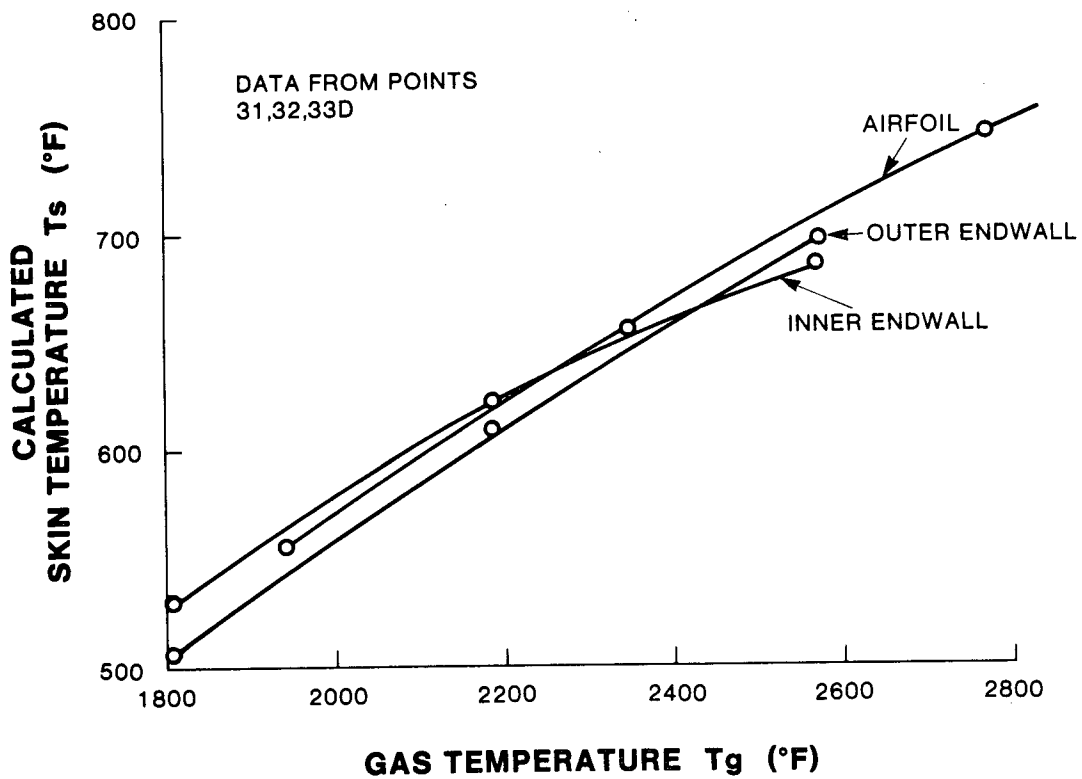
Figure 2-22. First-stage nozzle calculated surface temperature vs gas temperature

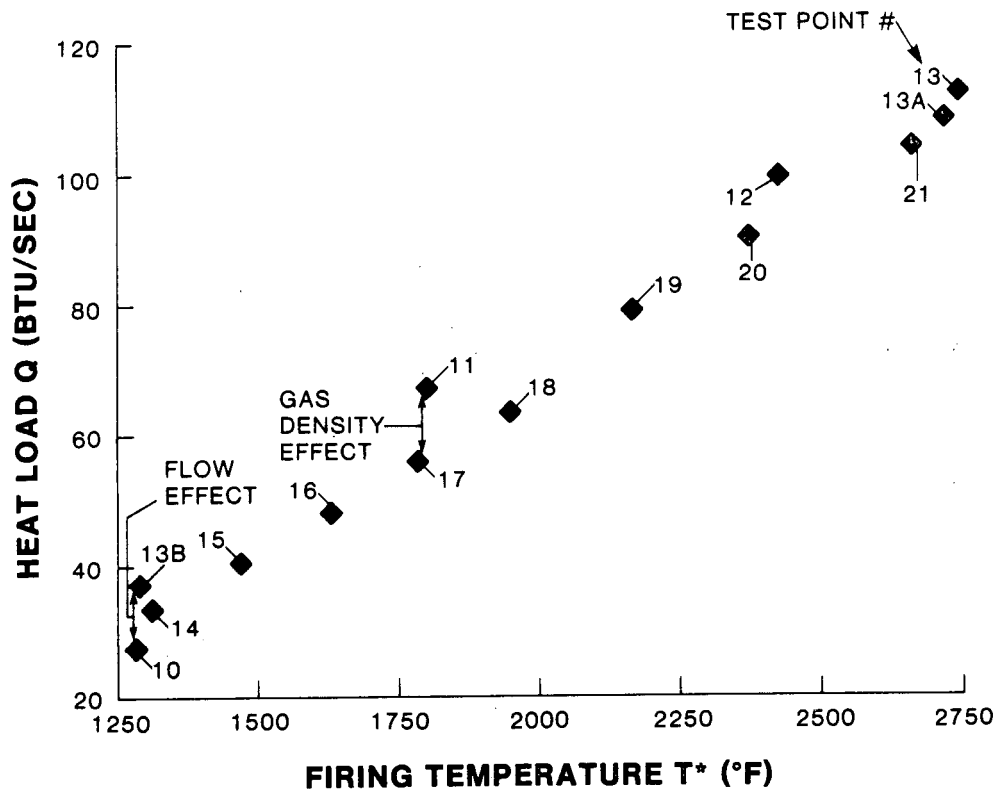
Figure 2-26. First-stage nozzle heat load

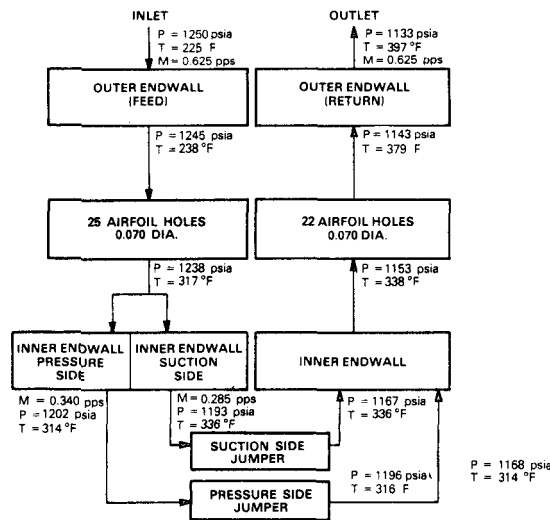
**Figure 3-13. Second-stage nozzle test cooling circuit**

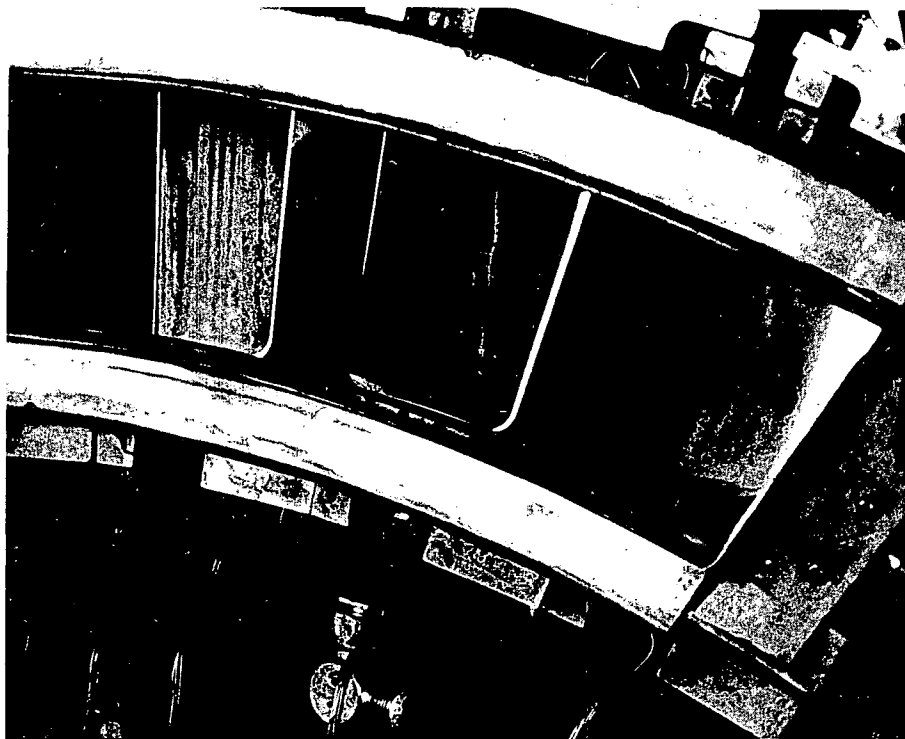
**Figure 3-47.** Second-stage nozzle at conclusion of extended testing (view downstream)

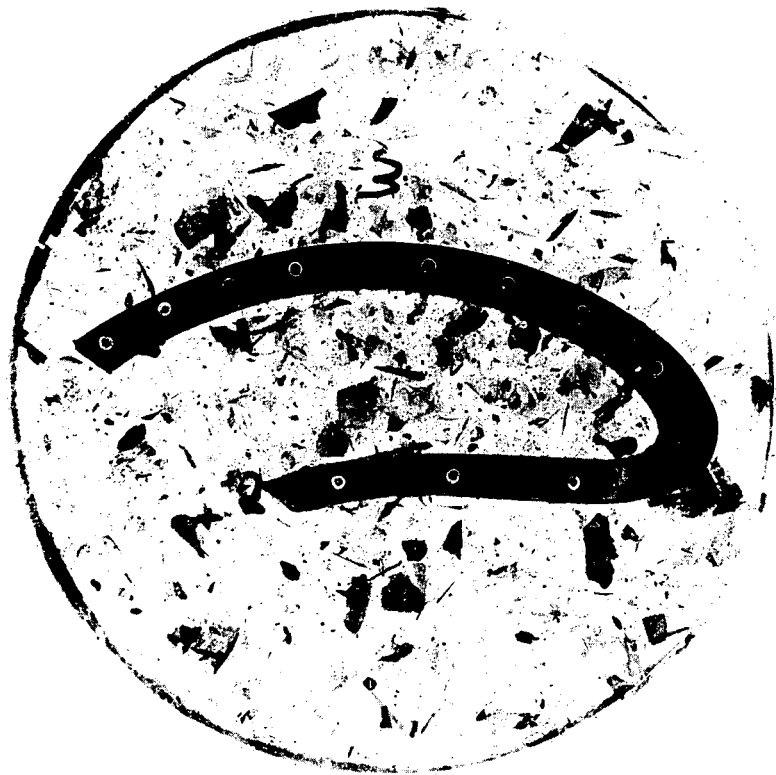
**Figure 3-51. Leading edge airfoil cross section taken near the outer endwall of the second-stage nozzle**

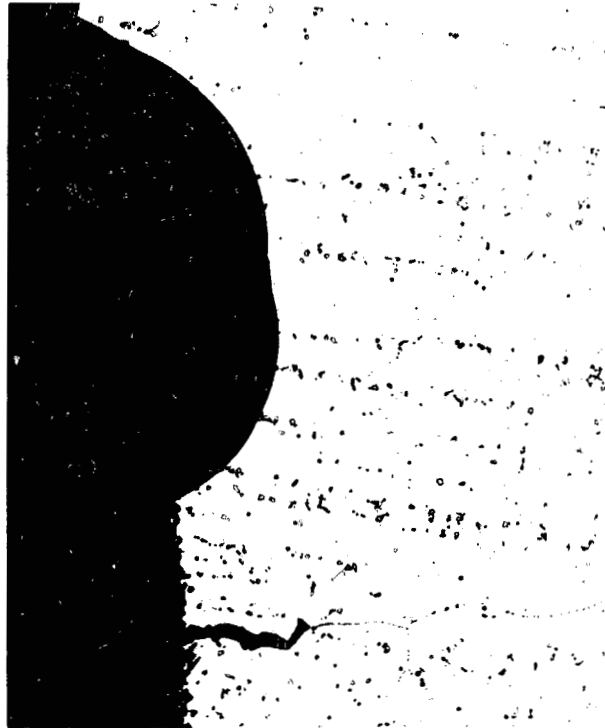
**Figure 3-59. Typical weld repair of the second-stage nozzle showing a microcrack (magnification 90X)**

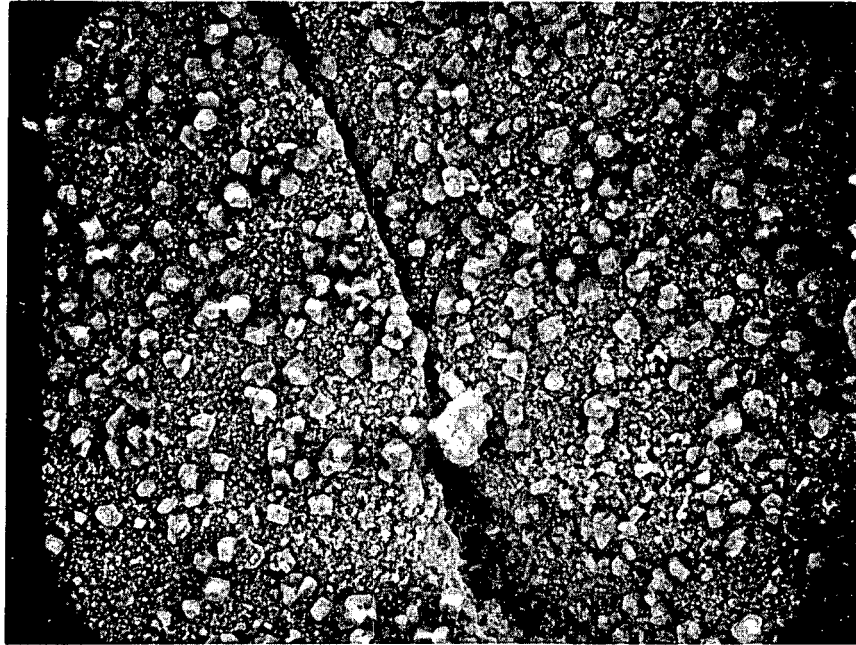
**Figure 3-66. Second-stage nozzle fifth cooling passage inside surface showing fissure in the oxide layer inside the passage (magnification 500X)**
