ADVANCED GAS COOLED NUCLEAR REACTOR MATERIALS EVALUATION AND DEVELOPMENT PROGRAM

PROGRESS REPORT
FOR PERIOD

January 1, 1980 - March 31, 1980

GENERAL ELECTRIC COMPANY
ENERGY SYSTEMS PROGRAMS DEPARTMENT
SCHENECTADY, NEW YORK 12345

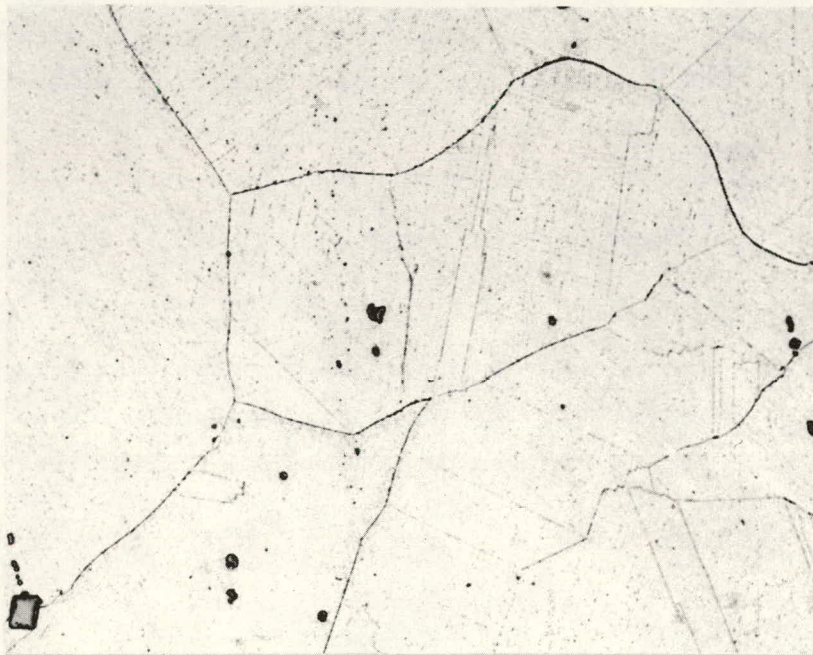
Figure 2.1 Optical Photomicrographs Showing Etched Internal Microstructure of Alloy 800H after Exposure in Controlled Purity He for (a) 1000 Hours at 750°C and (b) 1104 Hours at 850°C.

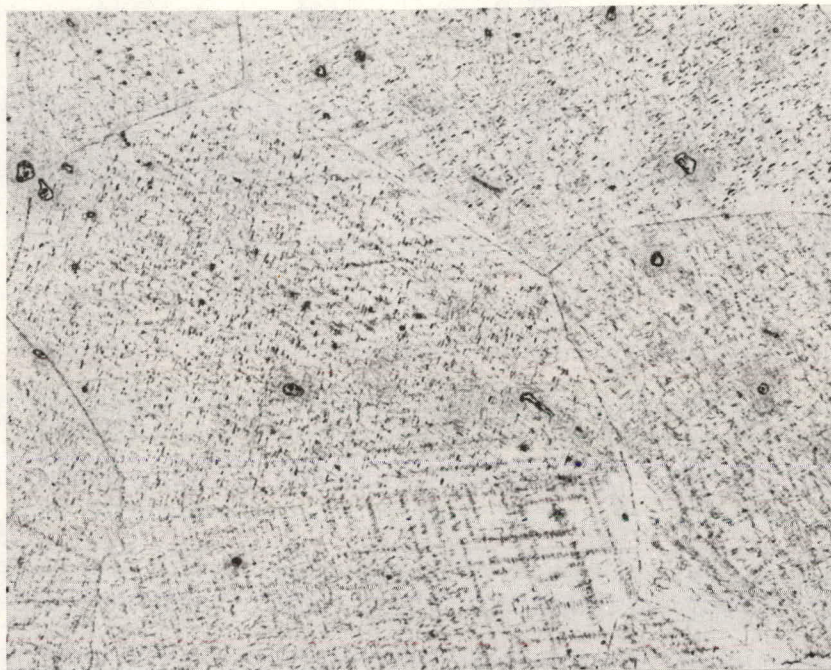
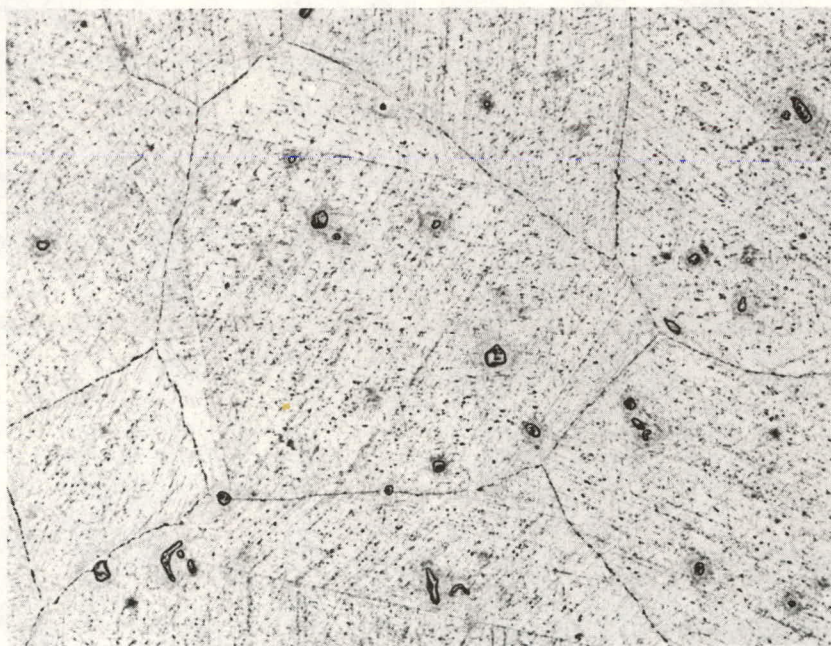
Figure 2.2 Optical Photomicrographs Showing Surface Condition and Subsurface Microstructure of Alloy 800H after Approximately 1000 Hour Exposure in Controlled Purity He at (a) 750°C and (b) 850°C.

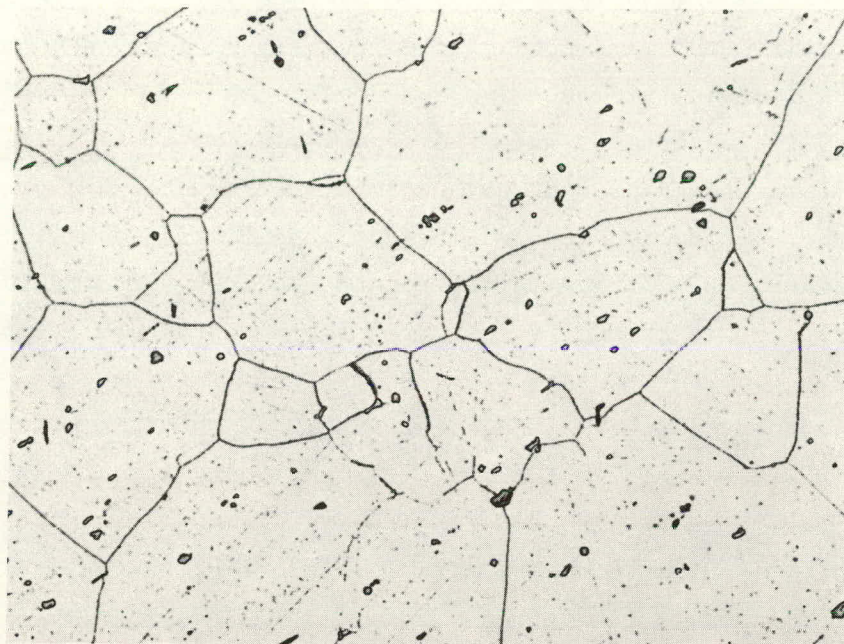
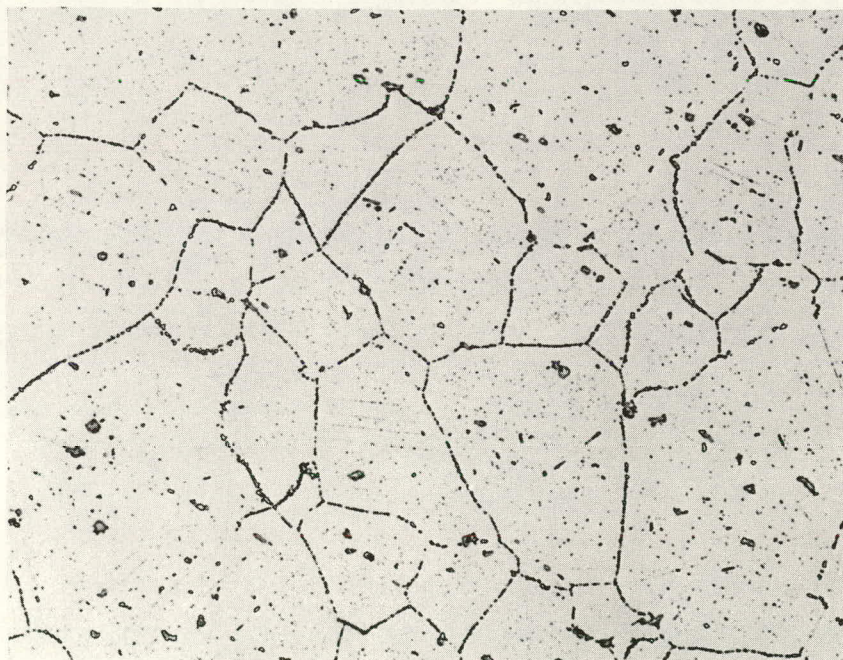
Figure 2.4 Optical Photomicrographs Showing Surface Condition and Etched Subsurface Microstructure of Incoloy 802 after Approximately 1000 Hour Exposure in Controlled Purity He at (a) 750°C and (b) 850°C.

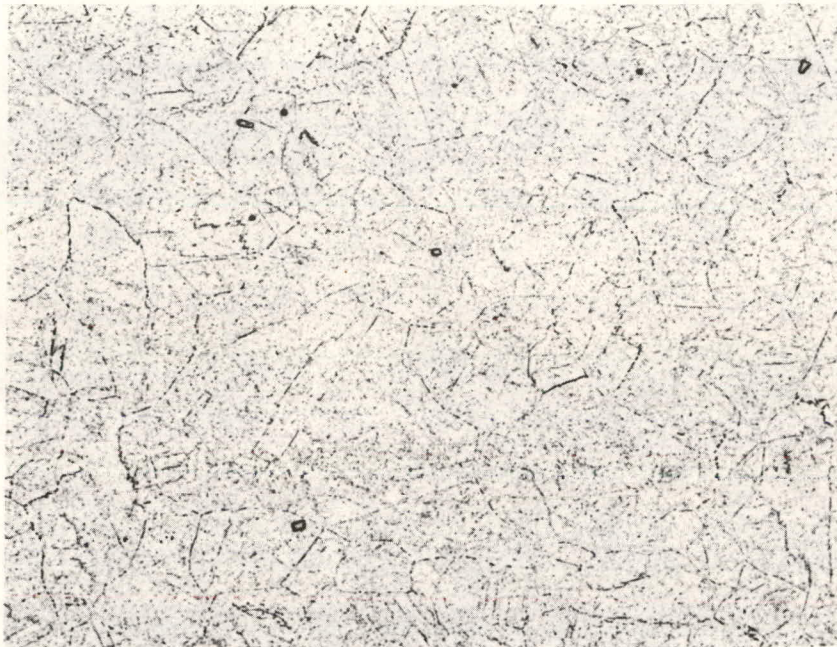
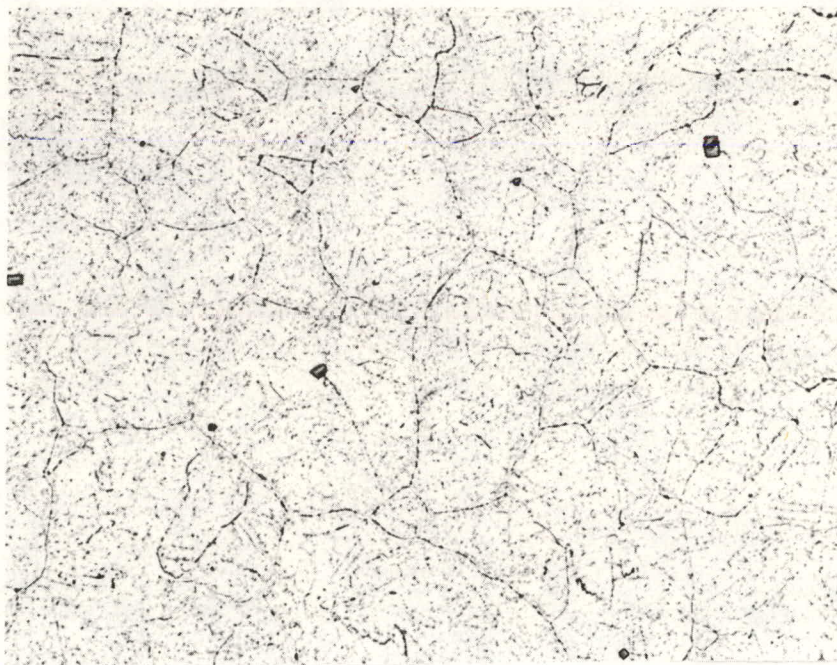
Figure 2.6 Optical Photomicrographs Showing Surface Condition and Etched Subsurface Microstructure of Incoloy 807 after Approximately 1000 Hour Exposure in Controlled Purity He at (a) 750°C and (b) 850°C.

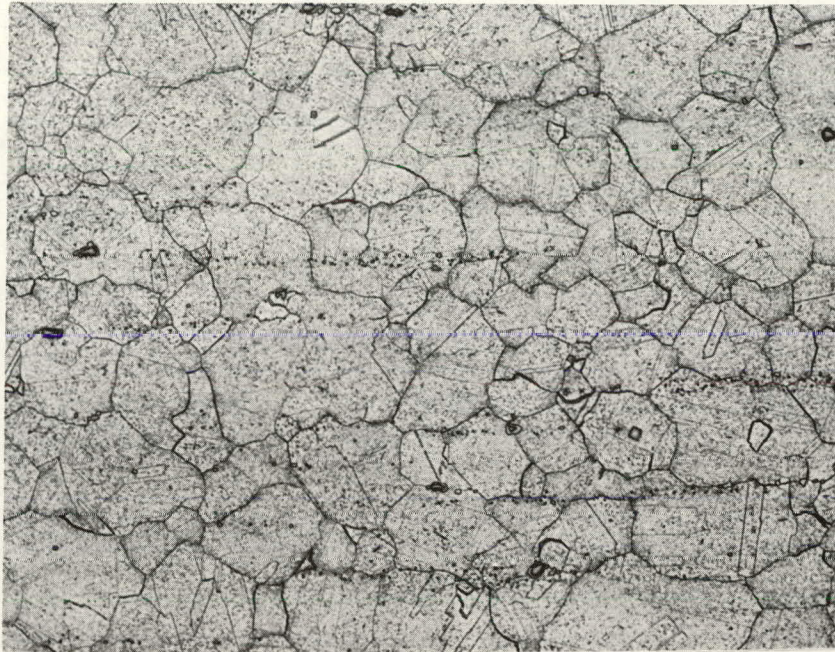
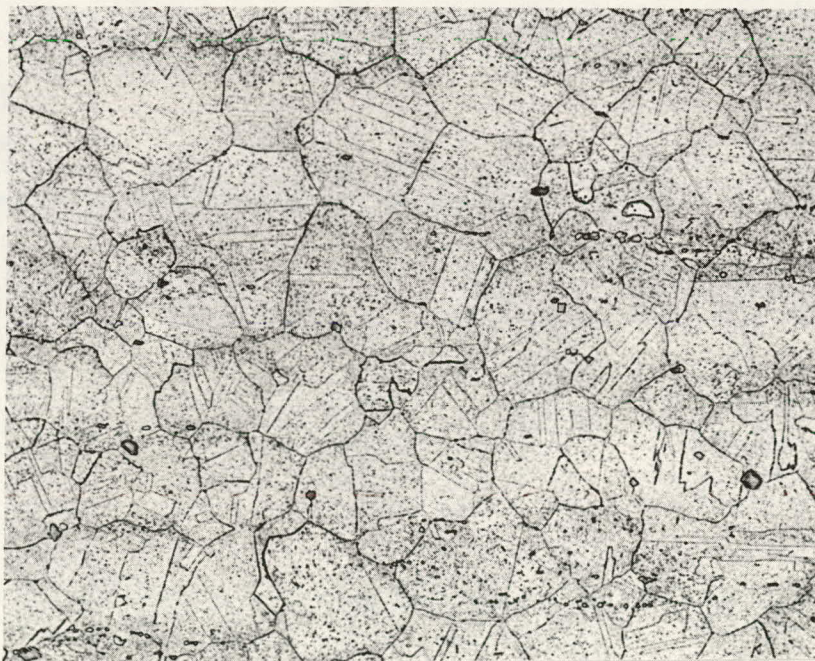
Figure 2.9 Optical Photomicrographs Showing Etched Internal Microstructure of HD-556 after Exposure in Controlled Purity He for (a) 1000 Hours at 750°C and (b) 1104 Hours at 850°C.

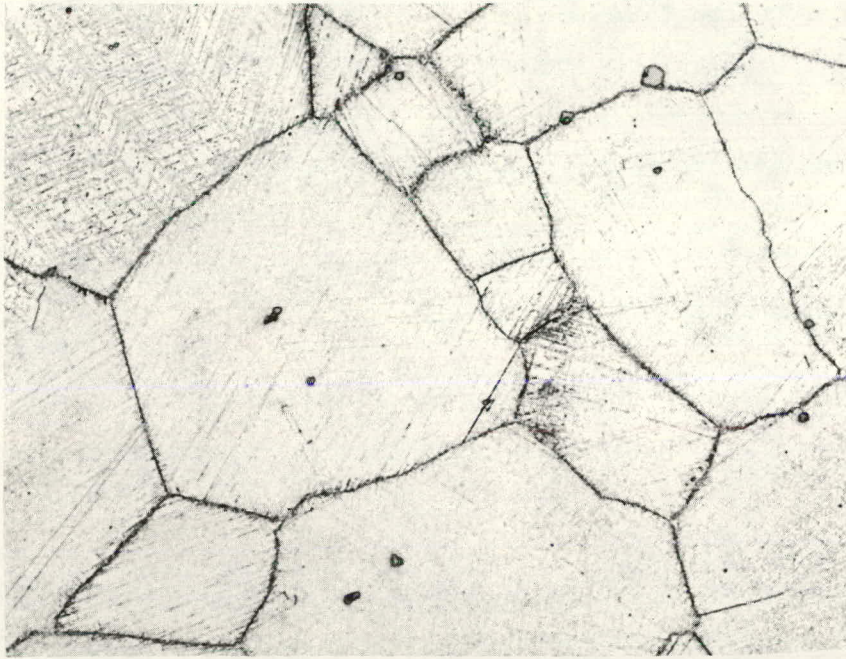
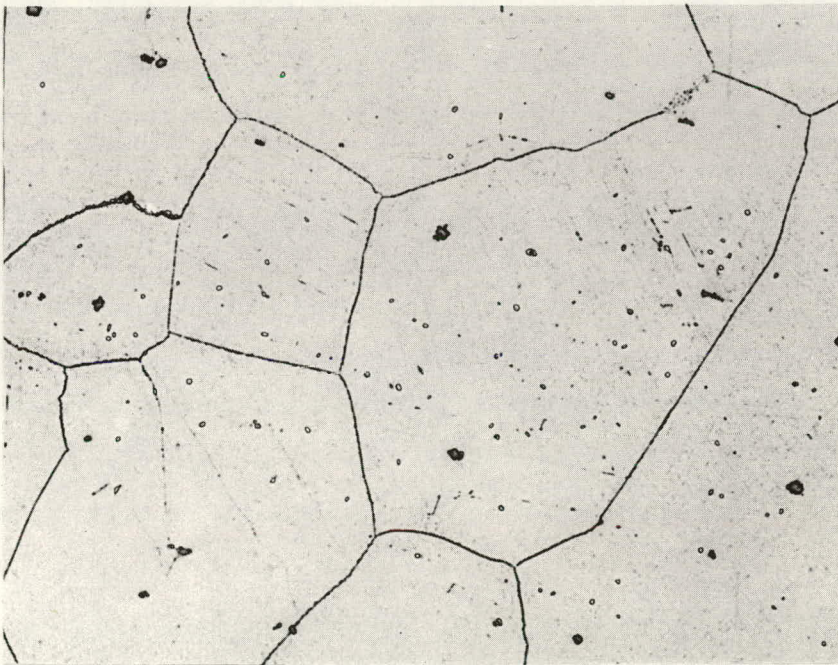
Figure 2.10 Optical Photomicrographs Showing Surface Condition and Etched Subsurface Microstructure of HD-556 after Approximately 1000 Hour Exposure in Controlled Purity He at (a) 750°C and (b) 850°C.

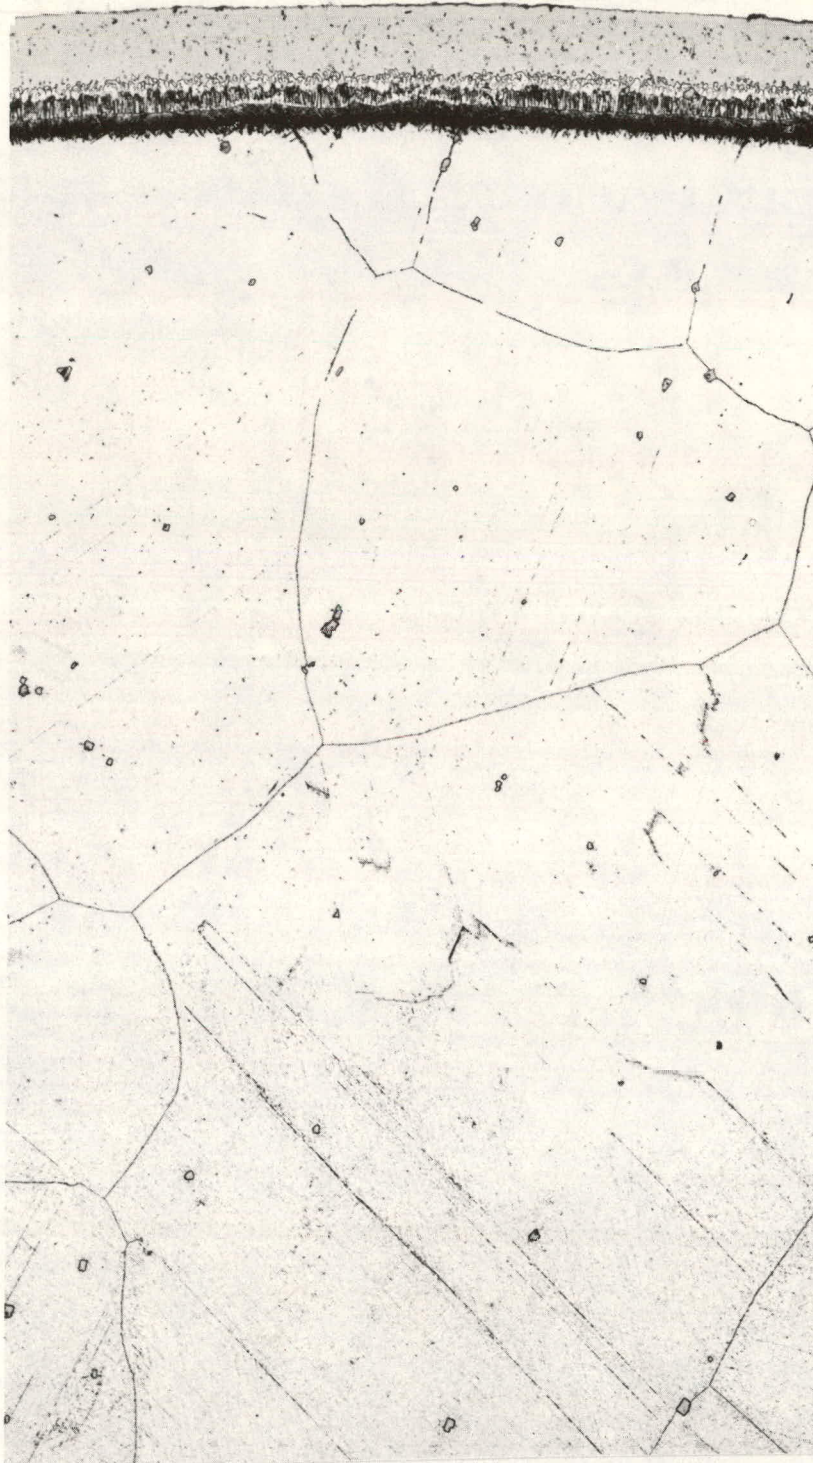
Figure 2.13 Optical Photomicrograph Showing Surface Condition and Etched Substrate Microstructure of Coated Inconel 617 after 1000 Hour Exposure in Controlled Purity He at 750°C. Note the fine precipitation in the formerly ~ 560 μm deep denuded zone below the coating.

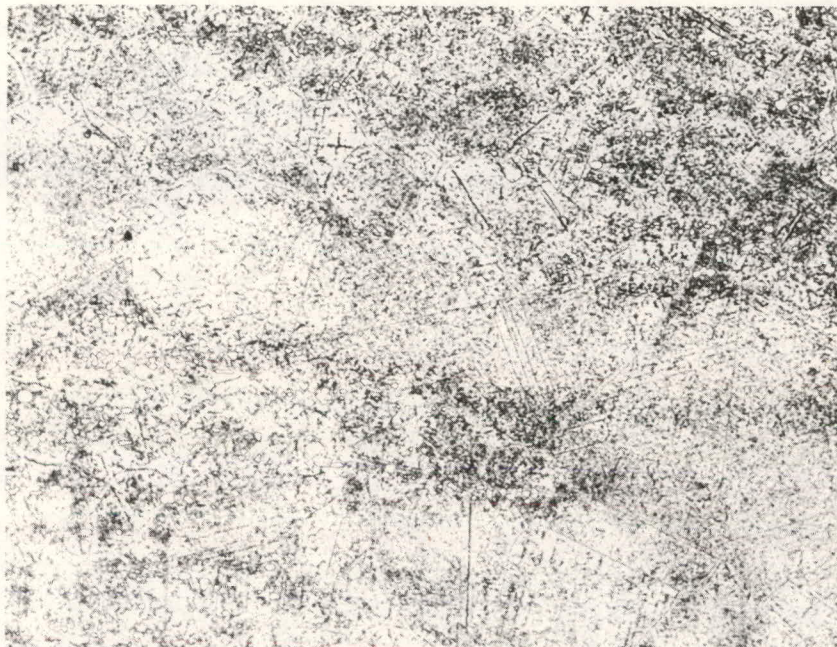
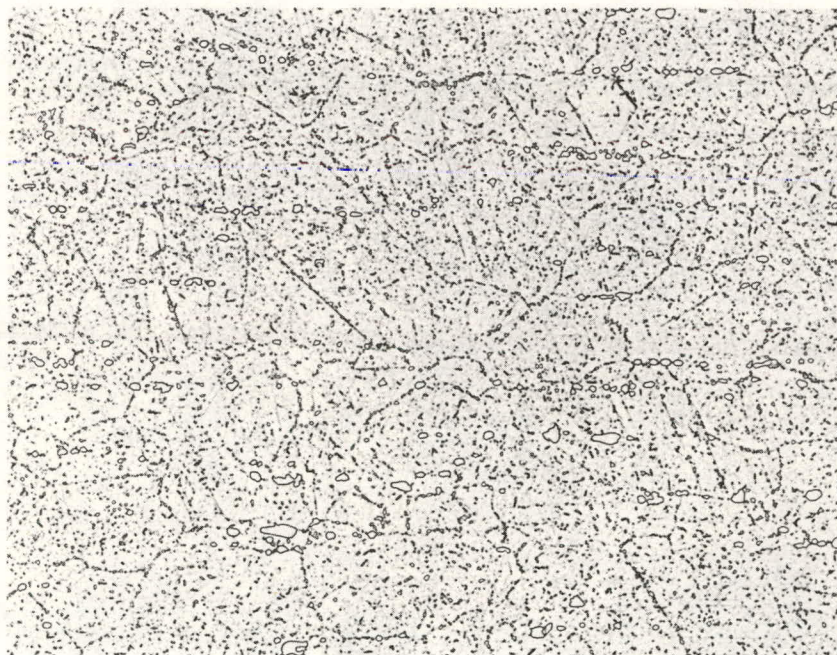
Figure 2.15 Optical Photomicrographs Showing Surface Condition and Etched Subsurface Microstructure of Inconel 618E after Approximately 1000 Hour Exposure in Controlled Purity He at (a) 750°C and (b) 850°C.

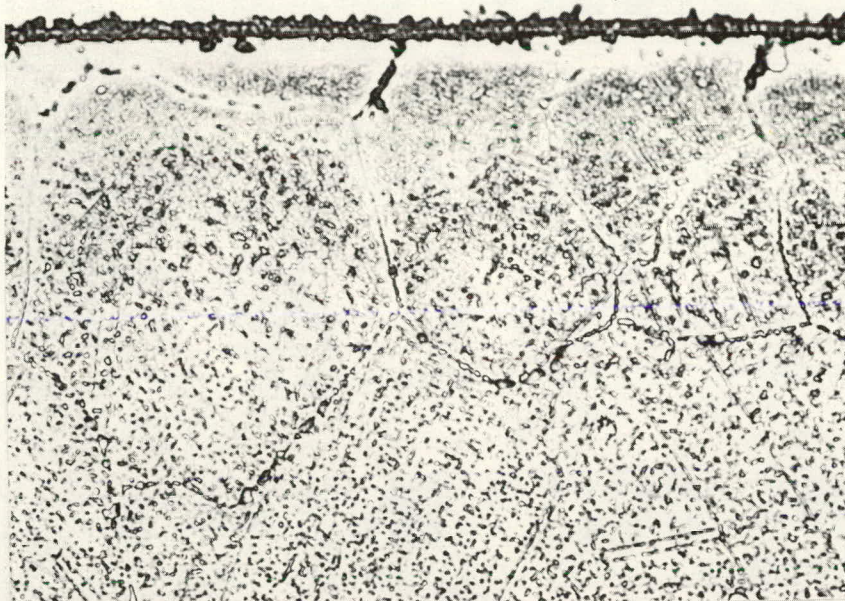
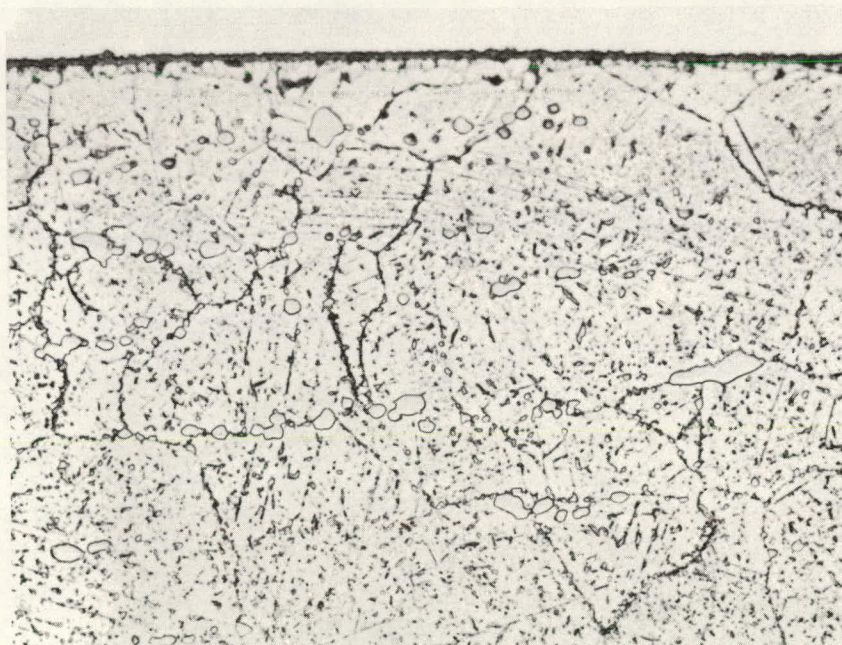
The photomicrographs shown in Figure 2.16 are typical of the microstructure of Hastelloy X after approximately 1000-hr aging in controlled purity He at 750° and 850°C (1382 and 1562°F). Microstructures were morphologically similar and consisted of a mixture of large globular carbides plus fine to intermediate precipitated carbides which appeared within grains and at grain and twin boundaries. Areas adjacent to grain boundaries appeared denuded after 750°C (1382°F) exposure.

Figure 2.16 Optical Photomicrographs Showing Etched Internal Microstructure of Hastelloy X after Exposure in Controlled Purity He for (a) 1000 Hours at 750°C and (b) 1104 Hours at 850°C.

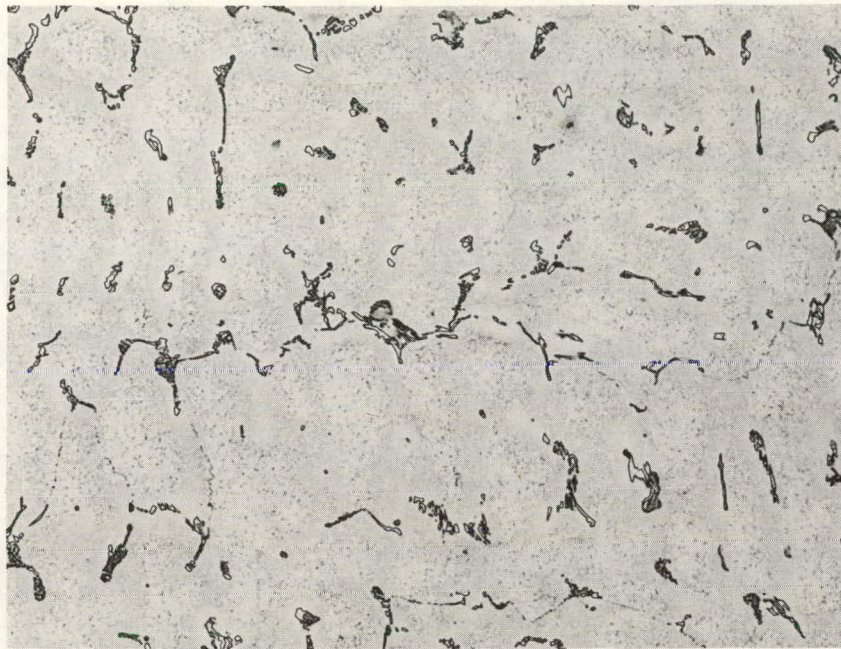
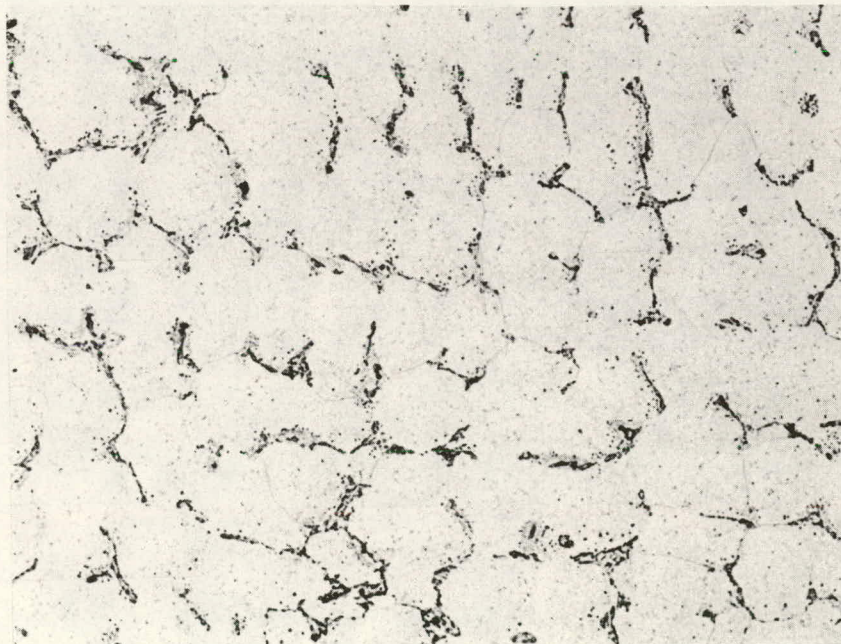
Figure 2.18 Optical Photomicrographs Showing Etched Internal Microstructure of HK-40 after Exposure in Controlled Purity He for (a) 1000 Hours at 750°C and (b) 1104 Hours at 850°C.

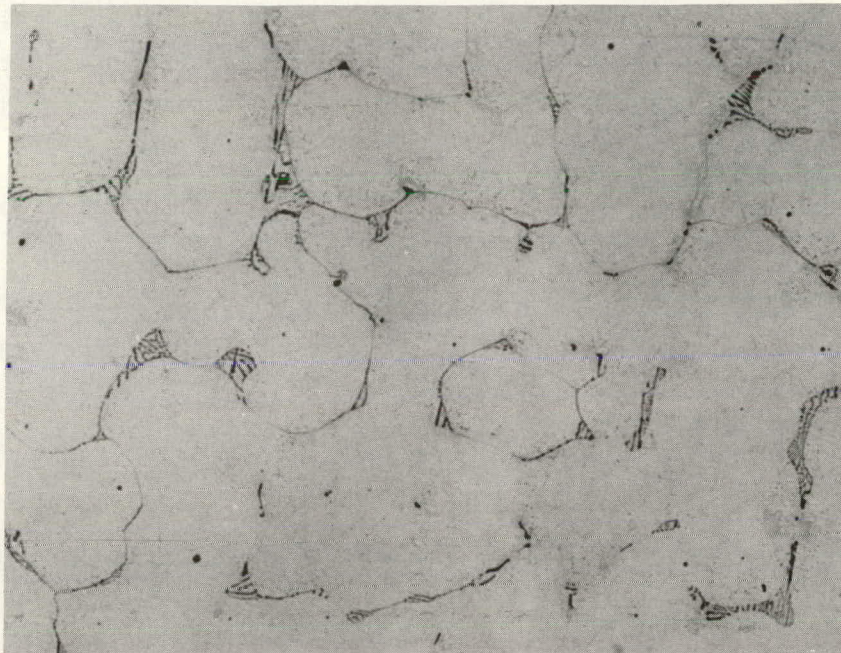
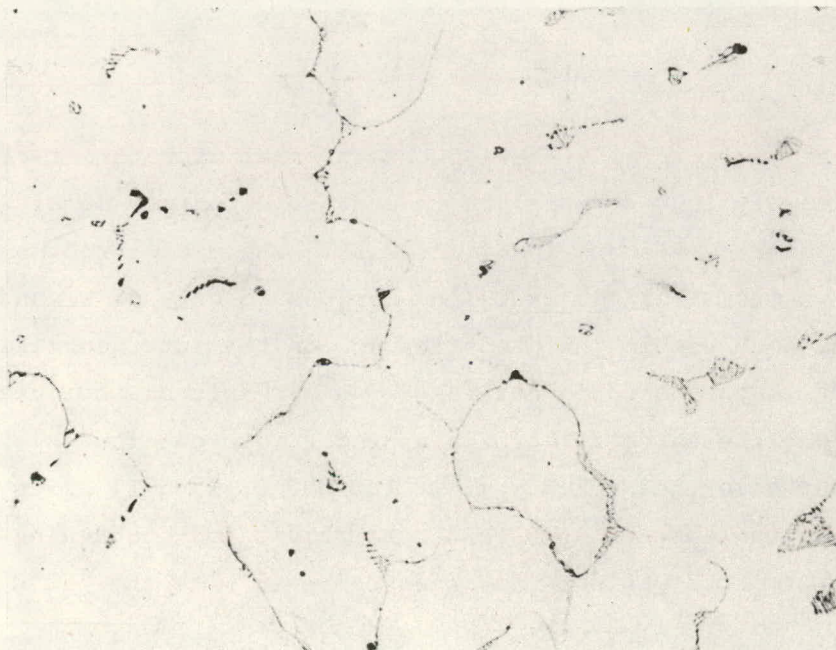
Figure 2.23 Optical Photomicrographs Showing Surface Condition (a) and (b), and Etched Subsurface Microstructure (a) only of Manaurite 36XS after ~ 1000 Hour Exposure in Controlled Purity He at (a) 750°C and (b) 850°C .

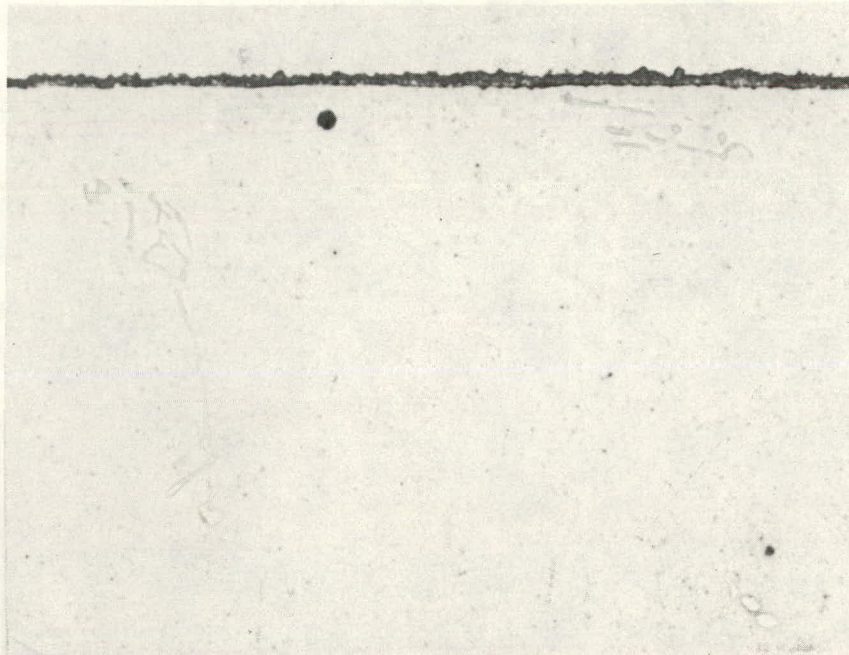
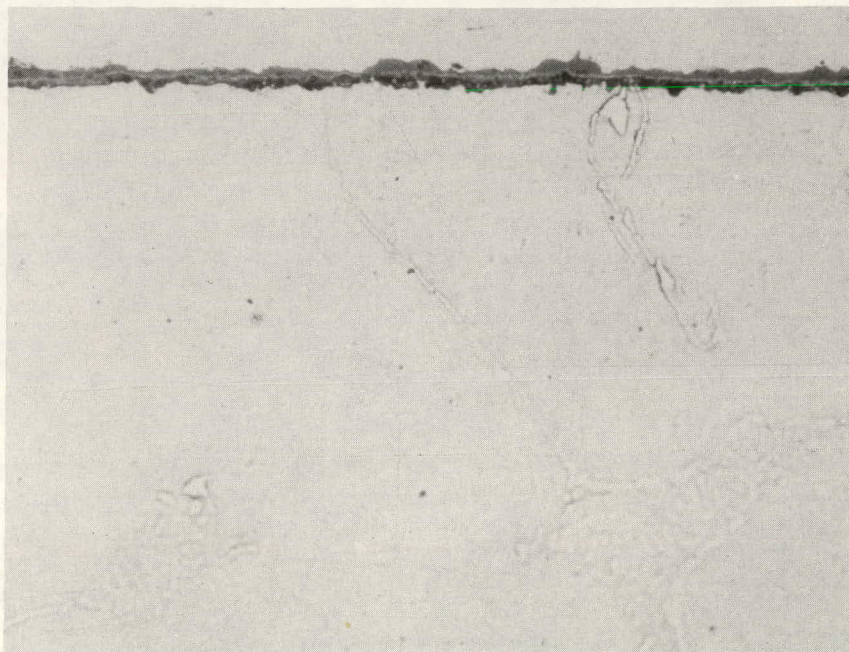
Figure 2.25 Optical Photomicrographs Showing Surface Condition of Manaurite 900 after ~ 1000 Hour Exposure in Controlled Purity He at (a) 750°C and (b) 850°C .

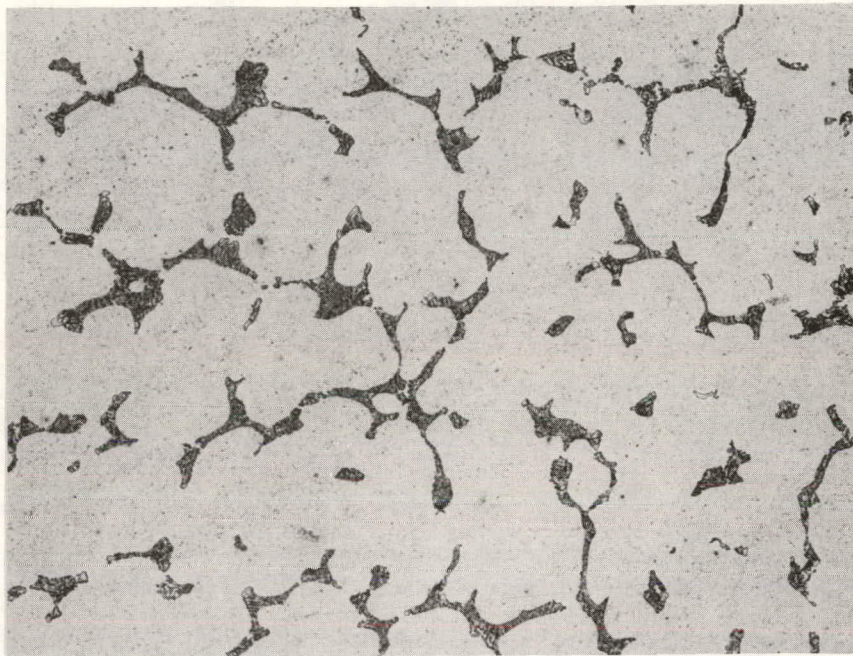
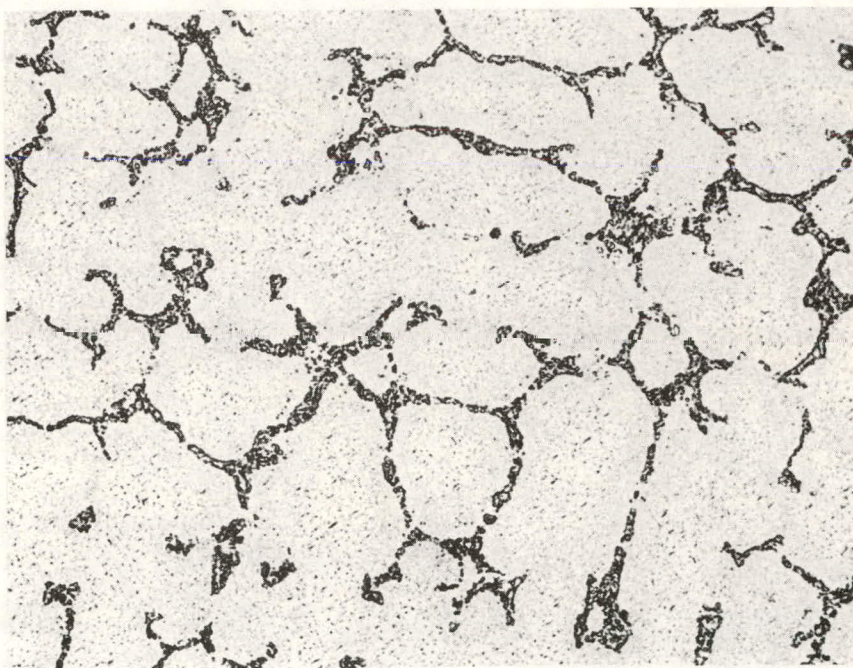
Figure 2.26 Optical Photomicrographs Showing Etched Internal Microstructure of Mo-Re 2 after Exposure in Controlled Purity He for (a) 1000 Hours at 750°C and (b) 1104 Hours at 850°C.

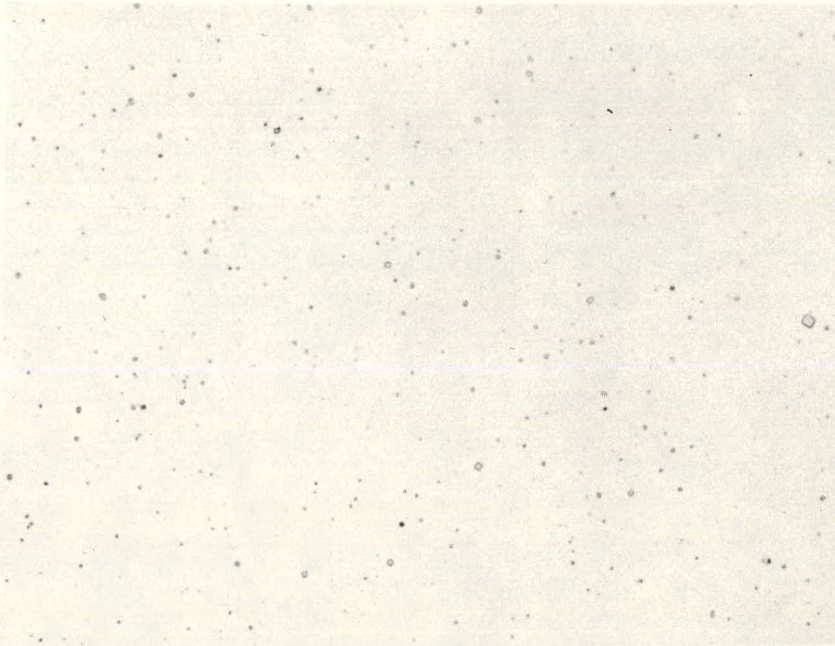
Figure 2.28 Optical Photomicrographs Showing (a) Etched Internal Microstructure and (b) Unetched Surface Condition of MA-956 after 1104 Hour Exposure in Controlled Purity He at 850°C.

A photomicrograph showing the microstructure representative of MA-956 both before and after exposure is shown in Figure 2.28. In the as-fabricated condition, the internal microstructure consists of a very fine dispersion of yttrium-aluminum oxide particles less than 50 nm in. (0.002 mils) in diameter. Additionally, fine dispersions of Cr_2O_3 and Ti (C,N) are reported to be present in this material. The size of the latter particles is indicated to be well above 100 nm (0.004 mils). After 1000-hr at 750 $^{\circ}\text{C}$ (1382 $^{\circ}\text{F}$) or 1104 hr at 850 $^{\circ}\text{C}$ (1562 $^{\circ}\text{F}$), no differences in the internal microstructure could be seen as compared to the as-received material, Figure 2.28. The fine dispersed particles seen in Figure 2.28 are presumably Ti (C,N).

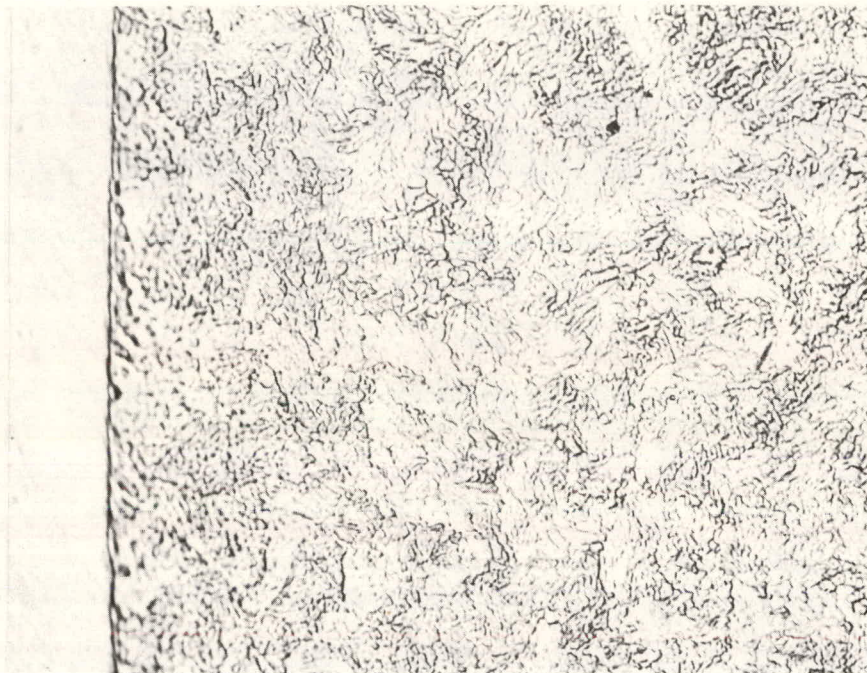
Figure 2.29 Optical Photomicrographs of TZM Exposed in Controlled Purity He at 750°C for 1000 Hours. (a) Uncoated, (b) W3 Coated.

TZM was exposed in controlled purity He at 750 $^{\circ}\text{C}$ (1382 $^{\circ}\text{F}$) for 1000 hours and 850 $^{\circ}\text{C}$ (1562 $^{\circ}\text{F}$) for 1104 hours. In neither case, were substantial changes in internal structure or surface character found. Figure 2.29 (a) shows the typical post exposure microstructure found at 750 $^{\circ}\text{C}$ (1382 $^{\circ}\text{F}$). The structure found at 850 $^{\circ}\text{C}$ (1562 $^{\circ}\text{F}$) is very similar to that seen at 750 $^{\circ}\text{C}$ (1382 $^{\circ}\text{F}$).

Figure 2.29 (b) shows the post 750°C (1382°F) exposure W3 coating and TZM substrate structure. It is evident that through cracks can be found in the coating. These openings provide a path for corrosive attack, and minor subsurface attack was found at both 750°C and 850°C (1382 and 1562°F).

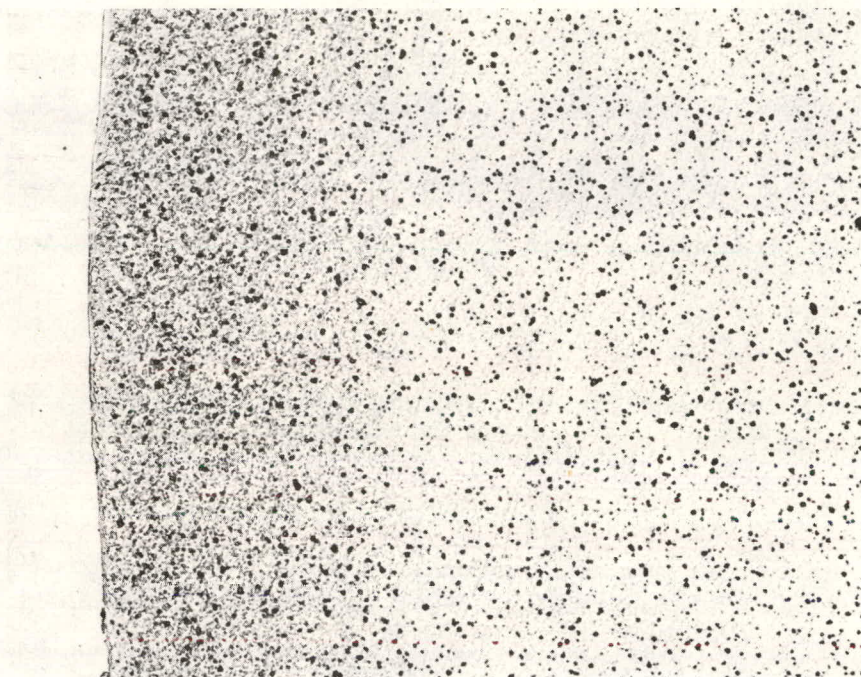
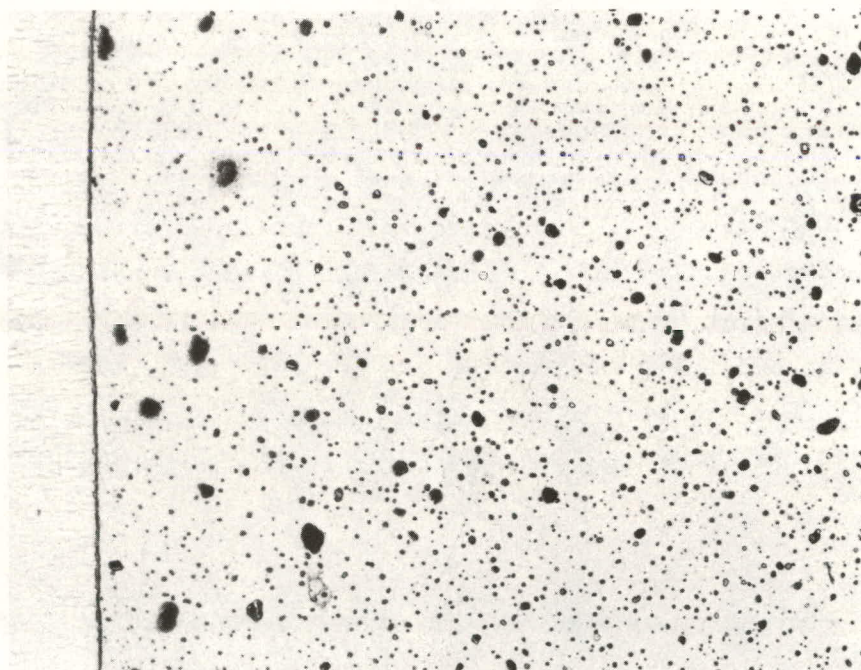
Figure 2.30 Optical Photomicrographs of Yd-Ni Exposed in Controlled Purity He for (a) 1000 Hours at 750°C and (b) 1104 Hours at 850°C.

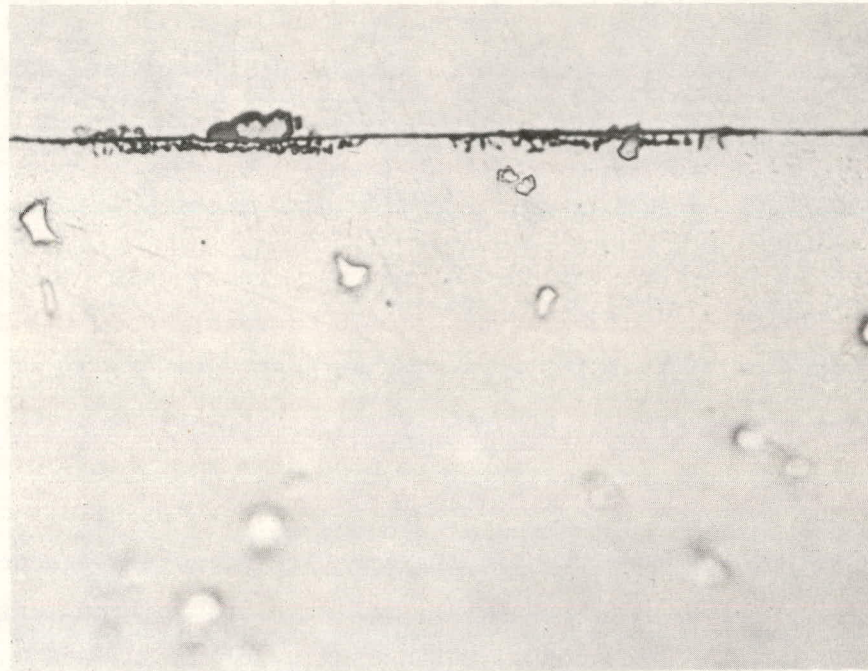
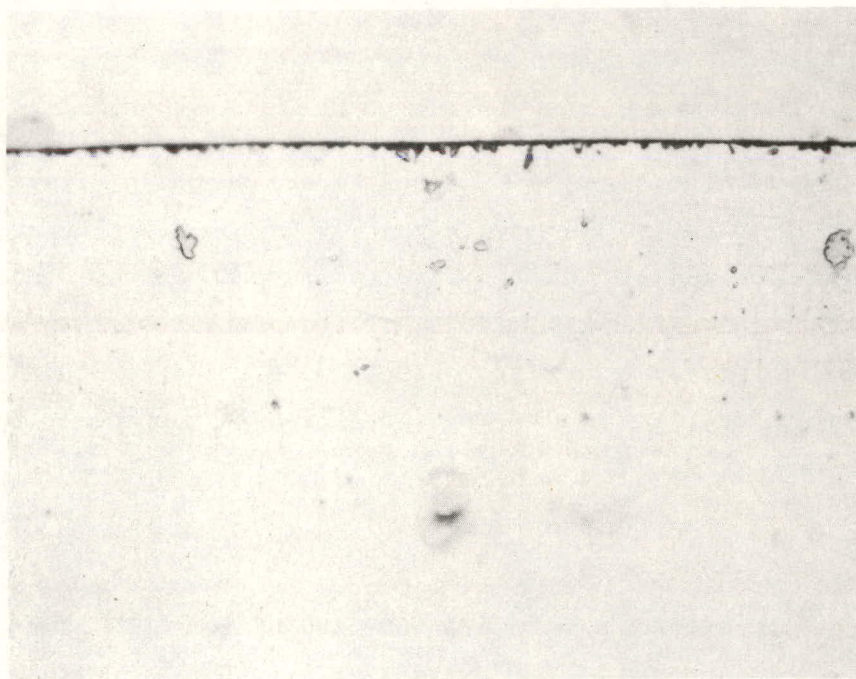
Figure 2.33 Optical Photomicrographs of MM-0011 Conventionally Cast Exposed in Controlled Purity He for (a) 1000 Hours at 750°C and (b) 1104 Hours at 850°C.

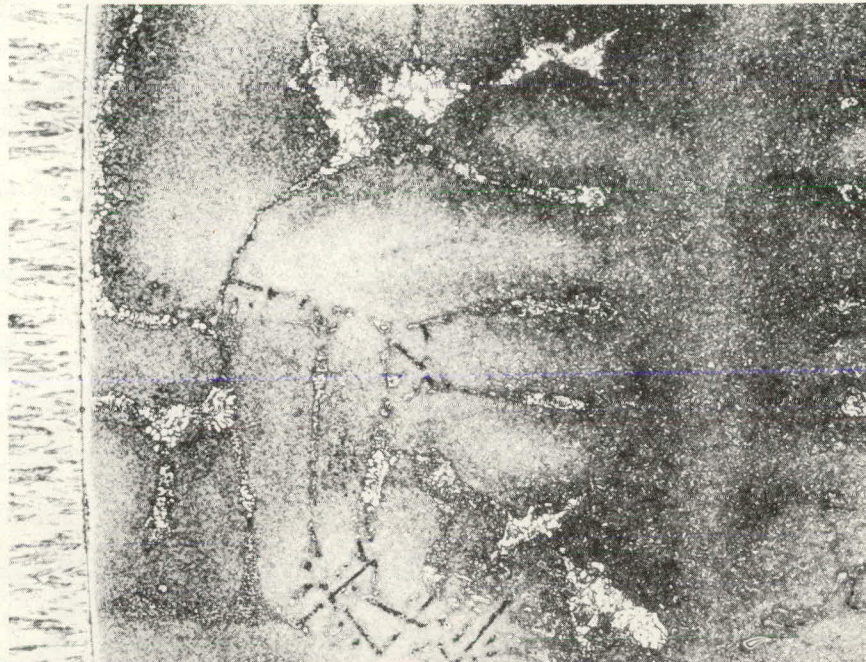
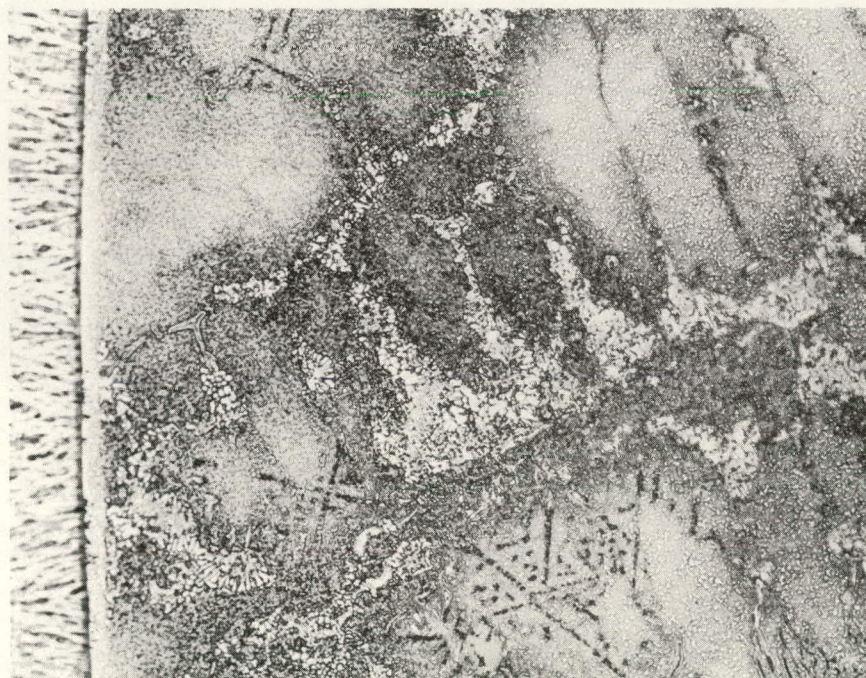
Figure 2.34 Optical Photomicrographs of MM-0011 Directionally Solidified Exposed in Controlled Purity He for (a) 1000 Hours at 750°C and (b) 1104 Hours at 850°C.

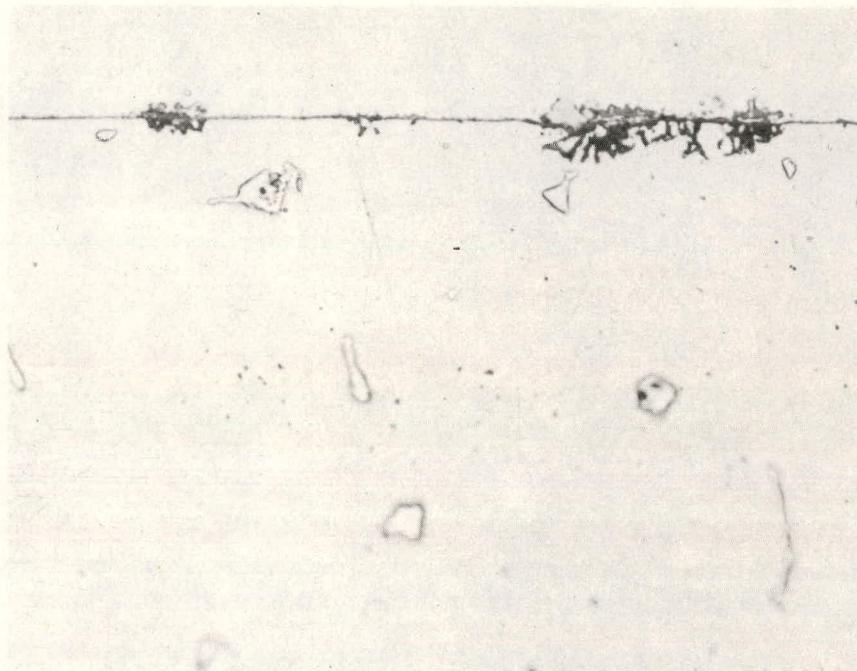
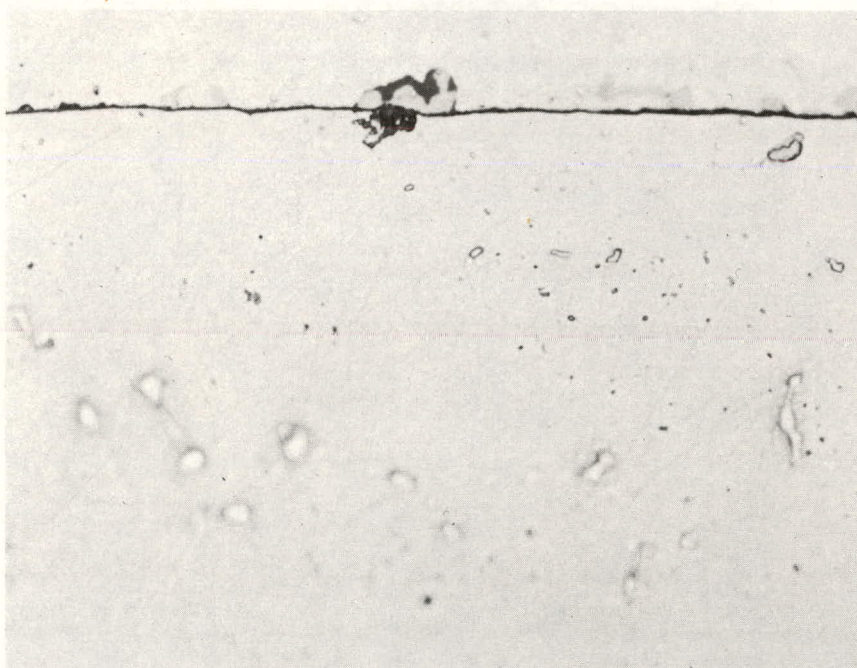
Figure 2.36 Optical Photomicrographs of Rene' 80 Exposed in Controlled Purity He for (a) 1000 Hours at 750°C and (b) 1104 Hours at 850°C.

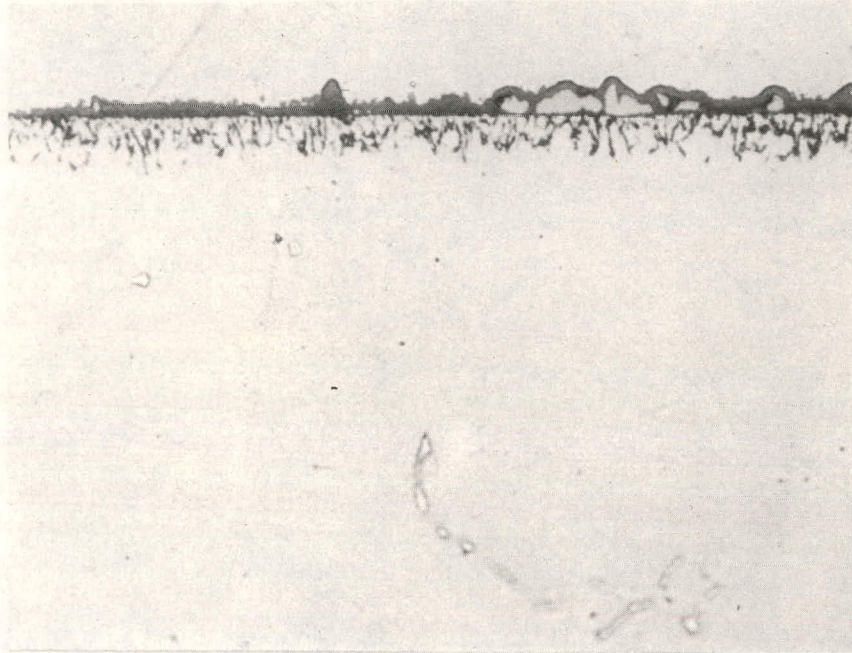
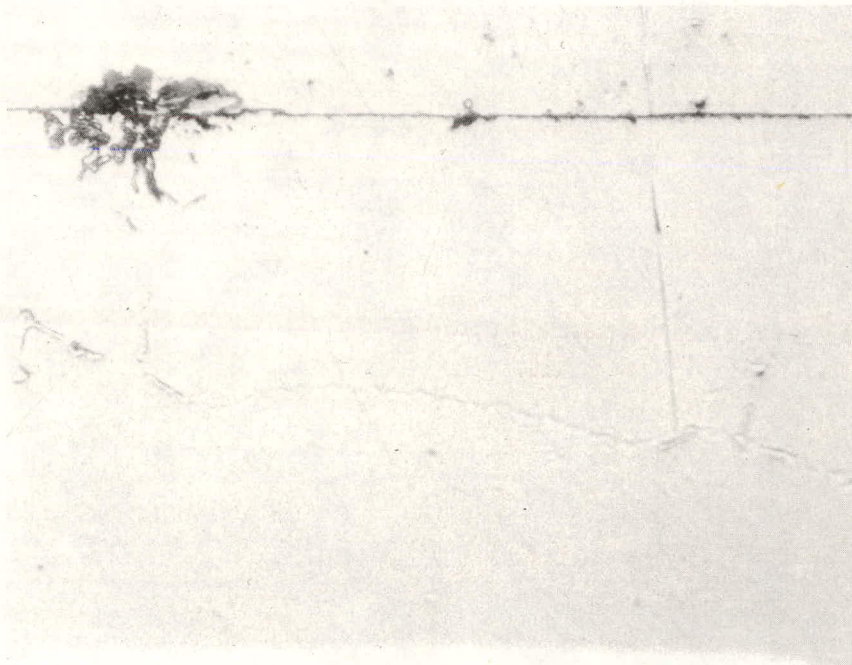
Figure 2.40 Optical Photomicrographs of IN-738 Exposed in Controlled Purity He for (a) 1000 Hours at 750°C and (b) 1104 Hours at 850°C.
