ADVANCED GAS COOLED NUCLEAR REACTOR MATERIALS EVALUATION AND DEVELOPMENT PROGRAM

PROGRESS REPORT
FOR PERIOD

January 1, 1980 - March 31, 1980

GENERAL ELECTRIC COMPANY
ENERGY SYSTEMS PROGRAMS DEPARTMENT
SCHENECTADY, NEW YORK 12345

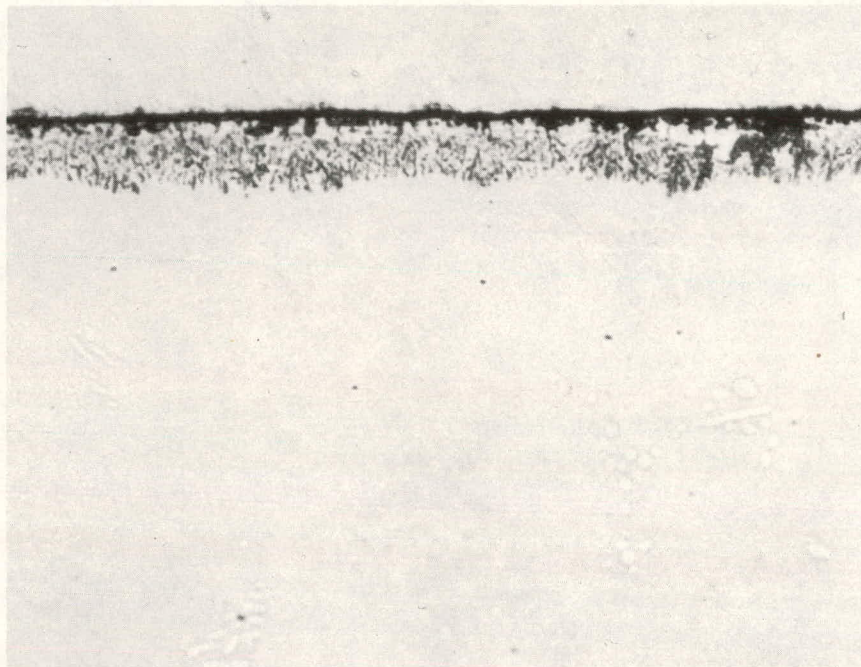
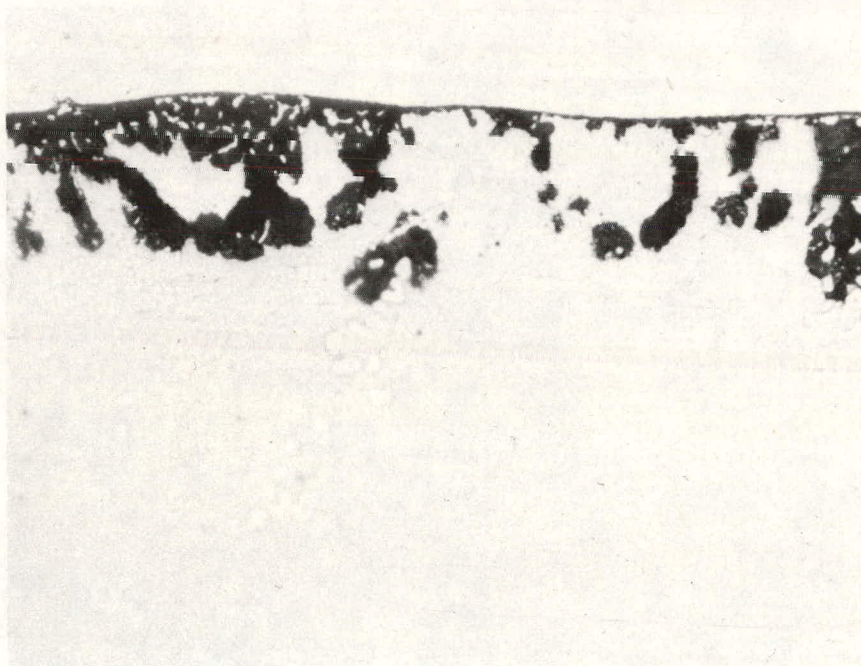
Figure 2.43 Optical Photomicrographs of NX-188 Exposed in Controlled Purity He for (a) 1000 Hours at 750°C and (b) 1104 Hours at 850°C.
