ORNL-3100  
UC-41 - Health and Safety  
TID-4500 (16th ed.)

DECONTAMINATION OF CELLS 6 AND 7,  
BUILDING 3019, FOLLOWING  
PLUTONIUM-RELEASE INCIDENT

J. R. Parrott

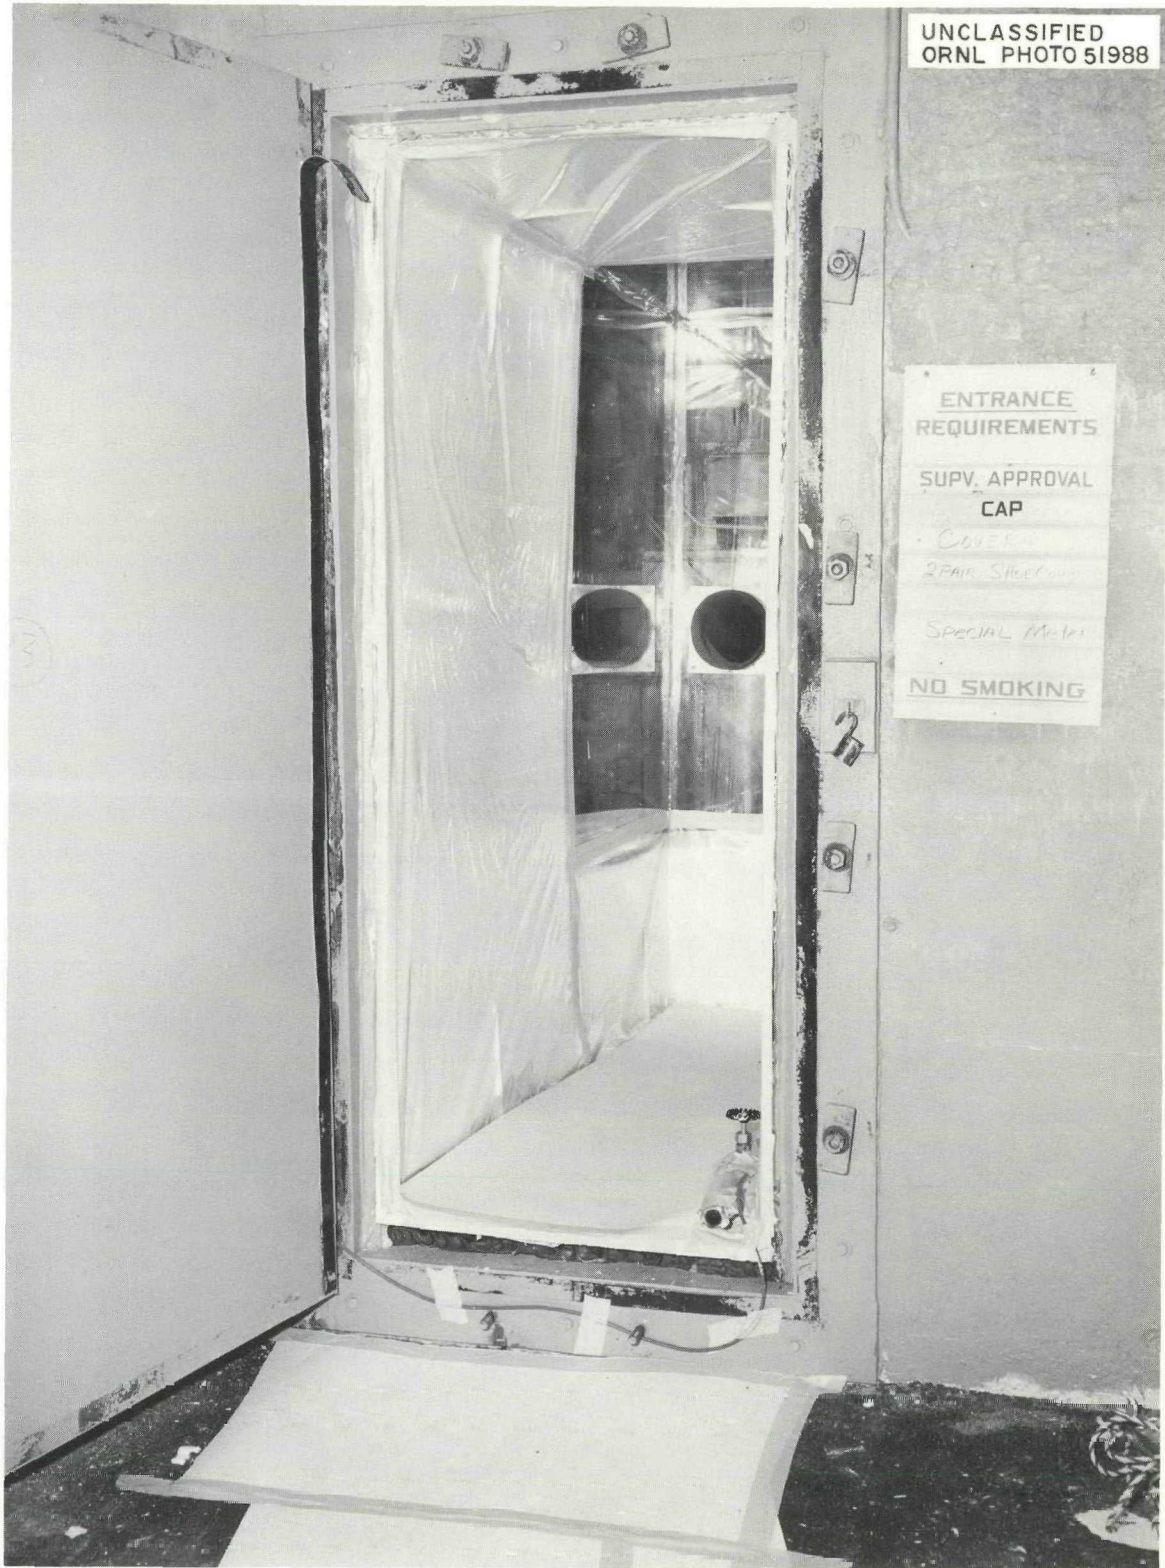
A cubicle constructed of Lucite and plywood was inserted in the south-east entrance to cell 6, from which initial cell decontamination was carried out and personnel working in the cell could be constantly observed. This "greenhouse" (Figs. 3.1 and 3.2) was installed at the 10-ft level directly opposite the ruptured evaporator.

Fig. 3.1. View of greenhouse from plenum chamber.

Fig. 3.2. View of greenhouse from upper level of cell 7.

The greenhouse was provided with a constant air purge to prevent possible accumulation of contaminated air in it. A continuous alpha air monitor plotted the contamination in the greenhouse. The cell was kept under  $\sim 0.5$  in.  $H_2O$  pressure less than that of the greenhouse, which prevented backflow of contaminated air. The greenhouse was checked daily for transferable as well as direct-reading alpha contamination. The Lucite was cleaned as required and the plywood was repainted on two occasions when the transferable contamination reached 30 d/m/100 sq cm.

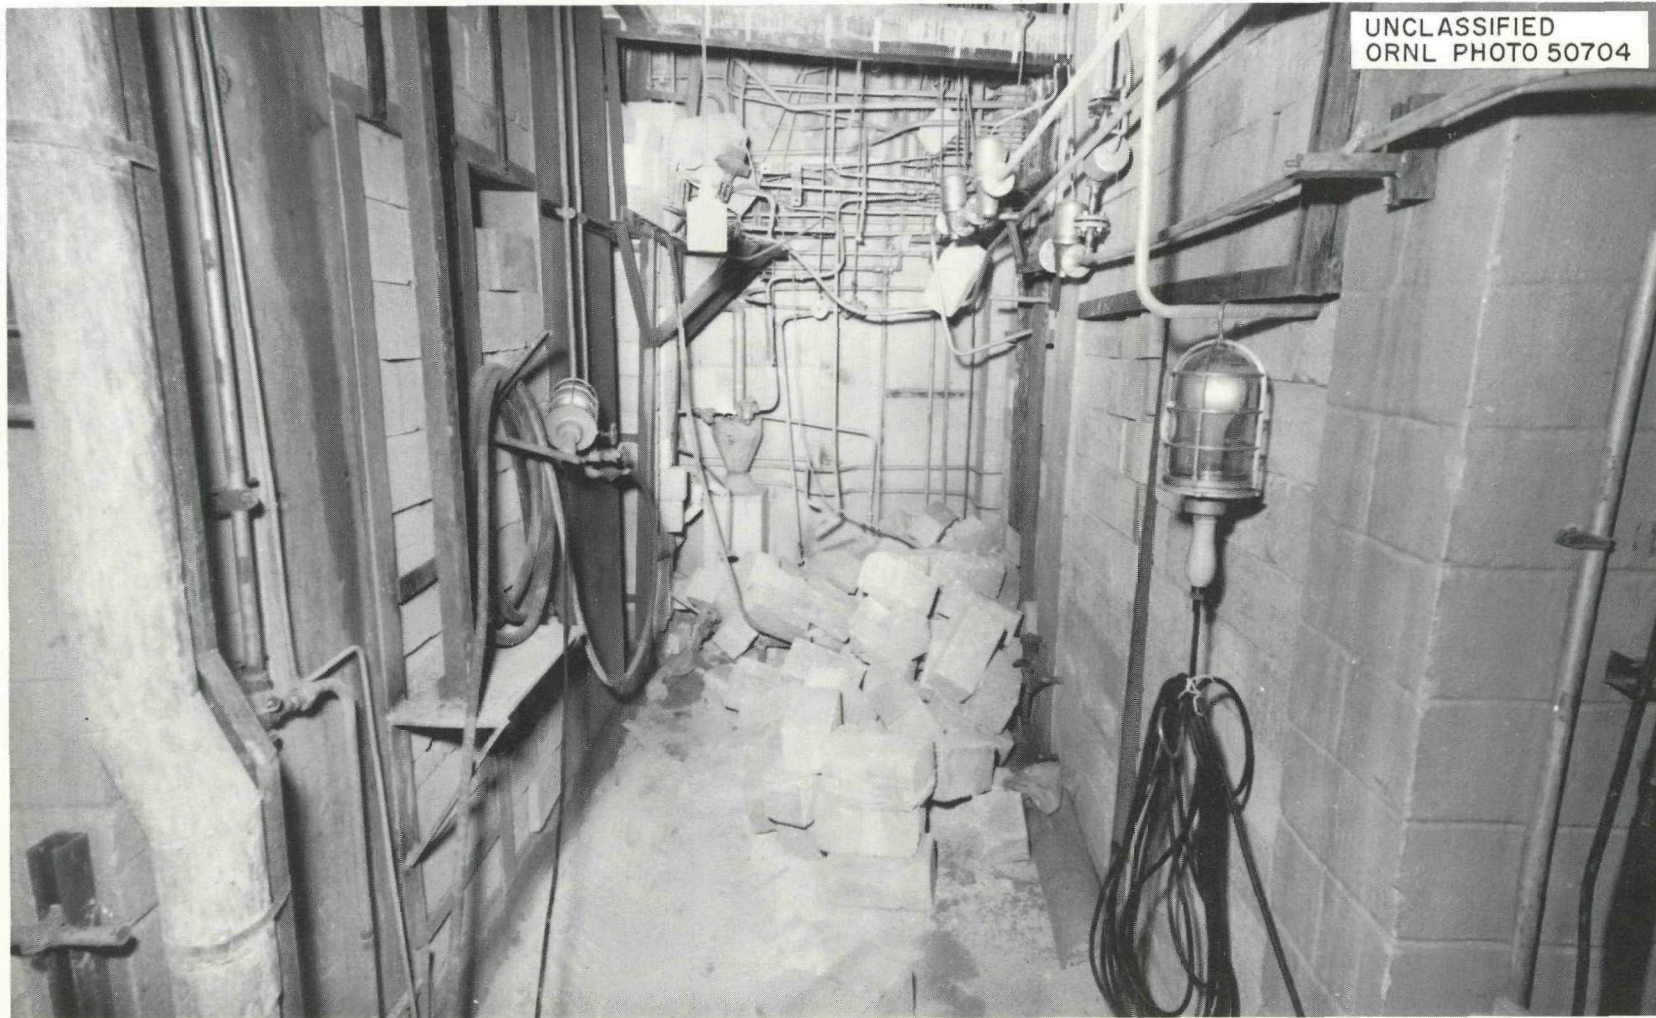
The second phase of the decontamination was removal of debris and approximately 1500 dry-stacked concrete shielding blocks from the cells (Figs. 5.1 and 5.2). In addition to providing a high alpha source in the cell, this material was a source of sand and grit which was detrimental to the sump jets used to transfer solutions and a possible medium for plugging the sump overflow lines to the tank farm. Access to the cell from the penthouse area was through a hinged metal door, which was installed in the cell roof.

Fig. 5.1. View of cell 6 lower level prior to block and debris removal.

Fig. 5.2. View of cell 6 from upper level of cell 7 after block and debris removal.

On Nov. 3, 1960, the debris, approximately 100 of the blocks which had been blown loose from in front of the evaporator, was removed in eight 50-gal drums. Beta-gamma readings, primarily from the debris itself, were up to 5 r/hr. Two workers and a Health Physics surveyor spent 1 hr in the cell in air suits. The two workers, who handled the contaminated material, received exposures of 230 and 260 mrem, respectively, and the surveyor, who handled the moving equipment, received 115 mrem. The procedure involved two separate operations: (1) packaging of the material in the cell and removal, and (2) repackaging in the penthouse and transferral to a truck and thence to the burial ground for disposal. The material was thoroughly wet prior to removal to decrease air-borne contamination.

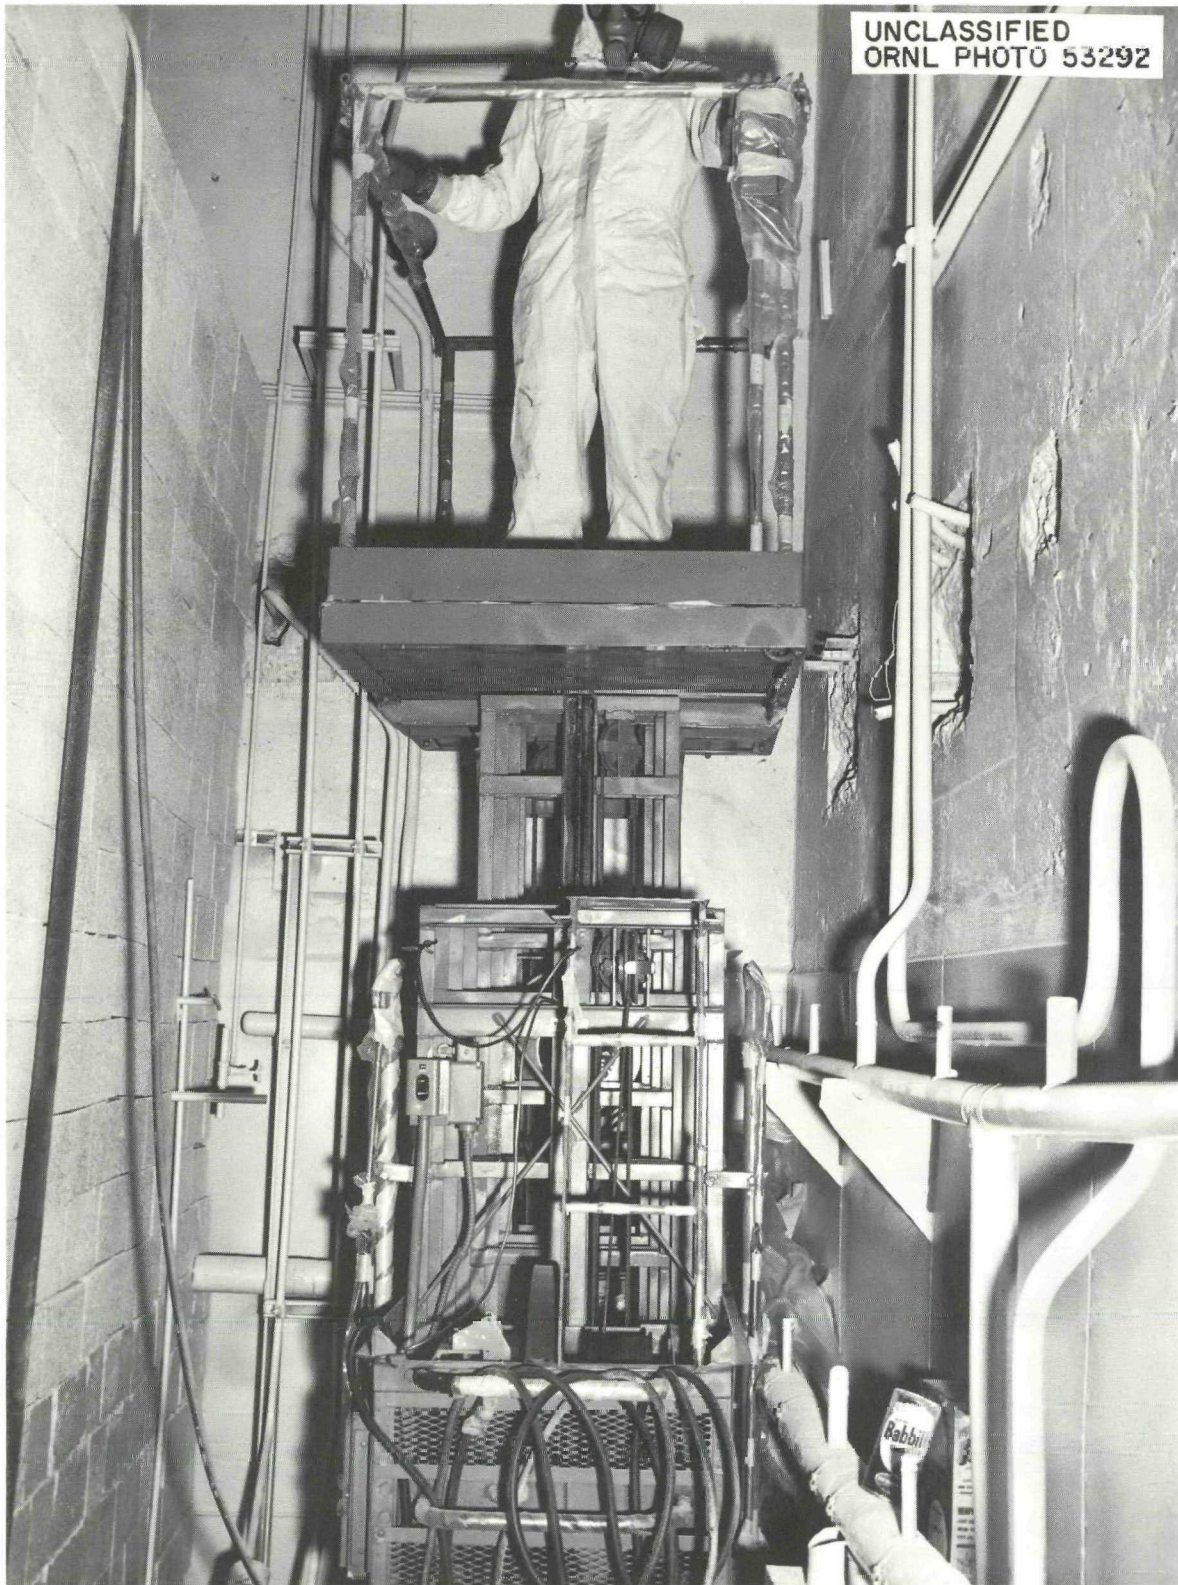
The dry stacked blocks from the shielding walls were removed in similar drums in a telescoping elevator (Fig. 5.3). The elevator had overall dimensions of 69 by 30 in., a platform size of 3 by 5 ft, a collapsed height of 5 ft 8 in., a maximum lift of 35 ft, and a maximum load of 600 lb. To decrease contamination as much as possible, the elevator was covered with plastic sheeting, so installed that it collapsed as the elevator was lowered. A fresh air supply was continuously bled into the plastic shroud to prevent inleakage of the contaminated cell air due to the vacuum created when the elevator was raised.

The elevator was lowered into the cell, rolled to the required location, and leveled with built-in screw jacks. A dolly on casters that served as a loading platform, 27 by 45 in., gave sufficient working area for a man and a drum. The platform height of 27 in. provided a good working elevation for the operator, who removed the blocks from the elevator and placed them in a drum. The casters on the dolly were necessary to permit moving of the loaded drum to a position under the crane hatch.

Fig. 5.3. Telescoping elevator used for removing shielding blocks.

The elevator was used to remove the blocks from four cubicle walls in the cell. Upon completion of block removal, the elevator was stripped of plastic in the cell, raised to the penthouse, re-covered with plastic, and used in adjacent cells for cleaning, surveying, and painting.

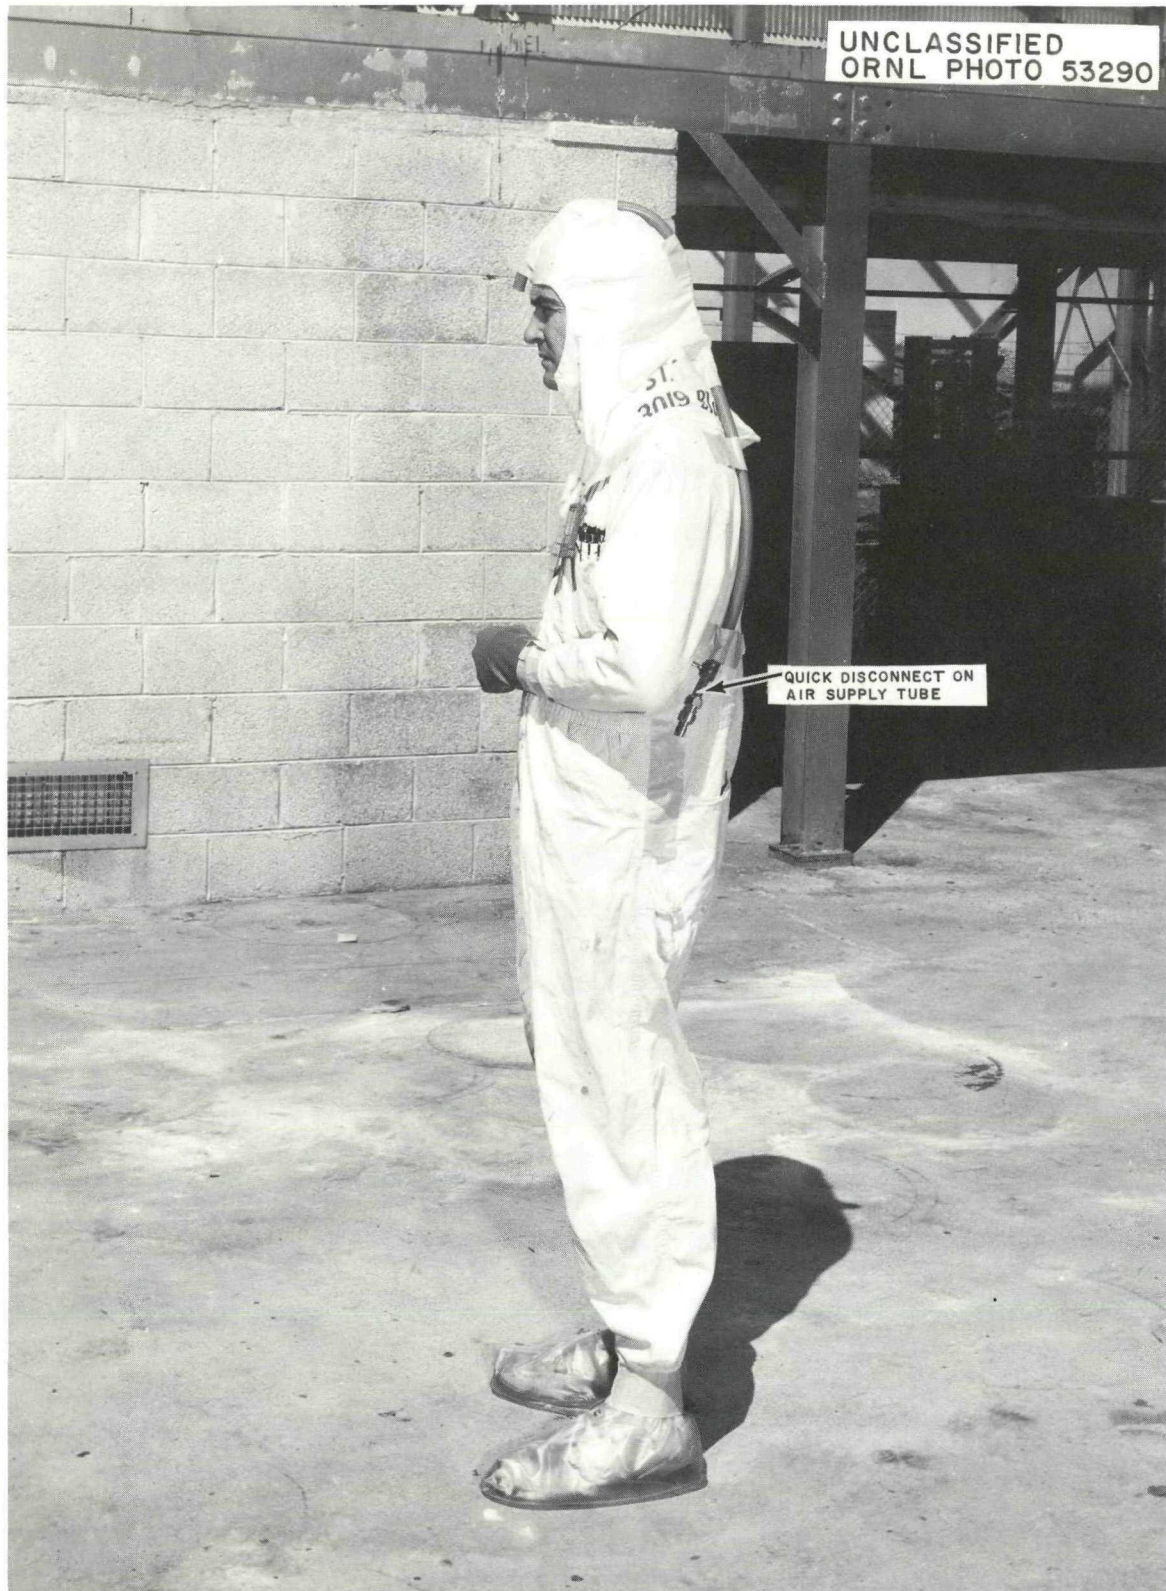
Fig. 7.2. Operator dress and air supply tube used inside plastic suit.
