Switching Tests for the LCTF Protective Dump Circuit

W. M. Parsons

Los Alamos Los Alamos National Laboratory
Los Alamos, New Mexico 87545

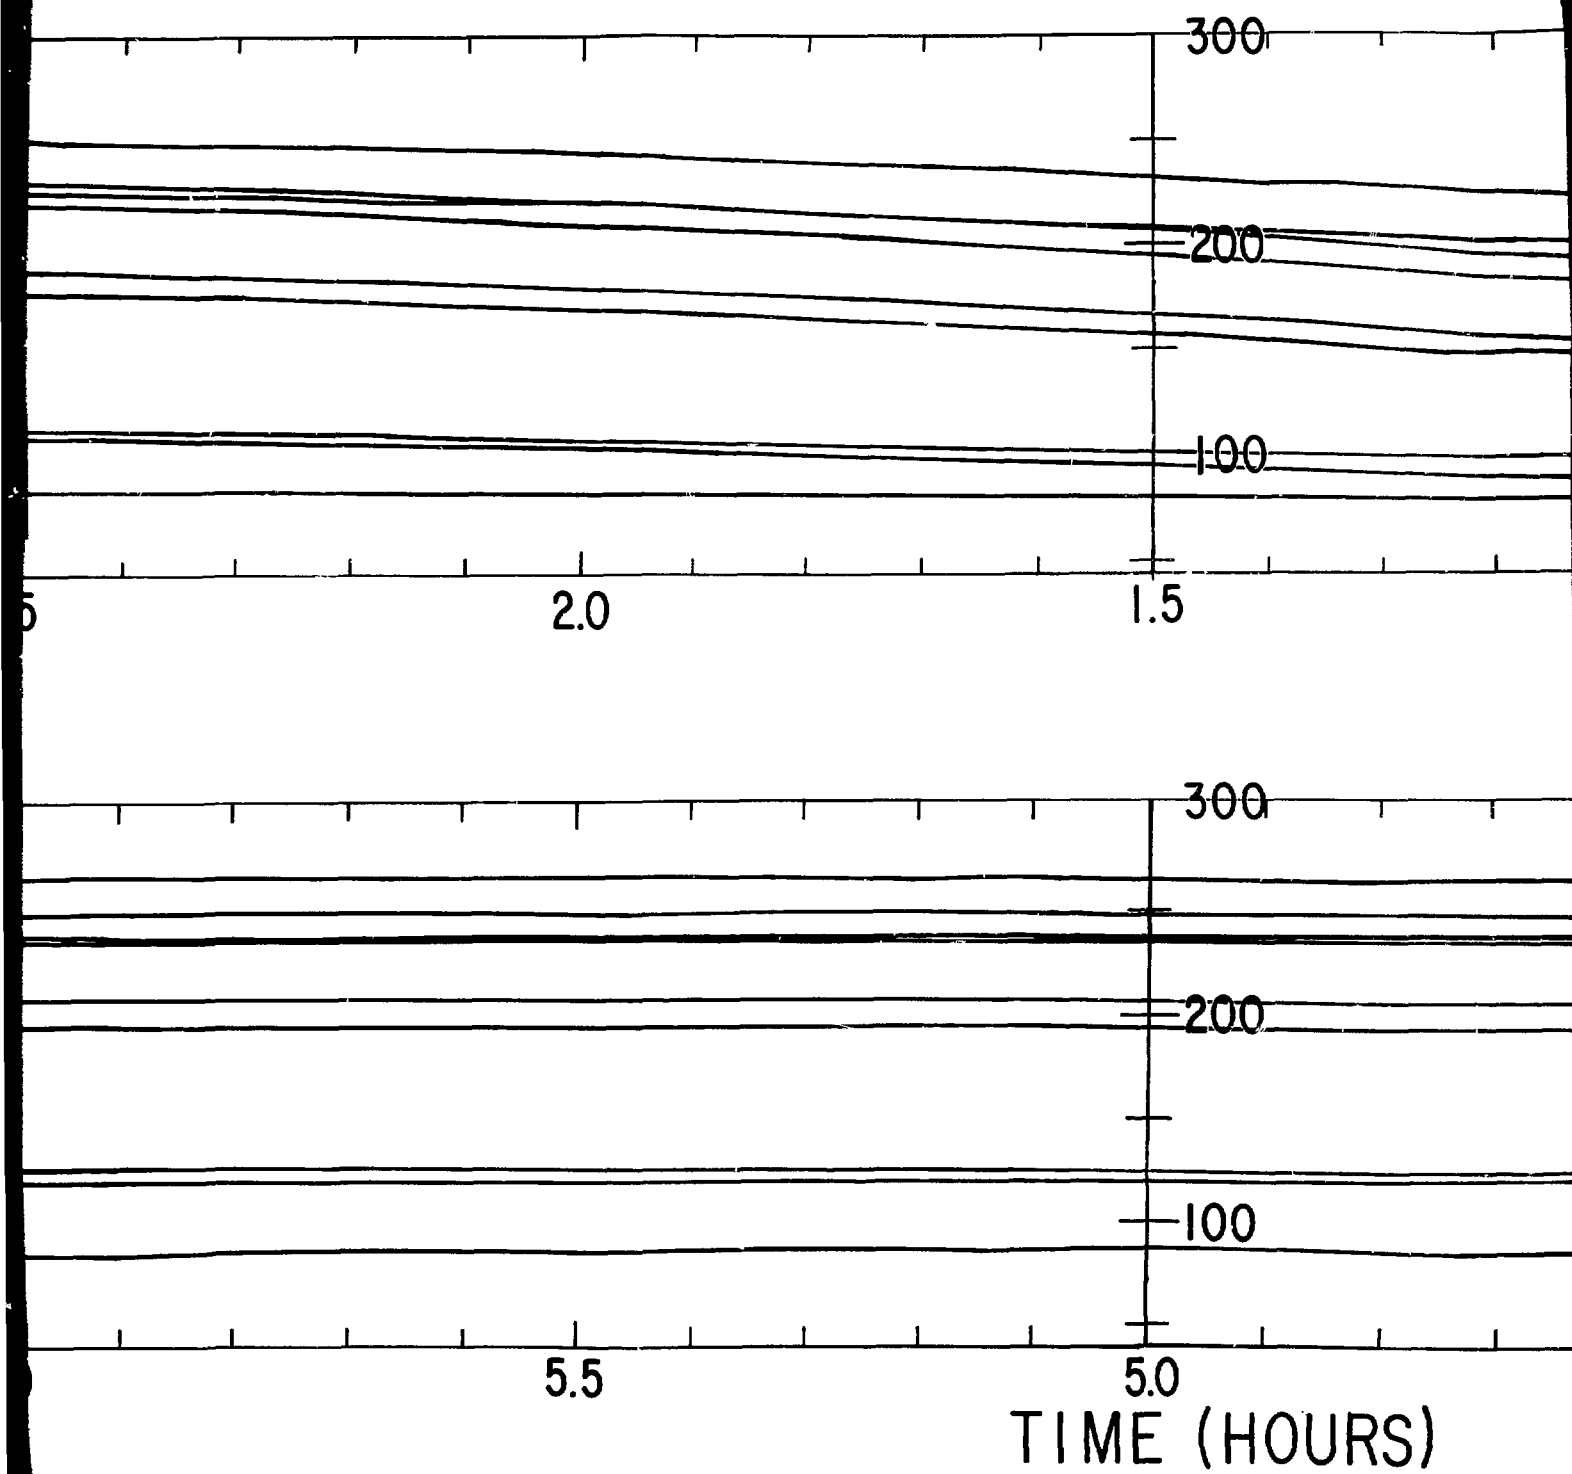
FIG. A-2

Figure A1 is the initial temperature rise test data for BP and PSCS at 23.2 and 25 kA, respectively. This test was performed before any make or break tests were done. Figure A2 is the temperature rise test for the same switches after approximately 200 make or break tests on each switch. The following references apply to the traces on Figs. A1 and A2 and include the maximum temperatures recorded.

Trace	Description	Max. Temp. °F
1	ambient air	86
2	BP oil	122
3	PSCS oil	128
4	BP rocker terminal	198
5	PSCS main terminal	210
6	BP main terminal	238
7	BP rocker guide	240
8	PSCS rocker terminal	250
9	PSCS rocker guide	266

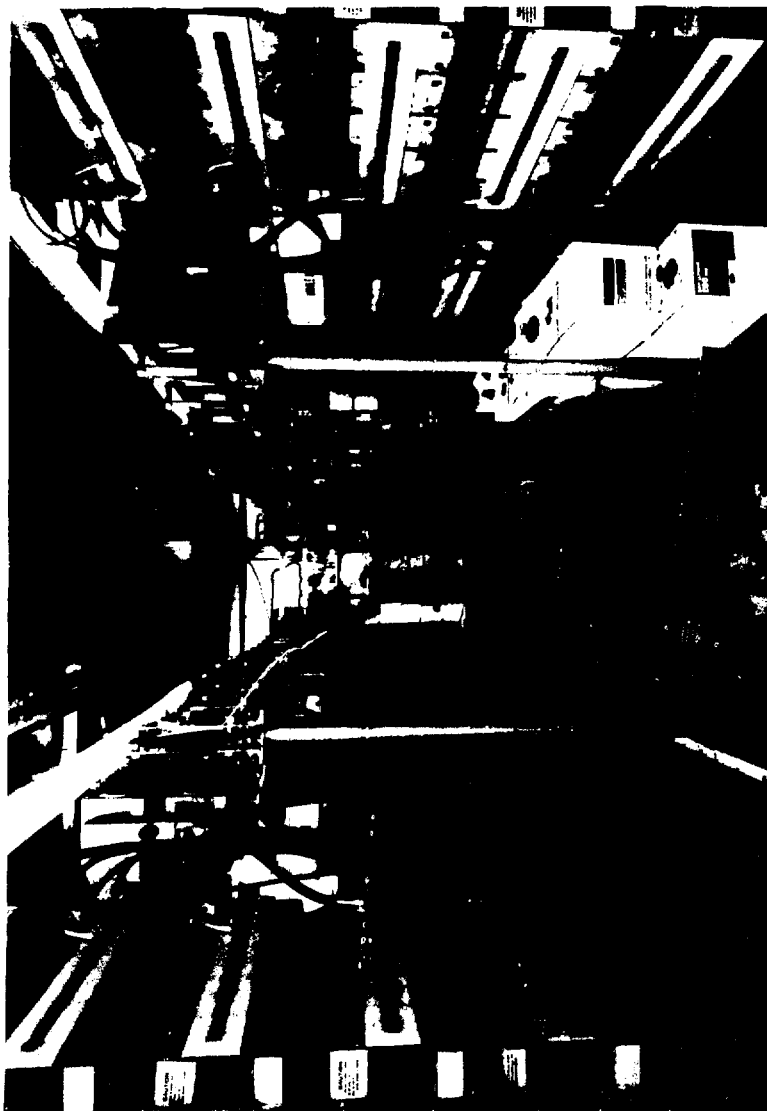
Fig. E1. Overview of test facility with the resistor on right and load coil in center.

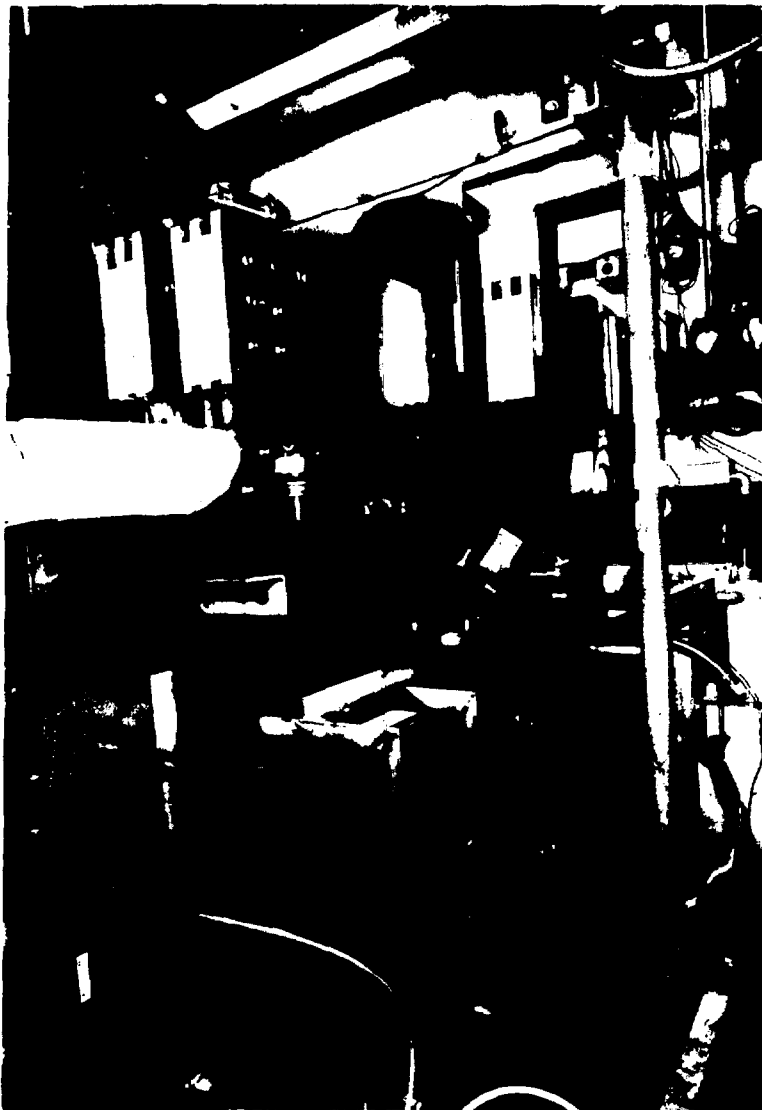
Fig. E2. BP in foreground and PSCS in background.

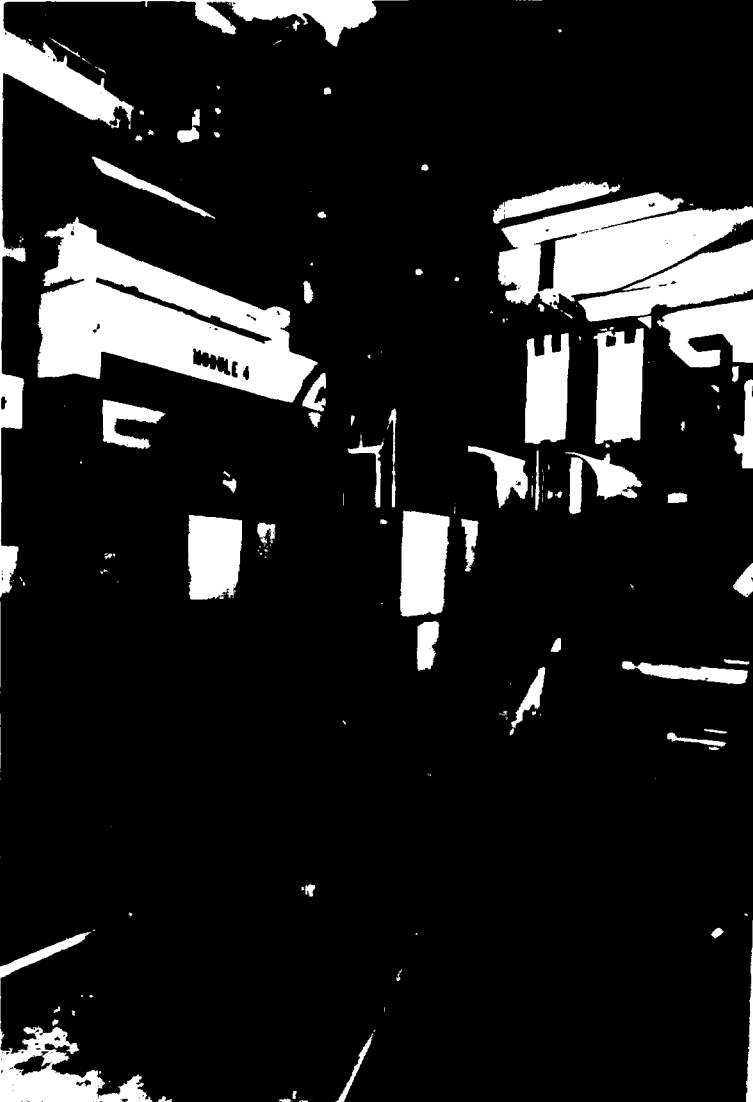
Fig. E4. Series connected DCCB's (left) and BP (right).

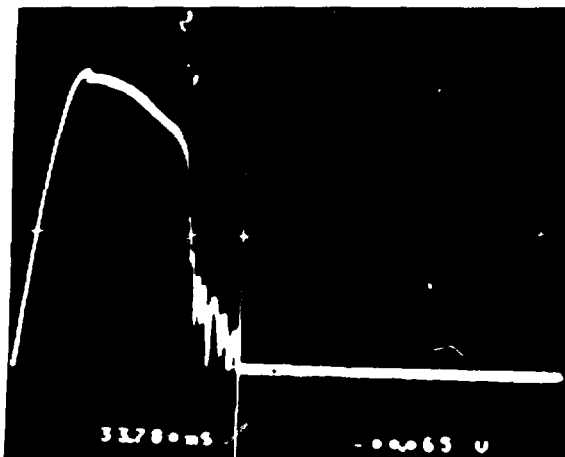
a. Breaker current.
Peak current is 25 kA.

b. Breaker voltage.
Peak voltage is 5 kV.
Recovery voltage is 2 kV.

c. Resistor current. Transfer current is 23 kA.

Fig. F5. Interruption at 2.0 kV showing multiple restrikes.
Time scales are different.
