CAMAS CREEK (MEYERS COVE) ANADROMOUS SPECIES HABITAT IMPROVEMENT

1990 Annual Report

USDA Forest Service Salmon National Forest Cobalt Ranger District

Project No. 84-23 Contract Number DE-AI79-84BP64321

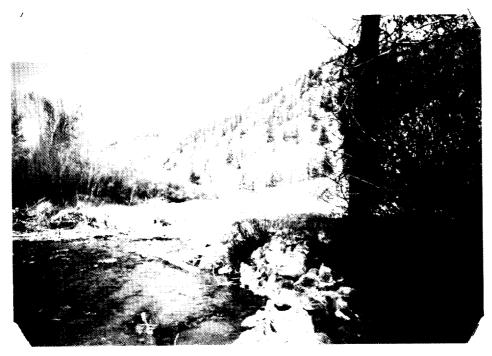
Photo 4: Watershed Stabilization Site 1 (October 1990) Note willow recruitment and increase in herbaceous vegetation.

Site 1-88 (Figure 4) required 120 yards of rock to stabilize 180 feet (linear) of streambank (completed November, 1988). Logs and woody material from an existing debris jam were anchored in place, providing additional rearing habitat and water deflecting structures (Appendix D, Photographs 3 and 4).

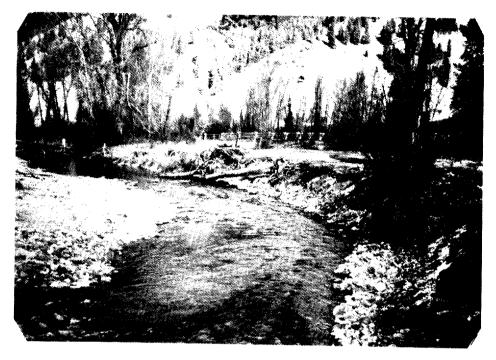
Photo 5: Watershed Stabilization Site 2 (November 1989) Prior to placement of logs at streams edge.

Work accomplished in October, 1989 at site 2-88 included bank stabilization and placing habitat structures (Figure 4; Appendix D, Photograph 5). Woody debris was anchored parallel along an eroding bank. Logs (with root wads attached) were placed to provide in-stream cover. Twenty cubic yards of rock were hauled and placed for construction of one water-deflection structure and streambank stabilization. Seven willow plugs were transplanted among the anchored woody debris. Additionally, over 40 willow cuttings were planted and the disturbed area reseeded with native grasses to accelerate revegetation (Appendix D, Photograph 6).

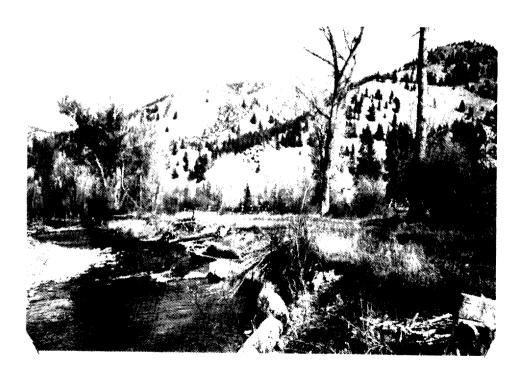
Photo 6: Watershed Stabilization Site 2 (October 1990) 11 months after treatment. Note stabilization of bank with grasses and willow recruitment.

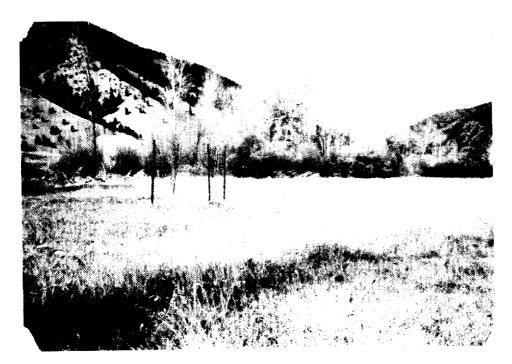
Photo 8: Herbaceous Photo Point No. 2 - Camas Creek Established October 1990 to monitor herbaceous vegetation.

Monitoring was completed in accordance with the plan design for the Camas Creek Anadromous Species Habitat Enhancement Project (Appendix B). The recovery of riparian areas is progressing slowly (as mentioned in Discussion-Riparian Vegetation Regeneration). Photographs, taken in 1990, show the current status of riparian vegetation. Before and after photographs were taken of work completed at bank stabilization sites (Appendix D, Photographs 3,4,5,6). The photographs included in this report identify streambank instability sites and provide a general overview of the project area and work accomplished. Now that construction work is complete, permanent photopoints should be established to monitoring revegetation and response to treatments (Appendix D, Photographs 7 and 8).

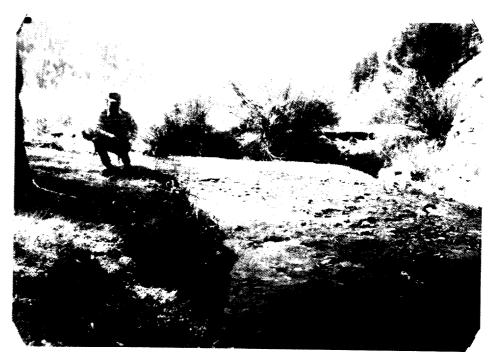
Photo 10: Cottonwood Regeneration along West Fork (September 1990). Note young cottonwoods next to stream.

Not all enhancement activities listed in the <u>Camas Creek (Meyers Cove)</u> <u>Anadromous Species Habitat Improvement Plan were implemented</u>. The cost/benefit of reseeding the riparian area and upper pasture was not feasible. The fencing and fertilizer applications will promote natural revegetation, a preferred alternative. Woody species regeneration and riparian greenline surveys are showing a dramatic increase in the number of young cottonwood and willow species within the exclosure (Figures 7 and 8; Appendix D, Photographs 9 and 10).
