Final Report: Conasauga Near-Surface Heater Experiment

FINAL REPORT: CONASAUGA NEAR-SURFACE HEATER EXPERIMENT

James L. Krumhansl
Geological Projects Division 4537
Sandia Laboratories
Albuquerque, New Mexico 87185

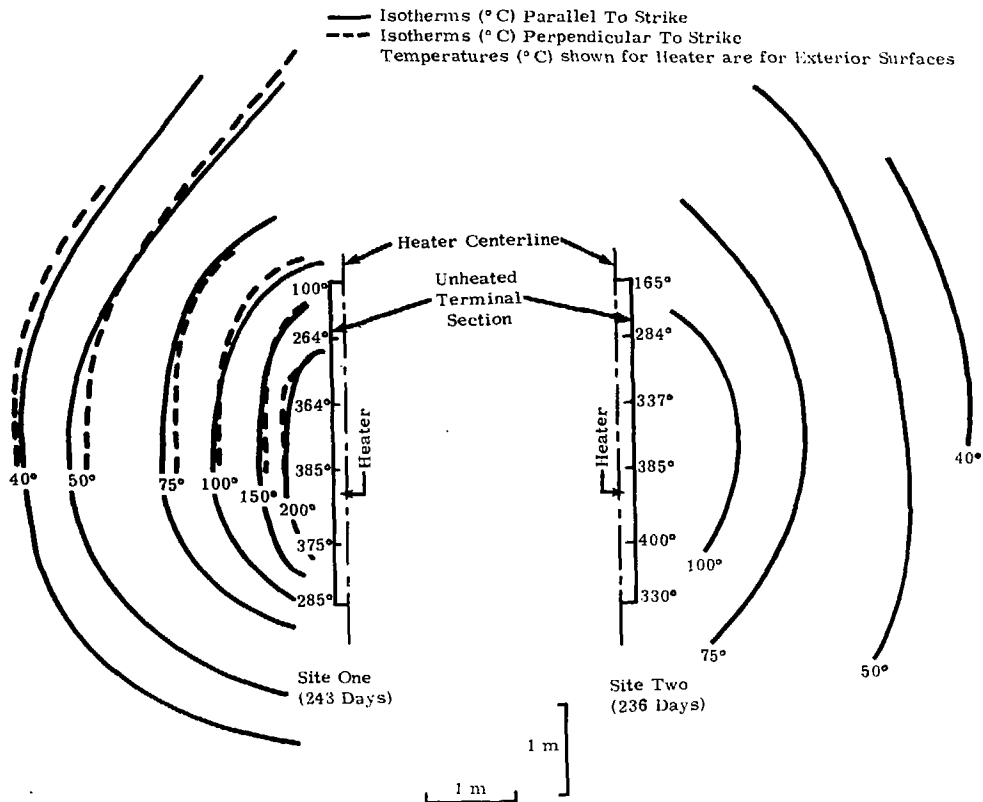
Figure 4. Isotherms at Sites 1 and 2 Just Before Heater Turnoff (1 August 1978)

On 1 August at 1330, power to both sites was turned off. The maximum temperature at either site before turnoff was 400°C at Site 2 (Figure 4). After 8 days, the maximum temperature at both sites had dropped below 100°C. No quenching effects due to groundwater influx were noted during this period. Airflow required to maintain preset air pressures in the Site 1 heater hole showed only a slight increase after heater turnoff (Figure 5). This response may have been due to the absence of steam or to minor contraction and cracking of the formation. At Site 2, a relatively permeable fracture zone in the heater hole at a depth of between 10 and 12 metres required a substantially higher airflow (8.5×10^{-2} m³/min) to prevent flooding during the test. Consequently, the relatively small changes induced by cooling could not be detected. Minor fluctuations in water level in satellite wells occurred during this period; however, they could not be related to the cooling process (Figure 6). In conclusion, only minor changes occurred within the shale as a consequence of cooling of the formation.

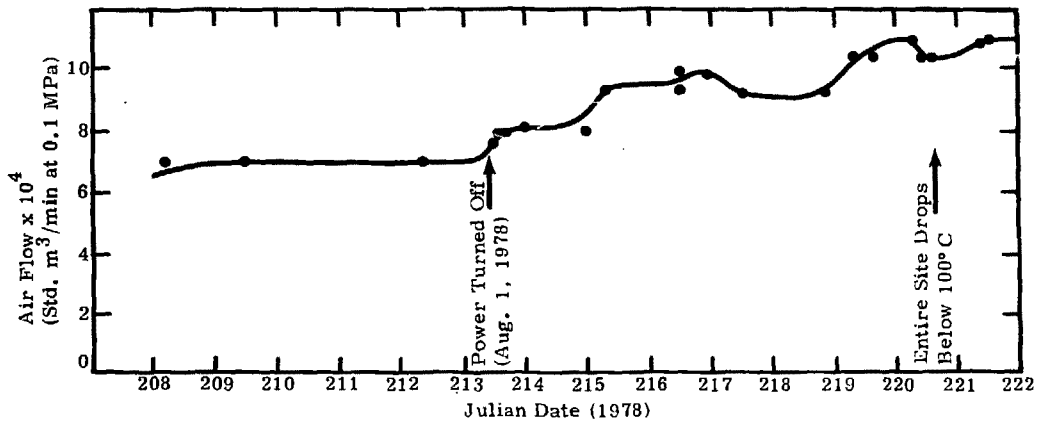
Figure 5. Airflow Required to Maintain 0.08 MPa on the Site 1 Heater Hole

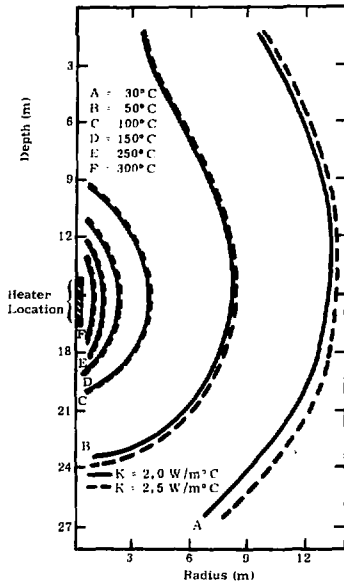
Figure 14. Calculated Isotherm Positions After 243 Days of Heater Operation, Using 2.0 and 2.5 W/m°C Thermal Conductivity and the Computer Code CINDA

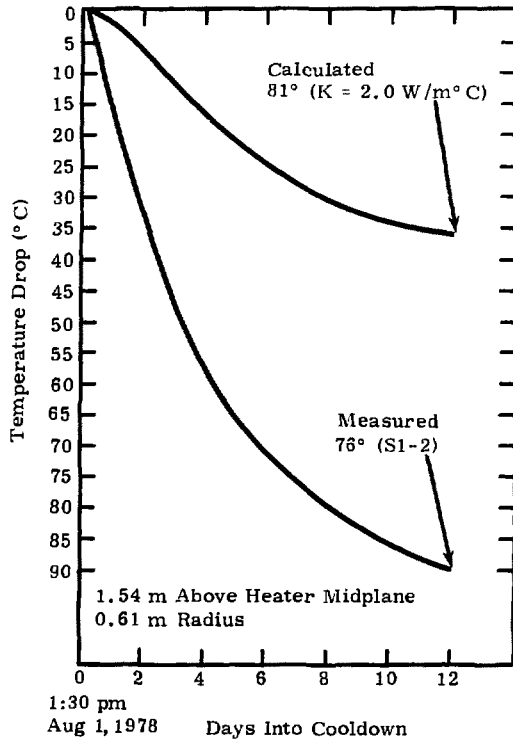
Figure 18. Comparison of Calculated and Actual Cooldown Rates at a Radius of 0.61 metre and 1.54 metre above the Heater Midplane. Final temperature together with modeled thermal conductivity or hole number are shown at the right.

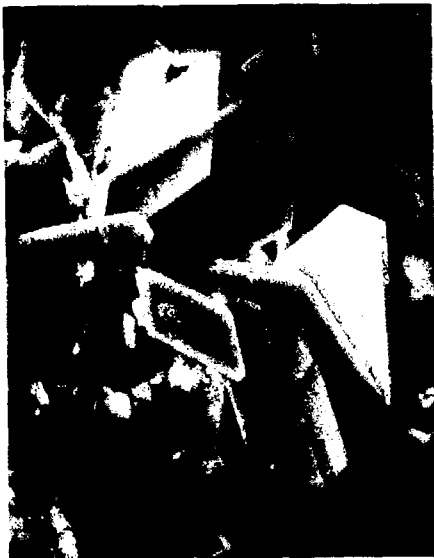
Figure 33. Gypsum Crystals That Formed After Cooling of the Site (200X)

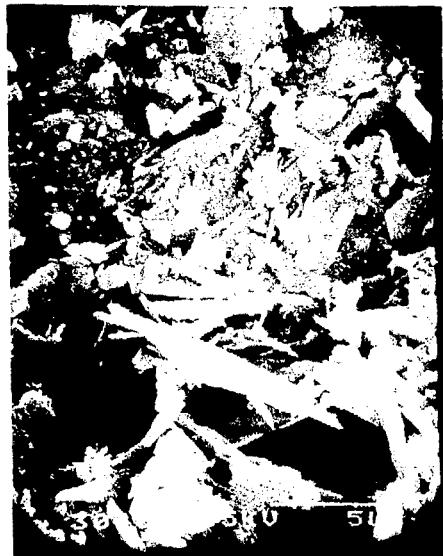
Figure 47. Scanning Electronic Photomicrograph of the Exterior of the Alteration Layer Showing a Mat of Acicular Crystals

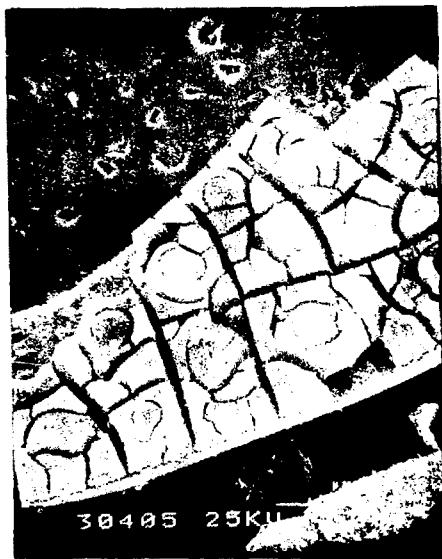
Figure 49. Interior Surface of Gel Alteration Layer.
