# SOLAR-POWERED STEAM GENERATOR HELIOSTAT

FINAL REPORT

J.G. Cottingham  
Principal Investigator

BROOKHAVEN NATIONAL LABORATORY  
ASSOCIATED UNIVERSITIES, INC.

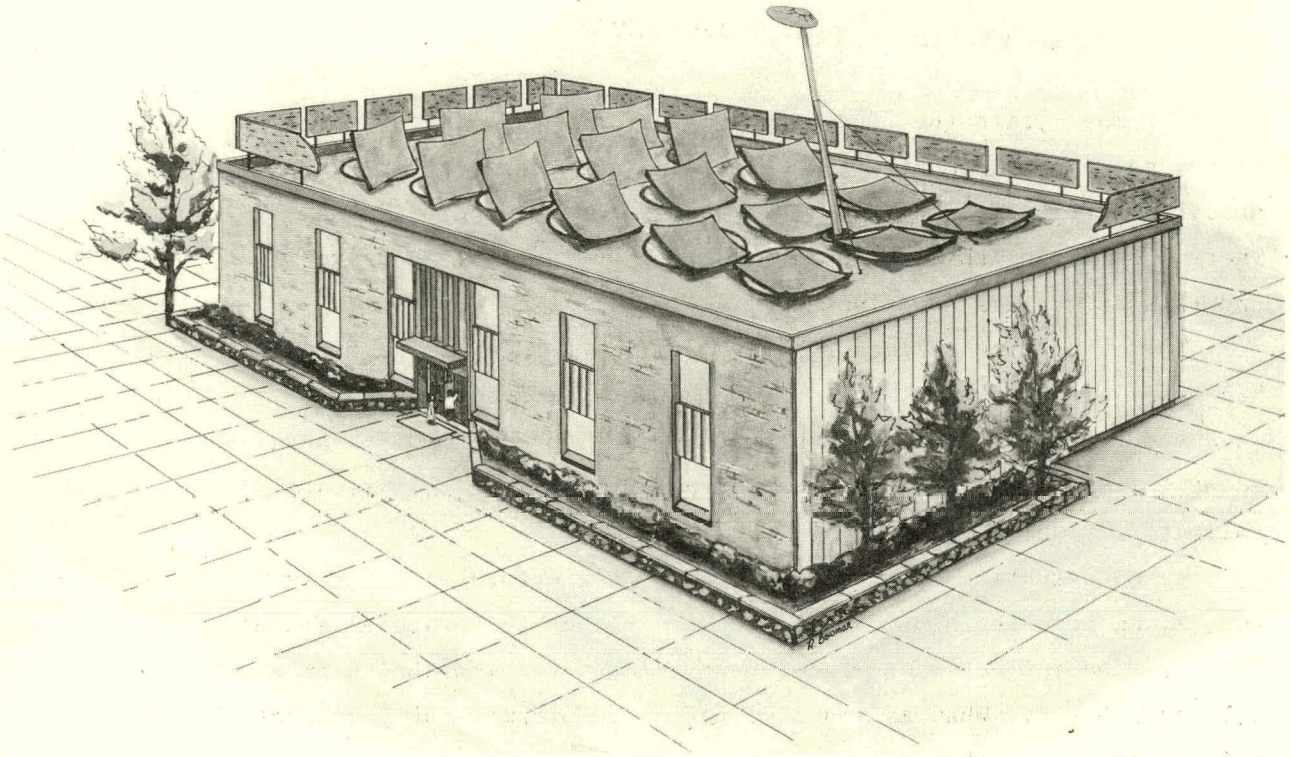
Figure 1. Artist concept of roof mounted "power-tower" solar energy collector.

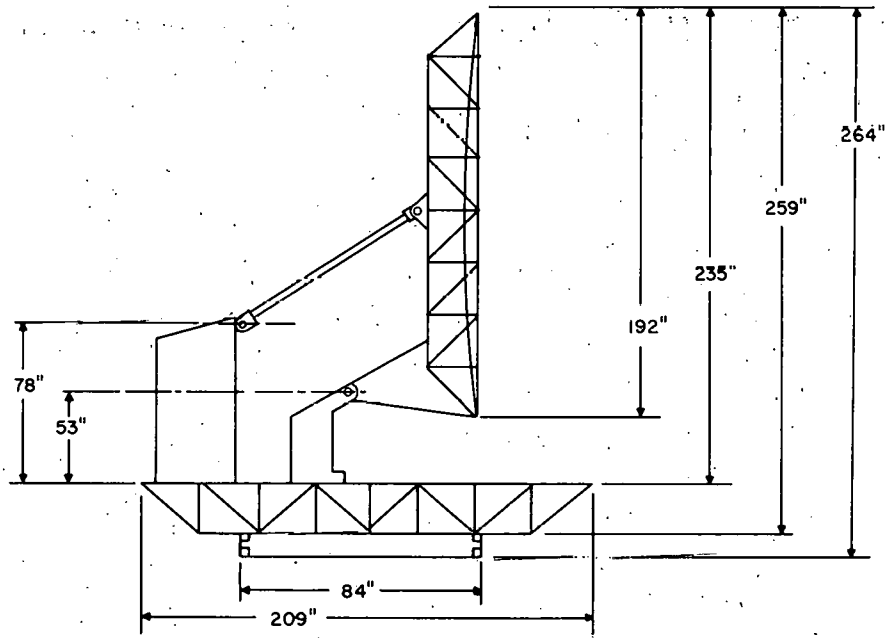
Figure 2. Heliostat design used in motion study.

Figure 2 shows the pivot point location optimized as a result of this motion study. Tables III.1 to III.3 summarize the forces that result in the optimized configuration.

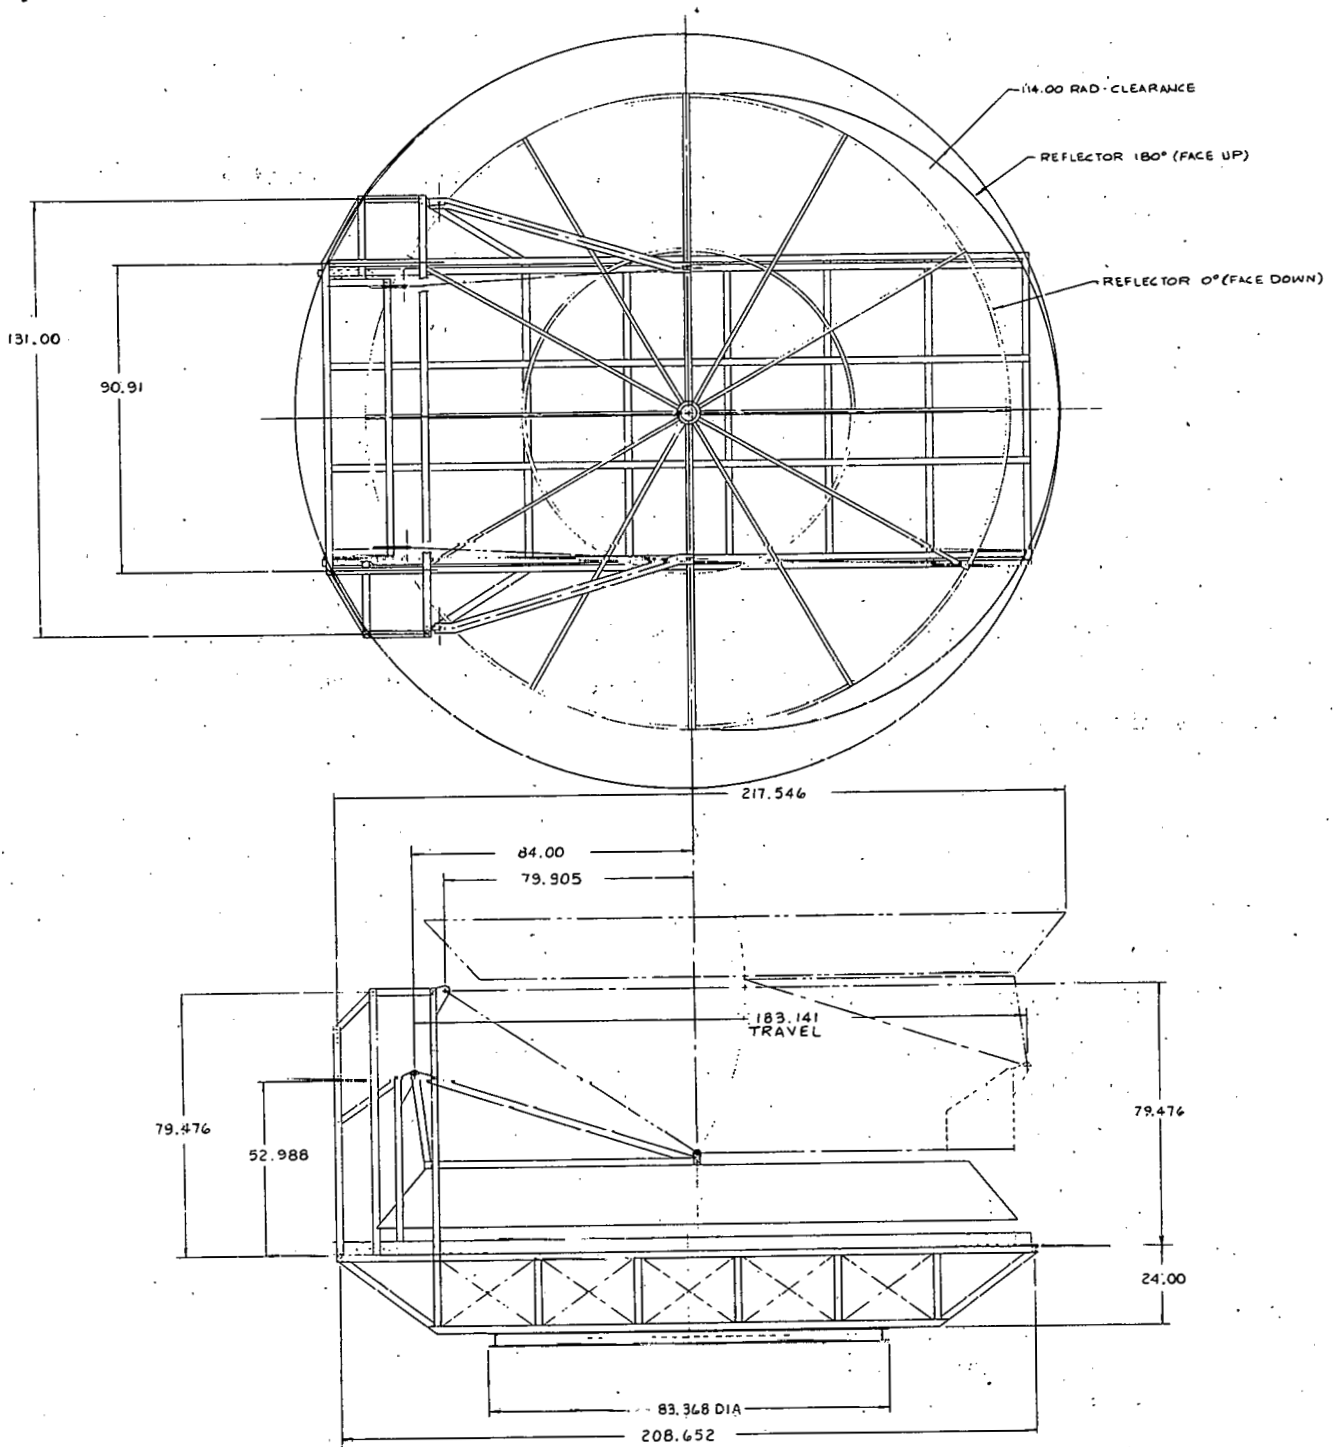
BROOKHAVEN NATIONAL LABORATORY
ASSOCIATED UNIVERSITIES, INC.
UPTON, N. Y. 11973
HELIOSTAT
16' DIAMETER
STRUCTURAL CONCEPT

Figure 3. Heliostat prototype design, side and plan view.

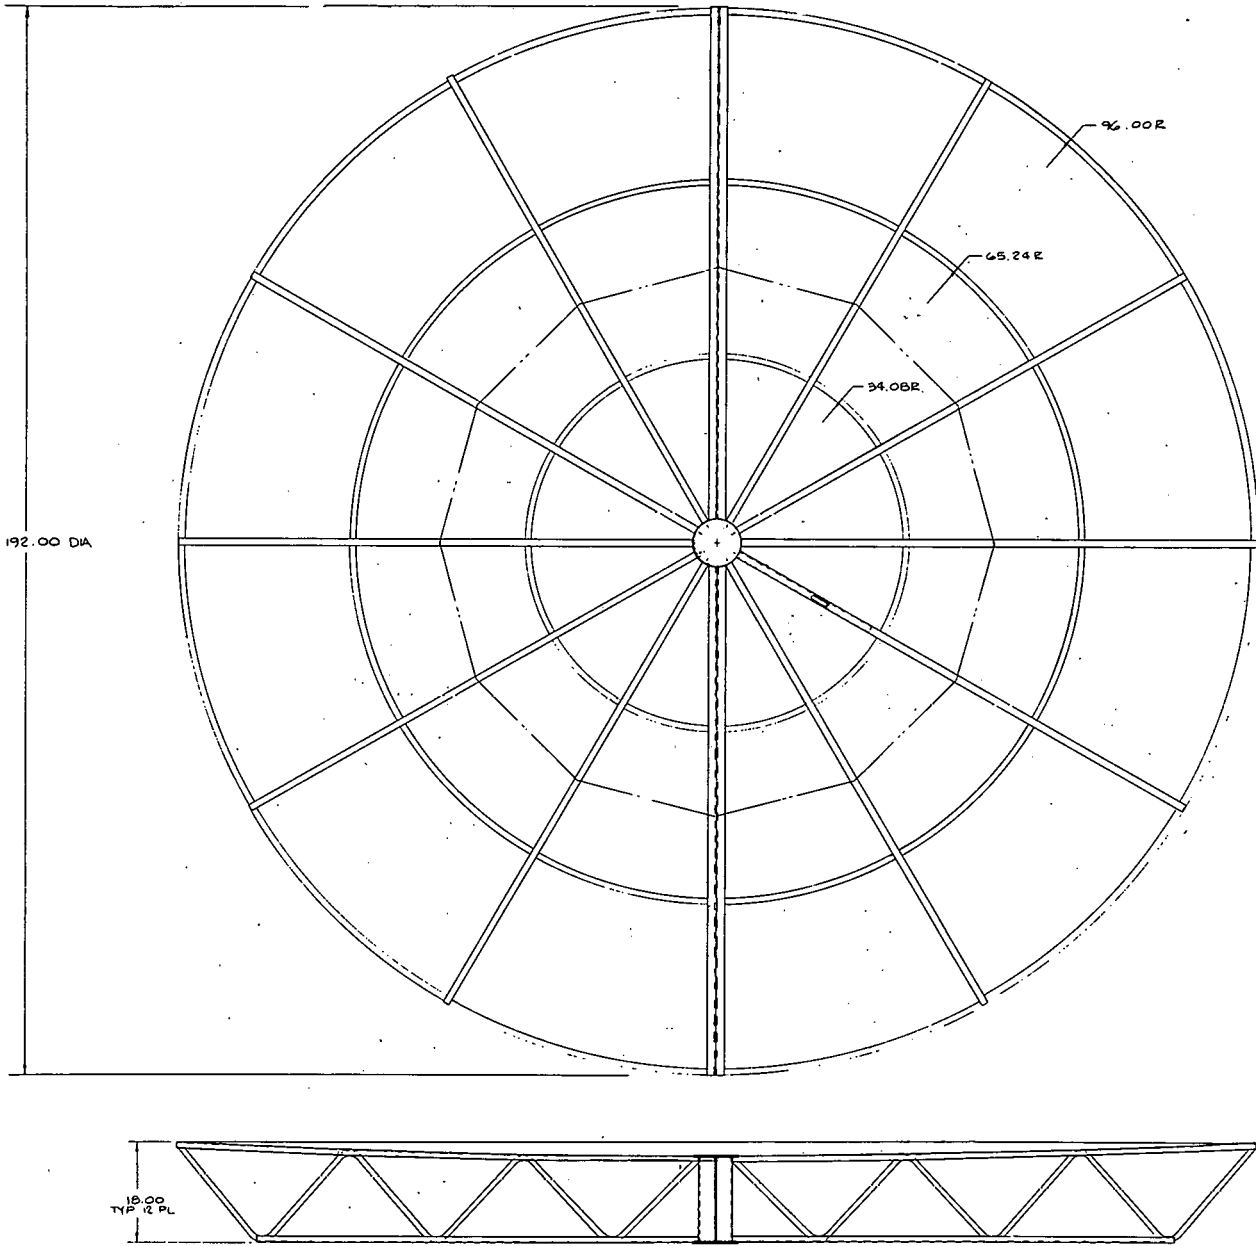
TYP CROSS SECTION  
OF CONSTRUCTION

Figure 4. Heliostat dish design.

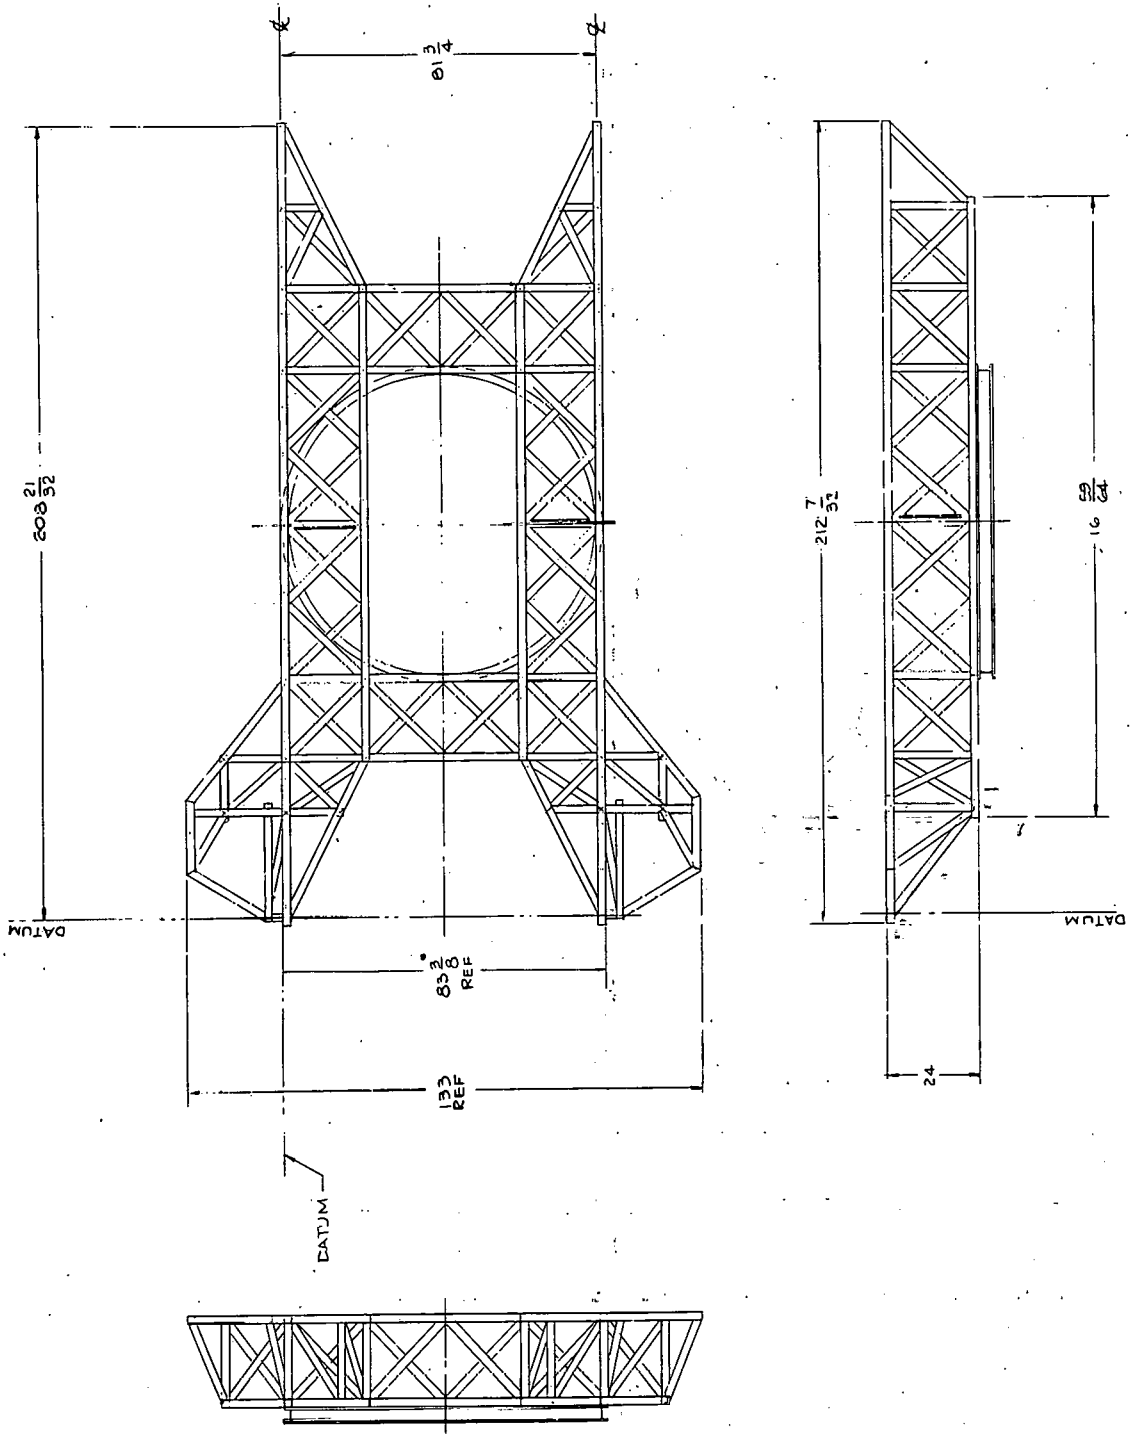
Figure 5. Drive platform assembly.

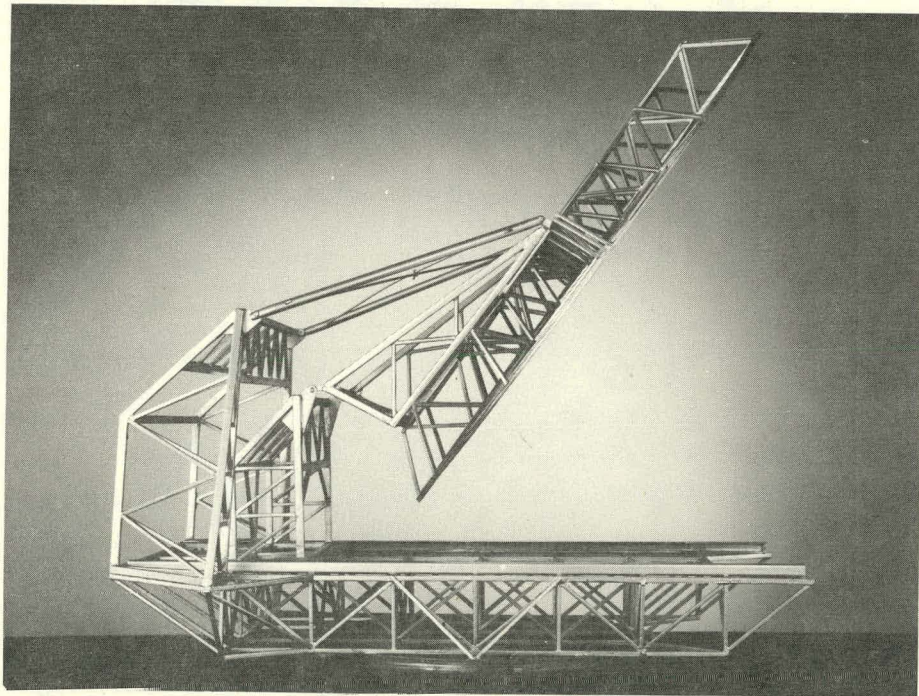
Figure 7. Heliostat model - folding action.

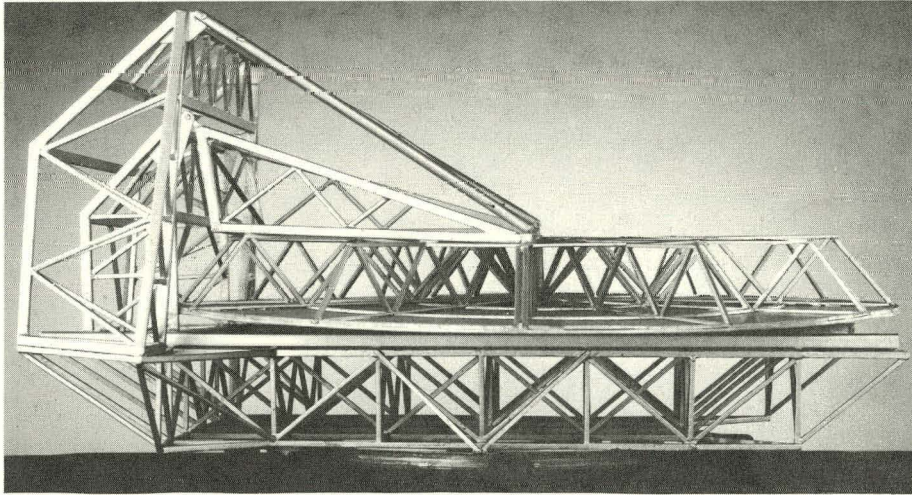
Figure 8. Heliostat model - stowed position.

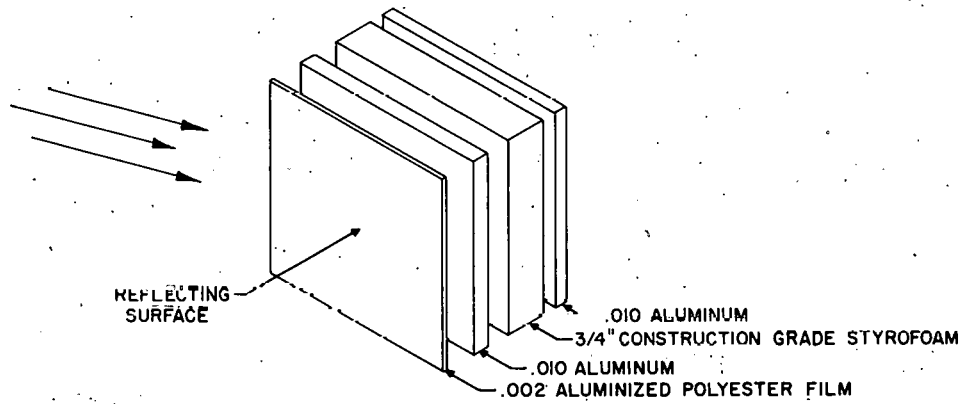
Figure 9. Lightweight plastic mirror assembly symmetrical package.

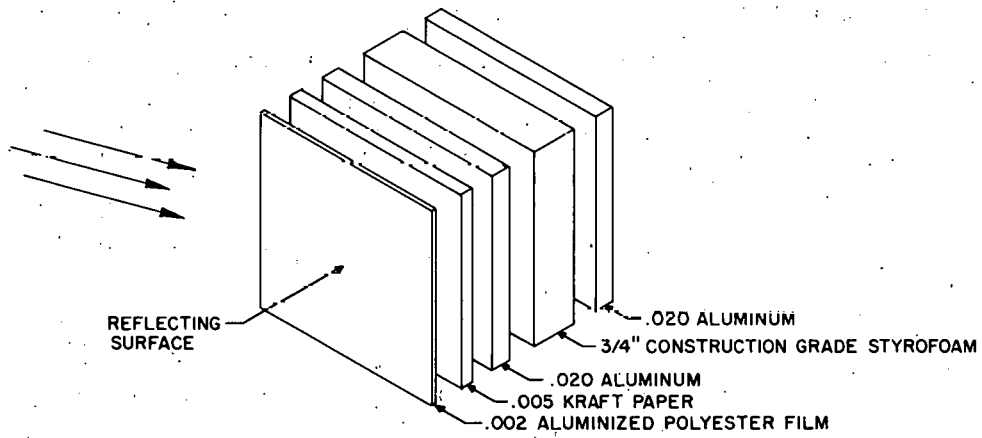
Figure 10. Lightweight plastic mirror assembly symmetrical package, with kraft paper.

From this trial and error two successful product designs evolved. The process described above and illustrated in Figure 11 yields a mirror with better specularly. The mirror package illustrated in Figure 10 is less costly to manufacture and has adequate specularly ( $<1$  milliradian) for the small tower application studied by Brookhaven. To produce this package, the Micarta sheet is removed and replaced by an epoxy-paper layer. The function of this layer is to buffer the reflecting film from the aluminum sheet. Without

The second type of bonding failure is similar but caused by a different procedural change. The specularly of the kraft-paper-type support package, Figure 10, is improved if the epoxy layer containing this paper is made thicker. This layer was made very thick, 1/16 in. in some cases, to yield

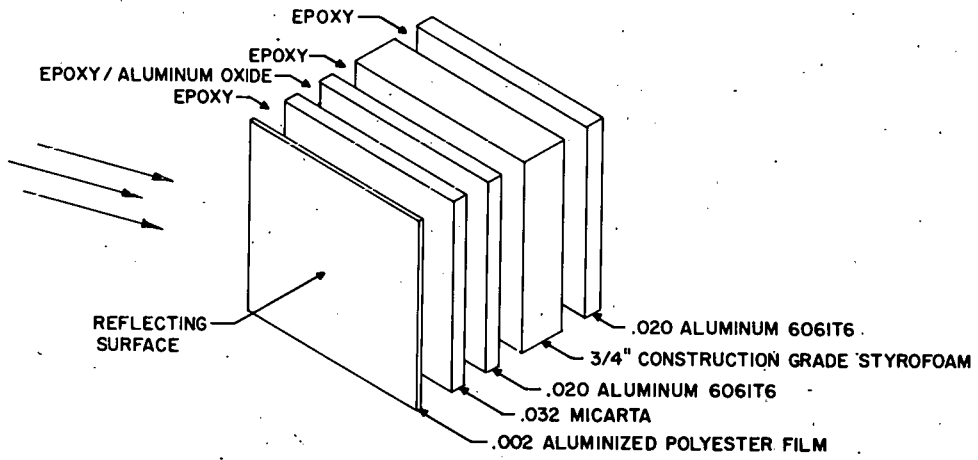
Figure 11. Lightweight plastic mirror assembly with Micarta.

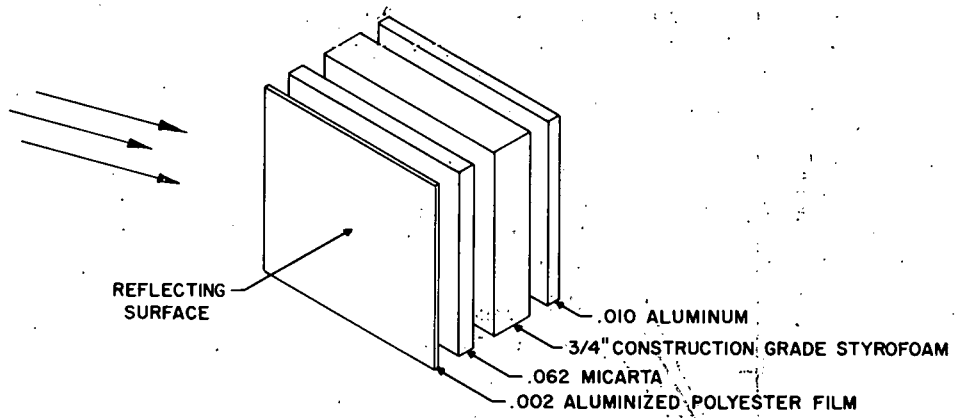
Figure 12. Lightweight plastic mirror assembly asymmetrical package.

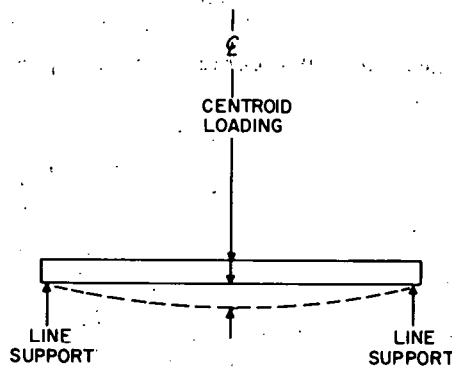
Figure 13. Deflection test.

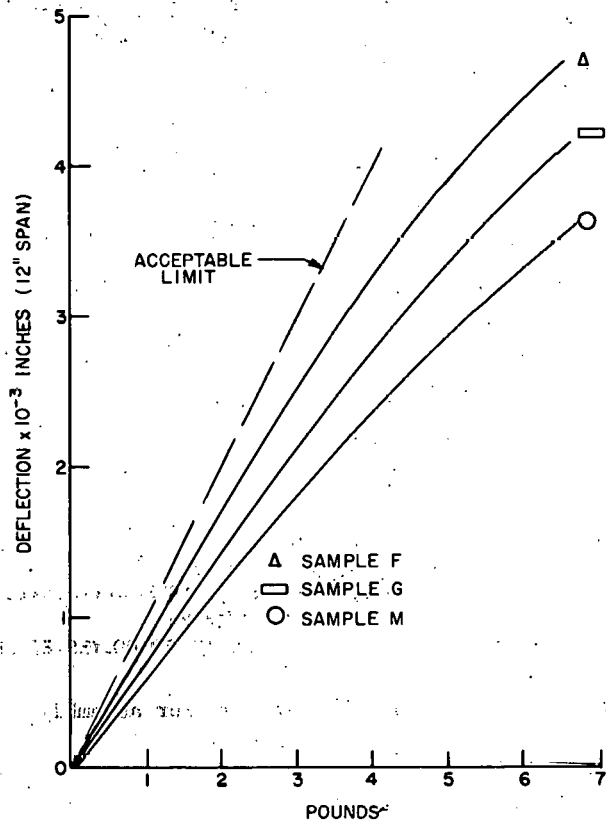
Figure 14. Deflection test results.

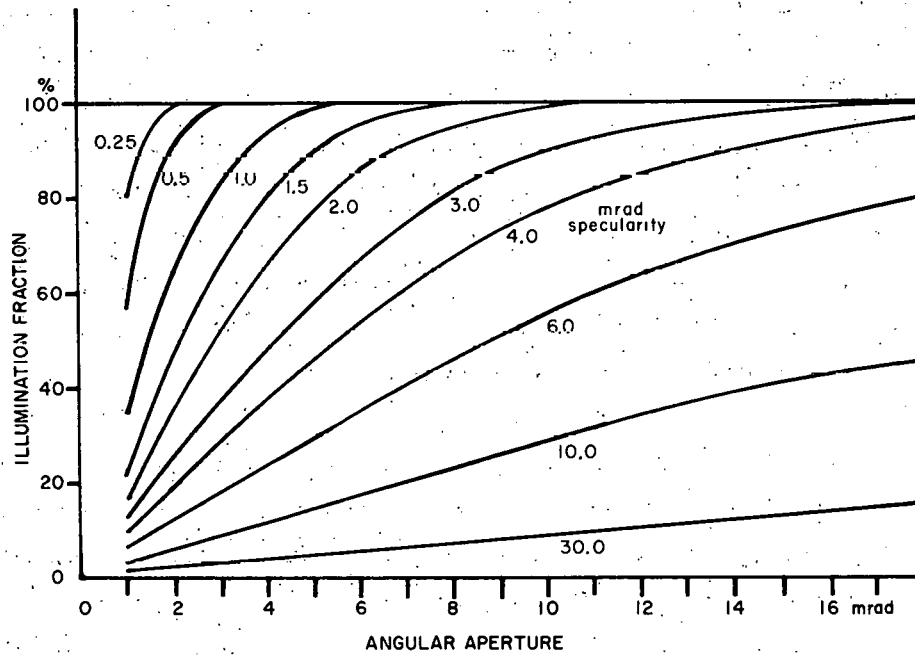
Figure 15. Computer derived specularity nomograph, copied from Sandia Report SAND-76-5310 by Richard Pettit.

Brookhaven built a simple but similar arrangement for measuring specularity following the Pettit concept. A tungsten light source was substituted for Dr. Pettit's monochromatic source. Using this test facility to measure specularity, production methods and product quality were monitored. Specularity varied during the course of production but improved as better handling methods were developed. A typical product displayed specularity better than 0.5 milliradians.

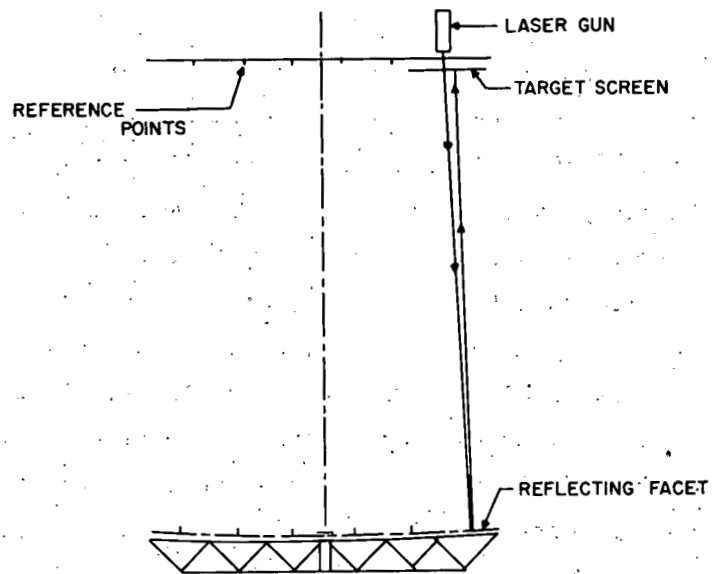
Figure 16. Laser alignment scheme.

After a horizontal row of facets is aligned, the heliostat dish is rotated about its optical axis to bring the next row of facets to the horizontal, and then that row can be aligned. This process is repeated until all facets are aligned. The optical axis is defined as the normal to a central reflecting facet which is rigidly fastened to the heliostat dish. Orientation

of the heliostat frame is adjusted until the laser beam reflected from this central facet strikes the laser target center when the laser is operated from the central reference point.

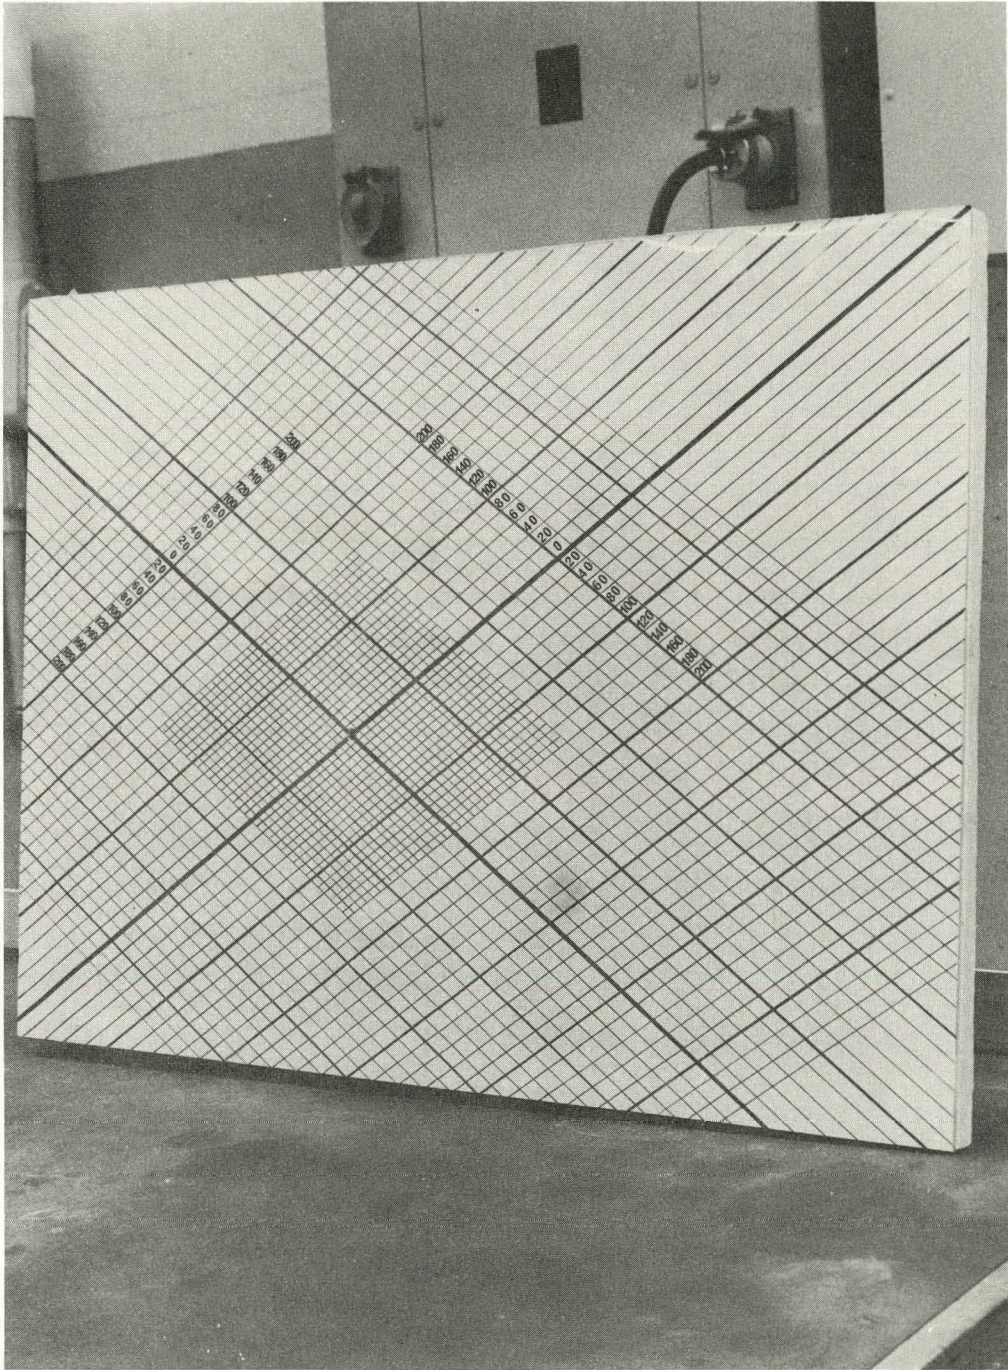
Figure 17. Screen from which correction shim values are read during laser alignment.

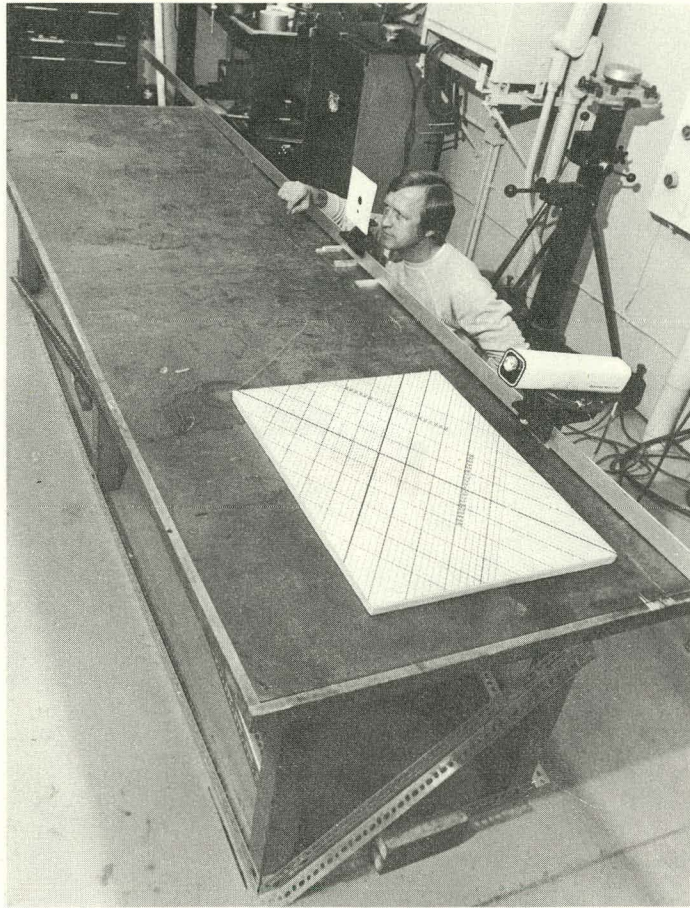
Figure 18. Laser optical bench showing central alignment procedure.

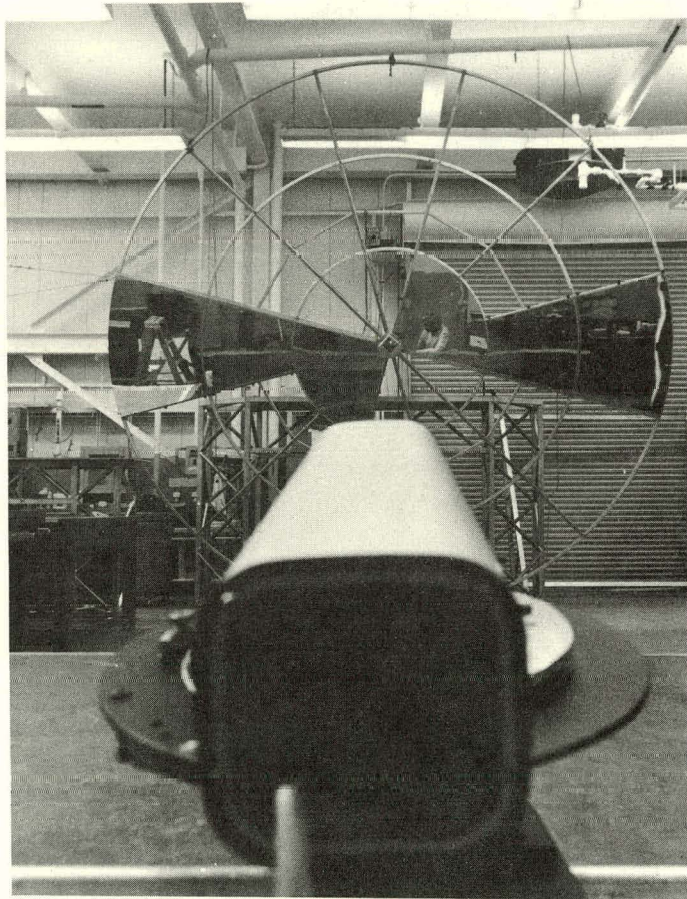
Figure 19. View looking over the top of laser gun.

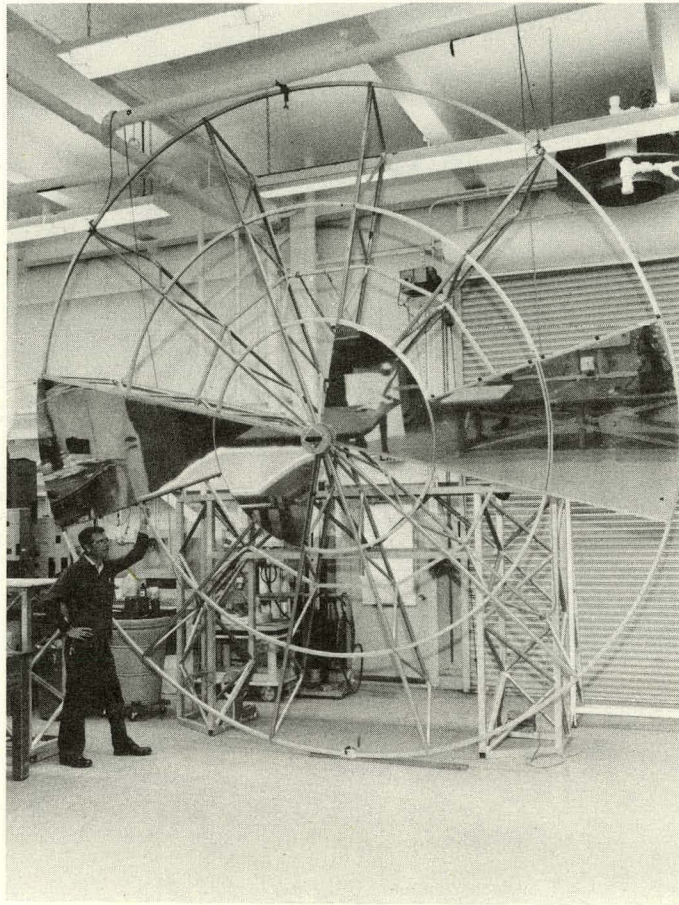
Figure 20. Heliostat undergoing laser alignment with only one row of reflecting facets in place.

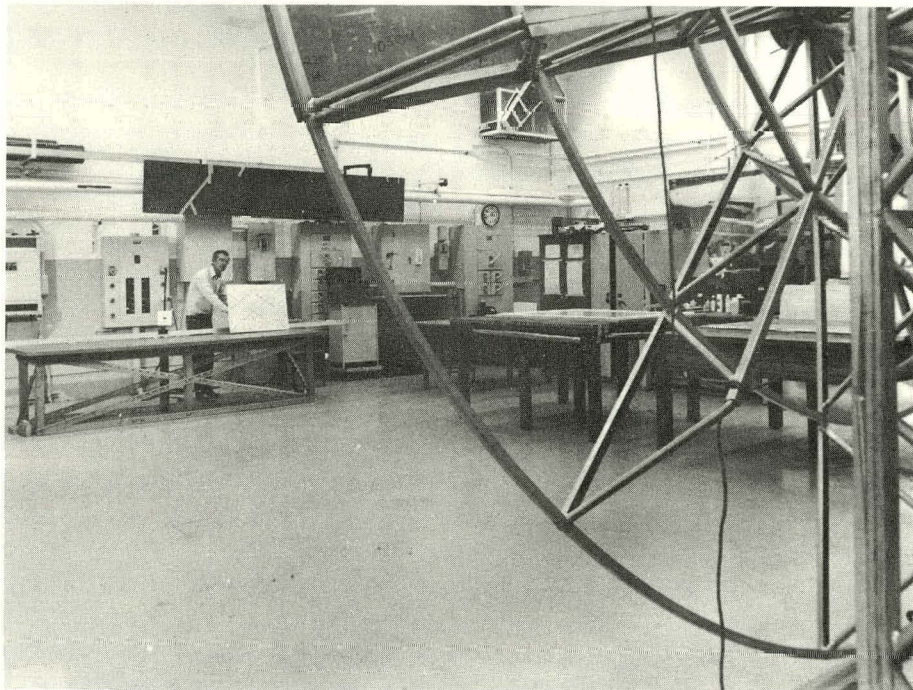
Figure 21. View of laser optical bench from behind the partially faceted heliostat dish.

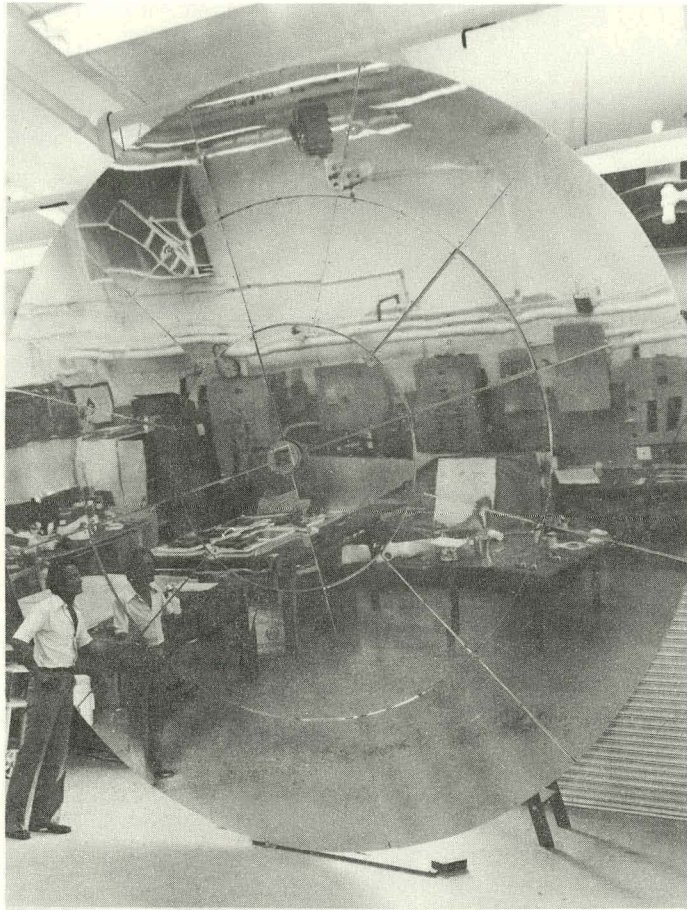
Figure 22. Fully faceted heliostat dish undergoing laser alignment, front view.

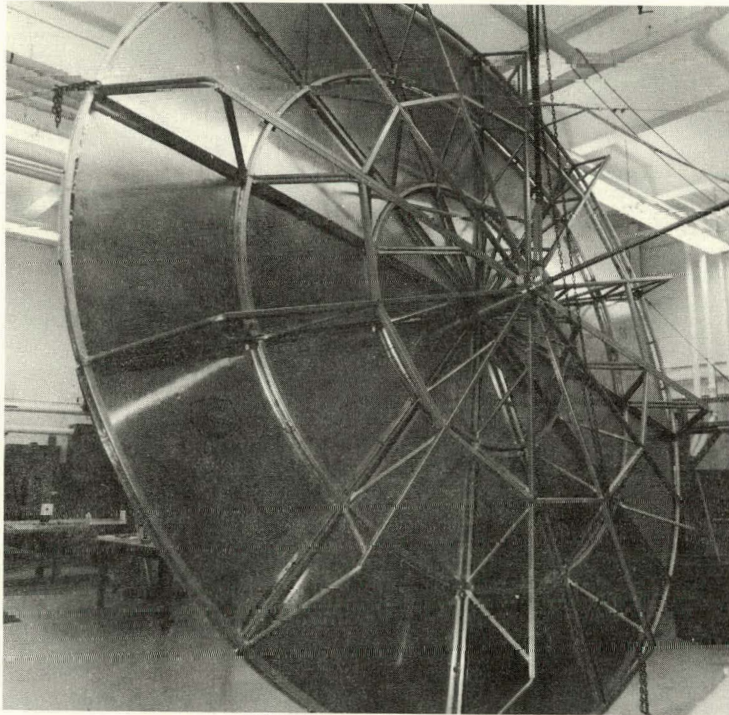
Figure 23. Rear view of heliostat dish in laser alignment facility.

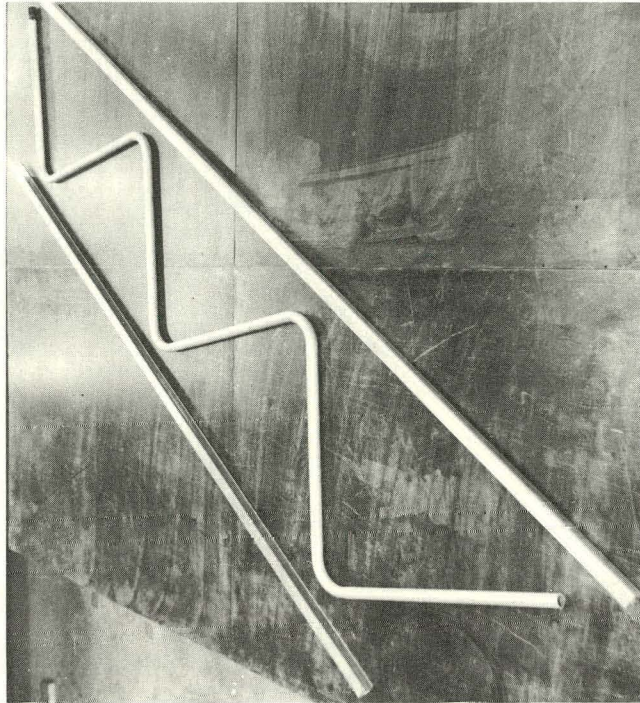
Figure 24. Bent tubing and U-shaped pieces that form heliostat dish truss assembly.

The frame for the heliostat dish, an important component from a weight consideration, was engineered in considerable detail. This effort resulted in a very low weight design employing aluminum tubing and a U-shaped channel formed by bending. These pieces, shown in Figure 24, are welded together to form truss assemblies which are the strength element of the dish structure. These trusses are in turn welded to other channel pieces to form the dish frame as seen in Figure 25. This frame is fitted with reflecting facets and

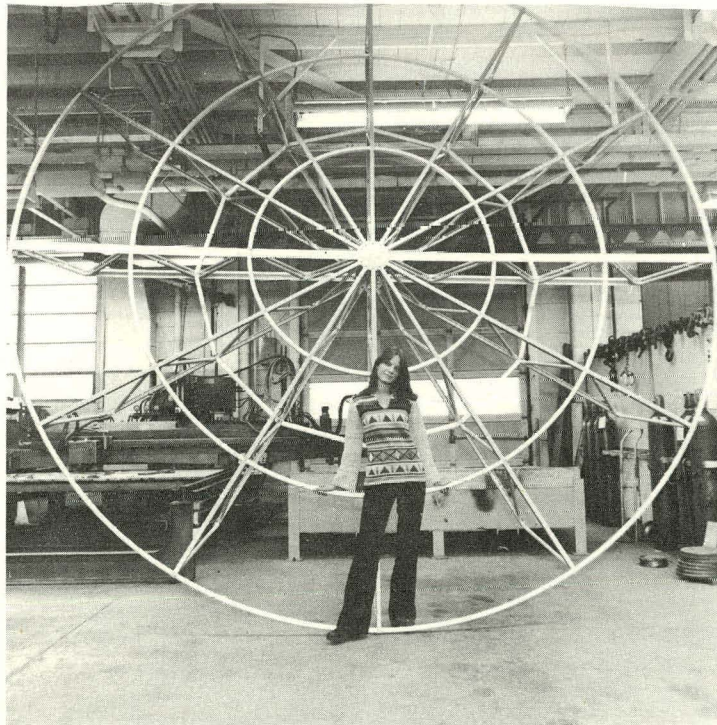
Figure 25. Heliostat dish support structure.

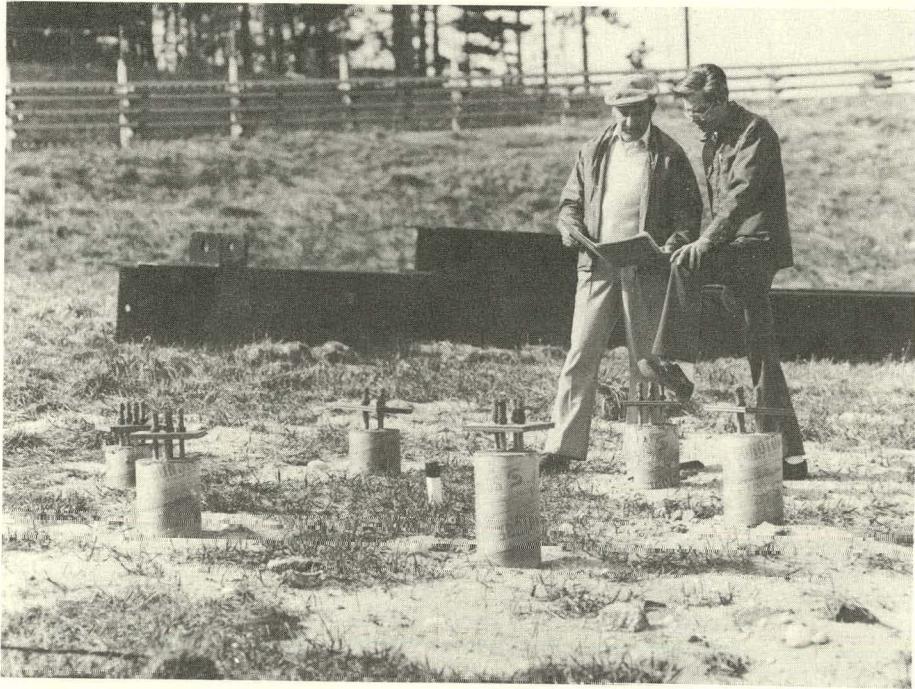
Figure 26. Heliostat footings.

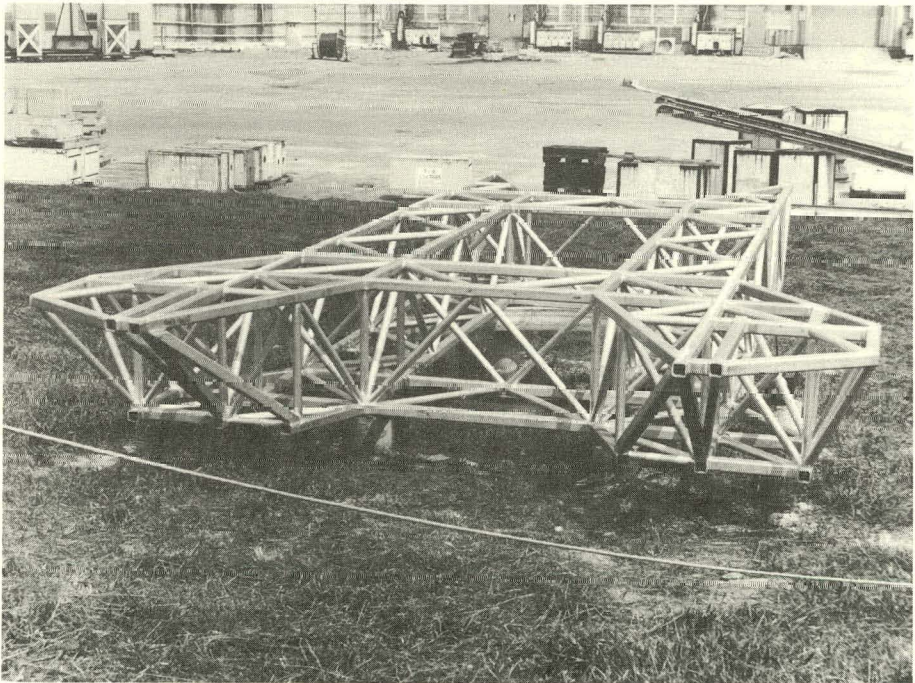
Figure 27. Heliostat base frame.

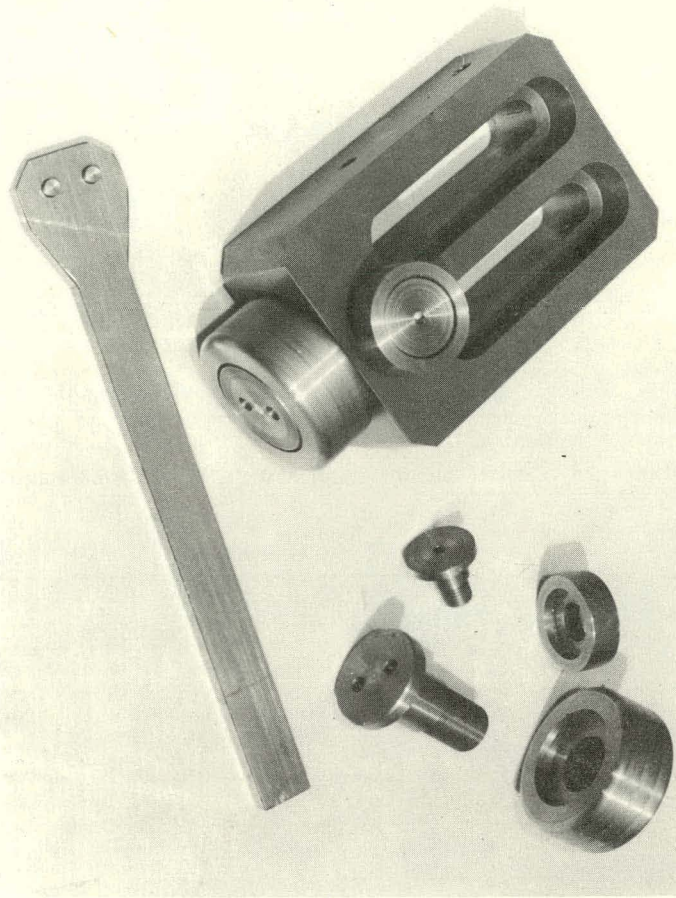
Figure 28. Heliostat roller assembly.

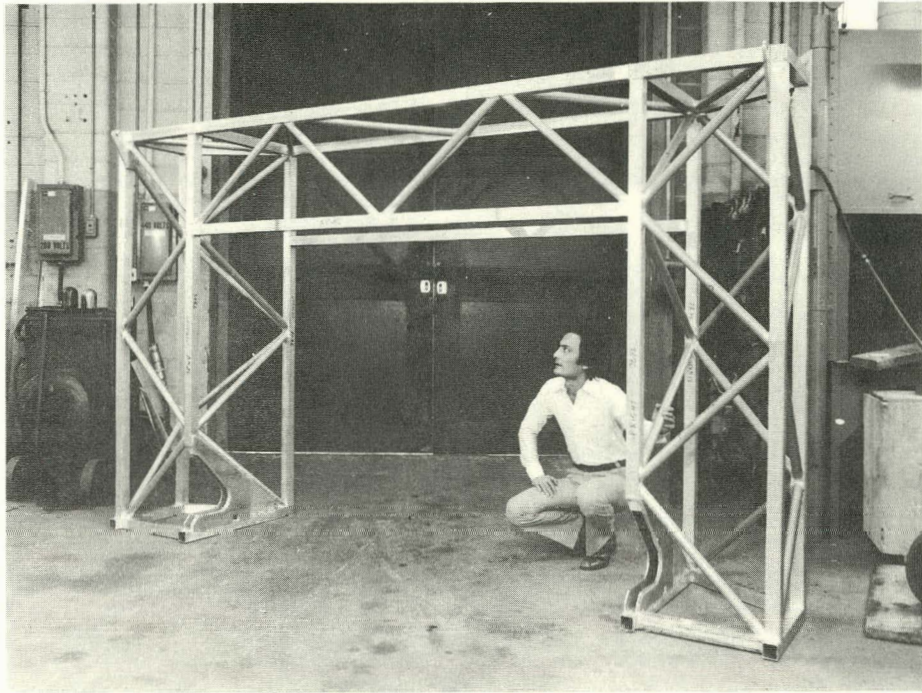
Figure 29. Rear station stanchion of heliostat assembly.

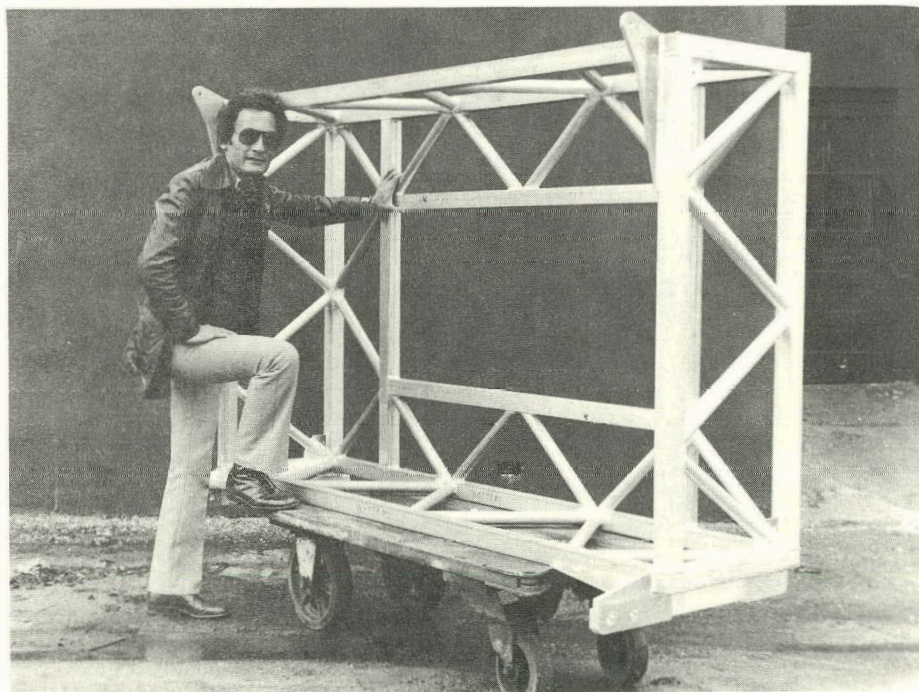
Figure 30. Movable stanchion of heliostat assembly.

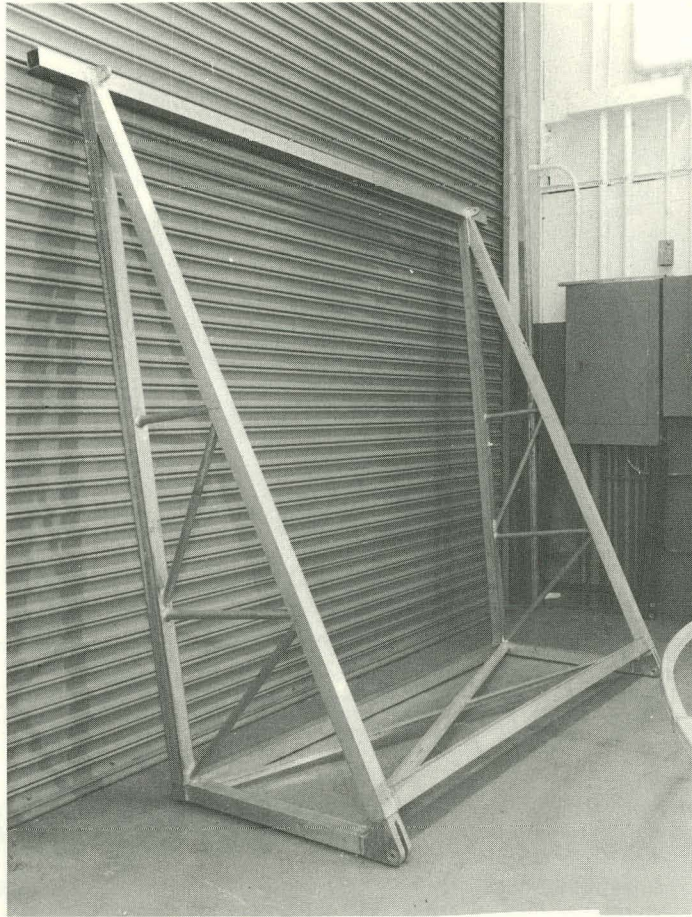
Figure 31. Wedge pivot structure of heliostat assembly.

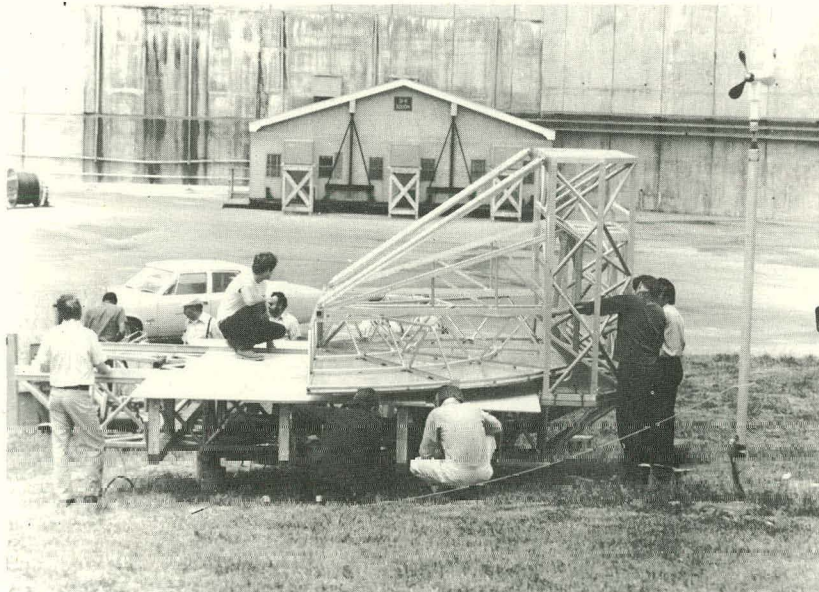
Figure 32. Heliostat undergoing field assembly - half dish in place on temporary plywood surface.

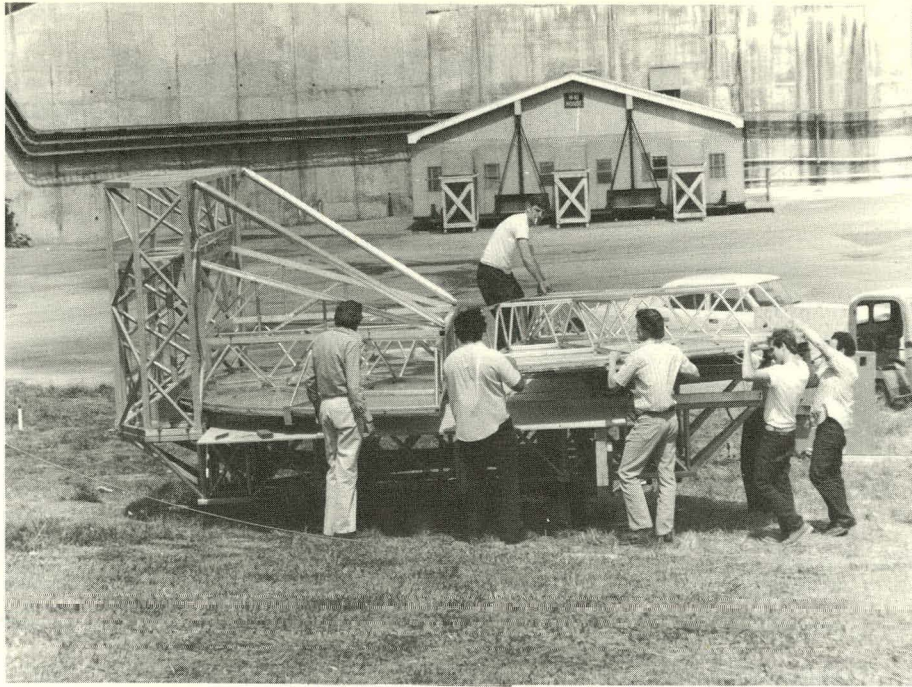
Figure 33. Field erection - second half of dish moving into place.
