# SOLAR-POWERED STEAM GENERATOR HELIOSTAT

FINAL REPORT

J.G. Cottingham  
Principal Investigator

BROOKHAVEN NATIONAL LABORATORY  
ASSOCIATED UNIVERSITIES, INC.

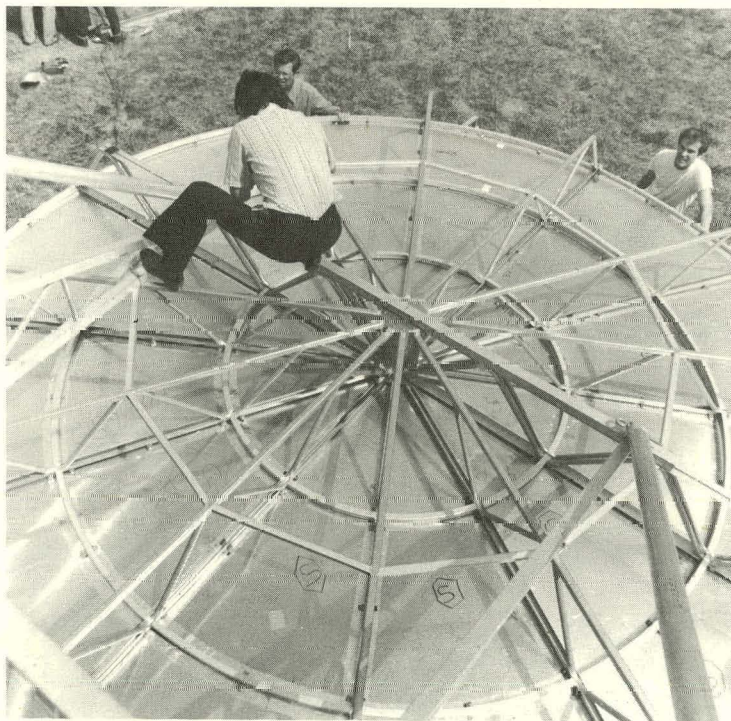
Figure 34. Field assembly of heliostat dish - two halves being bolted back together.

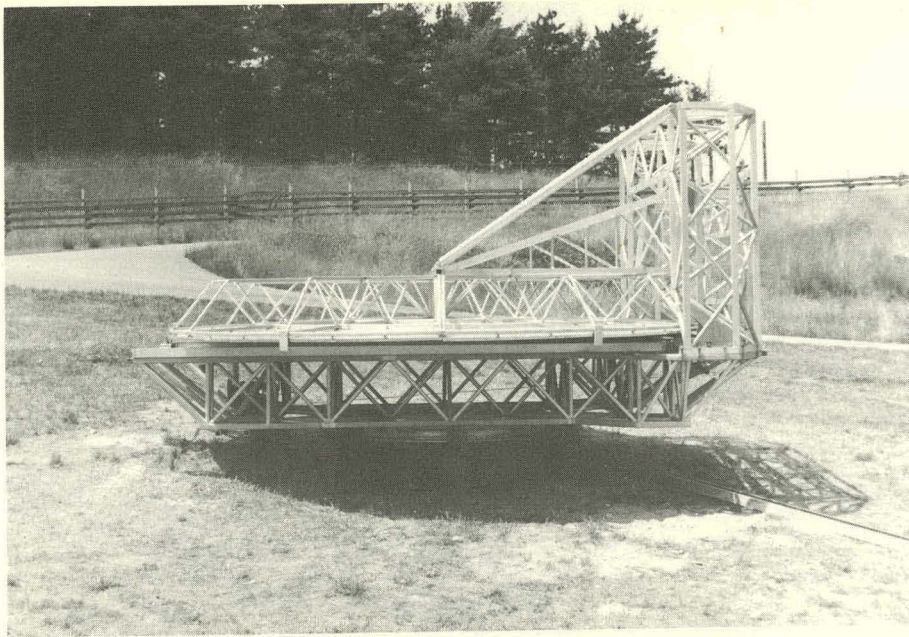
Figure 35. Heliostat prototype in face down wind avoidance position.

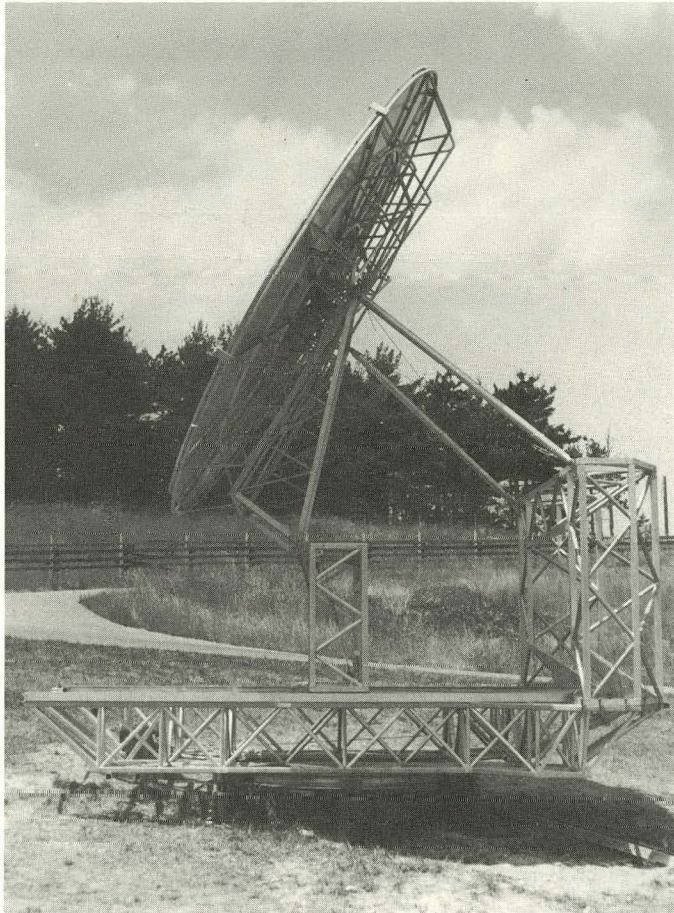
Figure 37. Heliostat in working altitude.

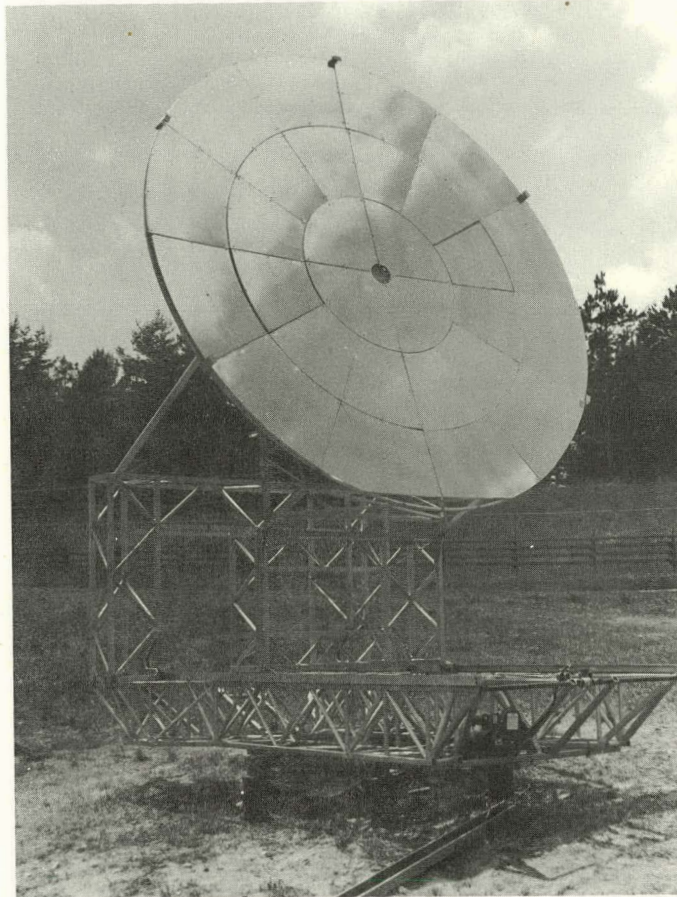
Figure 38. Heliostat prototype, front view.

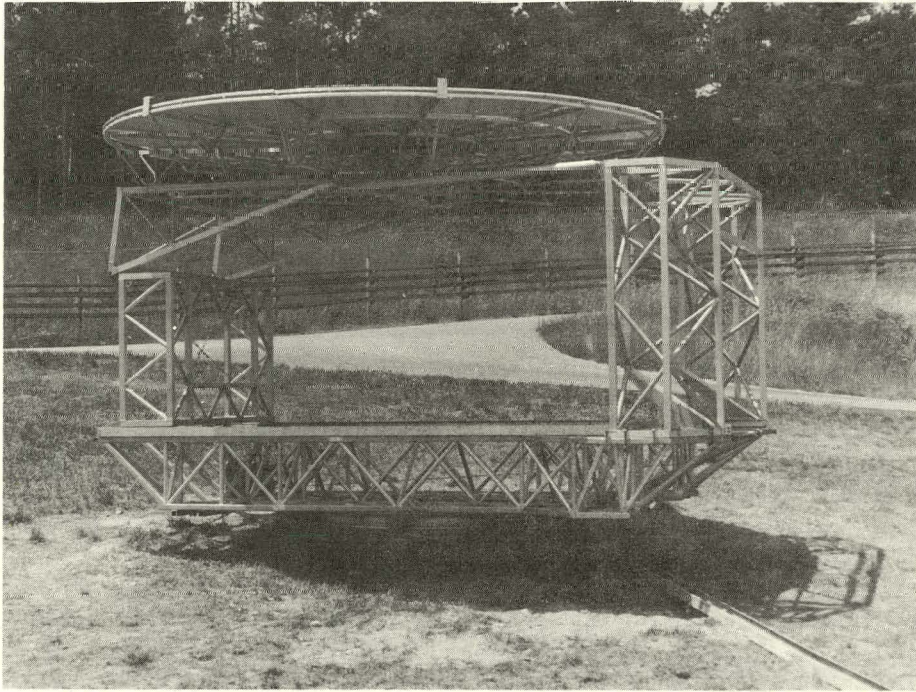
Figure 39. Heliostat prototype in the full up position.

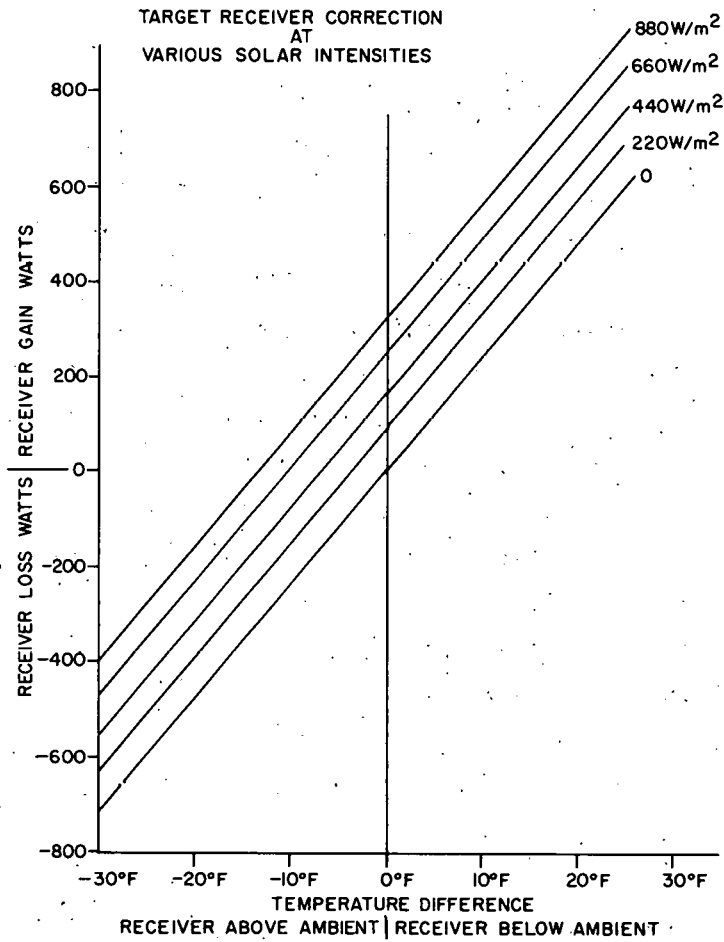
Figure 40. Receiver energy correction characteristic.

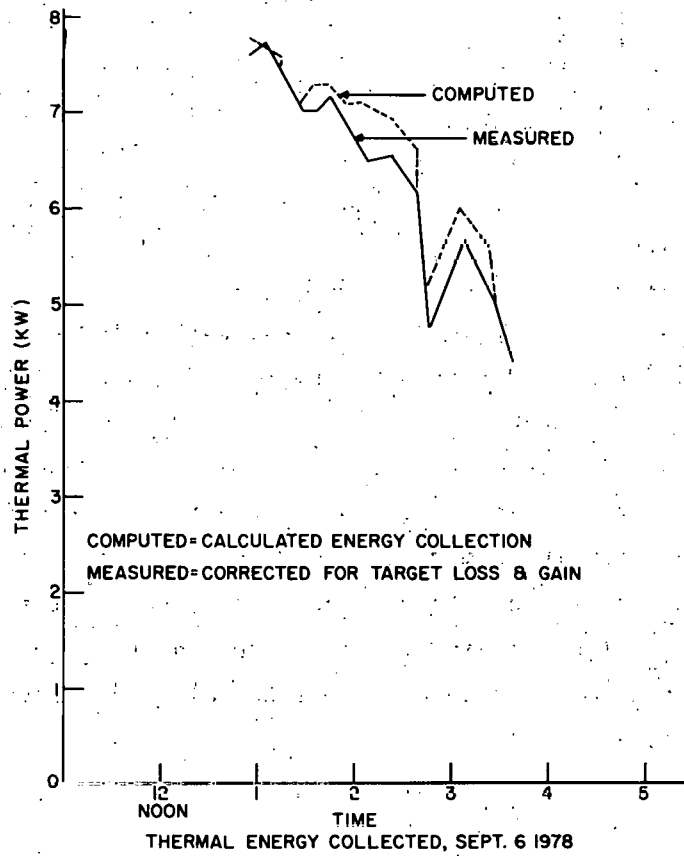
Figure 41. Heliostat performance confirmation experimental results.

Figure 41 is a comparison of measured thermal energy collected by the receiver and the computed thermal energy directed to the receiver by the heliostat.

The two curves of Figure 41 are in good agreement and differ by no more than  $\pm 2-1/2\%$ . Such measurements were conducted periodically from June 1978 to September 1978 at various solar intensities. The performance testing began in June with good agreement between measured and computed thermal values, but gradually a larger and larger discrepancy appeared. The computed value was always higher than the measured value and a difference of 25% was reached. Finally this discrepancy was traced to a number of mirror facets whose reflecting surface had delaminated, destroying their surface quality. Without the proper surface quality these mirror facets were not concentrating energy on the receiver. When these defects were corrected, good agreement was again obtained. The cause of the delamination is discussed in Section III.D.2. Figure 41 is a performance measurement made after all the defective mirror facets were identified.

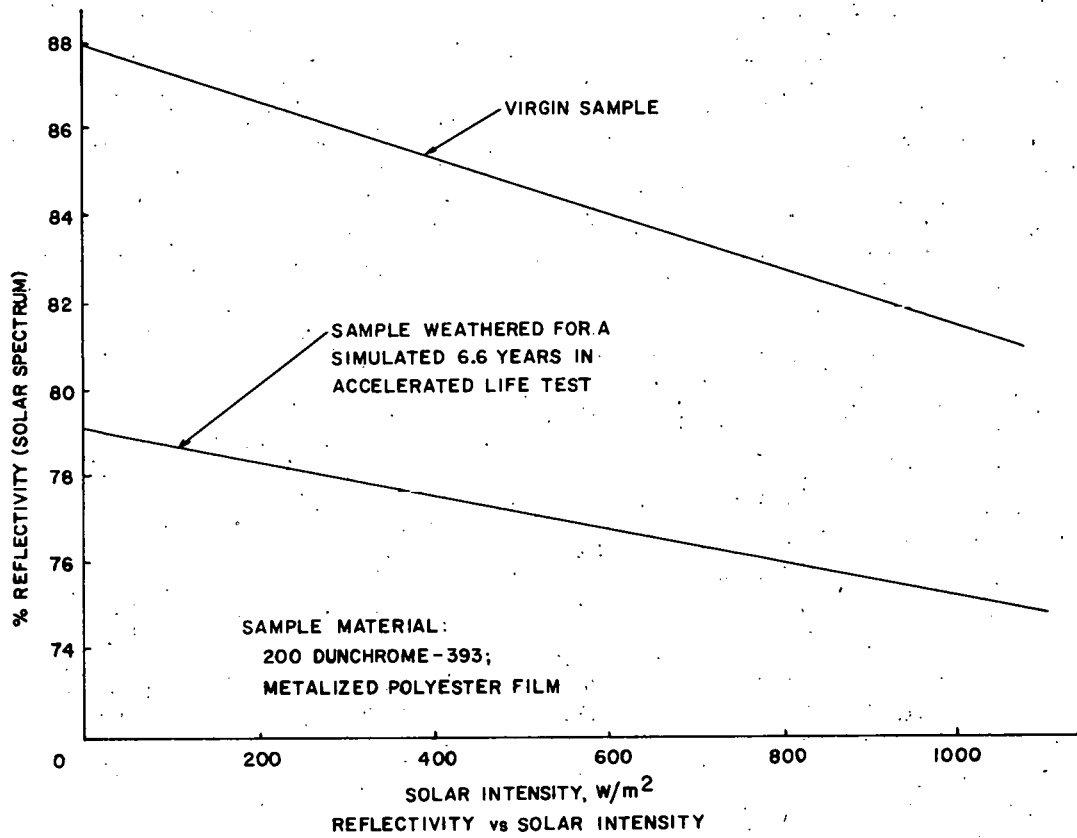
Figure 42. Reflectivity characteristic of Dunmore film 393.

It is interesting to note that the reflectivity of all the samples measured had a negative dependence on solar intensity similar to that shown in Figure 42. Two factors produced this result. At lower solar intensities more infrared is present in the solar spectrum and aluminum has a better coefficient of reflection for infrared than for visible light. Also the protective overcoats may be selective in their absorption spectra. The virgin reflectivity at solar intensities corresponding to typical air mass 1 and air mass 2 conditions for the 30 samples is summarized in Table V.2.

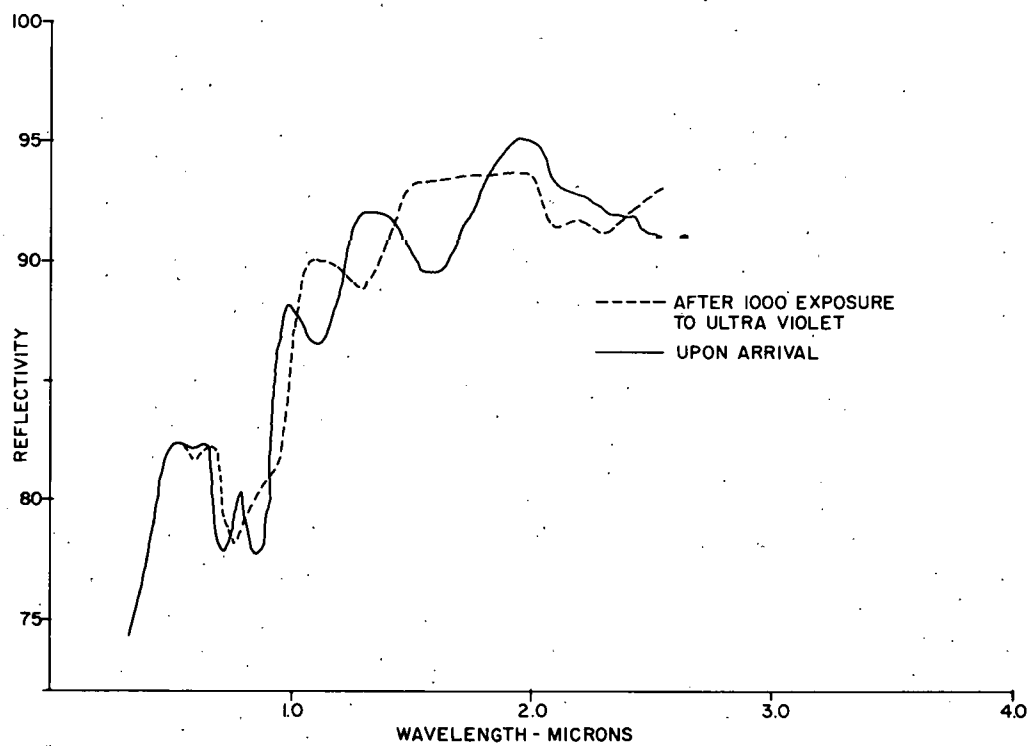
Figure 43. Reflectivity spectrum for Dunmore material 393 before and after exposure to ultra violet radiation.

A finished mirror panel made from dunmore material 393 was sent to the San Albuquerque Laboratory for testing and evaluation. The tests were conducted through arrangements made with Mr. L. G. Rainhart. Reflectivity versus illumination wavelength was measured both upon arrival and after a 1000 hour exposure to ultraviolet light. The reported results are shown in Figure 43. The average total spectrum reflectivity did not change measurably as a result of the ultraviolet exposure although the reflectivity/wavelength distribution character was altered.

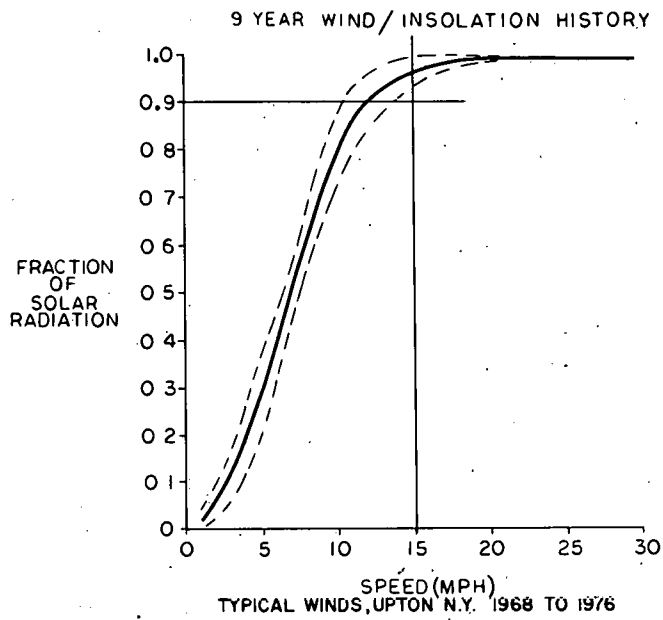
Figure 44. Wind-solar insolation correlation for Upton, NY.

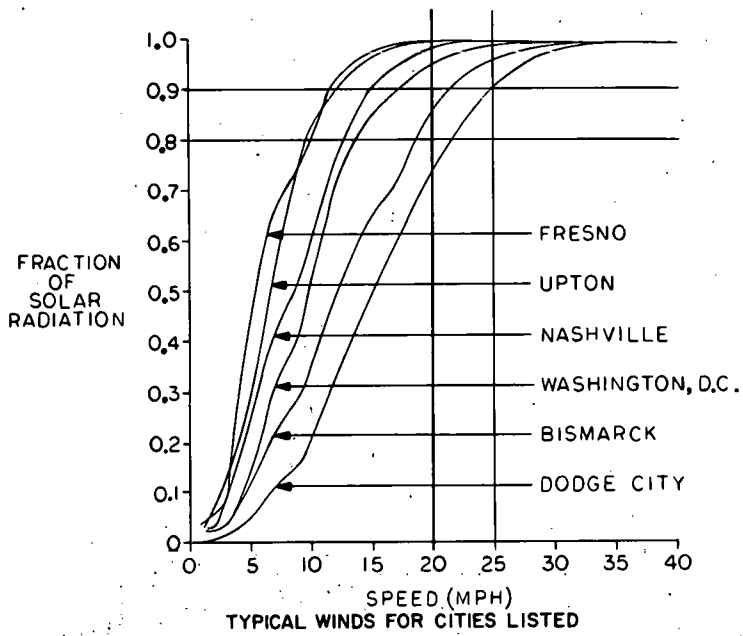
Figure 46. Wind-solar insolation history.

A map showing these locations is presented in Figure 45, and the expanded results are shown in Figures 46 and 47.

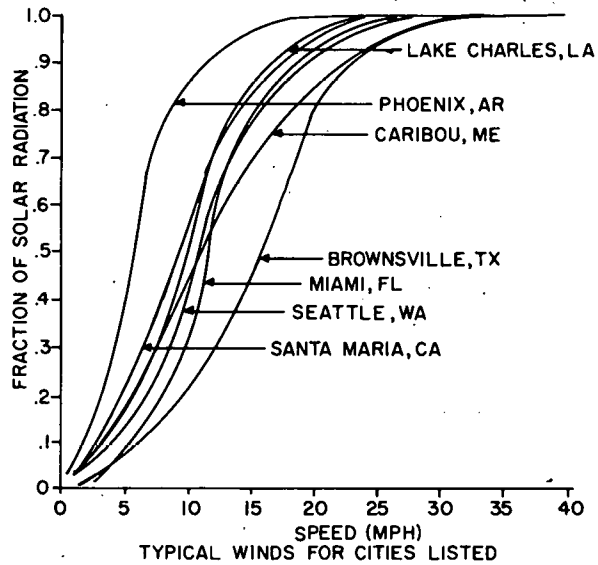
Figure 47. Wind-solar insolation history continued.

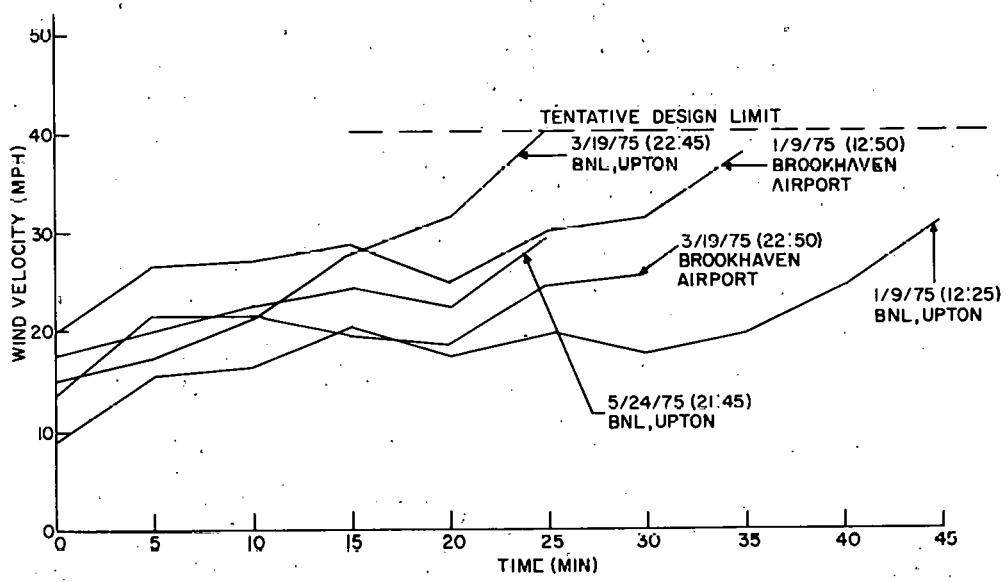
Figure 48. Wind gust record Upton, NY, and Brookhaven Airport.

One-year wind-gust data records from Upton, NY and from the nearby Brookhaven Airport were obtained and searched for periods of high wind (greater than 30 mph). The wind gust records for the worst of these periods are shown in Figure 48. In one case (3/19/75) the wind speed reached 40 mph 15 minutes after crossing the 20-mph criterion. A heliostat operating at this time could have experienced a 40-mph gust before reaching the safe fold-down position. This case occurred at night when the heliostat should be in the fold-down position and thus would have escaped exposure to this gust. Dr. S. Sethuraman, Brookhaven meteorologist, advised us to ignore this fact since there is no identifiable day-night preference for high wind storms.

In view of this wind-gust record, a heliostat damage wind velocity criterion of 50 mph was imposed for the up-position. This gave a 10 mph safety above the worst gust identified in the analysis described. Wind gusts of 50 mph are rare in this area and no record of such velocity could be found for sunlight conditions. In general, such wind velocities occur during or preceding hurricanes for which ample warnings are now given.

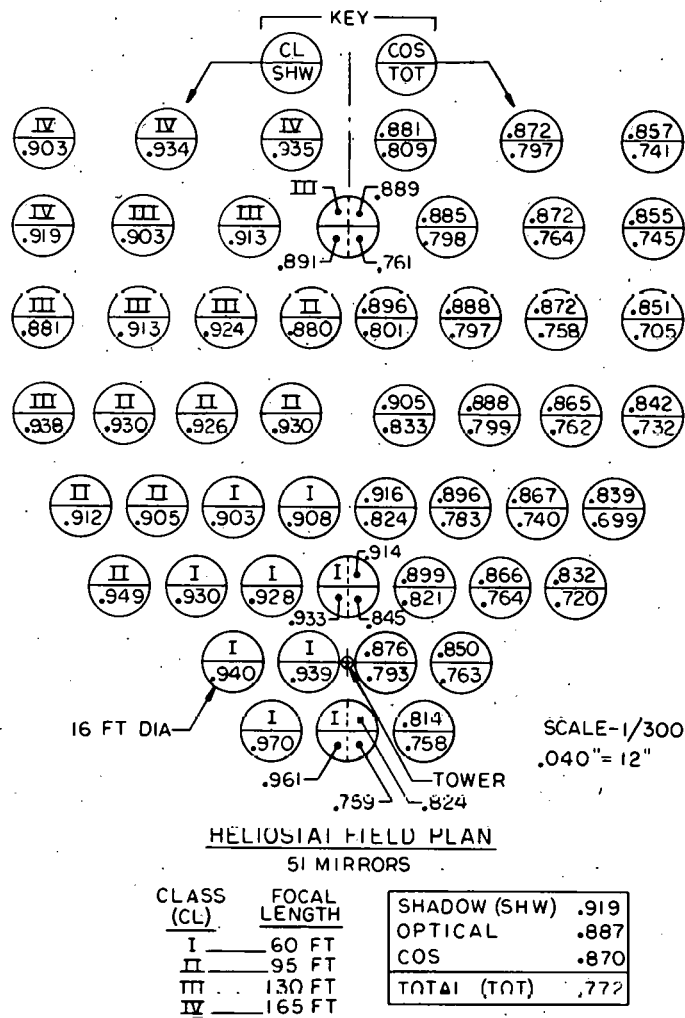
Figure 49. Heliostat field performance chart - 51 units design.

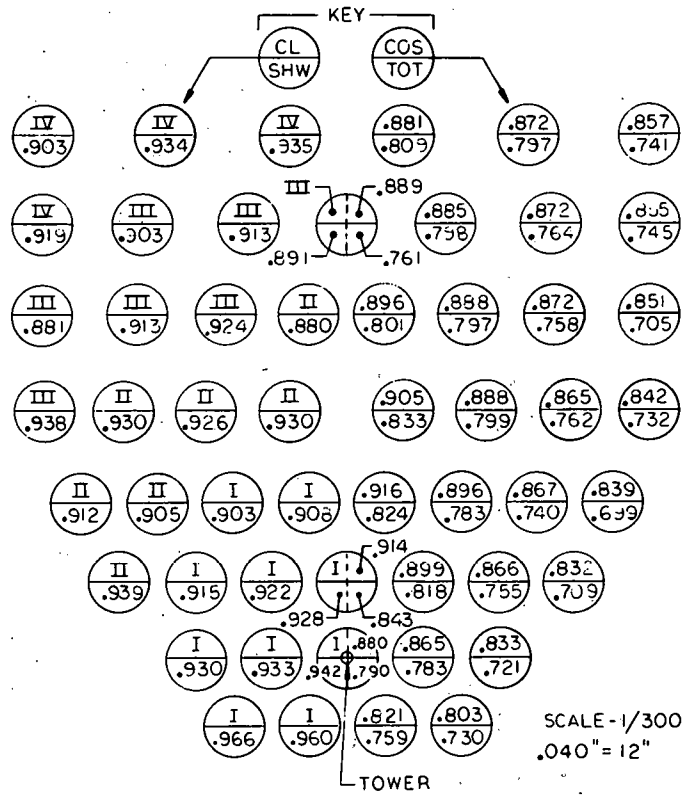
HELIOSTAT FIELD PLAN  
53 MIRRORS

CLASS (CL)	FOCAL LENGTH	SHADOW (SHW)	OPTICAL	COS	TOTAL (TOT)
I	60 FT	.918	.885	.868	.768
II	95 FT				
III	130 FT				
IV	165 FT

Figure 50. Heliostat field performance chart - 53 unit design.

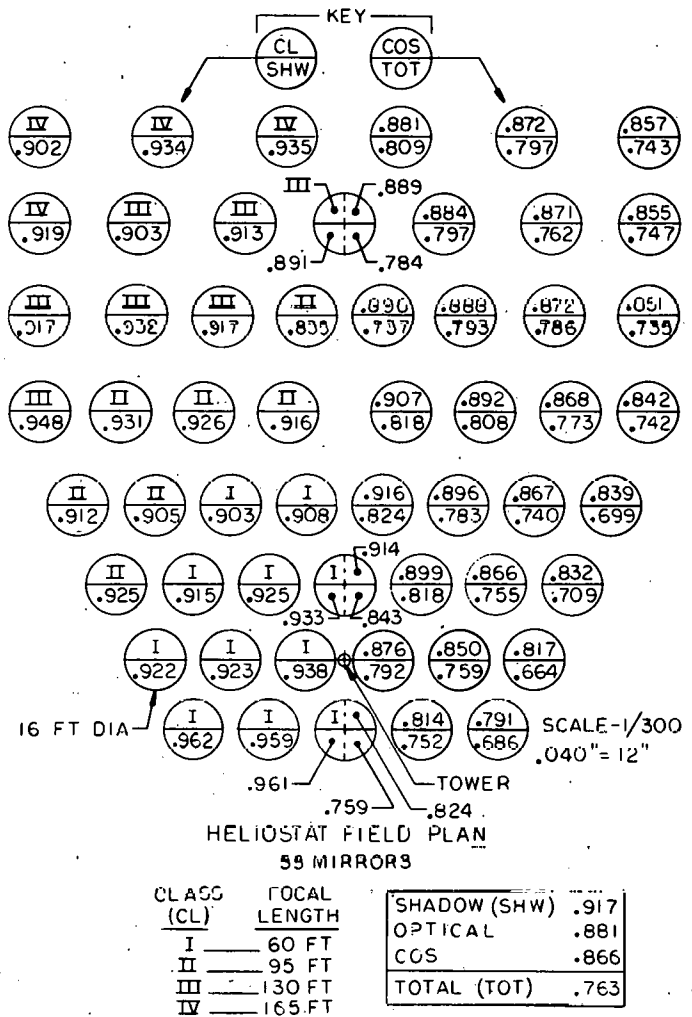
Figure 51. Heliostat field performance chart - 55 unit design.

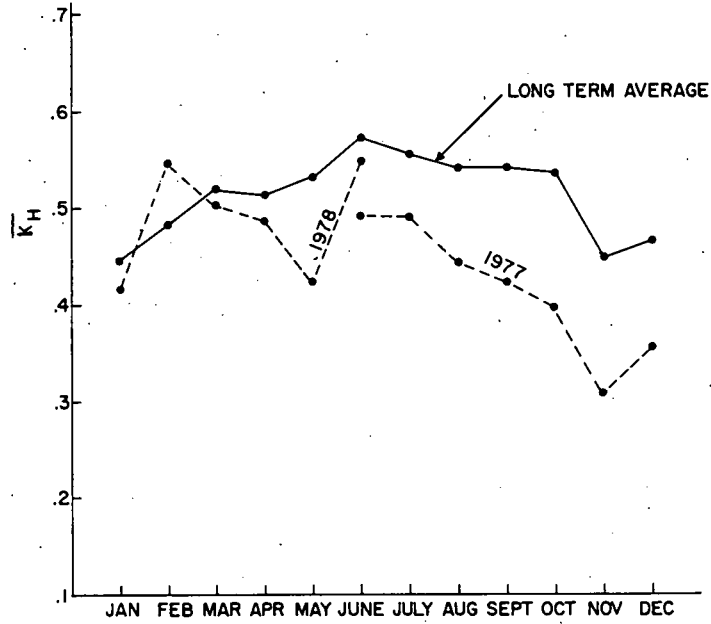
Figure 52.  $\bar{K}_H$ , the ratio of daily average radiation measured on a horizontal surface to that received outside the atmosphere, versus time.

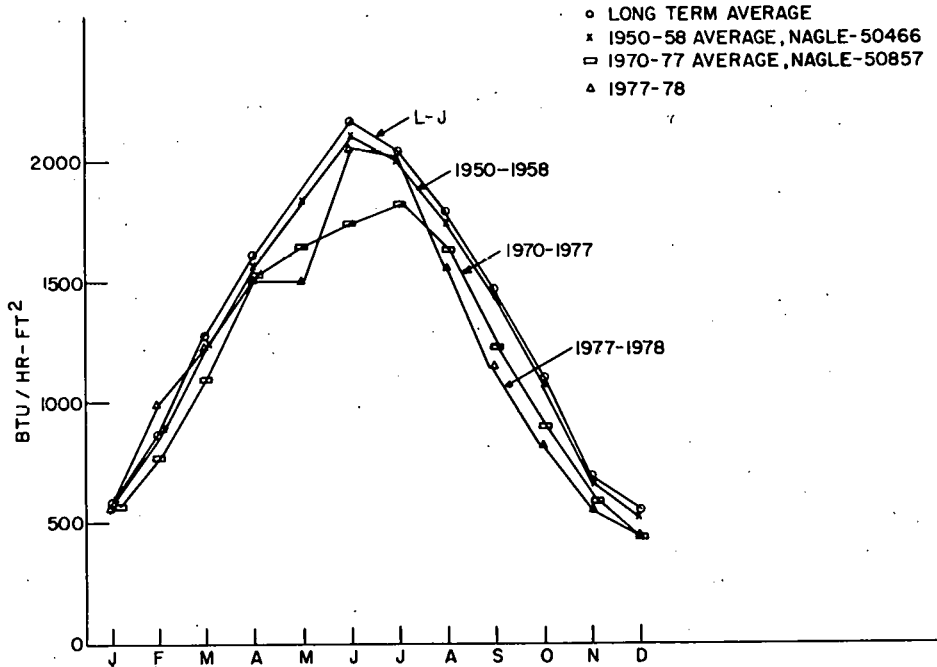
Figure 53. Solar radiation measured on a horizontal surface at Upton, NY, report by various authors and time periods.

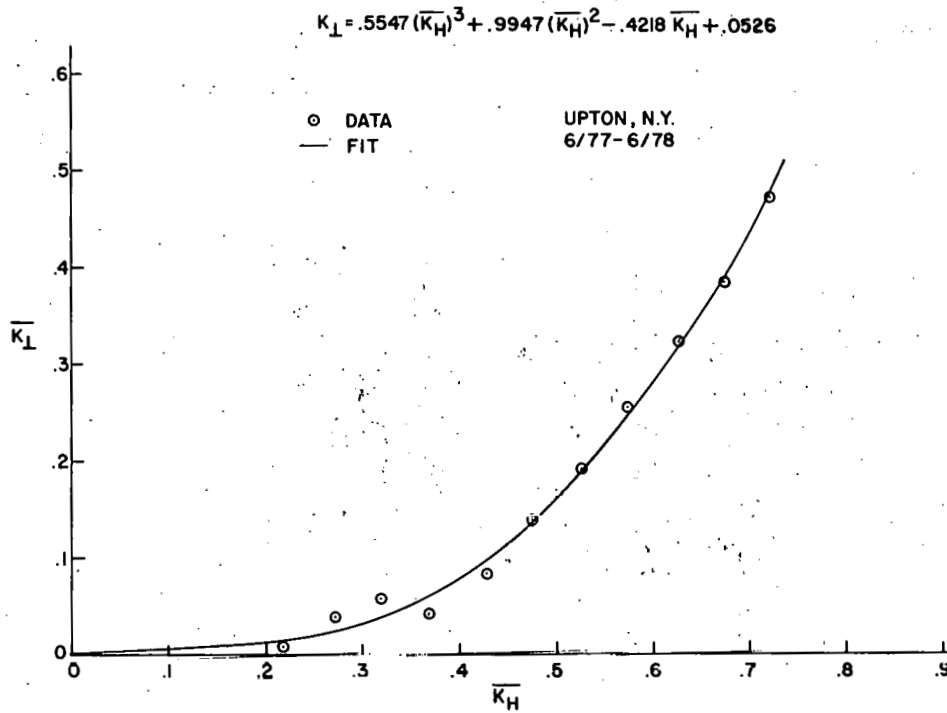
Figure 54. Measures values of  $\bar{K}_H$  versus  $\bar{K}$  grouped into bins and averaged for Upton, NY, 6/77 through 6/78 with least squares fit polynomial of 3rd order.

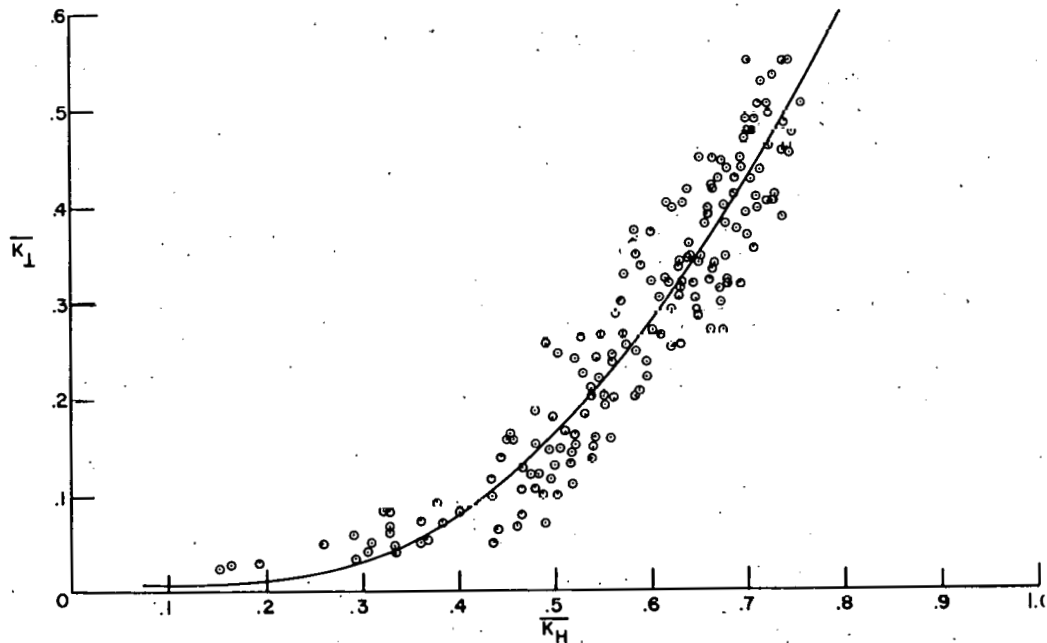
Figure 55. Daily values of  $\bar{K}_H$  and  $\bar{K}$  plotted against fit polynomial from Figure 3.

Figure 55 shows the daily data superimposed on this polynomial.

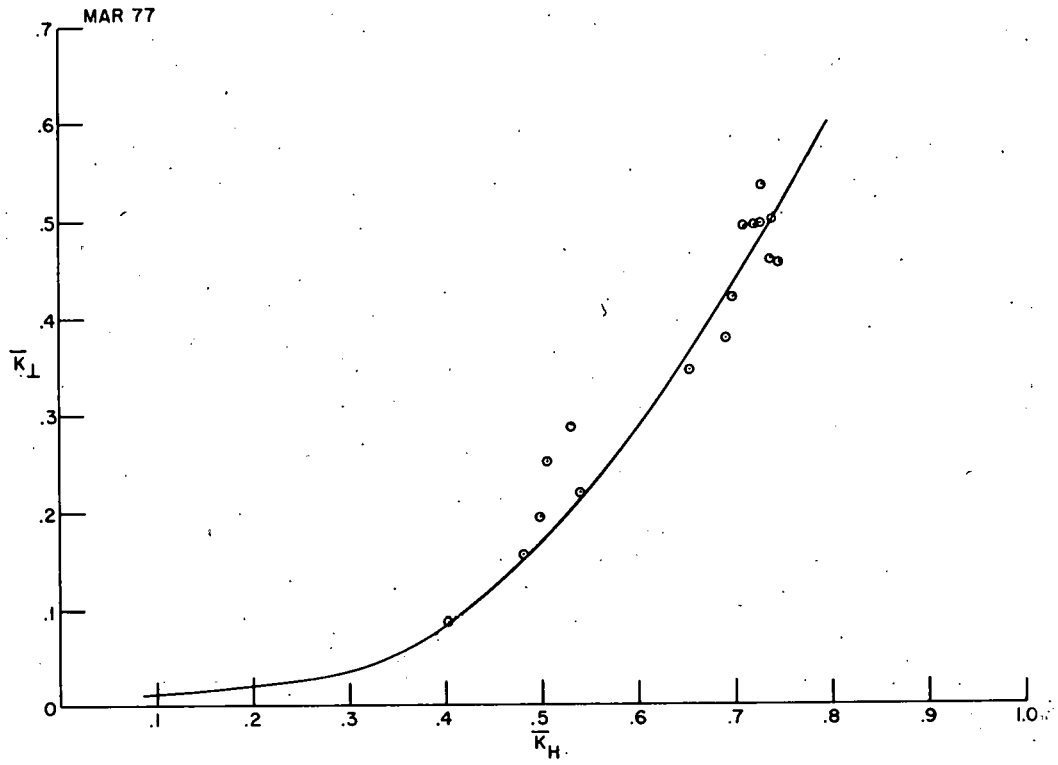
Figure 57. Curve fit versus data from March 1977.

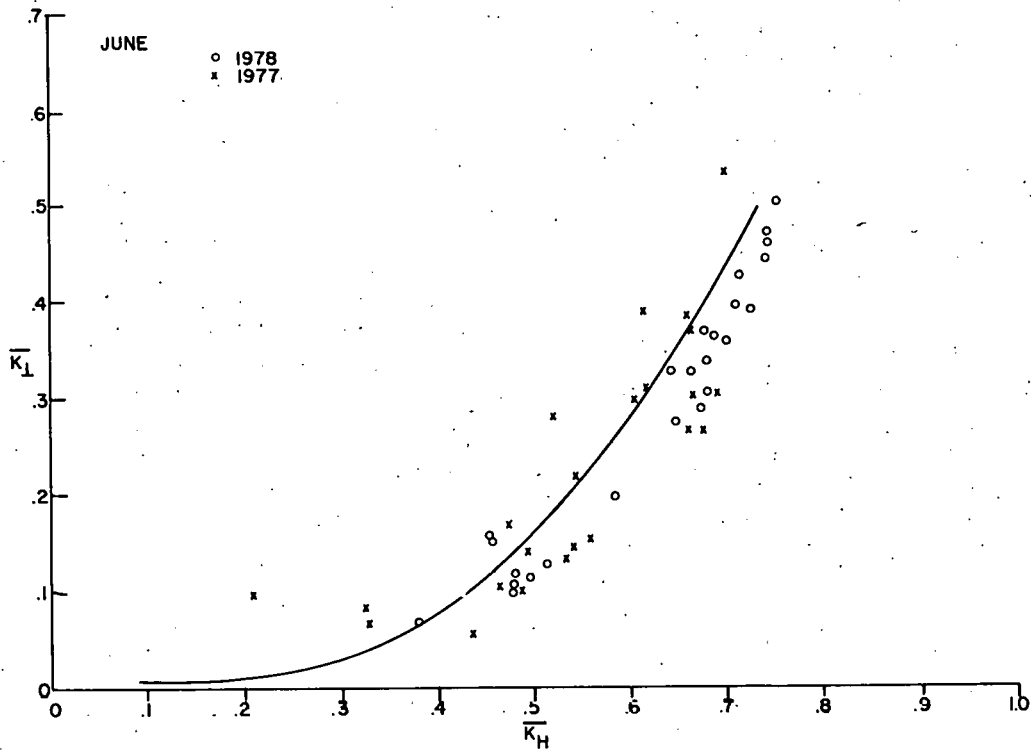
Figure 58. Curve fit versus data from June 1977 and 1978.

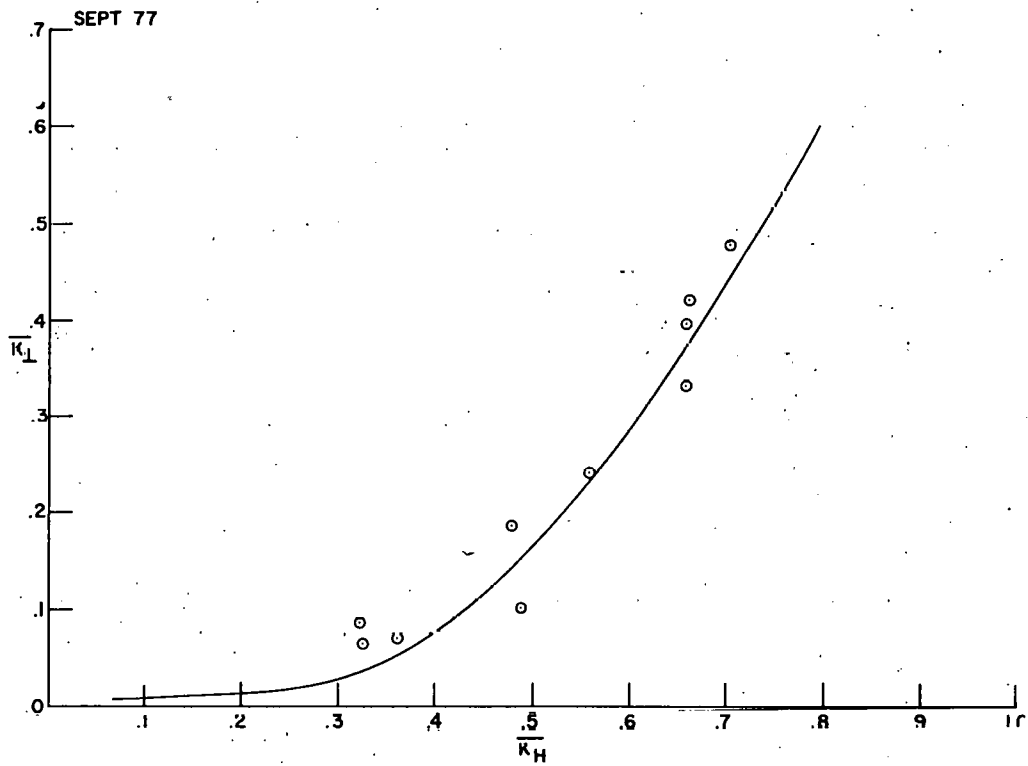
Figure 59. Curve fit versus data from September 1977.

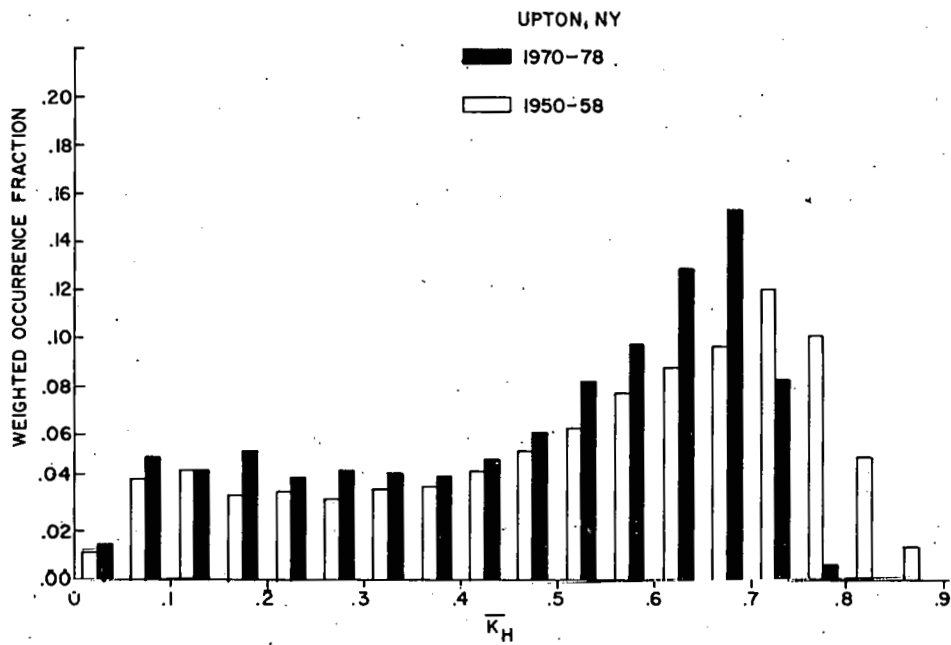
Figure 60. Weighted  $\bar{K}_H$  occurrence frequency for Upton, NY, for time period 1950-58 and 1970-78.

Figure 60 shows the weighted  $\bar{K}_H$  occurrence frequency for Upton for two different time periods and illustrates the effect of climatic changes upon this weighted sum. Figure 61 shows the long-term occurrence frequency of  $\bar{K}_H$  for four other locations and the variation in this parameter with location along the Eastern Seaboard.

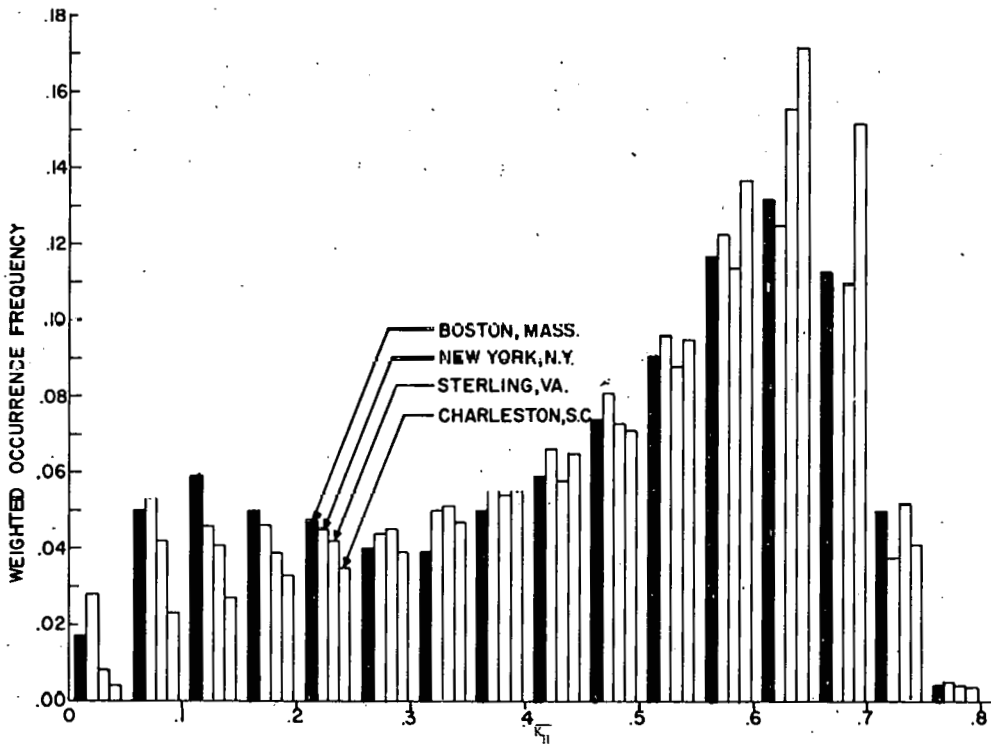
Figure 61. Long term weighted  $\bar{K}_H$  occurrence frequency for Boston, MA; New York, NY; Sterling, VA; Charleston, SC.

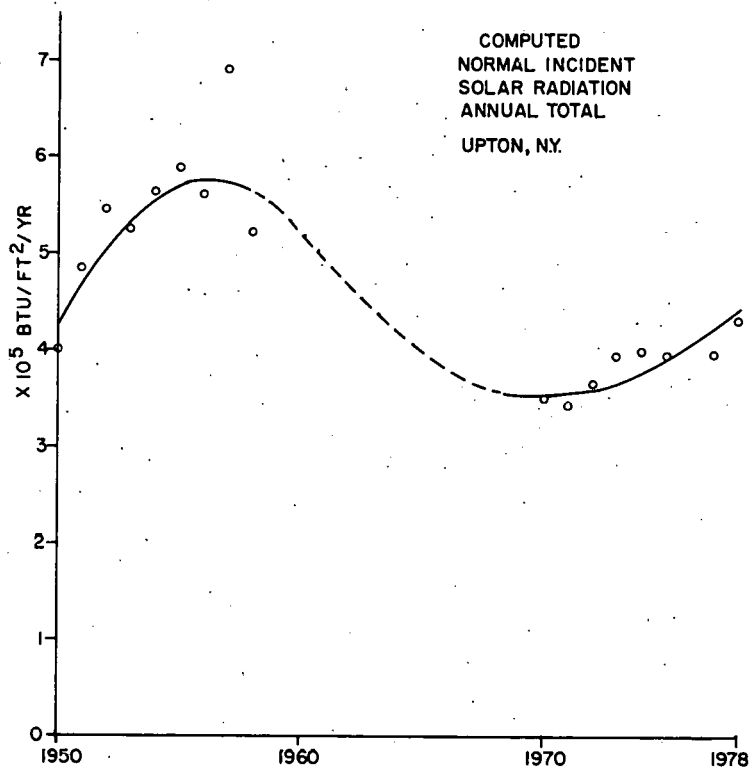
Figure 62. Computed annual normal incident solar radiation received at Upton, NY.

Annual normal incident solar radiation received at Upton, NY, can also be computed for each year for which good horizontal data are available. Figure 62 presents these results. Data for the 1960's are missing. A smooth curve

has been passed through the data of Figure 62 suggesting long-term seasonal changes. During the next decade, Upton, NY, might anticipate receiving an average of  $5.0 \times 10^5$  Btu-ft<sup>2</sup>-yr<sup>-1</sup> solar radiation at normal incidence, if extrapolation from Figure 62 is valid.

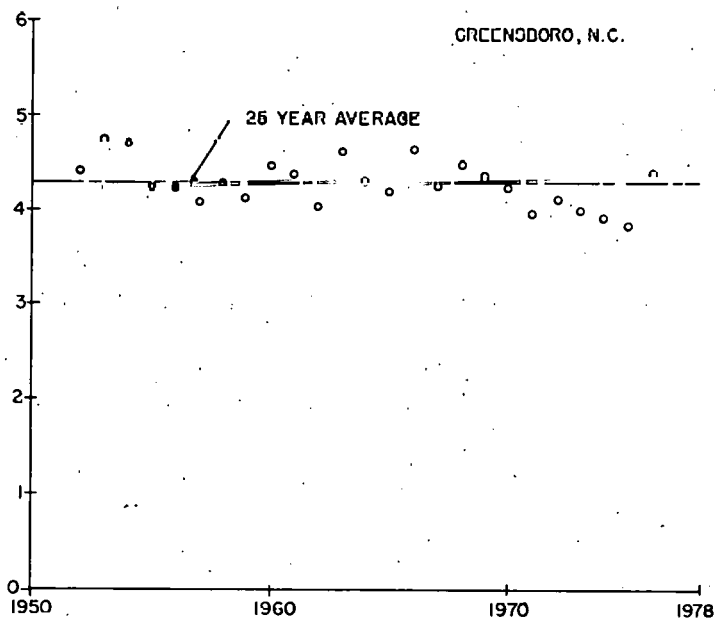
Figure 63. Computed annual normal incident solar radiation received at Greensboro, NC.

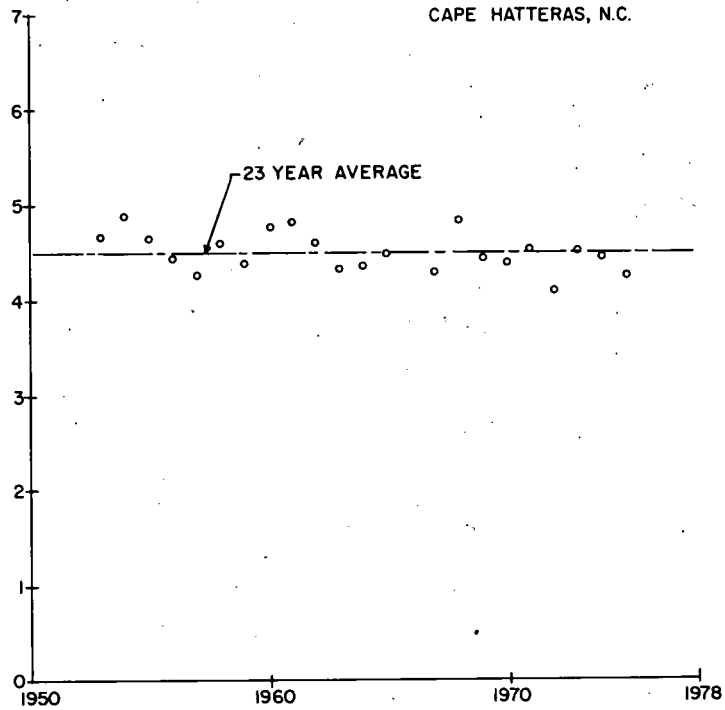
Figure 64. Computed annual normal incident solar radiation received at Cape Hatteras, NC.

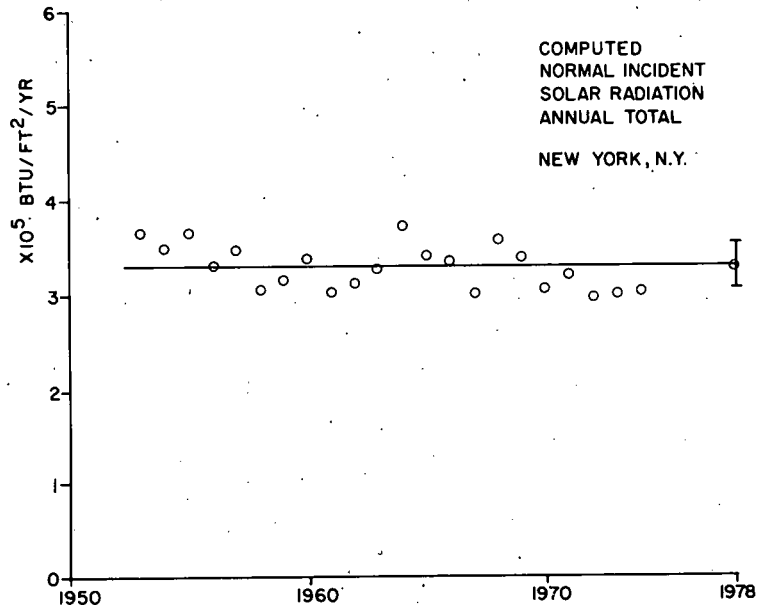
Figure 65. Computed annual normal incident solar radiation received New York, NY.
