NUREG/CR-5487
LA-11739-MS
RD

Static Load Cycle Testing of a Low-Aspect-Ratio Four-Inch Wall, TRG-Type Structure TRG-5-4 (1.0, 0.56)

Prepared by
C. R. Farrar, J. G. Bennett, W. E. Dunwoody, W. E. Baker*

Prepared for
Division of Engineering
Office of Nuclear Regulatory Research
U.S. Nuclear Regulatory Commission
Washington, DC 20555
NRC FIN A7221

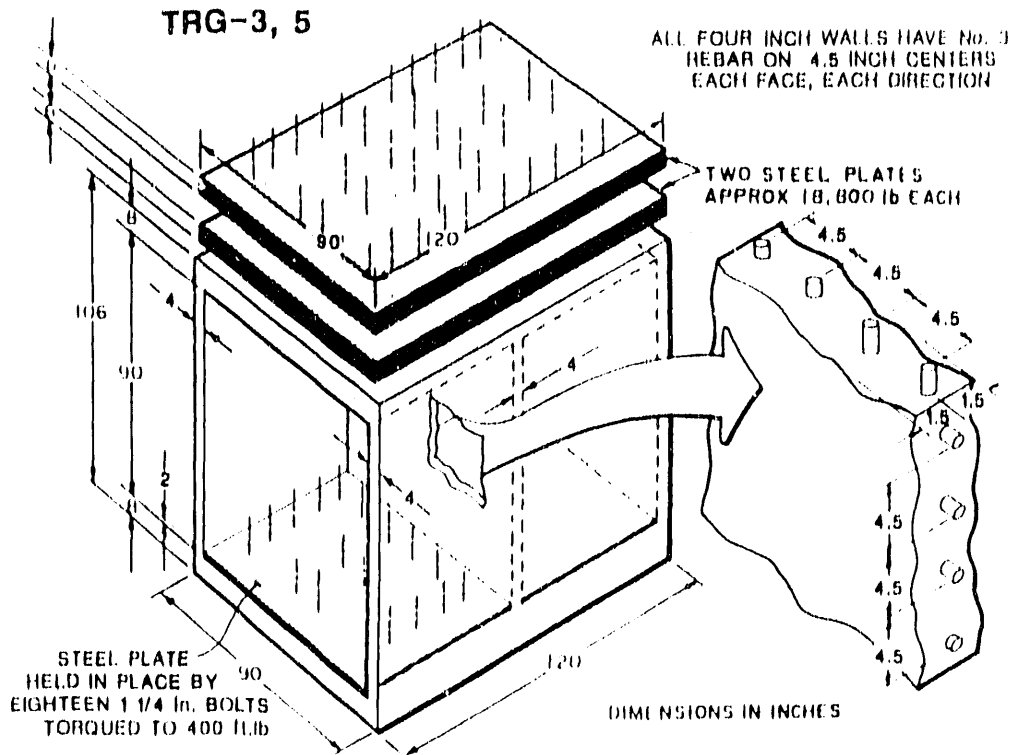
Fig. 1. Prototype TRG structure.

A prototype "TRG" structure designed to comply with these specifications (Fig. 1) was constructed using actual batch plant concrete and No. 3 rebar. In addition, a 1/4-scale model of the TRG structure was constructed with microconcrete and wire-mesh rebar and was tested prior to the prototype. Both structures were tested statically and then seismically to failure, or in the case of the prototype, to machine limits. The 1/4-scale model was TRG-1-1 (1.0, 0.6), and the prototype was TRG-3-4 (1.0, 0.56). A second 1/4-scale model, TRG-2-1 (1.0, 0.6), was constructed and partially tested. That model had obvious visual flaws (cracked sections) upon form removal and was never fully tested or reported.

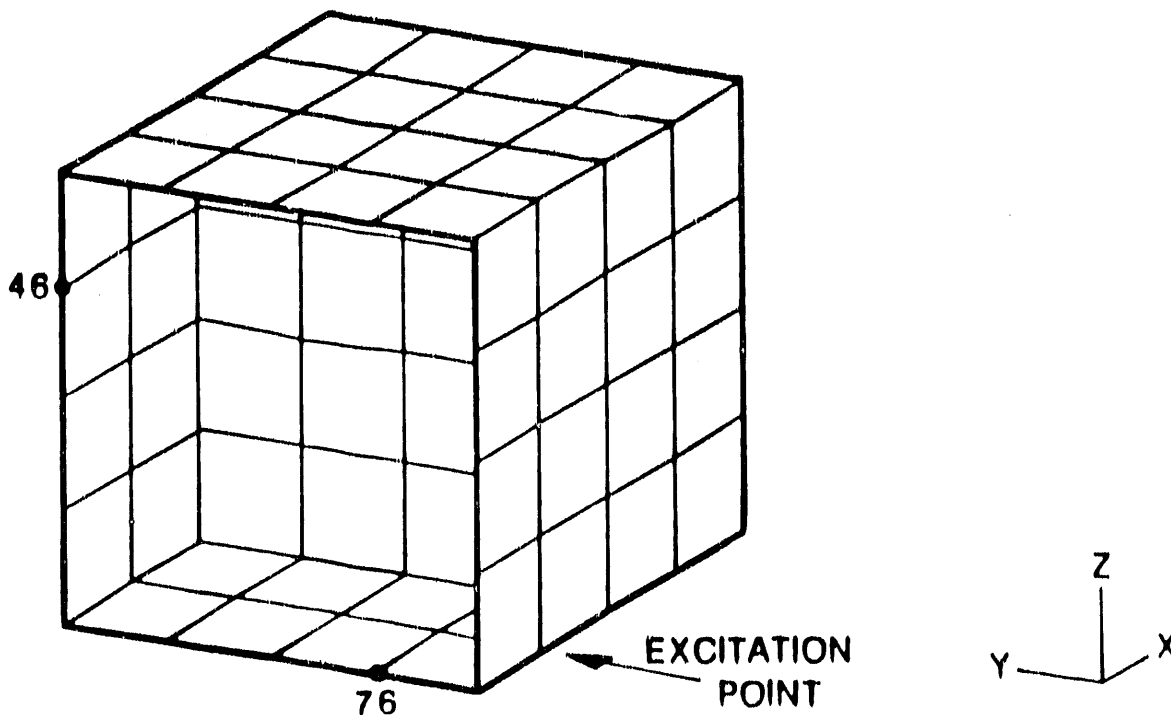
Fig. 5. The modal test measurement points. (Some points can not be seen because of hidden line removal).

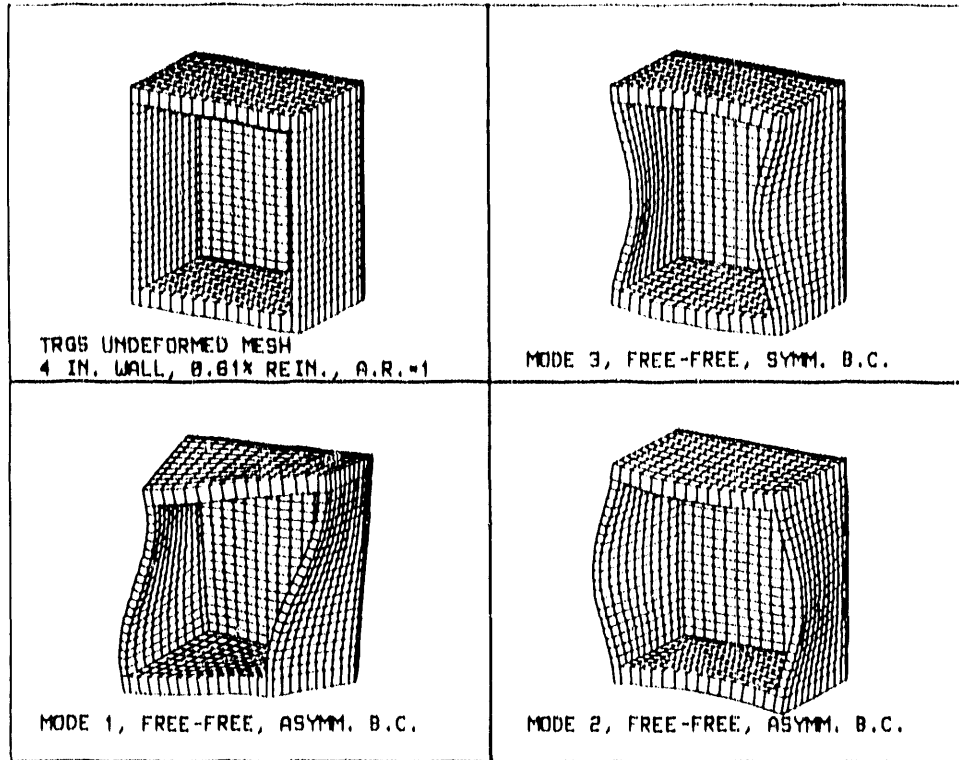
Fig. 9. Undeformed mesh and the first three modes from the finite element analysis using free-free boundary conditions with asymmetric boundary conditions on the plane of symmetry.

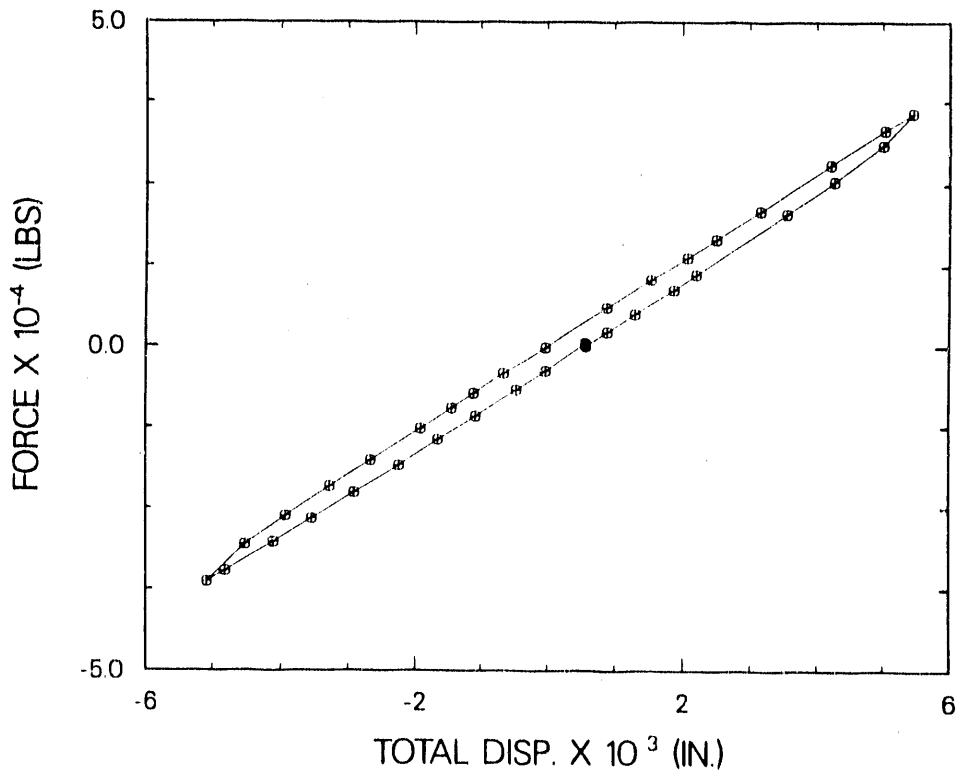
Fig. 20. TRG-5-4 (1.0,0.56) 100-psi ABSS load Cycle 3.

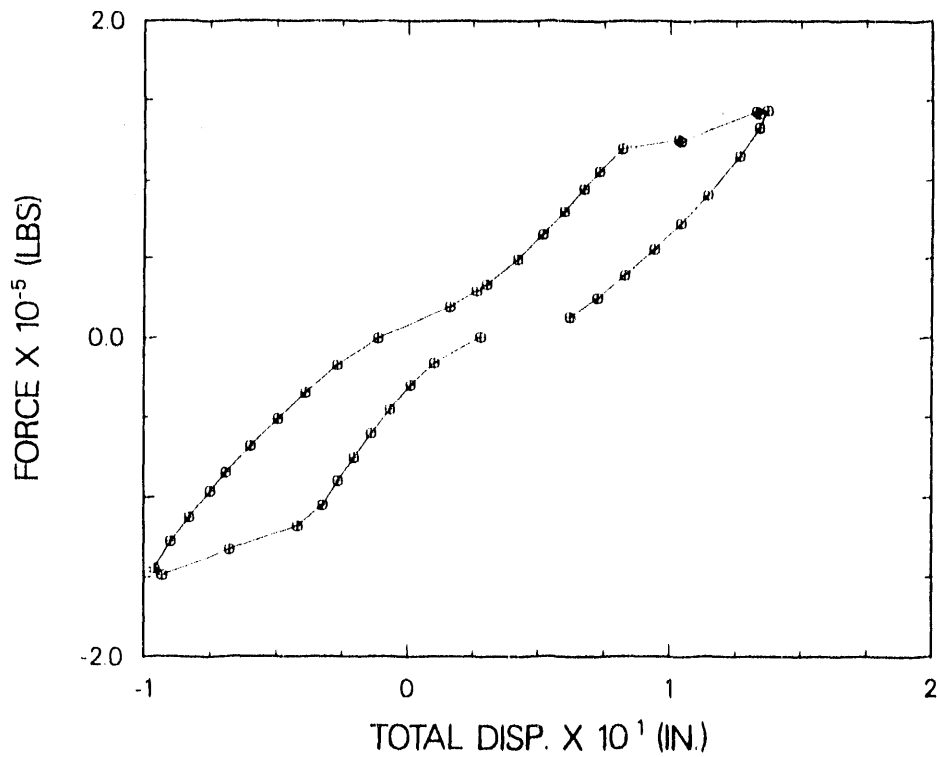
Fig. 28. TRG-5-4 (1.0,0.56) failure load cycle in first direction.

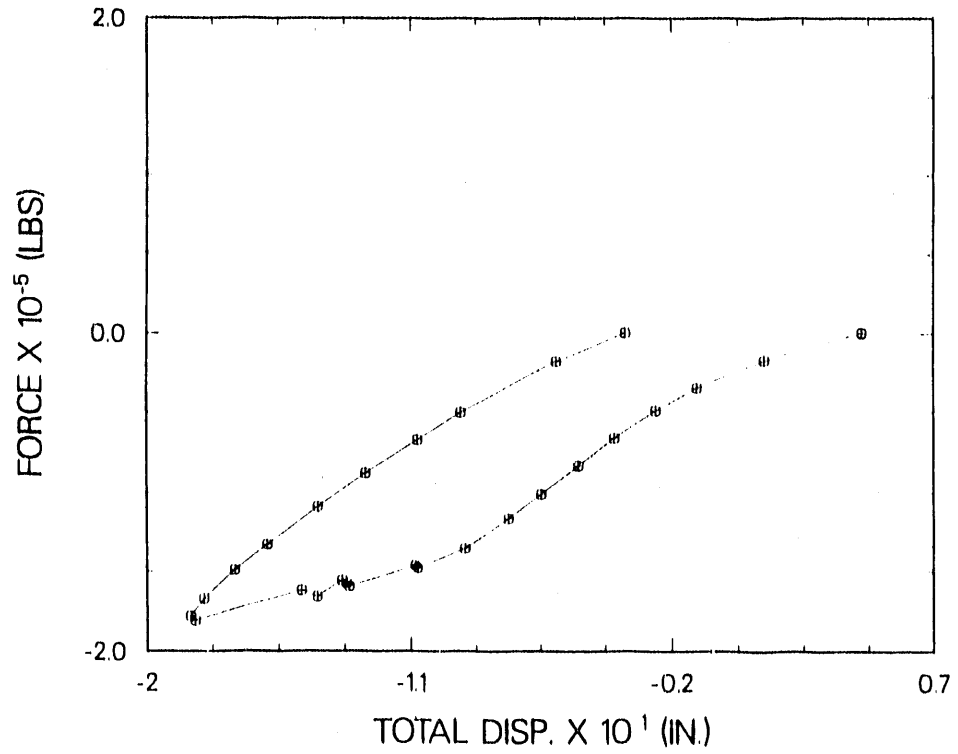
Fig. 29. TRG-5-4 (1.0,0.56) failure load cycle in second direction.

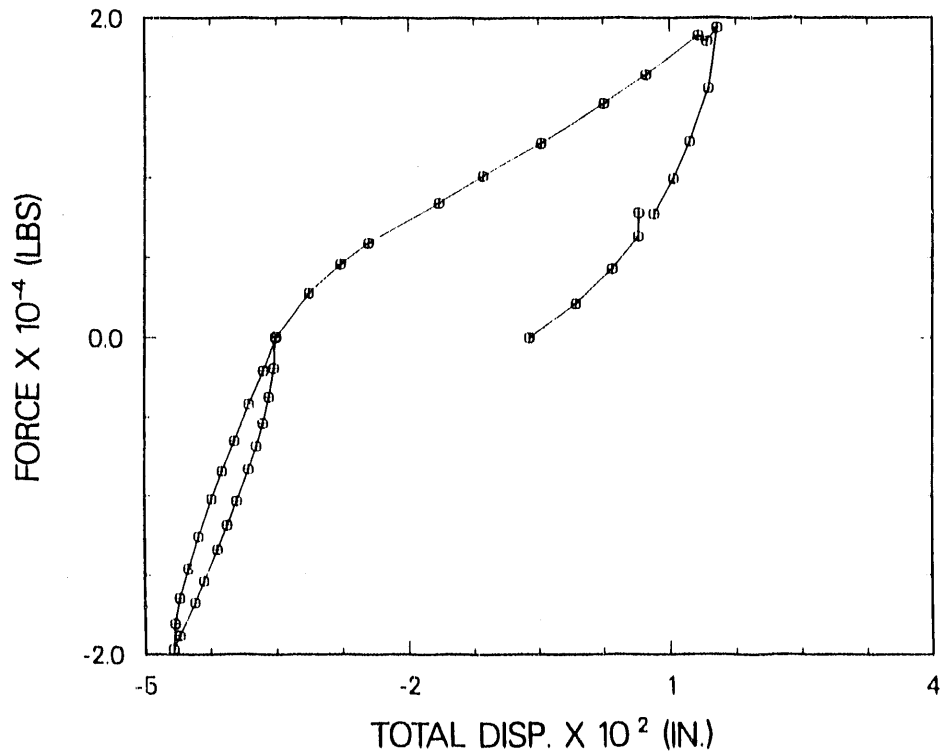
Fig. 30. TRG-5-4 (1.0,0.56) postfailure 50-psi load Cycle 1.

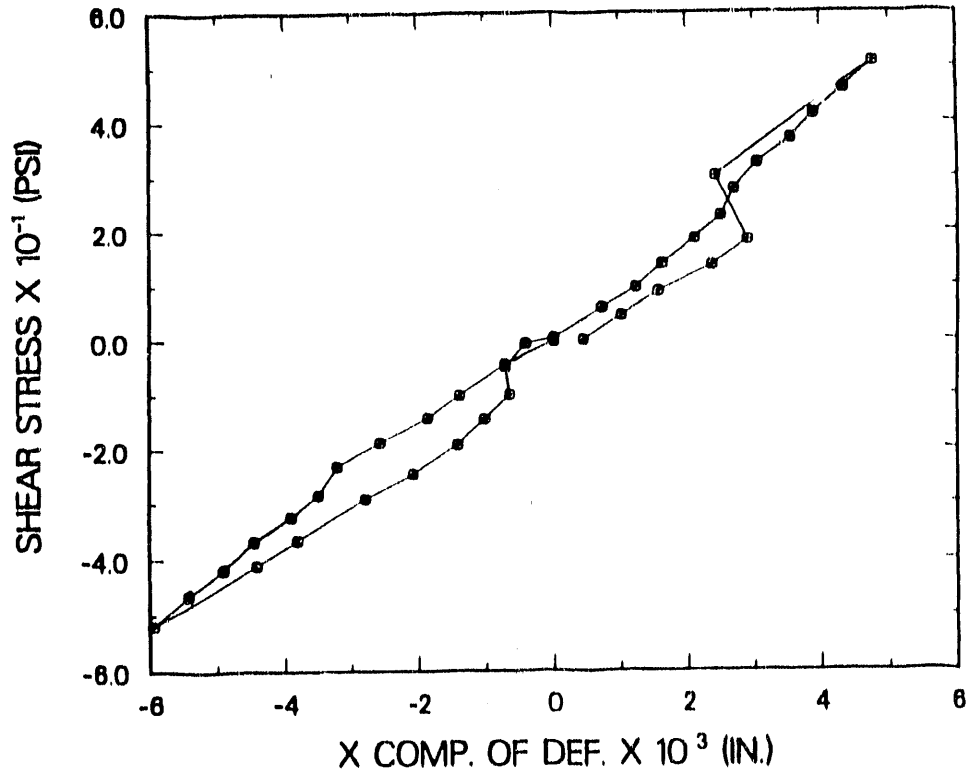
Fig. 34. TRG-5-4 (1.0,0.56) 50-psi ABSS Cycle 1 (external gages).

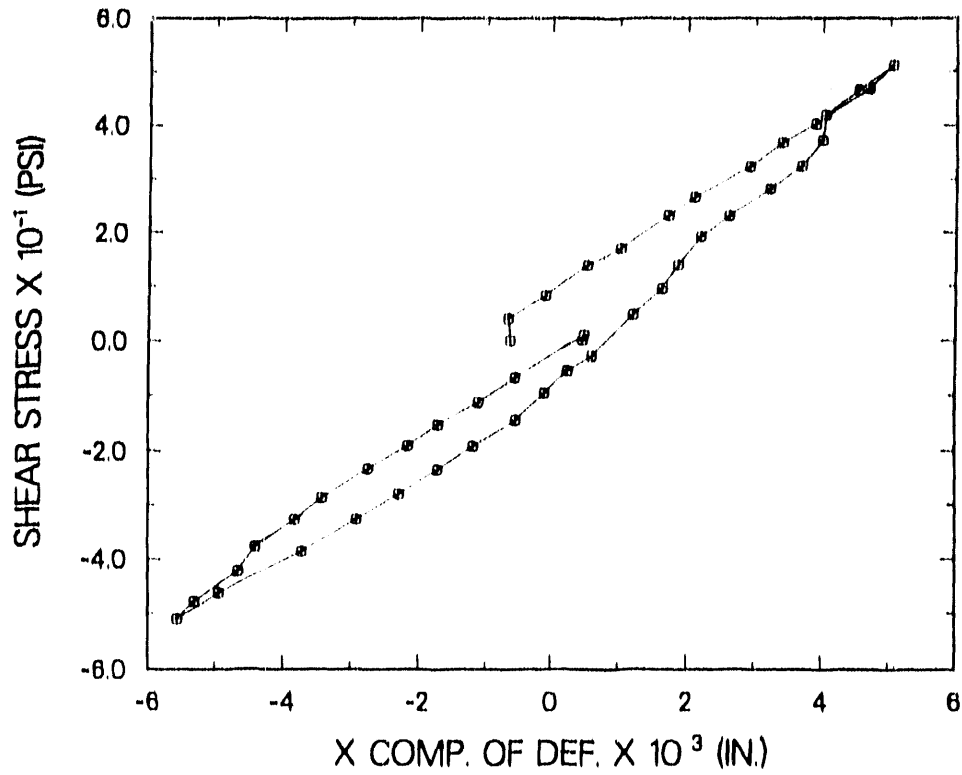
Fig. 35. TRG-5-4 (1.0,0.56) 50-psi ABSS load Cycle 2 (external gages).

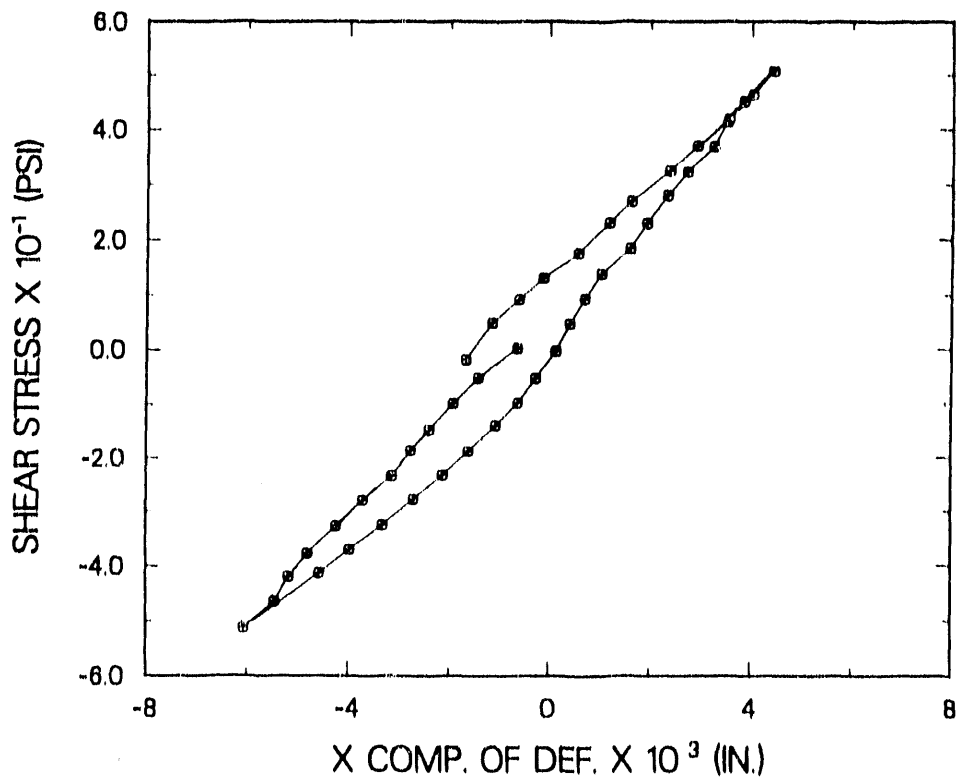
Fig. 36. TRG-5-4 (1.0,0.56) 50-psi ABSS load Cycle 3 (external gages).

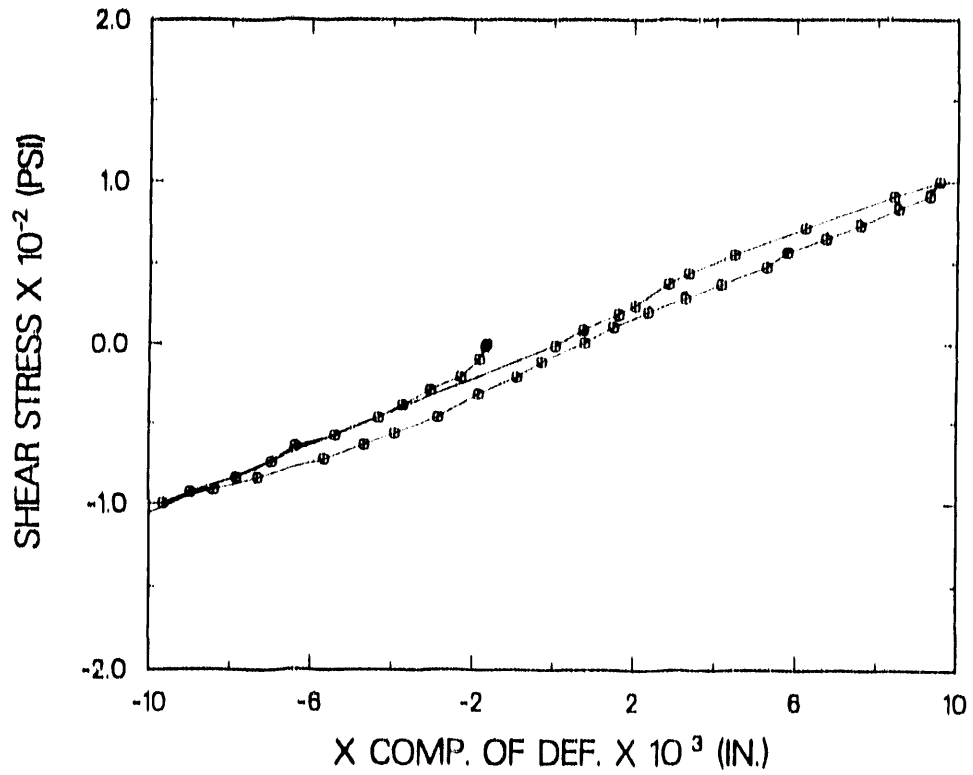
Fig. 37. TRG-5-4 (1.0,0.56) 100-psi ABSS load Cycle 1 (external gages).

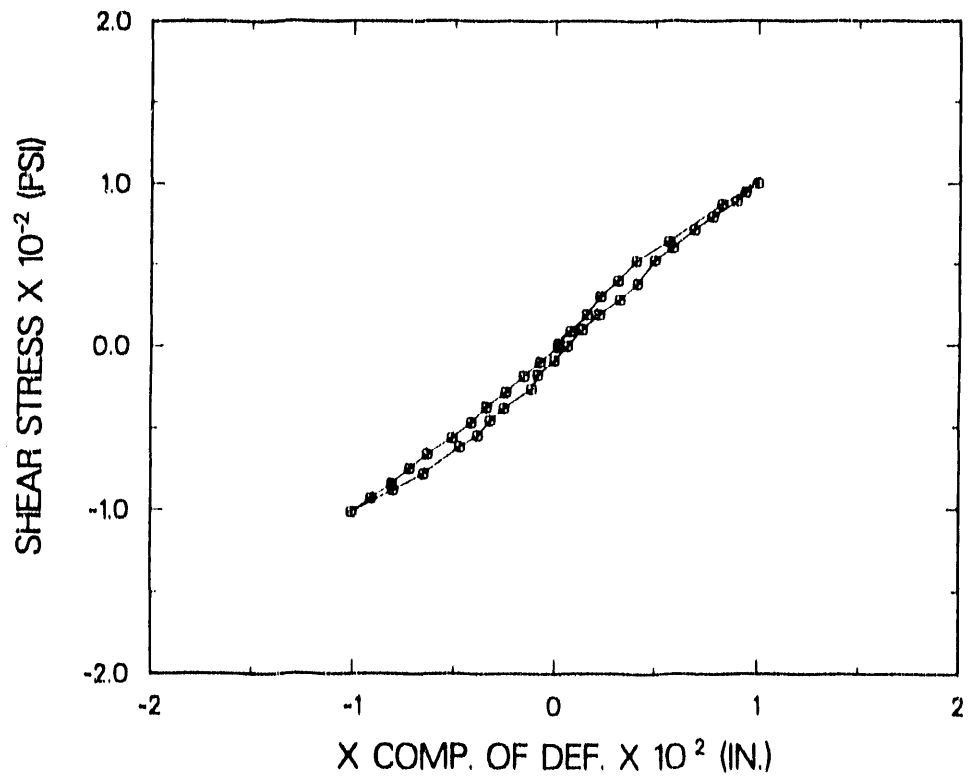
Fig. 38. TRG-5-4 (1.0,0.56) 100-psi ABSS load Cycle 2 (external gages).

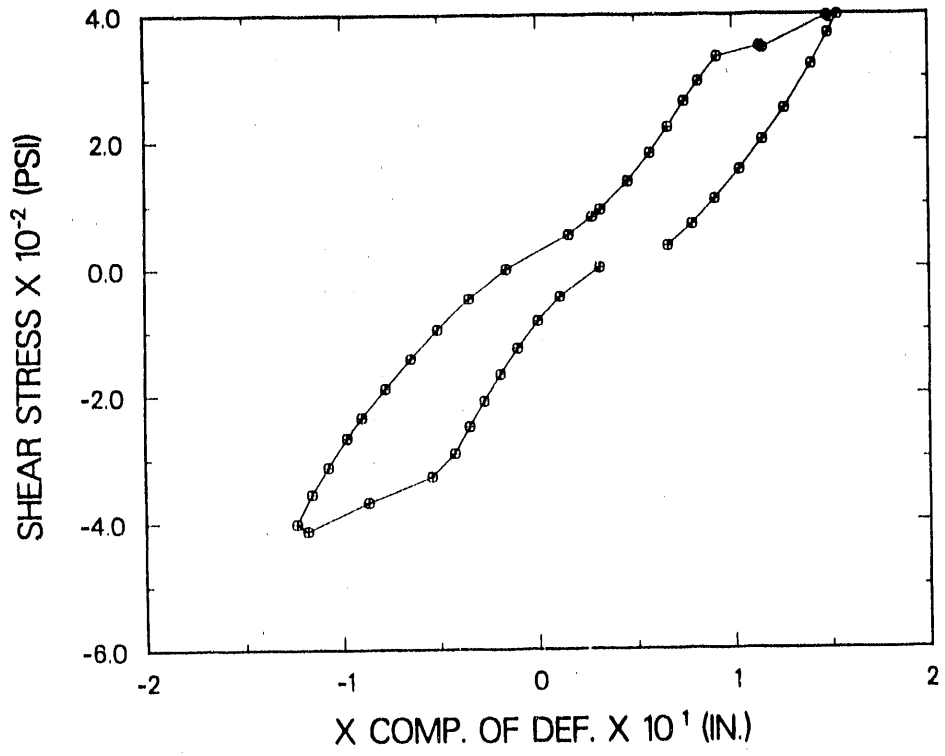
Fig. 47. TRG-5-4 (1.0,0.56) failure load cycle in first direction (external gages).

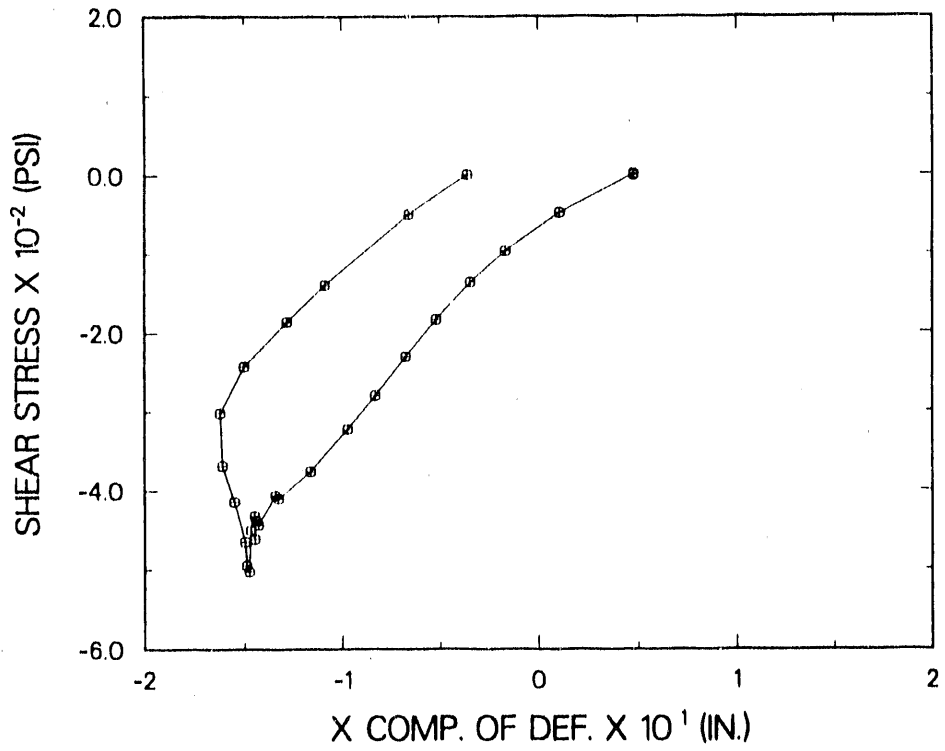
Fig. 48. TRG-5-4 (1.0,0.56) failure load cycle in second direction (external gages).

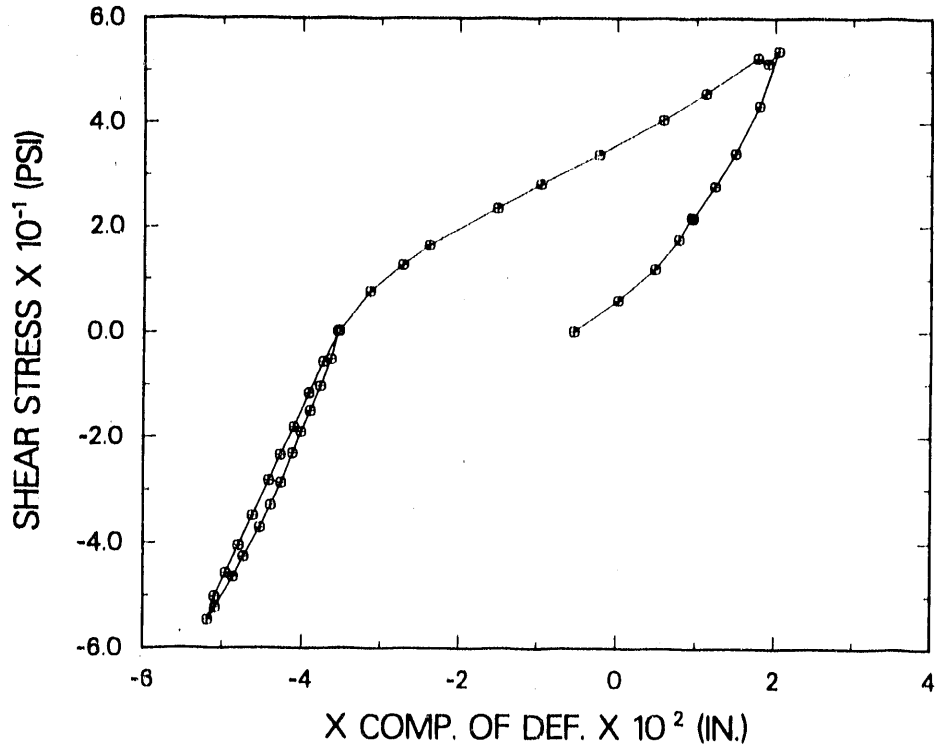
Fig. 49. TRG-5-4 (1.0,0.56) postfailure 50-psi load Cycle 1 (external gages).

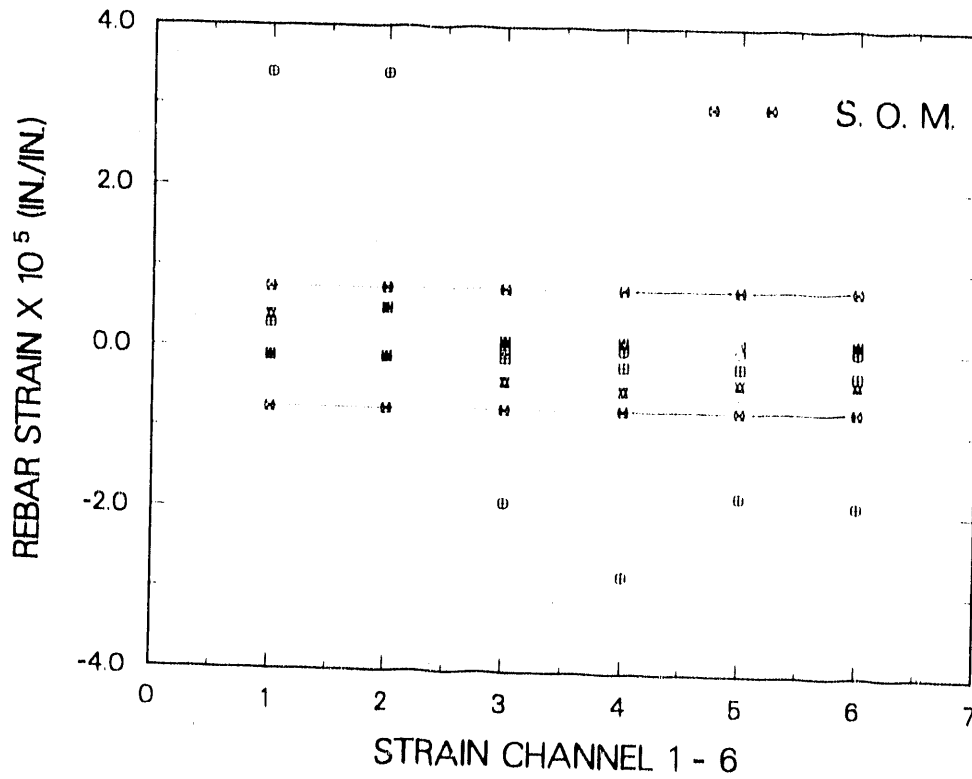
Fig. 54. Strain gage readings in the west end wall compared with SOM theory for the three 50-psi load cycles.

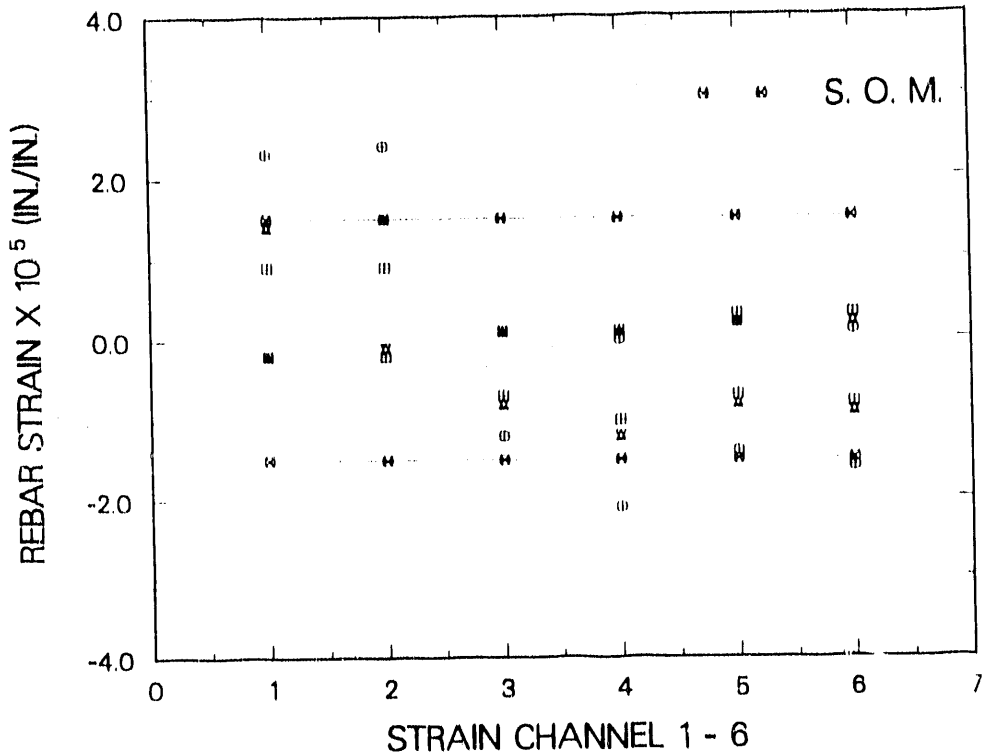
Fig. 55. Strain gage reading in the west end wall compared with SOM theory for the three 100-psi load cycles.

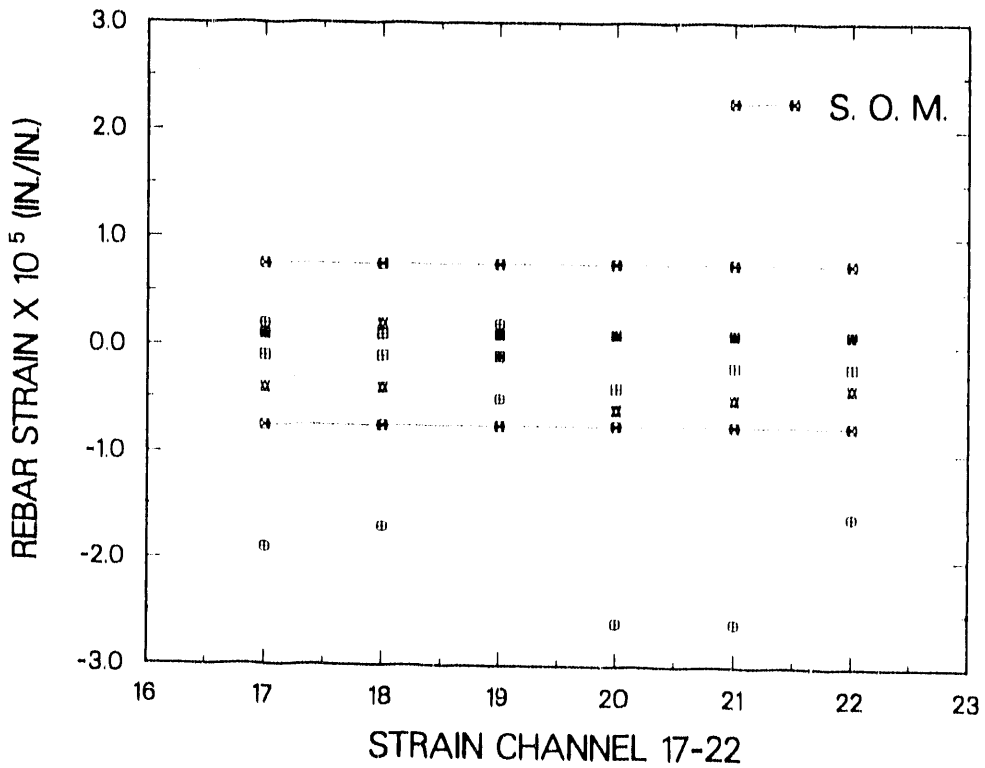
Fig. 58. Strain gage readings in the east end wall compared with SOM theory for the three 50-psi load cycles.

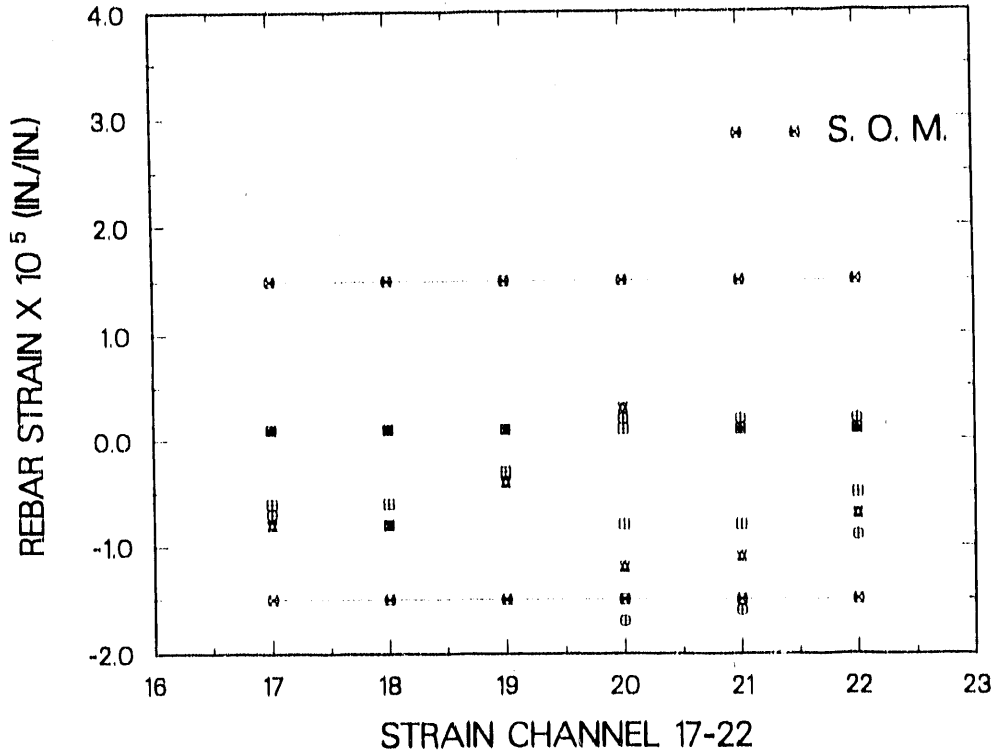
Fig. 59. Strain gage readings in the east end wall compared with SOM theory for the three 100-psi load cycles.

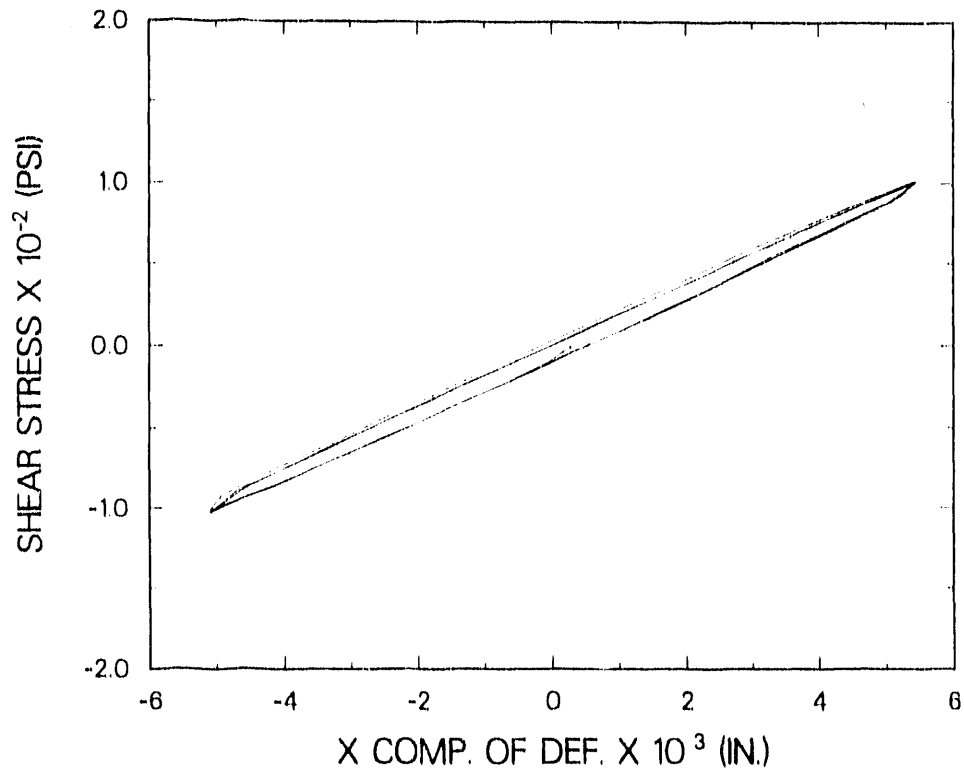
Fig. 62. Horizontal component of deformation from internal gages, 100-psi load cycle.

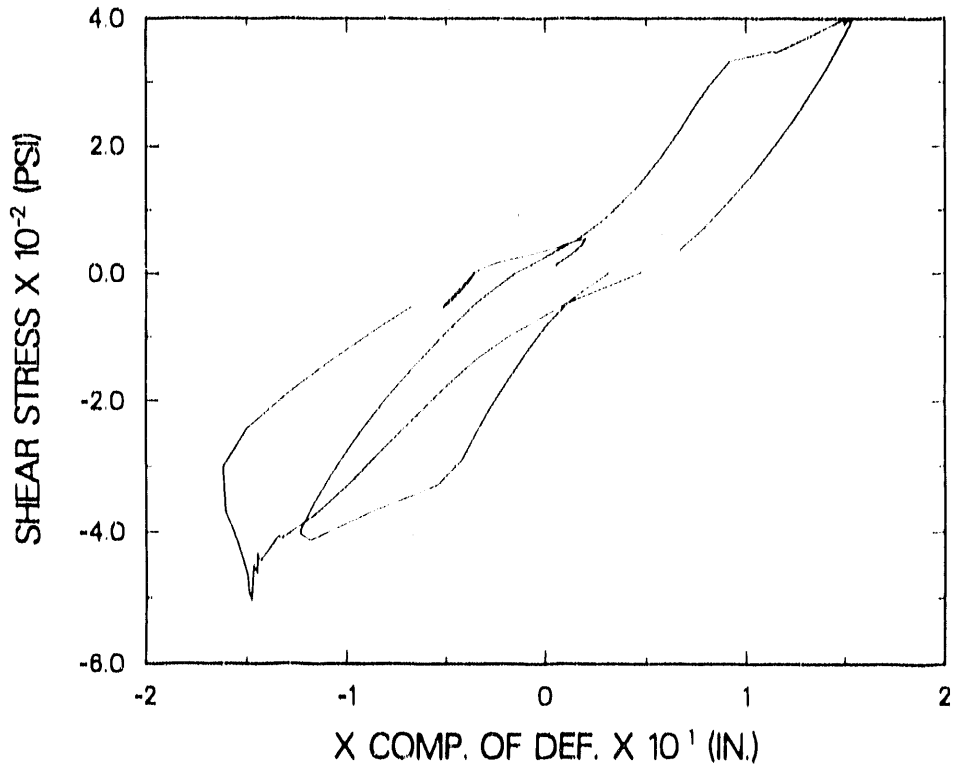
Fig. 69. Horizontal component of deformation from external gages, failure cycle and last 50-psi load cycle.

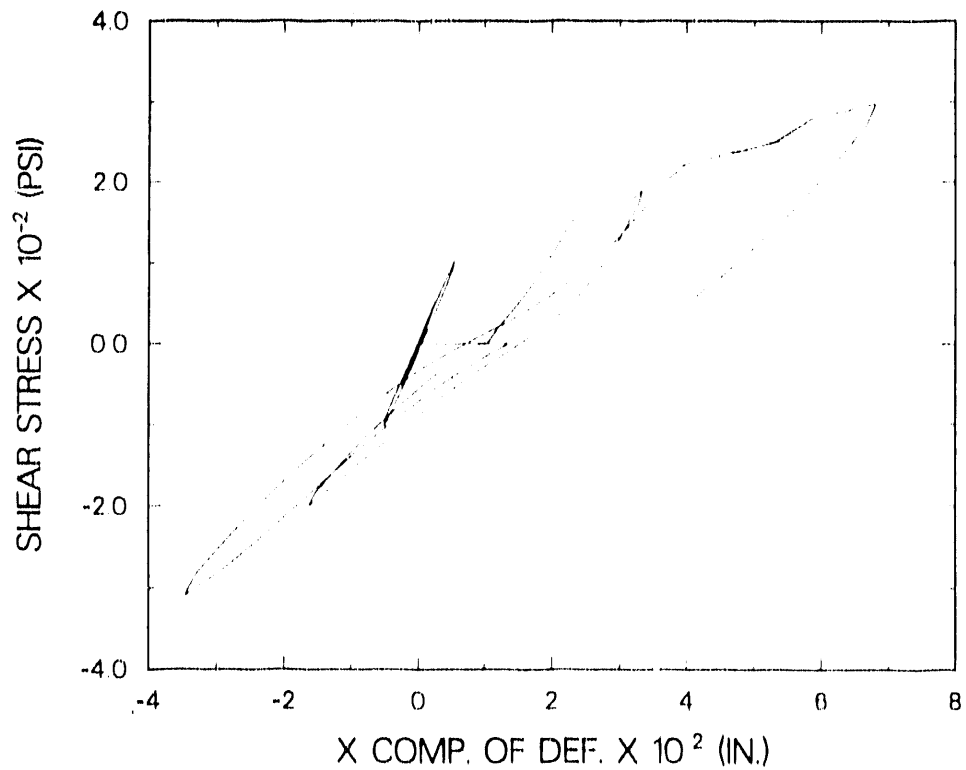
Fig. 70. Horizontal component of deformation from internal gages, first load cycle at each stress level.

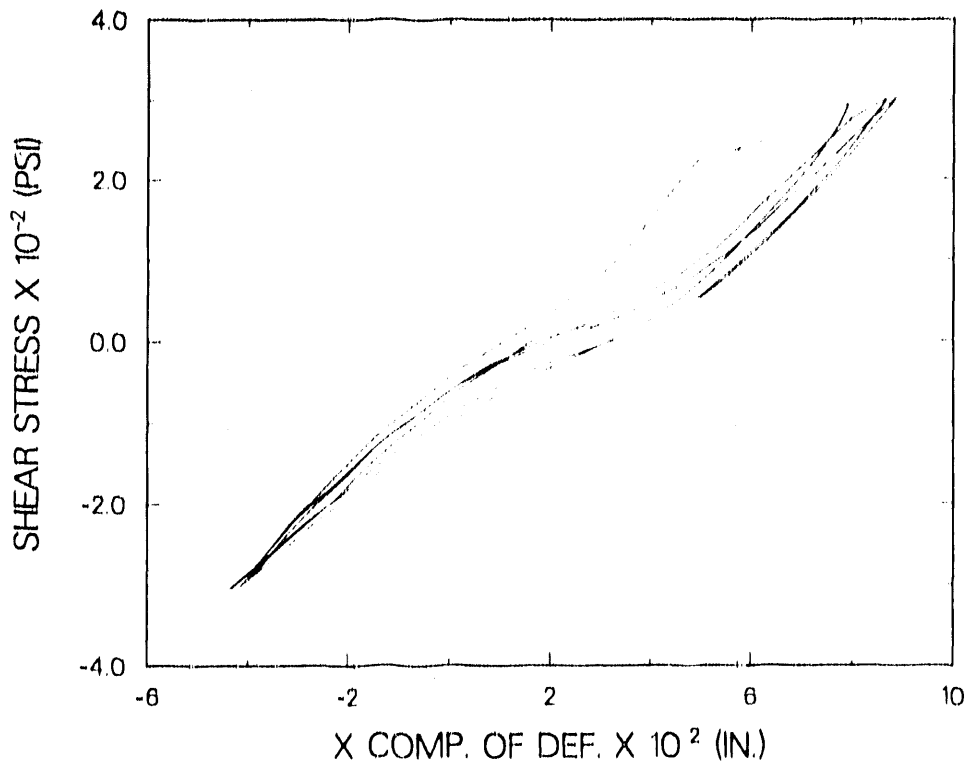
Fig. 67. Horizontal component of deformation from external gages, 300-psi load cycle.

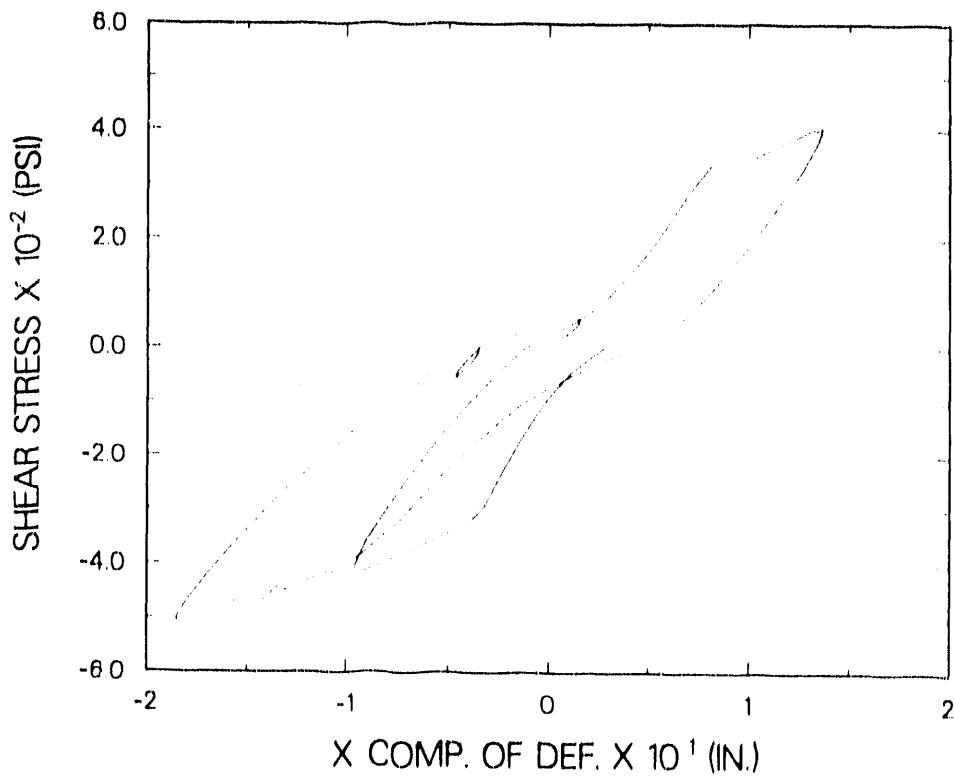
Fig. 68. Horizontal component of deformation from internal gages, failure cycle and last 50-psi load cycle.

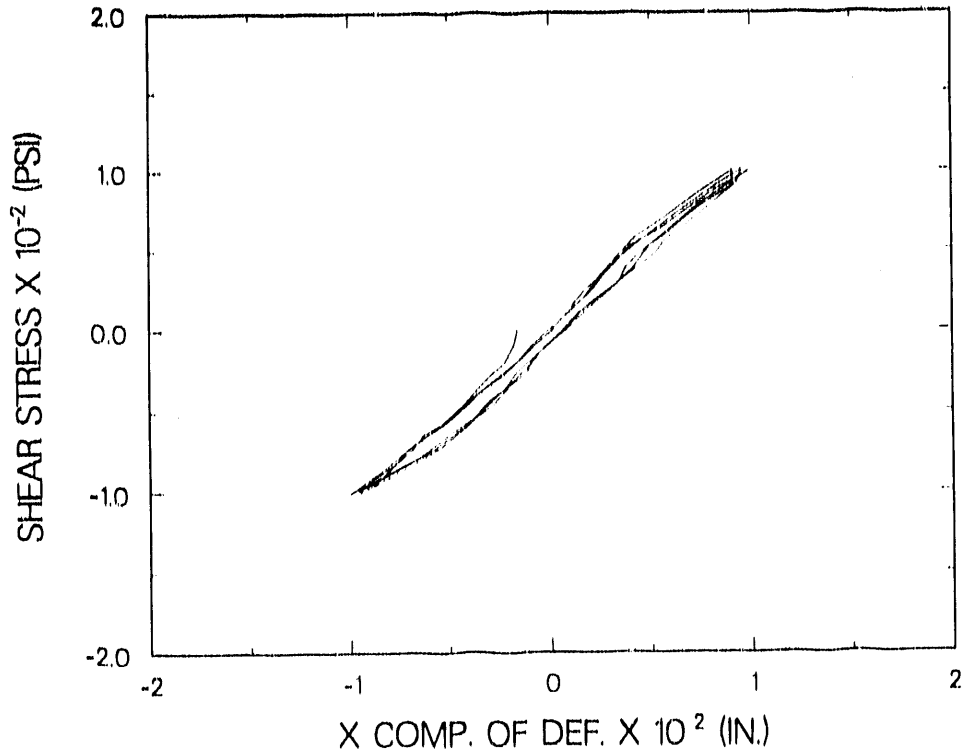
Fig. 63. Horizontal component of deformation from external gages, 100-psi load cycle.

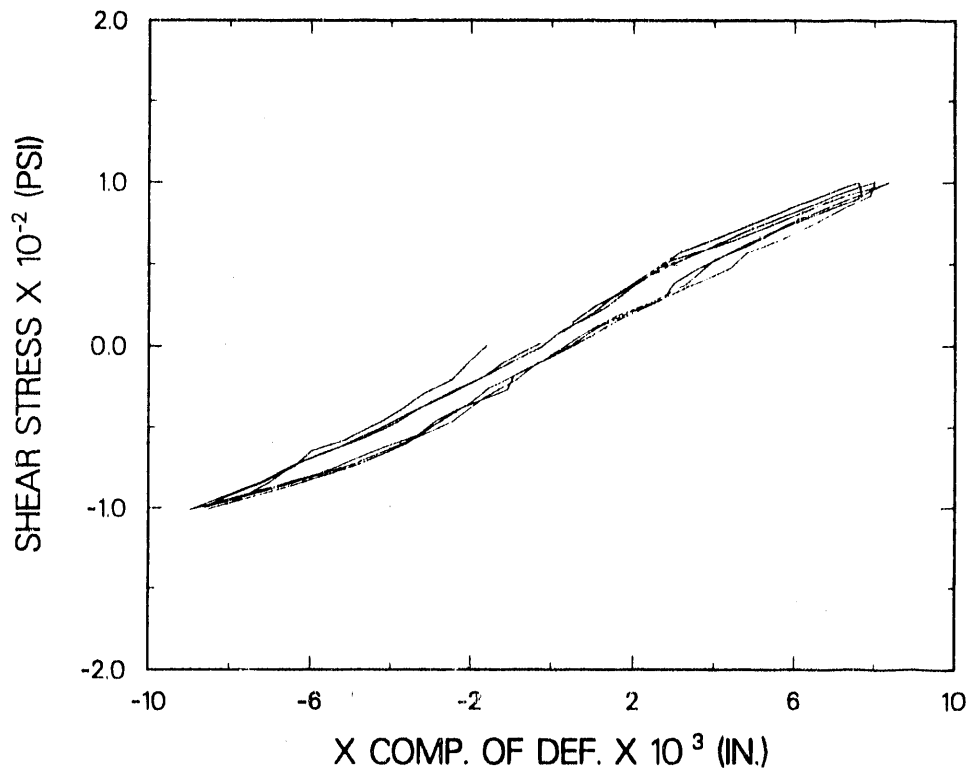
Fig. 76. Horizontal component of shear deformation from external gages, 100-psi load cycle.

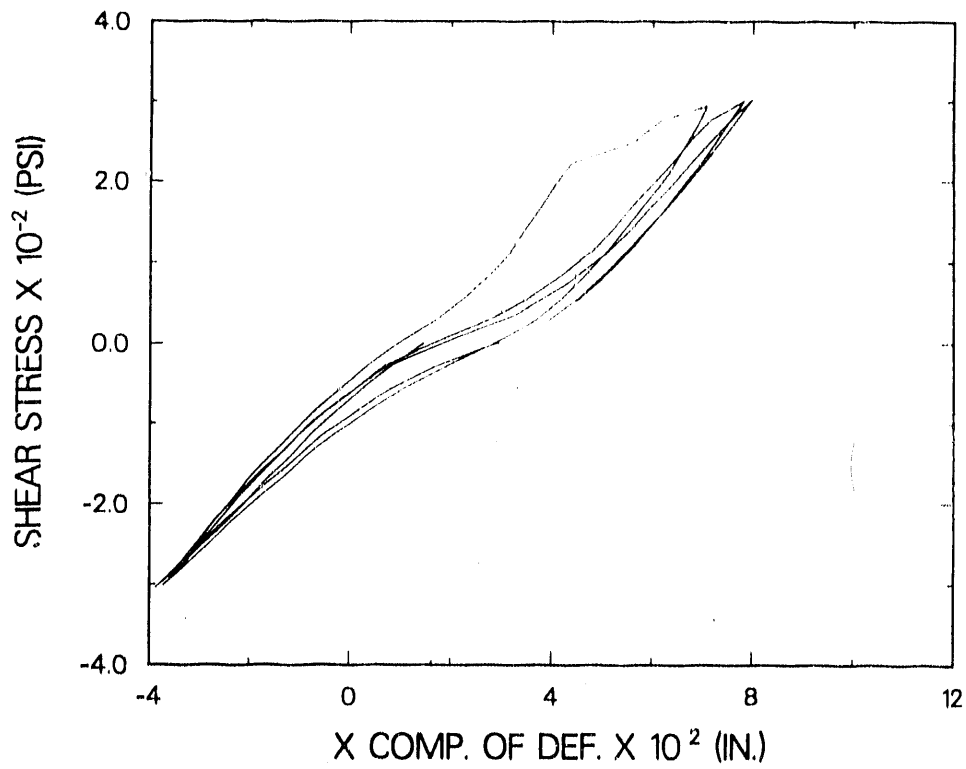
Fig. 80. Horizontal component of shear deformation from external gages, 300-psi load cycles.

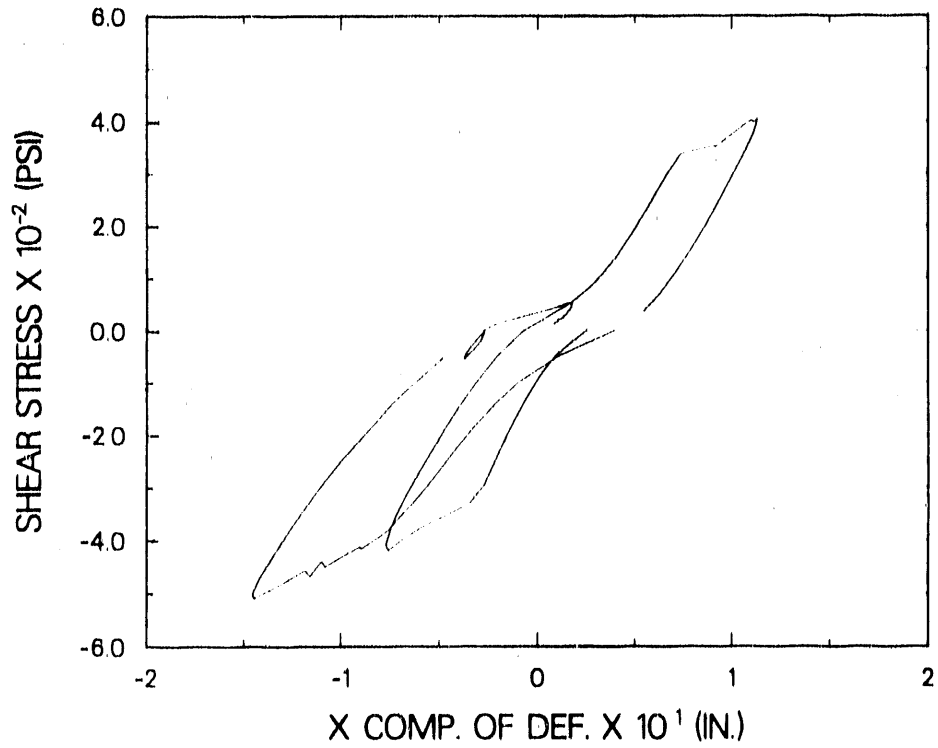
Fig. 81. Horizontal component of shear deformation from internal gages, failure cycle and last 50-psi load cycle.

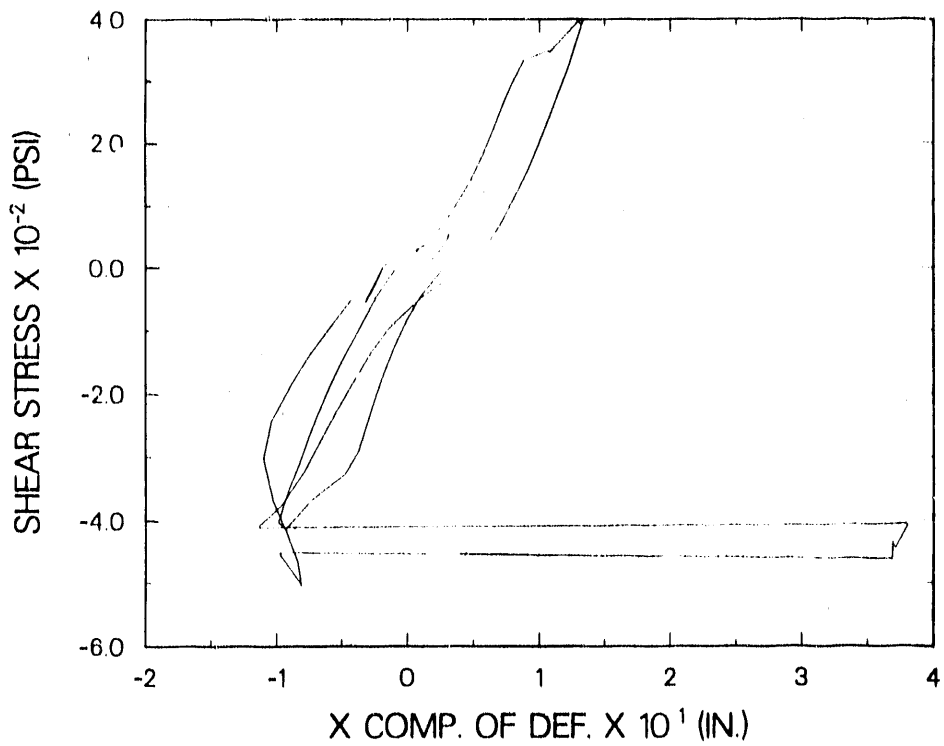
Fig. 82. Horizontal component of shear deformation from external gages, failure cycle and last 50-psi load cycle.

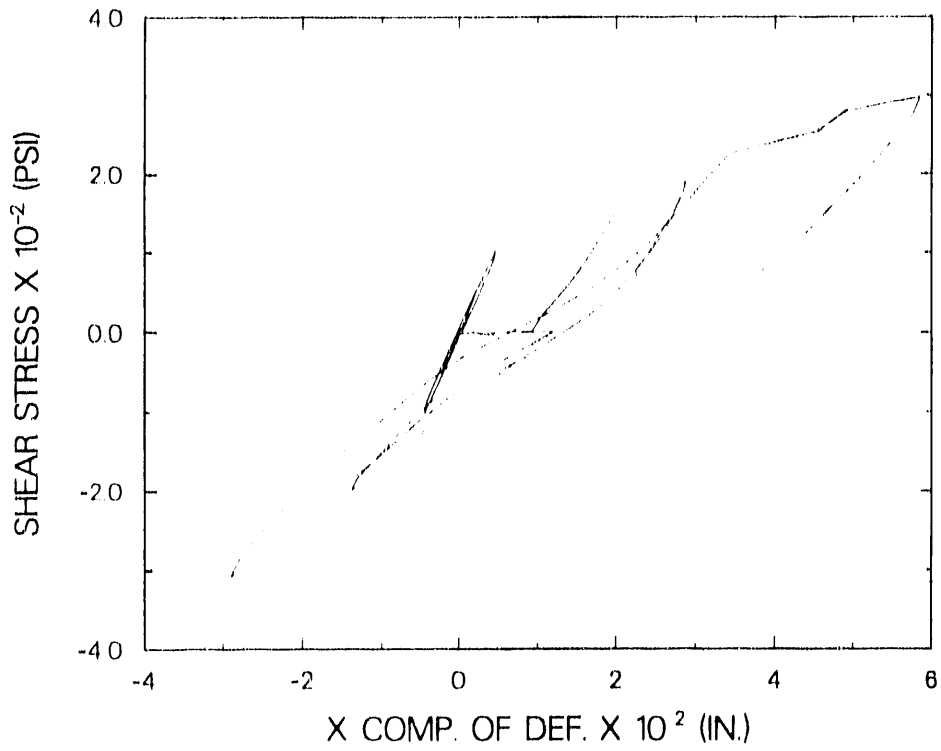
Fig. 83. Horizontal component of shear deformation from internal gages, first load cycle at each stress level.
