NUREG/CR-5487
LA-11739-MS
RD

Static Load Cycle Testing of a Low-Aspect-Ratio Four-Inch Wall, TRG-Type Structure TRG-5-4 (1.0, 0.56)

Prepared by
C. R. Farrar, J. G. Bennett, W. E. Dunwoody, W. E. Baker*

Prepared for
Division of Engineering
Office of Nuclear Regulatory Research
U.S. Nuclear Regulatory Commission
Washington, DC 20555
NRC FIN A7221

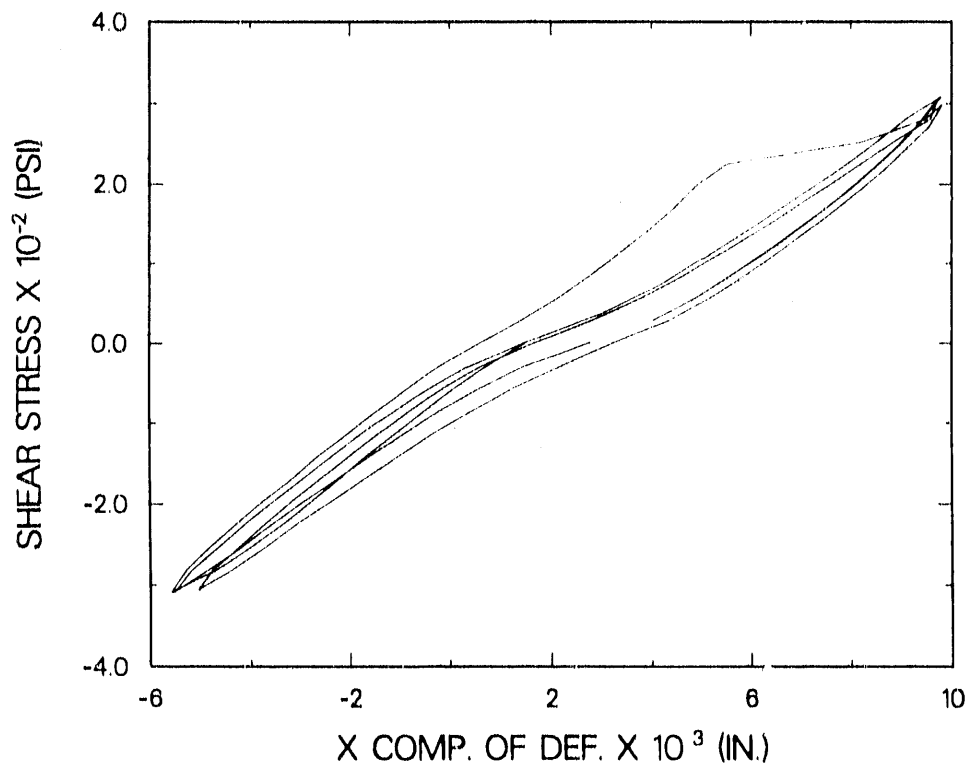
Fig. 90. Horizontal component of bending deformation from internal gages, 300-psi load cycle.

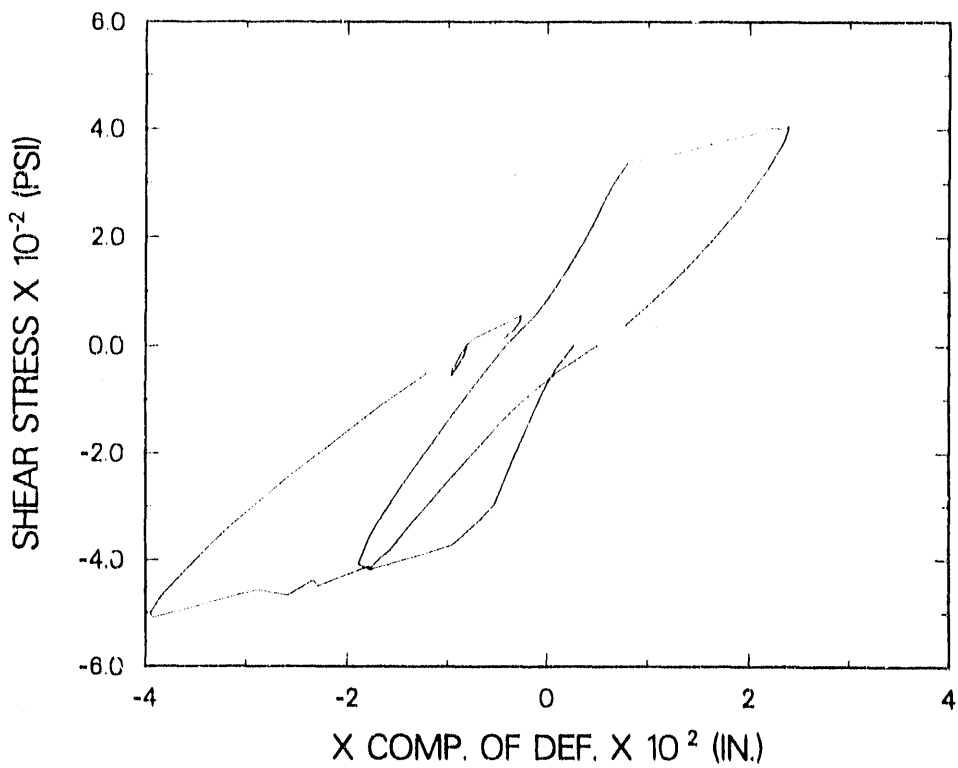
Fig. 92. Horizontal component of bending deformation from internal gages, failure cycle and last 50-psi load cycle.

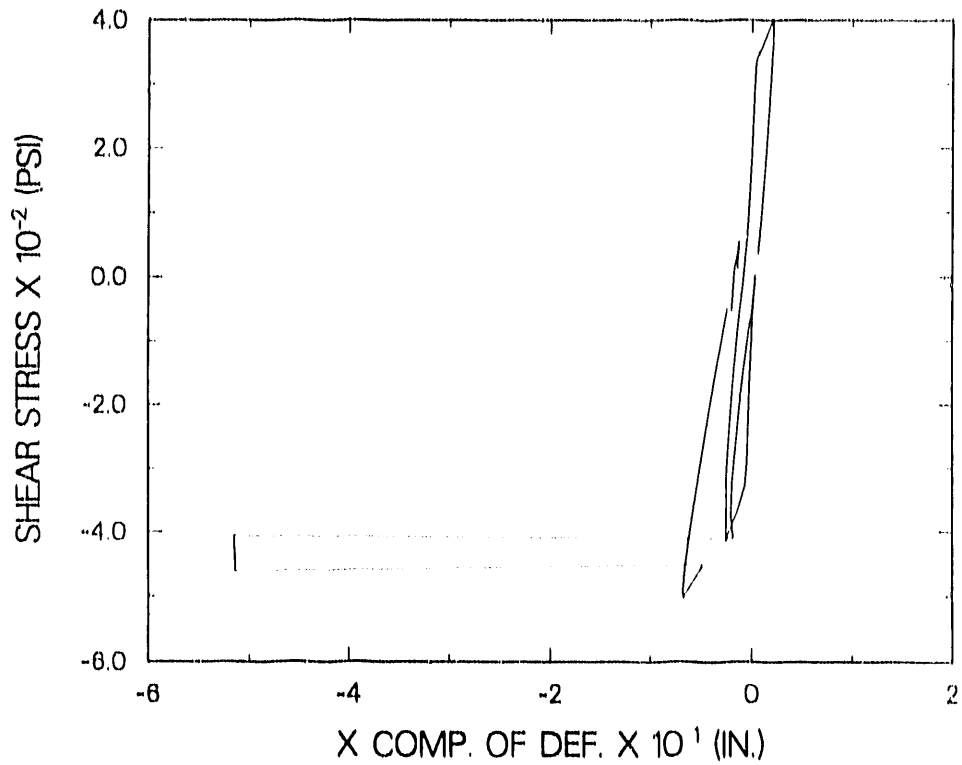
Fig. 93. Horizontal component of bending deformation from external gages, failure cycle and last 50-psi load cycle.

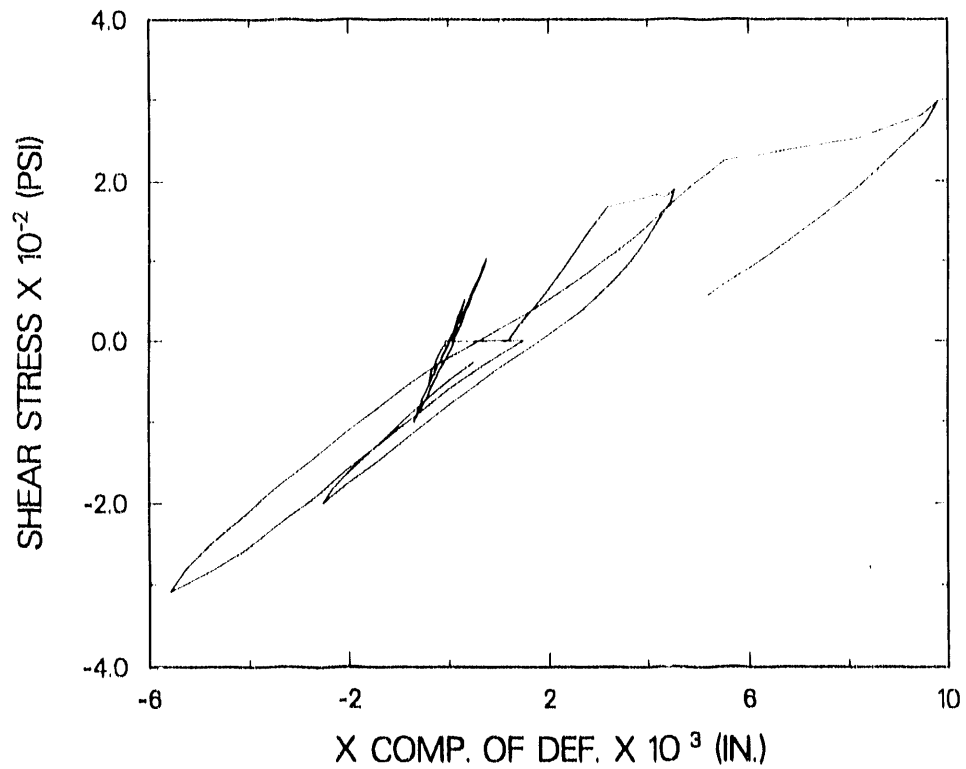
Fig. 94. Horizontal component of bending deformation from internal gages, first load cycle at each stress level.

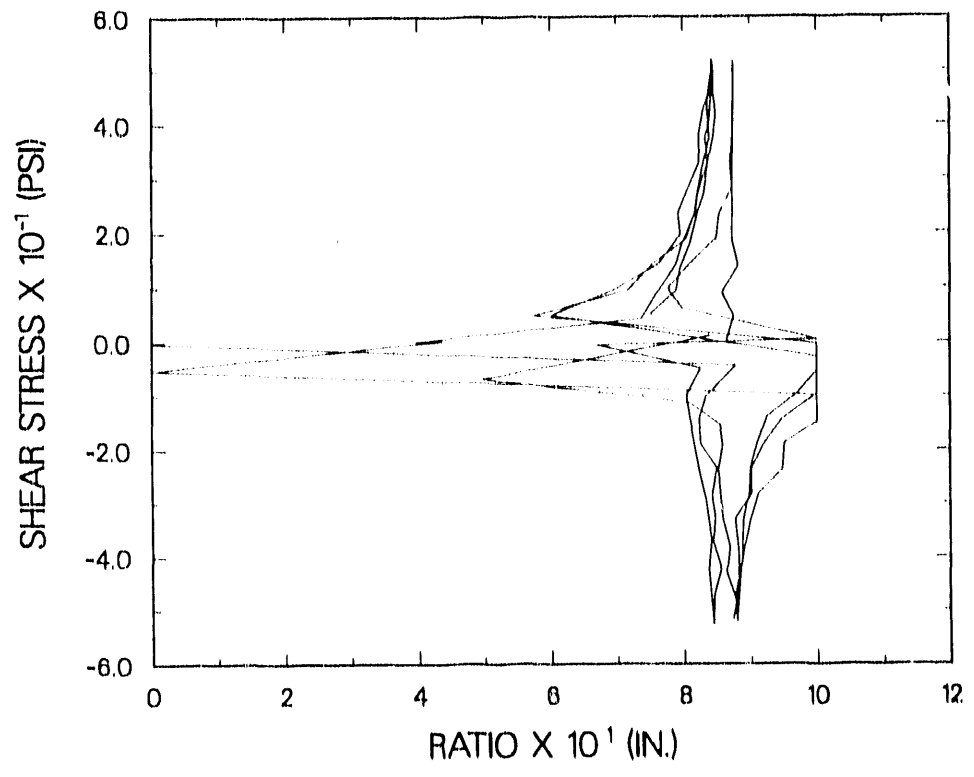
Fig. 96. Ratio of shear to total deformation for the 50-psi cycles.

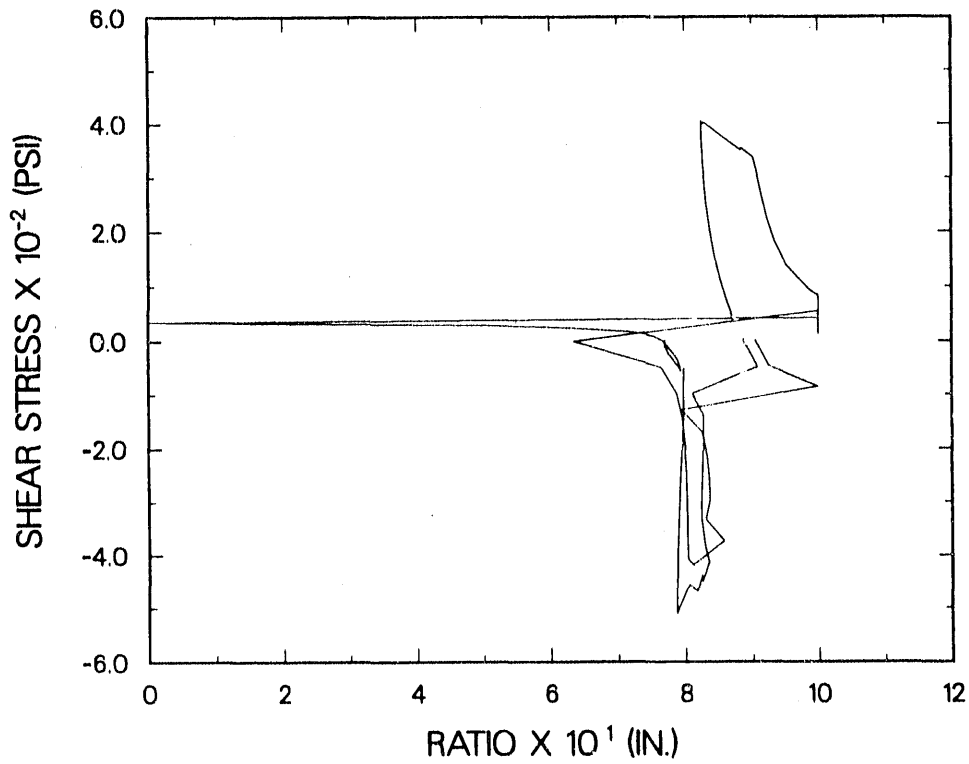
Fig. 100. Ratio of shear to total deformation for the failure load cycle and last 50-psi run.

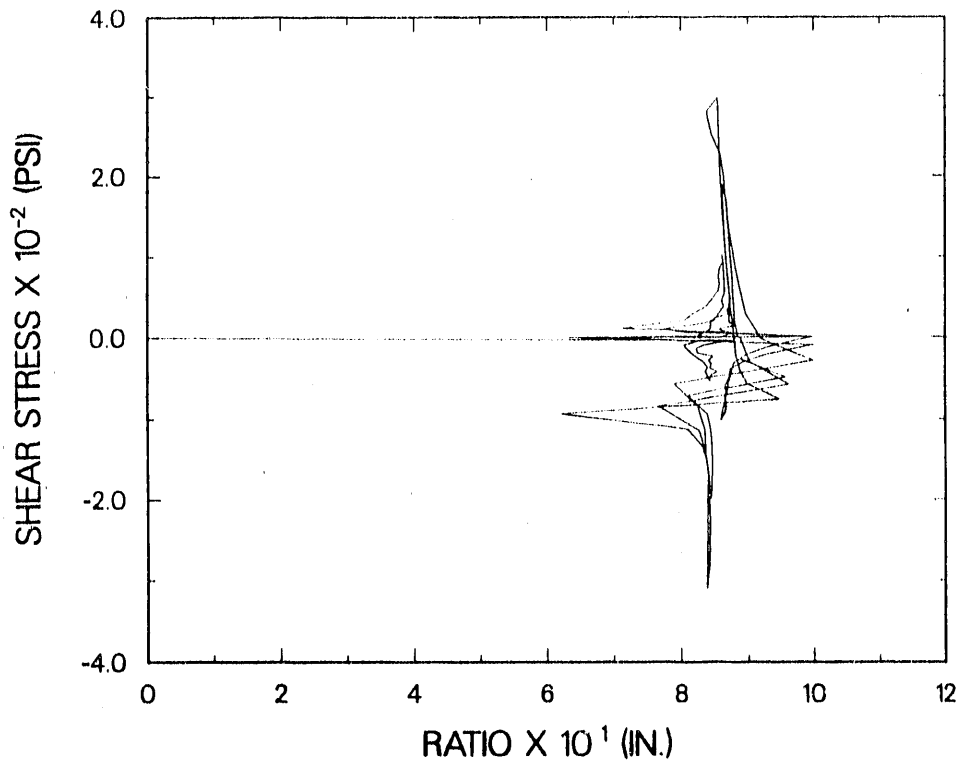
Fig. 101. Ratio of shear to total deformation for the first load cycle at each stress level.

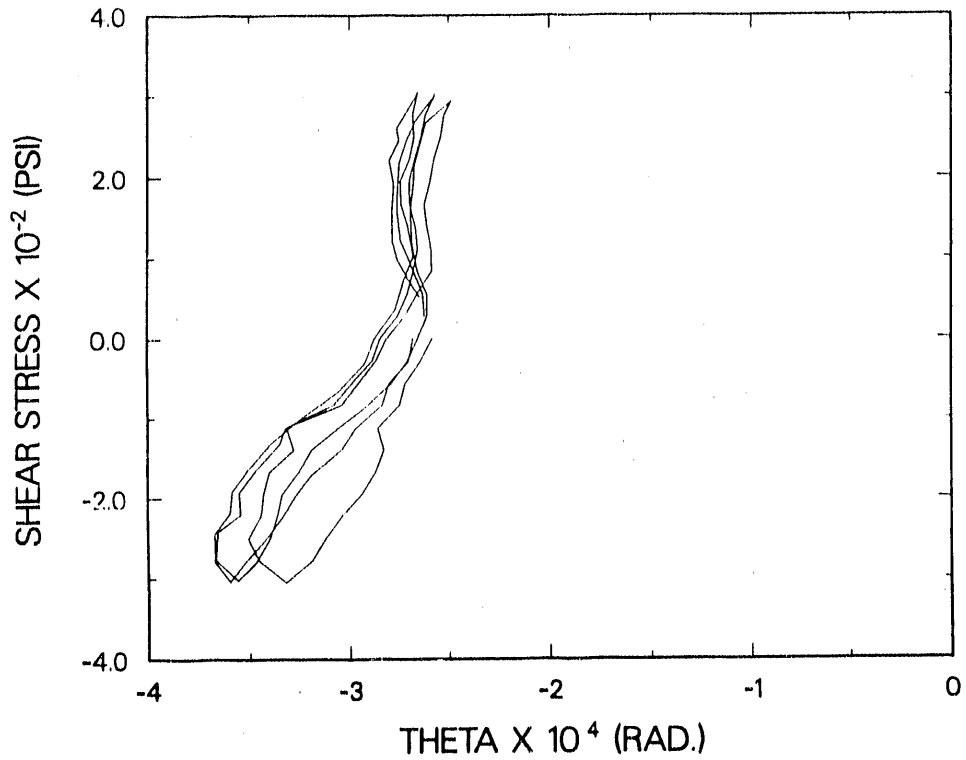
Fig. 107. Torsional deformation for the failure load cycle and last 50-psi load cycle.

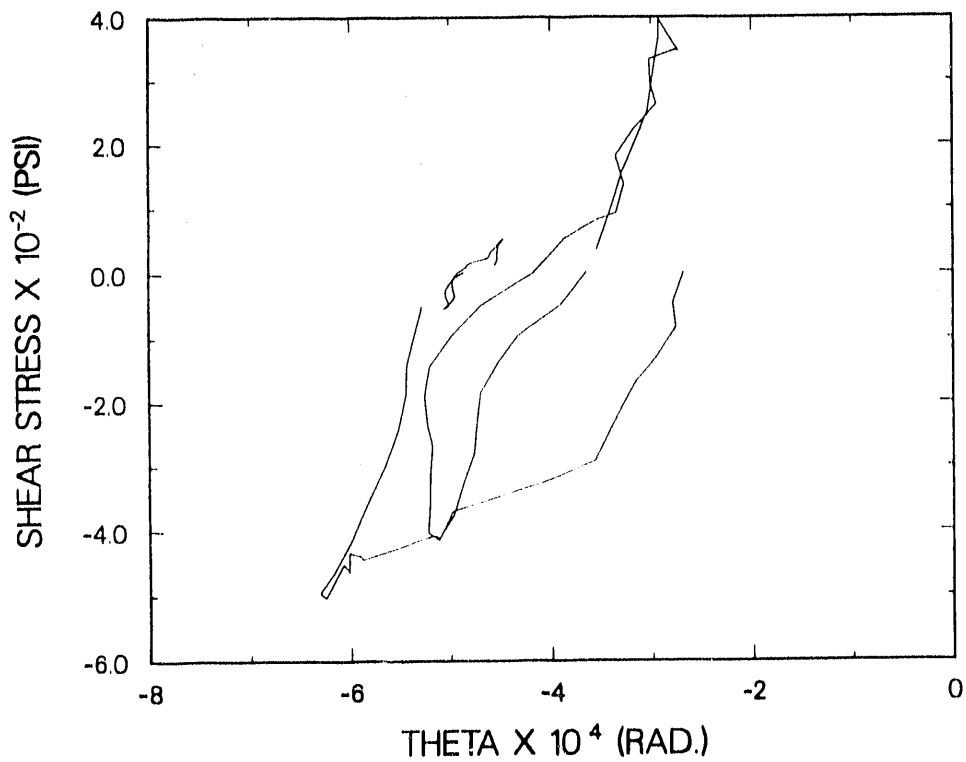
Fig. 108. Torsional deformation for the first load cycle at each stress level.

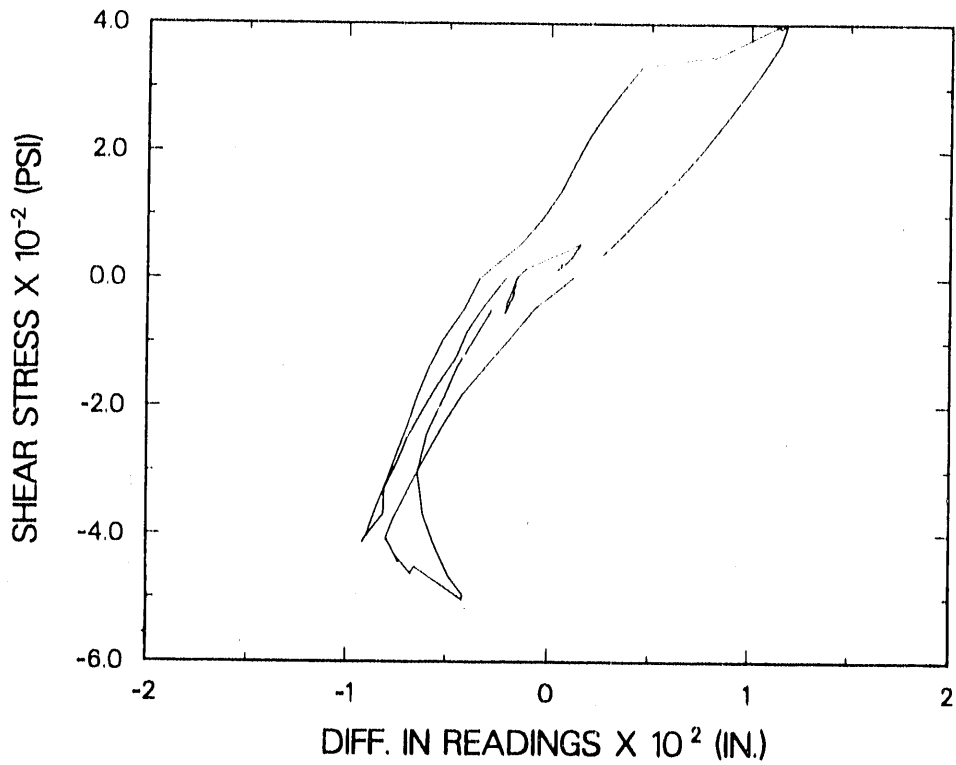
Fig. 113. Difference in readings of gages above and below floor for the failure load cycle and last 50-psi run.

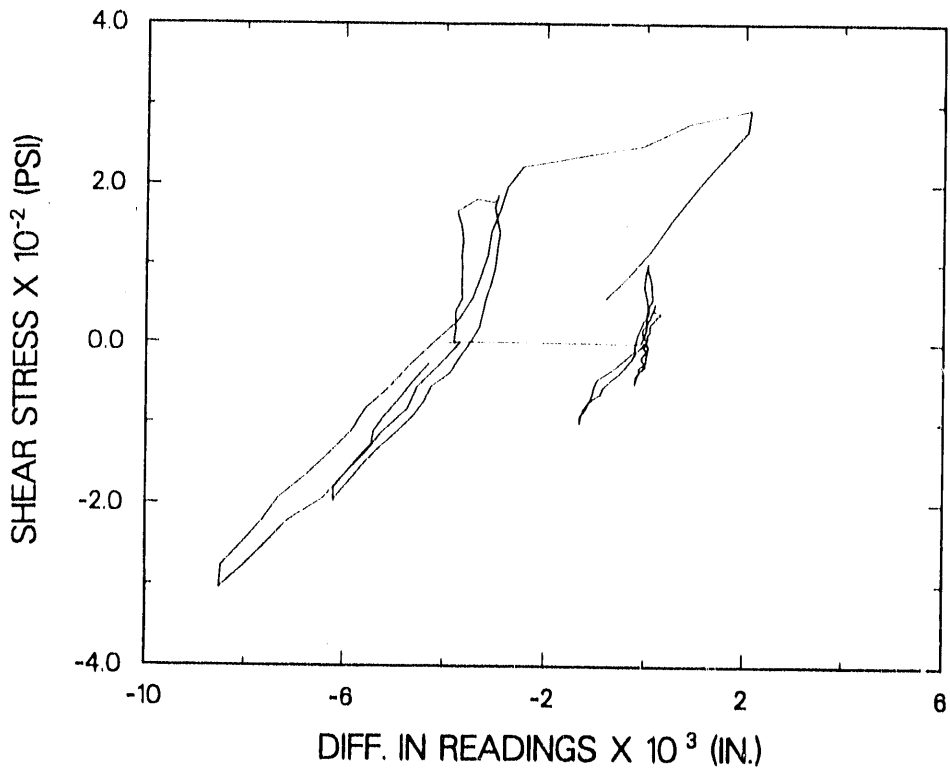
Fig. 114. Difference in readings of gages above and below floor for first load cycle at each stress level.

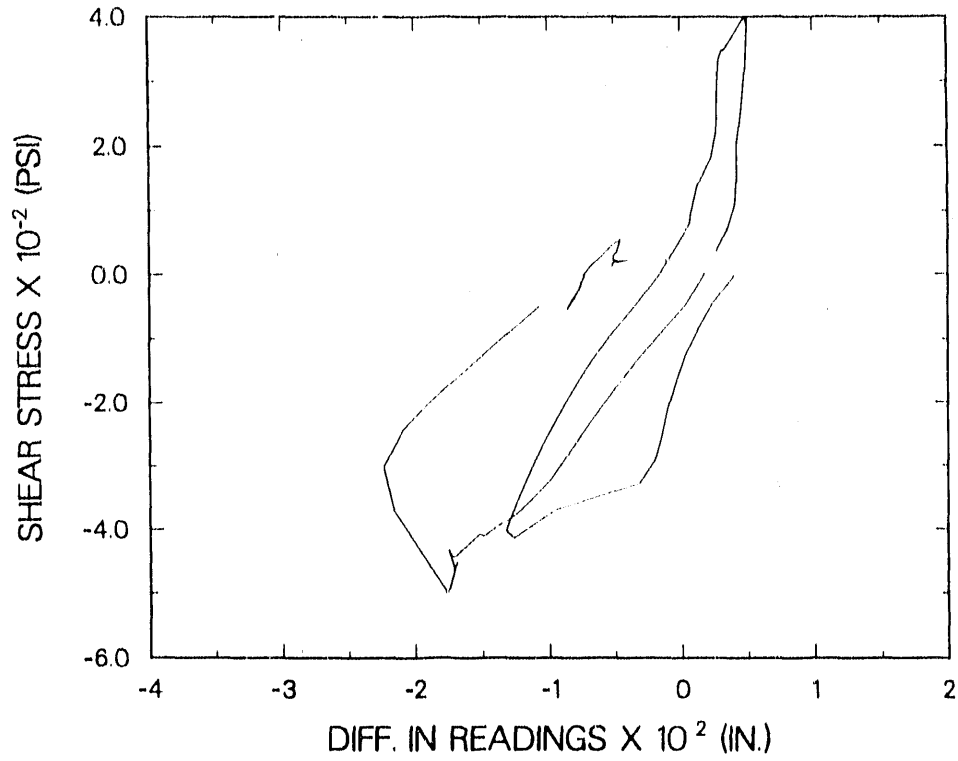
Fig. 119. Difference in readings of gages above and below ceiling for the failure load cycles and last 50-psi run.

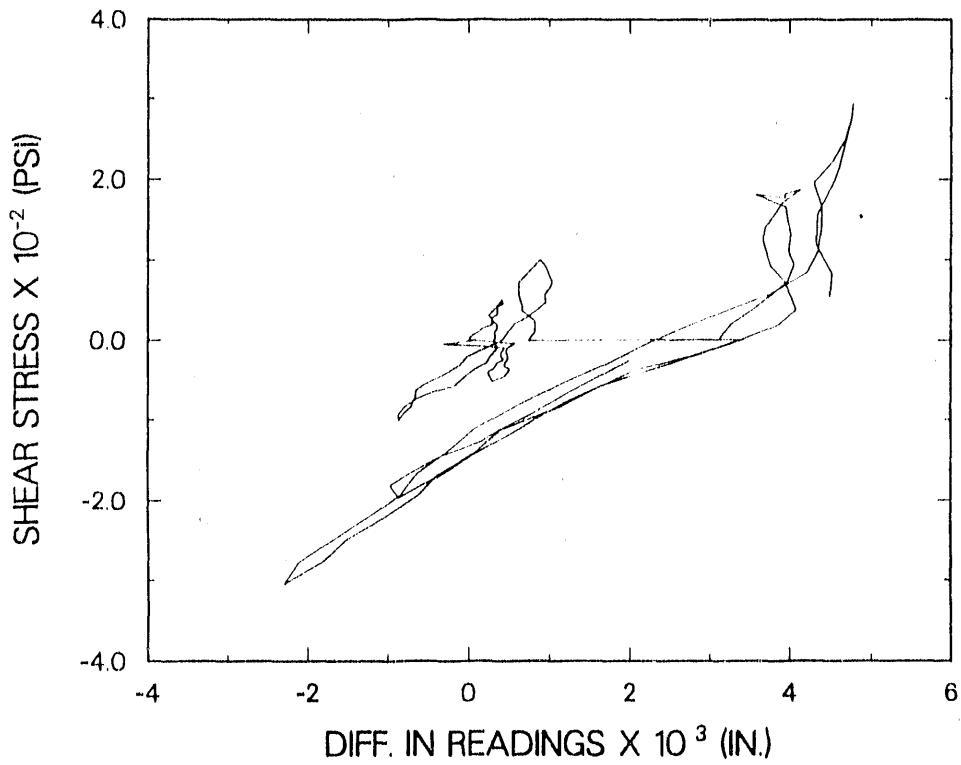
Fig. 120. Difference in readings of gages above and below ceiling for the first load cycle at each stress level.

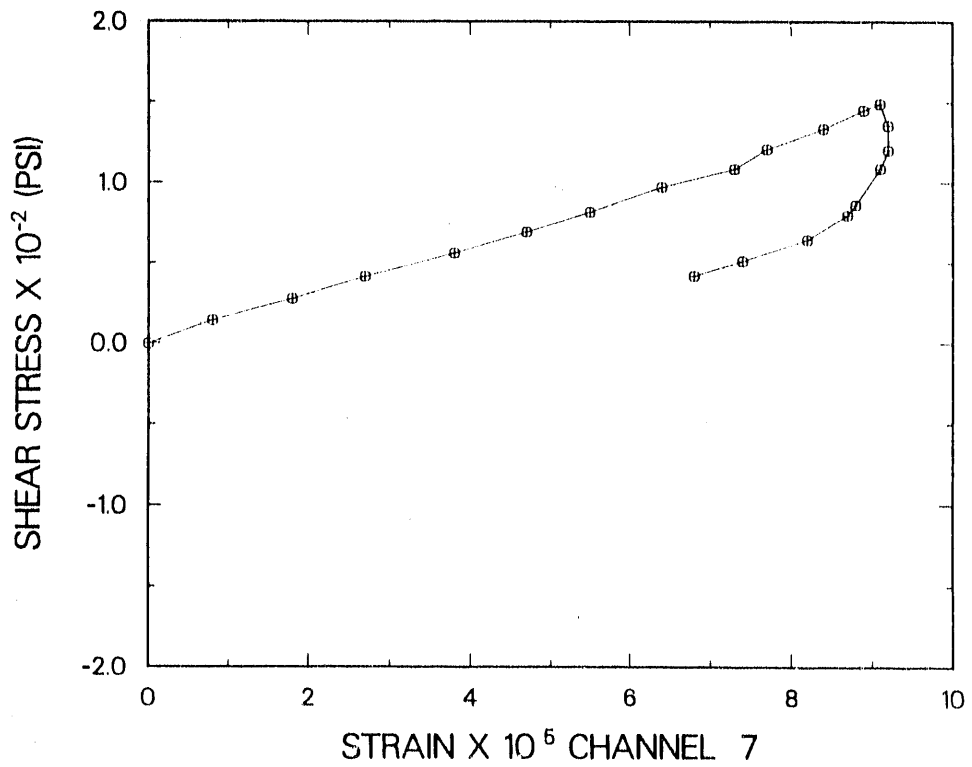
Fig. 126. Strain gage data, horizontal rebar in shear wall (channel 7), 150-psi cycle.

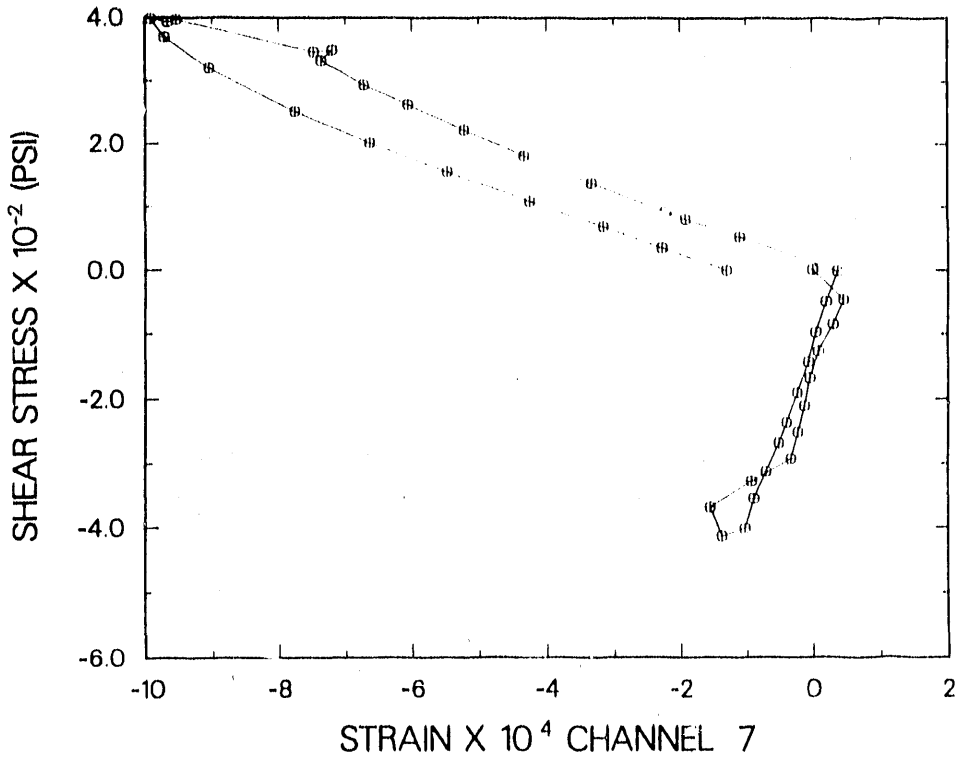
Fig. 133. Strain gage data, horizontal rebar in shear wall (channel 7), failure cycle.

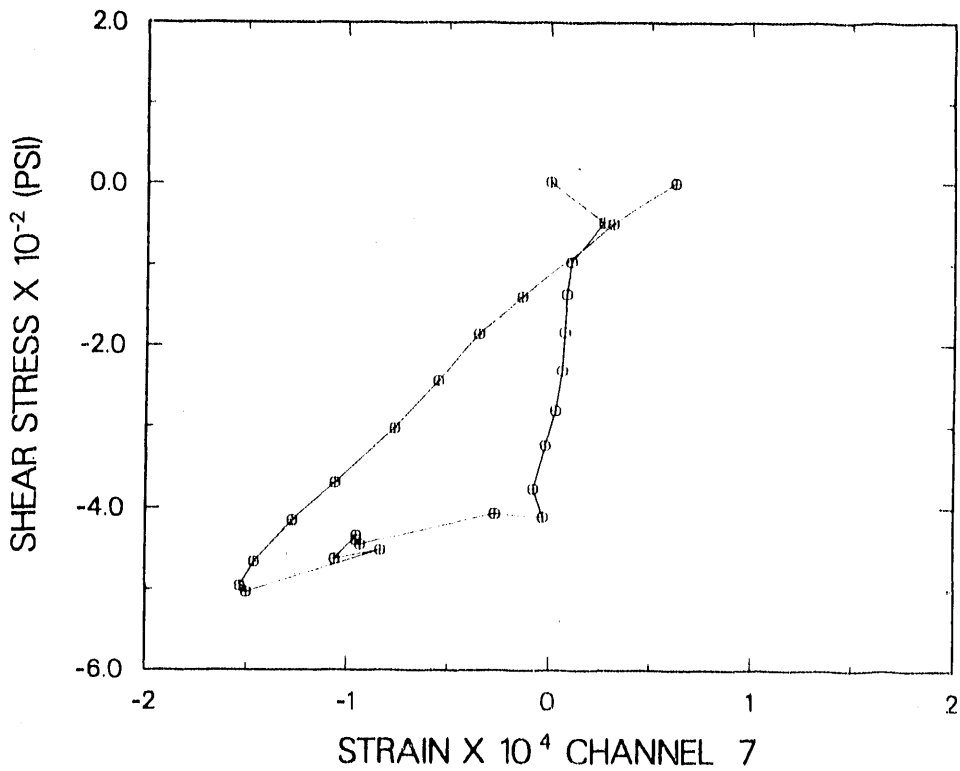
Fig. 134. Strain gage data, horizontal rebar in shear wall (channel 7), 400-psi cycle.

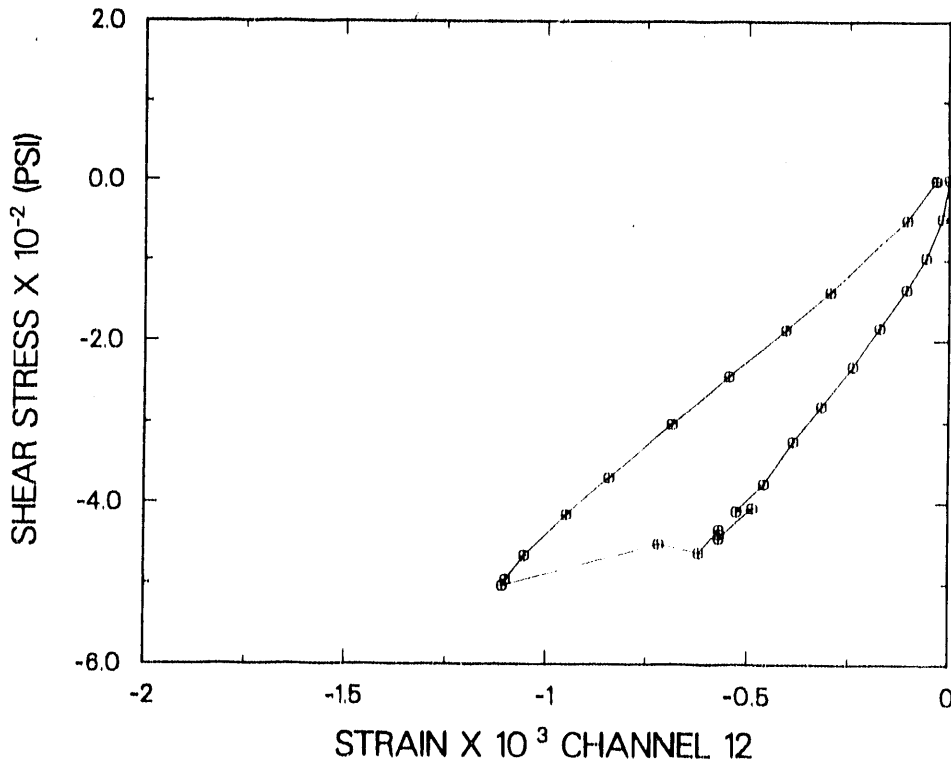
Fig. 138. Strain gage data, horizontal rebar in shear wall (channel 12), failure cycle.

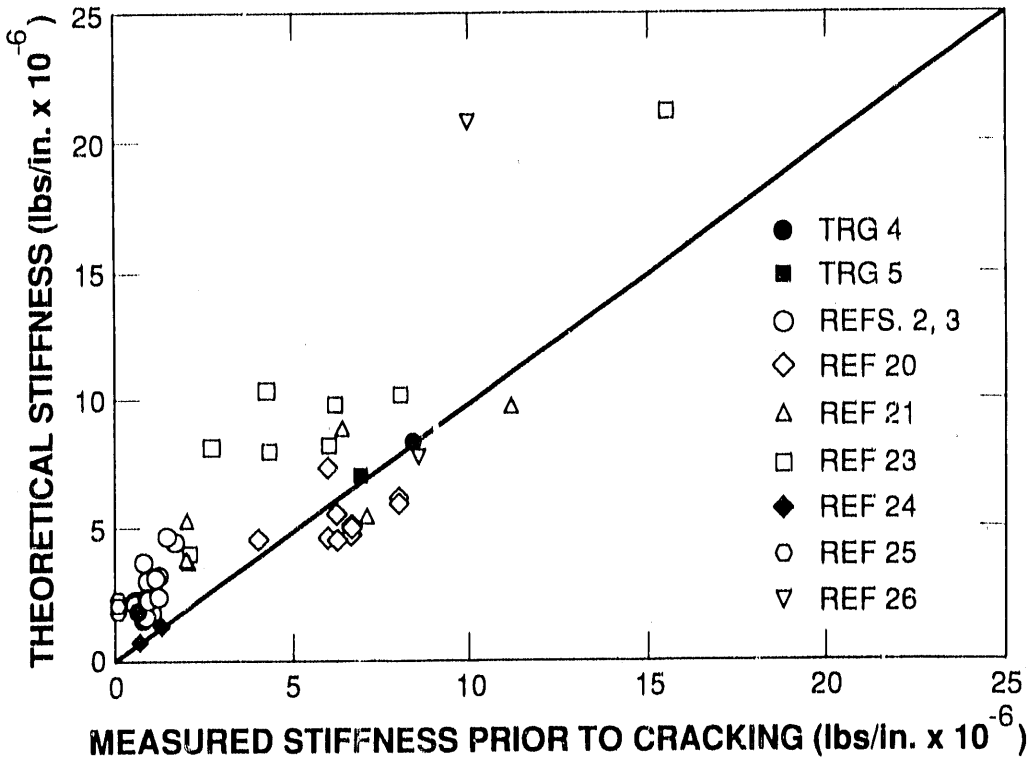
Fig. 139. Other investigators' results plus this investigation: a correlation of theoretical and measured stiffness.

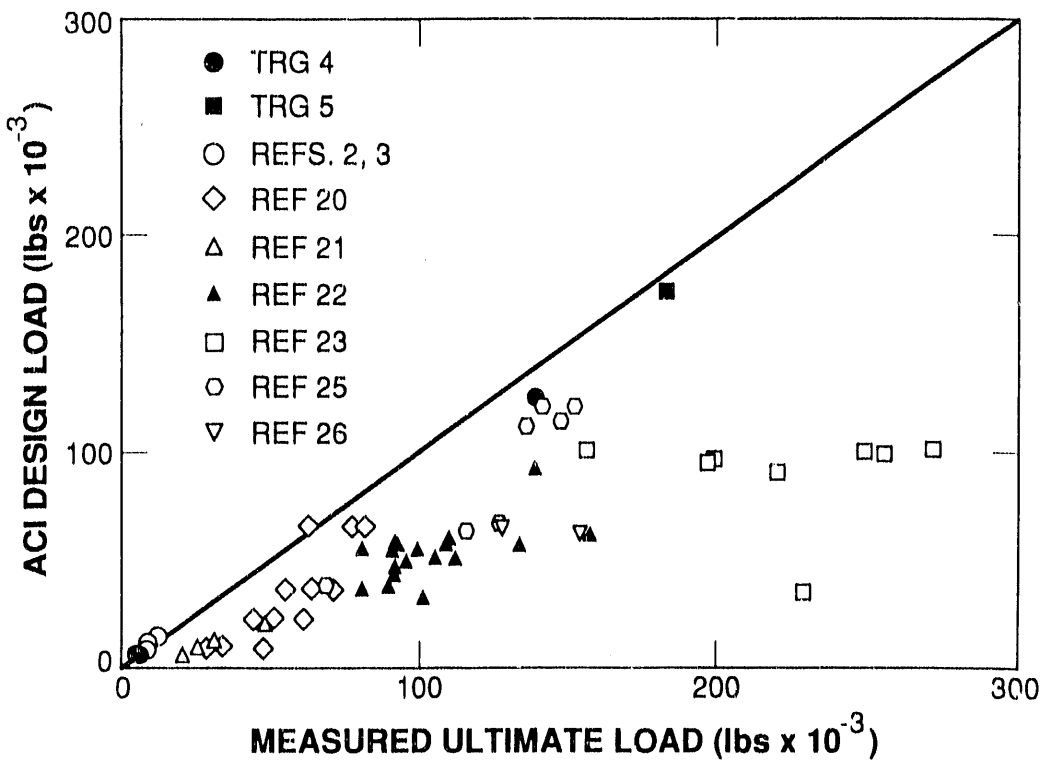
Fig. 140. Same title except: A correlation of ACI design load and the measured ultimate load.

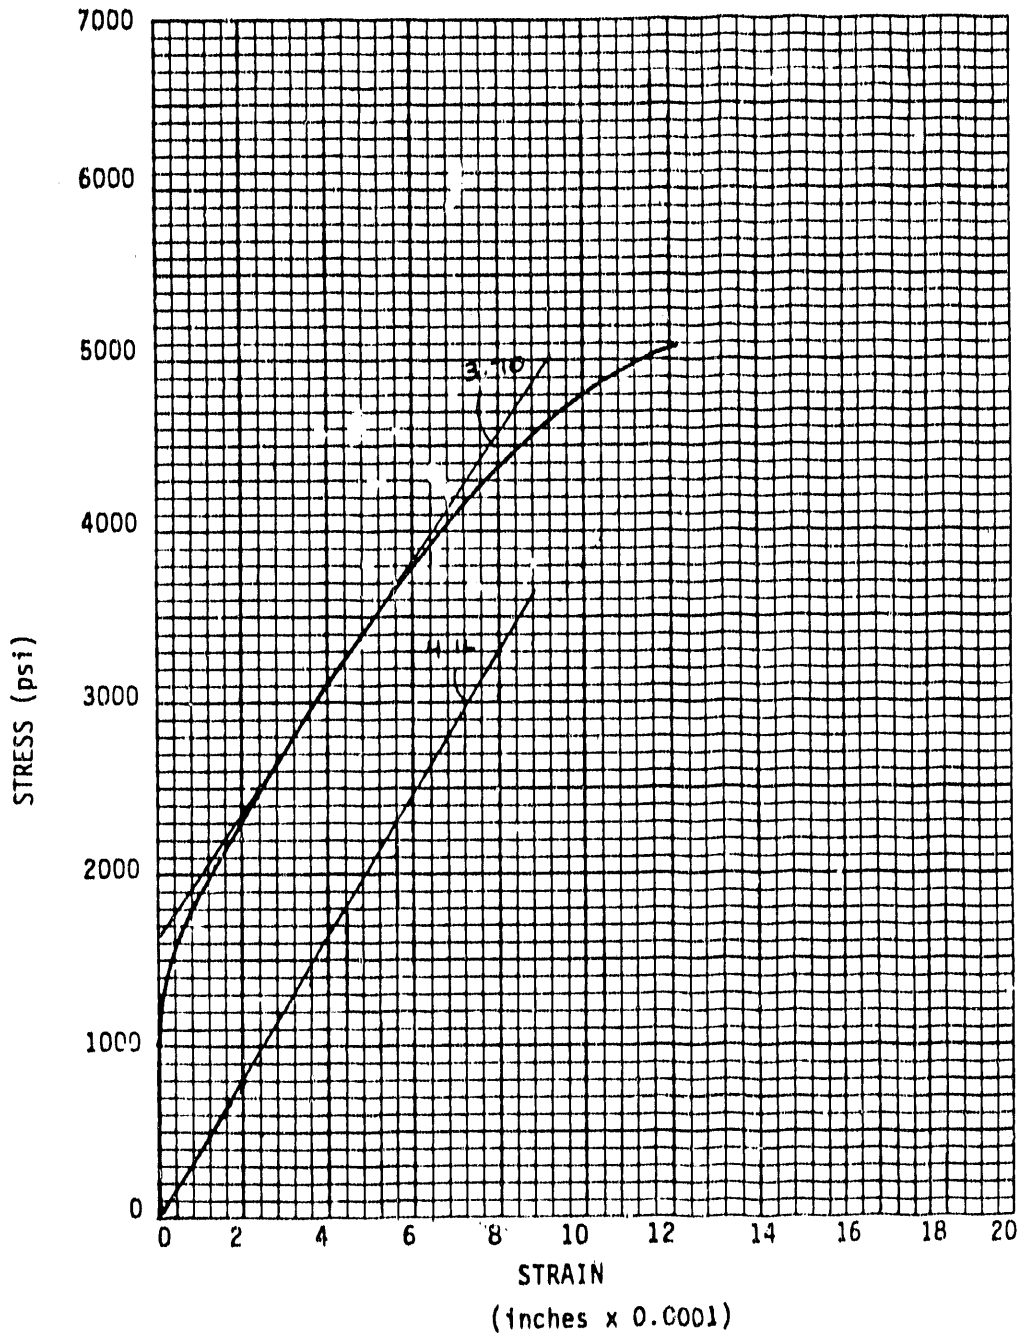
TRG #5
 Truck No. 1
 Cylinder No. 1

$E = 4.160 \times 10^6$
 Ult. Compressive Strength = 5040 psi

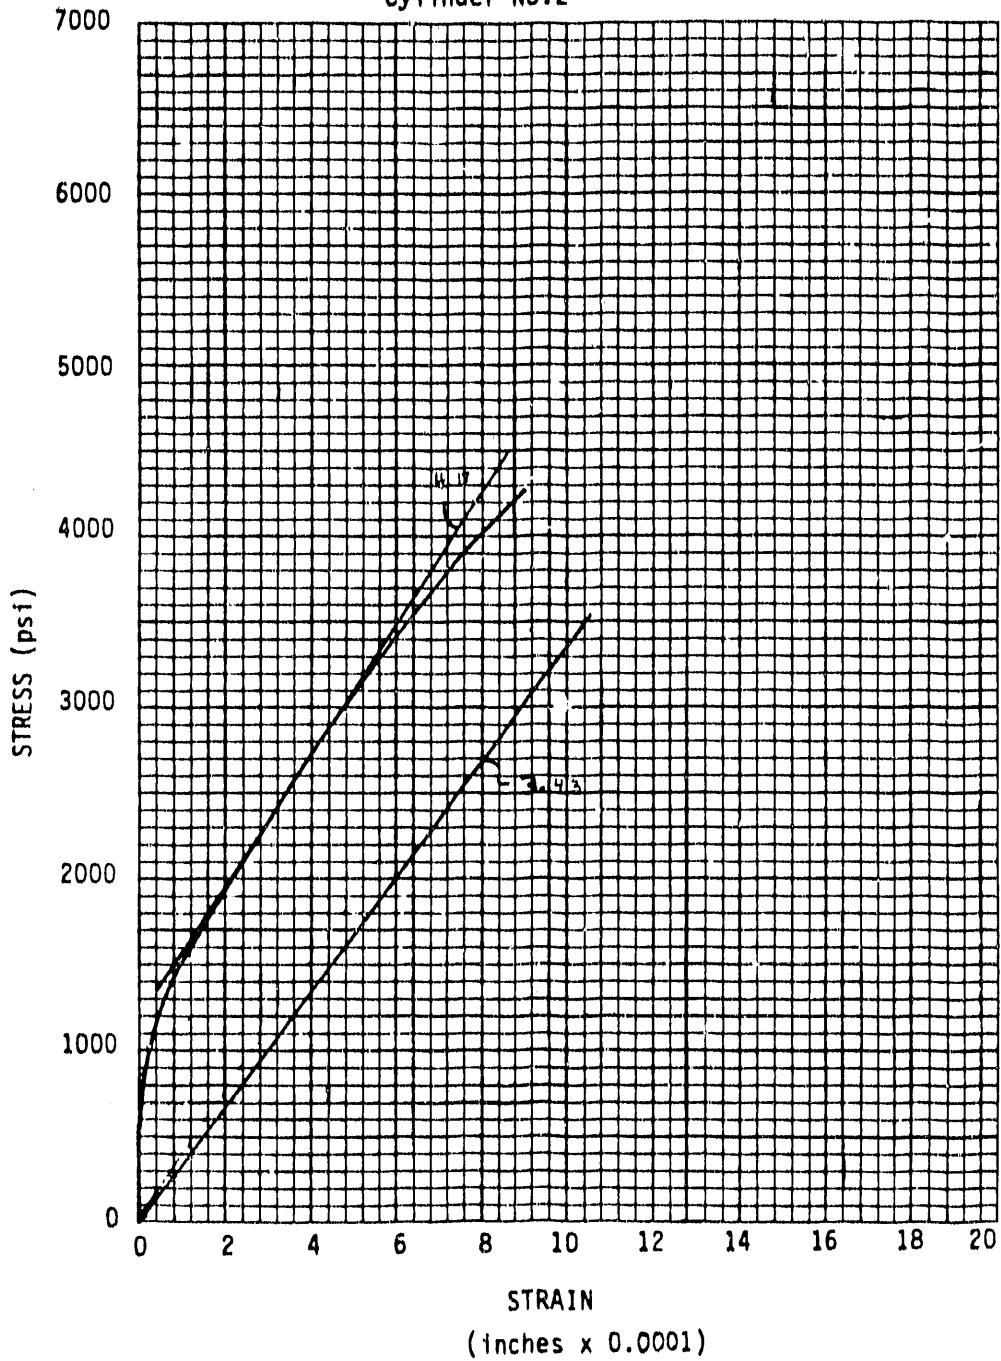
TRG #5
 Truck No. 1
 Cylinder No.2

$E = 3.433 \times 10^6$
 Ult. Compressive Strength = 4460 psi

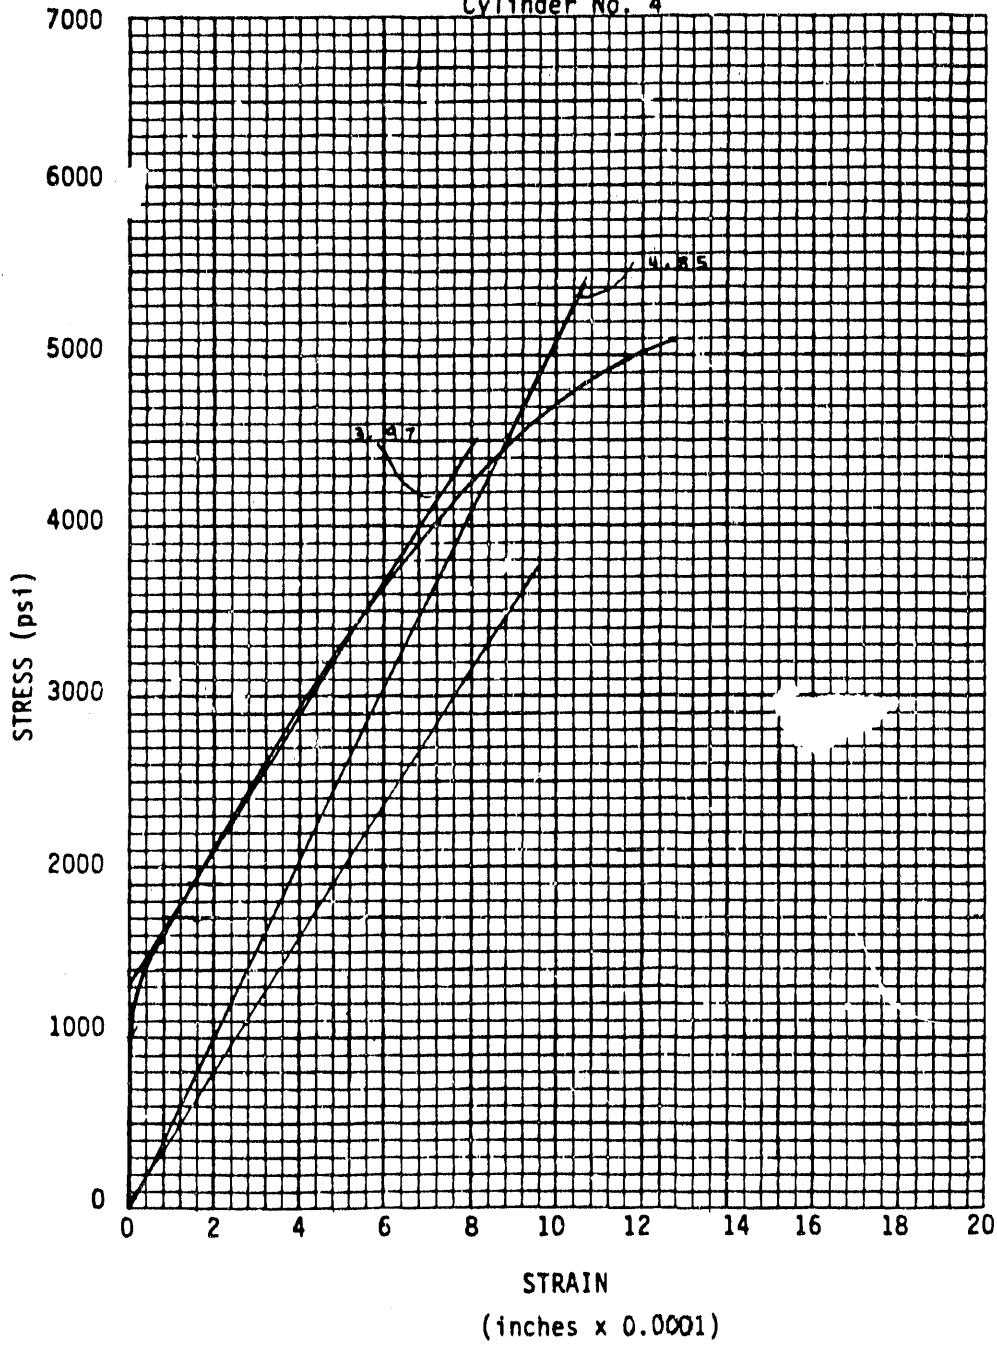
TRG #5
 Truck No. 1
 Cylinder No. 4

$E = 4.846 \times 10^6$
 Ult Compressive Strength = 5130 psi

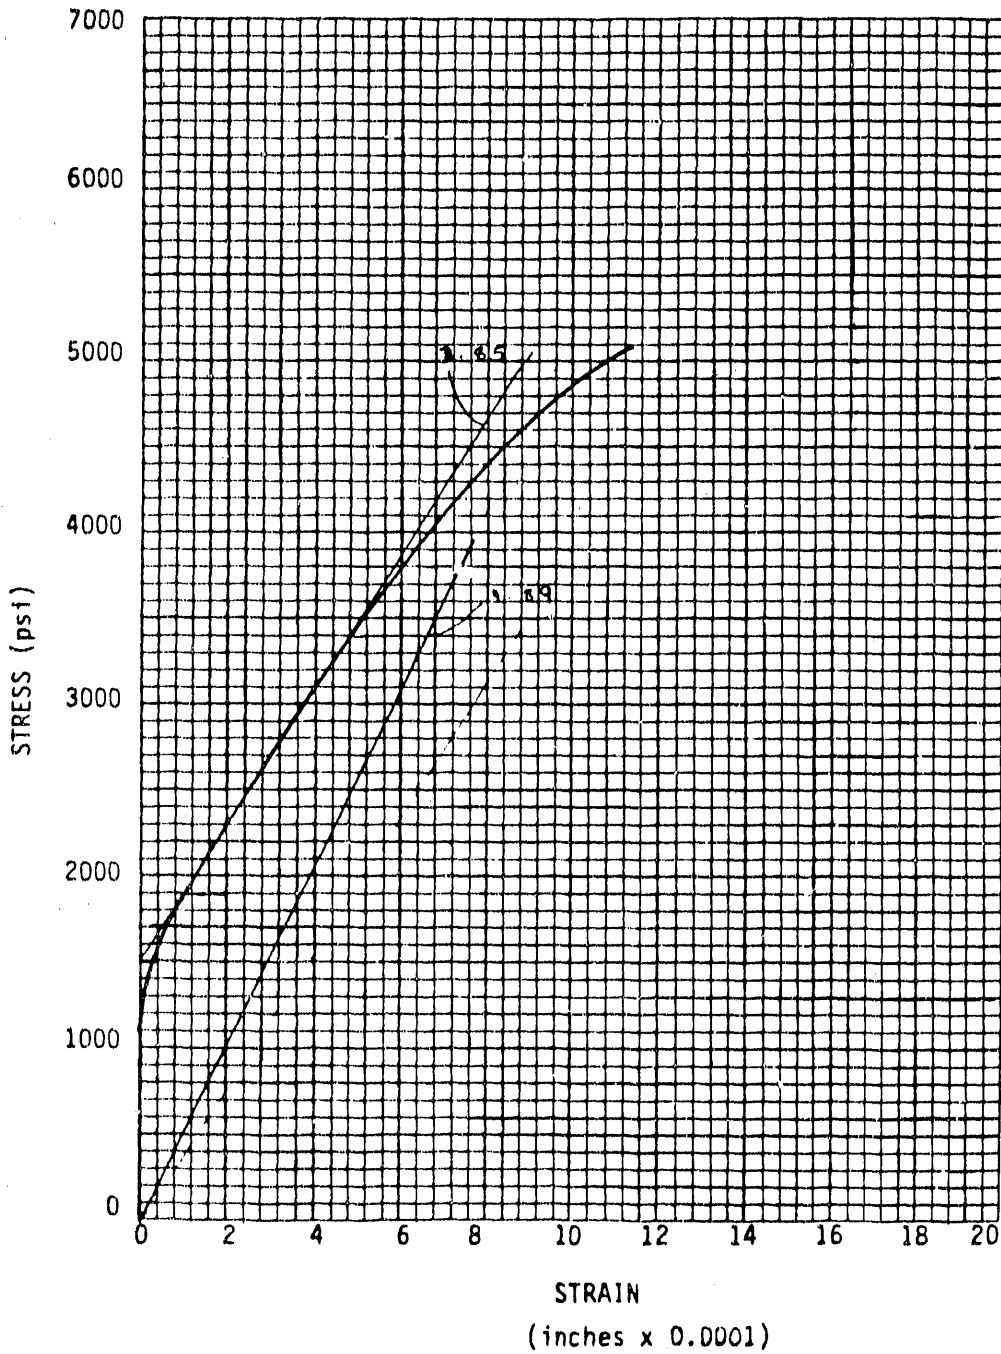
TRG #5
 Truck No. 1
 Cylinder No. 6

$E = 4.889 \times 10^6$
 Ult. Compressive Strength = 5095 psi

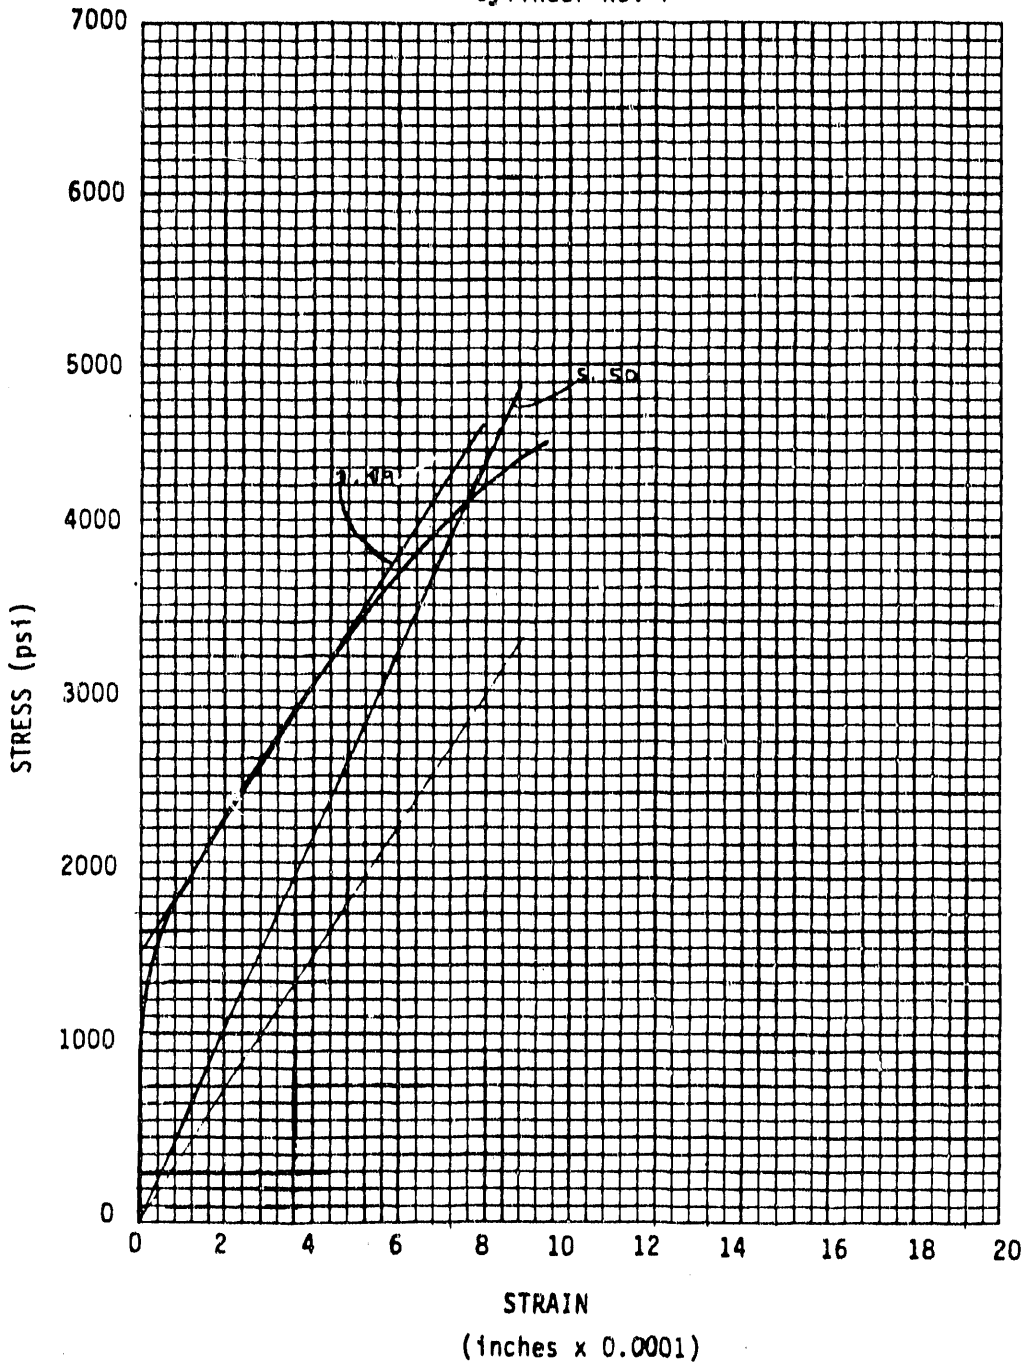
TRG #5
 Truck No. 1
 Cylinder No. 7

PROJECT NAME Concrete Testing Los Alamos Labs Los Alamos, NM	$E = 5.500 \times 10^6$	
	Ult Compressive Strength = 4720 psi	
	PROJECT NO 531-70177-1	DATE 9/26/87

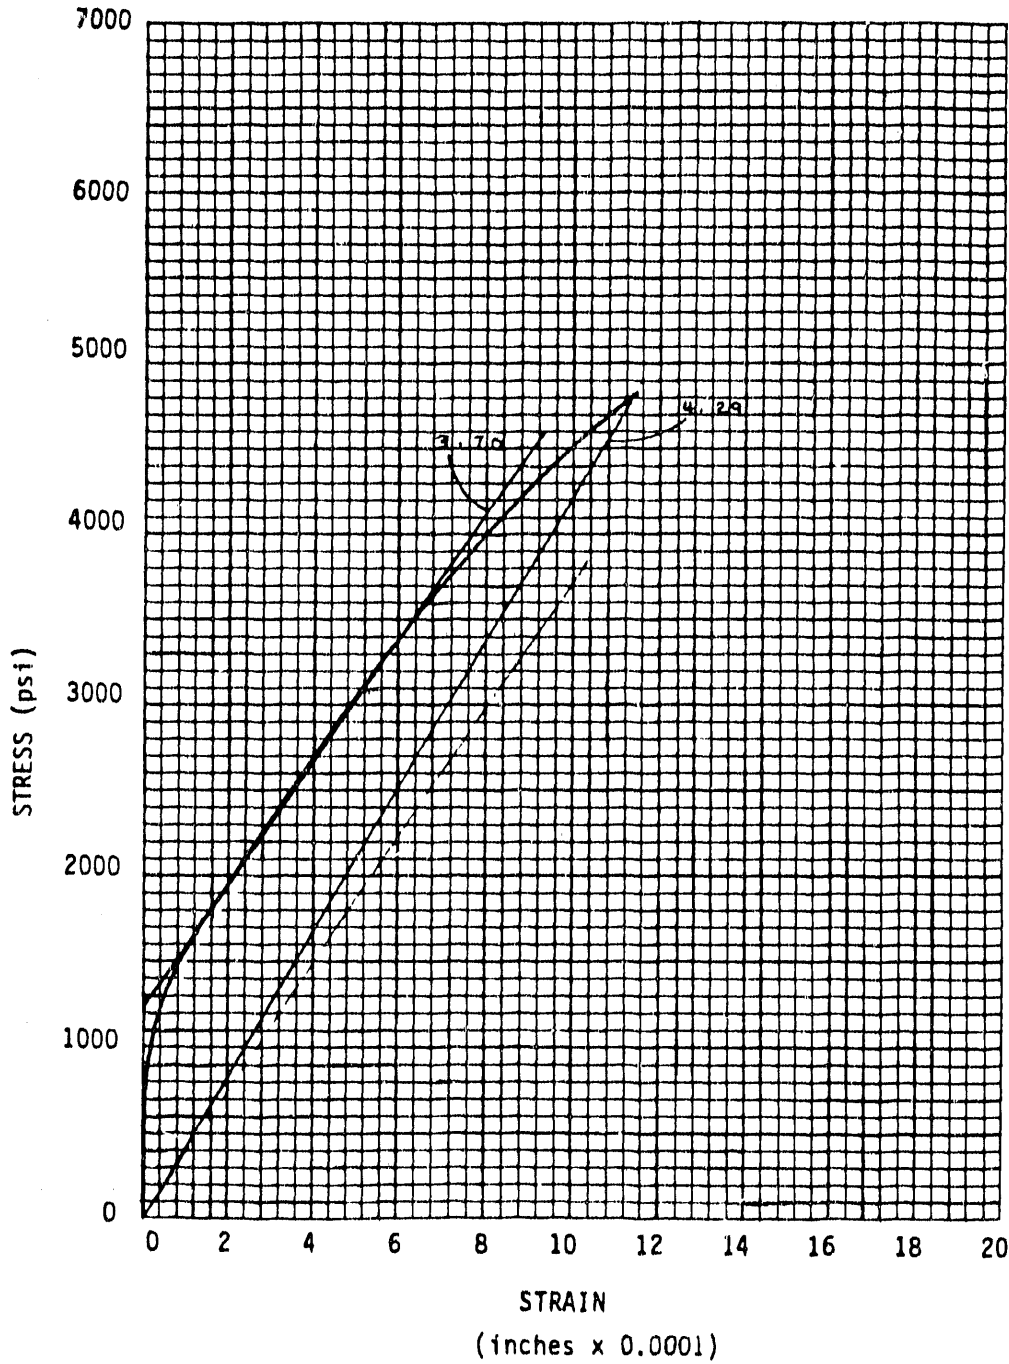
TRG #5
 Truck No.1
 Cylinder No.8

$E = 4.294 \times 10^6$
 Ult Compressive Strength = 5075 psi
