NUREG/CR-5487
LA-11739-MS
RD

Static Load Cycle Testing of a Low-Aspect-Ratio Four-Inch Wall, TRG-Type Structure TRG-5-4 (1.0, 0.56)

Prepared by
C. R. Farrar, J. G. Bennett, W. E. Dunwoody, W. E. Baker*

Prepared for
Division of Engineering
Office of Nuclear Regulatory Research
U.S. Nuclear Regulatory Commission
Washington, DC 20555
NRC FIN A7221

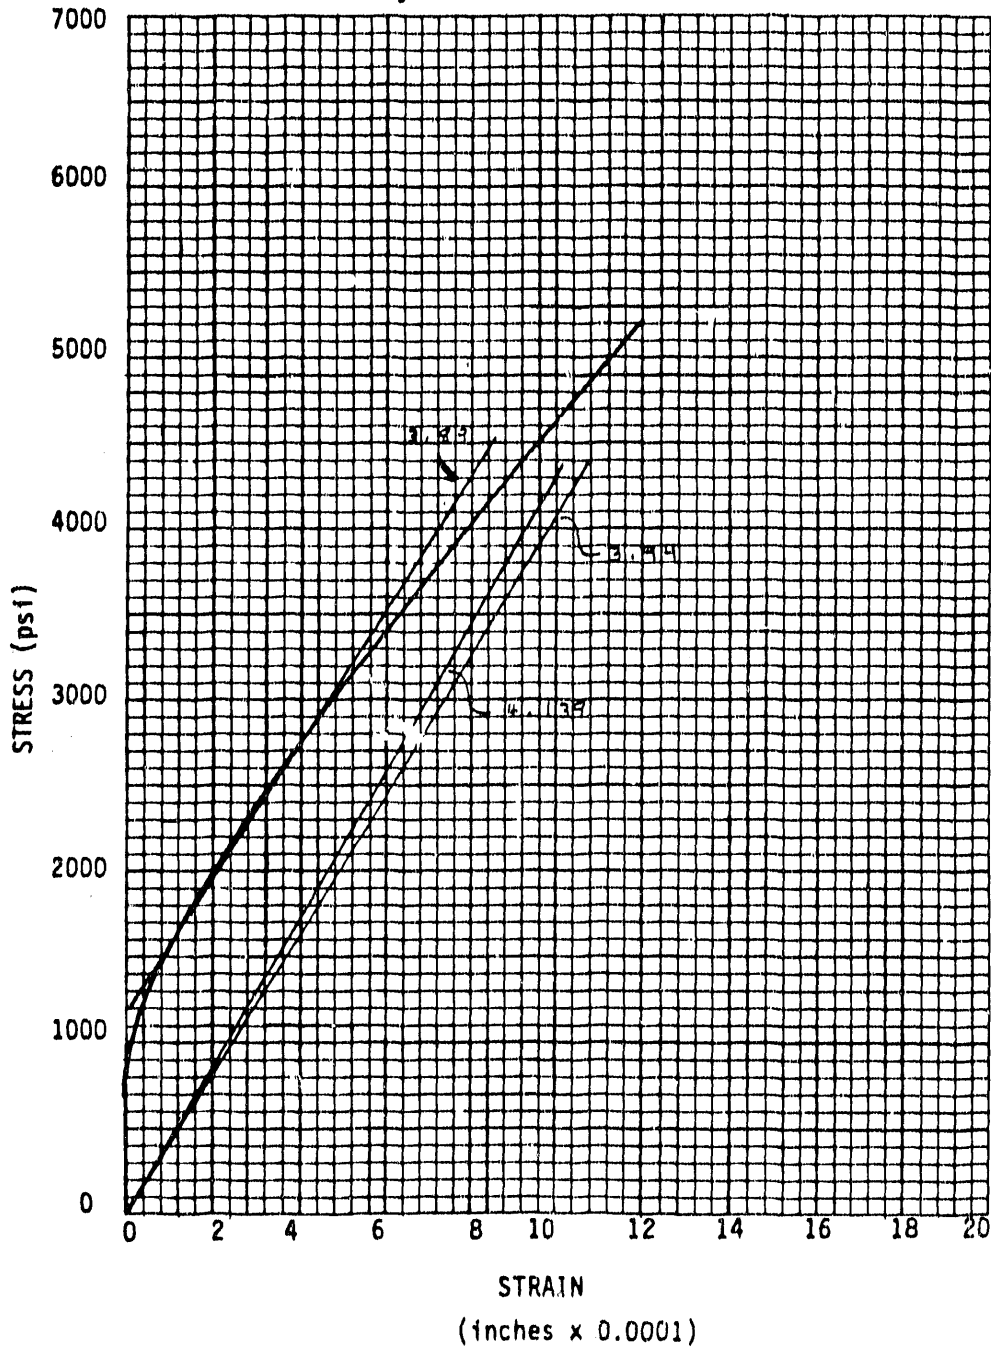
TRG #5
 Truck No.2
 Cylinder No. 1

$E = 4.139 \times 10^6$
 Ult. Compressive Strength = 5240 psi

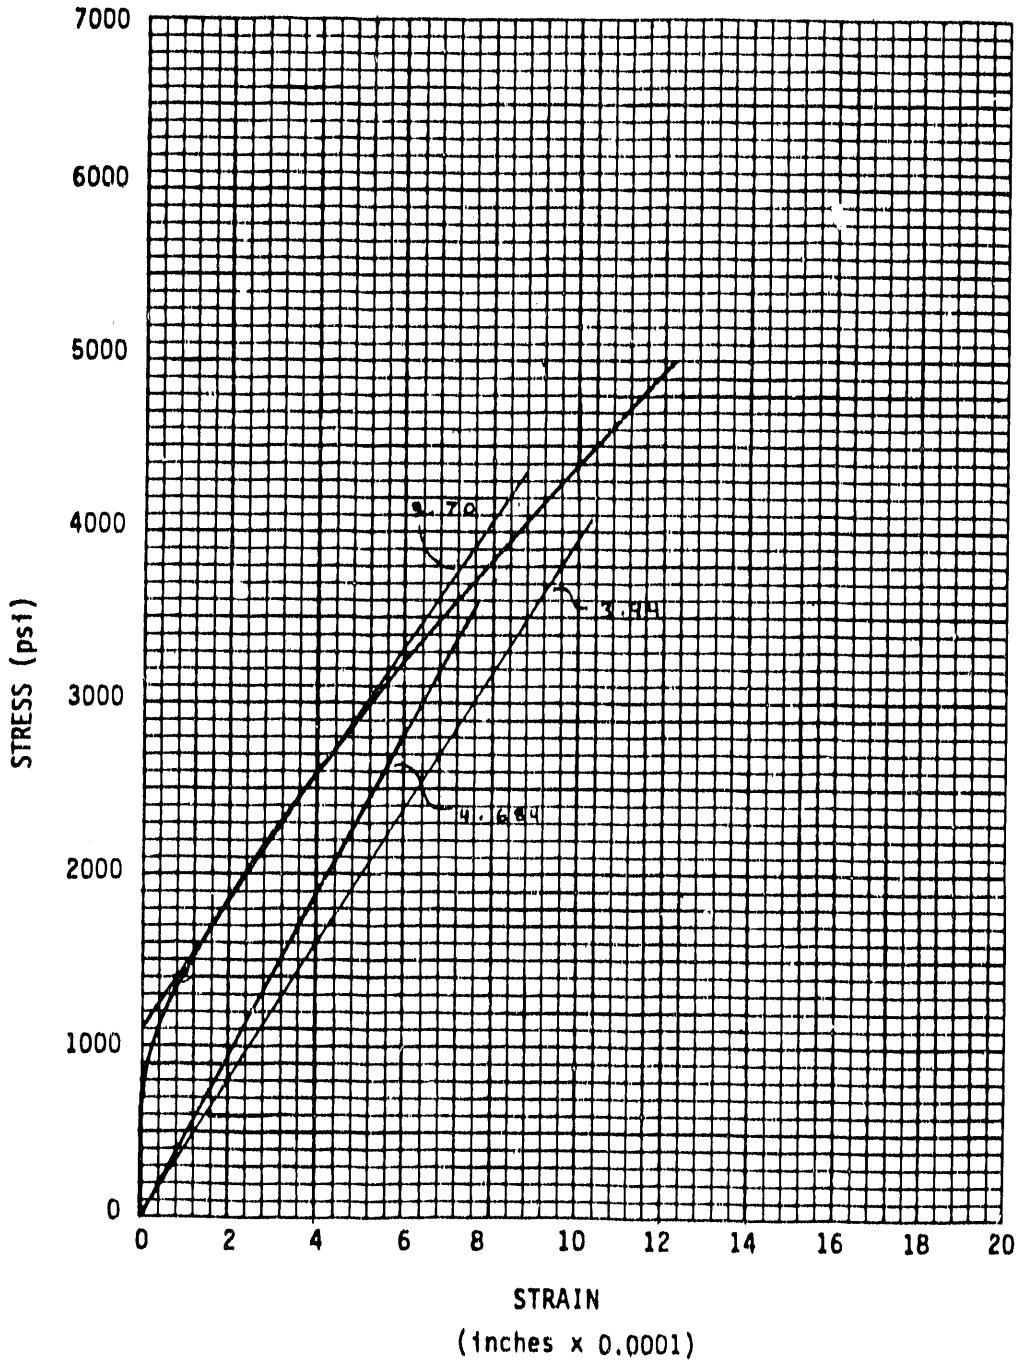
TRG #5
Truck No. 1
Cylinder No. 2

$E = 4.684 \times 10^6$
Ult. Compressive Strength = 5020 psi

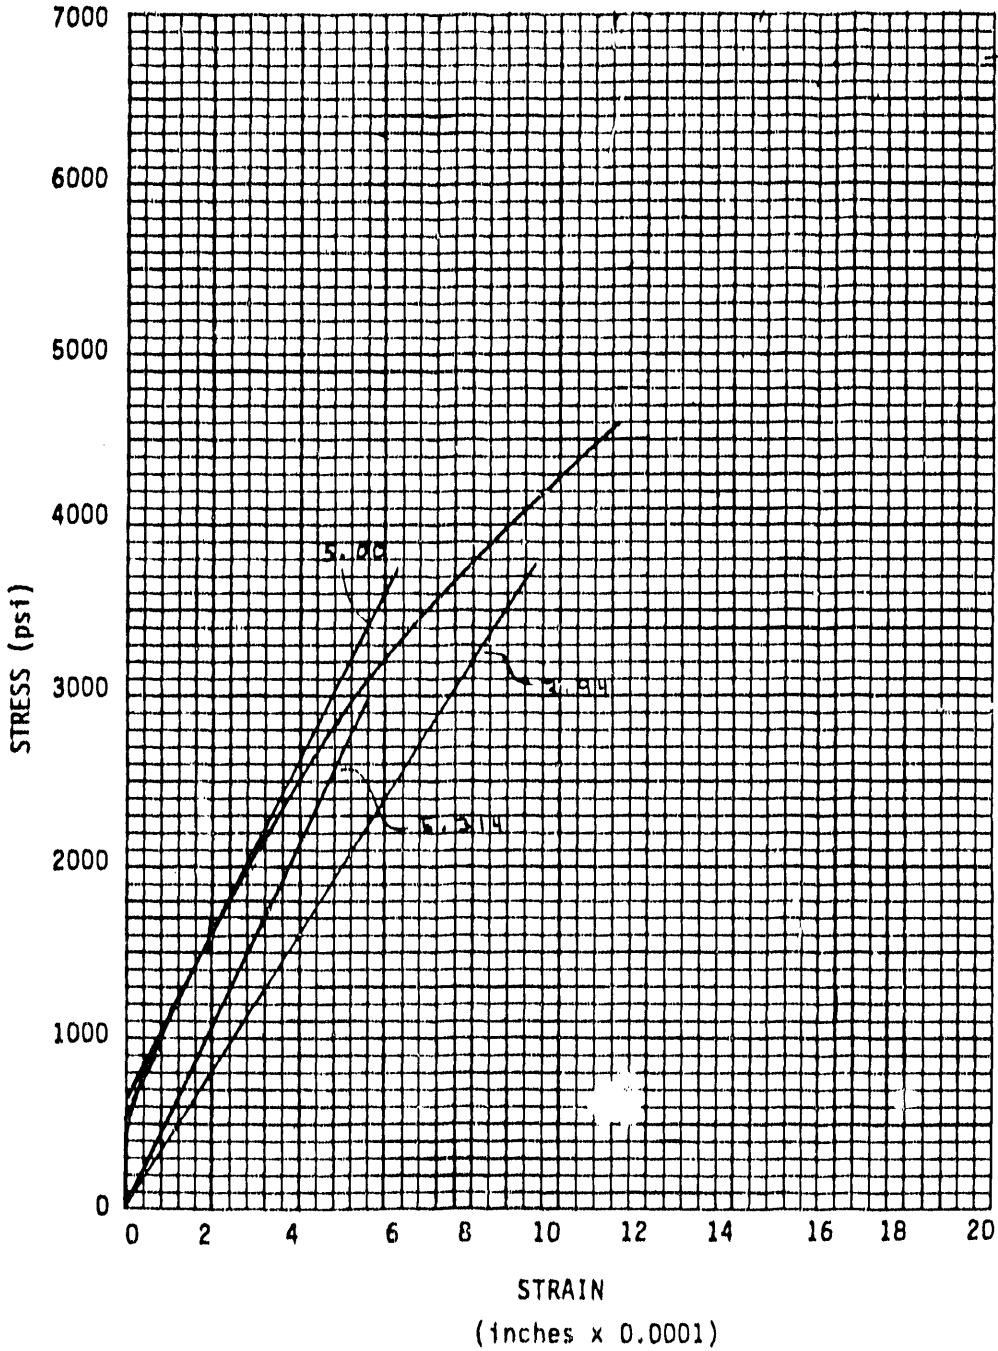
TRG #5
Truck No. 2
Cylinder No.3

$E = 5.314 \times 10^6$
Ult. Compressive Strength = 4790 psi

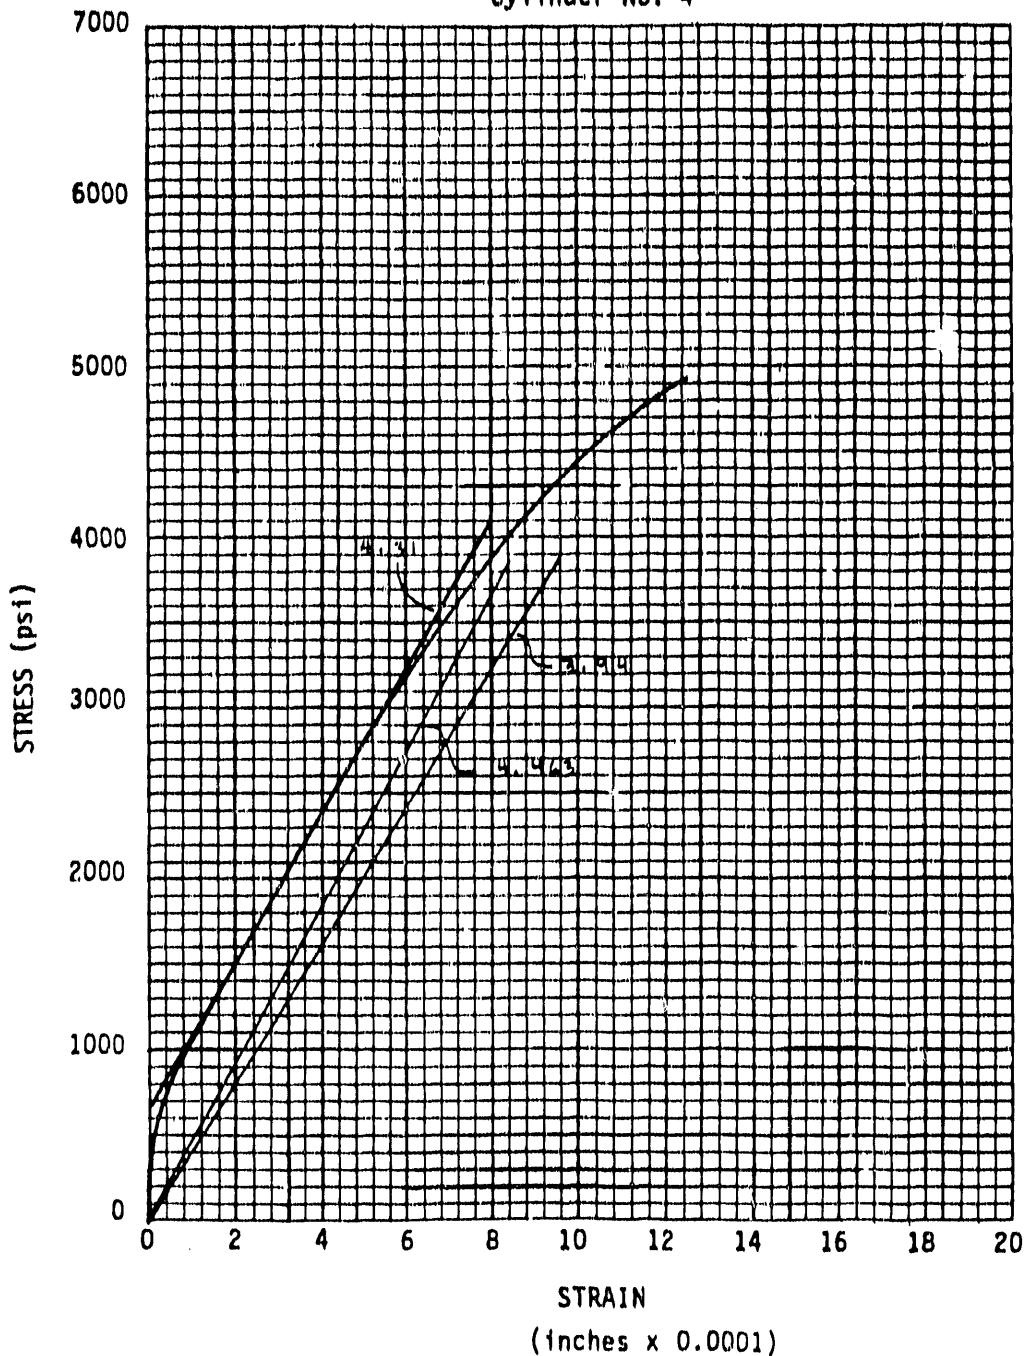
TRG #5
 Truck No.2
 Cylinder No. 4

PROJECT NAME Concrete Testing Los Alamos Labs Los Alamos, NM	$E = 4.463 \times 10^6$ Ult. Compressive Strength = 5220 psi		
	<table border="1"> <tr> <td data-bbox="839 1832 1148 1929"> PROJECT NO 531-70177-1 </td> <td data-bbox="1148 1832 1445 1929"> DATE 9/26/87 </td> </tr> </table>	PROJECT NO 531-70177-1	DATE 9/26/87
PROJECT NO 531-70177-1	DATE 9/26/87

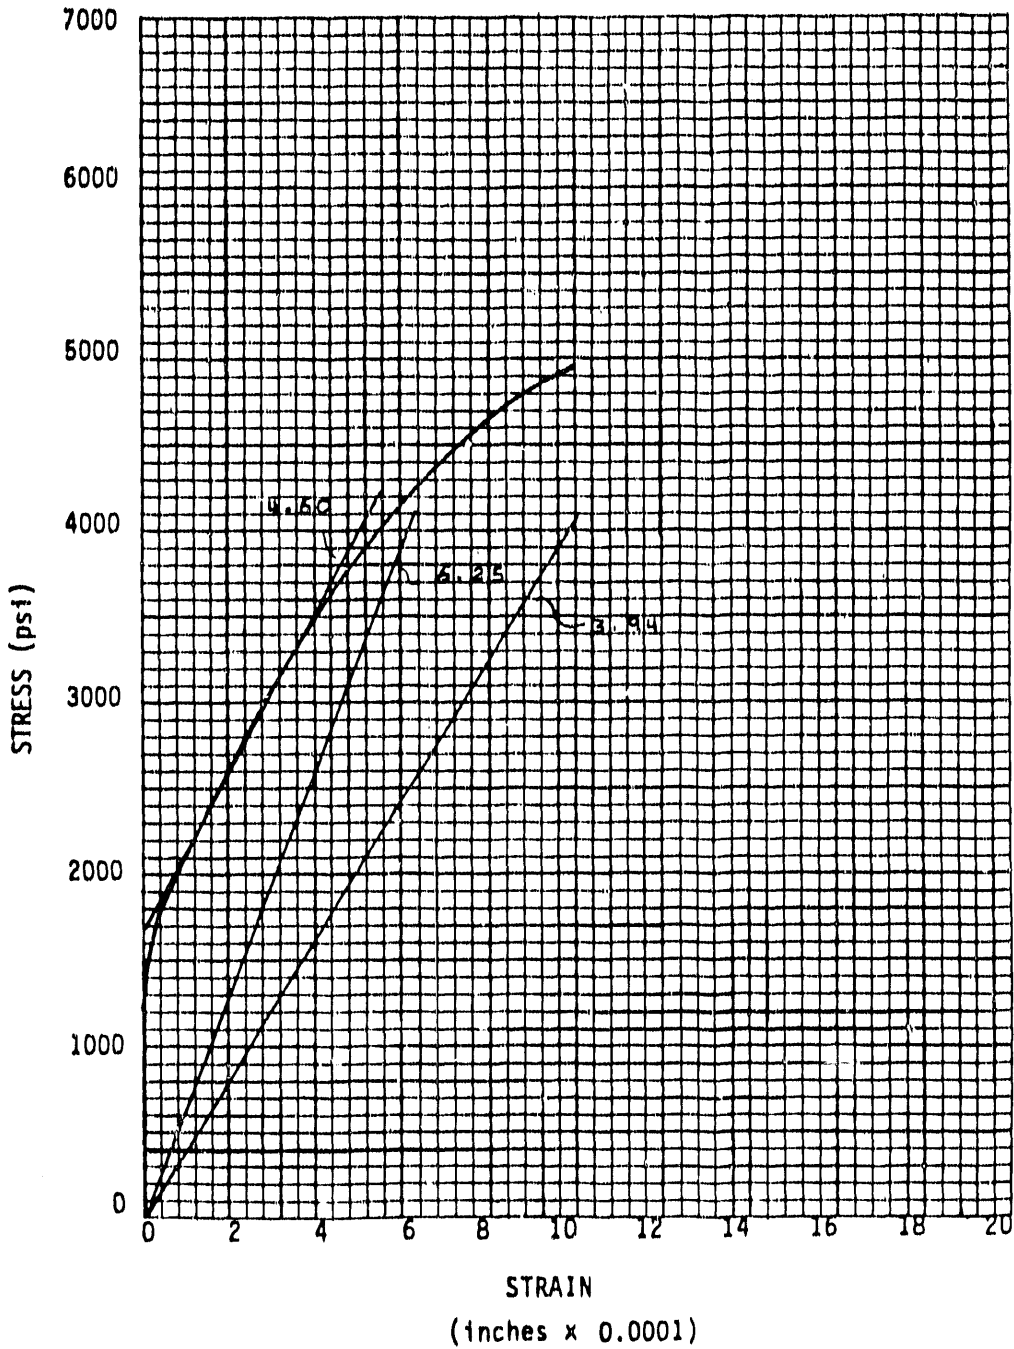
TRG #5
 Truck No. 2
 Cylinder No.6

PROJECT NAME		E = 6.250 x 10 ⁶	
Concrete Testing Los Alamos Labs Los Alamos, NM		Ult. Compressive Strength = 5130 psi	
PROJECT NO		DATE	
531-70177-1		9/26/87

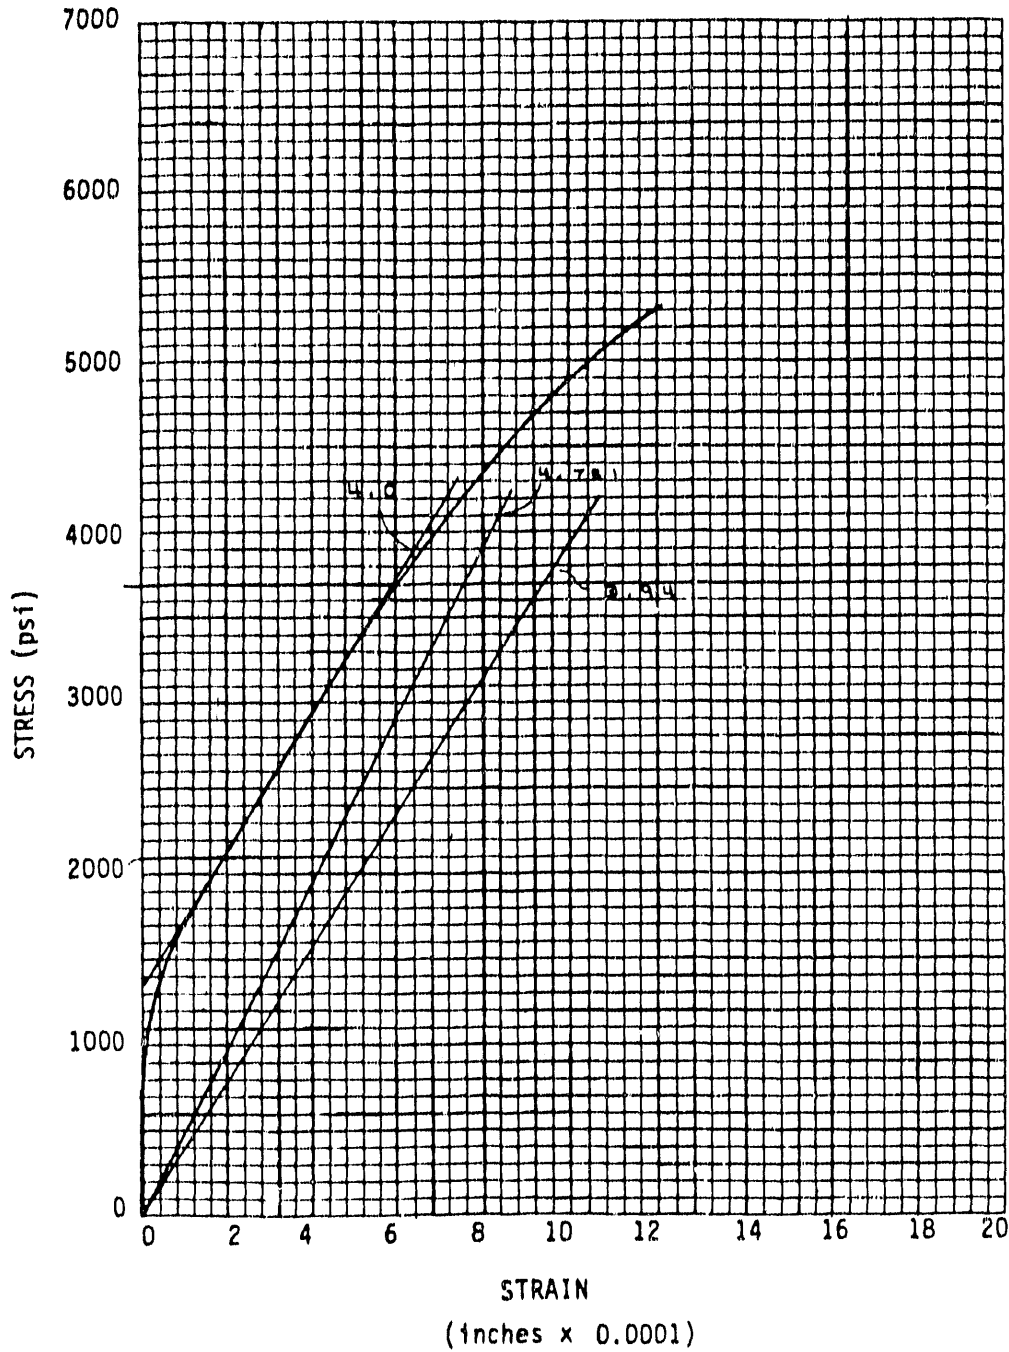
TRG #5
 Truck No. 2
 Cylinder No. 7

$E = 4.781 \times 10^6$
 Ult. Compressive Strength = 5410 psi

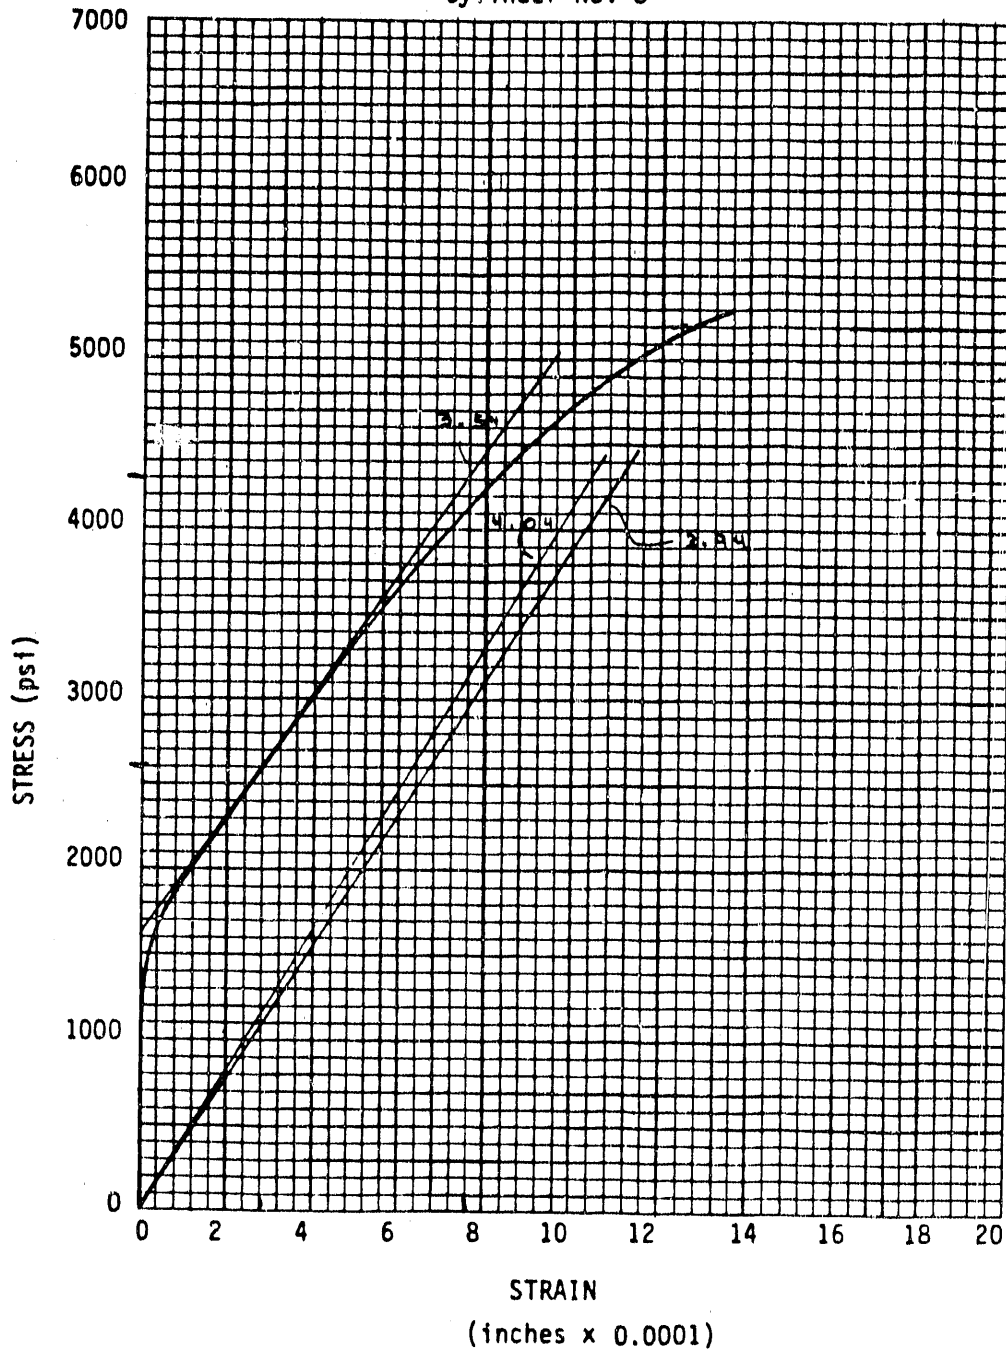
TRG #5
 Truck No. 2
 Cylinder No. 8

PROJECT NAME Concrete Testing Los Alamos Labs Los Alamos, NM	E = 4.045 x 10 ⁶	
	Ult. Compressive Strenght = 5360 psi	
PROJECT NO 531-70177-1	DATE 9/26/87

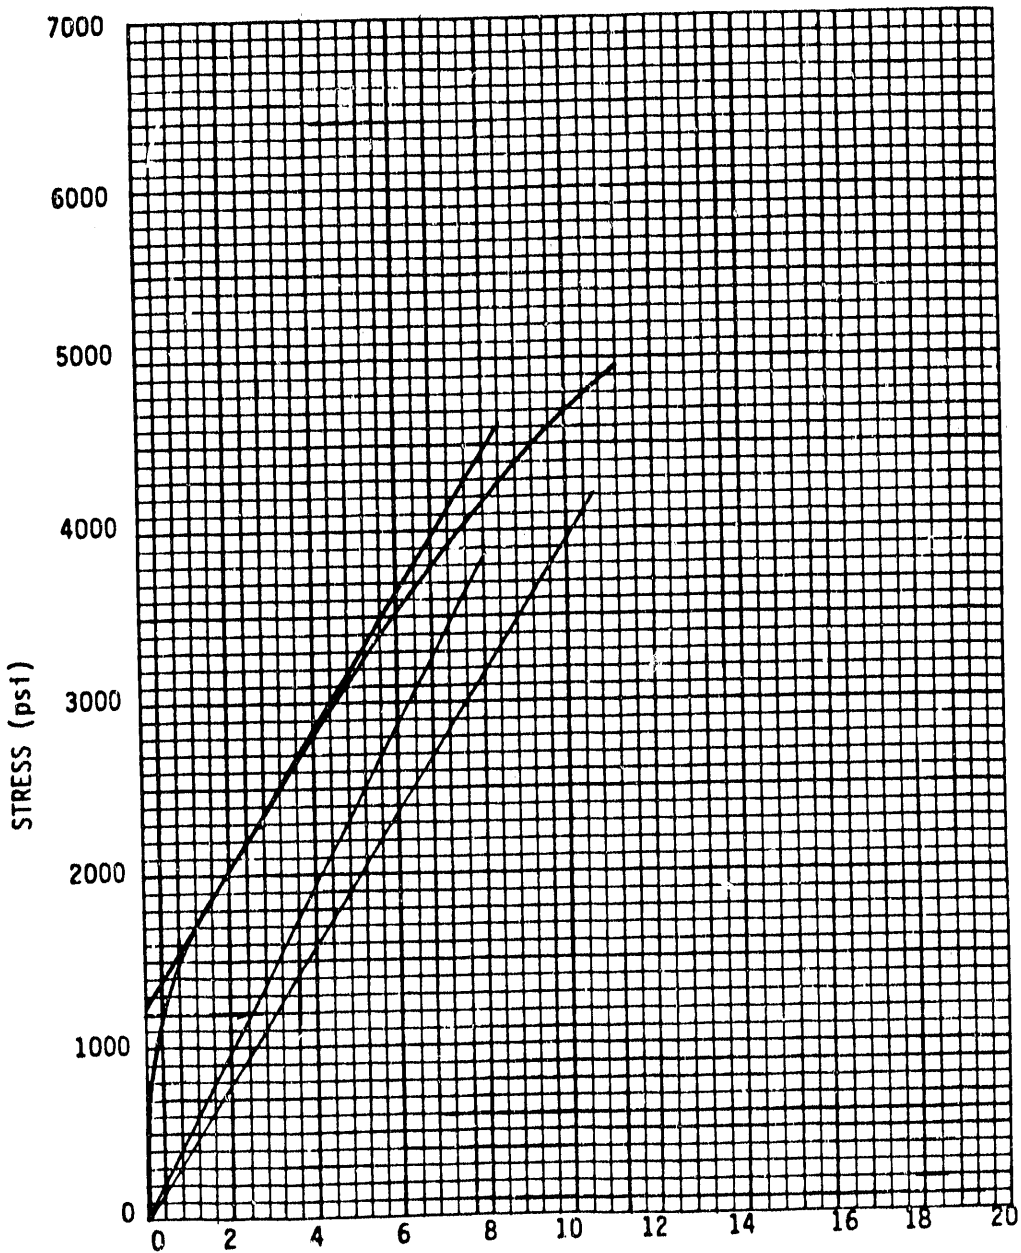
TRG #5
 Truck No. 2
 Average *

* Note: Average of Stress & Strain Readings
 Unit Wt.: 142.8 pcf
