## **Fracturing of Simulated High-Level Waste Glass in Canisters**

**R. D. Peters  
S. C. Slate**

**September 1981**

**Pacific Northwest Laboratory  
Operated for the U.S. Department of Energy  
by Battelle Memorial Institute**

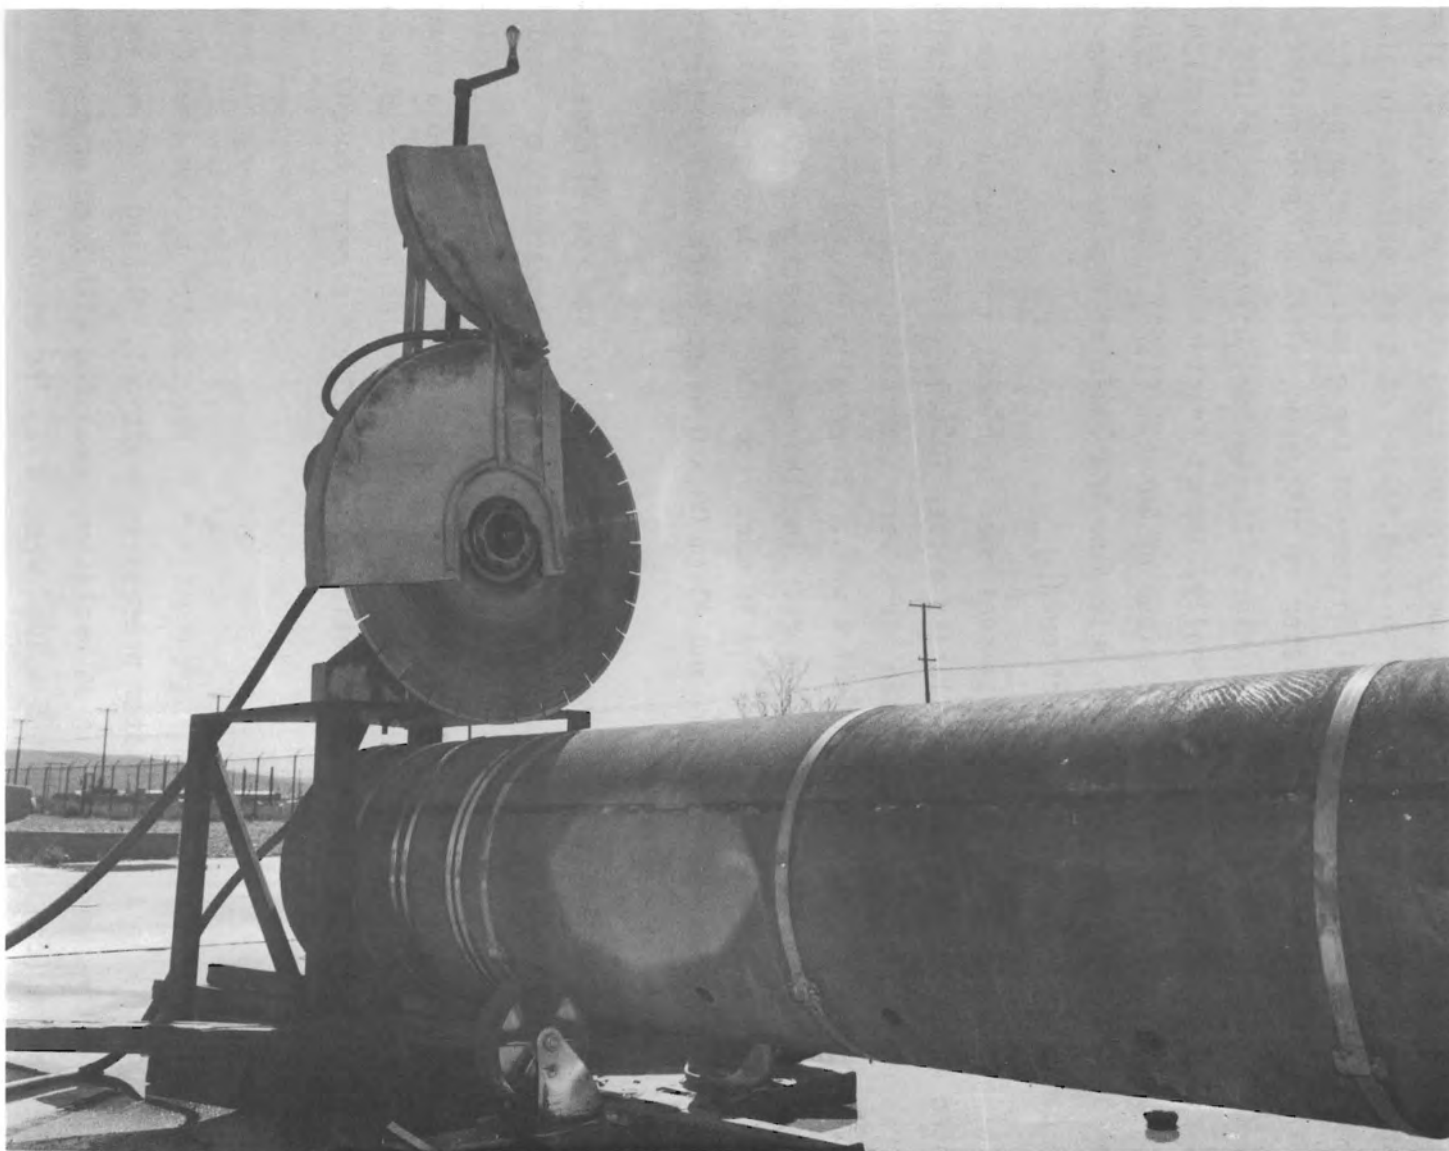
FIGURE 1. Radial Cross-Sectioning Arrangement for Full-Scale Canisters

The principal method of canister examination was to saw radial cross-sections with commercial concrete-cutting equipment. A subcontractor performed canister sectioning with 90-cm-dia diamond-impregnated blades. Figure 1 illustrates the arrangement for cutting the 60-cm-dia canisters (a 40-cm-dia canister is being cut here). To reduce blade wear, a 2.5-cm-wide metal strip around the canister perimeter at the cut location was removed via air-arc torch.

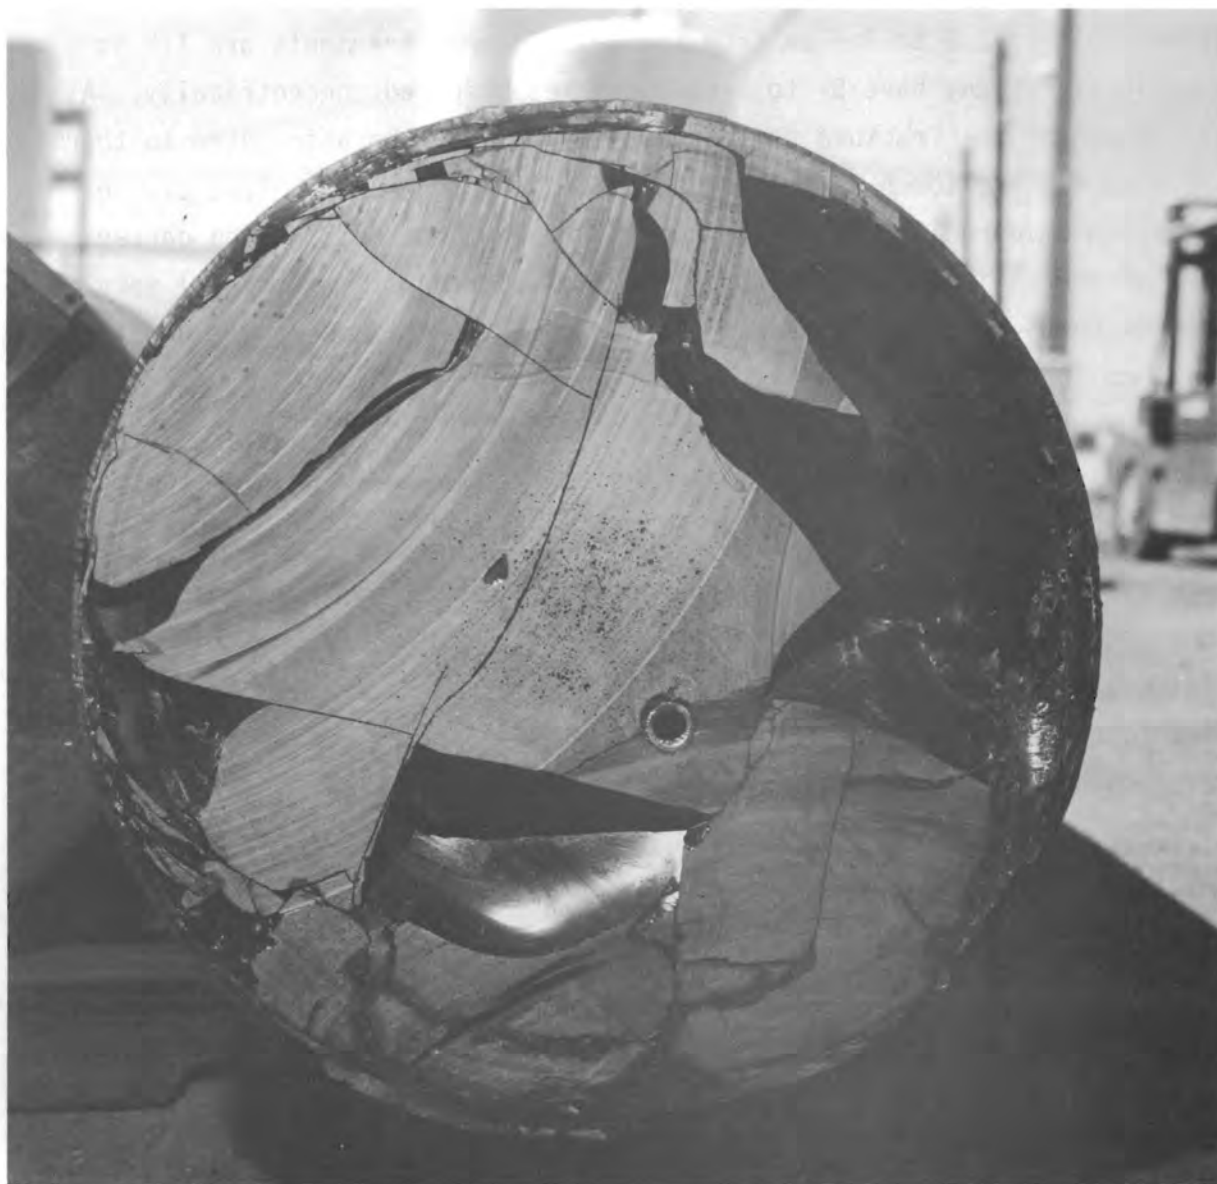
FIGURE 5. Sixty-Centimeter-Diameter Cross Section of Canister 144, 60 cm from Bottom

Figure 5 shows the result of fairly slow cooling (Canister 144). Temperature gradients are greatly reduced when the canister is wrapped with 2.5-cm insulation, in addition to being placed in the enclosure as seen in Figure 6. The damage is much reduced compared to that of Canister 200 (Figure 3), which was cooled about twice as fast. The cross section in Figure 5 is characterized by large fragments that have edges of 10 to 20 cm. Glass fragments 5 to 15 cm in size fell away from this cross-section plane, leaving depressions. Fracturing is generally more severe near the wall, but in a few locations a large fragment borders with the metal canister. The slow cooling apparently caused some crystallization in the glass since brown discoloration is visible, especially near the wall. Crystals evidently nucleated on the iron oxide coating of the carbon steel canister. Westsik et al. (1979) have shown that devitrification has a minimal effect on glass leaching.

Fracturing in this canister is fundamentally different than that in canisters without fins. Cracks seem much more randomly oriented compared to cracks in the cross-section in Figures 3 or 5. More fracturing occurs near

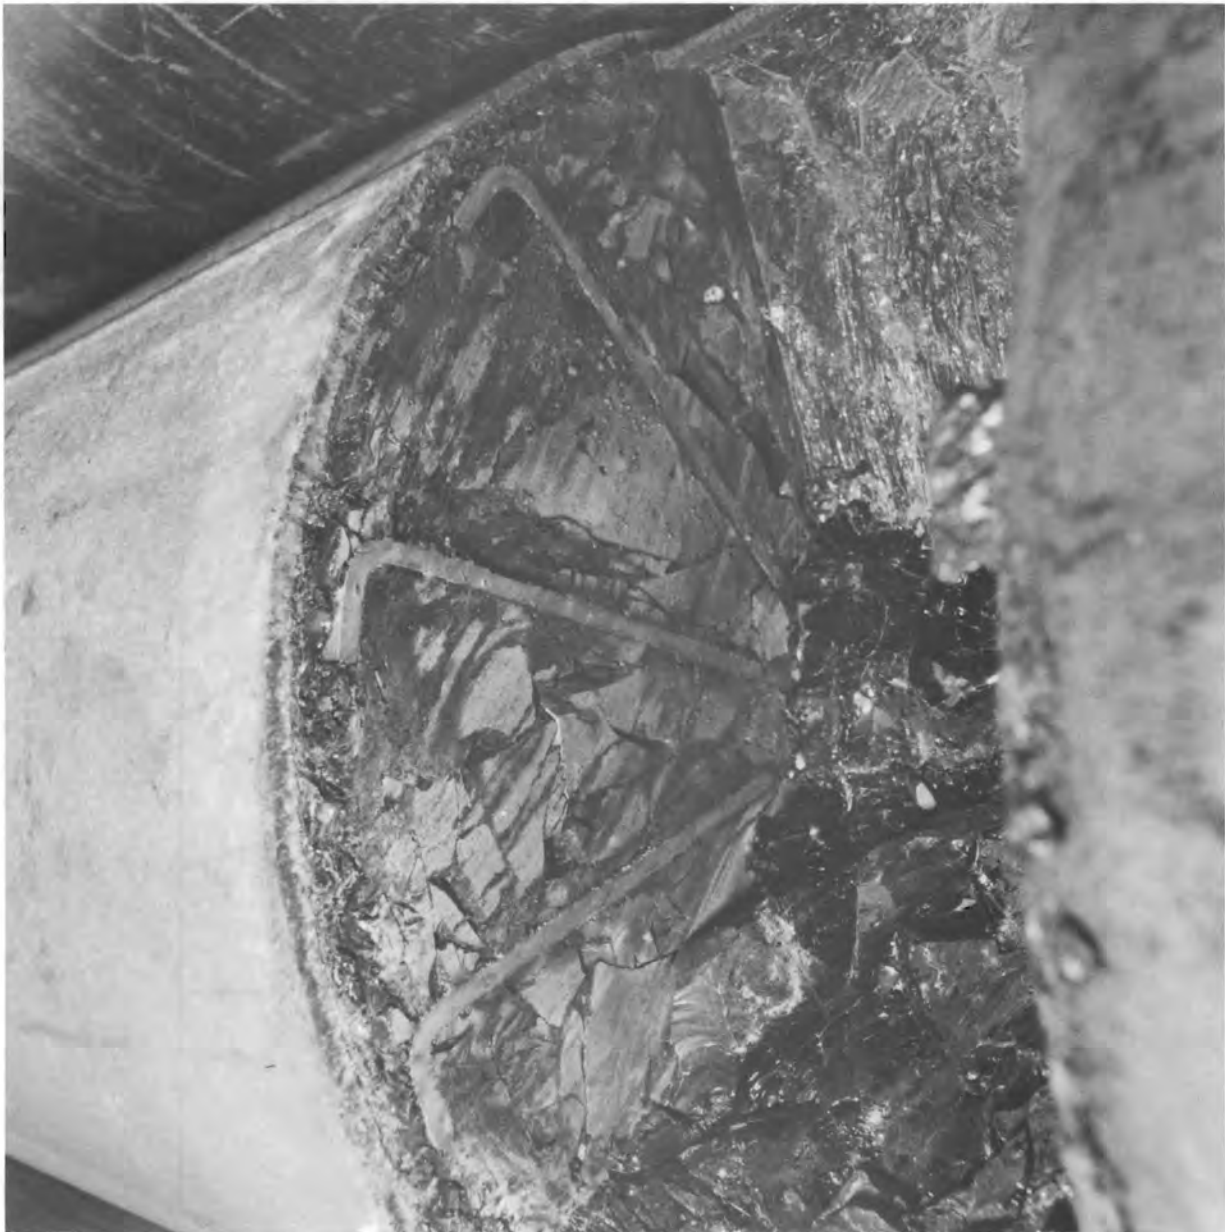
FIGURE 7. Partial Section of Canister 150 (60 cm dia) with Ten Internal Fins, 130 cm from Bottom

Because of difficulties encountered when sawing through steel fins, only a partial cross section is available for finned Canister 150 (see Figure 7). The use of internal carbon-steel fins was effective in reducing gradients in Canister 150, as Figure 8 shows. Gradients near the wall were steep because

the fins extended only up to about 2.5 cm from the wall as Figure 7 shows. Profiles through the bulk of the radius are quite similar to those of Canister 144, which took 90 h to cool (the finned canister only took 35 h to cool).

the outside wall, which can be largely attributed to a fairly sharp temperature drop through this region (see Figure 8). The gradients 5 to 8 cm from the wall are fairly flat and are similar to gradients found 5 to 10 cm from the center of Canister 200, as Figure 4 shows. However, the fracturing is much more extensive at this wall location in Canister 150 than at the center of Canister 200. Thus, in addition to thermal stresses, interaction between carbon steel and glass, which have different thermal expansion coefficients, probably accounts for fracturing. Cracks run parallel to the fins, particularly to the middle fin in Figure 7, which may have been caused by shearing of the glass. Glass is well bonded to the fins, as the right side of the figure shows. Here an exposed fin is covered with adhered glass. A major difference between this radial section and those of canisters without fins is the tight compression of fragments that occurs in this canister. Sawing did not vibrate any fragments and widen the cracks as occurred in the canisters without fins. Also few, if any, fragments could be extracted from the cross-section, whereas in other canisters many fragments tended to fall out. Apparently, fins compress against the glass and offer structural support.

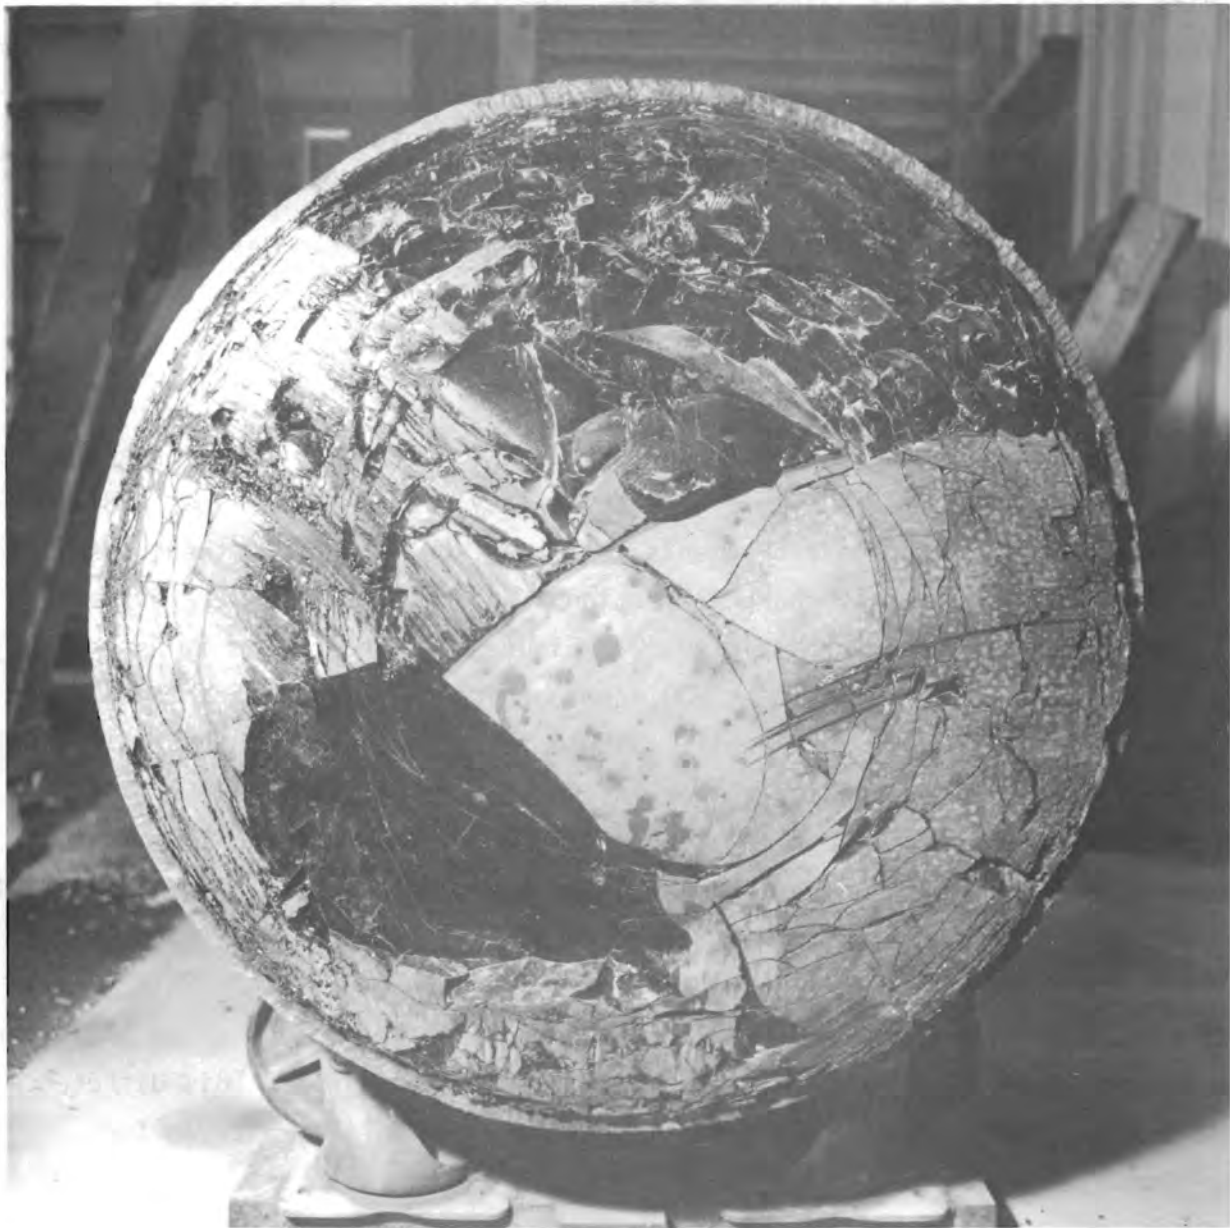
FIGURE 10. Partial Section of Canister ICM-7 (60 cm dia), 60 cm from Bottom

The radial cross-section of Canister ICM-7, produced at the Savannah River Laboratory (SRL) TNX development facility, is shown in Figure 10. During inspection, many loose fragments fell away, but enough of the cross-section remains intact to permit characterization. Some similarities are evident between this canister and Canister 200 (Figure 3). The center is essentially intact, and similar to Canister 200, concentrically oriented fragments prevail from about mid-radius to the wall. Within about the last inch up to the canister wall, fracturing becomes rather extensive, and cracks are less than 0.32 cm apart. This type of fracture is inherently different than the type found in the CM canisters where much larger fragments are observed. It is likely that the thermal expansion mismatch between the stainless steel and glass caused shear stresses and thus fractured the glass. During cooldown, shear forces due to resistance to movement of the canister relative to the glass are determined by their difference in thermal expansion coefficient. This difference is  $8.2 \times 10^{-6}/^{\circ}\text{C}$  between 304L stainless steel and TDS-411, whereas for carbon steel, the difference is only  $3.1 \times 10^{-6}/^{\circ}\text{C}$ . Also, stainless steel bonds to glass much more aggressively than does carbon steel, probably due to the absence of a thick oxide layer on stainless steel. Furthermore, ICM canisters are subjected to higher temperatures (1050 to 1100°C) than CM cans, which increases enameling of glass to the canister wall.

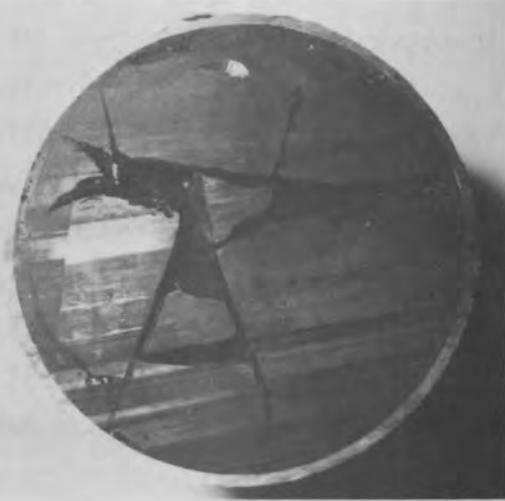
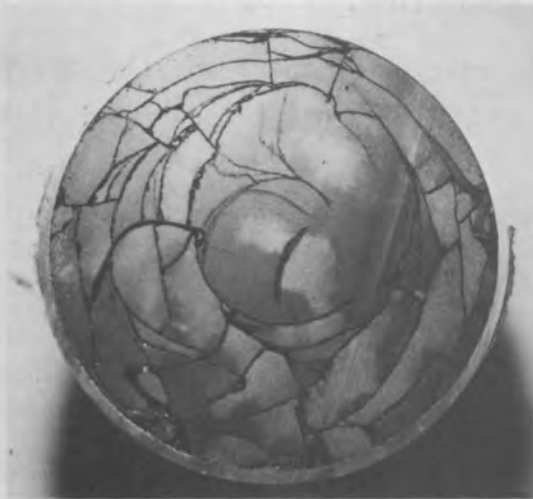
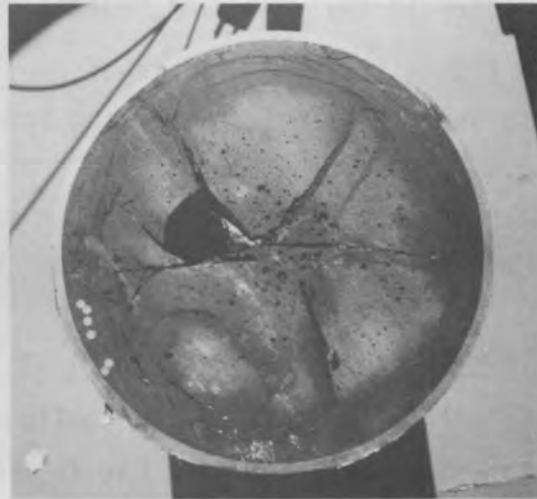
FIGURE 14A-D. Cross Sections of Bench-Scale, 17-cm-dia Canisters

Canister 1 (Figure 14A) was filled and cooled with 5 cm of ceramic fiber insulation (conductivity,  $5 \times 10^{-4}$  W/cm<sup>0</sup>K) around the cooling pod. The centerline temperature was 100<sup>0</sup>C after 40 h. This was the slowest cooldown performed during the bench-scale tests. Except for some gouges caused by

a) SLOW COOLING--40 h

b) INTERMEDIATE COOLING RATE--28 h

c) RAPID COOLING--7 h

d) MULTISTAGED COOLING--15 h

aggressive cutting, the cross section of this canister is nearly crack-free. Canister 2 (Figure 14B) cooled in 28 h with 2.5 cm of kaowool insulation and was clearly damaged from cracks.
