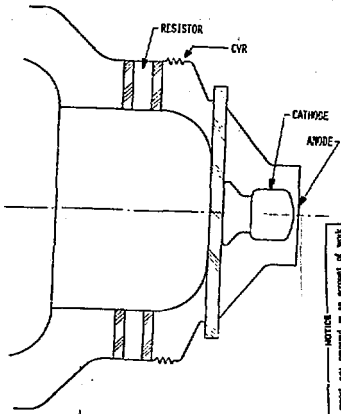
Fig. 1. Diagram of the RTF-I diode.

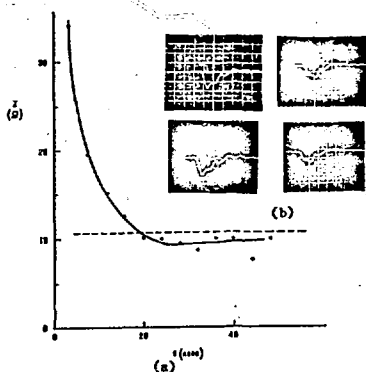
Fig. 2. a. Impedance waveform 17,000 shot run.
b. Voltage (left, 160 kV/div.) and current (right, 8 kA/div.), 20 ns/div.

Figure 2a shows data from a 17,000 shot run at 500 kV on the RTF-I PFL. A 3.5 cm diameter cathode with cross hatching to provide some field enhancement was found to produce a reasonably uniform beam. Figure 3

shows this type of cathode. Although it does not produce the perfectly uniform cylindrical beam which is the basis for the space charge limited flow equation 1, the overall impedance follows that equation well as illustrated by the horizontal dashed line on the experimental waveform in Fig. 2a. After the diode turn on phase (the falling impedance region) the diode impedance curve flattens out near the theoretical value. This impedance waveform was calculated from the current and voltage waveforms of Fig. 2b. These were taken at a repetition rate of 20 Hz, each trace being a composite of approximately 10 shots. The shot-to-shot stability of RTF-I and its diode is apparent. In addition, since the two sets of traces were taken approximately 5000 shots apart, their similarity indicates a long term stability.

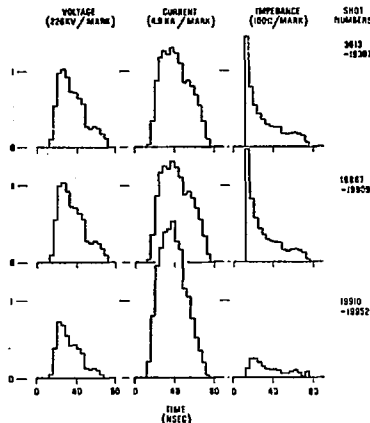
Fig. 4. Computer waveforms from 20,000 shot run.

anode opposite the heavily damaged region. These were observed to have occurred halfway through the run. This lattice mirrors the cathode cross hatching and indicates the formation of beamlets at the corners of the cathode structure. These beamlets do not diverge significantly in crossing the A-K gap as the damage spots are small compared to that spacing. The outer beamlets are bent inward by the self-magnetic field of the total electron beam and penetrate into the anode at their angle of incidence which is approximately 35° to the normal. This is illustrated by the needle mounted in one of the beamlet holes in Fig. 3. These beamlets result in a nonuniform loading of the anode which explains its rapid destruction. Nevertheless, as the anode material is being deposited throughout the diode, the operating characteristics are remaining relatively unchanged. A series of data points stretching over the entire run are shown in Fig. 4. Note that voltage, current, and impedance remain stable until virtually the end of the run at which point the diode shorts. The first triplet of waveforms show the voltage, current, and impedance for most of the run. The middle set shows the last 43 stable events. The 43 events of the lowest 3 traces indicate a nearly short circuit condition. The run was stopped manually 3 shots later, the final 3 shots being completely short circuited. Clearly the diode remains stable prior to its catastrophic failure. Because the lowest three waveforms are an average over 43 events, it is possible that the waveforms remain stable until the anode ruptures destroying the vacuum and that these waveforms deviate from the norm because they average good shots with short circuit events.

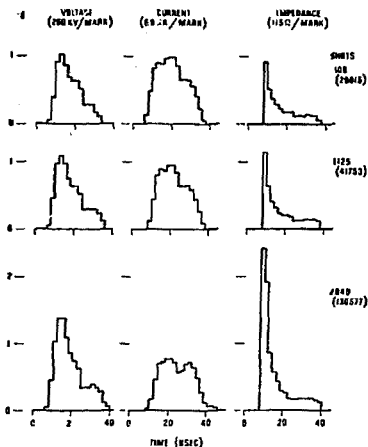
Fig. 6. Online waveforms from 157,000 shot run.

That diode parameters do change during the course of so long a run is illustrated in Fig. 6. Voltage, current, and impedance waveforms are presented which are averaged over the number of shots given in the figure. These are online data, consequently, it is impossible to determine which shots were analyzed. The number in parenthesis is the last shot of the analyzed data. The upper and middle triplets of waveforms are separated by 15,700 shots, an interval similar to the total interval of Fig. 4. They illustrate the diode's stability over a run of this duration. The repetition rate in this case was 20 Hz.

Going to the third triplet of waveforms 89,000 shots later, the initial voltage spike, during which the pulse from the RTF-I PFL reflects from a poorly emitting cathode, becomes larger, indicating that the cathode plasma is becoming increasingly harder to form. The flat portion of the voltage pulse disappears and a large current appears late in time. This current is due to the voltage reflected from the diode early in time which re-reflects from the transformer end of the RTF-I PFL and upon returning to the diode finds the emitting cathode plasma well formed. The impedance at the end of the pulse remains a constant 16Ω . As the cathode ages, most of the PFL energy still goes to form beam but later in time than was the case before cathode aging.
