# Evaluation of Concrete and Related Materials for Desalination Plants Second Annual Progress Report

By United States Department of the Interior, Bureau of Reclamation, Denver, Colorado, for the Office of Saline Water, J.A. Hunter, Director; Everett N. Sieder, Chief, Distillation Division; Paul G. Tomalin, Project Engineer

USBR-OSW Agreement No. 14-01-0001-544  
Work Orders No. 1 and 6

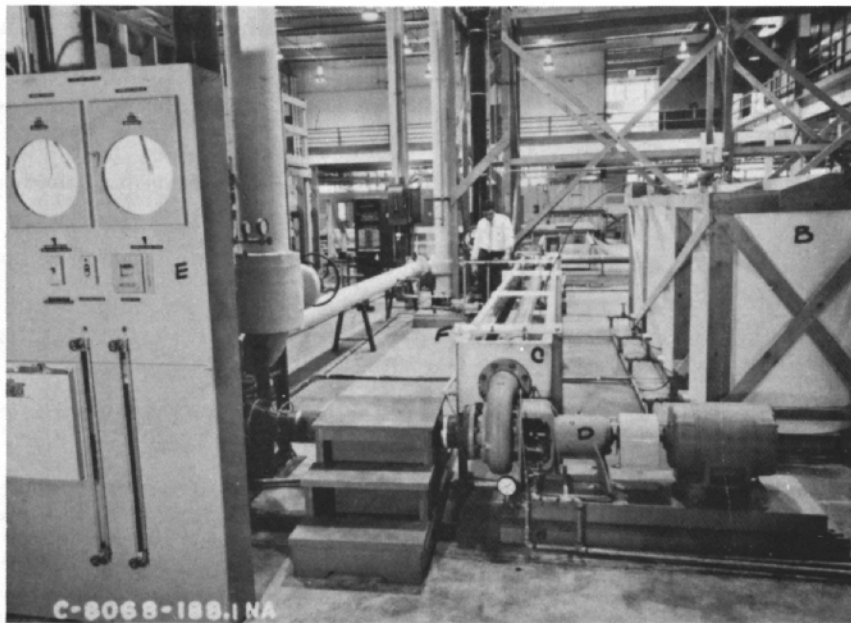
Figure III-5. Original high- and low-temperature synthetic sea water test systems.

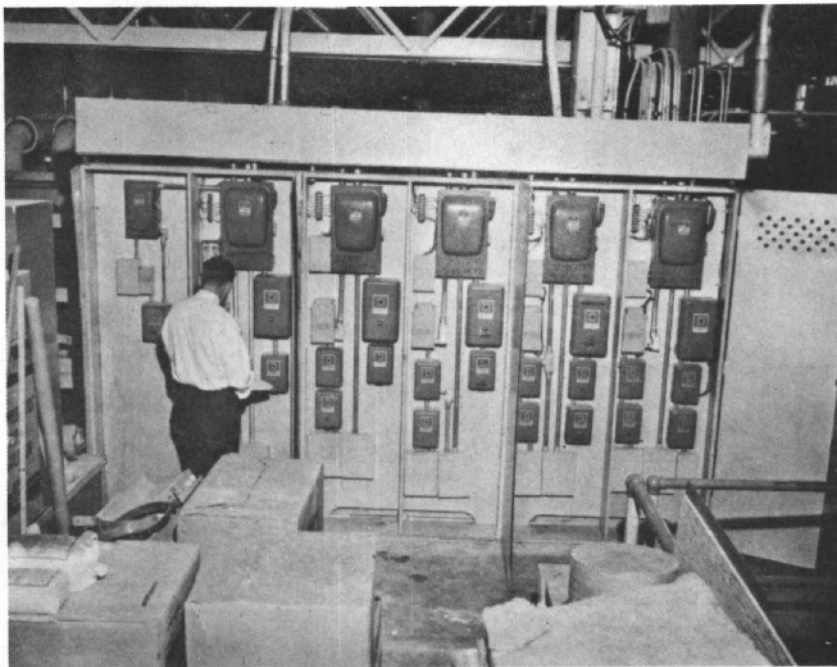
Figure III-11. View showing arrangement of contactors, relays, transformers, etc., used in operation of saline water test equipment. Photo PX-D-60855

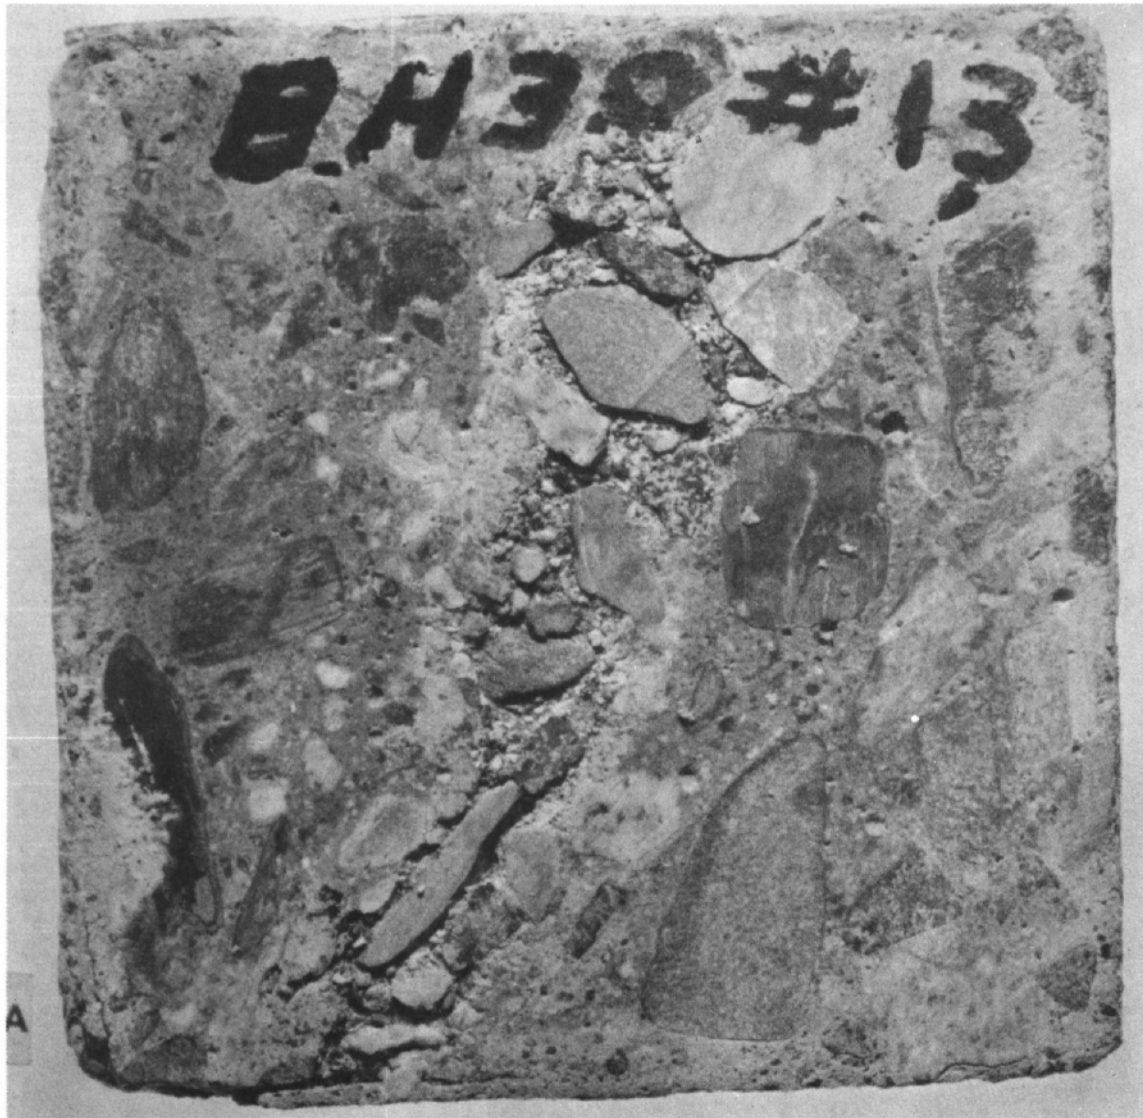
Figure III-18. Concrete containing no available free lime is still susceptible to leaching by hot distilled water. Photo PX-D-55290 NA

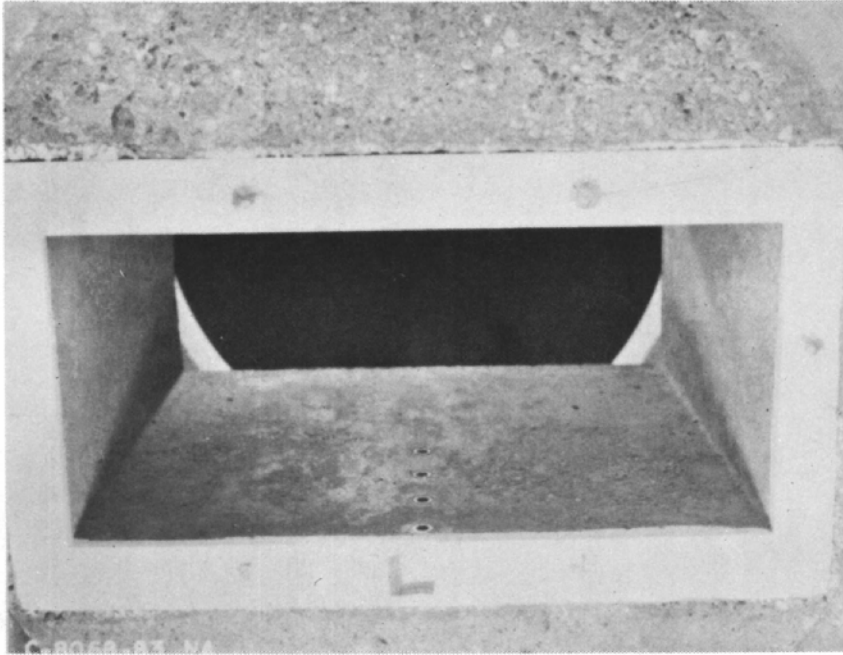
Figure III-63. Concrete orifice 4 by 9 by 8 inches prior to subjected continuous 10-feet-per-second flow of 100° F synthetic sea water. Photo PX-D-55286 NA

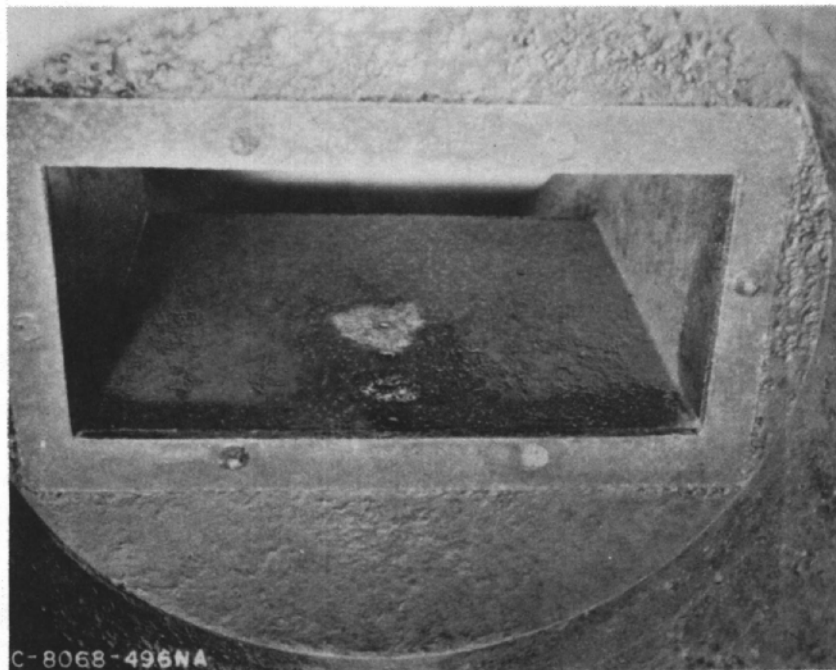
Figure III-64. Concrete orifice after 2 years' subjection to flowing 100° F synthetic sea water. Photo PX-D-60853

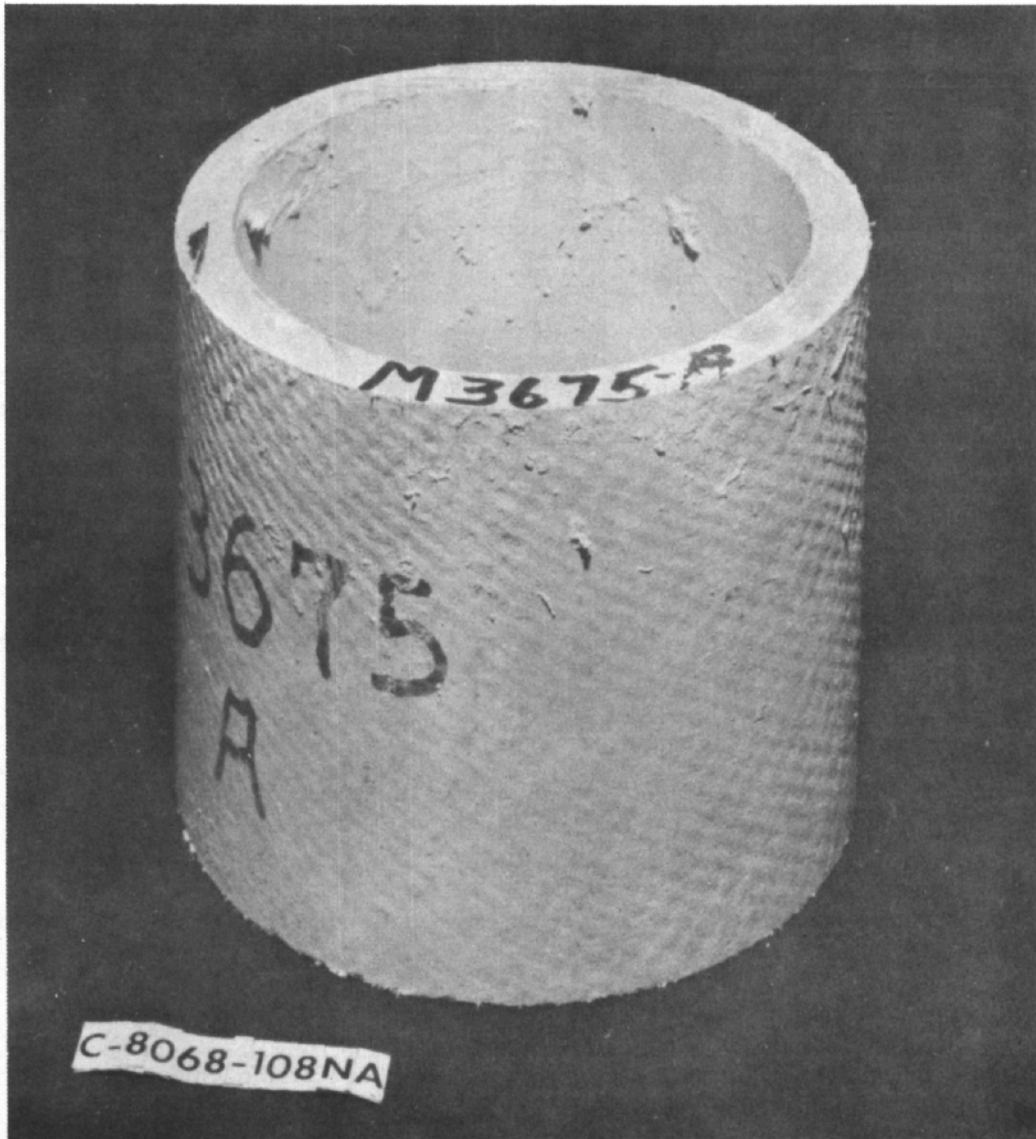
Figure III-69. Typical 8-inch-diameter section of asbestos-cement pipe as tested in the 290° F brine. Photo PX-D-55291 NA

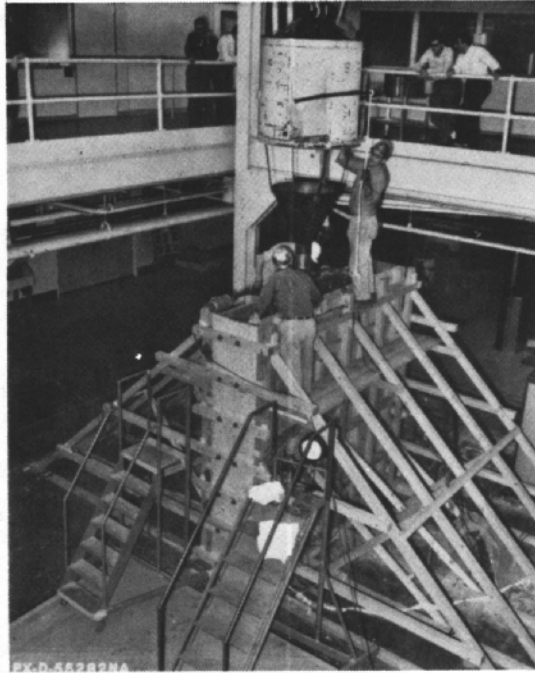
Figure IV-6. View of the forming and bracing during concrete placement.  
Photo PX-D-55282 NA

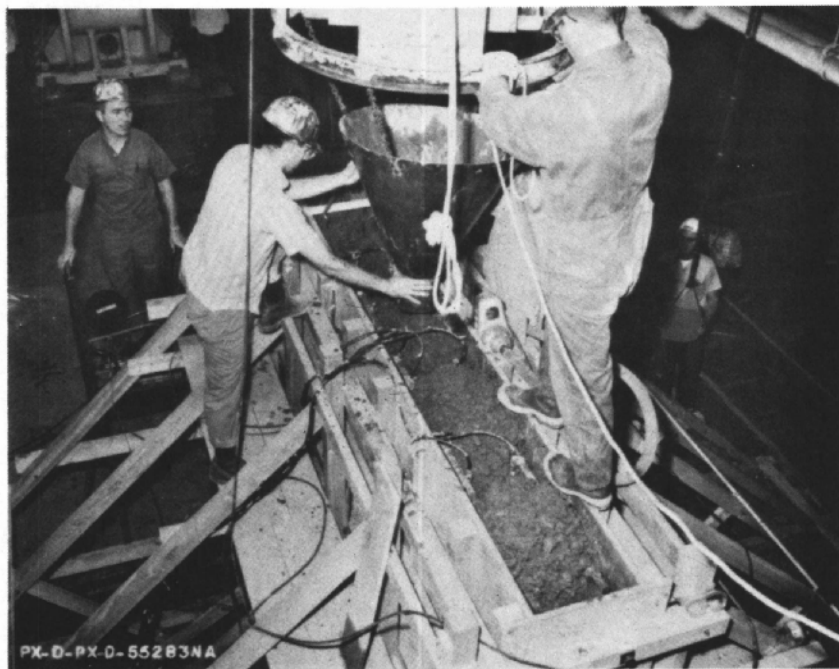
Figure IV-7. View during the latter stages of the concrete placement operation.  
Photo PX-D-55283 NA

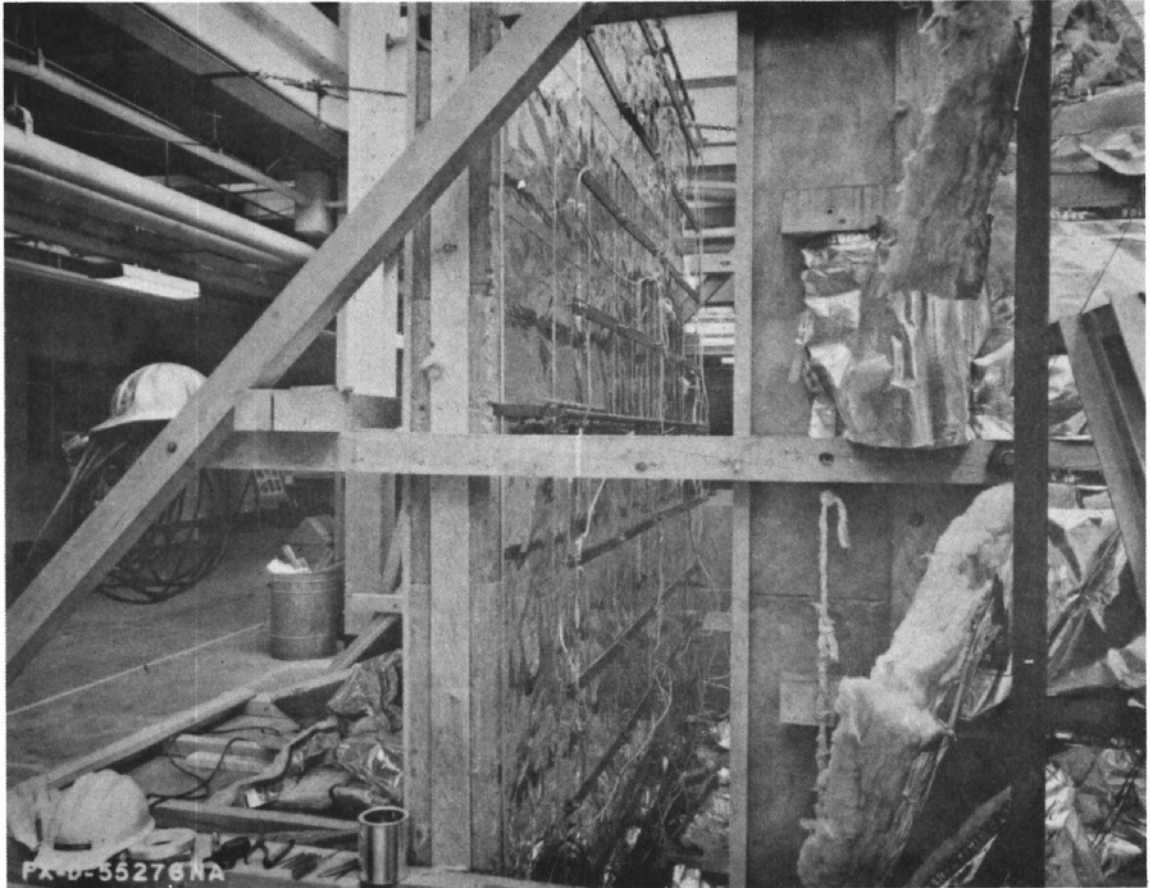
Figure IV-9. View of horizontal arrangement of strip heaters which supply the heat energy during testing. Photo PX-D-55276 NA

chamber. Holes were drilled in the length of tubing across the top in such a manner that the released air helped to maintain a uniform temperature distribution over the hot face. During cooling, the insulation forming the ends and top of the heat chamber was removed in stages and fans and blowers were used to regulate the cooling temperatures on the hot surface.

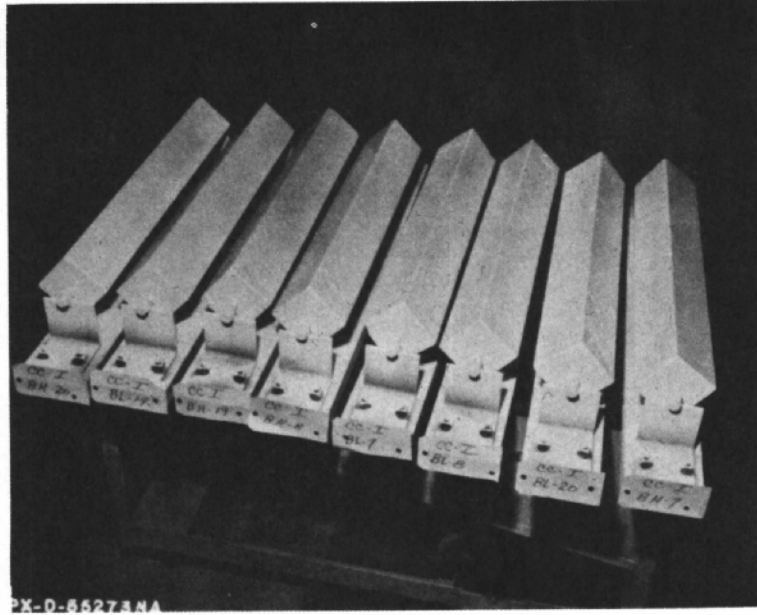
Figure V-3. Concrete test bars coated with silicone alkyd coating, Material No. IV, are shown before exposure. Photo PX-D-55273 NA

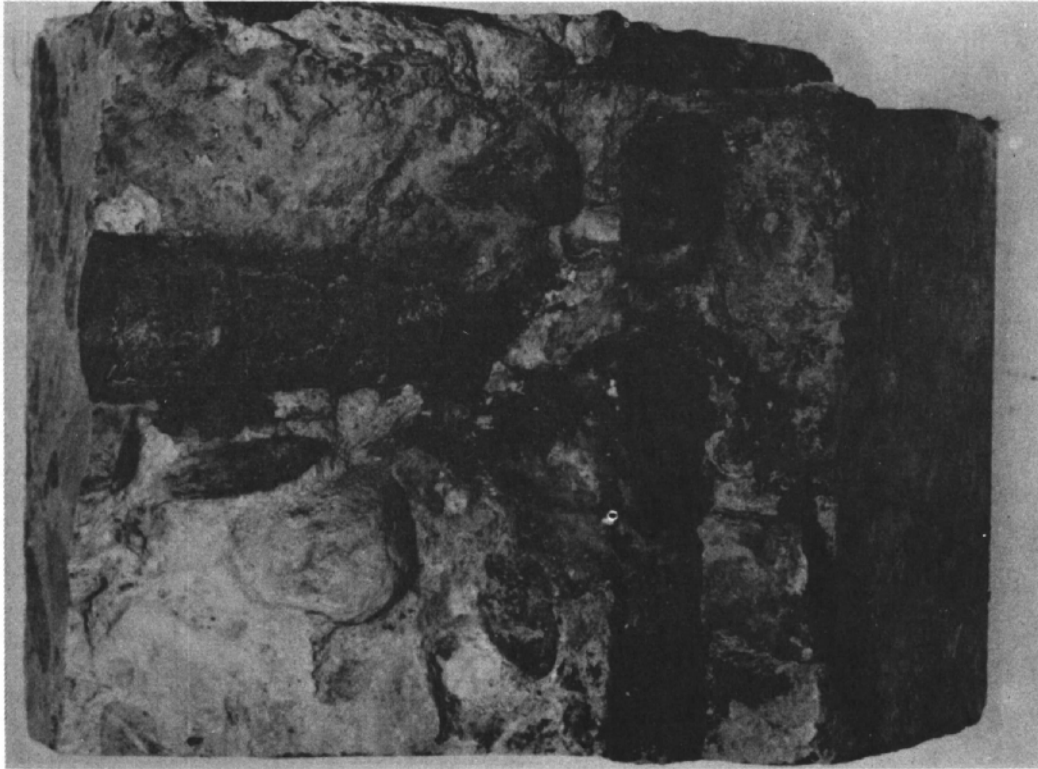
Figure VII-8. Photograph of reinforced pipe section showing staining around rebar.  
Photo PX-D-60859

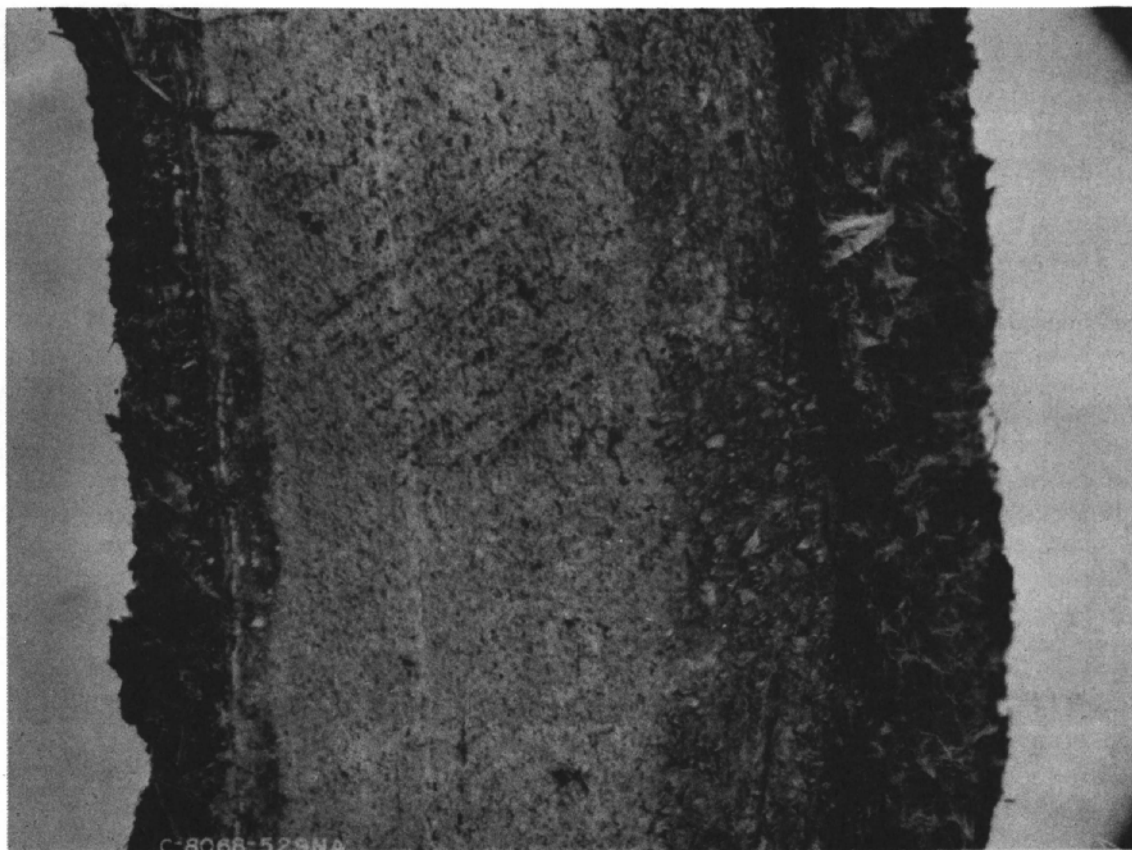
Figure VII-9. Photograph of asbestos-cement pipe showing alteration of outer surfaces (left and right sides). Photo PX-D-60860
