*Decommissioning the UHTREX Reactor
Facility at Los Alamos, New Mexico*

*Miguel Salazar
John Elder*

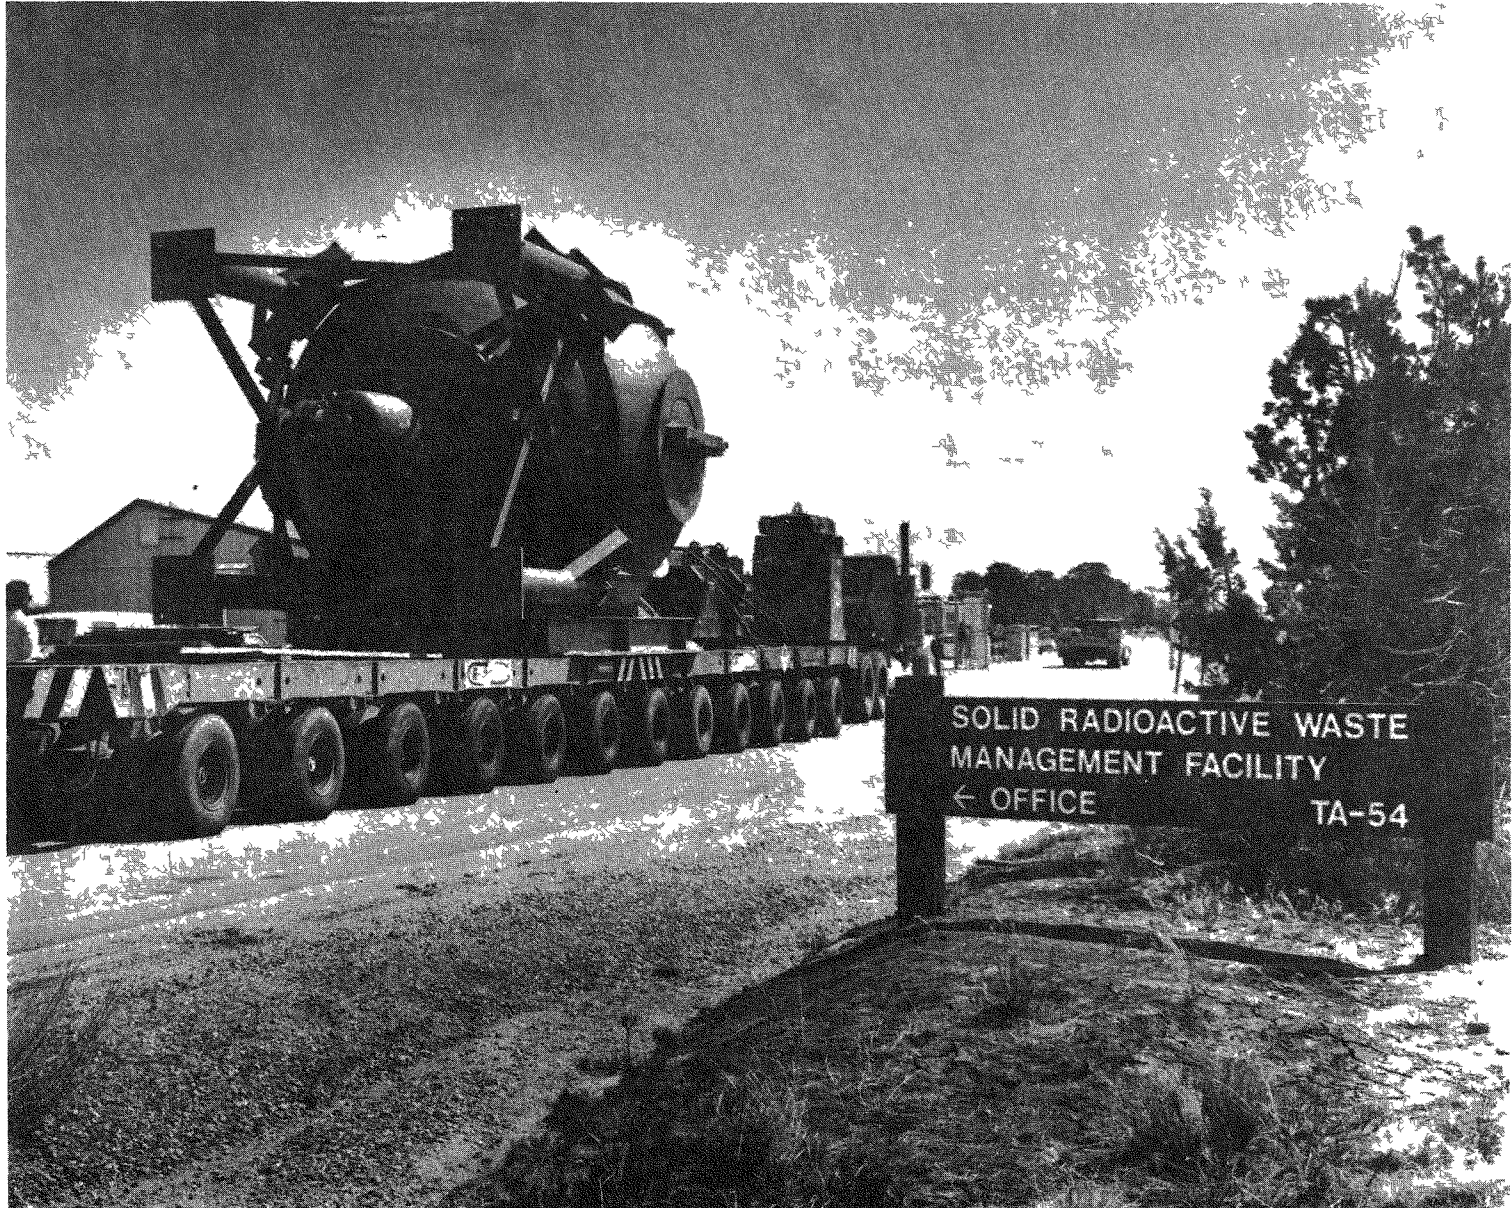
Fig. 17. Reactor vessel traveling on the road.

The roadway between TA-50 and TA-54 was closed for about an hour on Saturday, March 31, 1990, to transport the vessel. The closure eliminated potential road hazards and allowed personnel to work unhampered if a problem occurred. The vessel was transported without difficulty on a multi-tired Scheuerle platform trailer (Fig. 17). The trailer distributed the load to comply with AASHTO HS20 highway loading. Each axle on the trailer could be independently steered for sharp cornering. The trailer, or load platform, also adjusted itself to provide a continuous horizontal and level platform for the load. Maximum grade was approximately 4 percent (4 ft vertical per 100 ft horizontal) with one sharp turn into a side road. The trailer negotiated a reverse curve of approximately 30-ft radius.
