INTERGRANULAR FAILURES OF ALLOY 600
IN HIGH TEMPERATURE CAUSTIC ENVIRONMENTS

R. Bandy, R. Roberge* and D. van Rooyen

Materials Research Group
Department of Nuclear Energy
Building 703M
Brookhaven National Laboratory
Upton, NY 11973

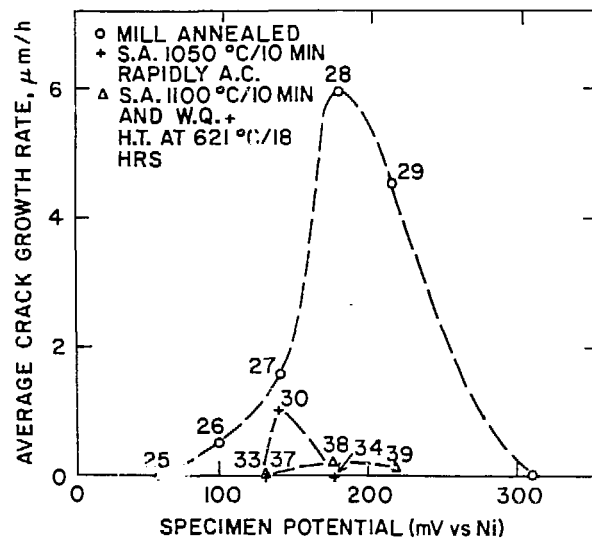
Fig. 2. Relationship between electrochemical potential and average crack propagation rate of C-rings under three different metallurgical conditions in 10% NaOH + 0.1% Na₂CO₃ solution at 300°C. Numbers on figure refer to specimen nos.; test duration 168 hours.

The SCC test results with multiple C-rings using the modified Seys and Van Haute technique are shown in Fig. 2. The tests were run in 10% NaOH + 0.1% Na₂CO₃ at 300°C. The crack propagation rate shown is the average value based on the total testing time and the maximum crack depth. The specimens were tested under mill annealed (MA), solution annealed (SA), and "sensitized" (SAS) conditions, as shown on the diagram. All the MA C-rings held between 100 mV and 220 mV underwent SCC, with a maximum crack propagation rate at +177 mV. Similar potential dependence of SCC was observed by various previous investigators⁽¹⁵⁻¹⁷⁾. Some of the SA and SAS specimens also cracked in the potential zone studied, but generally with a marked difference in the maximum crack depth.

The SCC testing with multiple C-rings using the modified Seys and Van Haute technique proved to be a very successful method leading to considerable saving in testing time and eliminated variations that can occur between individual tests. Our data in Fig. 2 are in excellent agreement with those of earlier investigators⁽¹⁵⁻¹⁷⁾, thus giving necessary support for the validity of the method. The technique has recently been used successfully to study SCC at room temperature⁽¹⁹⁾.

Fig. 2 shows that the CPR of the MA material is much higher than that of the SA or the SAS materials. However, because of the heat treatment, the SA and SAS materials have much lower yield strength, and since all our C-rings were given the same amount of deflection, the stress level reached by the SA and SAS C-rings were lower than that of the MA C-rings. Therefore, it is not clear whether this factor is responsible for an apparent improvement in SCC performance or whether the heat treatments actually improved SCC resistance. In the literature, there is ample evidence that sensitizing heat treatments generally improve the caustic SCC resistance of Alloy 600^(15,17). However, these tests were conducted with C-rings or other constant deflection type specimens and it is not clear whether the heat treatment improves the SCC resistance by merely improving the initiation behavior. Tests with precracked wedge-opening-load specimens in 50% NaOH showed that the SAS specimens of Alloy 600 actually registered greater crack growth than SA or MA type specimens⁽²⁰⁾.

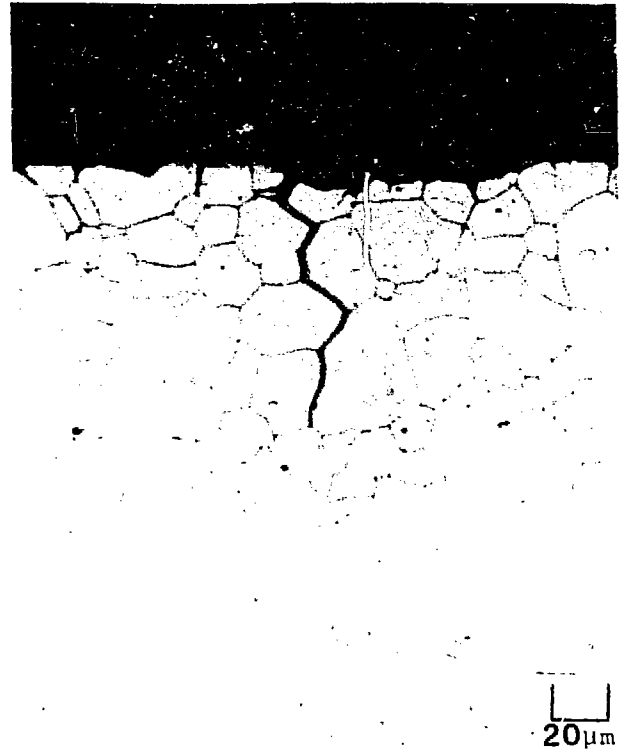
Fig. 3. Micrographs comparing the phenomena of (a) IGA and (b) SCC produced on MA C-rings in 10% NaOH + 0.1% Na₂CO₃ solution at 300°C.

IGA was observed in this environment on the MA C-rings over a wide range of potential - from about -84 mV up to about 60 mV. Some of these samples showing IGA were exposed in the environment in two successive test runs for a total of 343 hours. Fig. 3(a) shows a typical IGA attack in its early stage on a MA C-ring held between 12 and 20 mV for 343 hours. The maximum depth of IGA on these samples varied from 50 to 140 μm and no difference was observed in its extent against potential within the range mentioned above. Unlike SCC, shown typically in Fig. 3(b), IGA spread laterally on the surface and penetrated only a few grains. In some samples suffering SCC, there were areas where both SCC and some shallow IGA were observed. The SA C-rings also showed IGA between -50 to +80 mV in a 10 day test in the above environment, although the attack was generally shallower than that in the MA samples.

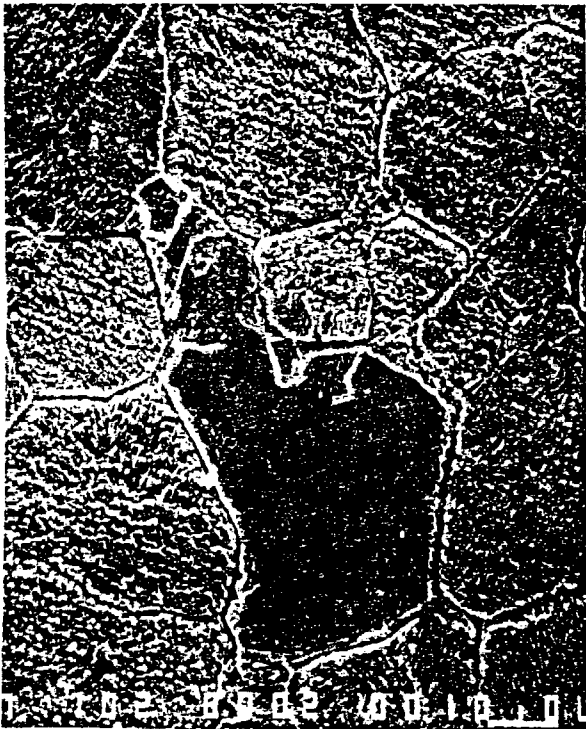
(e) 25 to 45 mV; outside the crevice

(f) same as (e); inside the crevice

Fig. 6. Nature of surface attack on Alloy 600 creviced coupons after exposure for 10 days in 10% NaOH + 1% Na₂SO₄ solution at various potentials.

Fig. 6 (a) - (b) show the nature of surface attack on an Alloy 600 coupon in 10% NaOH + 1% Na₂SO₄ outside and inside the crevice after a 10 day exposure. The specimen was held at a potential in the range of -40 to -55 mV. The EDX analysis of the matrix region or the particles in Fig. 6(a) gave only nickel spectra, presumably from cathodic deposition of nickel in preference to iron and chromium. The area under the crevice appears very different from that outside the crevice and the spectra consist of nickel, iron and chromium. Table 2 summarizes the Ni:Fe and Ni:Cr for various coupons inside and outside the crevice in various samples examined in this environment. The flake mentioned in Table 2 refers to the small flaky deposit in Fig. 6(b). Fig. 6(c)-(d) illustrate the surfaces outside and inside the crevice of the coupon that was held at 0 mV. The spectra for various regions, shown in Table 2, show that some particles outside the crevice were highly enriched in chromium, whereas others were pure nickel. Inside the crevice, some particles were also enriched in chromium. Fig. 6(e)-(f) represent the areas outside and inside the crevice for a coupon at 25 to 45 mV. The area outside the crevice is generally etched, but some areas were completely covered with a dark film. EDX indication from the oxide and outside the oxide were very similar, presumably because the film was very thin. The area inside the crevice was filled with a dark film with regions of relatively thicker deposits, giving spectra different from those in the matrix. The nature of attack on the specimen held at 60 to 80 mV was very similar to that at 25/45 mV with patches of dark oxide on a generally etched surface outside the crevice, and dark deposits inside the crevice with some scattered particles. The surface of the coupon held at 150 mV was mostly covered with a black film with some isolated bare areas as shown in the optical micrograph in Fig. 6(g) showing the filmed and the stripped areas. The spectra from the film shows considerable enrichment in iron and chromium (Table 2) compared to that in the stripped area which probably resembles the Alloy 600 substrate. However, the fact that the oxide composition is so different from the material underneath implies that it is thicker than that observed at lower potentials. Fig. 6(h) shows details of attack in the stripped area in Fig. 6(g), revealing considerable grain boundary grooving. The area inside the crevice in this sample showed a range of attack, as shown typically in Fig. 6(i) and (j) for two different areas within the crevice.

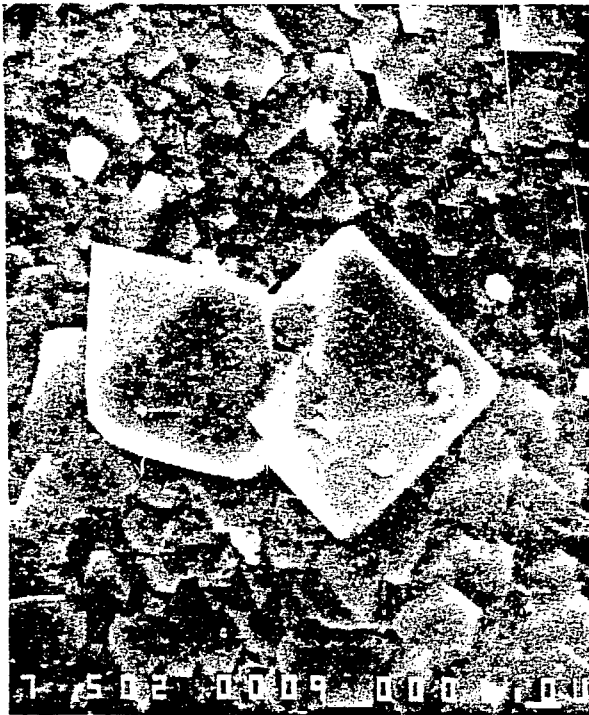
(i) same as (g); inside the crevice

(j) same as (g); inside the crevice
