CORROSION RESISTANT BRAZING ALLOYS FOR ZIRCALOY

Final Report

Westinghouse Electric Corporation  
Atomic Power Division  
P. O. Box 1468  
Pittsburgh 30, Pennsylvania

The objective of this program was the development and evaluation of filler metals suitable for the brazing of Zircaloy for service in high temperature water.

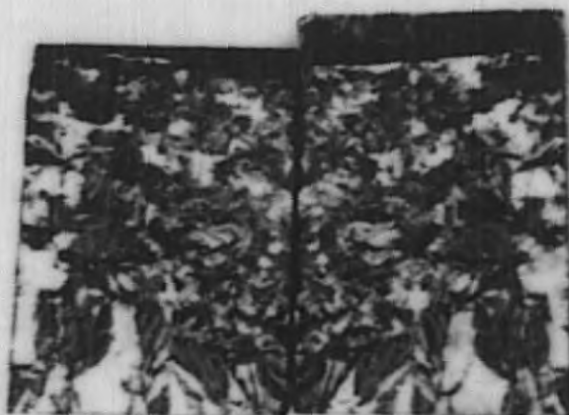
Figure 4 - Appearance of the Above Braze After  
1212 Hours of Exposure in 680°F Water.

One such composition was Cu-20% Pd-3% In-7% Zr 2. This alloy formed a relatively thick joint as seen in Figure 3, and extensive erosion occurred in the base metal at the fillet. After exposure of 1212 hours, the brazement was broken apart and was found to be unattacked except for a thin corrosion line around the edges (Figure 4).

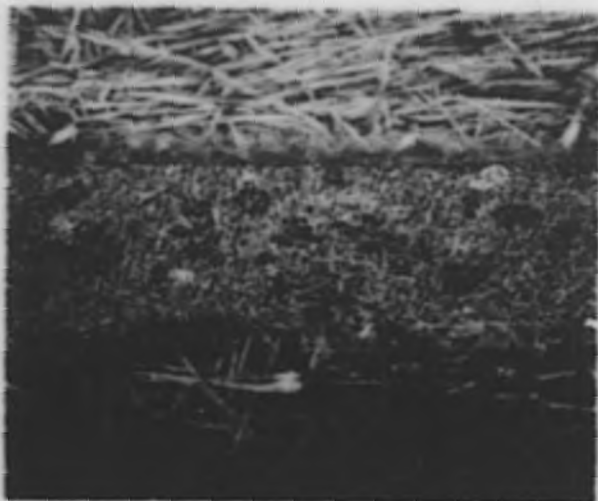
Figure 9 - Microstructure of 3-Mil Spaced Bracement  
with Cu-20% Pd-3% In-3% Ni-3% Fe Filler Metal.

A Cu-20% Pd-3% In-3% Ni-3% Fe brase (Figure 9) sustained no corrosion damage during 1212 hours of exposure (Figure 10); however, erosion of the base metal occurred during brazing.

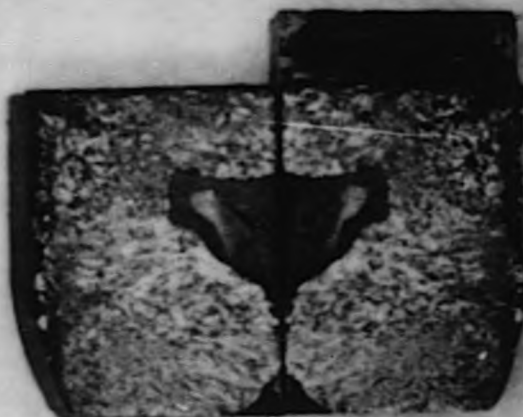
Figure 18 - Appearance of Above Specimen After  
1256 Hours of Corrosion Testing in  
680°F Water.

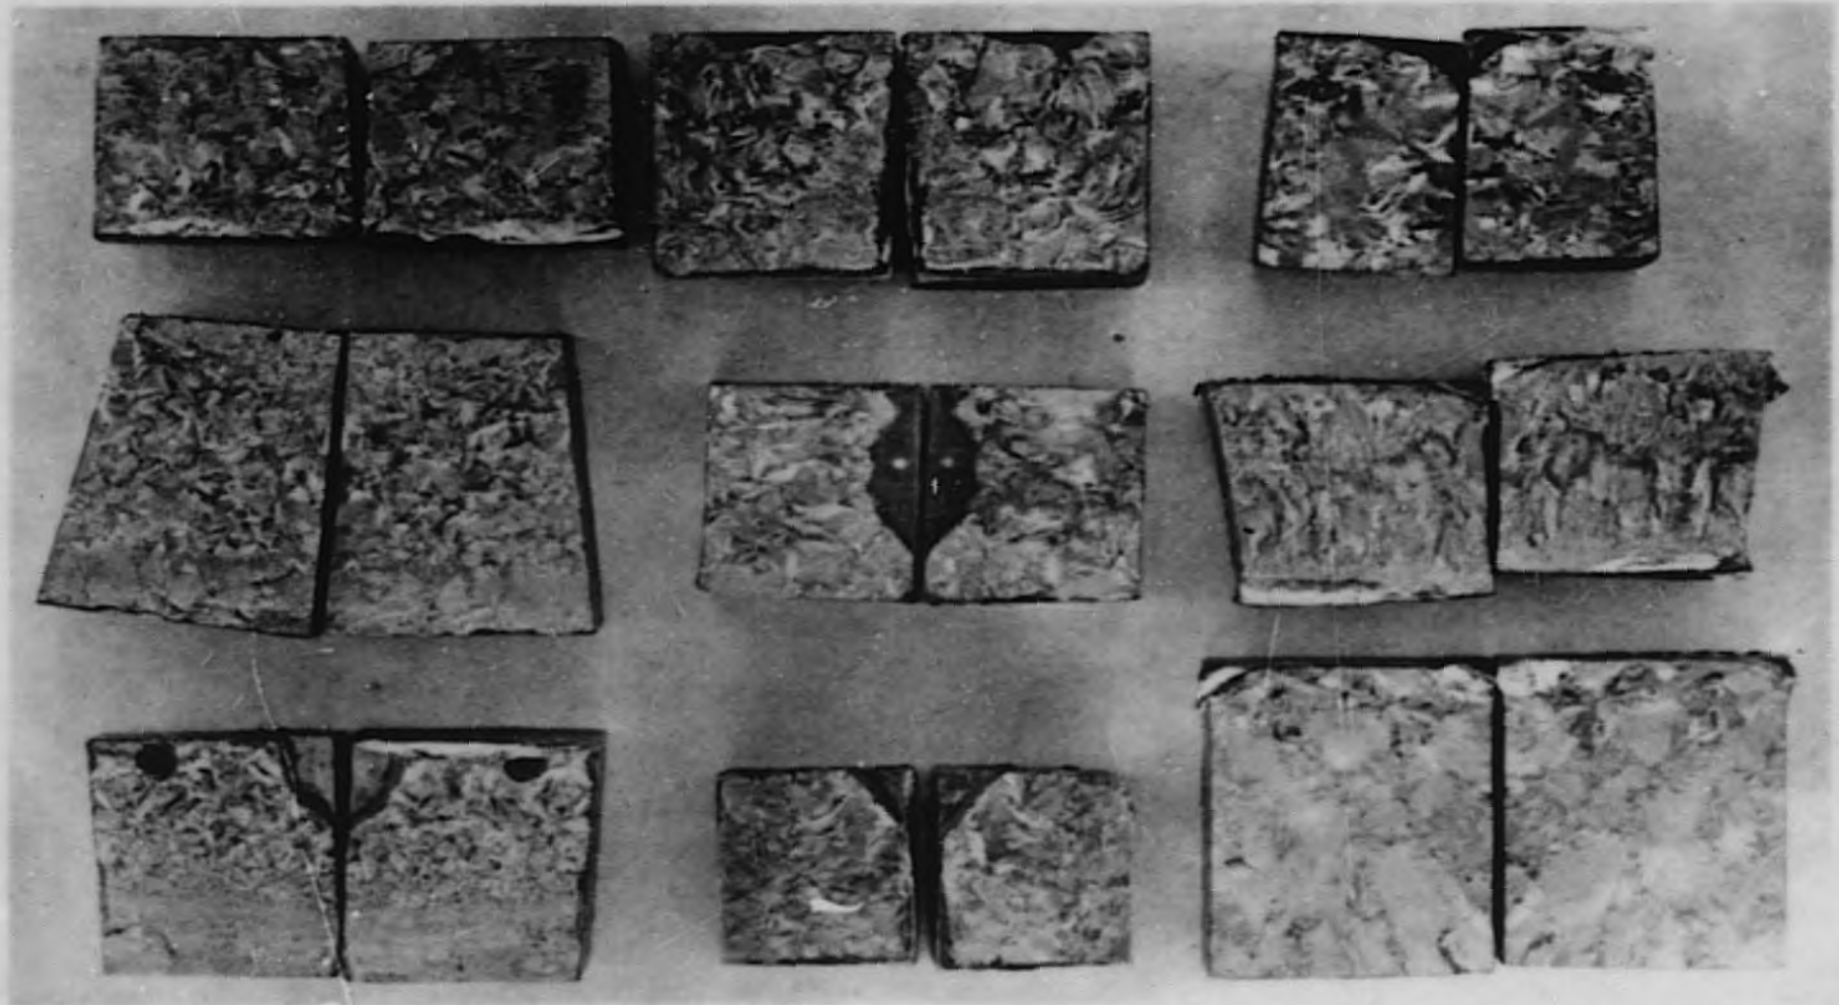
Figure 3k - Appearance of 3-Mil Spaced Brassments with Cu-20% Pd-3% In Filler Metal  
After 137 1/2 Hours of 600°F Corrosion Testing.

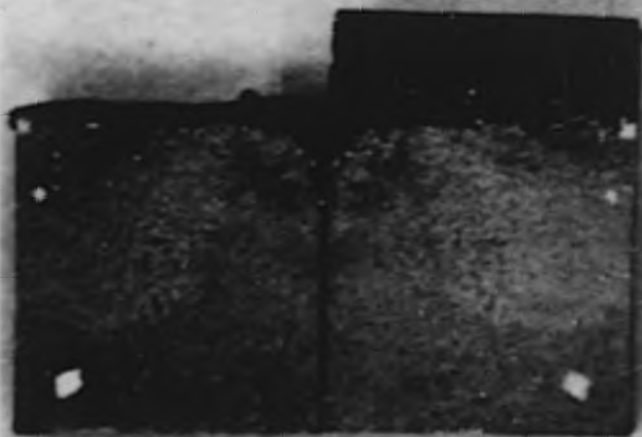
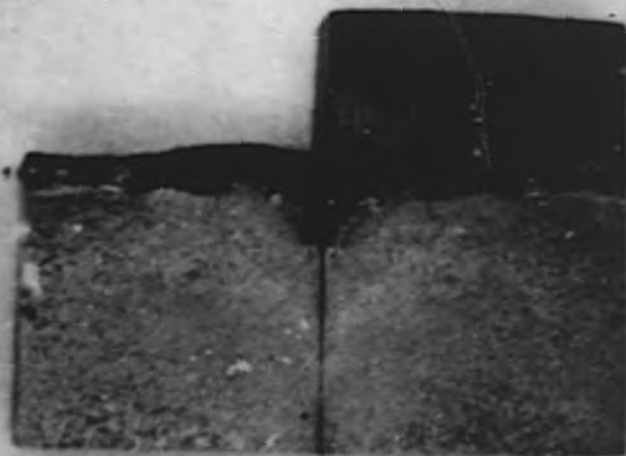
Figure 44 - Appearance of 1-Mil Spaced Braces Made with Ni-20% Pd-10% Si Filler Metal After 1349 Hours of Corrosion Exposure in 680°F Water.

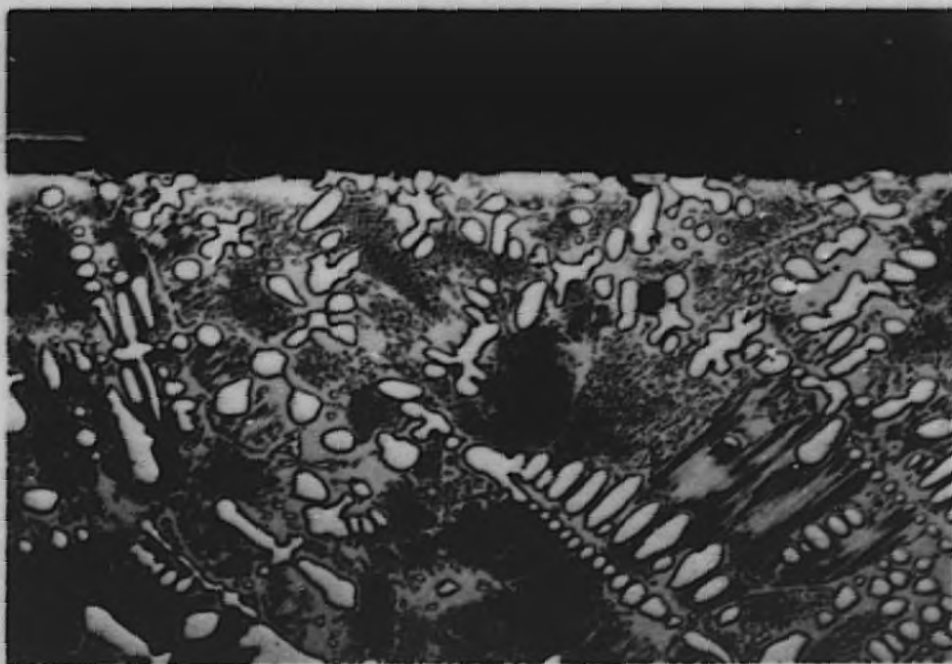
**Figure 54 - Cross Section of Kanigen Block After 3379 Hours of Exposure in 680°F Water.**

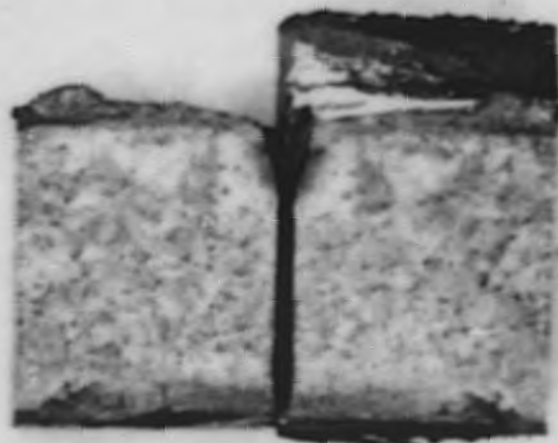
Figure 61 - Appearance of 1-Mil Spaced Joints Braised with  
Zr-4% Be Filler Metal After 1279 Hours at 600°F.

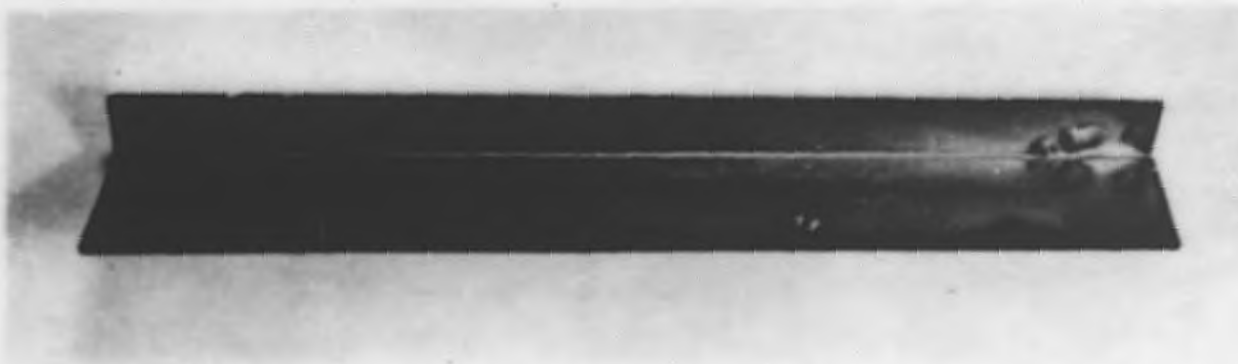
Figure 66 - Furnace Brazed T-Joint Brazed with Zr-4% Be Filler Metal.
