NUREG/CR-1729
BMI-2066
Vol. 1

Evaluating Strength and Ductility of Irradiated Zircaloy Task 5

Experimental Data
Final Report

Battelle Columbus Laboratories

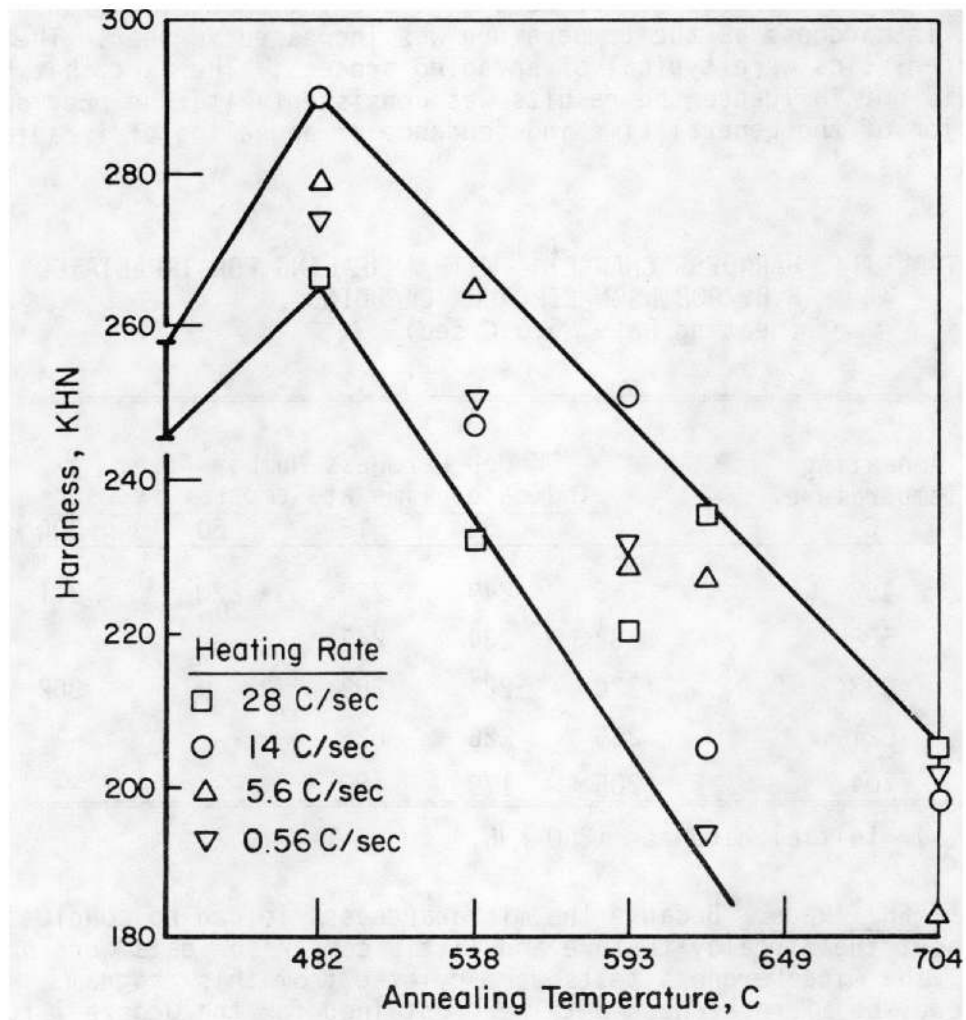
FIGURE 2. EFFECT ON HARDNESS OF TRANSIENT HEATING (ZERO HOLD TIME AT TEMPERATURE) TO THE MAXIMUM ANNEALING TEMPERATURE INDICATED FOR IRRADIATED H.B. ROBINSON FUEL ROD P-8

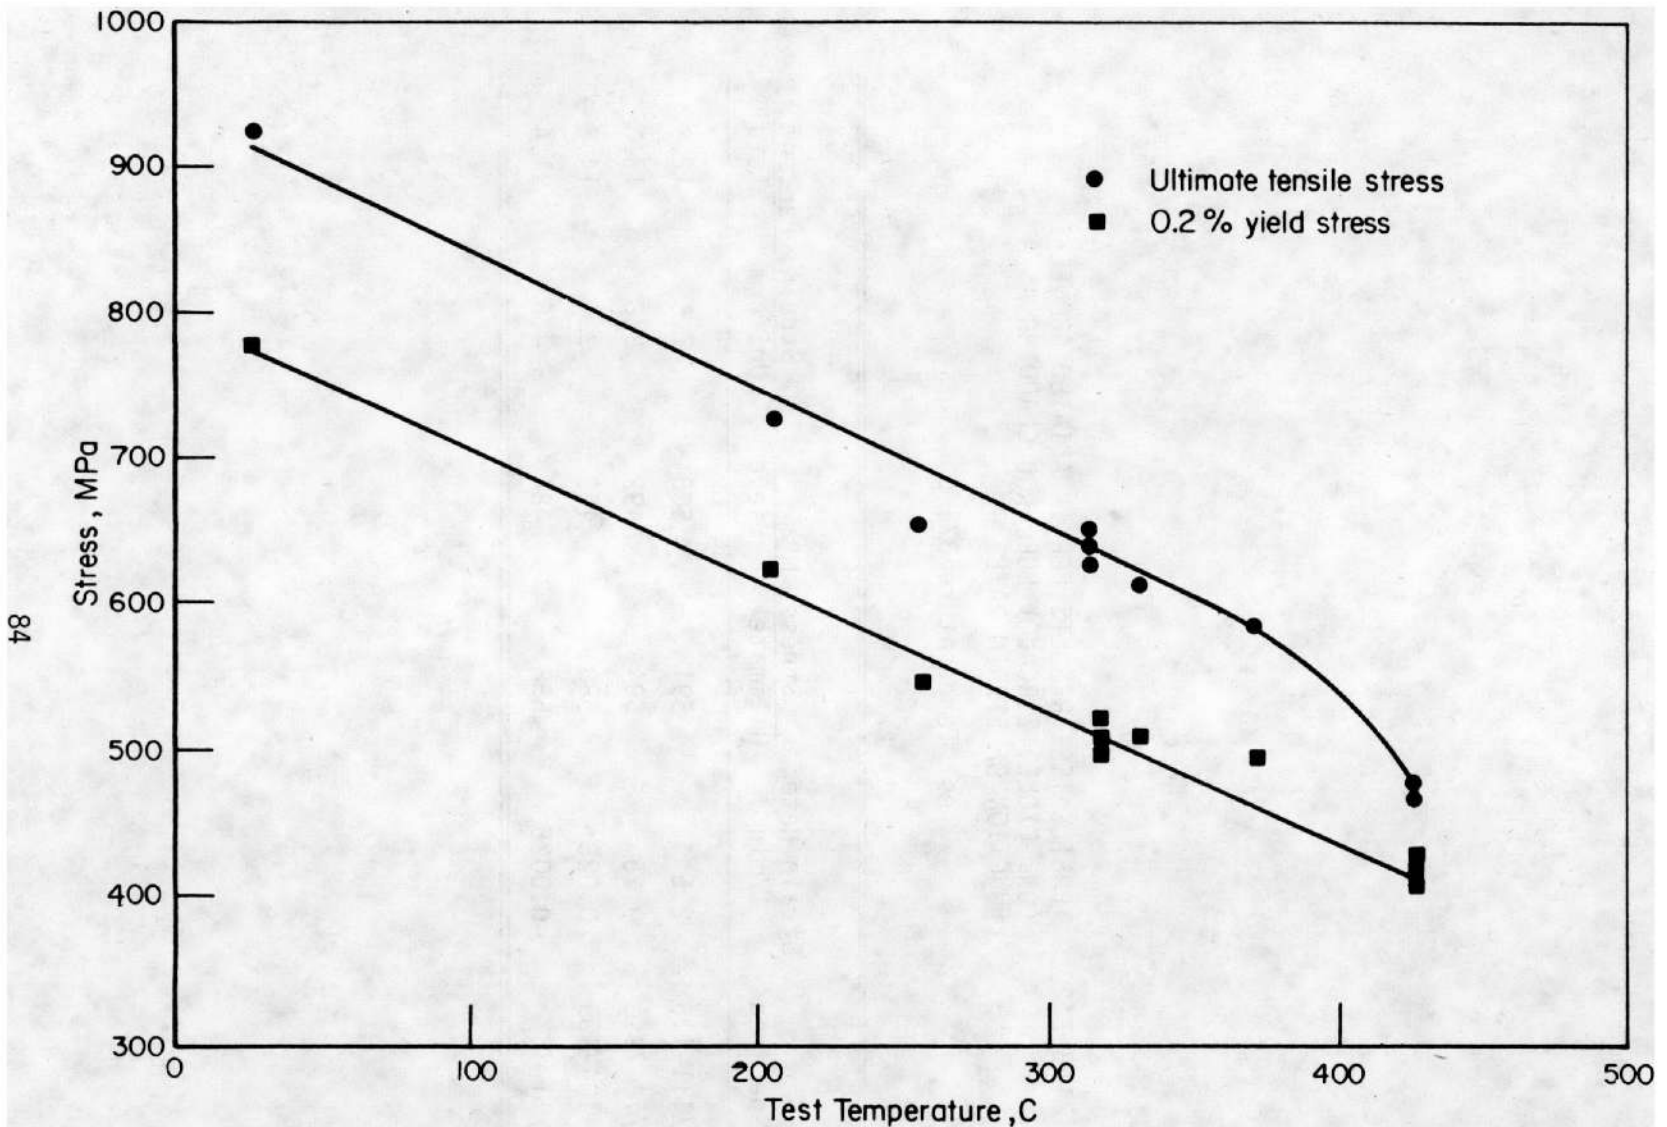
FIGURE 28. ENGINEERING TENSILE STRESS FOR IRRADIATED OCONEE I (ONE CYCLE) FUEL-ROD CLADDING AS A FUNCTION OF TEMPERATURE

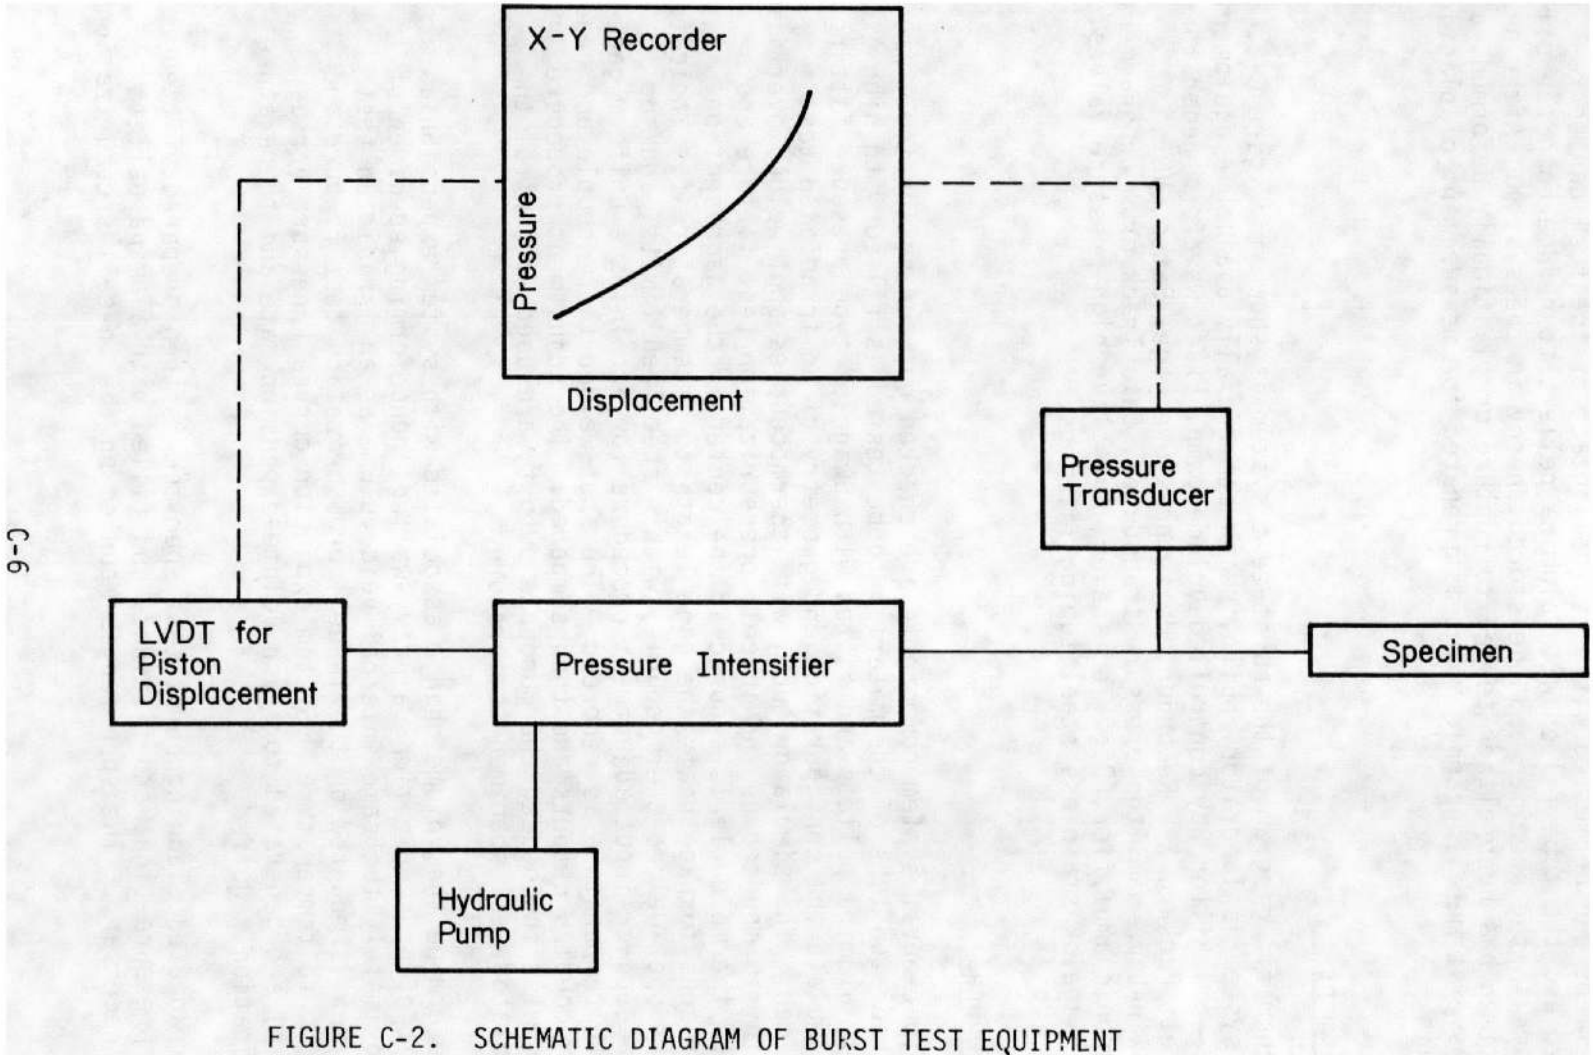
FIGURE C-2. SCHEMATIC DIAGRAM OF BURST TEST EQUIPMENT
