DATE: January 5, 1957
SUBJECT: HIGH PRESSURE FLANGE STUDIES
TO: J. C. Bresee
FROM: K. J. Fritz

1.0 ABSTRACT

During the 1956 Spring quarter, 2500 psi ring type flanges, ring gaskets, bolts, and special connectors were tested for adaptability to the aqueous homogeneous reactor. The testing procedure and results are presented.

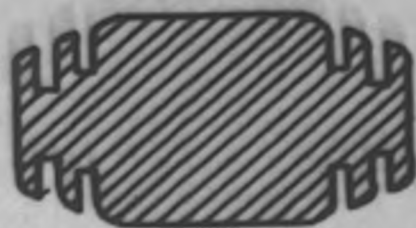
Figure 6.3

Three special ring gaskets were designed. These gaskets are shown in cross section in Figures 6.2 and 6.3.

spring ring wing ring

finned octagonal ring

The octagonal ring with its larger contact surface area requires a slightly greater bolt loading to effect a seal. Because it is desirable to limit initial bolt loading to 6000 pounds, a compromise between the oval and octagonal ring gasket is made in the finned octagonal ring. This gasket has not been tested to date.

The two split rings shown will make separate mechanical seals on the inside and outside flange seats. In addition to making sealing possible with less loading, the split in these rings will provide some protection against thermal warping. These rings have not yet been tested.

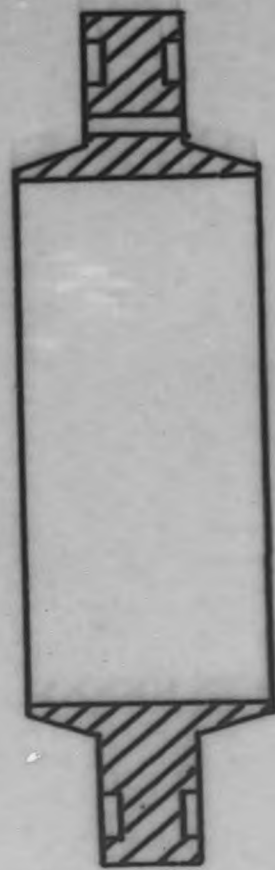
FIGURE 7.1
HIGH PRESSURE FLANGE STUDIES
MODIFIED GRALOC CONNECTOR

Used successfully in the petroleum industry, the Graloc connector seemed a logical connector for application in the HRT Chemical Processing Plant. Modification in the connector resulted in the closure shown in Figure 7.1. Contact on the inner sealing surface could not be obtained. Further modifications are now underway.

seal ring

graloc flange
