Effects of Various Polishing Media and Techniques
on the Surface Finish and Behavior of Laser Glasses

Richard L. Landingham, Alton W. Casey and Roy O. Lindahl

November 7, 1978

This paper was prepared for presentation at the
American Ceramic Society's Ceramic Machining and
Surface Finishing II, Gaithersburg, Md.,
November 13-15, 1978

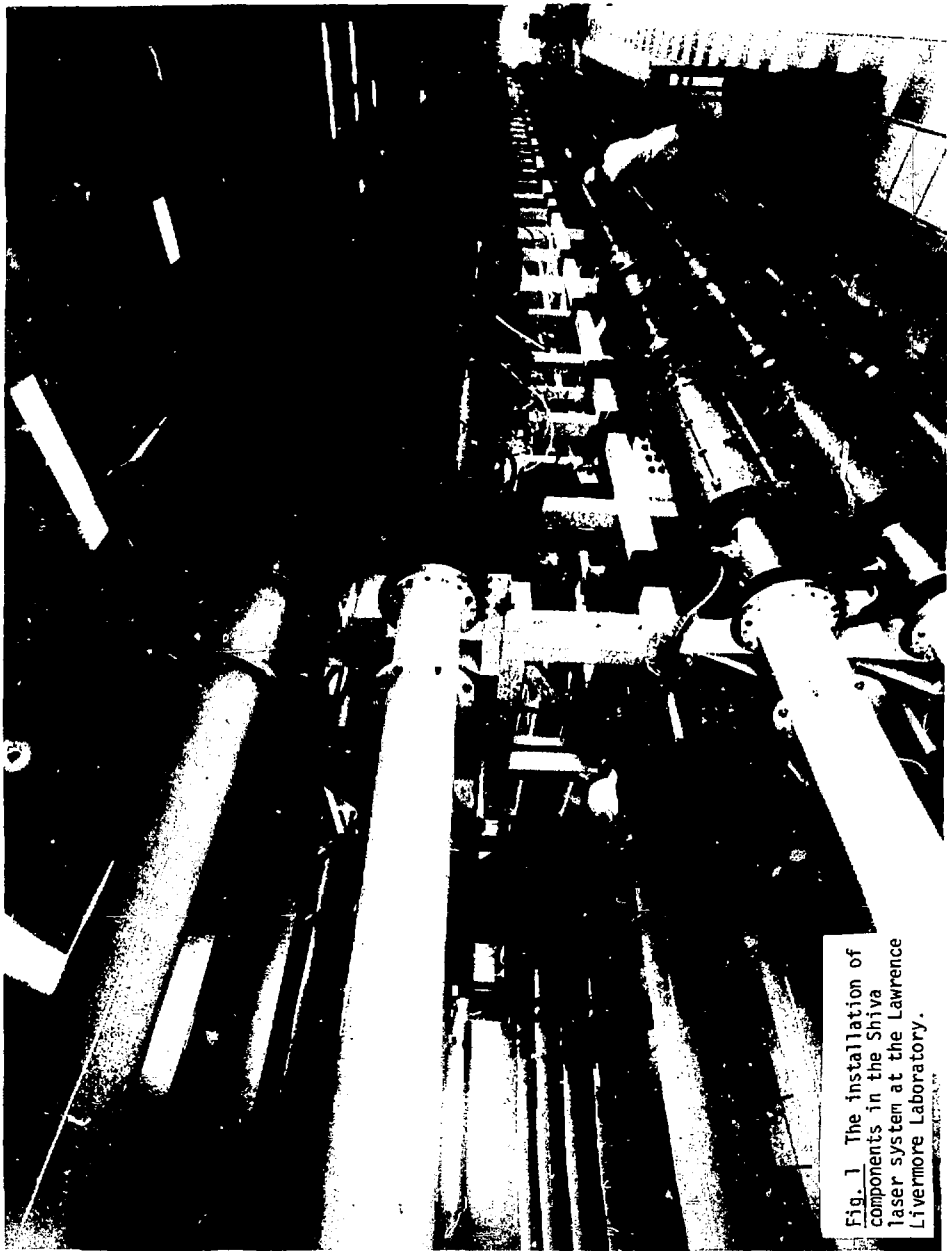
Fig. 1 The installation of components in the Shiva laser system at the Lawrence Livermore Laboratory.

High-power lasers are used to implode D-T targets at LLL. Results from such implosions demonstrate the feasibility of generating electrical power by inertial confinement fusion. The 30-TW SHIVA laser (the world's most powerful laser) was designed and built at LLL for this purpose. This first design used neodymium-doped oxide glass as the amplifying medium. A typical laser chain (50-in long) is shown in Fig. 1. Large increases in laser power are anticipated by using fluoride-base laser glass instead of oxide-base glass in the next upgrade: 200-to 300-TW NOVA solid-state laser design. Such improvements are possible because fluoride amplifiers will have high gain and low nonlinear refraction index. High gain is achieved with optimum balance between emission cross section of the lasing ion and duration of the laser pulse. A smaller cross section is generally needed with increasing pulse width. The emission cross section is host-dependent.

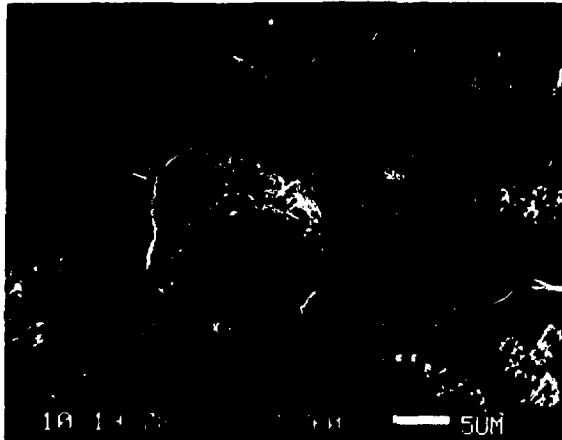
Fig. 6. Buildup (Snowballing) of large agglomerates in the final polishing slurry were photographed (above) in the SEM and analyzed by EDS. These agglomerates were made up of aluminum, silicon, and oxygen and formed during final polish of silica glass with Al_2O_3 polishing compounds.

Polishing with Al_2O_3 (ERC-HP-DBR) powder was stopped because of excessive foaming. This foaming action was attributed to the Mg doping agent in this hot press powder. Satisfactory polishing rates were obtained with the Al_2O_3 (4071) powder, but subsurface scratches persisted after 35 h of polishing with the same slurry. Starting with a finer agglomerate size ($< 5 \mu\text{m}$ diam) Al_2O_3 slurry and continuously removing large agglomerates ($> 5 \mu\text{m}$ diam) from the slurry reduced subsurface scratches. Preliminary evidence indicates a rapid buildup (snowballing) of agglomerates comprised of Al_2O_3 particles.

and silica from the glass (see Fig. 6). This buildup was also observed by determining the particle distribution size of the slurry before and after polishing. Further evaluation of this buildup mechanism is in progress because it could account for the common belief that Al_2O_3 is "too hard" to polish glass.
