U. S. DEPARTMENT OF COMMERCE

Bulletin 345

**CONCRETE STOPPINGS
IN COAL MINES FOR RESISTING EXPLOSIONS:
DETAILED TESTS OF TYPICAL STOPPINGS
AND STRENGTH OF COAL AS A BUTTRESS**

GEORGE S. RICE, H. P. GREENWALD

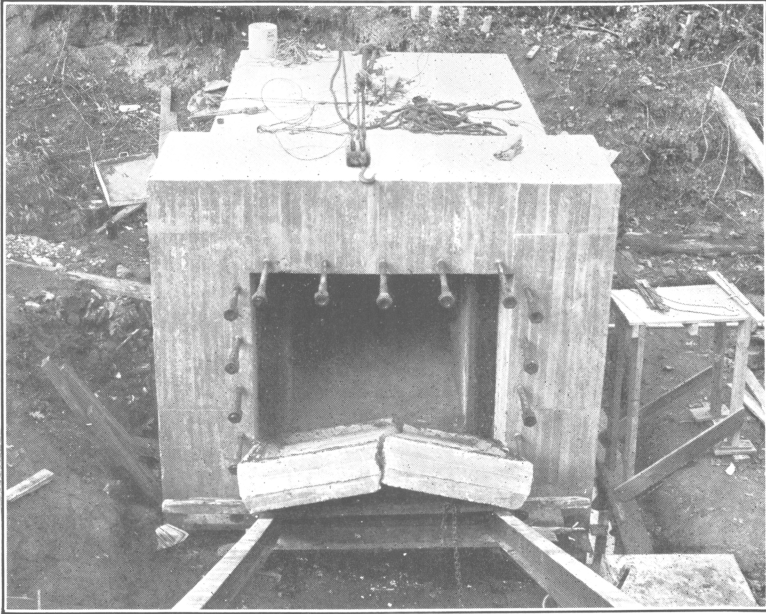
FIGURE 4.—Front of stopping-test chamber at Bureau of Standards

The chamber was made of reinforced concrete with walls 2 feet thick; the interior was 4 feet square and 8 feet long. The rear wall was pierced by a door or manhole, and the front was open and specially shaped to receive the test specimens. Figure 4 is a photograph of the front and top of the chamber and shows a broken specimen partly removed. The method of holding the slabs in place is shown more clearly in Figure 6, which is a horizontal cross section of the front half of the chamber. The slab representing the stopping was of the desired thickness over an area exactly 4 feet square, and outside this it was thicker to provide the necessary excess strength at the bearing surface. The surface bearing against the chamber was grooved to receive a solid, round, rubber gasket thick enough to prevent the slab bearing directly on the chamber; this gasket was fastened in the groove with hot tar before the slab was placed. The space marked *A* was filled with quick-hardening cement mortar after the slab had been placed to prevent escape of the compressed gases and restrict the application of pressure to the desired area. Pressure on the slab was transmitted to fabricated-steel bearing blocks at

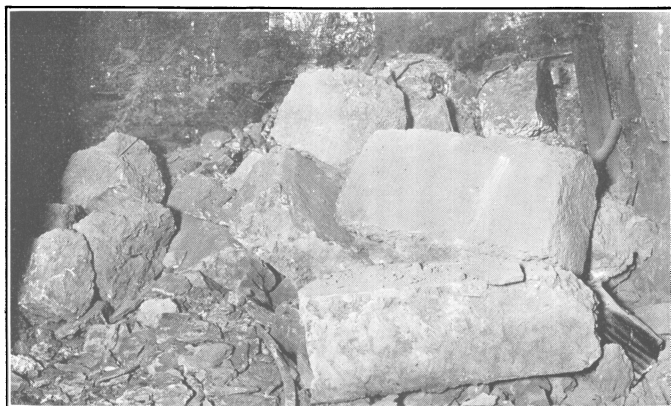
FIGURE 12.—Débris from stopping 3

The central crack was visibly wider after each test; and there was additional cracking of the plaster at the junction of the inner face and the ribs, caused by the forward thrust of the stopping. Figure 9 shows the stopping after test 11. The tension crack is visible, particularly near the roof. The blackened spots at the roof are places where gas blew over the top, and small areas can be seen where the surface has spalled. The stopping was still serviceable for ventilation, particularly if the openings at the roof were plastered shut, and it was evident that the pressure required to cause failure was considerably more than 148 pounds. Because of the difficulty of keeping the chamber gas-tight it was decided not to proceed further with this stopping, and it was broken up with dynamite.

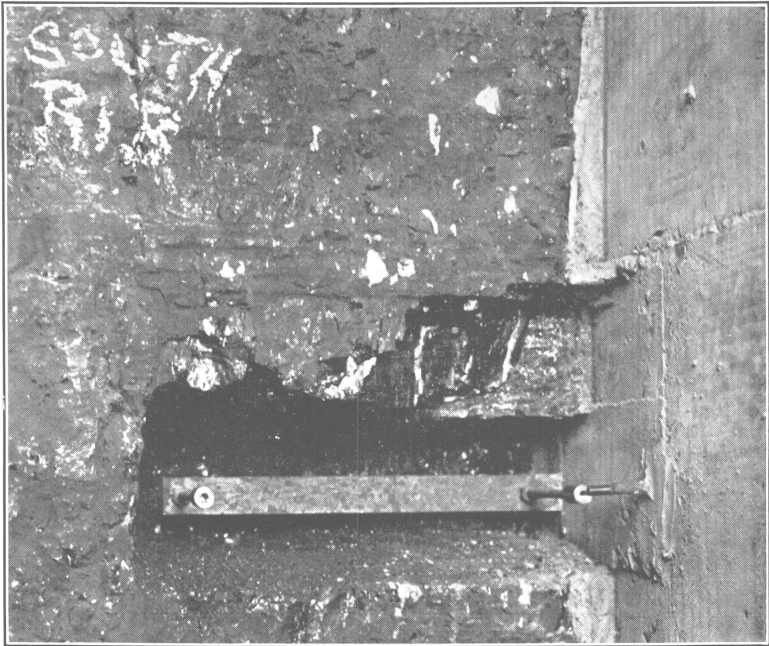
FIGURE 16.—Steel bar set in end of stopping 4 to measure end movement

An attempt was made to analyze end movement of the stopping. Steel bars imbedded close to the ends of the concrete projected 12 inches into narrow recesses cut in the ribs. The arrangement is

shown in Figure 16, a photograph taken at the south rib. Rods were fastened at right angles to this bar 1 and 11 inches from the outer face of the stopping and connected to deflection-measuring devices. If there was rotational movement, the record at the outer point would be greater than at the inner point, and it would be possible to determine the amount thereof if the center of rotation could be determined from the other records.

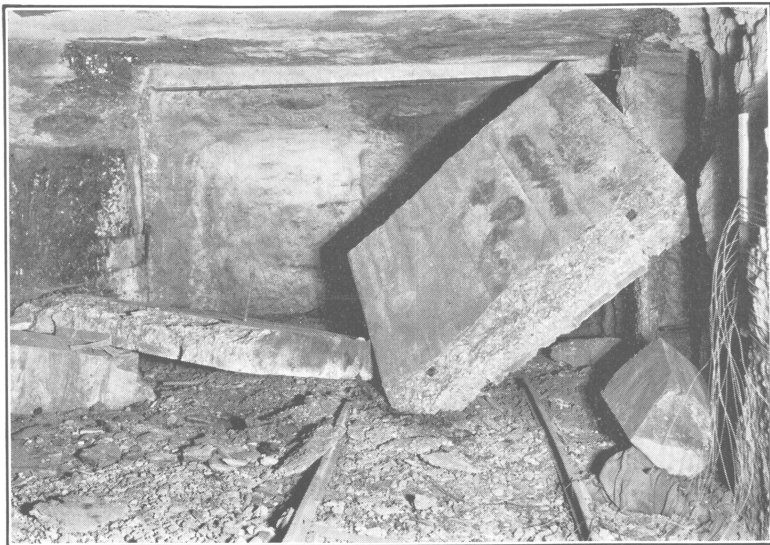
FIGURE 30.—Stopping 6 after first test

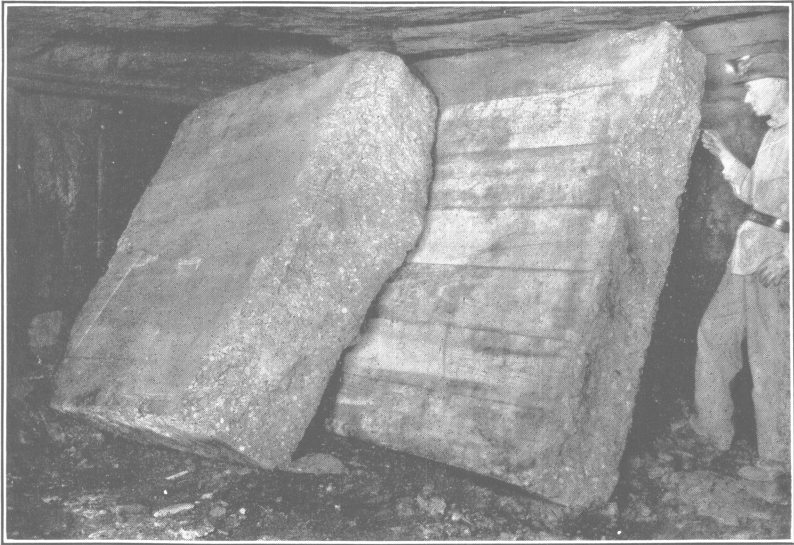
FIGURE 35.—Débris of stopping 7, viewed from original position
