UCRL-2053

**SPARK DAMAGE AND HIGH VOLTAGE BREAKDOWN OF METALS IN VACUUM AT 14 MEGACYCLES**

Paul K. Byerly, Jr., Warren W. Chupp, and Harry G. Heard

December 15, 1952

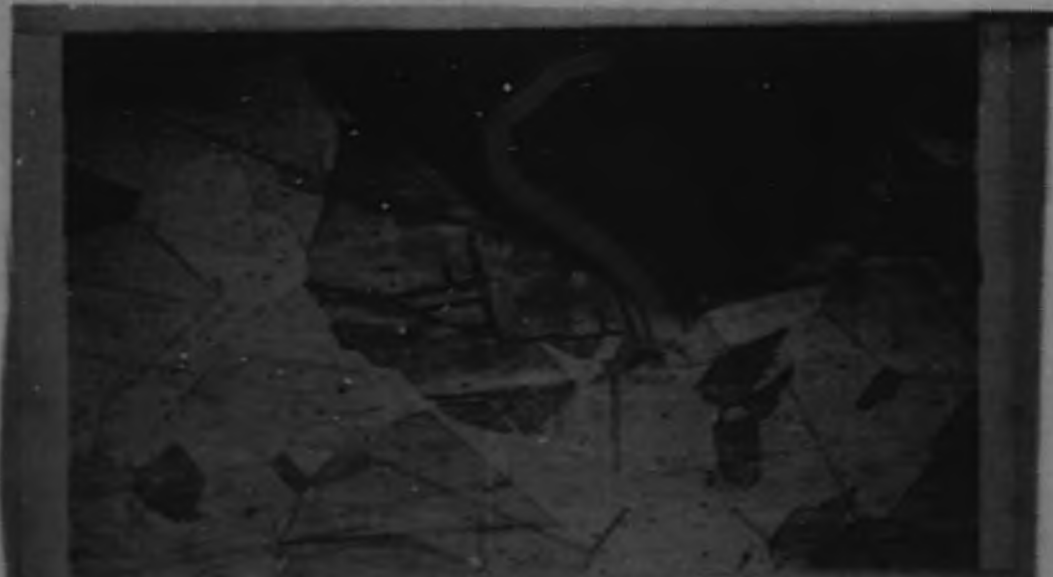
Fig. 11

Photomicrograph (68x) of grain structure in work hardened sample of DHP copper (surface shows spark craters)

Photomicrographs of these two DHP copper samples were made (see Figures 11 and 12). The sample holding the most voltage had been subjected to work hardening annealing cycles. The other sample was not work hardened. The grain size of the first of these samples has a grain structure several times larger than the non-work hardened sample. The process of work hardening and annealing is known to increase crystal growth. This suggests that crystalline structure effects the voltage holding capacity of a material as was previously noted in UCRL-1962.

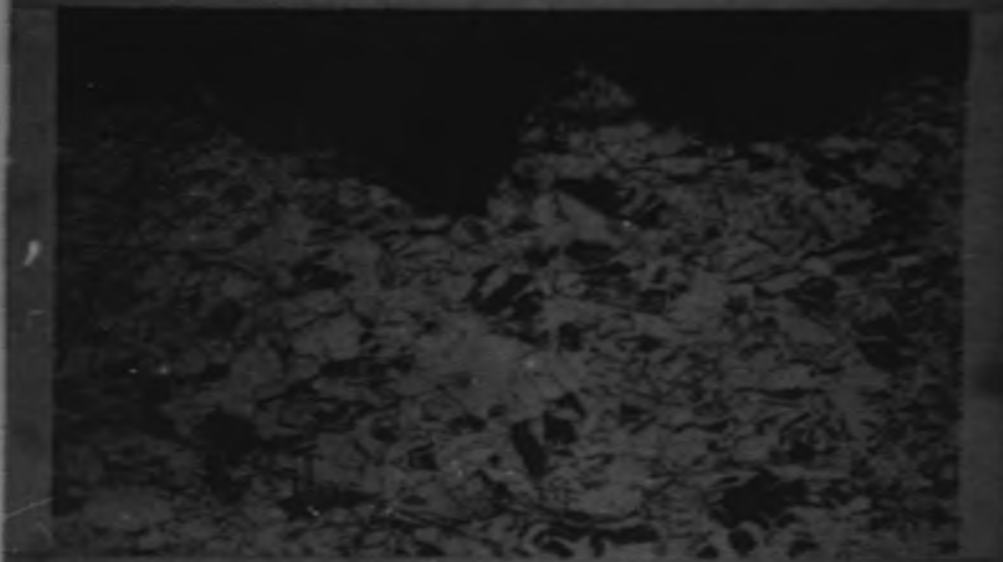
Fig. 12

Photomicrograph (68x) of grain structure in non-work hardened sample of DHP copper (surface shows spark craters)
