**MITIGATION AND MONITORING PLAN
FOR IMPACTED WETLANDS AT THE
GUNNISON UMTRA PROJECT SITE,
GUNNISON, COLORADO**

December 1994

**Prepared for
U.S. Department of Energy
UMTRA Project Office
Albuquerque, New Mexico**

**Prepared by
Jacobs Engineering Group Inc.
Albuquerque, New Mexico**

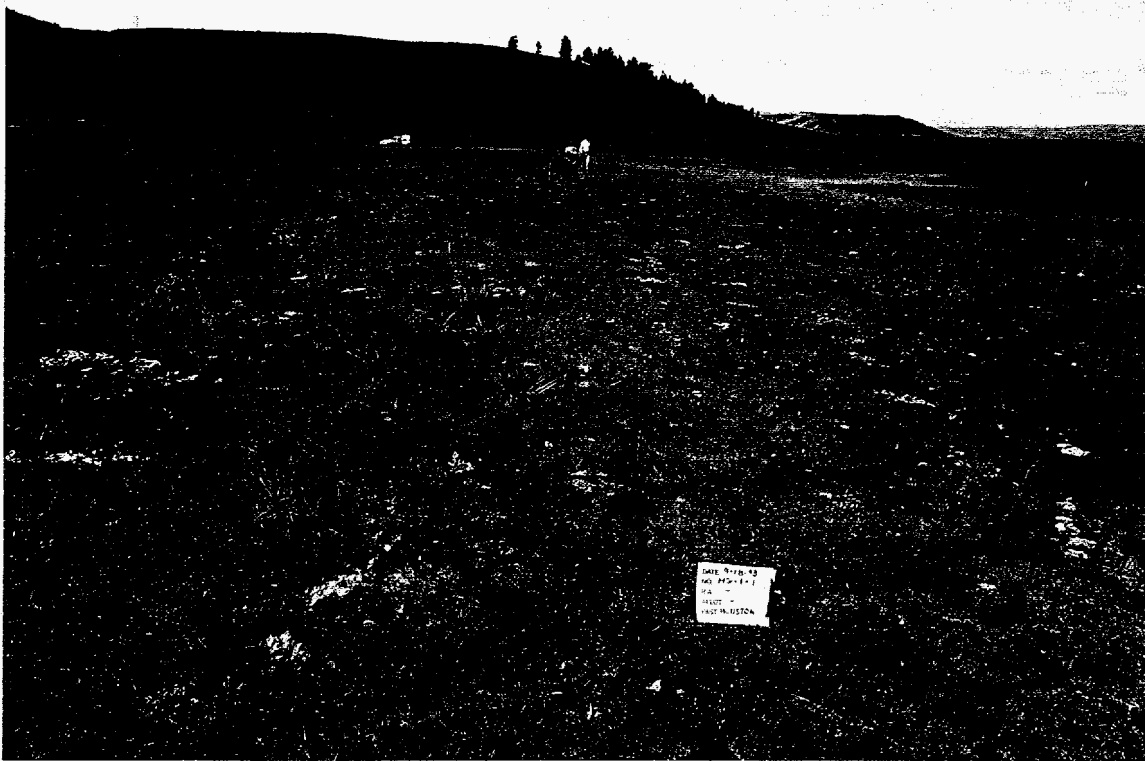
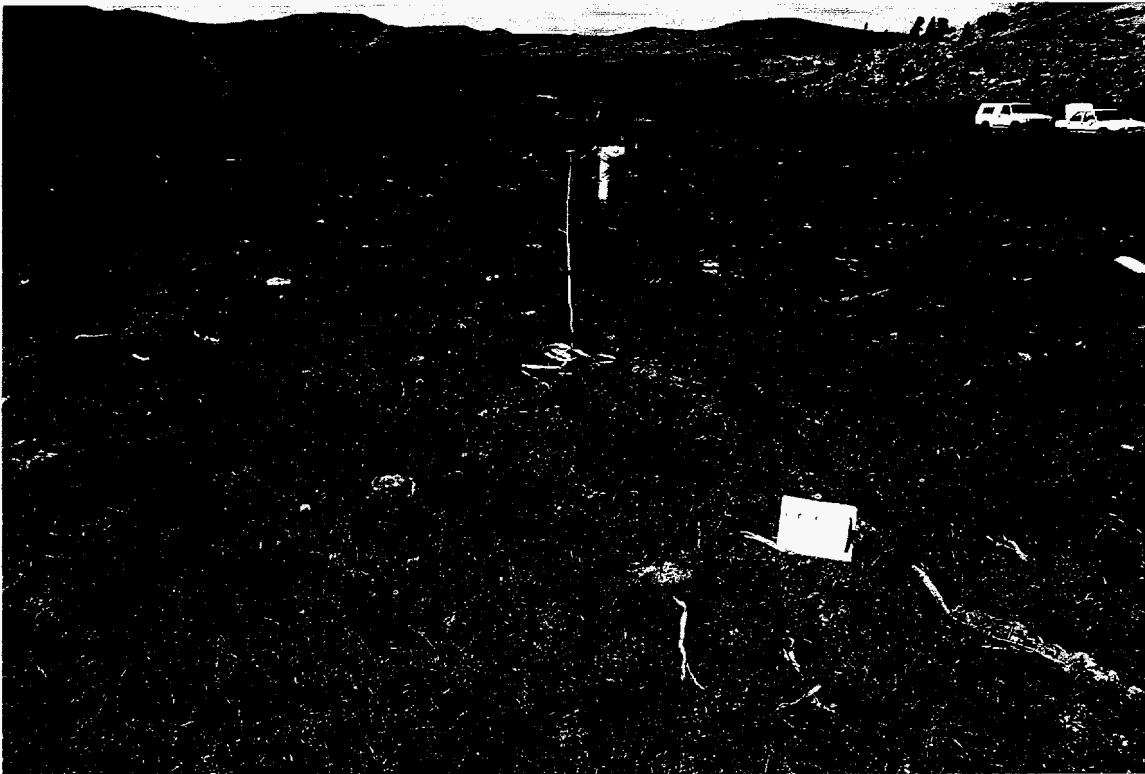
Photographic Series 1
Grazed Upper Riparian Grassland Plant Community

**UPPER RIPARIAN GRASSLAND PLANT COMMUNITY, HOUSTON GULCH
SEPTEMBER 1993**

**UPPER RIPARIAN GRASSLAND PLANT COMMUNITY, CAMP KETTLE SPRING
SEPTEMBER 1993**

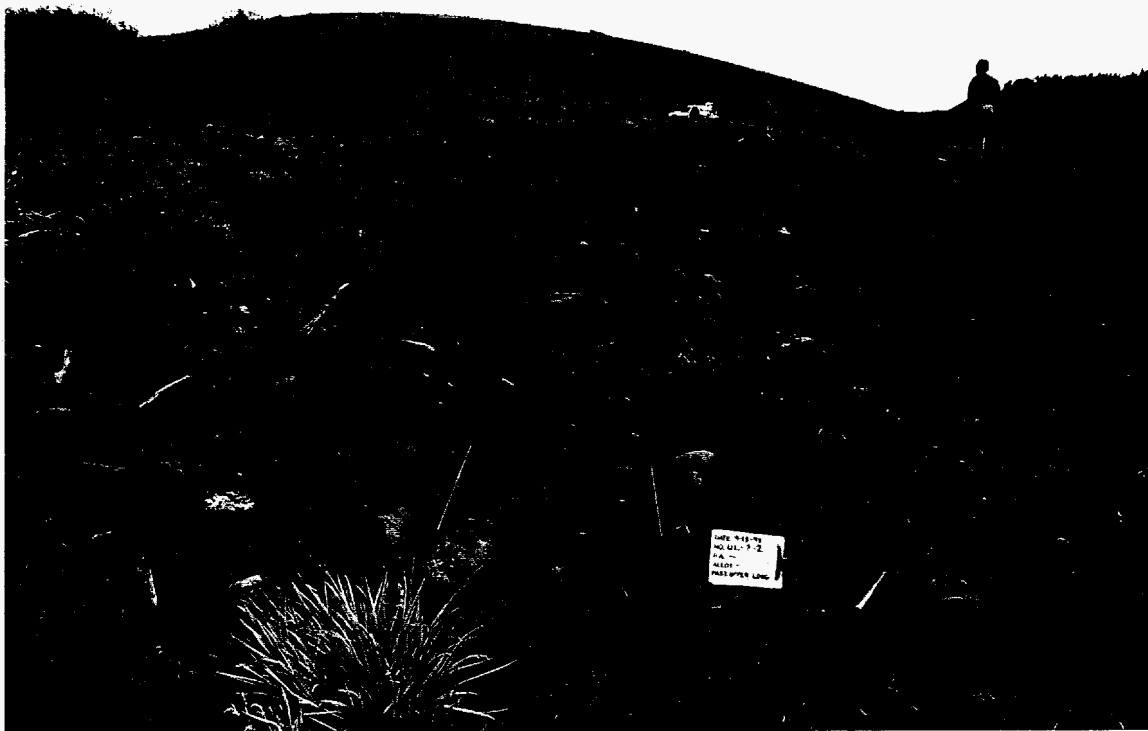
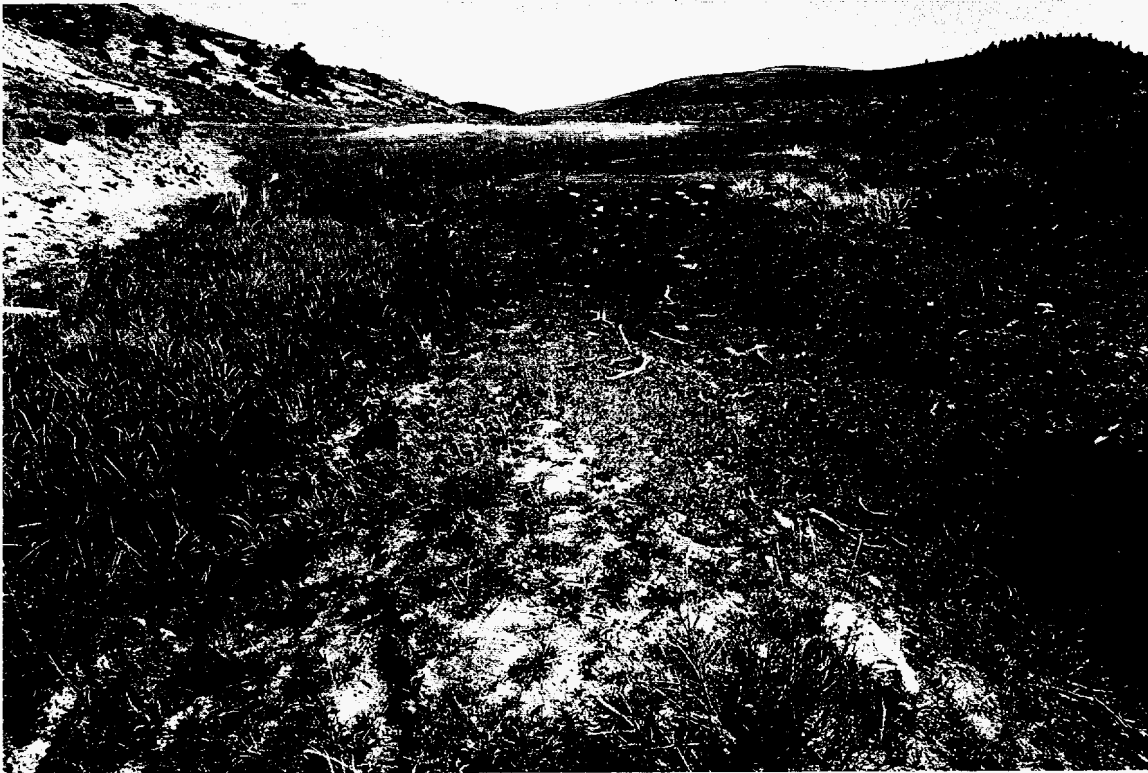
Photographic Series 2

Grazed Lower Riparian Grassland Plant Community

**LOWER RIPARIAN GRASSLAND PLANT COMMUNITY, UPPER LONG'S GULCH
SEPTEMBER 1993**

**LOWER AND UPPER RIPARIAN GRASSLAND PLANT COMMUNITY, HOUSTON GULCH
SEPTEMBER 1993**

Wetlands dominated by grass, baltic rush, and sedges occur in lower lying areas below the upper riparian plant community (Attachment C, Photographic Series 2). This lower riparian grassland plant community tends to have greater plant species diversity and more dominant plant species than the upper. Wetland hydrological conditions such as standing water, saturated soil, and gleyed soil and/or other indicators such as hummocks created by cattle activity were present.

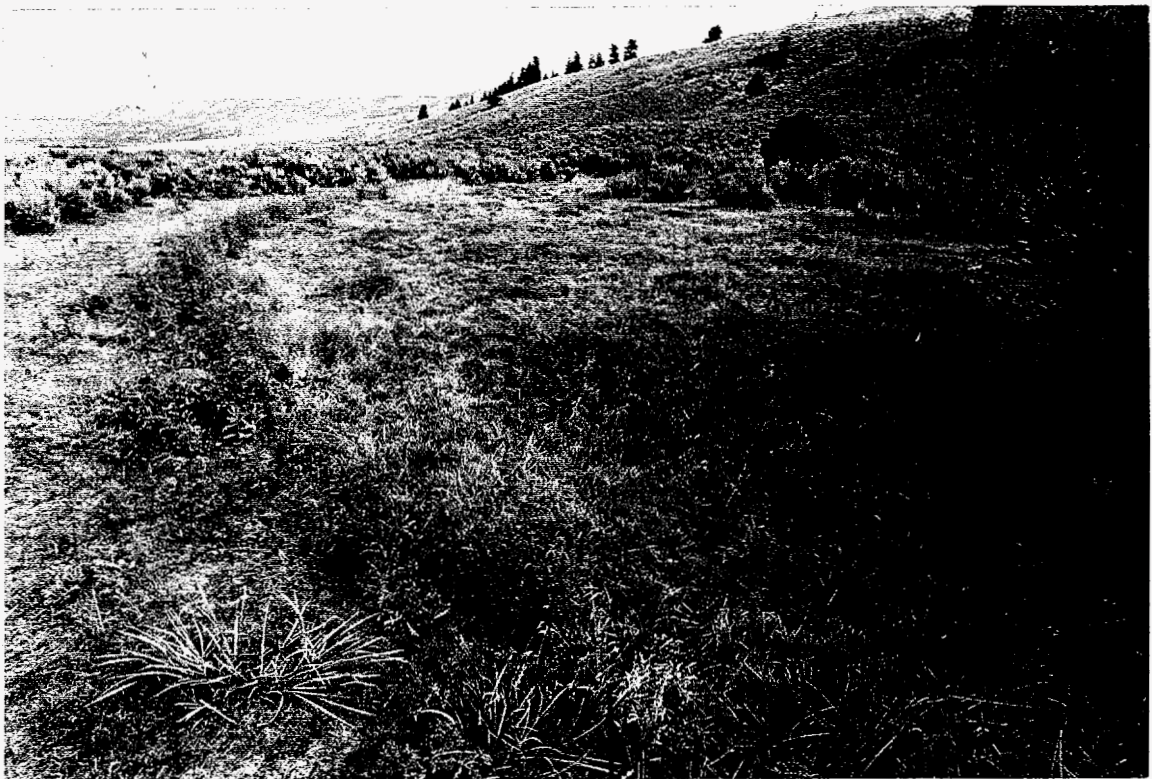
Photographic Series 3
Grazed and Ungrazed Sedge Wetlands

CAREX PLANT COMMUNITY, UPPER LONG'S GULCH, SEPTEMBER 1993

GRAZED CAREX PLANT COMMUNITY, SAGE HEN SPRING, SEPTEMBER 1993

A sedge-dominate plant community (beaked sedge [*Carex rostrata*] or water sedge [*Carex aquatilis*]) grows in the lowest lying areas at all the mitigation sites except Lower Long's Gulch (Attachment C, Photographic Series 3). This type of plant community consists of a homogenous stand of sedges with few other species. The sedge plant community grows in areas with generally permanent surface water or saturated soil conditions. This type of plant community was typically grazed only around the edges.

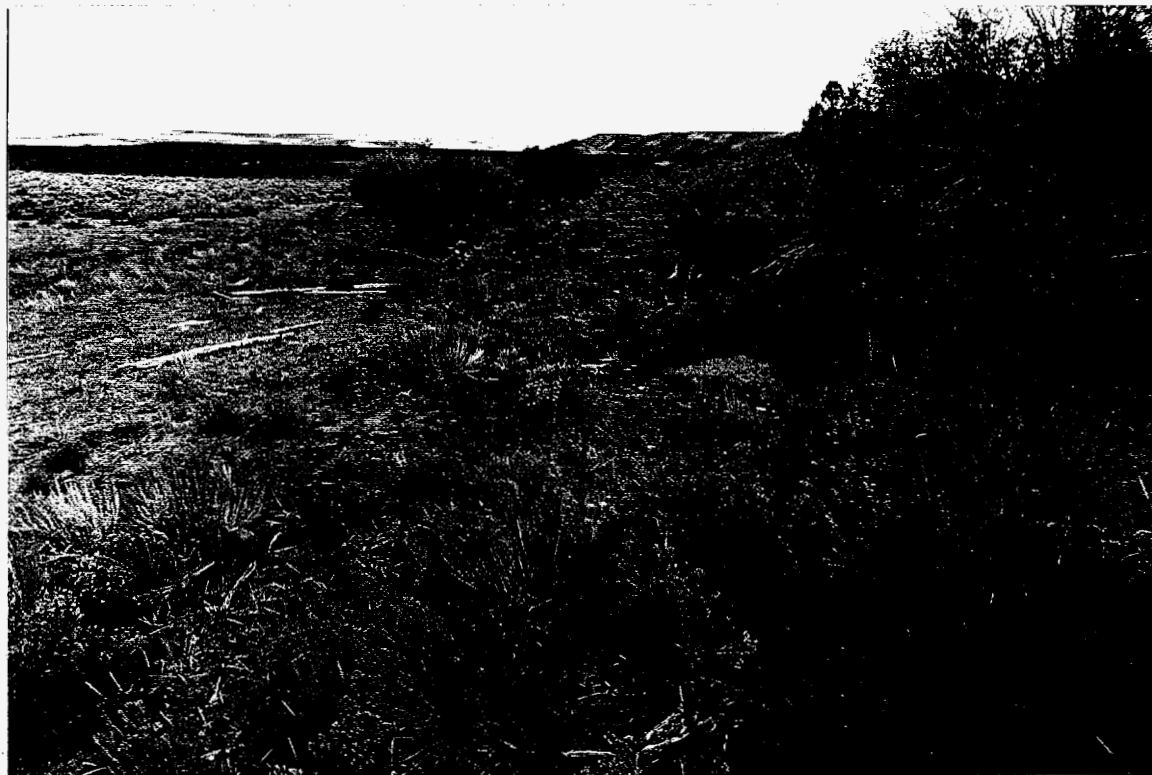
Photographic Series 4
Willow Thickets Impacted by Grazing

**WILLOW PLANT COMMUNITY, UPPER LONG'S GULCH, *CAREX* AND
UPPER RIPARIAN GRASSLAND PLANT COMMUNITY ALSO IN EVIDENCE
SEPTEMBER 1993**

WILLOW PLANT COMMUNITY, SAGE HEN SPRING, SEPTEMBER 1993

Willow thickets occur at three of the six mitigation sites (Attachment C, Photographic Series 4). The willows typically are damaged by cattle and are old plants. No willow reproduction was observed at these sites.

Willows may be interplanted within the 0.4 ac (0.2 ha) of existing degraded willow stands at the Upper Long's Gulch, Lower Long's Gulch, and Sage Hen Spring mitigation sites. These willow stands were severely damaged by livestock and many dead and partially dead willows were in evidence. Willows do not currently occur at the Prospector Spring, Houston Gulch, and Camp Kettle Spring mitigation sites and willows will not be planted at these areas.

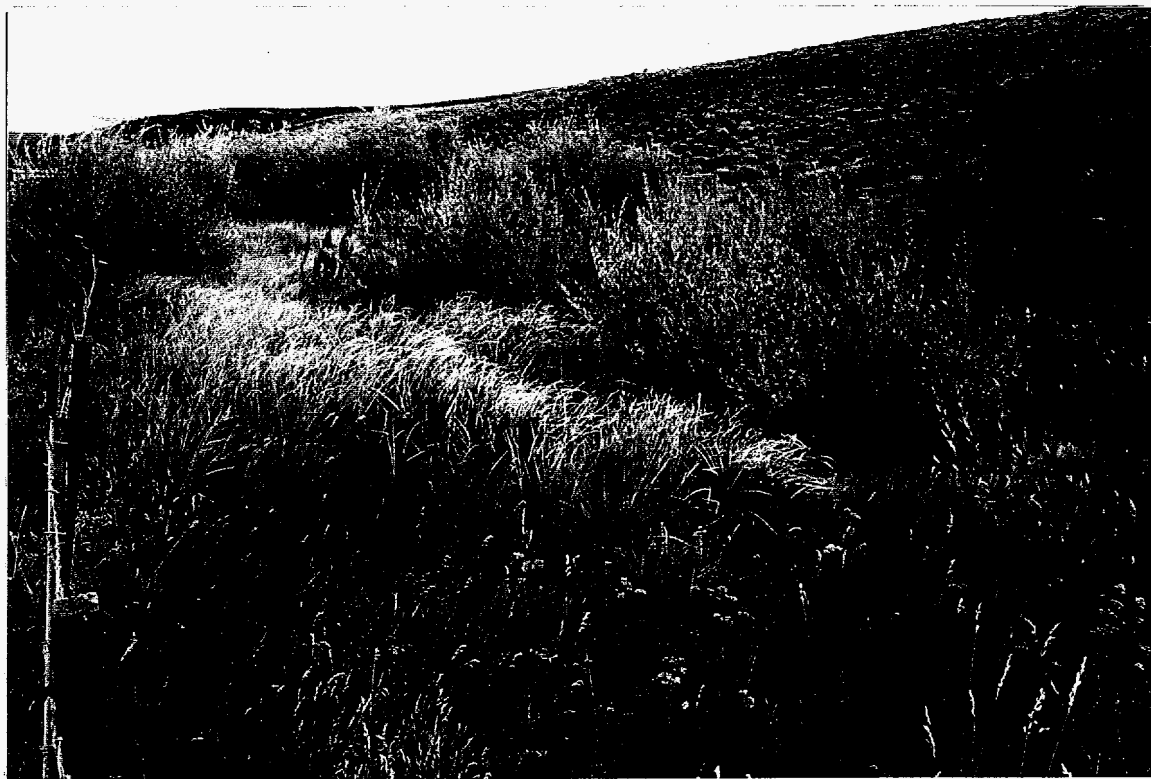
Photographic Series 5
Cattle Exclosure at Valdez Spring

VALDEZ SPRING EXCLOSURE, SEPTEMBER 1993

A cattle enclosure was placed around an approximate 0.3-ac (0.1-ha) area at Valdez Spring 10 to 12 years ago (Capodice, 1993). A marked difference between the plant growth inside and outside the fence was noted in September 1993 (Attachment C, Photographic Series 5). The plant community outside the fence looked like the heavily grazed upper and lower riparian grassland plant communities at the mitigation wetland sites. Fowl bluegrass grazed down to 1 to 2 inches (3 to 5 cm) was dominant. Inside the fence directly adjacent to this heavily grazed grassland was a dense growth of baltic rush 12 to 15 inches (30 to 38 cm) high. Very little bluegrass was observed; other frequently observed species in the upper riparian grassland type of the mitigation sites such as dandelion, aster, and yarrow were greatly reduced within the enclosure. Elsewhere inside the fence, a healthy stand of *Carex* sp. (probably beaked or water sedge) had developed. This sedge was not restricted to saturated ground; it grew in moist soil conditions. Willows of various ages also were scattered throughout the fenced area. Foxtail barley, which is fairly common in the six mitigation sites, was very limited; it grew only in soil disturbed by gopher activity (TAC, 1993). The enclosure at Valdez Spring probably was not planted and the plant growth observed here established itself naturally. The Valdez Spring enclosure was not monitored so no information is available on how long it took this area to recover from heavy cattle grazing. However, the conditions observed at this site provide significant information regarding the vegetational changes that will occur at the mitigation sites.
