PNL-8618
UC-~~510~~ 902

106-AN GROUT PILOT-SCALE TEST
HGTP-93-0501-02

L. M. Bagaasen

May 1993

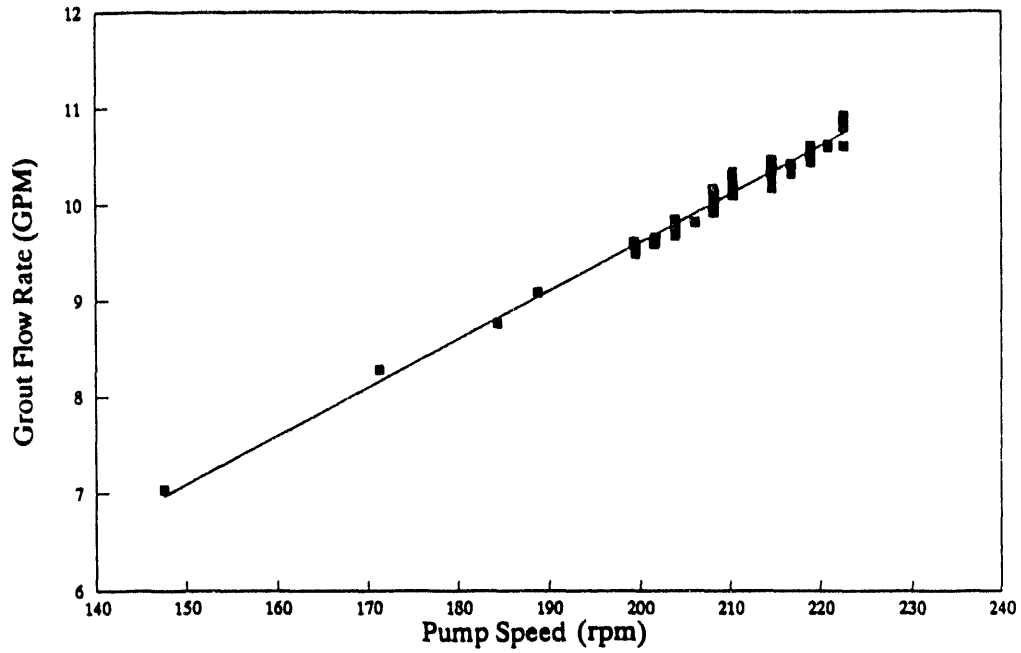
FIGURE 4.1. Grout Pump Speeds and Flow Rates During Main Production Run

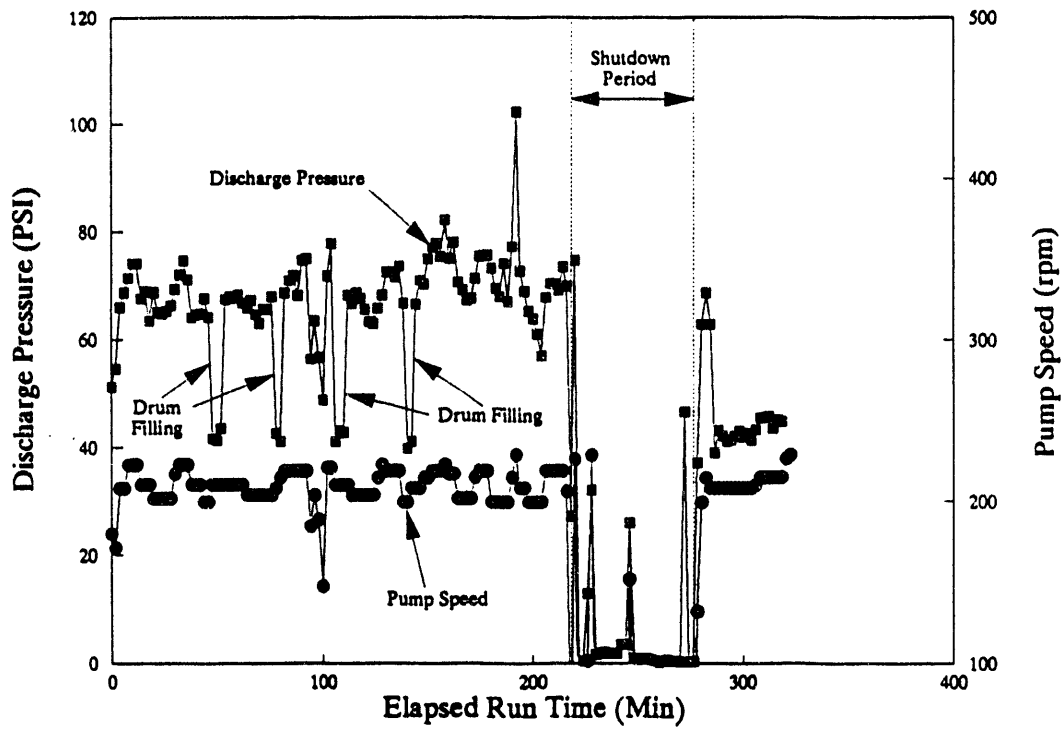
FIGURE 4.3. Grout Pump Speeds and Discharge Pressures During Main Production Run

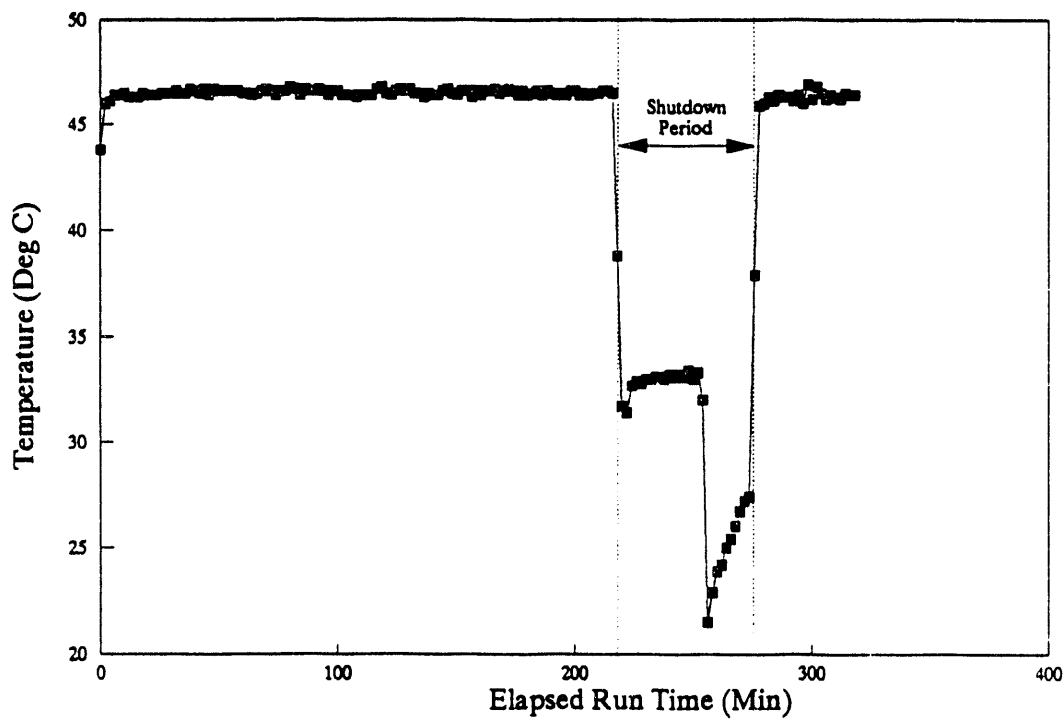
FIGURE 4.4. Waste Inlet Temperature

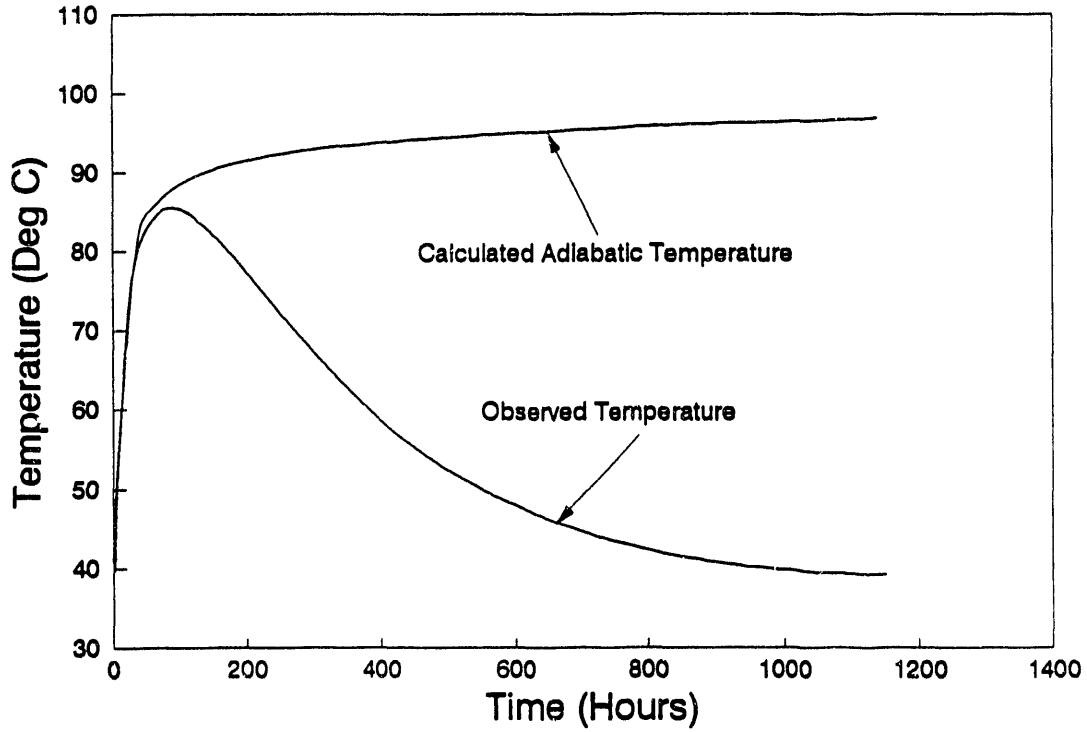
FIGURE 6.5. Calculated Adiabatic Temperature and Observed Temperature in Gradient Mold

Figure 6.5 shows the observed and calculated adiabatic temperature as a function of time. The calculated adiabatic temperature rise after 7 weeks of curing (assuming a starting temperature of 40°C) is 57°C, and the maximum calculated adiabatic temperature is 97°C.

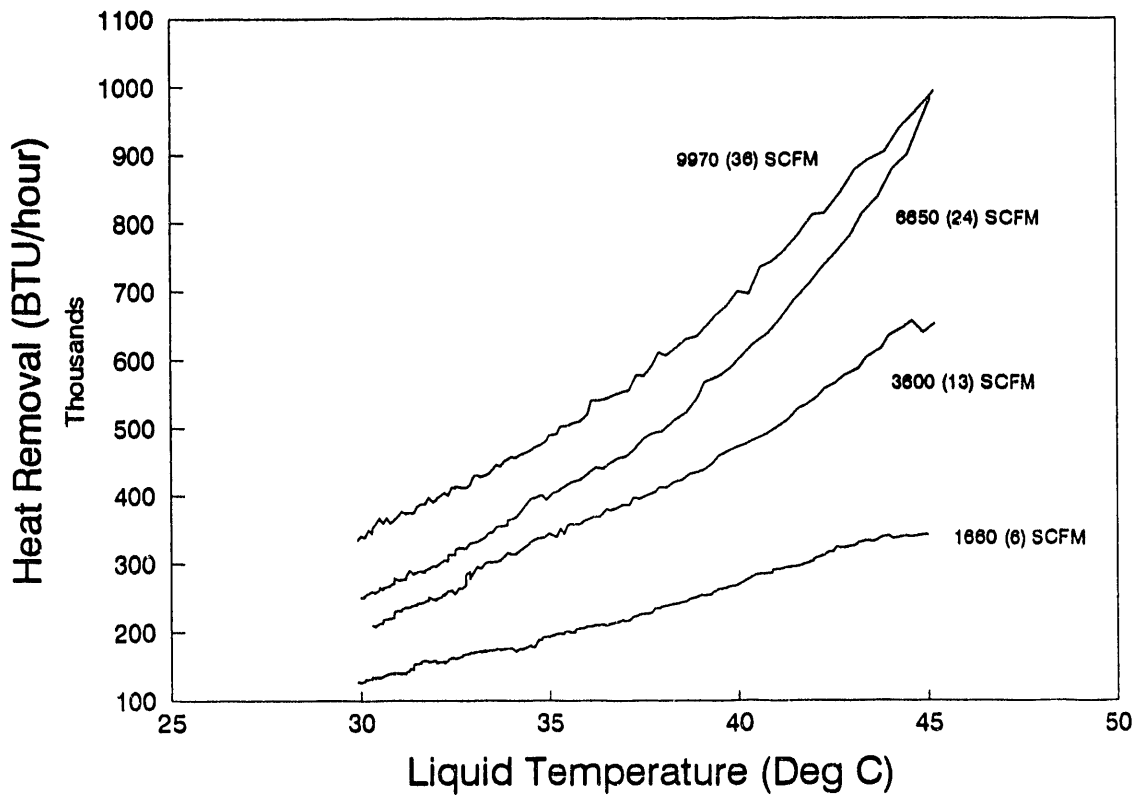
FIGURE 6.8. Heat Removal from the Surface of a NaNO₃ Solution

Figures 6.7 and 6.8 show that the heat removal was a strong function of liquid temperature with 2 to 3 times more heat removal at 45°C compared to 30°C. The rate of airflow also affected heat removal rates. Increasing the airflow from 1660 (6) scfm to 3600 (13) scfm significantly increased the heat removal rates. The outlet air conditions in the 1660 (6) scfm case were saturated (100% RH for the water, 96.5% RH for the salt solution) for all liquid temperatures tested. This indicates that the potential for evaporation of the water or salt solution was greater than the removal rate of a 1660 (6) scfm airflow. Increasing the airflow to 3600 (13) scfm removed sufficient quantities of water to bring the outlet conditions below saturation for liquid temperatures below 39°C. Thus, at 3600 (13) scfm the evaporation rate from the surface became the limiting process, and cooling was not proportional to airflow.

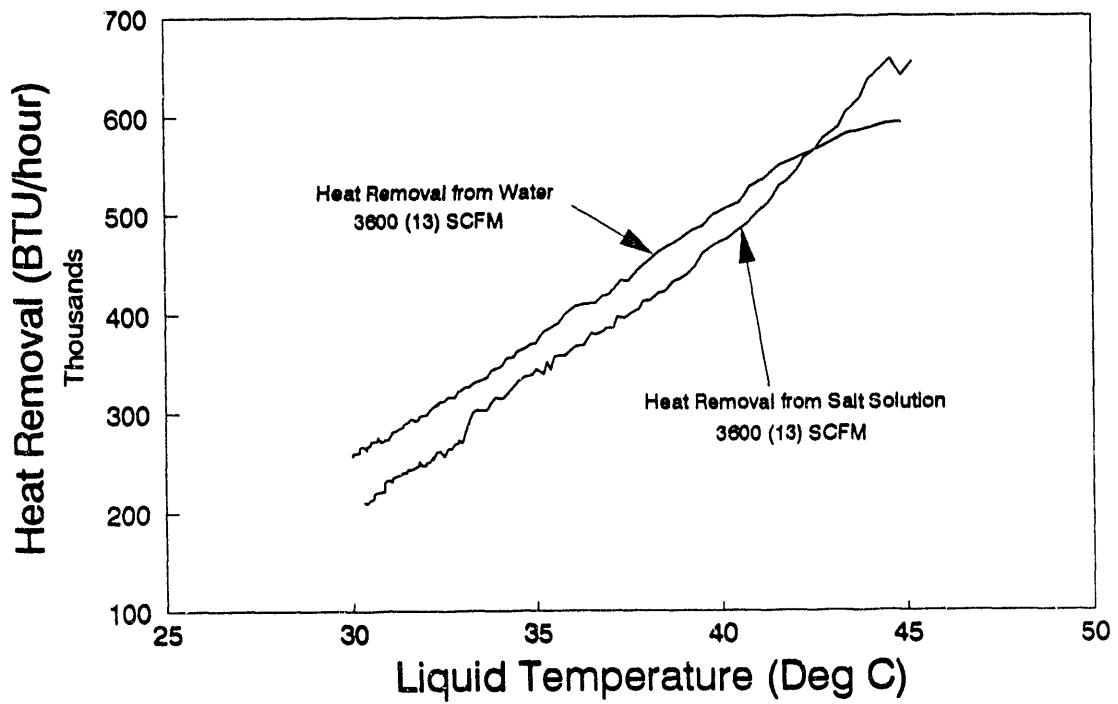
FIGURE 6.9. Comparison of Heat Removal from Water and NaNO₃ Solution with a 3600 (13) scfm Airflow

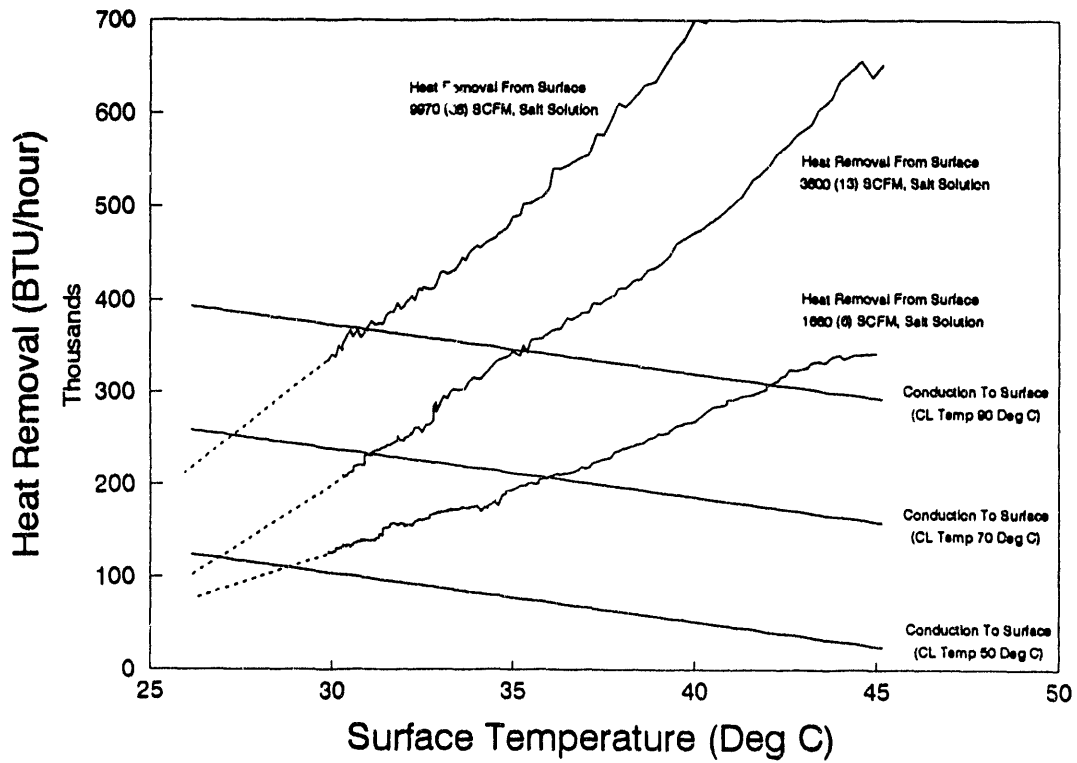
FIGURE 6.10. Rate Limiting Step in Grout Heat Removal

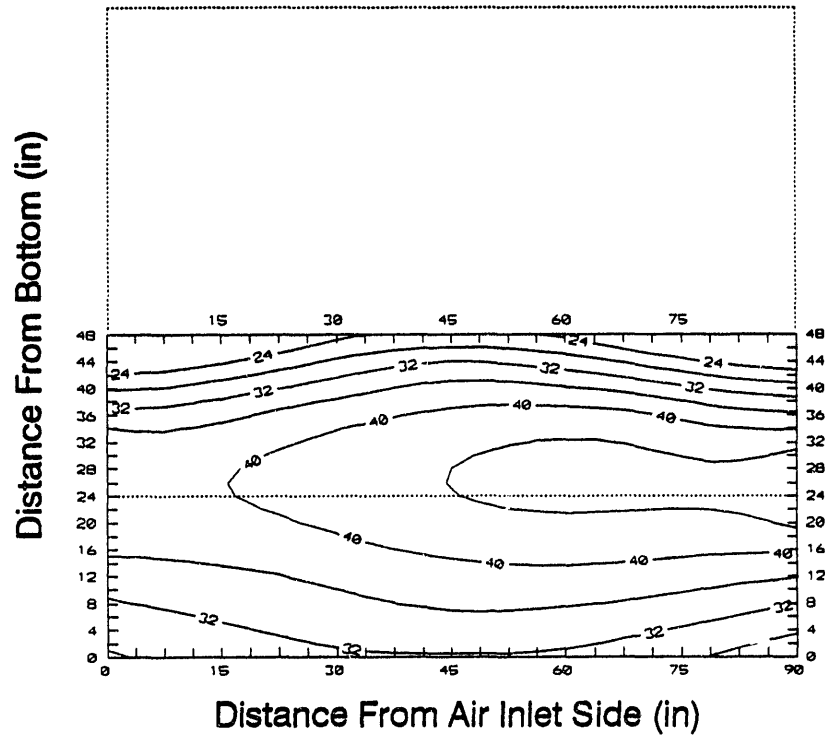
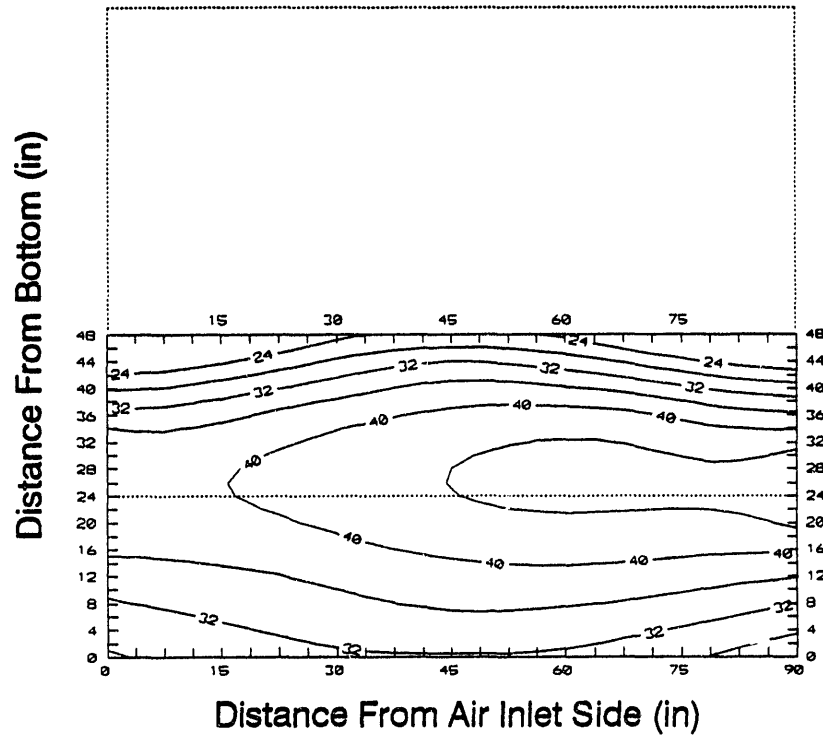
FIGURE 6.21. Temperature Profile After Cooling Lift 2 for 1 Week
(Centerline Temperatures at $t = 332$ hours)

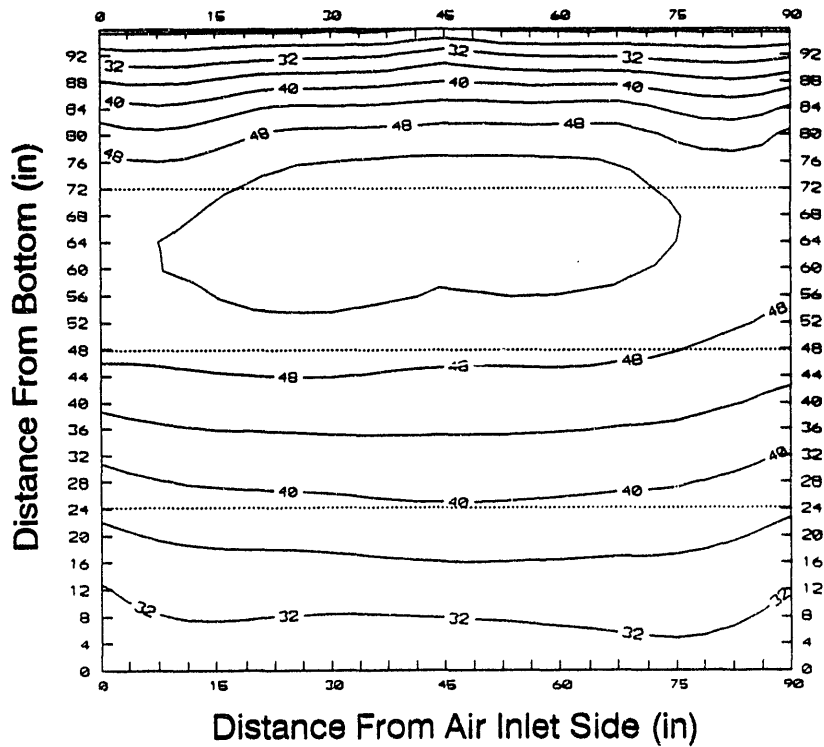
FIGURE 6.25. Temperature Profile After Cooling Lift 4 for 1 Week
(Centerline Temperatures at $t = 668$ hours)

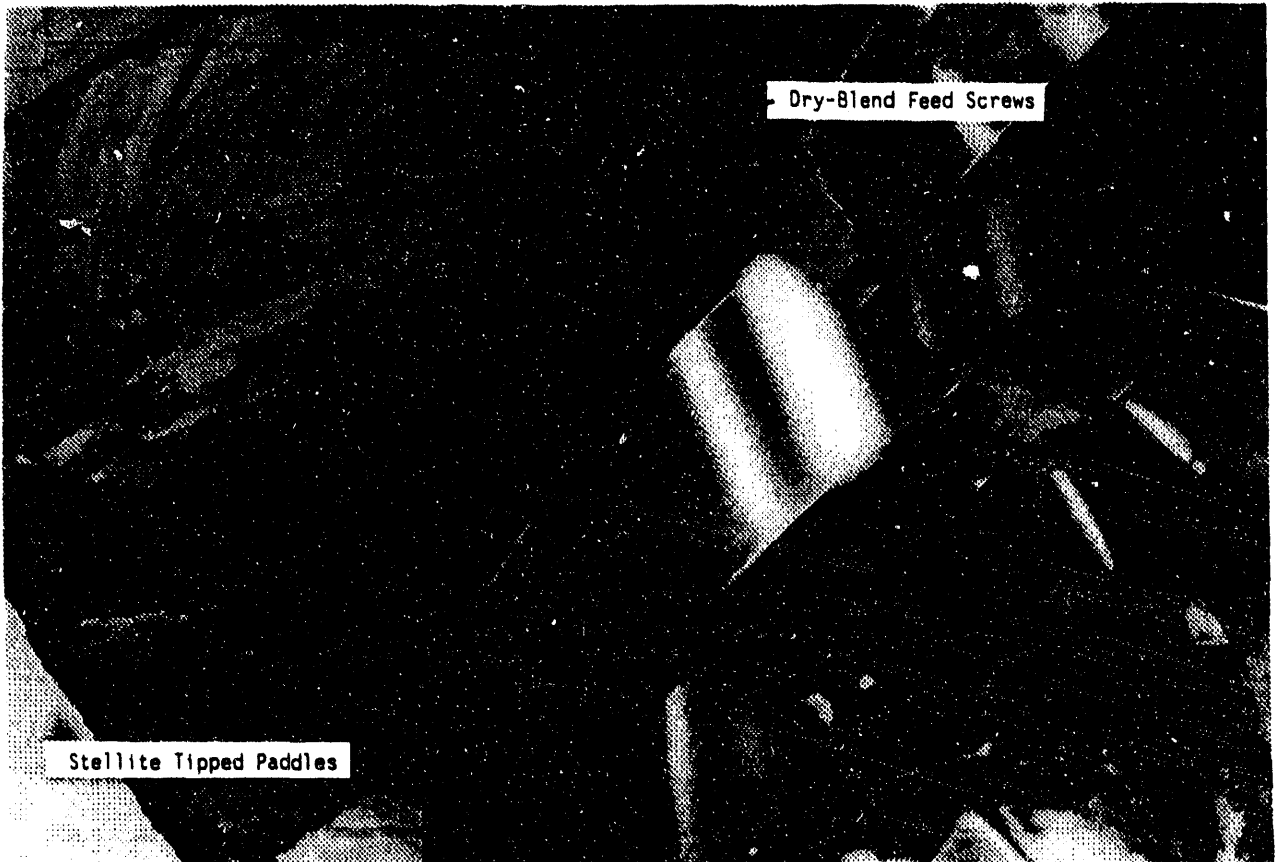
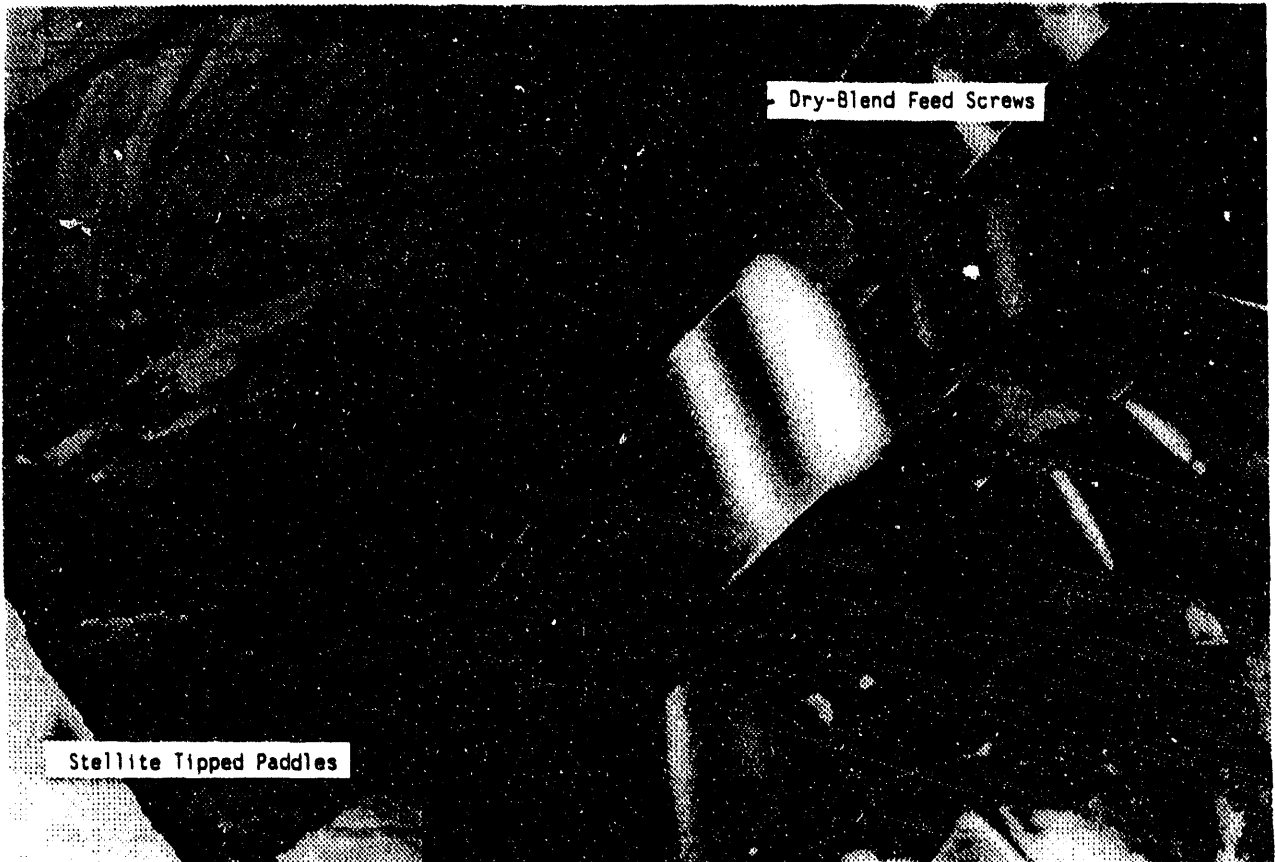
FIGURE 7.5. Stellite Tipped Mixer Paddles Under Waste Feed Inlet

Significant wear on the first set of mixer paddles and the dry-blend feed screws was observed in previous pilot-scale pours (Fow et al. 1987). For the current pilot-scale tests, dry-blend feed screws were replaced with stellite feed screws and the first four pairs of mixer paddles were replaced with stellite-tipped paddles. Since the production mixer has stellite components, the wear seen in this pilot-scale test should be more representative of the wear that might be expected in the production equipment. Figure 7.5 shows that there is little wear on either the first paddle or the feed screws. This indicates that stellite components reduce wear concerns.

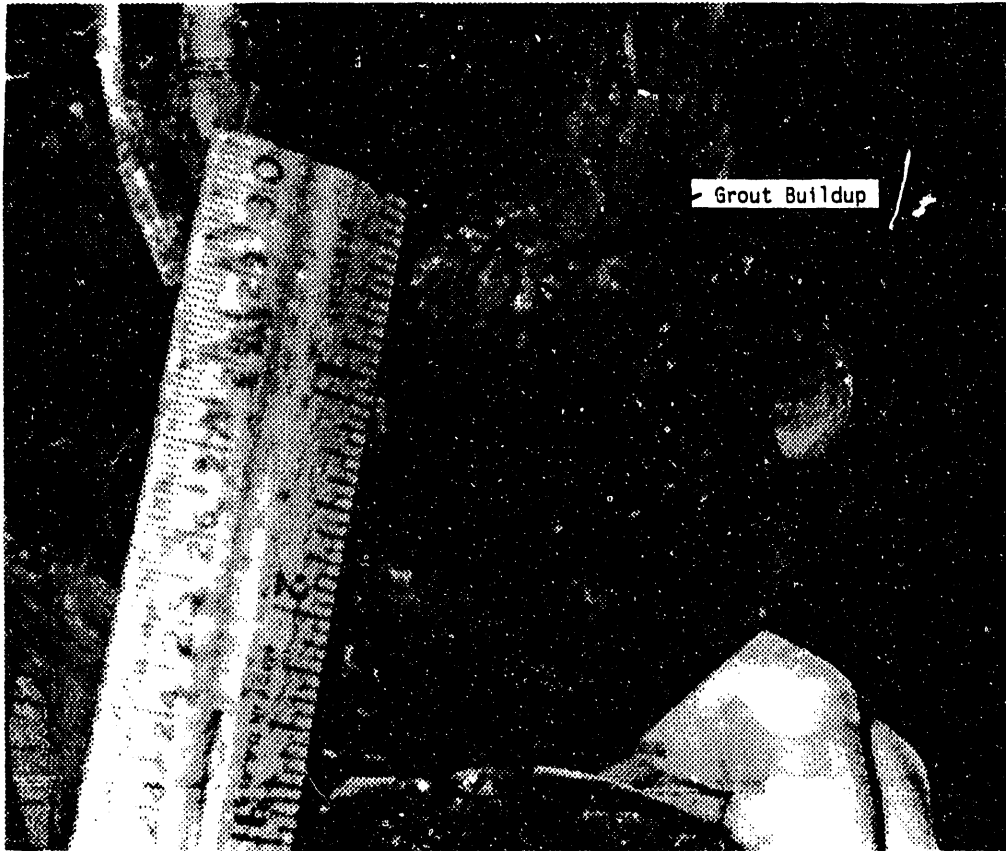
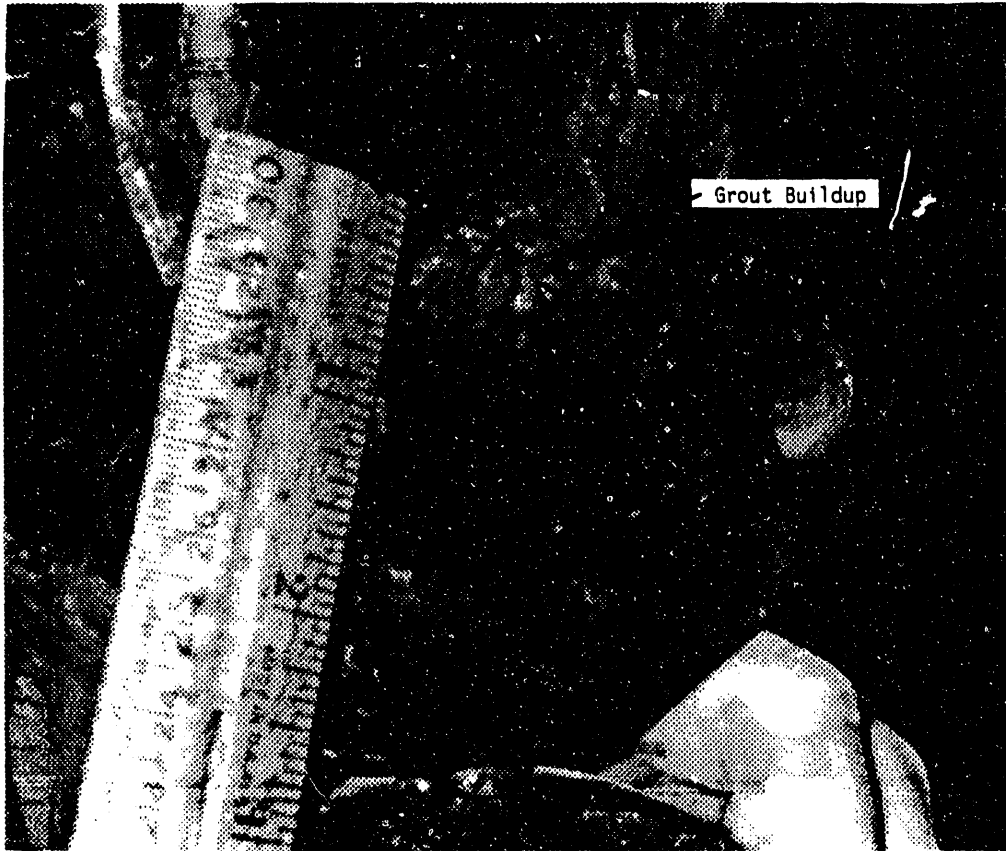
FIGURE 7.10. Grout Buildup at Pump Discharge
