PNL-SA-23641

POST-IRRADIATION DEFORMATION CHARACTERISTICS
OF HEAVY-ION IRRADIATED 304L SS

J. I. Cole^(a)
S. M. Bruemmer

Presented at the
17th International Symposium for the American
Society for Testing and Materials
June 1994
Sun Valley, Idaho

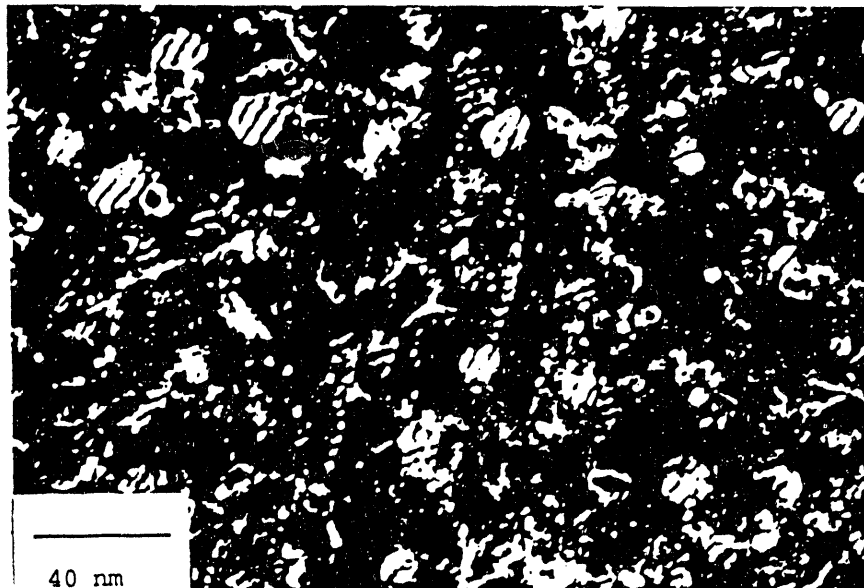
FIG. 3--Weak beam dark field micrograph of 304L SS ion-irradiated to 5 dpa

Interactions of the growing loops leads to the formation of the dislocation tangles. The weak beam TEM micrograph shown in Figure 3 of the 5 dpa sample shows more clearly the presence of the faulted Frank loops.

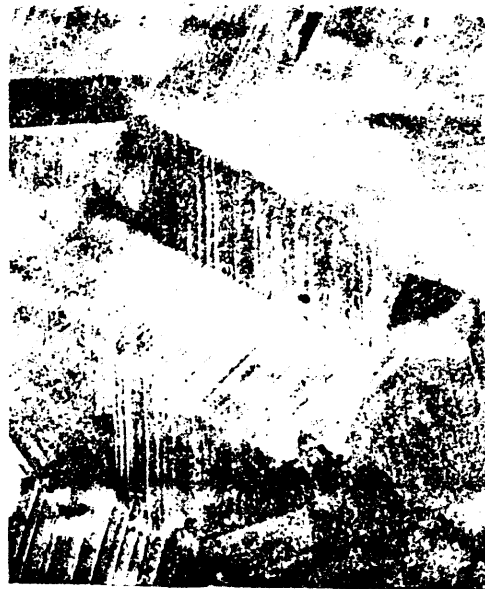
Fig. 4--SEM Micrographs of the 304L SS surface: (a) unirradiated and deformed to 5% at 25°C (b) irradiated to 5 dpa and deformed to 5% at 25°C (c) irradiated to 5 dpa and deformed to 10% at 288°C

Surface examination of the samples after tensile deformation indicated that fundamental differences existed in deformation characteristics between the irradiated and unirradiated regions. All of the samples examined in the SEM exhibited steps or ledges on the surface following deformation (Figure 4). Within each sample, the density of ledges varied greatly from grain to grain. However some general trends with strain, dose level, and temperature were observed. A higher density of ledges was seen in the 0 and 1 dpa samples compared to the 5 dpa samples at equivalent strain when deformed at 25°C. The density of ledges in the 0 and 1 dpa samples appeared to saturate at a strain of about 2%, becoming more pronounced in straining up to 10% (Figure 4a). In comparison, the density of steps nearly doubled in the 5 dpa sample in straining from 5% to 10%. Ledges in the 5 dpa sample deformed to 10% at 25°C (Figure 4b) were not as distinct as in the unirradiated case, which may have been a result of lower strain in the irradiated region caused by radiation-induced hardening. Straining to 10% at 288°C (Figure 4c) produced a high density of very faint ledges which are much shallower than in the sample deformed at 25°C.
