BNWL-SA-6002

Corrosion Experience in Nuclear Waste  
Processing at Battelle Northwest

For presentation at the NACE Conference  
San Francisco, California  
March 14-18, 1977

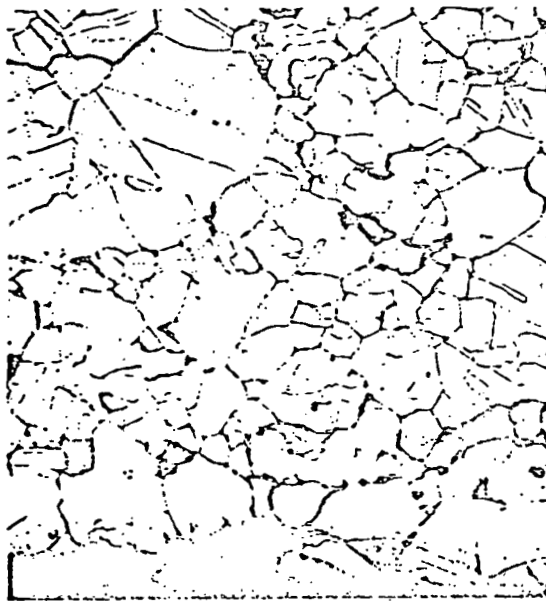
FIGURE 3. Photomicrographs of Canister Wall Section  
from WSEP Canister 36--Sample Area #1  
(Oxalic Acid Electrolytic Etch)

We have had experience of one canister failing via a cracking mechanism. The canister was made of 310SS and contained radioactive waste from the WSEP Program.<sup>(6)</sup> The canister was stored one year in water, followed by 3 1/2 yr of air storage at 400°C, and then 10 months in water at 50°C, which was when the failure occurred. The water showed high amounts of dissolved oxygen and 13 ppm chloride. A Huey test was run on samples from this canister along with samples from a 304L canister which had been stored in air for 2 years at 400°C. The results, given in Table 2, show that both samples were eventually sensitized. The samples had weight losses representing a uniform penetration rate of 40 mil/month. Micrographs indicate gross intergranular cracking near the fracture area. Intergranular cracking is indicative of stress assisted cracking, not stress corrosion cracking. Areas free of macrocracks were also free of microcracks. Figure 3 has a picture of the inside and outside edge of a piece in the area of the crack.

Internal Surface Edge 75X

External Surface Edge 75X

Internal Surface Edge 225X

External Surface Edge 225X

The cracking of this canister was not unexpected; the canister was stored under very adverse conditions and was severely sensitized. Canisters of 304L, taken directly from the ICM furnace, have much lower Huey Test corrosion rates. The maximum corrosion rate for samples taken from the walls of these canisters was 1.15 mil/month and samples from the neck were 9.1 mil/month. The means, under the operation conditions seen at this time for the ICM melter, sensitization of any importance exists only in the neck. This will not always be true in every case and not if the process steps change.
