ORNL-1868

DISASSEMBLY AND POSTOPERATIVE EXAMINATION
OF THE AIRCRAFT REACTOR EXPERIMENT

OAK RIDGE NATIONAL LABORATORY
Oak Ridge, Tennessee
operated by
UNION CARBIDE CORPORATION
for the
U.S. ATOMIC ENERGY COMMISSION

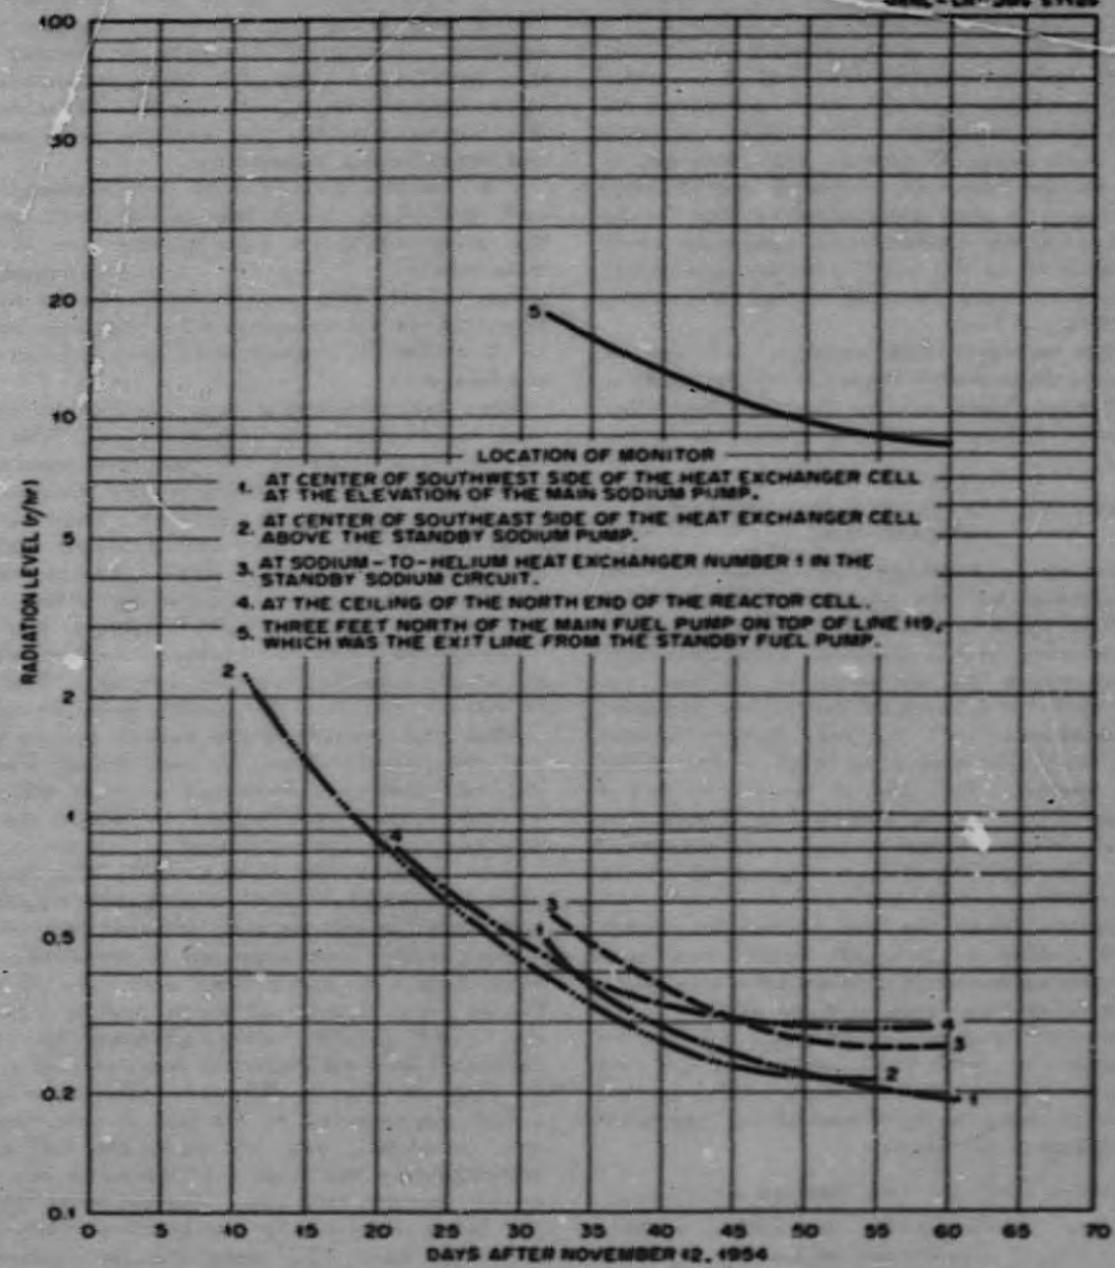
Fig. 4. Radiation Decay Curves for Five Locations in ARE System.

Radiation surveys were used as a basis for planning the disassembly sequence and techniques. The radiation decay curves obtained from data taken daily at five monitoring points are shown in Fig. 4.

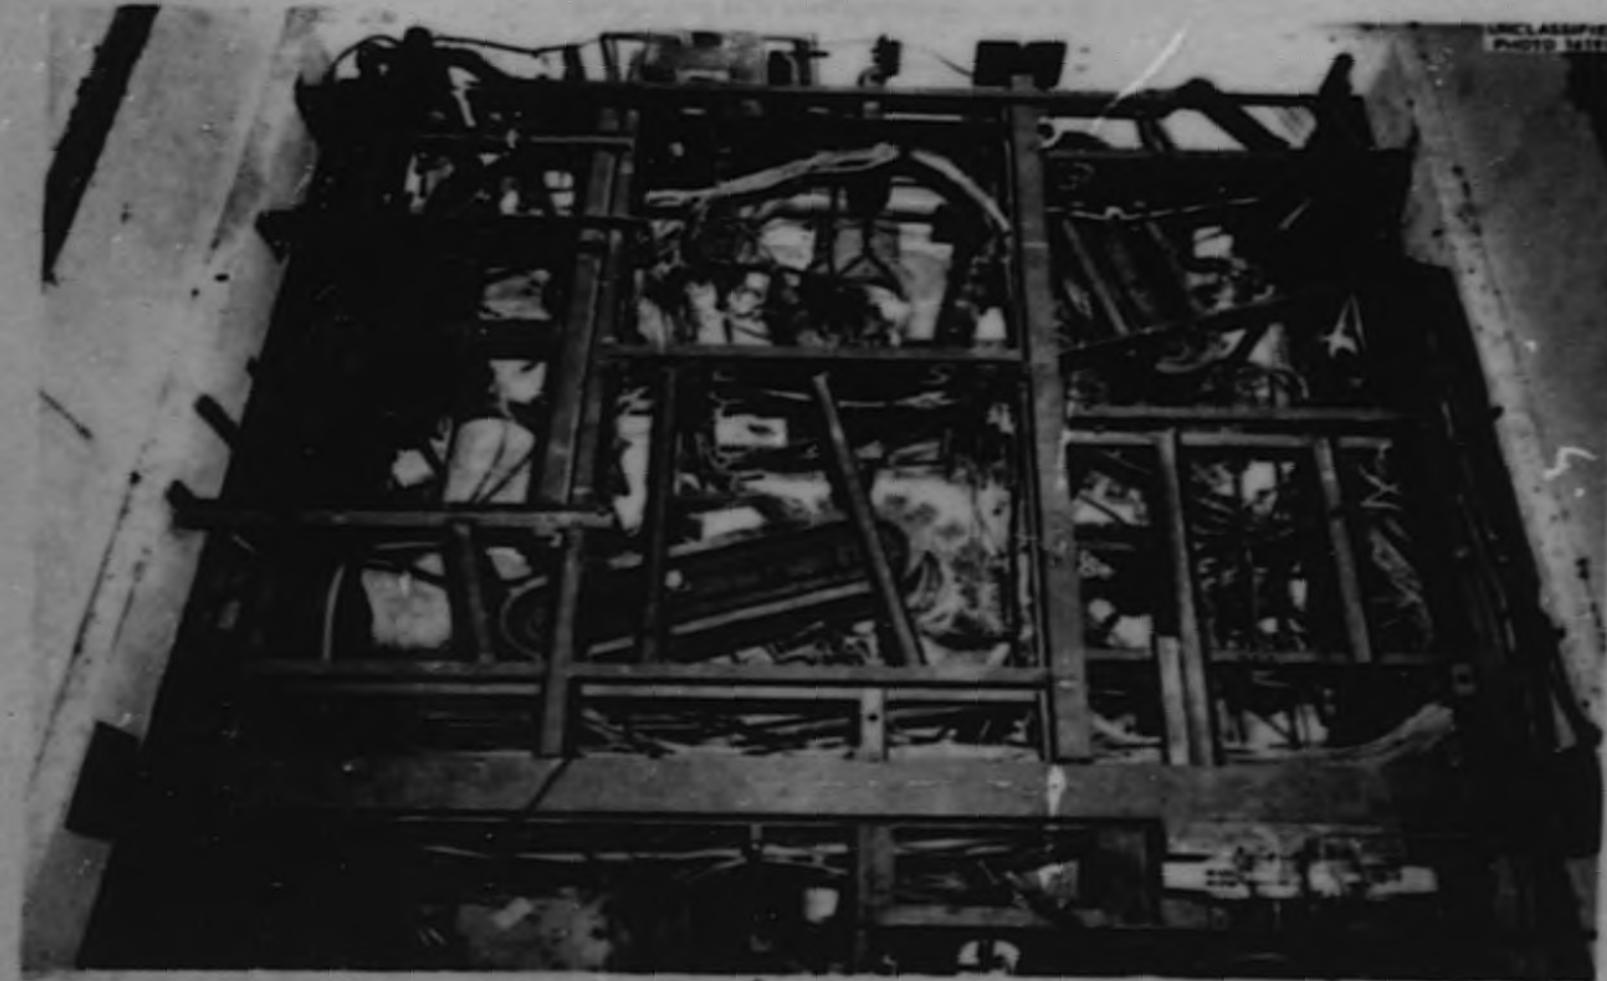
Fig. 6. Heat Exchanger Pit Showing Components of Fuel System Before Dismantling Operation.

The components of the fuel system are illustrated in Fig. 1, and a photograph of the cell containing the fuel pumps is presented in Fig. 6. The disassembly work was started with the main fuel pump which was causing a high radiation field. Removal of the rotary assembly caused a small burst of air activity that cleared in 2 to 3 min. The radiation level of the rotary assembly was 20 r/hr at 5 ft. After removal of the rotary assembly, the lines to the pump were cut and sealed and the pump was lifted out of the cell, as shown in Fig. 7. The radiation level of the main fuel pump bowl was 900 mr/hr at 5 ft. The standby fuel pump was removed in a similar manner. This pump was not used during

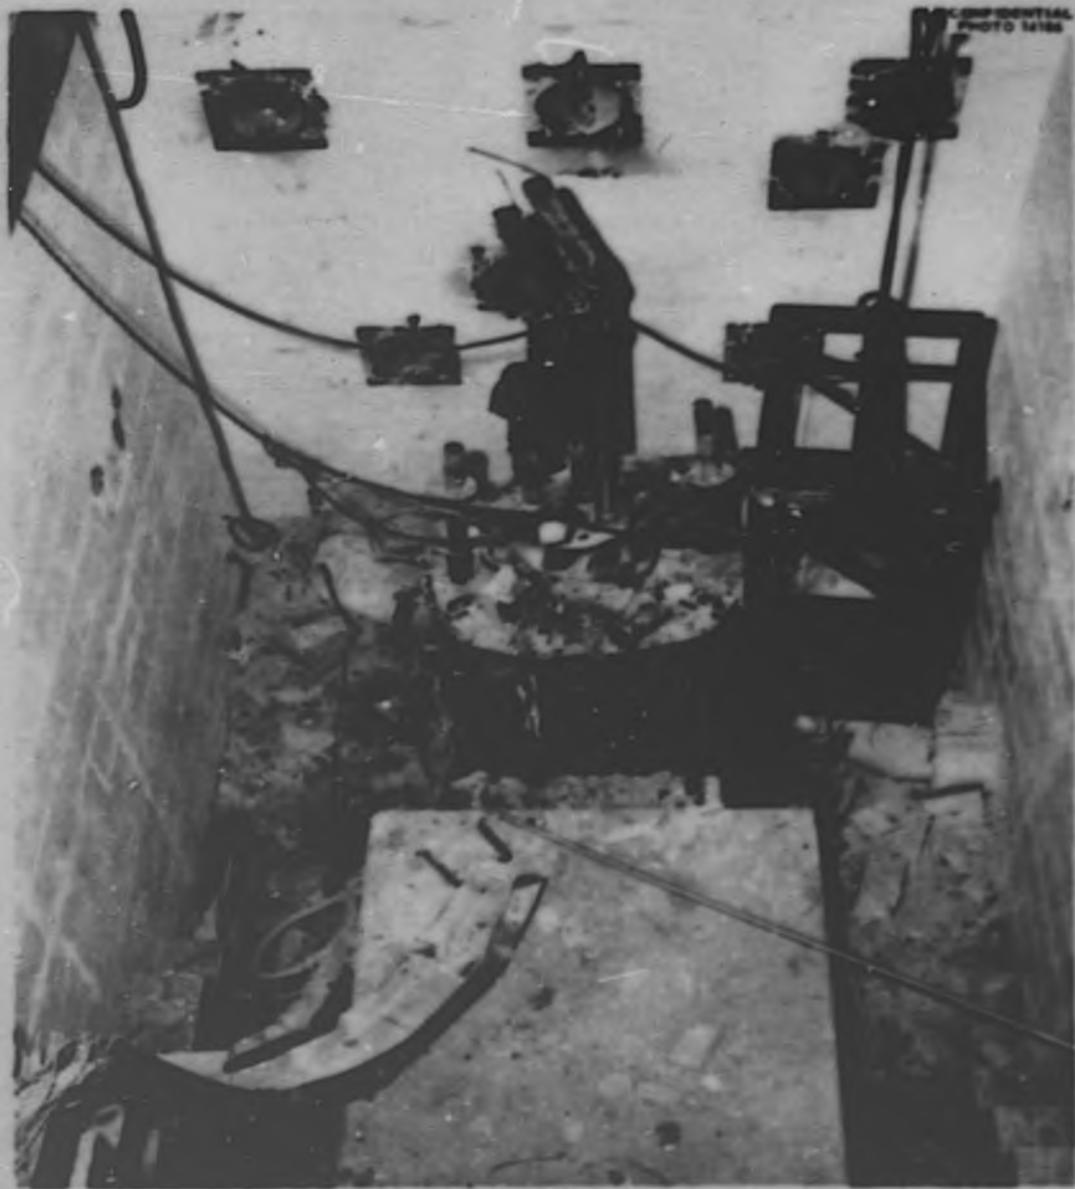
Fig. 9. Gas-Tight Shell Being Removed from Reactor.

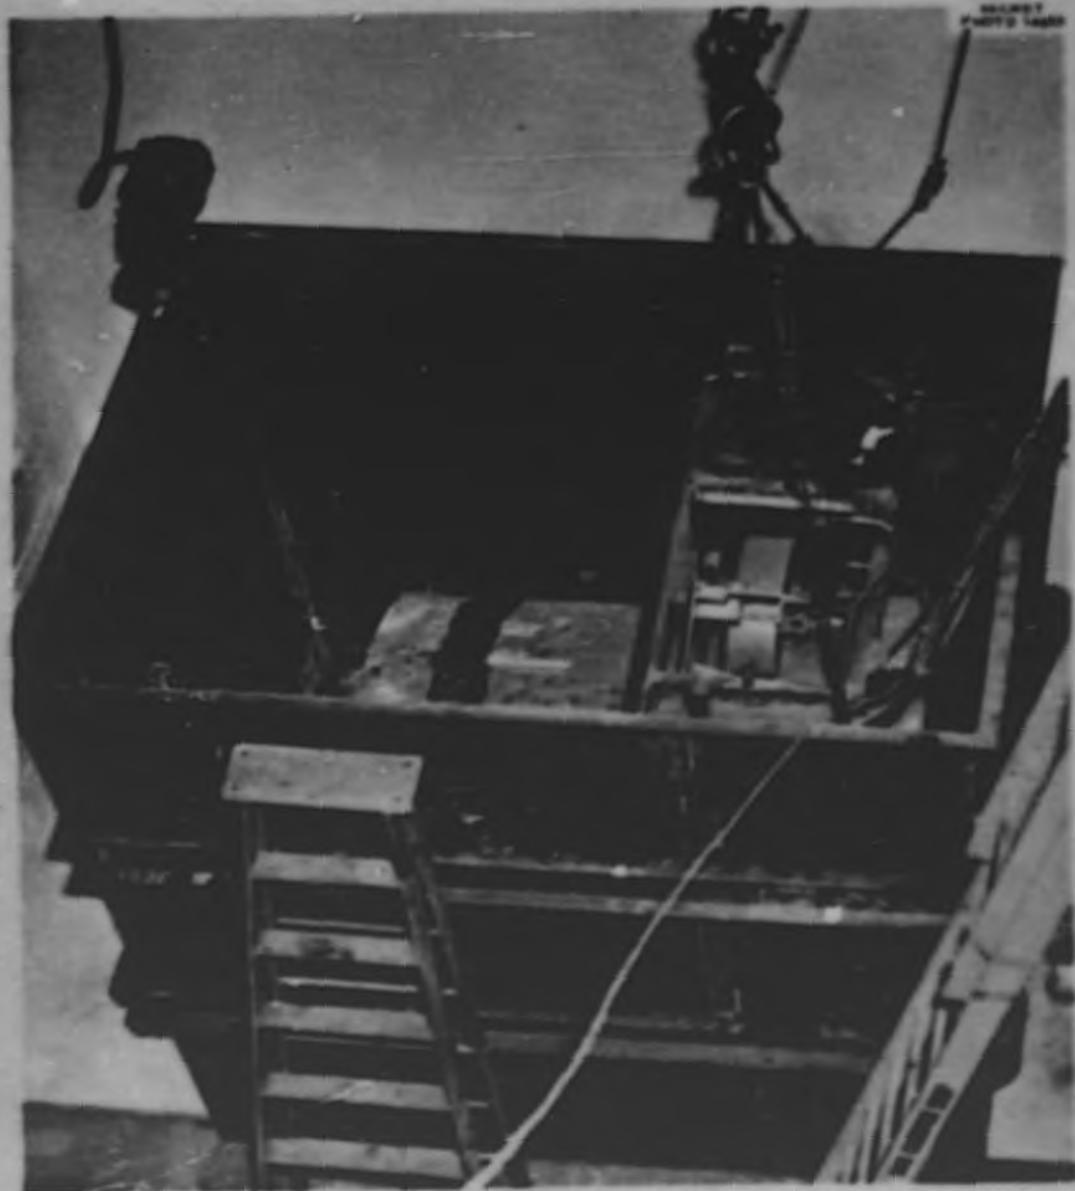
Fig. 10. Reactor Positioned in Disassembly Tank for Grinding.

is shown in Fig. 10 positioned in the tank for grinding, and the cutting side of the grinder, which was designed to be used under liquid, is shown in Fig. 11. With this equipment, a period of five 8-hr days was required to cut the 2-in.-thick pressure shell. Upon removal of the shell, a radiation check was made. The

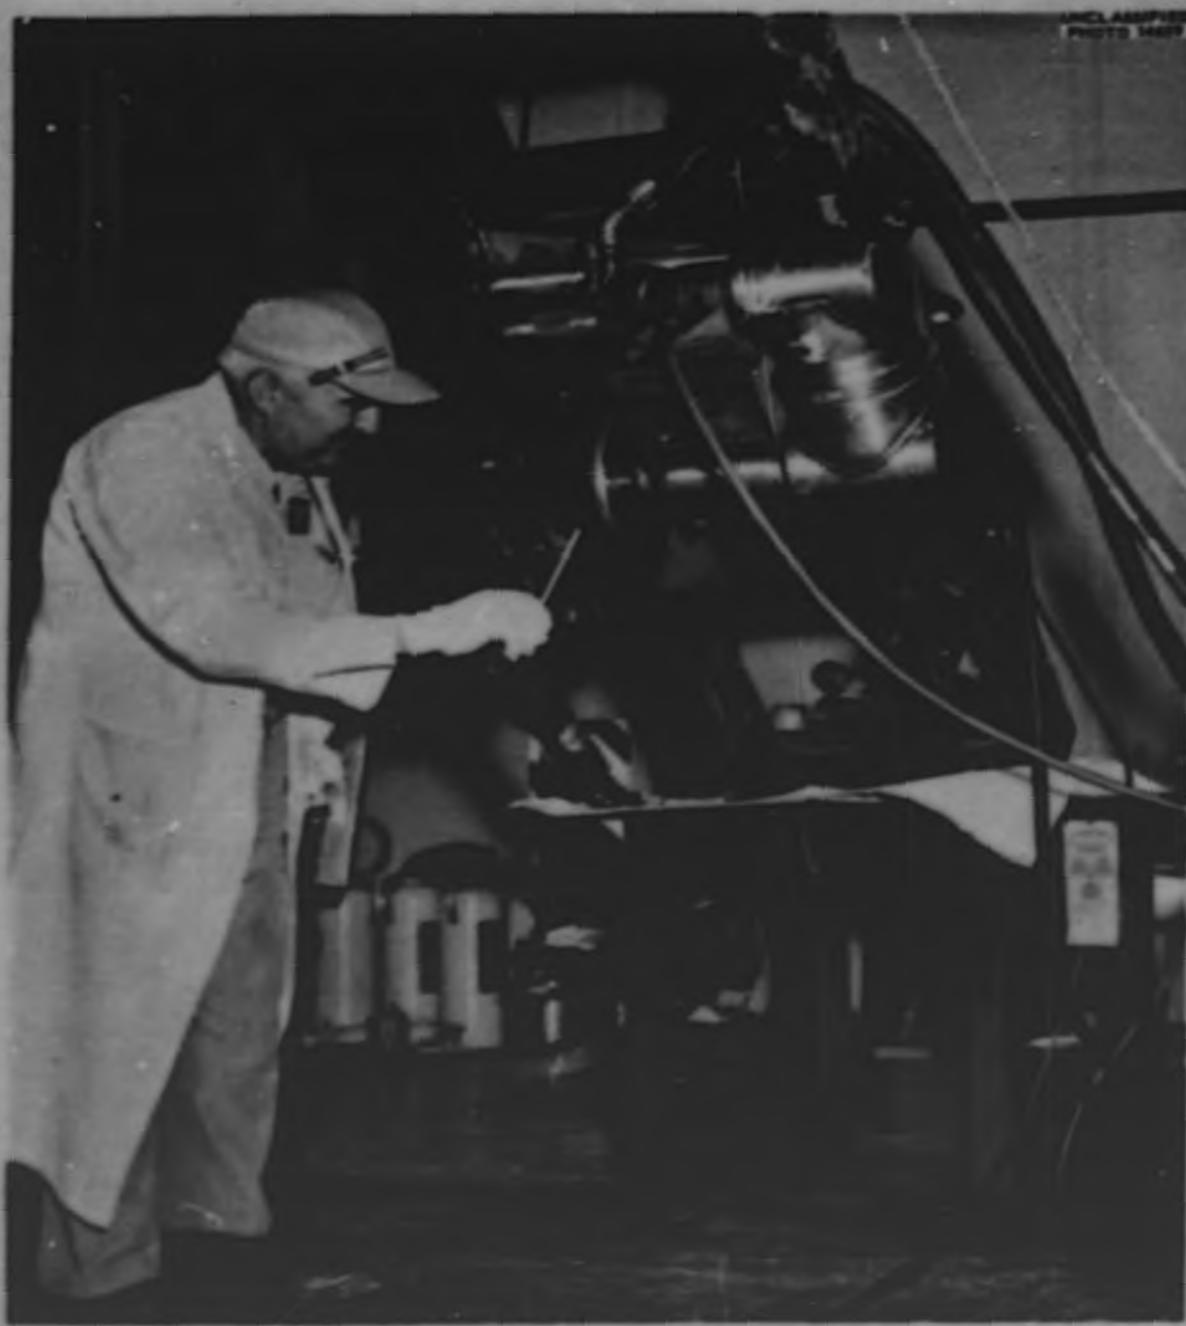
Fig. 11. Cutting Side of Grinder for Dismantling the Reactor.

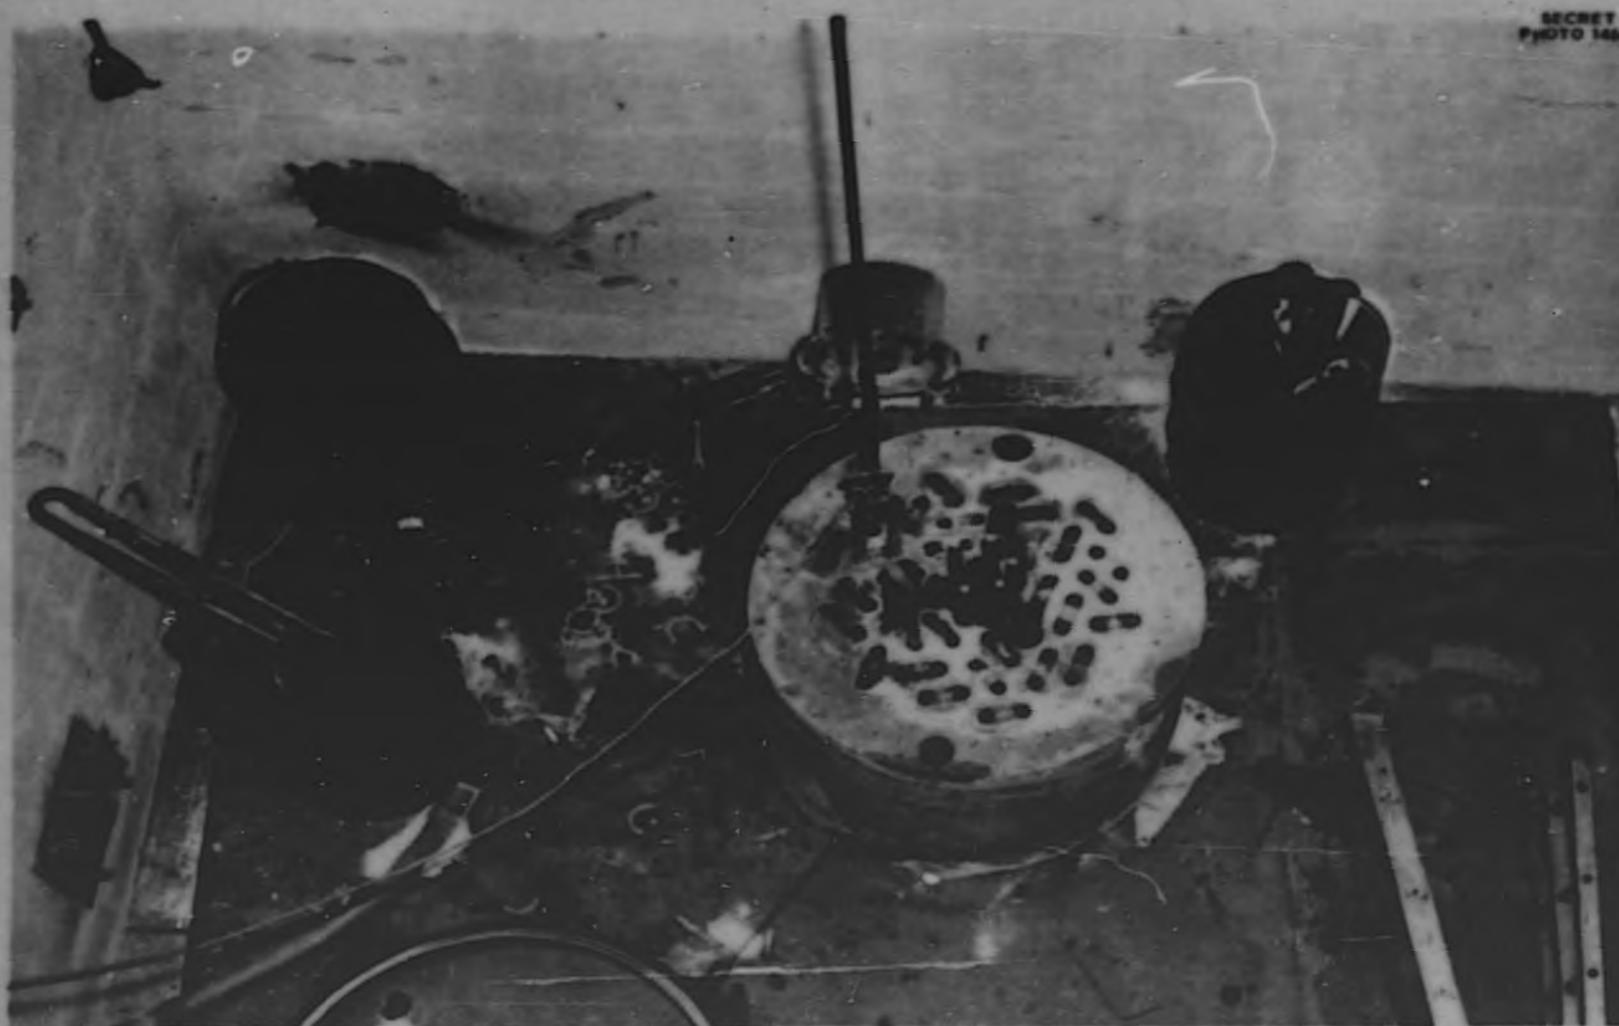
The next task was the removal of fuel tubes and samples of the BeO moderator blocks. The fuel tubes and the BeO blocks were encased in a stainless steel can with welded seams, shown in Fig. 12, and the small sodium tubes

Fig. 12. Top of Reactor After Removal of Pressure Shell and Some of the Sodium and Fuel Tubes.

that penetrated the BeO blocks were welded to the top and bottom of the can. In order to free the top of the can, the welds holding the sodium tubes were drilled out and the outer edge of the can was cut. The reactor was then placed in a horizontal position and the fuel tube bonds were cut off flush with the bottom of the can. After removal of the bottom tube bonds, the reactor was set upright and the crane was used to pull out the fuel tubes and to place them in drums, as shown in Fig. 12.

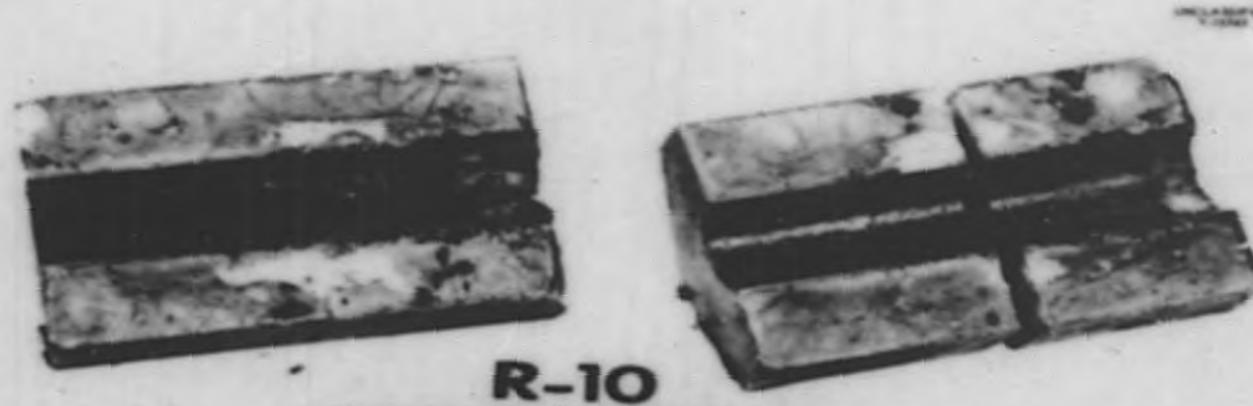
R-10

The block shown in Fig. 14, which had surrounded a fuel tube in the central region of the reactor, has many visible cracks and one half of the block had fractured. Previous tests of the as-received blocks had revealed that nearly all the blocks had at least one crack and some of the blocks had several cracks.³ Comparison with photographs of the as-received blocks showed that slight erosion of the edges occurred during reactor operation. The presence of small flakes of BeO adhering to the surface of the block indicated some spalling.

Fig. 14. BeO Block Which Had Surrounded a Fuel Tube in the Central Region of the Reactor.

The blocks that were removed are shown in Figs. 14, 15, and 16. It was found that draining the reactor had left the surfaces of the BeO blocks essentially free of sodium. Since it was not necessary to strip sodium from the blocks it could be assumed that any damage that was found during the initial examination had occurred during operation or was present in the as-fabricated material. The post-test handling could not have caused further damage.

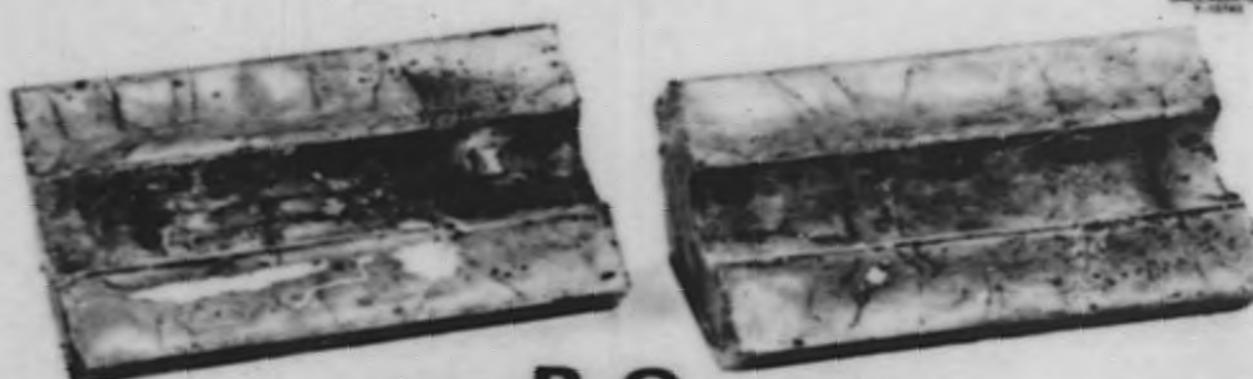
R-9

A BeO block that surrounded a fuel tube in the outer region of the reactor is shown in Fig. 15. The droplets visible on the surface are sodium hydroxide produced from sodium that remained after removal from the reactor. There were no complete fractures of this block, but many cracks are visible.

Fig. 15. BeO Block Which Had Surrounded a Fuel Tube in the Outer Region of the Reactor.

Only the BeO block taken from the outer region of the core (Fig. 15) was examined to determine the depth of penetration of the sodium. The dark areas in the transverse sections shown in Figs. 17 and 18 indicate high sodium concentrations in porous material, whereas the light areas, which were not penetrated by sodium, are dense material. The dark lines indicate sodium in cracks and cavities. As may be seen, the core of the block is more porous than the periphery. Cracks did not propagate through the dense material. In general, the BeO blocks withstood the operation of the ARE reasonably well.

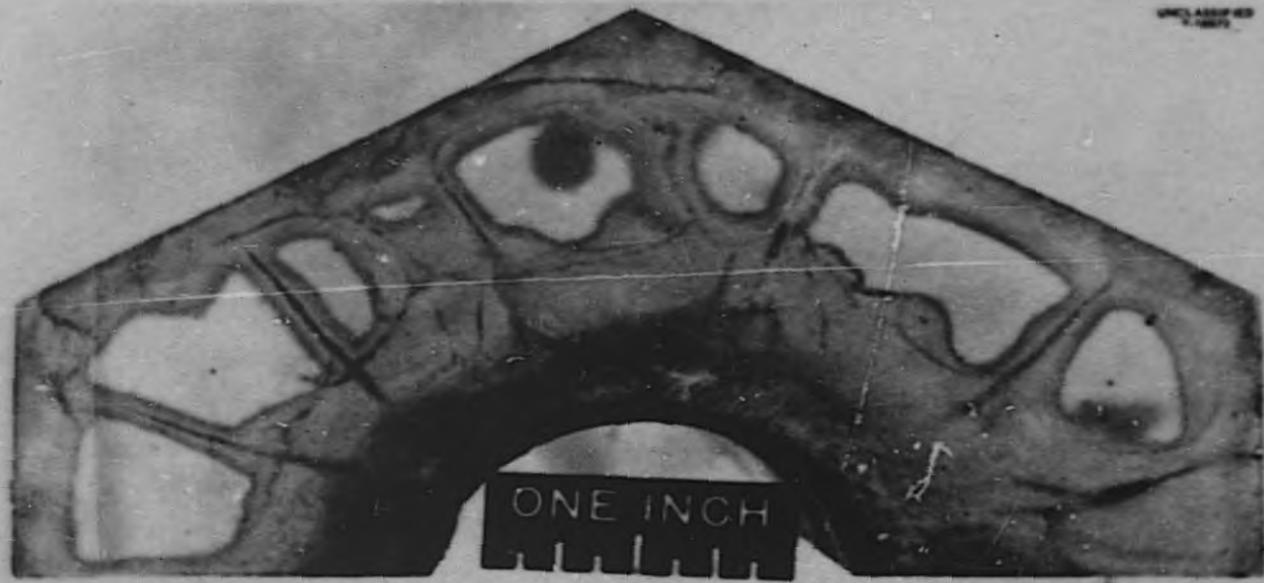
Fig. 17. Transverse Section of Block Shown in Fig. 15.

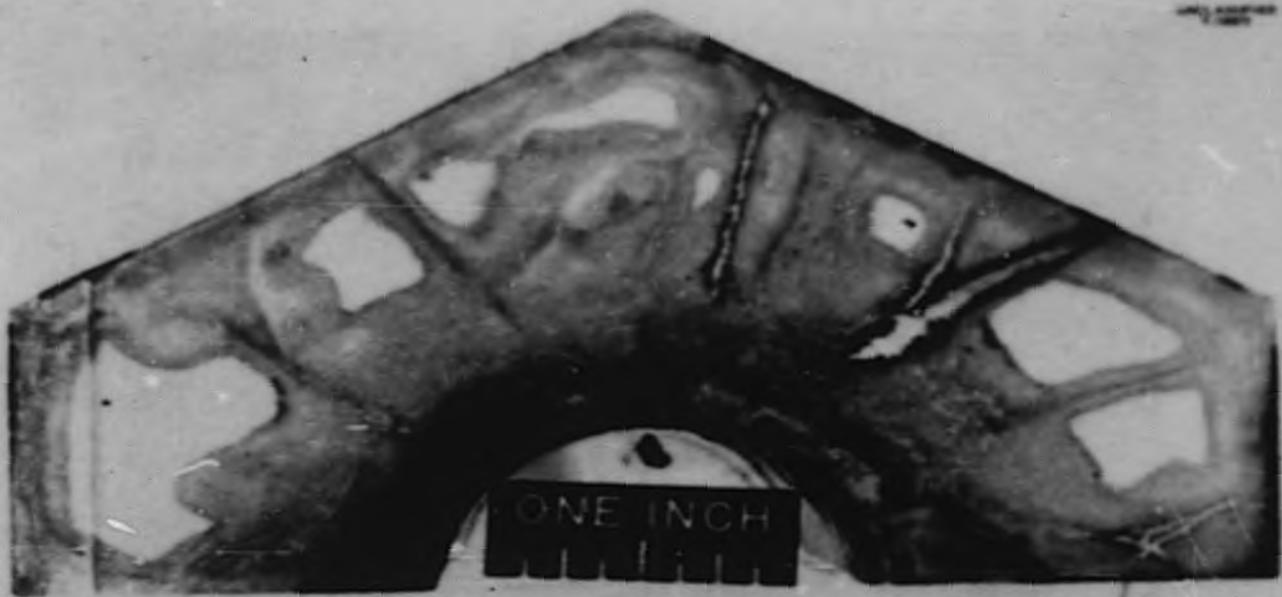
Fig. 18. Another Transverse Section of Block Shown in Fig. 15.

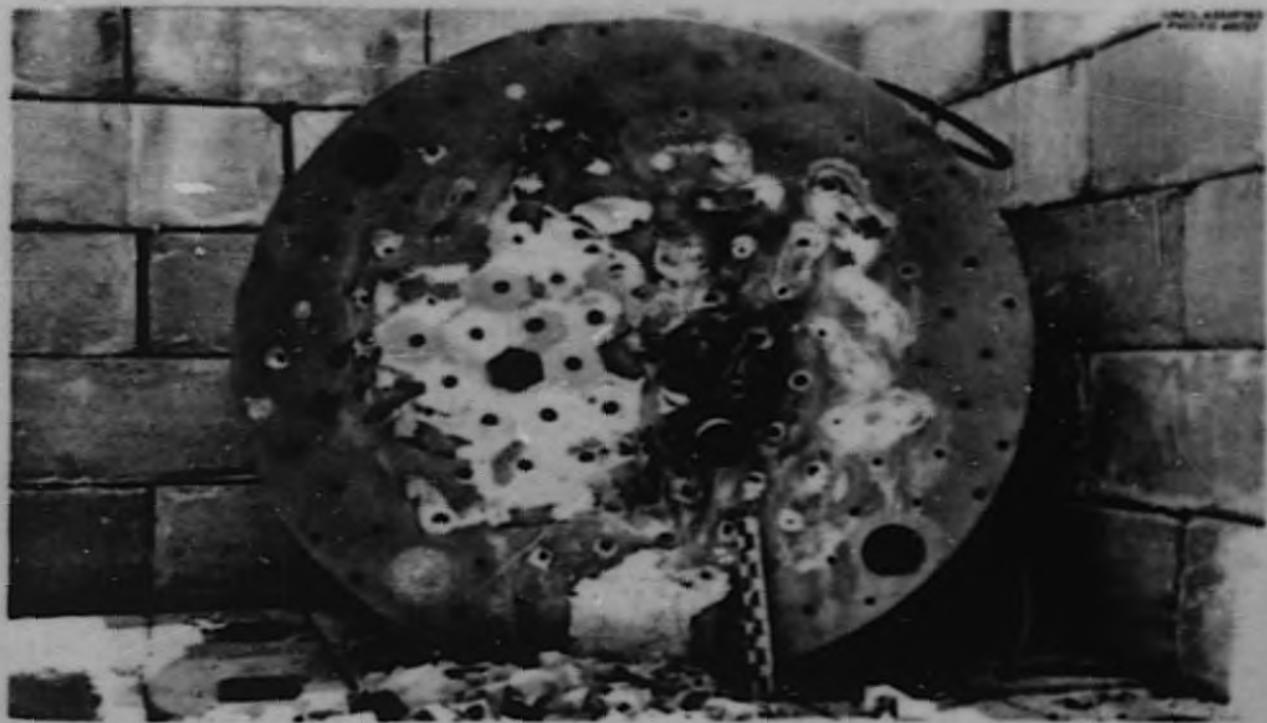
The remainder of the blocks were stored in place in the reactor. When final disposition of the reactor was to be made in October 1957, it was found that, as a result of atmospheric action on the adsorbed sodium, the blocks had deteriorated to the point where they had lost their structural strength. Since the blocks could serve no further useful purpose, they were buried along with the reactor. The results of attempts to remove blocks for examination prior to the disposal decision are shown in Figs. 19 and 20, and the reactor may be seen in Figs. 21, 22, and 23 just prior to burial.

Fig. 19. Condition of Reactor when Removed from Storage in October 1957. The broken pieces of BeO blocks on the floor resulted from attempts to remove blocks for examination.

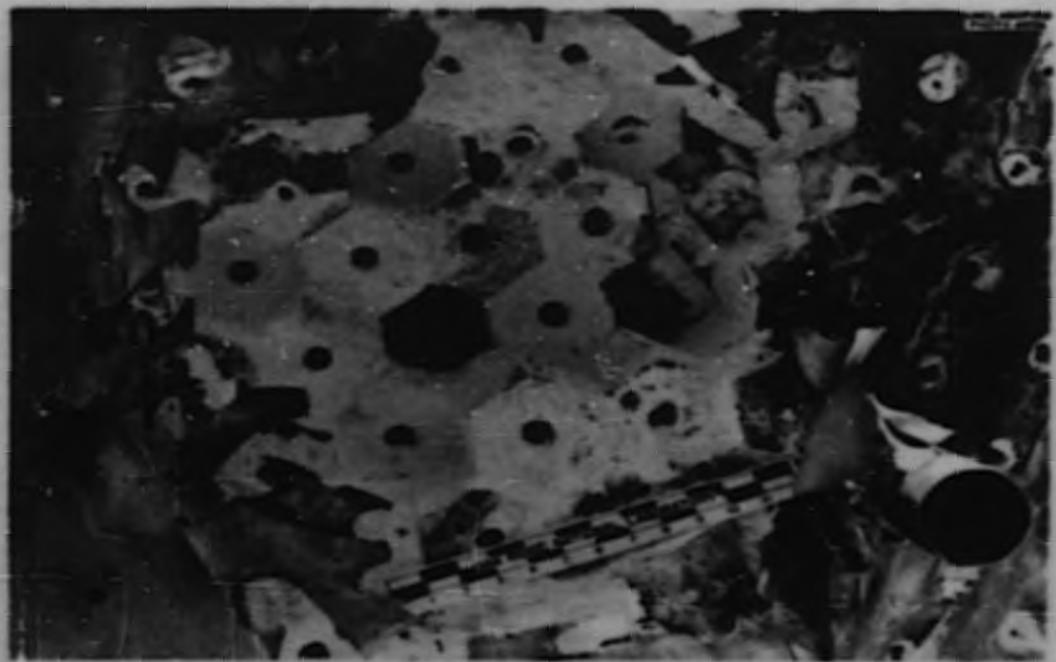
Fig. 20. View of Deteriorated BeO Blocks in Reactor.

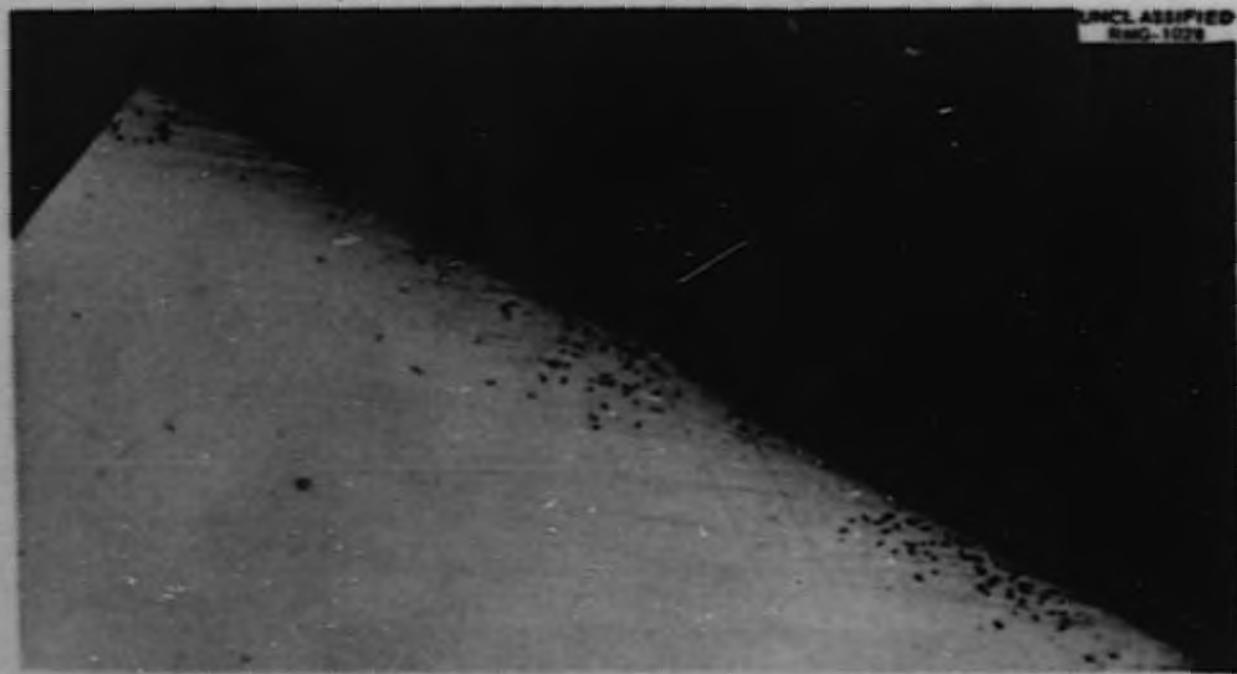
Specimen F1 from fuel supply line 120 was found⁴ to have general surface attack to a depth of 1 to 2 mils (Fig. 24), and the surface was rough, as shown in Figs. 25 and 26. Stereophotographs were taken of the seats and plungers from valves U-1 and U-23 (specimens F11, F12, S4, and S5).⁵ As shown in Figs. 27 and 28, there were dark deposits on the Stellite seat and plunger from valve U-1. The Stellite plunger from valve U-23 was scored, as shown in Fig. 29; the seat of valve U-23 is shown in Fig. 30.

Fig. 24. Inner Surface of Fuel Supply Line 120 (Specimen F1). Unetched. 200X.

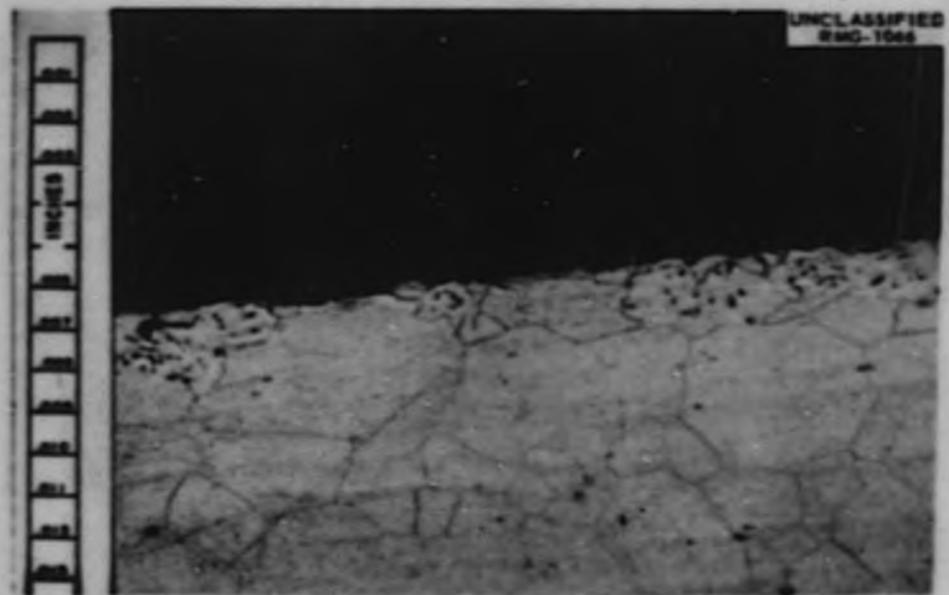
Fig. 25. Etched Section from Specimen F1. Etchant: electrolytic oxalic acid (10%). 250X.

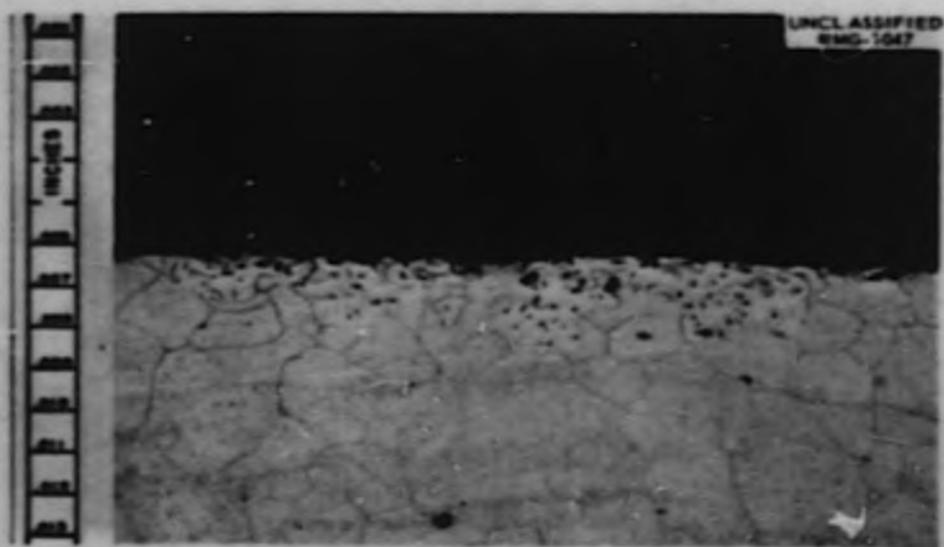
Fig. 26. Another Section from Specimen F1. Etchant: electrolytic oxalic acid (10%). 250X.

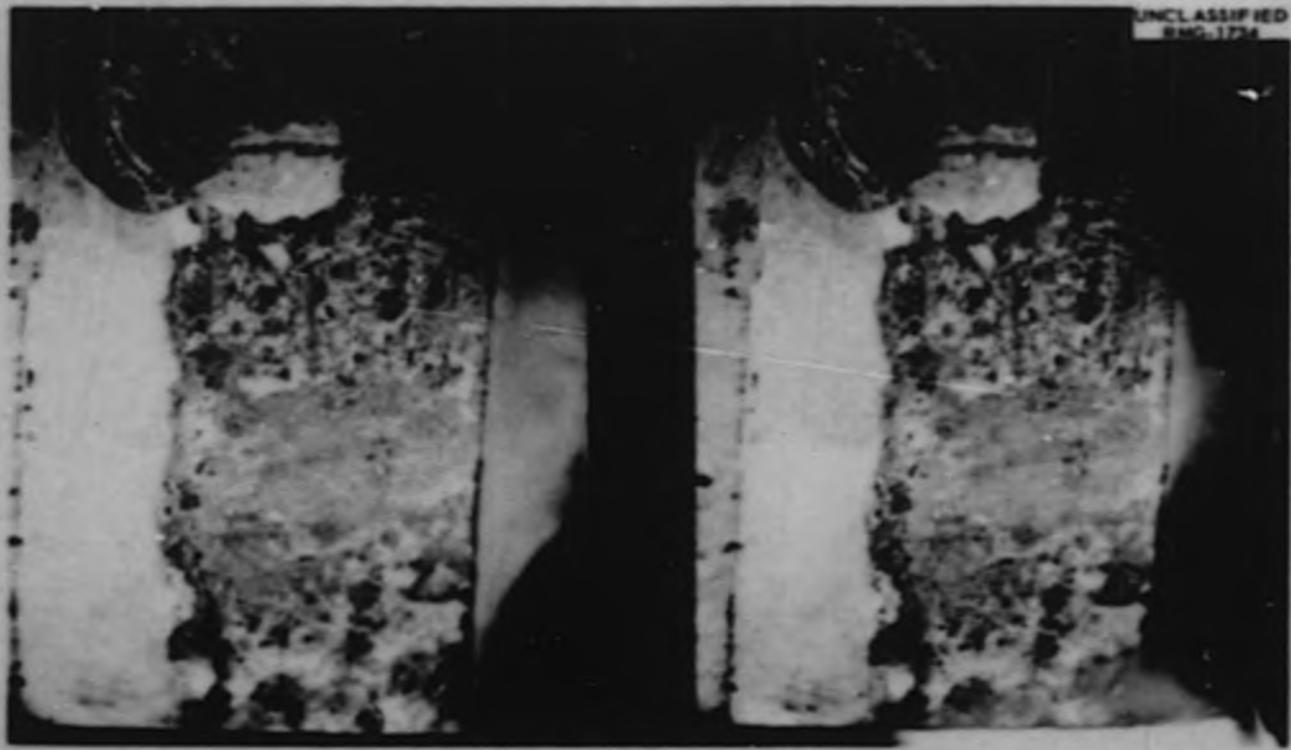
Fig. 27. Plunger from Valve U-1. 5X.

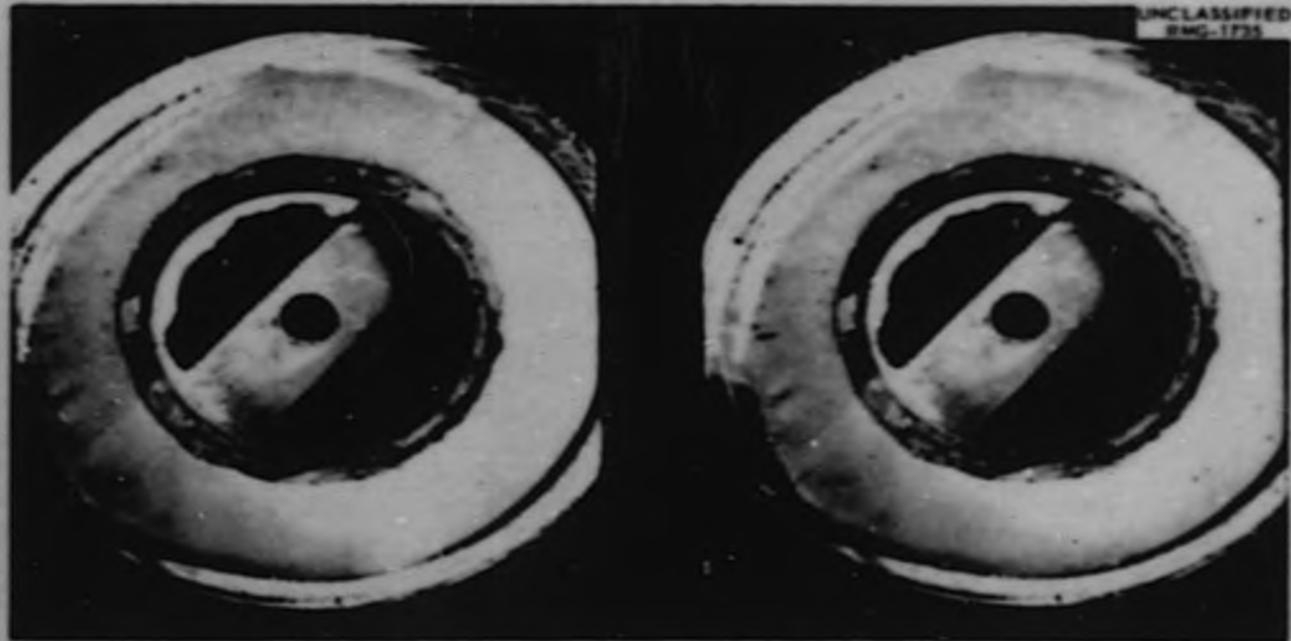
Fig. 28. Seat from Valve U-1. 5X.

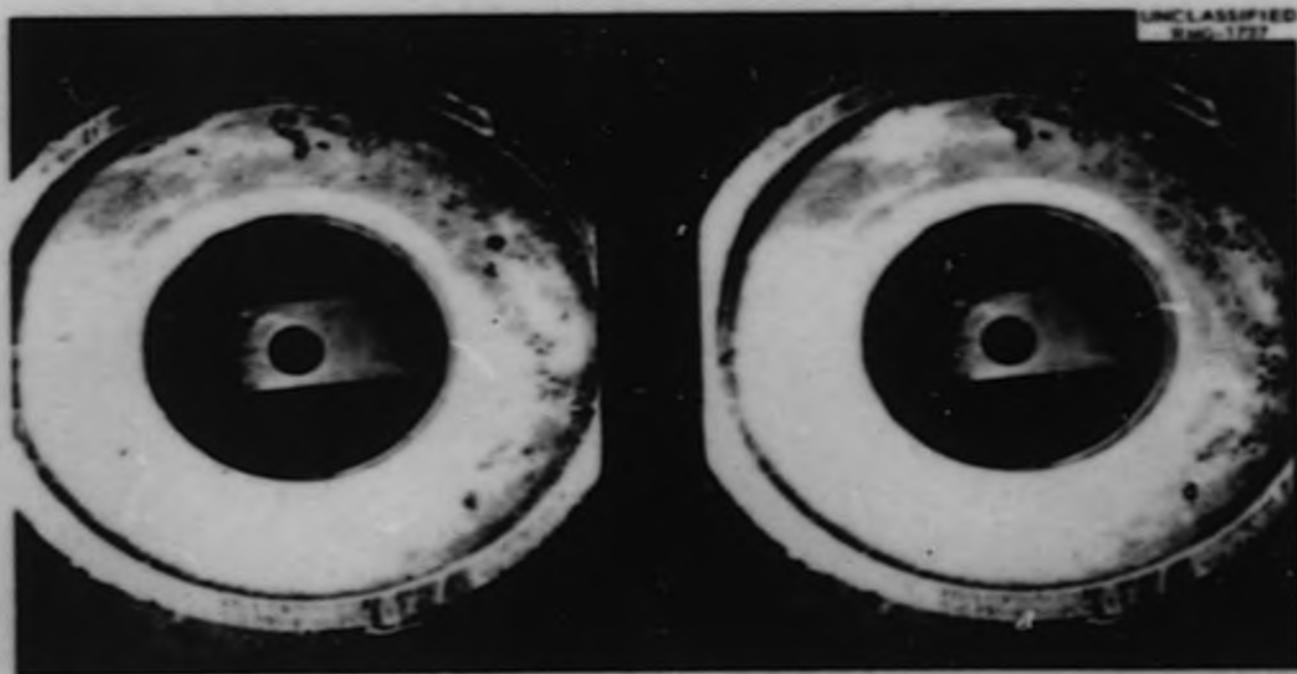
Fig. 30. Seat from Valve U-23. $\frac{1}{2}$ X.

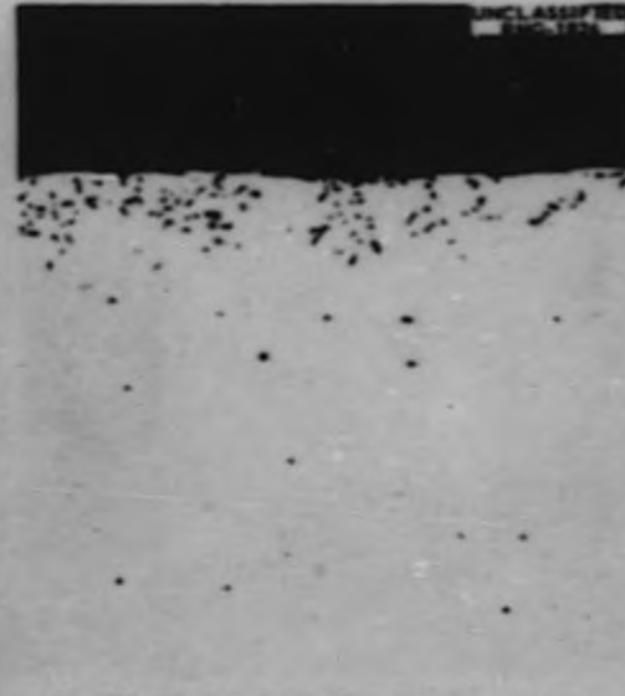
Fig. 32. Section from a Serpentine Bend in a Fuel Tube in the ARE Core, Specimen 87. As polished. 250X. (Secret with caption)

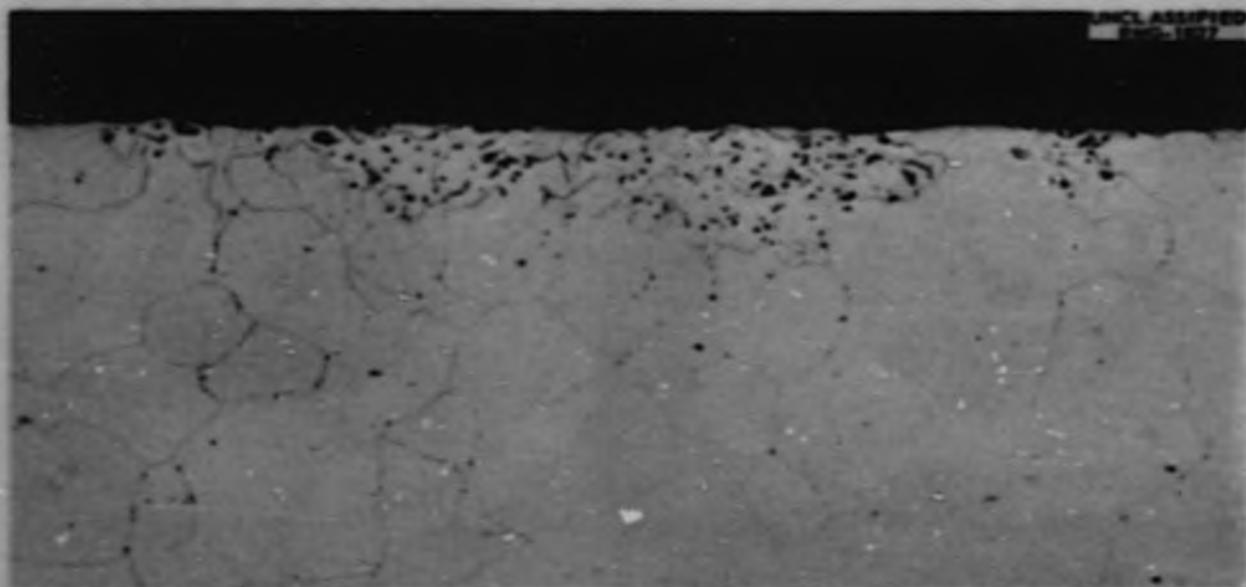
Fig. 33. Section Shown in Fig. 32 After Etching. 250X. (Secret with caption)

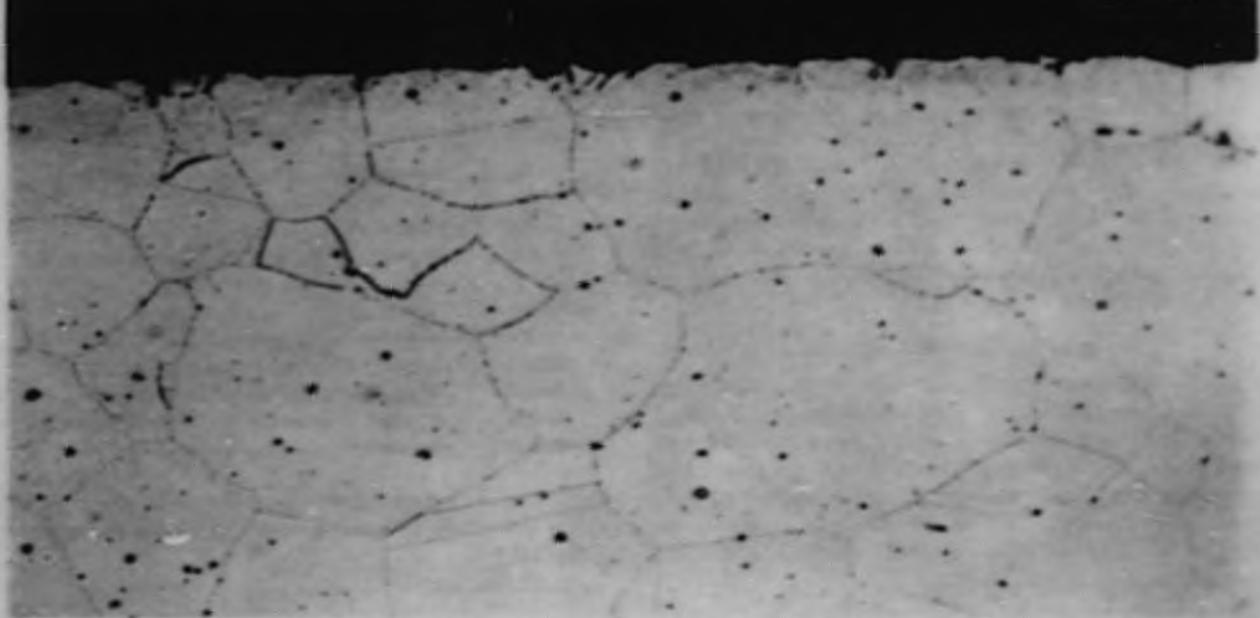
Specimen R3, which was also taken from a serpentine band in a fuel tube in the center of the core, also showed some subsurface void formation; however, the density and depth of penetration were not so great as for specimen R7. The areas of attack were localized, and some areas of the wall showed no attack, as may be seen in Figs. 35 and 36. No deposit similar to that found on specimen R7 was noted on the exterior wall.

Fig. 35. Section of Specimen R3 Taken from Serpentinel Bend in Fuel Tube in ARE Core. Etched. 250X. (Secret with caption)

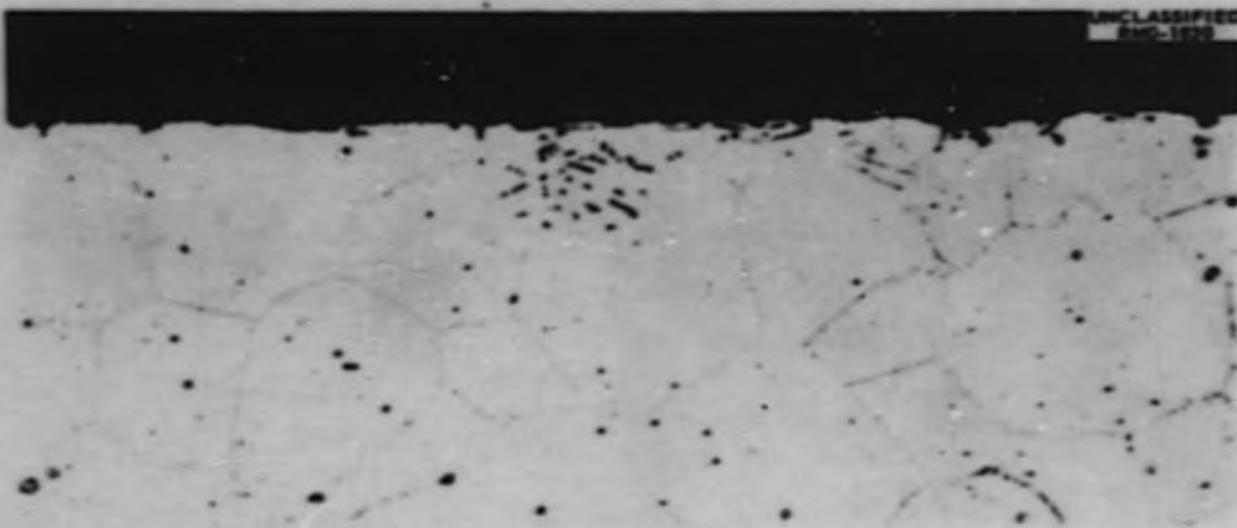
Fig. 36. Another Section of Specimen Shown in Fig. 35. Etched. 250X. (See note with caption)
