ORNL-1868

DISASSEMBLY AND POSTOPERATIVE EXAMINATION
OF THE AIRCRAFT REACTOR EXPERIMENT

OAK RIDGE NATIONAL LABORATORY
Oak Ridge, Tennessee
operated by
UNION CARBIDE CORPORATION
for the
U.S. ATOMIC ENERGY COMMISSION

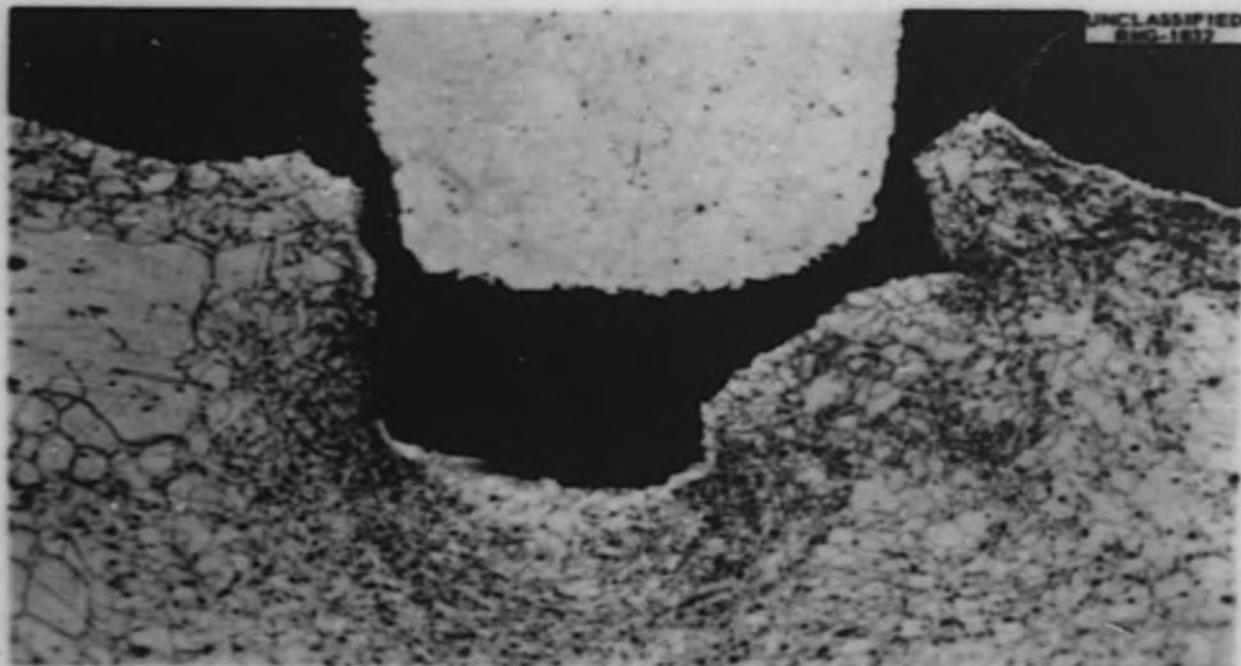
Specimen F5, which was taken from the inlet of a fuel-to-helium heat exchanger, was cast in epoxy resin so that the fins on the tube would not be damaged during cutting. The fin-to-tube wall junction is shown in Fig. 37. (In the ARE fuel-to-helium heat exchangers the fins were helical strips placed in grooves on the tubes. The strips were not brazed to the tubes.) The interior wall of the tube showed subsurface voids to a depth of 4 mils, as shown in Figs. 38 and 39. Specimen F9, which was taken from the middle of a bend in a fuel-to-helium heat exchanger, also showed subsurface voids to a depth of 4 mils, as shown in Figs. 40 and 41. Specimen S6, the bottom bellows from sodium valve U-23, was also cast in epoxy resin. No cracks in the bellows folds were found, and only a slight roughening of the inside surface was noted, as shown in Fig. 42.

Fig. 37. Section of Specimen P3 Showing Fin-to-Tube Wall Junction in ARE Two-to-Medium Heat Exchanger. Fins were wound helically in grooves and were not brazed to the tubes. Etched. 100X. (Secret with caption)

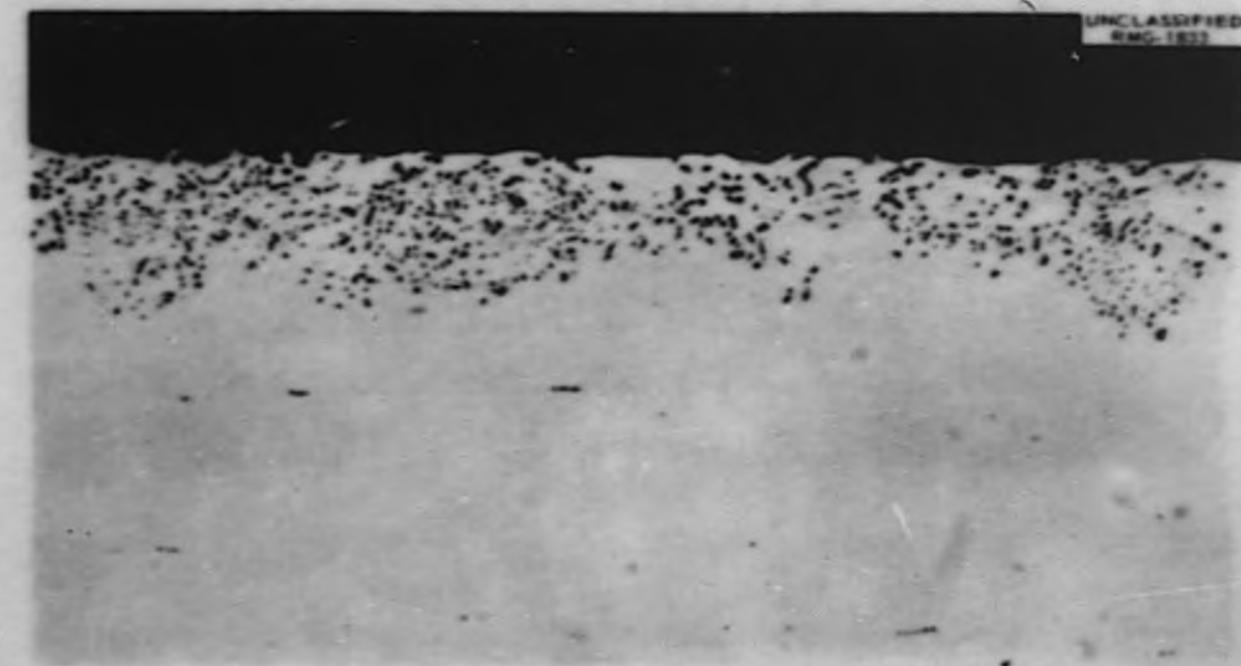
Fig. 38. Interior Wall of Tube Shown in Fig. 37. As polished. 250X. (Secret with caption)

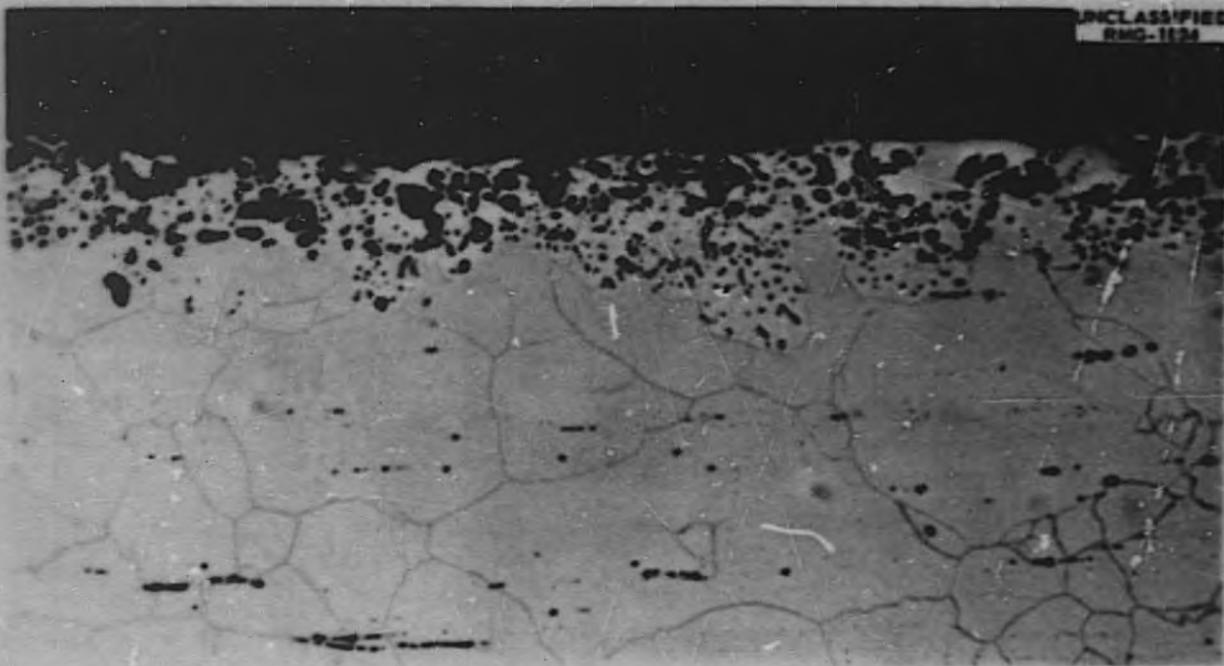
Fig. 39. Section Shown in Fig. 38 After Etching. 250X. (Secret with caption)

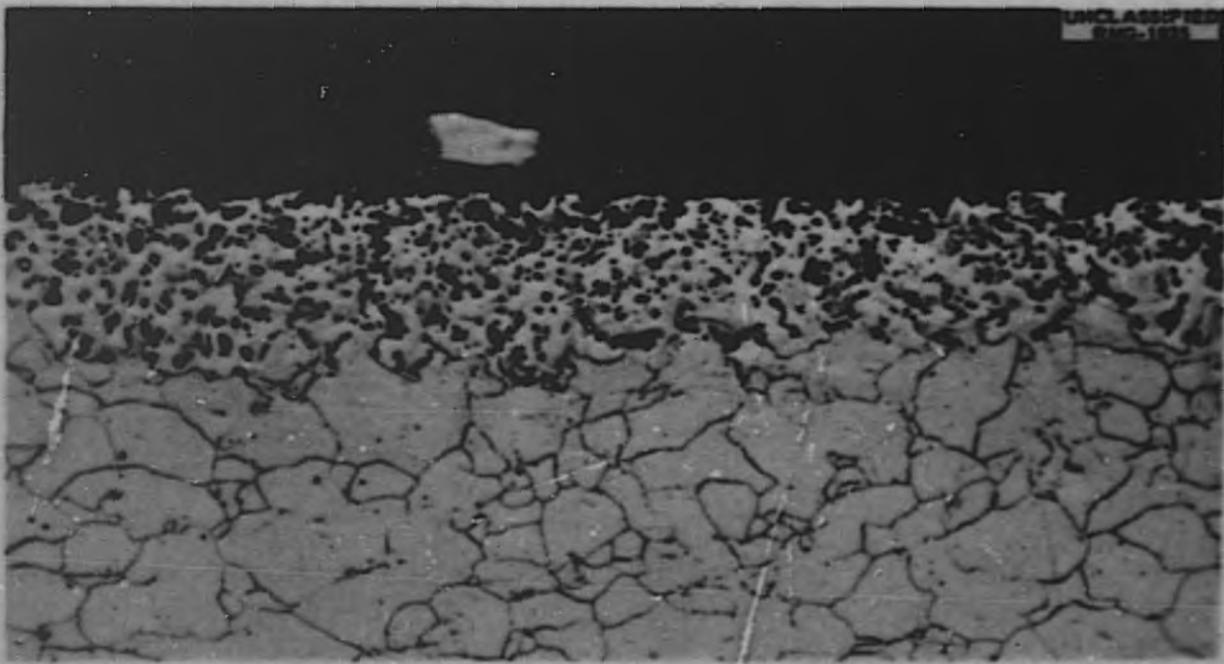
Fig. 40. Section of Specimen P9 Taken from Middle of a Bond in an ARE Fuel-to-Helium Heat Exchanger. As polished. 250X. (Secret with caption)

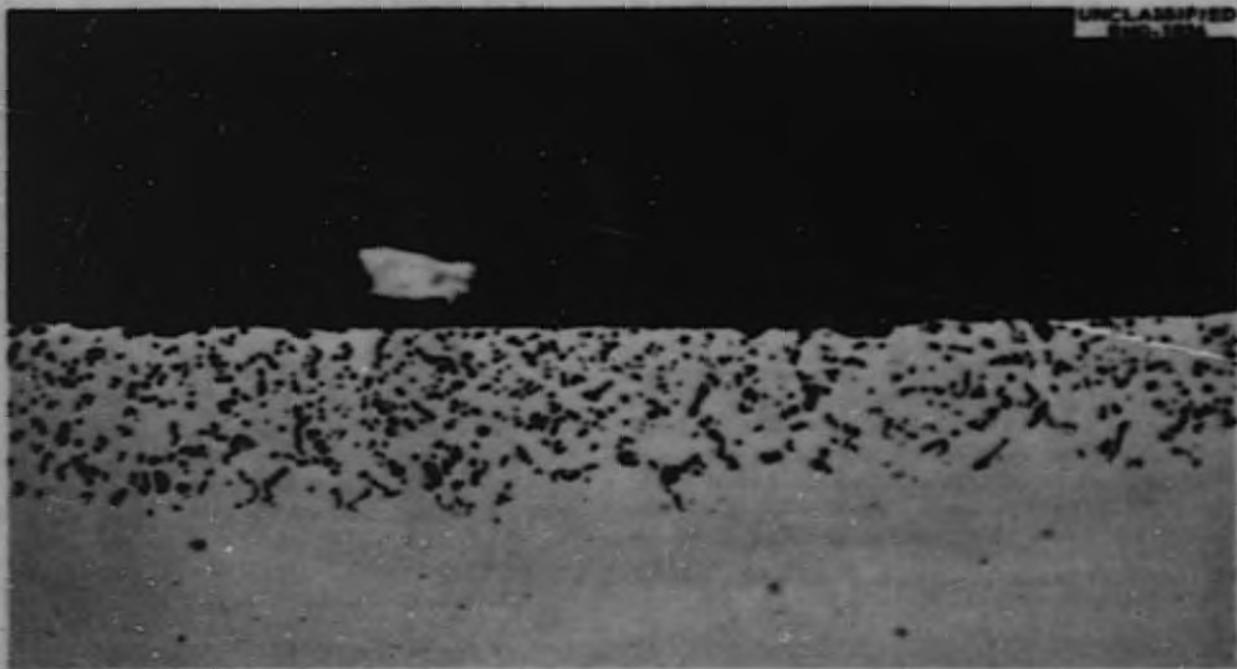
Fig. 41. Section Shown in Fig. 40 After Etching. 250X. (Soarer with caption)

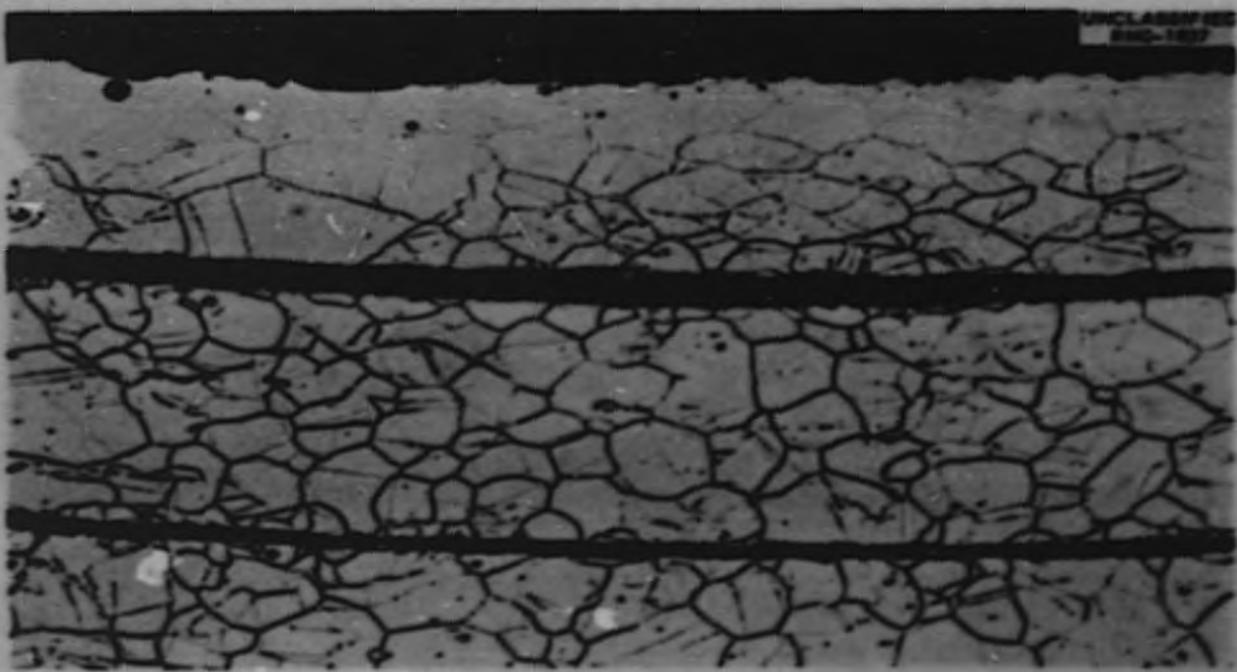
Fig. 42. Section of Specimen 56 Taken from the Bottom Bellows of Sodium Valve U-23. Etched. 250X. (Soarer with caption)

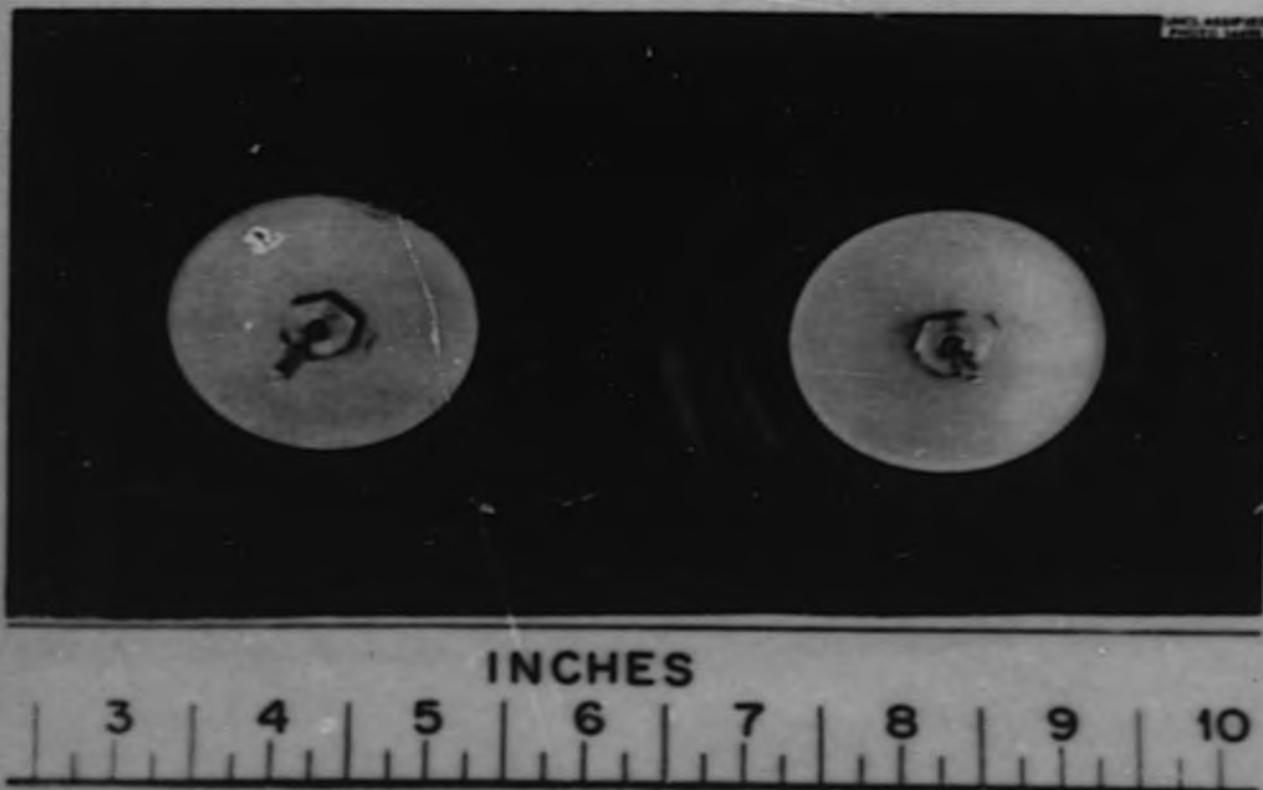
The main and standby fuel pump pressure transmitters (PXT-6 and PXT-7) were examined for calibration shifts, zero shift, radiation damage, and mechanical damage. The standby pump unit was in excellent condition, but the main pump unit was inoperable because of a failure of the glass-cloth pressure-sensing diaphragm, as shown in Fig. 43. Replacement of the diaphragm showed the unit to be otherwise undamaged. The ruptured diaphragm was not the source of the initial fission-gas leak in the ARE, inasmuch as several checks of the unit at the time the heat exchanger pits were closed indicated that the diaphragm was satisfactory. It is believed, however, that the subsequent rupture of the diaphragm was the source of the leak that developed after shutdown of the fuel system. As stated above, the fission-gas leaks that existed prior to shutdown

Fig. 43. Main and Standby Fuel Pump Pressure Transmitter Diaphragms. The ruptured diaphragm was removed from the main fuel pump pressure transmitter.

were probably due to one or more of several potential leaks around the fuel pump.
